PEABODY AVENUE
Pimlico
London SW1

An archaeological Standing Building Report

January 2009

Site Code: PBA08

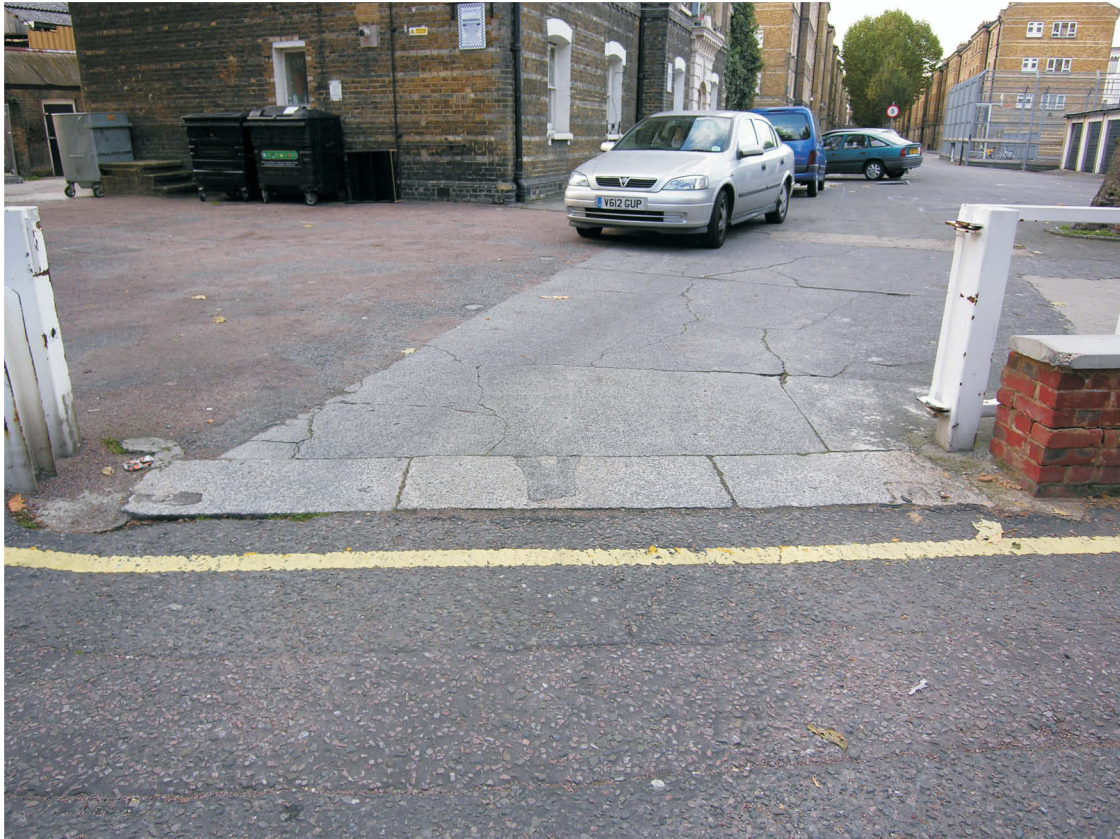
Fig 8 Looking north-west at the paving where the south end of Peabody Avenue meets Turpentine Lane. Note the scars of a former double-leaf gate (posts on either side and central scar where the two leaves of the gate would meet when closed).

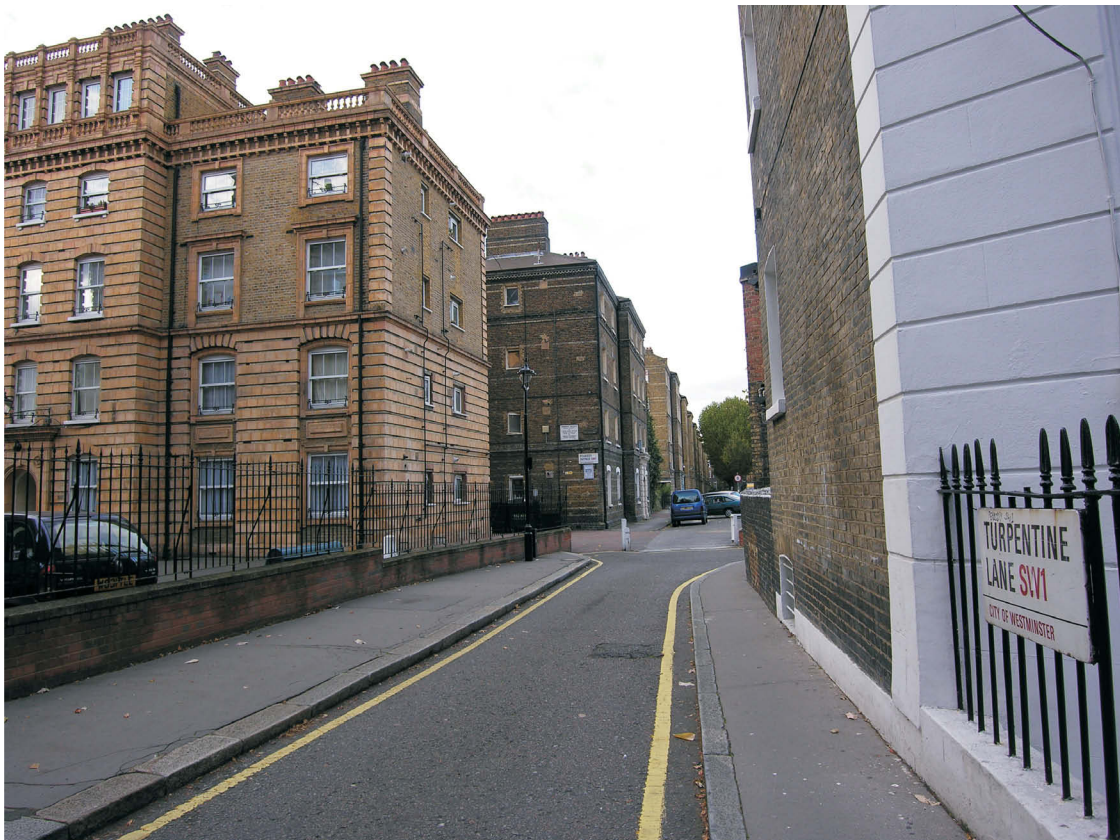
Fig 9 Looking north, up Turpentine Lane, toward Peabody Avenue. Block 3 is the first building on the left and Block Z is the second (beyond Block 3).

Figures 8, 9 and 10 show the southern end of Peabody Avenue at its southern junction with Turpentine Lane. These images, together with Figure 11, show how Peabody Avenue is walled-in, for most of its length, by the tall tenement buildings on either side. The overall impression is of a canyon of brick, stone and paving in which the central row of trees provides a striking element of greenery. The structures lining the avenue are notable for their geometric regularity and rectilinearity. A granite sill at the southern end of the avenue bears the scars of the former double-leaf gate fixings (Fig 8). It is possible that this gate was tied to brick piers similar to those at the north side of the avenue, although no such piers are now present.

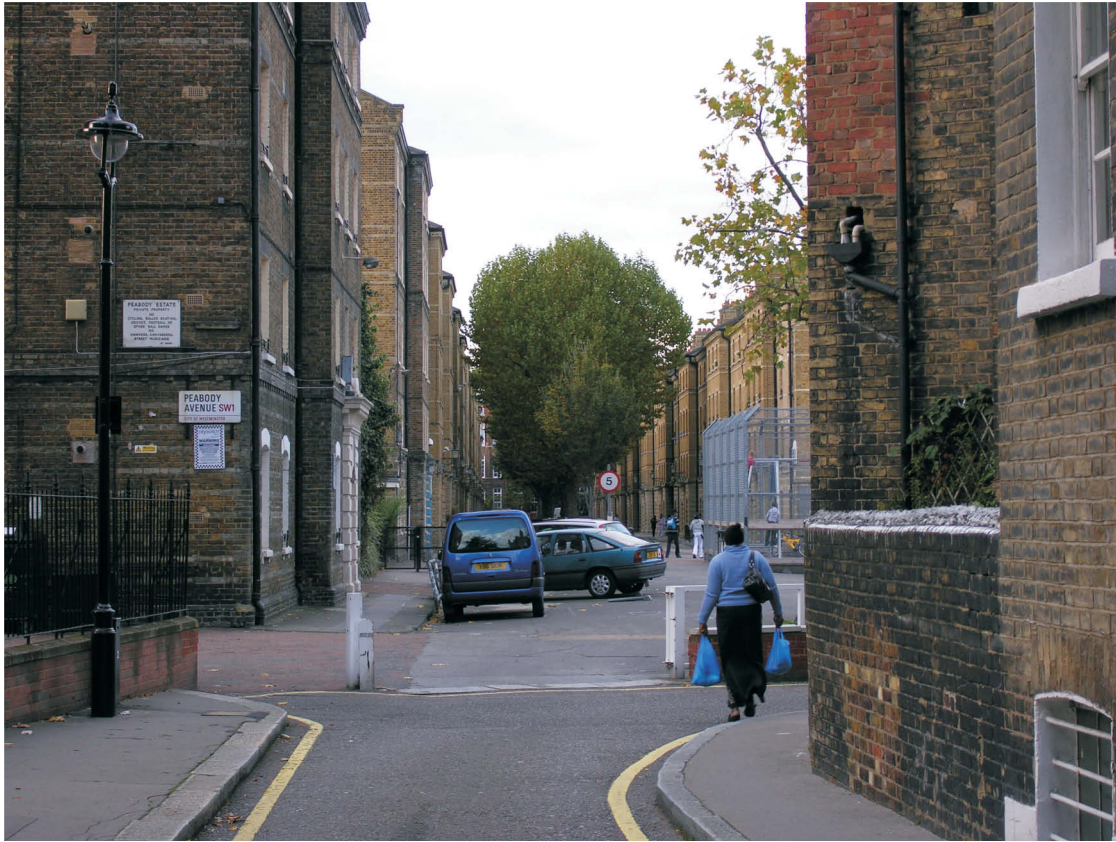
Fig 10 Looking north from Turpentine Lane toward the southern junction of Peabody Avenue. Block Z is on the left (with signs for the 'Peabody Estate' and Peabody Avenue). In the distance, Peabody Avenue runs northerly between the long ranges of the estate

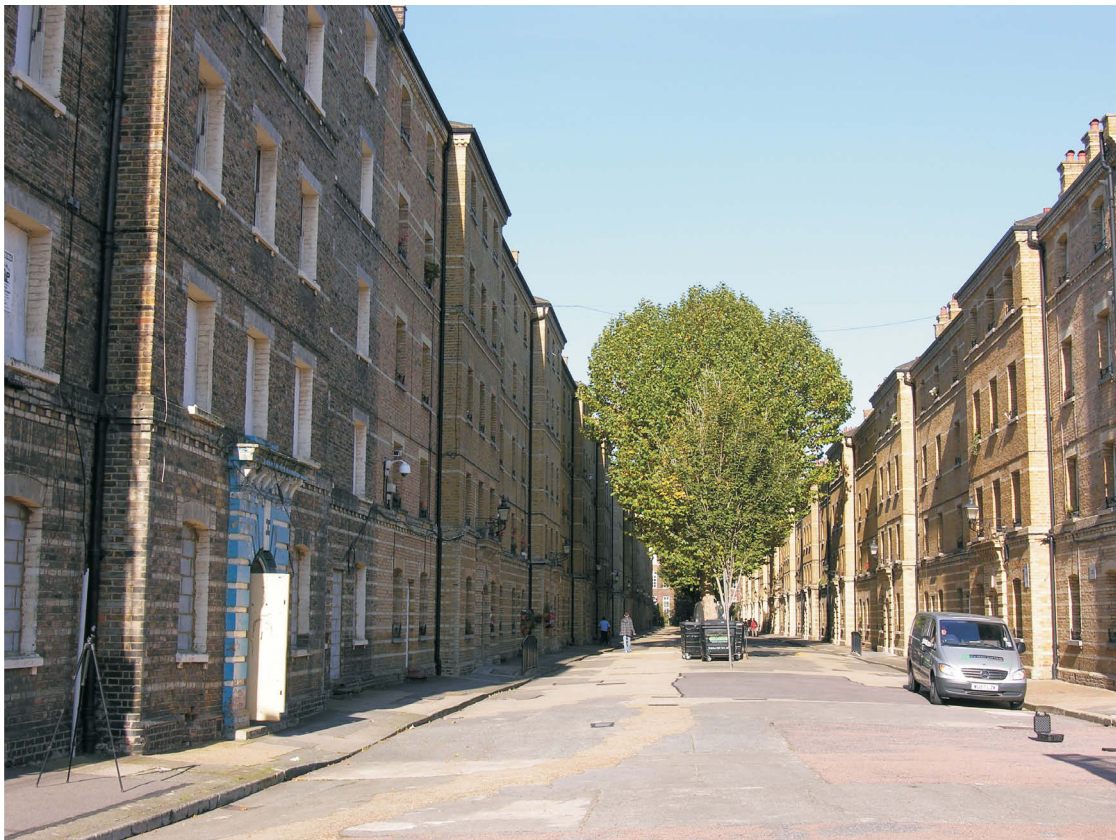
Fig 11 Looking north along Peabody Avenue, with Block X on the left side of the view

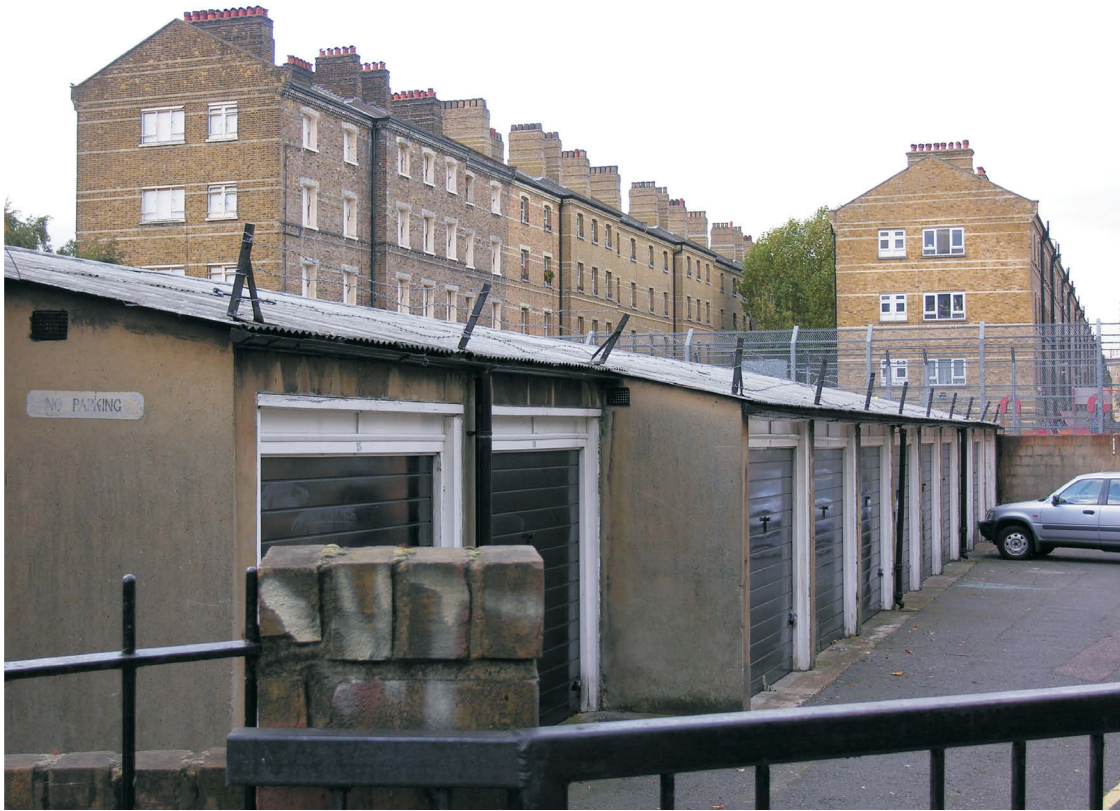
Fig 12 Looking north-west toward the Pimlico Estate from Lupus Street. Block X is the leftmost tenement in the view

Figure 12 provides a view of the garages and fenced-in ball court and play area where Blocks K, L and M formerly stood, in the south-east corner of the estate.

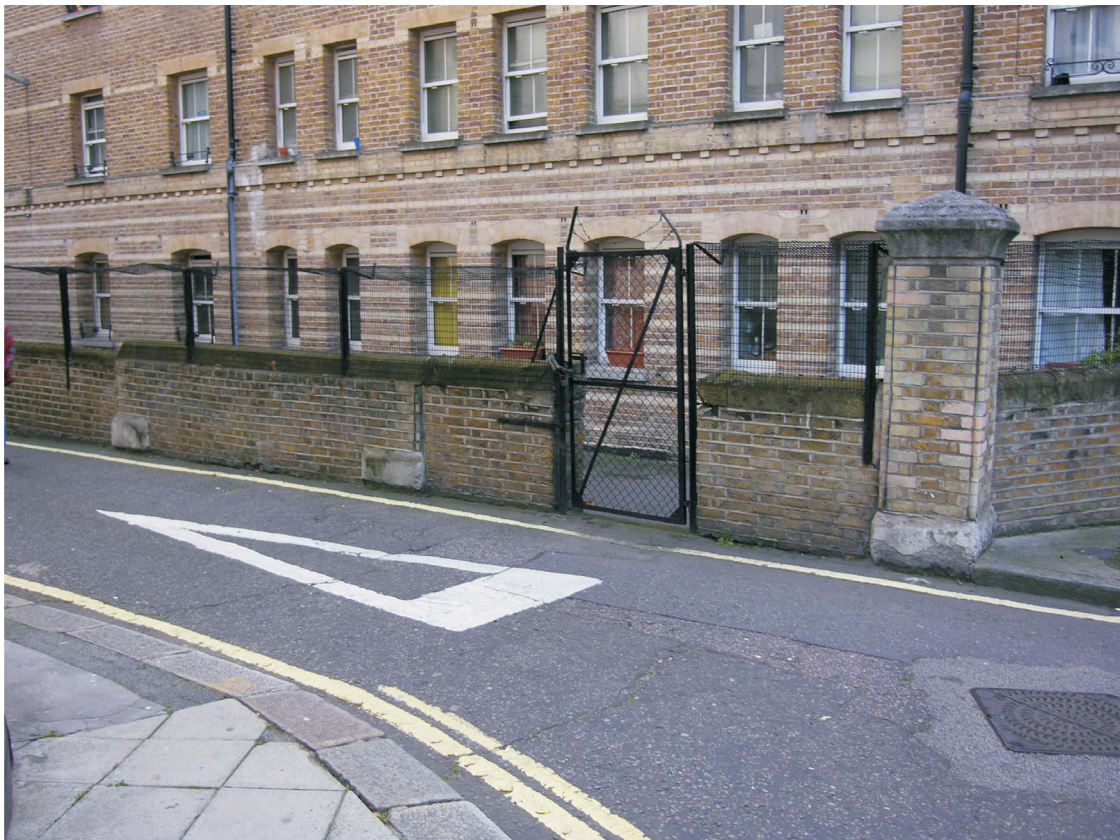
Fig 13 Looking south-west across Turpentine Lane, just to the south of the Pimlico Estate's northern gate, with the long eastern range of the estate in the background. The brick wall of the estate runs along the far side of Turpentine Lane in this view

Figures 13, 14 and 15 show the low brick wall at the north-eastern boundary of the estate together with three taller brick piers, two of which form the posts of the estate's northern gate. The piers and the low wall appear to be part of the original estate design, but the wall appears to have been subsequently altered by the removal of the tops of additional piers to the south of the presently existing ones, as shown by the two pier bases on the left side of the view in Figure 13. In addition, the coping of the low wall still encases the cut-off remnants of iron fencing that must once have stood on top of the wall. The brick piers have stone bases and moulded stone caps, and the brick corners of the piers each feature a vertical bead that echoes the decorative brickwork around the arched, main doorway of each Peabody Avenue block. As with the block buildings, the piers feature a decorative arrangement of differently-coloured bricks (ie, different shades of yellow brick).

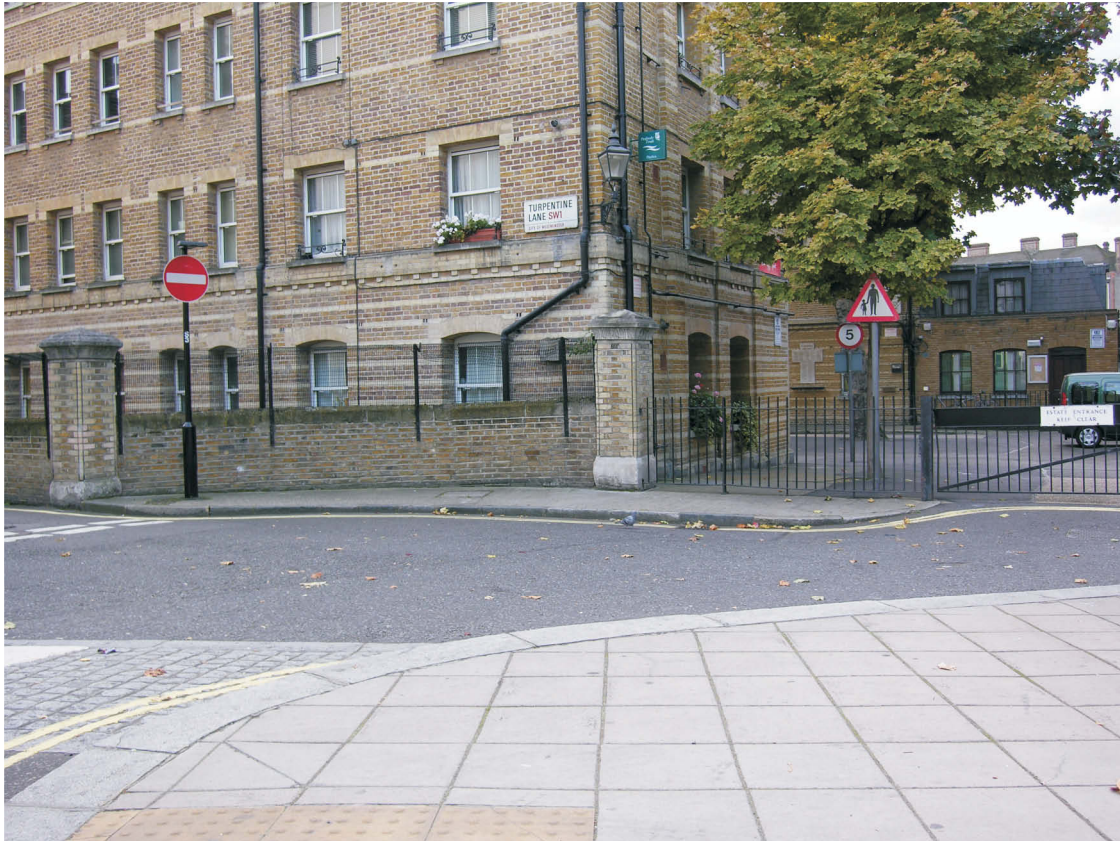
Fig 14 Looking south-west toward the northern extent of Turpentine Lane, with the northern gate of the Pimlico Estate on the right

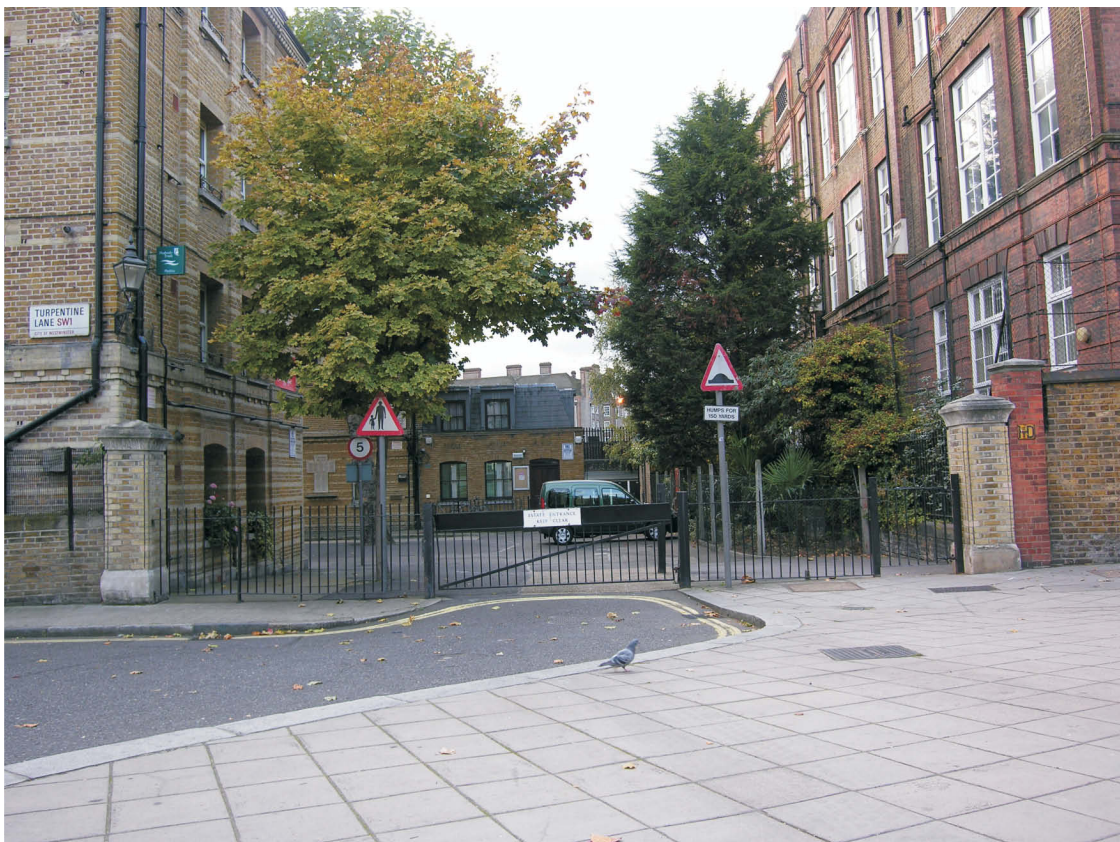
Fig 15 Looking west toward the northern gate of the Pimlico Estate in Turpentine Lane, with the present two-storey City Guardians' office building in the background (on the far side of Peabody Avenue)

In the background of Figure 15, the present City Guardians' (ie, Westminster street wardens) office can be seen projecting from the northern side of the western range of tenement buildings. The office building is a two-storey, yellow-brick (in stretcher bond) structure, the upper storey of which is formed by a three-sided, flat-topped mansard roof with flat-topped dormers set behind a low, brick parapet. The western elevation, fronting on Peabody Avenue, is divided into three bays. The southern and central bays have, on the ground floor, segmentally-arched windows, with dormer windows above (on the first floor). The northern bay has a segmentally-arched doorway on the ground floor, with no dormer above. As shown in Figure 16, the northern and eastern elevations do not have the same fenestration as the western elevation. Overall, the structure does not match the ornamentation scheme of the tenement blocks, and evidently post-dates the 1913 survey for the 1916 edition of the 1:2500 Ordnance Survey map (see Fig 6). While it is possible that the brick frontage of the building, with its segmental arches, is older than the present northern and western elevations, it is equally possible that it merely appears so – its higher visibility having led to an effort to better harmonise the façade with those of the tenement blocks. The entire City Guardians' office building may, in fact, date to the late 20th century.

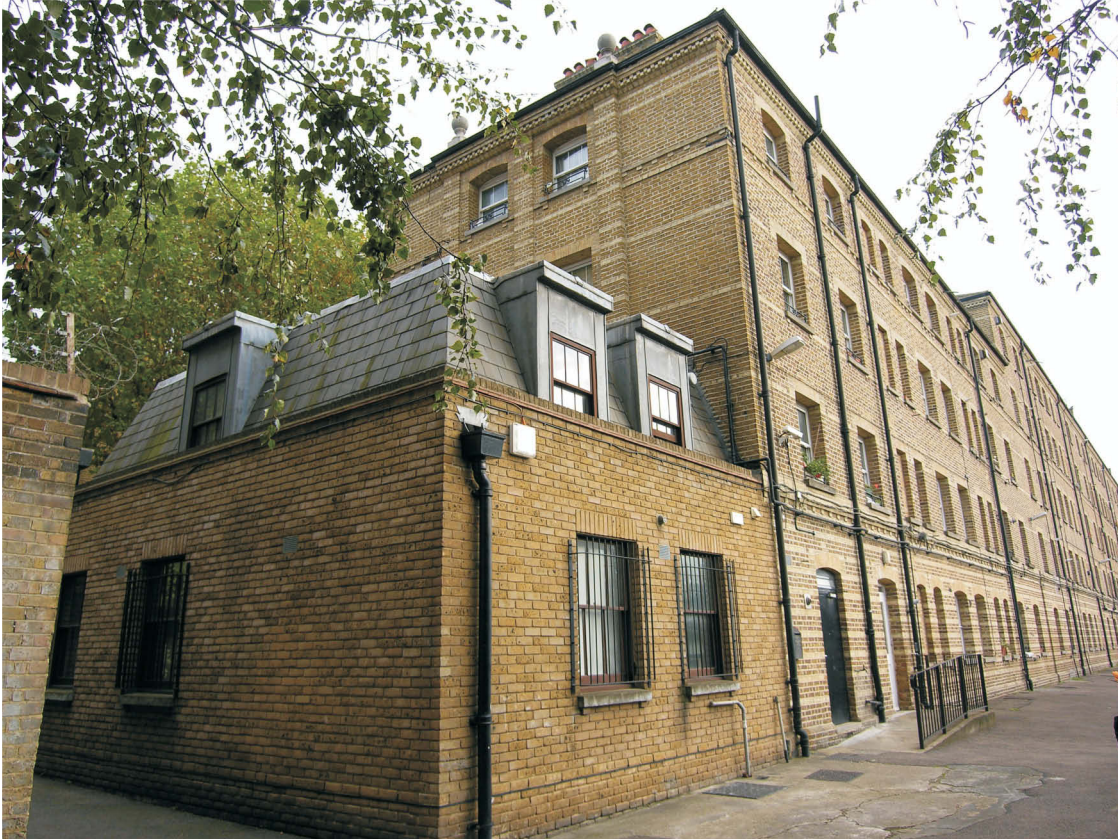
Fig 16 Looking south-east from the north end of the alley behind the western range of the Pimlico Estate. The present City Guardian's office is in the centre of the view, with the northern elevation of Block N above it. The backs (western elevations) of the western range extend southward in the view.

An alley runs along the western edge of the Pimlico Estate, parallel to Peabody Avenue, behind the western range of tenement blocks, as shown in Figures 16, 17 and 18. Several ranges of pram sheds have been built against the wall that separates the estate from the railway land to the west, as well as a 'bath house' (so called by Haworth Tompkins) which is outside of the areas of proposed redevelopment (see Fig 2). As with the boiler house, it has not been possible to provide independent verification for Haworth Tompkins' identification of a building as the bath house, but there does not appear to be any reason to doubt that they are correct. The brick boiler house is also adjacent to the western boundary wall, behind Block Z, as shown in Figure 19.

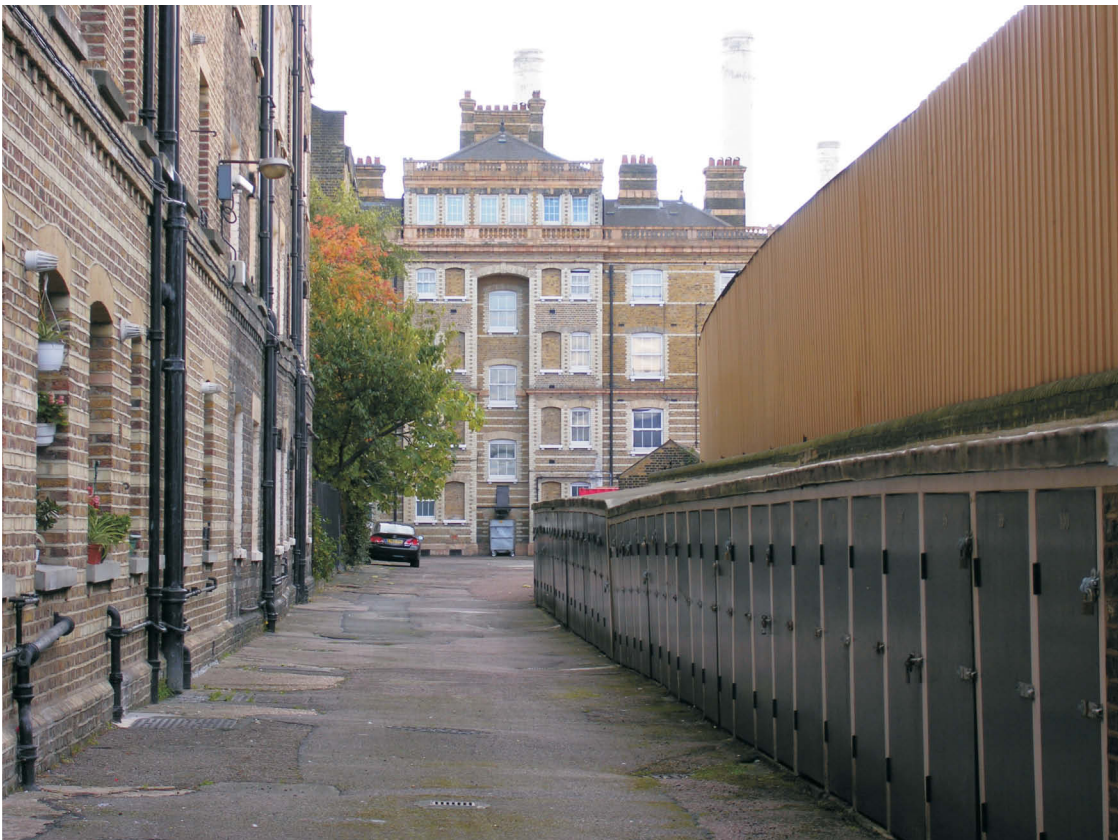
Fig 17 Looking south toward Block 3 from the alley behind the western range of the Pimlico Estate. Block X is the structure on the left in front of the trees.

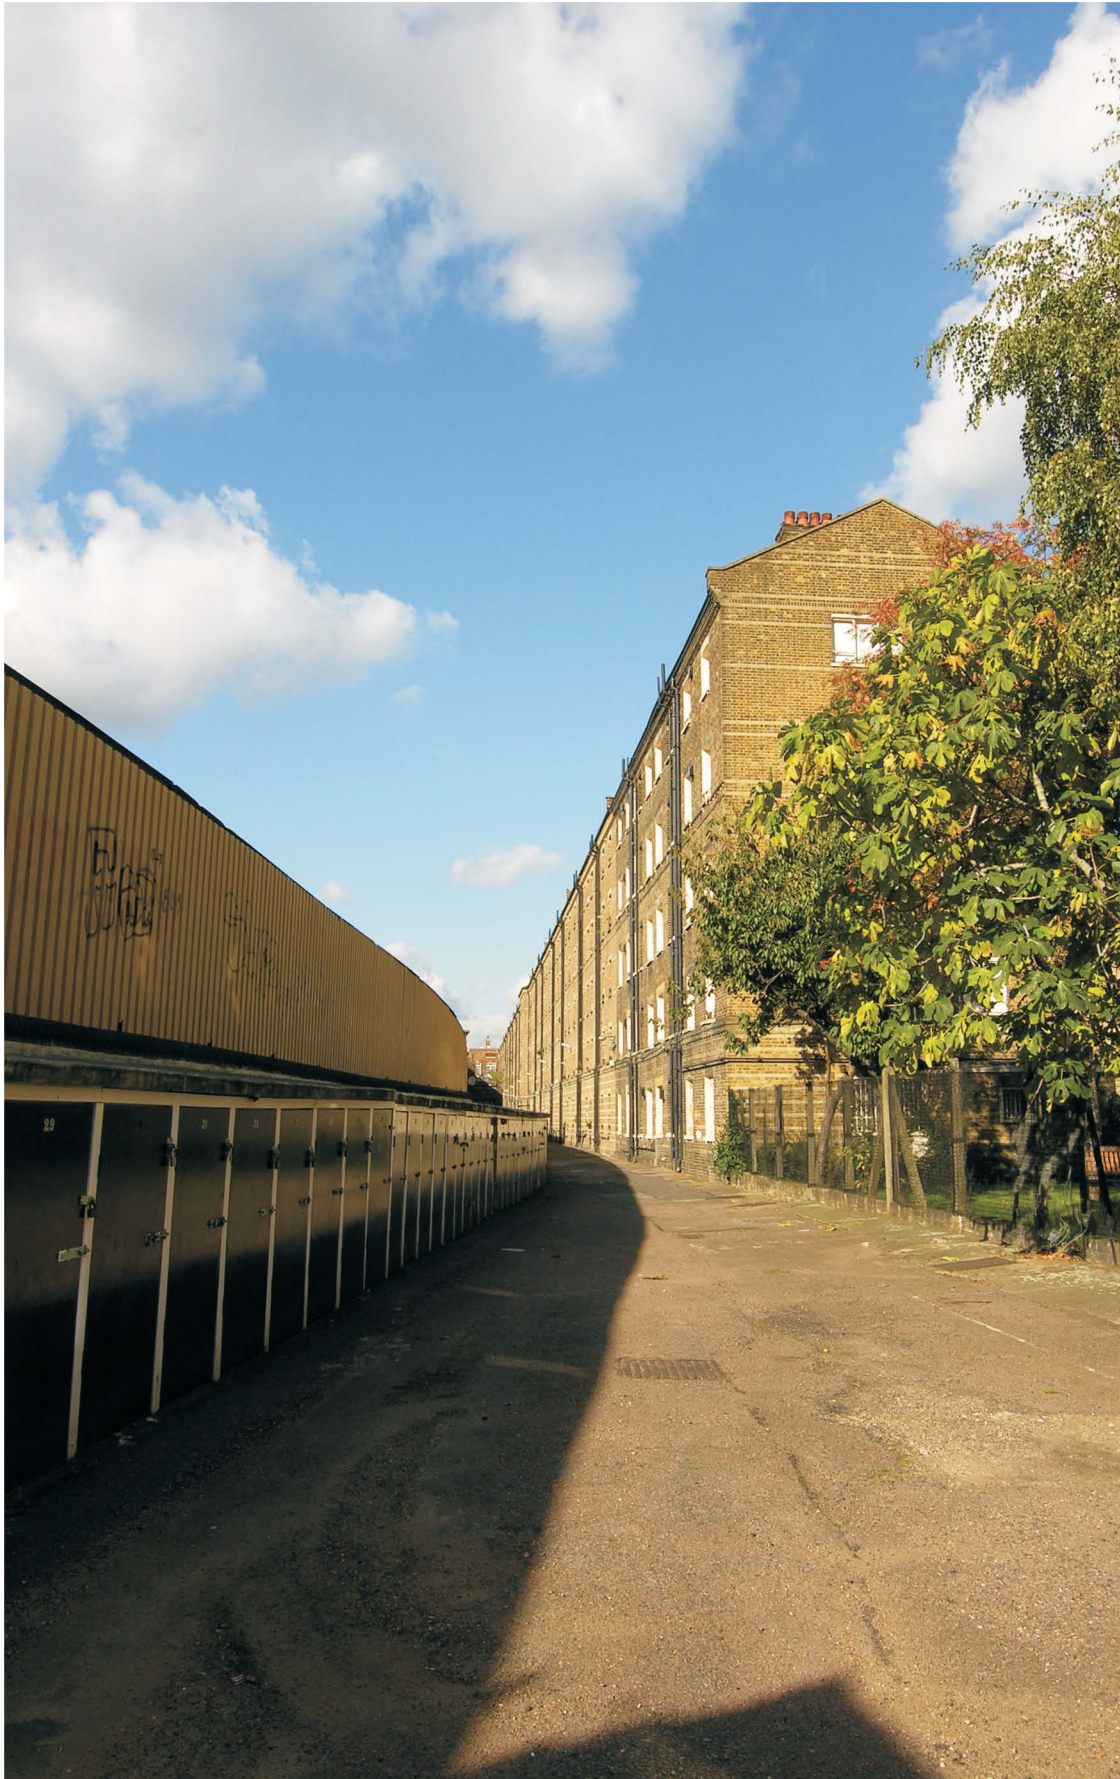
Fig 18 Looking north toward the alley behind the western range of the Pimlico Estate. Block X is the structure on the right beyond the trees.

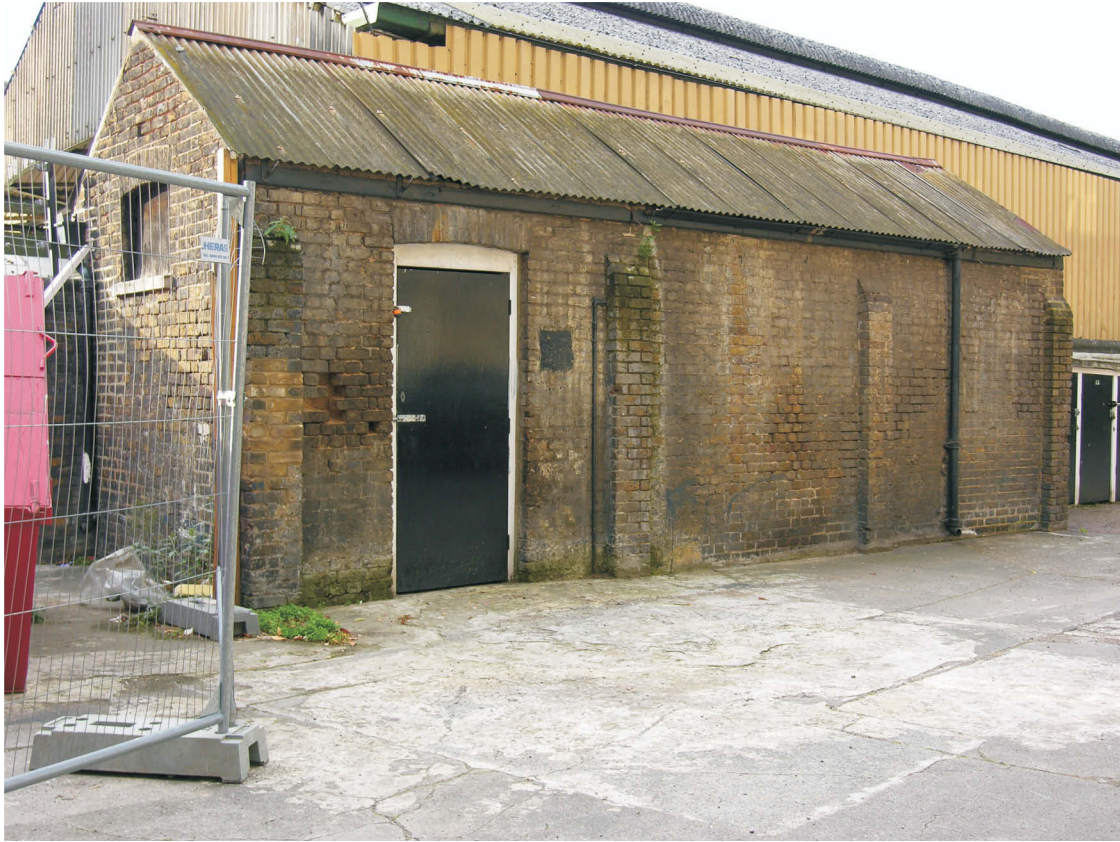
Fig 19 Looking north-west toward the small, brick boiler house at the western edge of the estate

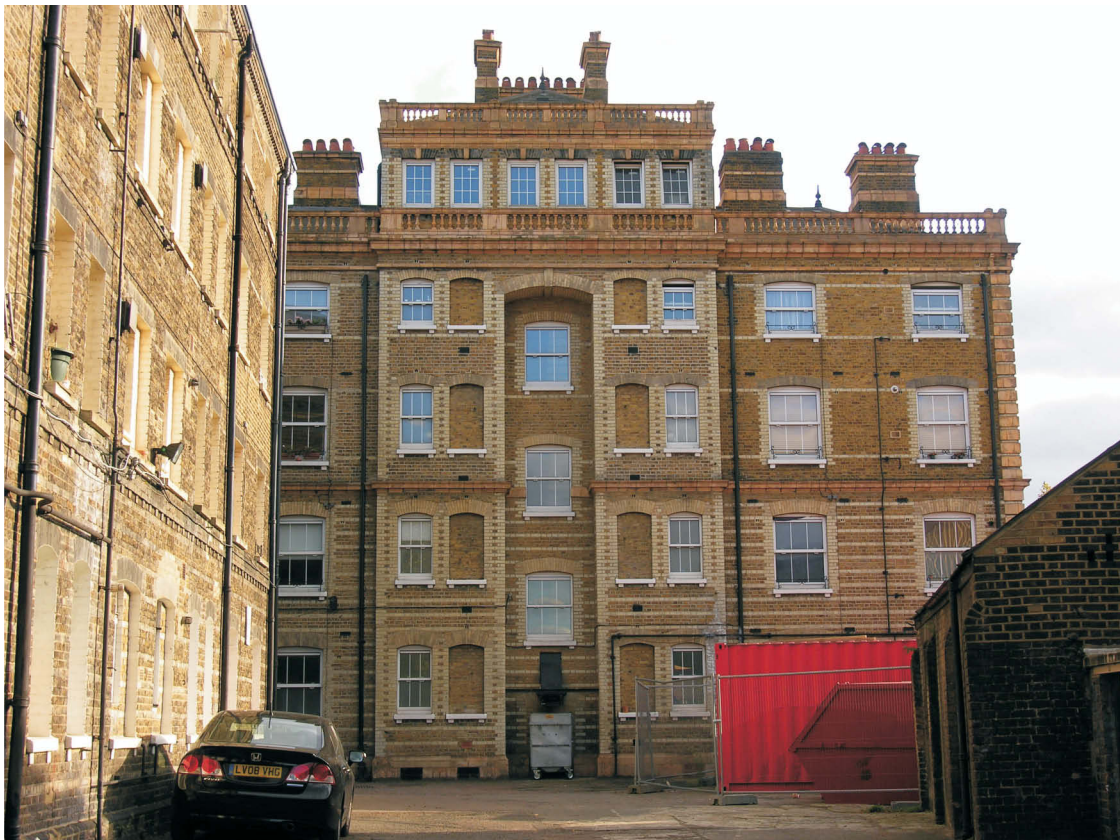
Fig 20 Looking south toward the northern elevation of Block 3

Figures 20 and 21 show the northern elevation of Block 3, which forms the limit of the main area of demolition and removals. Block 3 is representative of the original Peabody Close buildings, which have a footprint similar to that of the Peabody Avenue blocks but are altogether more elaborate, with a central pavilion having an additional storey (rather than simply a projecting central portion on the façade – see below, 3.2), overall different fenestration and many more embellishments (for example, the parapet balustrades).

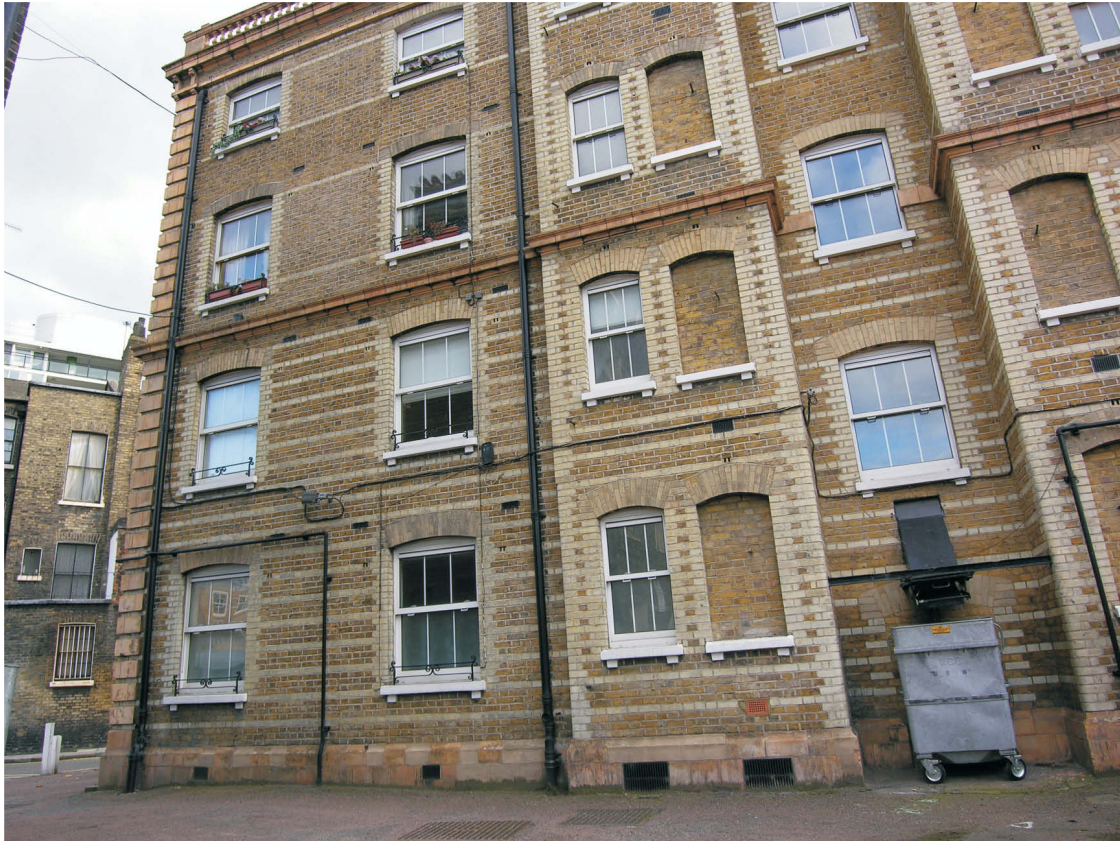
Fig 21 Looking south-east toward the eastern side of Block 3, northern elevation

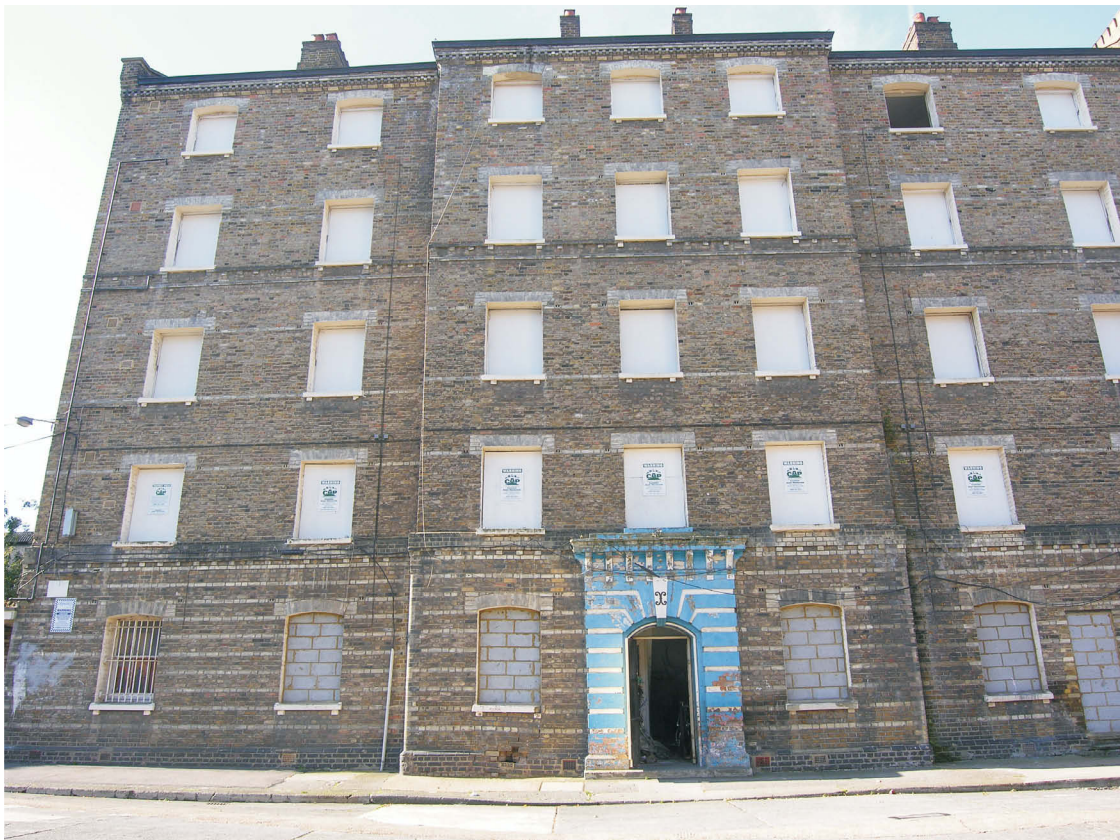
Fig 22 Looking west toward the eastern elevation of Block X

The eastern elevation has 34 windows with flat or segmental arches (depending on which storey): six on the ground floor and seven on each of the upper floors (Fig 22 and Fig 23). The western elevation has 50 windows (ten on each storey) with flat or segmental arches (depending on which storey), except where arches have been replaced by more recent concrete lintels (Fig 25). The southern elevation has nine rectangular window openings (some of which are divided inside the building by partition walls), featuring mid-to-late 20th-century glazing (Fig 24). Almost all of the windows have been blocked in some fashion, as discussed below.

The building is in yellow brick, decorated for the most part with bands of paler and sometimes projecting yellow bricks. The ornamental central portal features brick rustication, an arched doorway with a wrought-iron letter 'X' on the keystone, and a bracketed cornice (Fig 22 and Fig 26). The porch has been painted blue and white.

The eastern elevation is divided into seven bays, with the central three bays on the forward-projecting central third of the elevation. The two outer thirds of the eastern elevation have two bays each (Fig 22 and Fig 23). As noted above, there is a small, flat-roofed, single-storey, brick block built against the south face of the building (Fig 24). Only the western half of this block is completely enclosed, leaving its eastern half as a porch supported at the south-eastern corner by a square brick column. The door of this addition, at the back of the porch, faces onto Peabody Avenue.

The most striking element of the ground floor of Block X (and of Block Z as described below) is the rusticated brick porch for the main, central entrance (Fig 22 and Fig 26). Over the doorway arch, this rustication imitates large voussoirs surrounding the keystone. Unlike Block 'Z' (and most, if not all, of the other Peabody Avenue blocks), Block X's central porch is not topped by a roundel (to which a lighting fixture would probably have been attached). It seems likely that such a roundel was once present.

The windows of the eastern elevation's ground floor have segmental, rubbed-brick arches; however, all but the southernmost of the windows (that of the site attendants' office) have been sealed with concrete blocks (Fig 22 and Fig 23). The channelling of the brick rustication of the central portal is carried along the ground floor of the eastern elevation not as recessed courses but as courses of much paler yellow brick. The same pale brick is used for the arches of the windows.

The first, second and third floors of the eastern and western elevations have flat arches of pale rubbed brick, while the fourth floors of both elevations have the same segmental arches as the ground floor (Fig 22, Fig 23, and Fig 25). These elevations also have decorative brick cornices below the shallow eaves of the roof. Several string courses of paler brick run across both elevations, some of them projecting outwards. These string courses are continued on the southern elevation, but only as paler brick not as projecting courses. The fenestration of the repaired southern elevation does not match the symmetrical style of the original building; each floor has two rectangular window openings (one larger and one smaller) offset slightly toward the east side of the elevation (Fig 24).

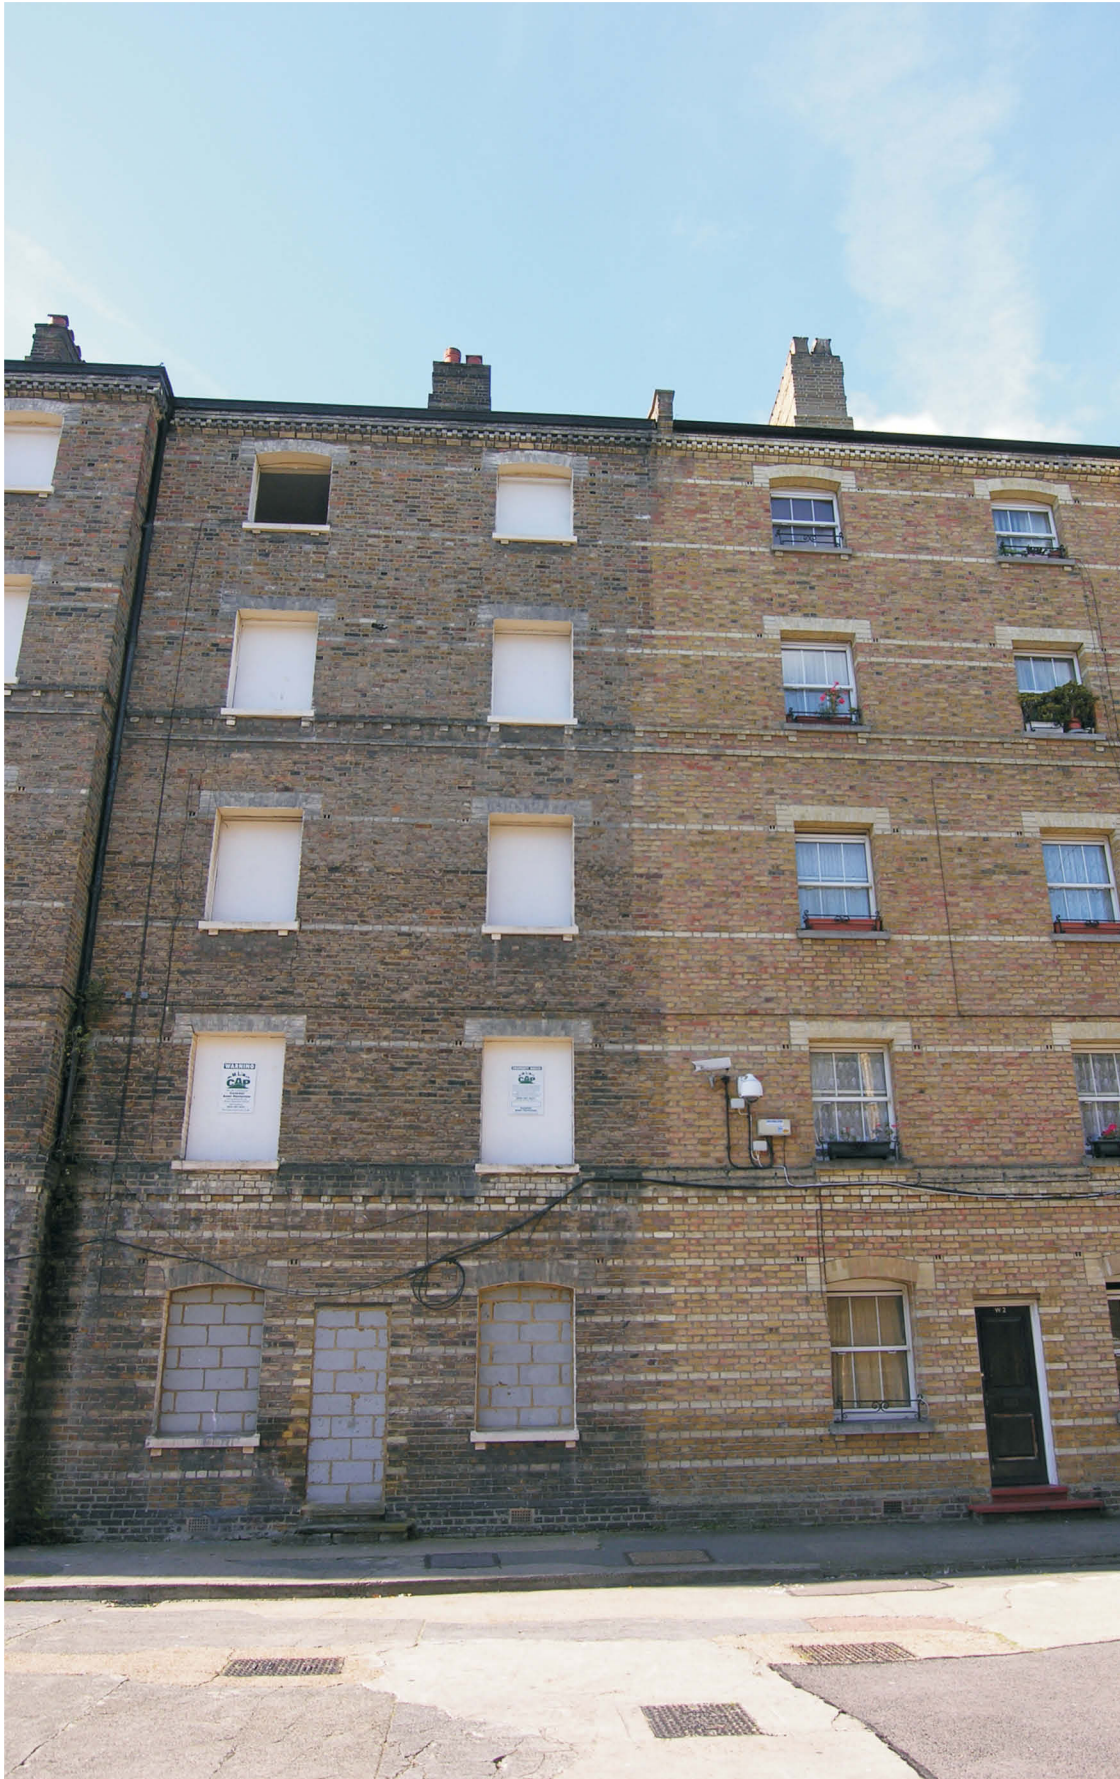
Fig 23 Looking west toward the north half of the eastern elevation of Block X and also the south half of the eastern elevation of Block W (with cleaned brickwork)

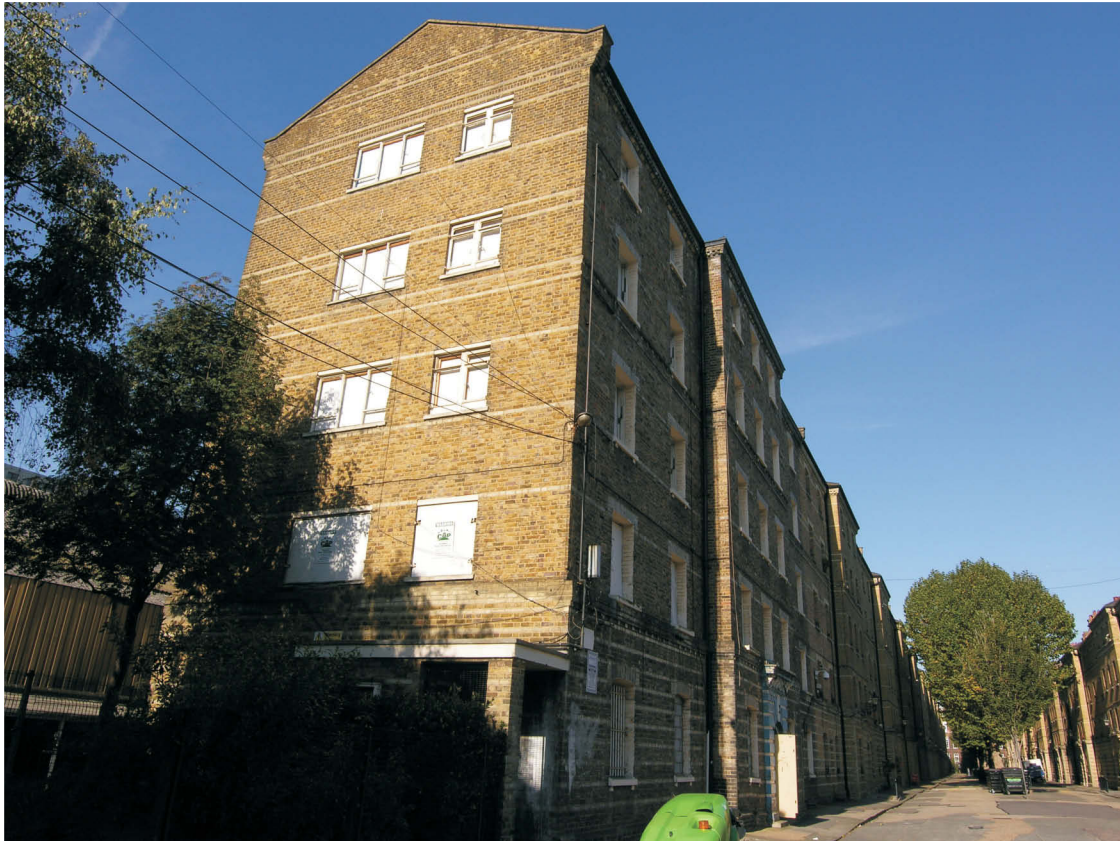
Fig 24 Looking north-west, showing the southern elevation of Block X

Block X (Figs 22–28) is rectangular in plan with a small, rectangular addition on the south side (at the south-eastern corner, for a porch and vestibule – see Fig 24). The block is oriented north–south along the west side of Peabody Avenue. The central third of the eastern elevation projects slightly in plan. Above ground, the structure is supported on load-bearing brick walls and is on five storeys. There is also basement. The nature of the foundations was not discovered during the site visit, and it is uncertain whether or not the system of brick arches supported on concrete piers, as described by Darbishire (above, 2.1) was, in fact, used for this building. The gable roof is framed on either side by gable up-stands, the northern one shared with the building that abuts Block X to the north (ie, Block W) (see Fig 12). There is a hipped link-dormer roof over the shallowly-projecting, central portion of the eastern elevation.

western range, on the far side of the Memorial Garden that has replaced the demolished Block Y. Block Z's ground floor, first floor, and second floor are essentially the same as those of Block X, but without blocked windows (although some windows have been narrowed). The third floor of Block Z, as the top floor, is essentially the same as the fourth floor of Block X. The repaired south and north elevations of the building are different from those of Block X (which does not have an exposed north elevation, instead being joined on that side to Block W) (see Fig 30 and Fig 34; compare Fig 24).

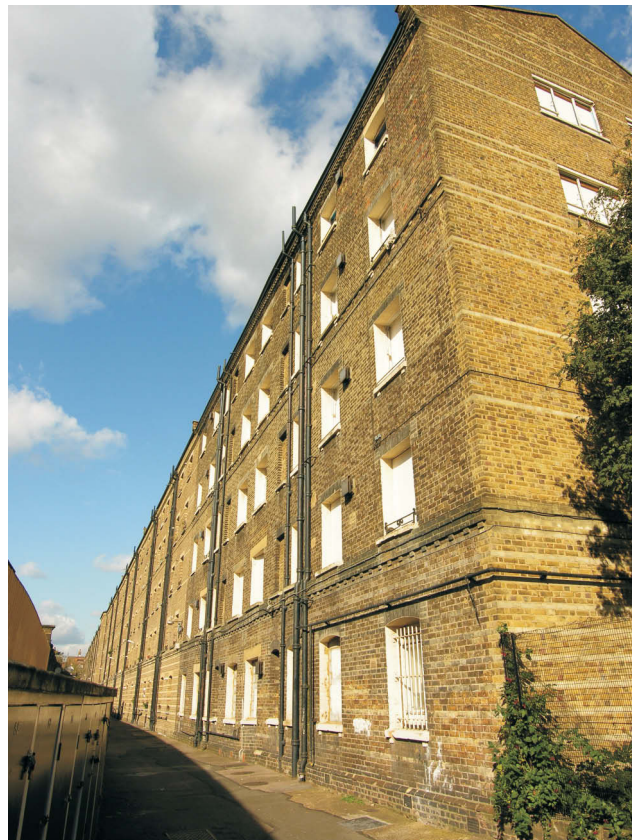
Fig 25 Looking north-east, showing the western elevation of Block X
