PEABODY AVENUE
Pimlico
London SW1

An archaeological Standing Building Report

January 2009

Site Code: PBA08

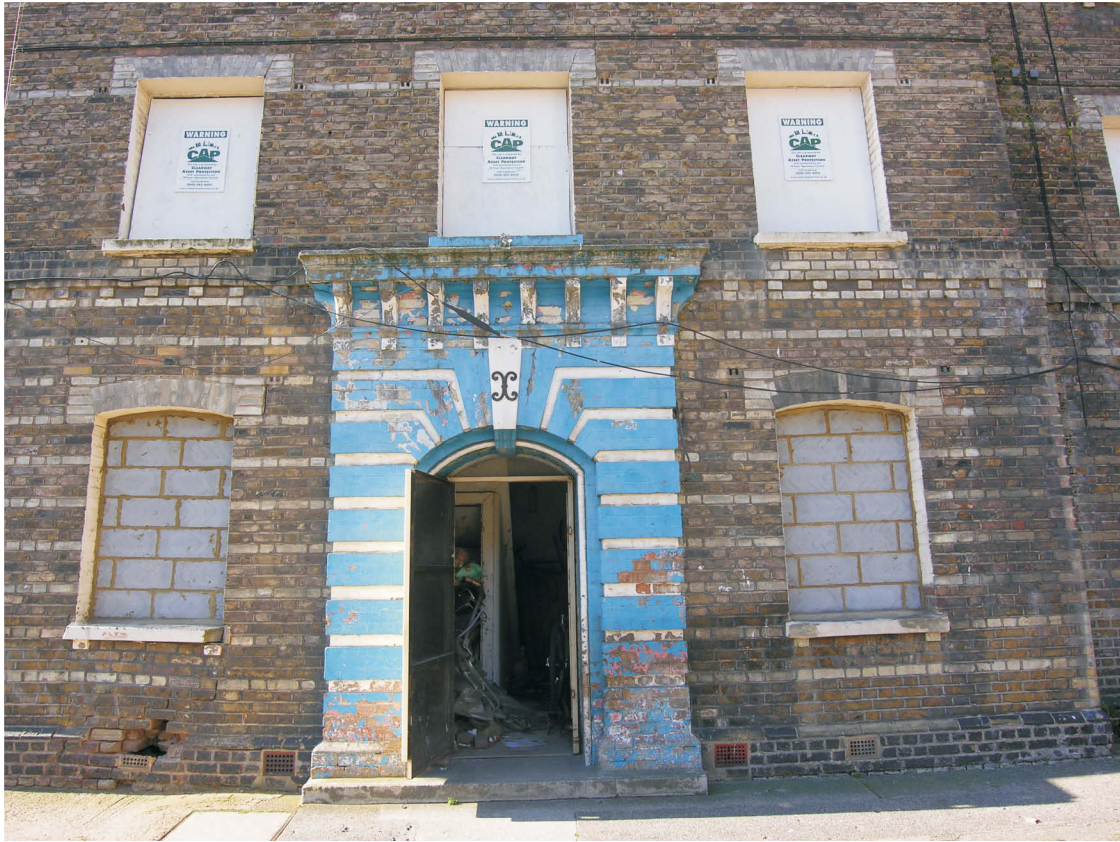
Fig 26 Looking west through the main entrance into Block X

The building is in yellow brick, decorated for the most part with bands of paler and sometimes projecting yellow bricks. The ornamental central portal features brick rustication, an arched doorway with a wrought-iron letter 'X' on the keystone, and a bracketed cornice (Fig 22 and Fig 26). The porch has been painted blue and white.

The most striking element of the ground floor of Block X (and of Block Z as described below) is the rusticated brick porch for the main, central entrance (Fig 22 and Fig 26). Over the doorway arch, this rustication imitates large voussoirs surrounding the keystone. Unlike Block 'Z' (and most, if not all, of the other Peabody Avenue blocks), Block X's central porch is not topped by a roundel (to which a lighting fixture would probably have been attached). It seems likely that such a roundel was once present.

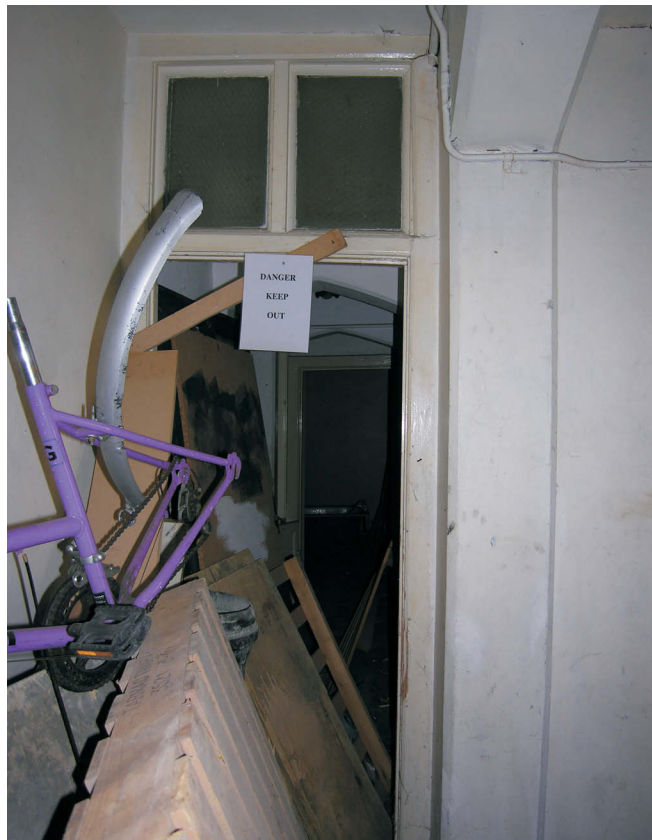
Fig 27 Looking north into the northern ground floor area of Block X from the main vestibule. This area was not accessible during the survey

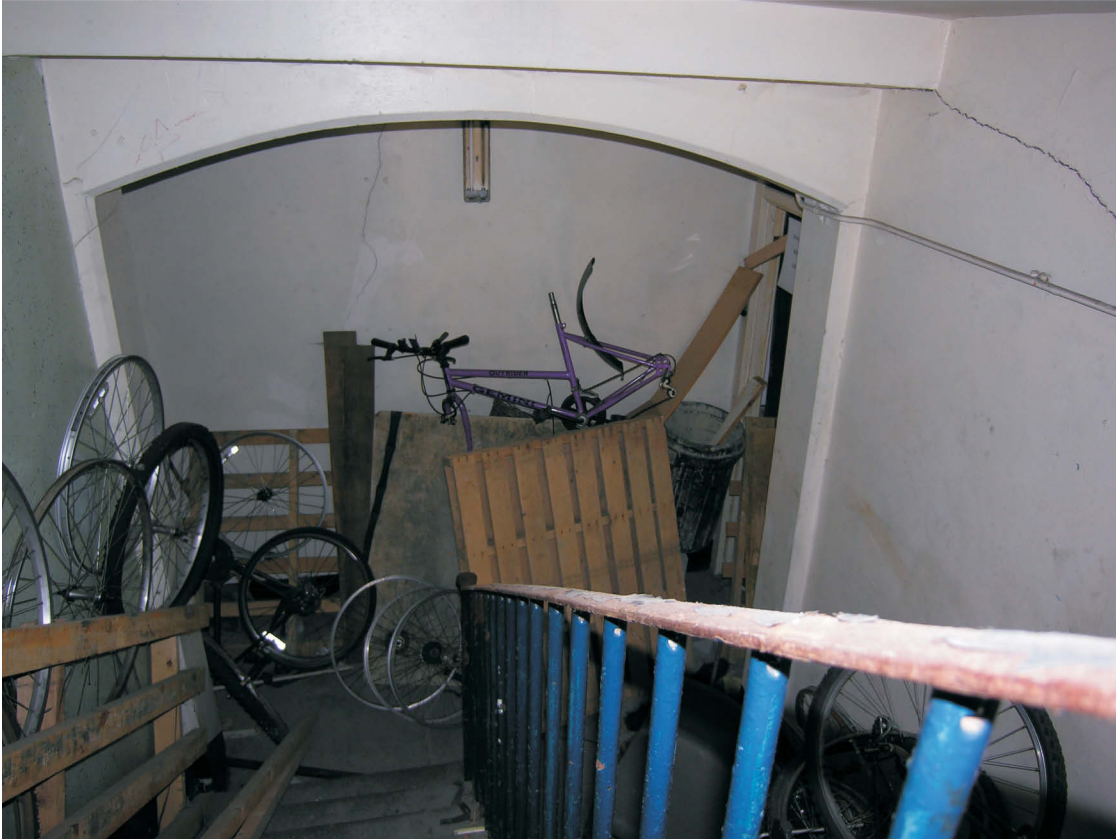
Fig 28 Looking down and westward toward the ground floor vestibule from the halfspace landing on the stairs to the first floor, Block X

Access to the upper floors and basement is via an internal stairway in the centre of the eastern half of the building (see Fig 26, Fig 27 and Fig 28).

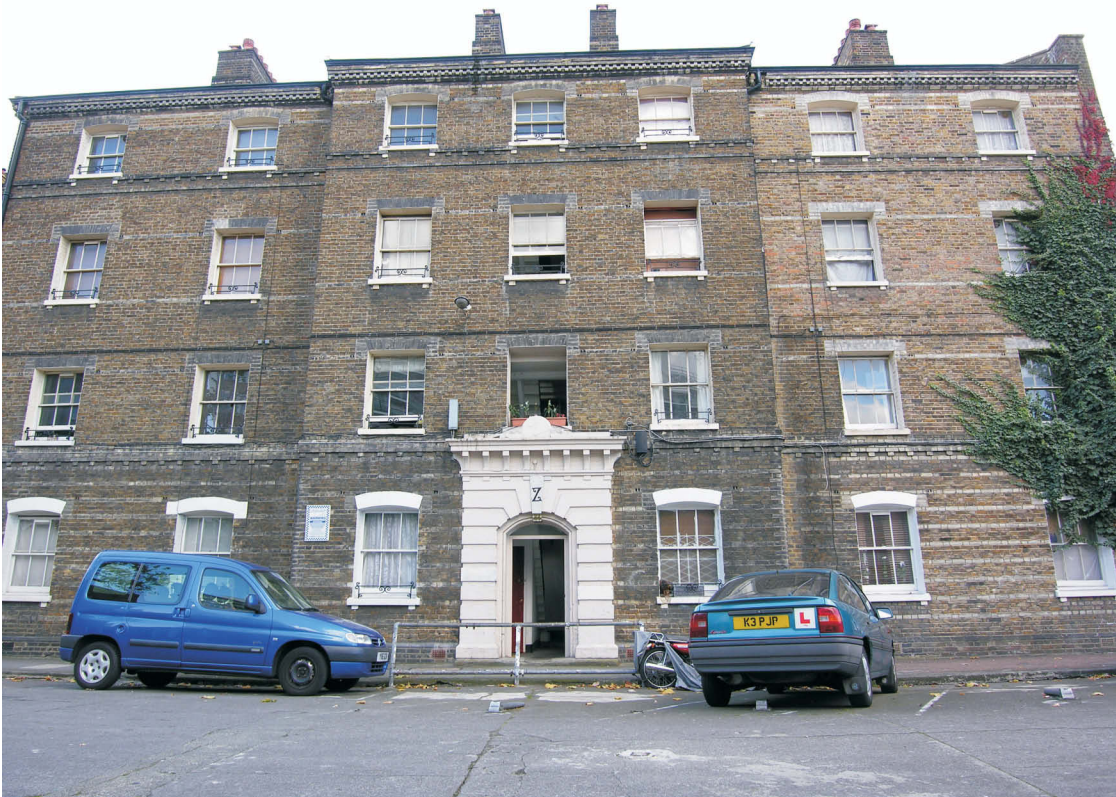
Fig 29 Looking west, showing the eastern elevation of Block Z

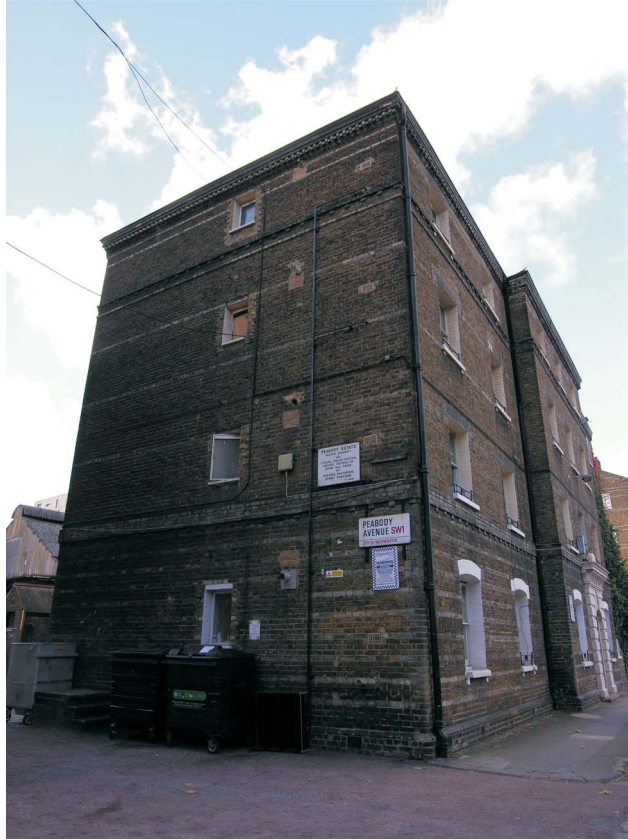
Fig 30 Looking north-west, showing the southern elevation of Block Z

western range, on the far side of the Memorial Garden that has replaced the demolished Block Y. Block Z's ground floor, first floor, and second floor are essentially the same as those of Block X, but without blocked windows (although some windows have been narrowed). The third floor of Block Z, as the top floor, is essentially the same as the fourth floor of Block X. The repaired south and north elevations of the building are different from those of Block X (which does not have an exposed north elevation, instead being joined on that side to Block W) (see Fig 30 and Fig 34; compare Fig 24).

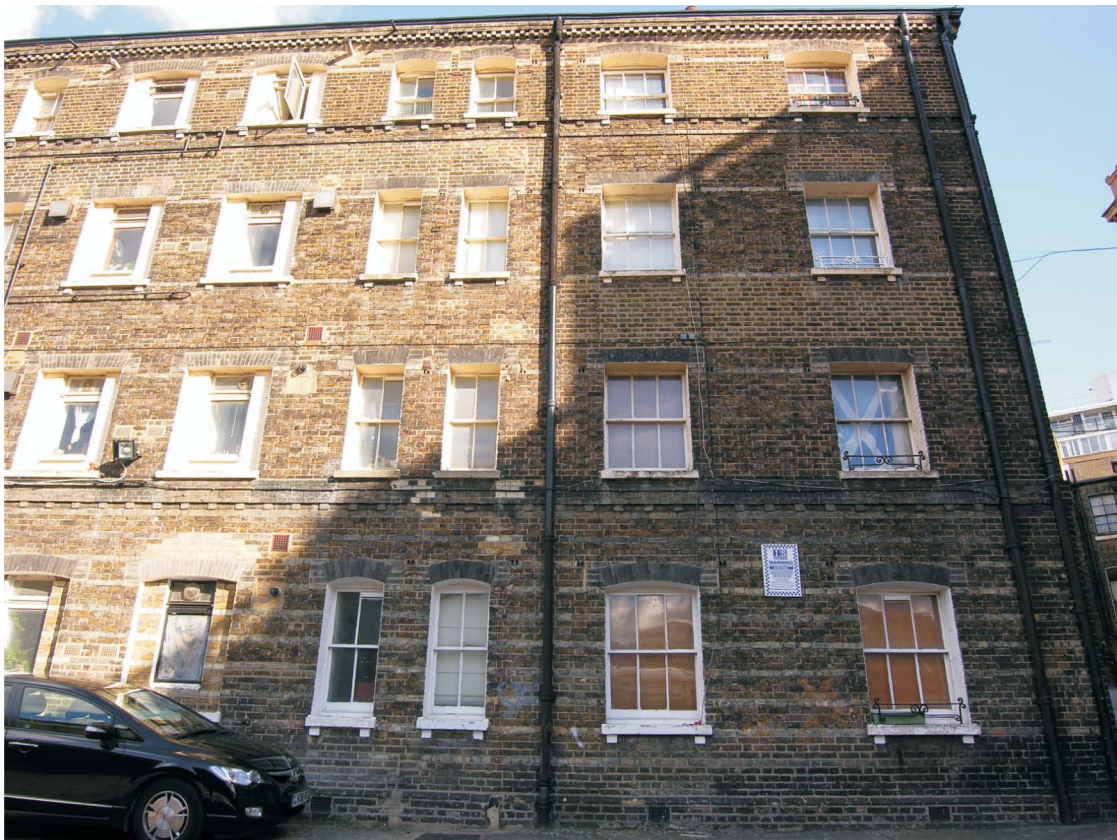
Fig 31 Looking east, showing the western elevation of Block Z

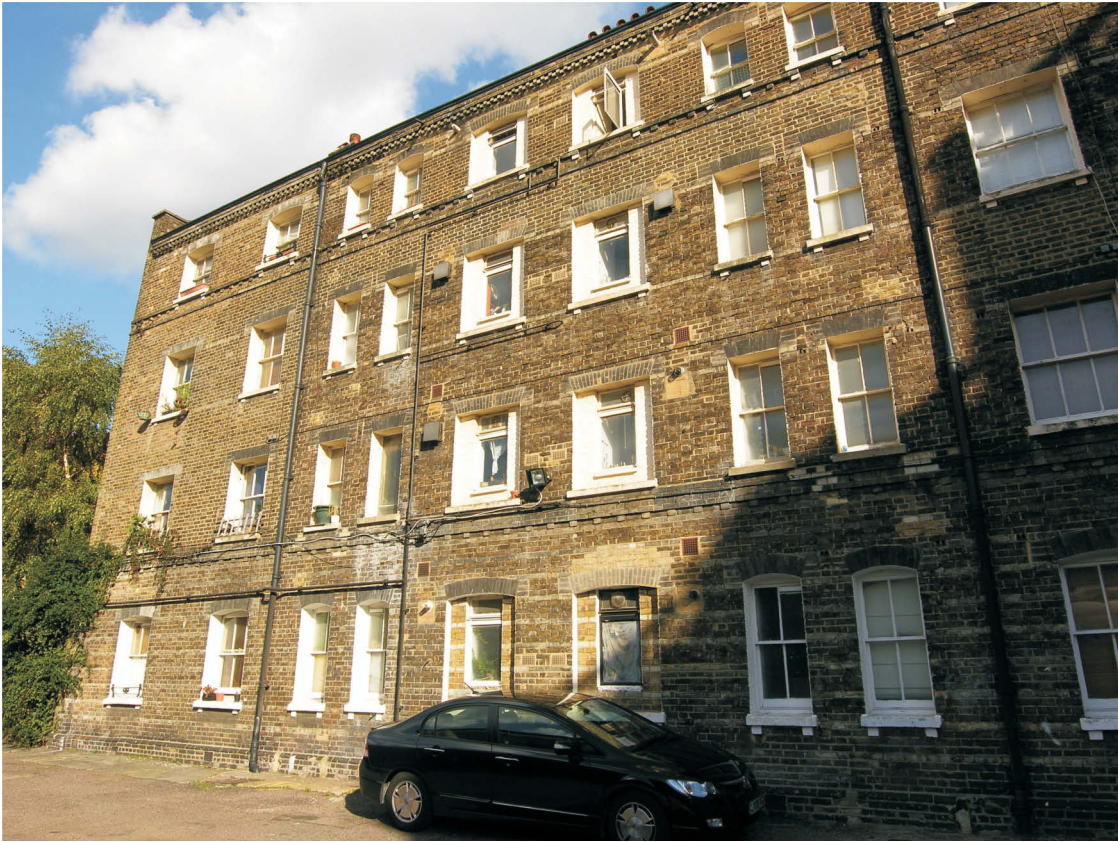
Fig 32 Looking north-east, showing the western elevation of Block Z

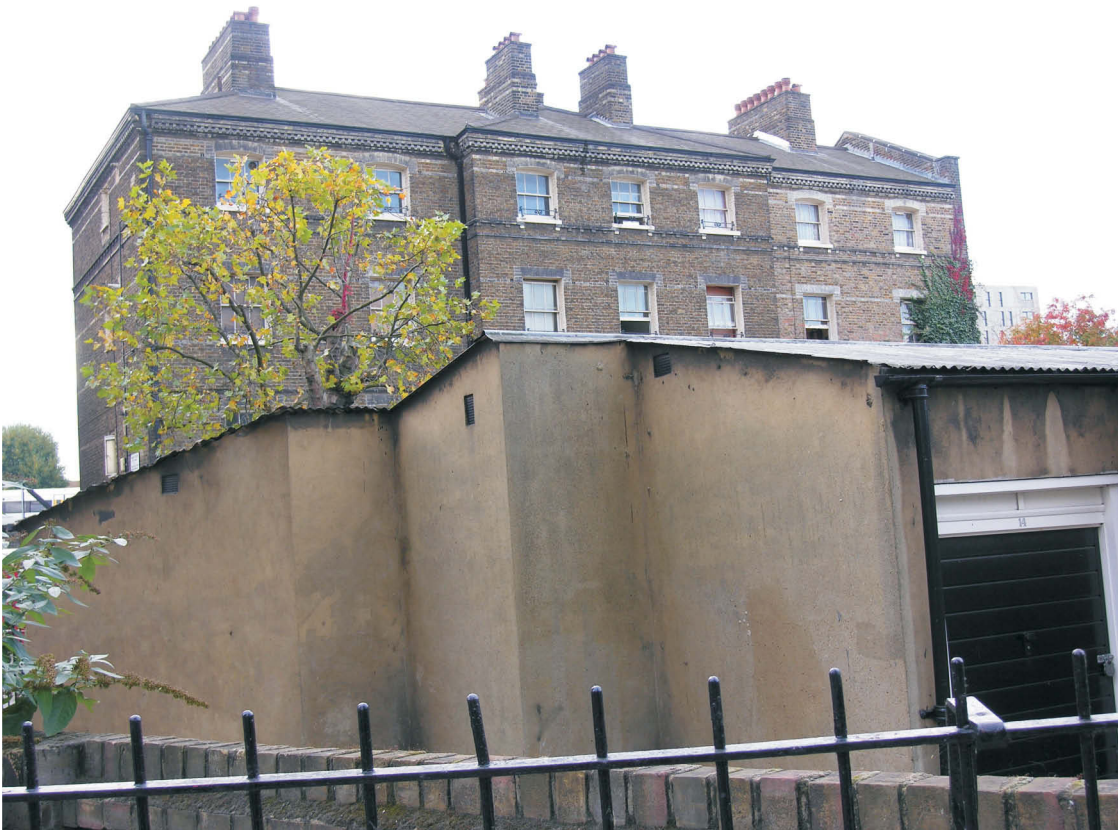
Fig 33 Looking west-north-west from Lupus Street, showing the upper storeys, roof and chimney stacks of Block Z

There are five rectangular-plan chimney stacks (see Fig 33). Two of the stacks are aligned east–west and are centrally placed across the roof ridge at a set back from the north and south elevations. The southern one of these sits at the top of the south-facing end slope. In the middle of the building, two more east–west-aligned stacks extend eastward from the roof ridge at points on either side of the central bay of eastern elevation. The fifth stack is aligned north–south and is centrally placed near the top of the western slope of the roof.

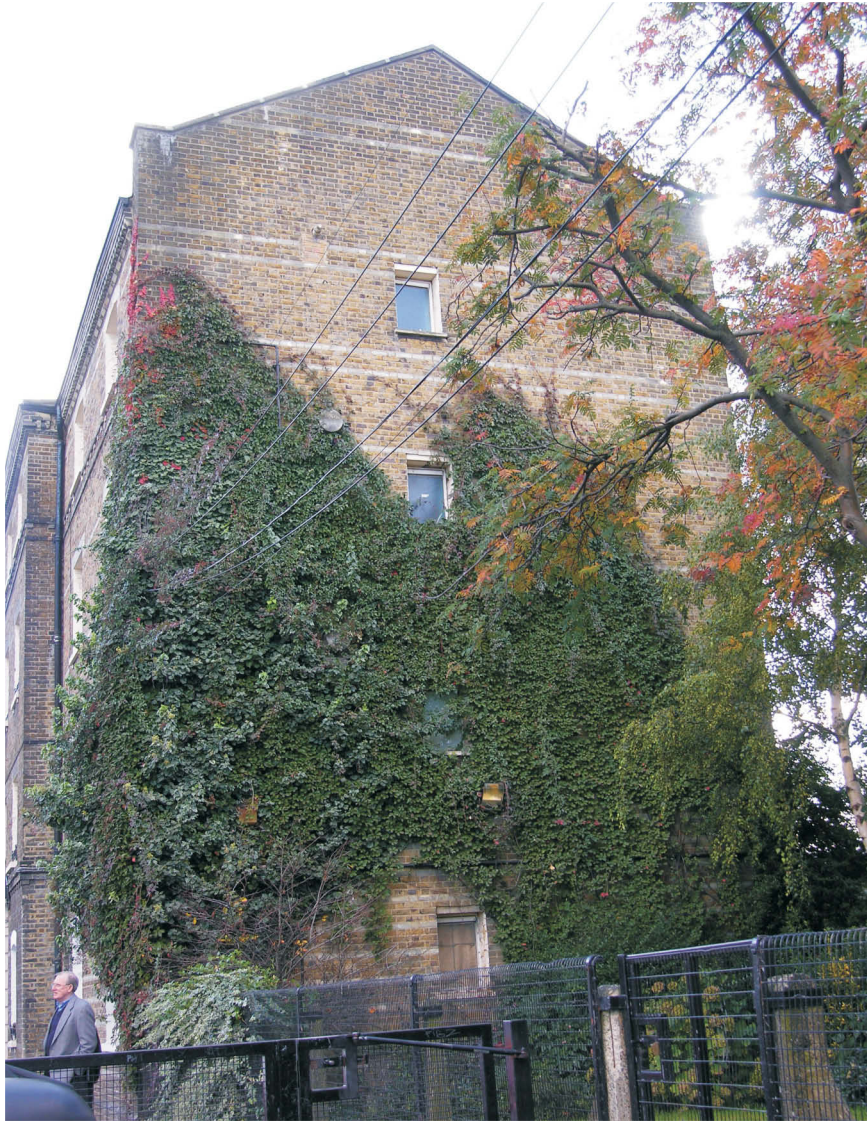
Fig 34 Looking south toward the northern elevation of Block Z

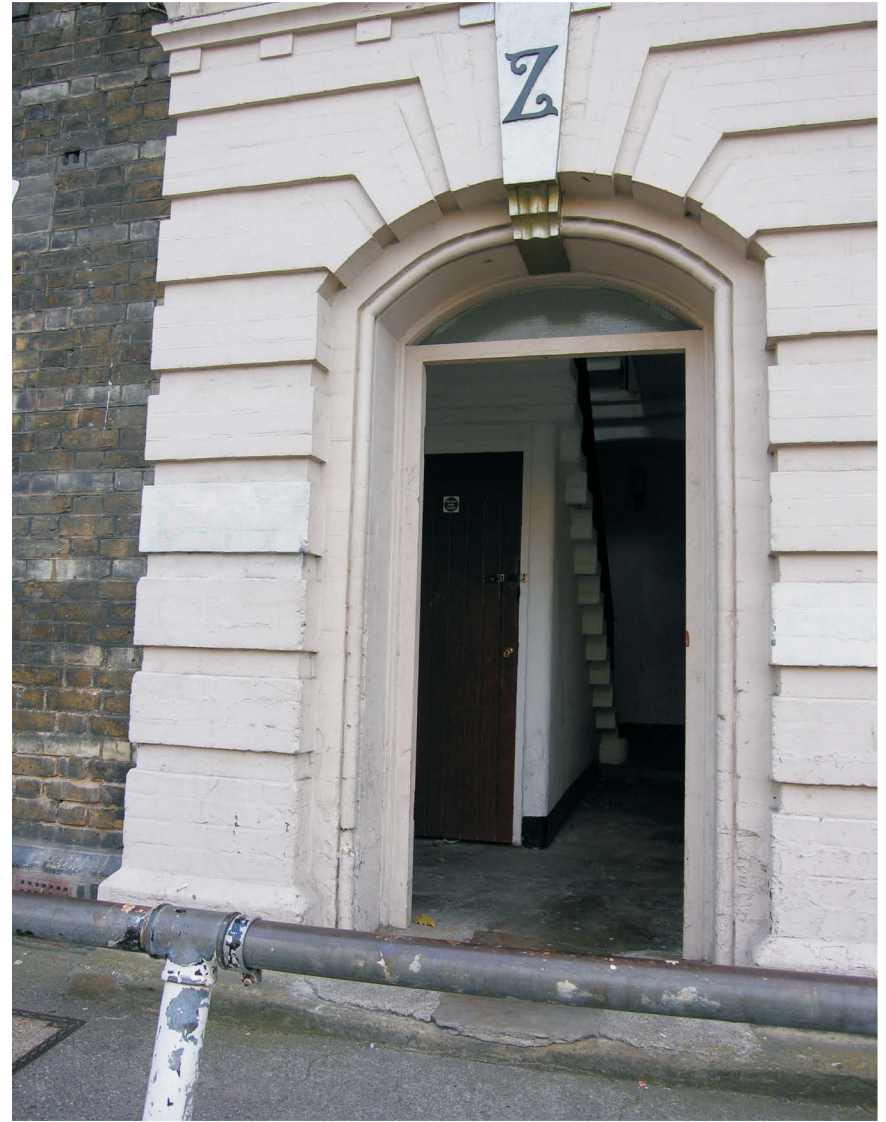
Fig 35 Looking west through the main entrance into Block Z
