**TREMBATHS
Talbot Way
Letchworth**

Hertfordshire

An archaeological evaluation report

Site Code: LRT-HE-TMB09

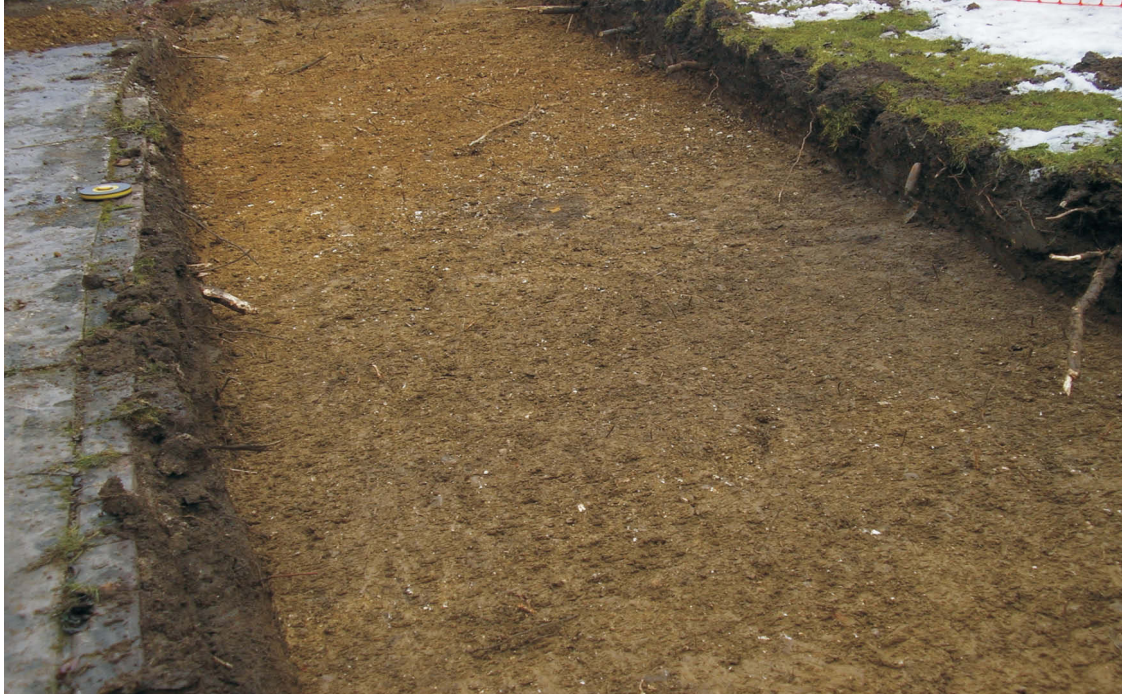
Front cover: Trench 2, tree hole [1] looking east

Undisturbed natural ground was of glacial till deposits, consisting of mid-light yellow brown sandy silt with moderate sub angular gravels [4]. This was located at 88.52–88.54m OD. However, lightly disturbed soils consisting of natural glacial till with the addition of frequent chalk particles [2] were located in the central part of the trench; this was in turn disturbed by tree root activity [3] and a tree hole [1] in the southern limit of the trench. The tree hole was 1.65m long by 0.55m wide, with a diffuse border with the surrounding disturbed ground. Roots were observed to lie within the feature which was only 0.10m deep.

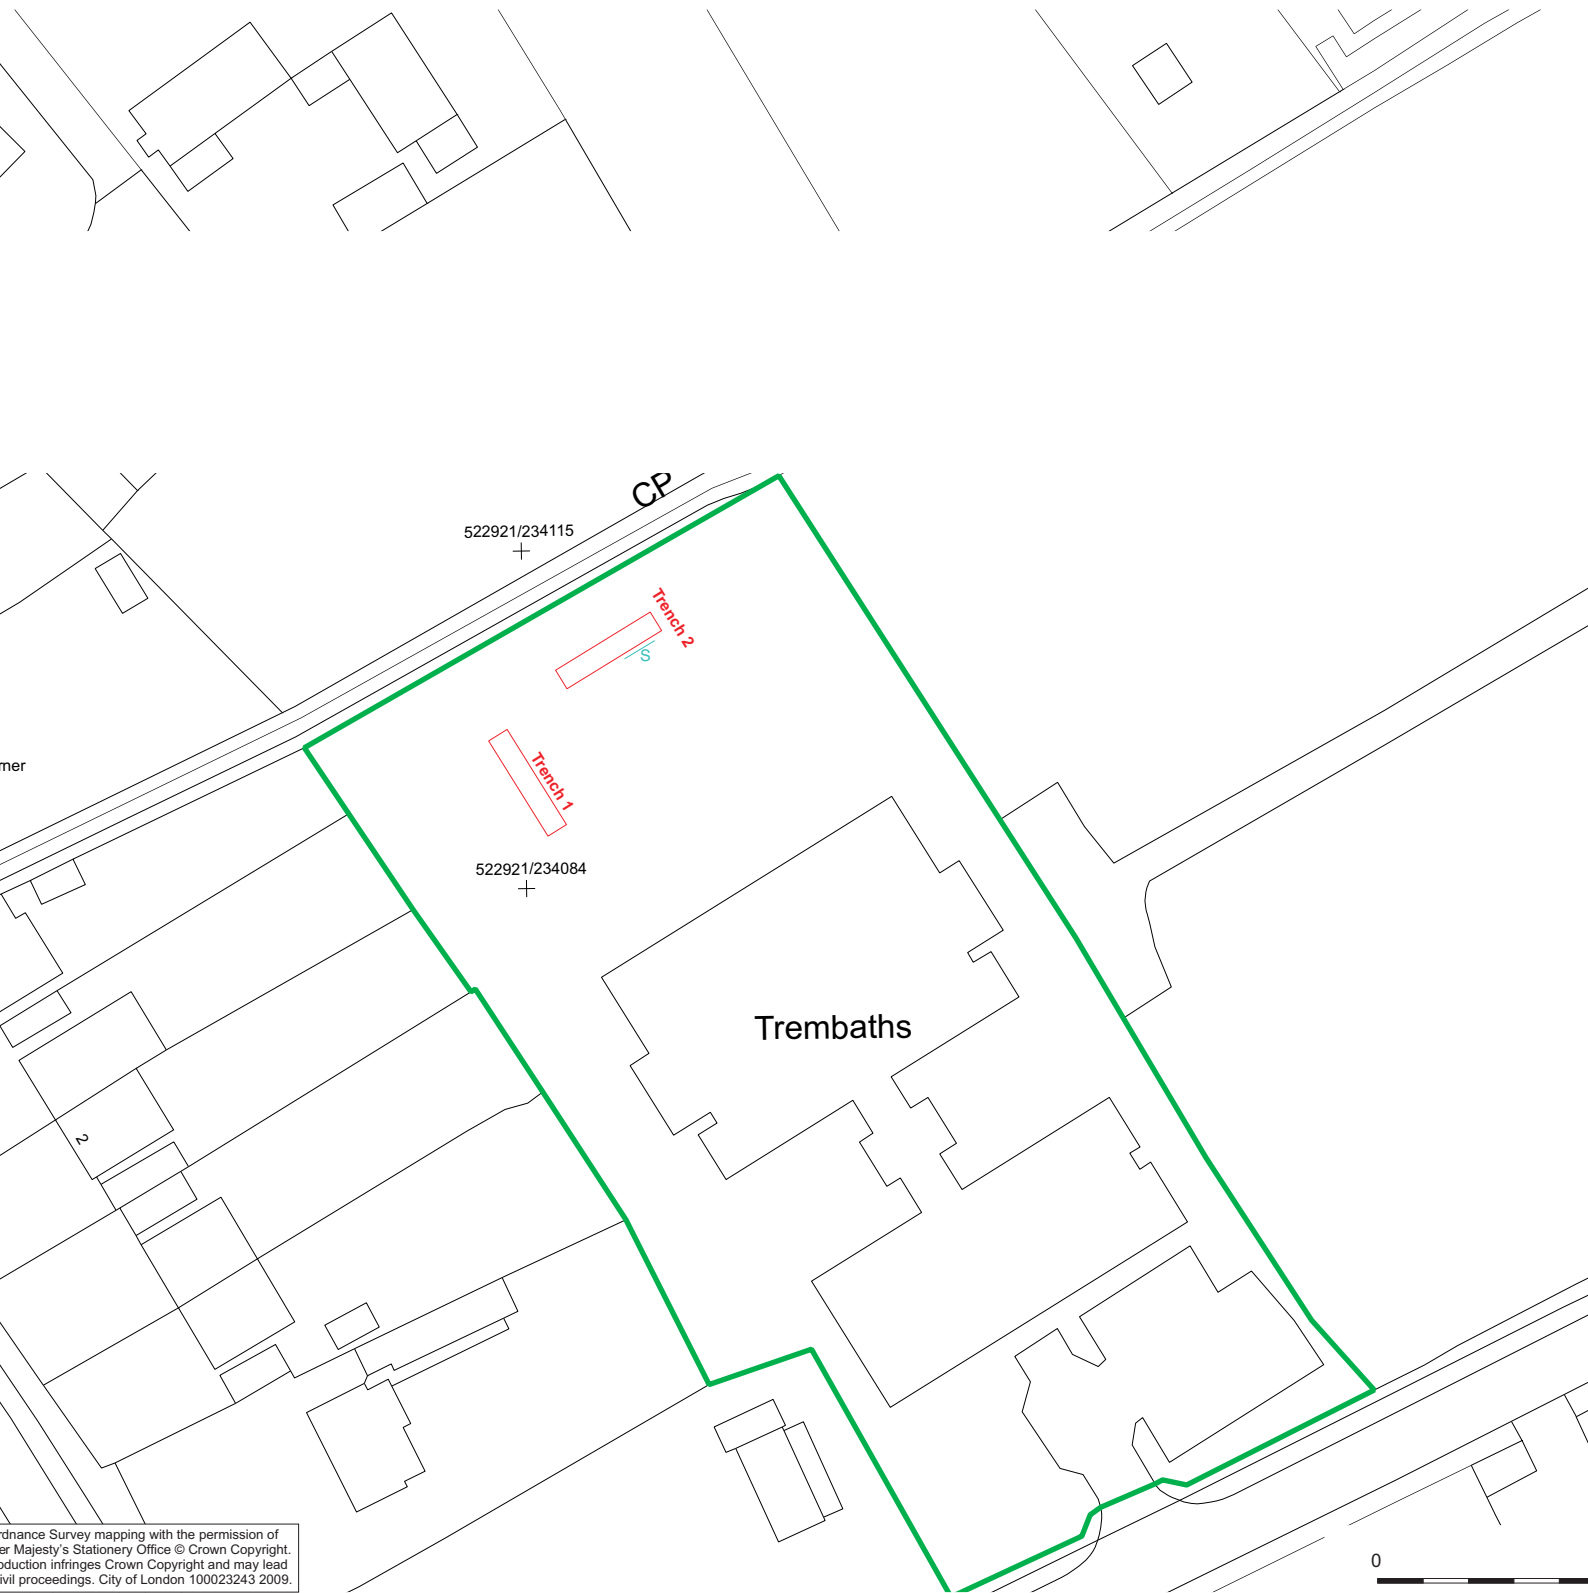
as of evaluation

Two evaluation trenches were excavated within the footprint of the new building, Trench 1 was oriented north-west–south-east and Trench 2 oriented south-west–north-east.

For trench locations see Fig 2.

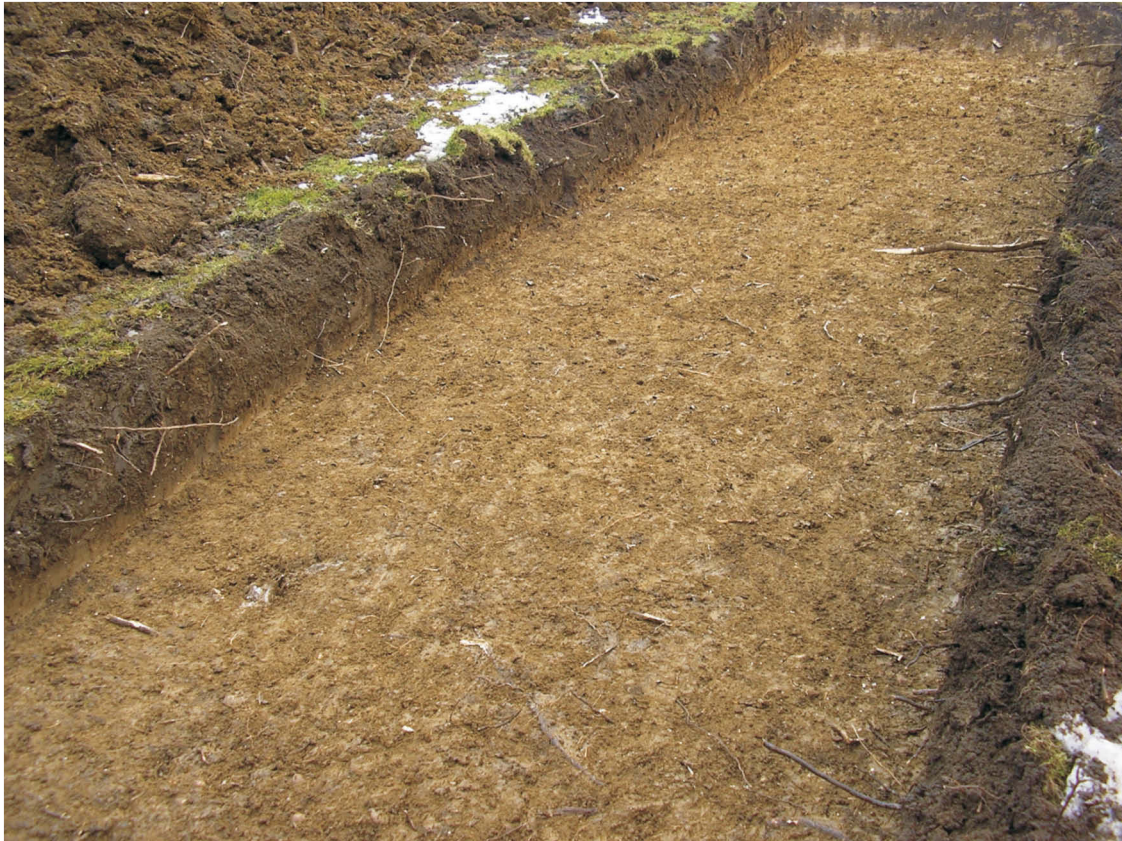
Fig 3 Trench 1, looking south

Undisturbed natural ground was of glacial till deposits, consisting of mid-light yellow brown sandy silt with moderate sub angular gravels [4]. This was located at 88.54–

88.58m OD and contained frequent small tree roots. Overlying the natural was a subsoil of dark–mid grey brown sandy silt with occasional gravel and flint inclusions, averaging 0.26m deep, this in turn was overlain by topsoil and turf. No archaeological features or finds were located in this trench.
