**4-6 NEW INN BROADWAY
London EC2**

Evaluation report
May 2009

Site Code: NIN08

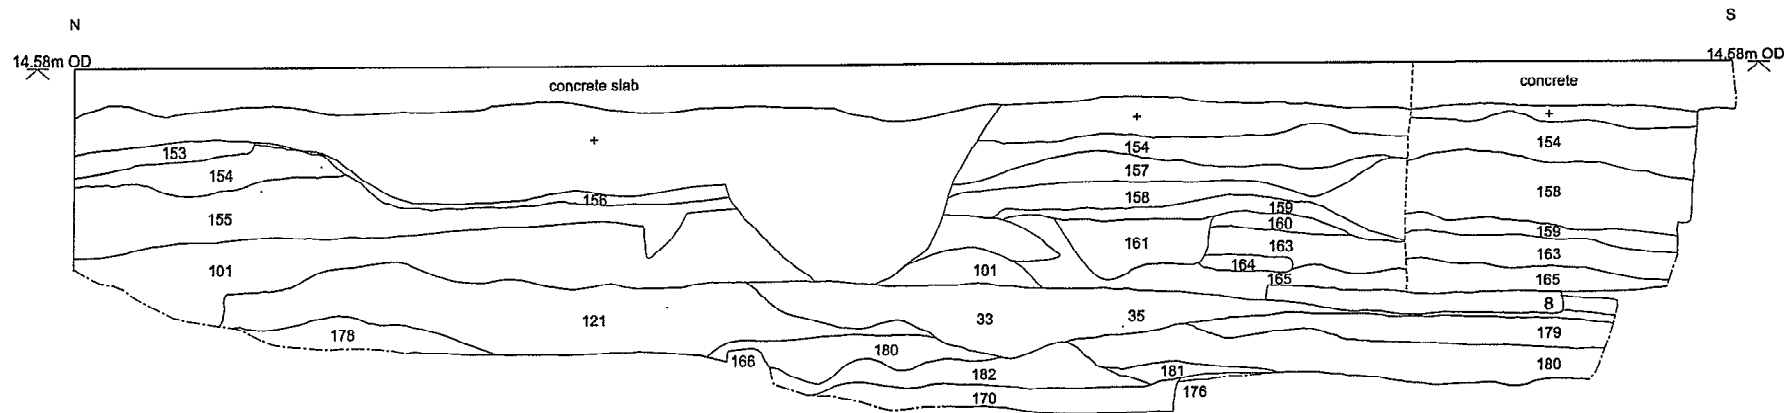
Fig 5 Composite of west facing section Trench 4

Above the brick floor [164] was a demolition dump [163], which formed the bedding layer for a further brick floor [160]. Above this was a pit containing demolition rubble [162] and a series of demolition deposits [159], [158] and [157], which like [155] was sealed beneath [154]. [154] was the bedding layer for [153], a 19th century cobbled surface, originally recorded in the phase 1 evaluation as [100]. The cobbles were recorded at a height of 14.23m OD. All of these deposits, with the exception of [100] on the western side of the site, were recorded in section (see Fig 5).
