A programme of archaeological works during  
landscape improvements at Langley Park, Wexham  
February 2009 – February 2010

Joe Prentice &  
David J Leigh  
Report 10/39  
July 2010

**A PROGRAMME OF ARCHAEOLOGICAL WORK  
DURING LANDSCAPE IMPROVEMENTS AT LANGLEY PARK,  
WEXHAM, BUCKINGHAMSHIRE  
JULY 2009 – FEBRUARY 2010**

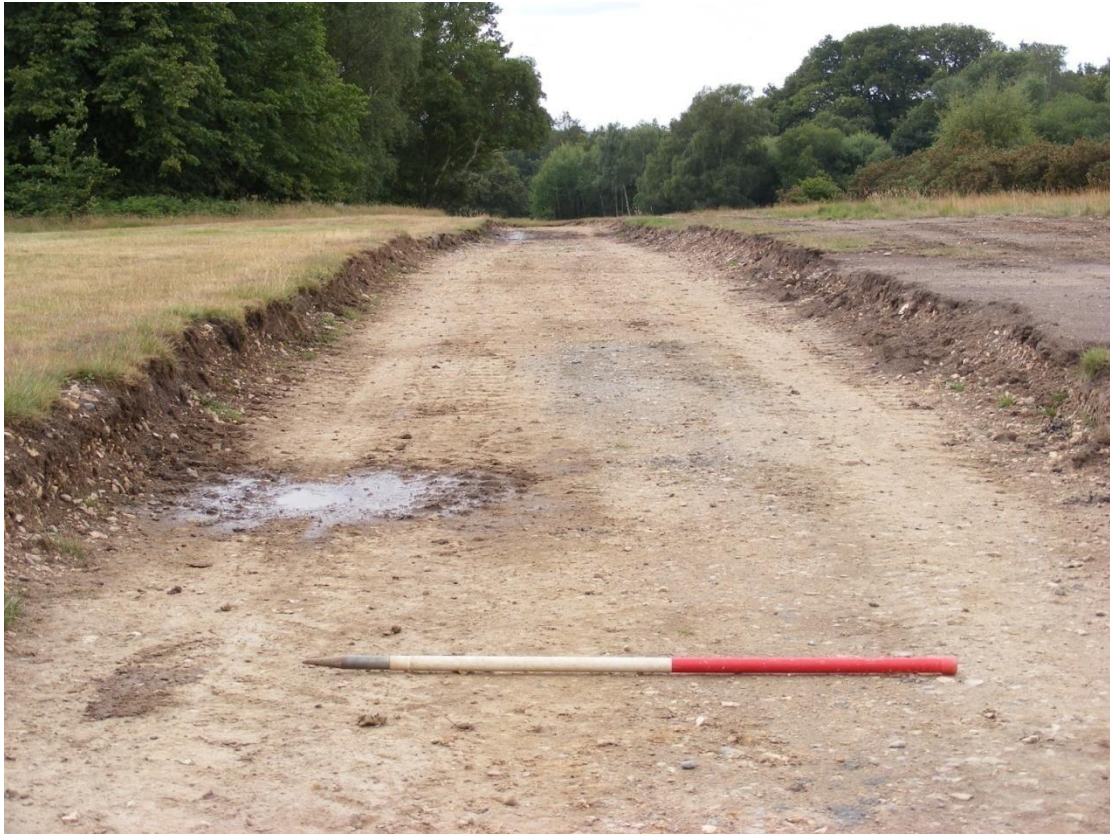
Approximately 3,500sq m of new footpaths were constructed which extended across the park from the visitor centre to the northern end of the lake (Figs 3, 4 and 5) and measured approximately 3.0m wide and were excavated to a maximum depth of 0.30m below present ground level.

The footpaths during construction, looking to the south: Fig 4

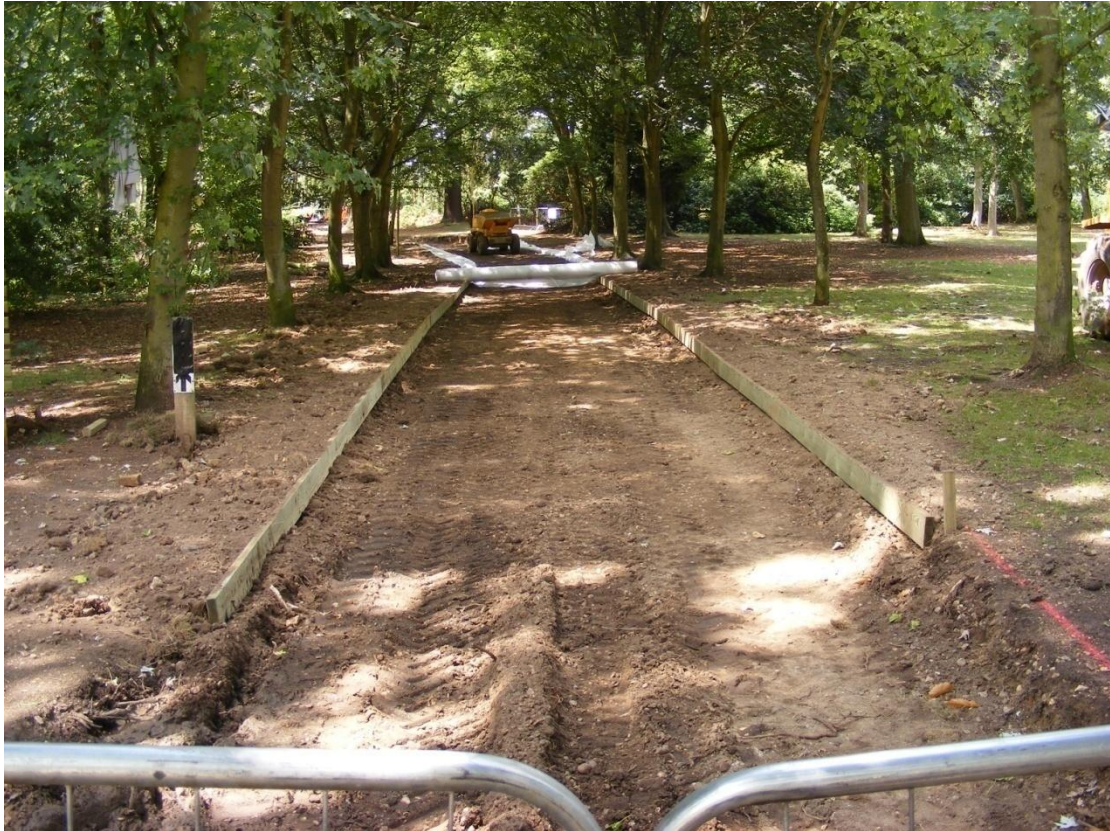
The footpaths during construction, looking towards the visitor centre: Fig 5

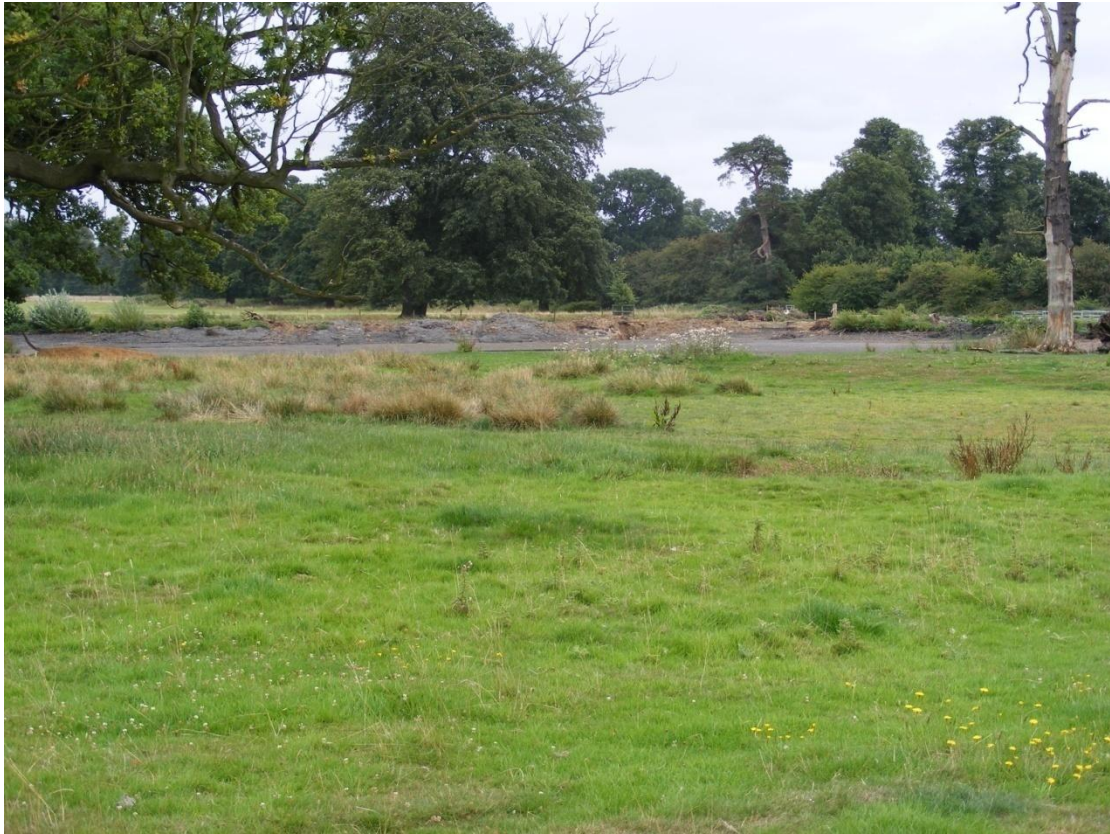
An earthwork survey was carried out of an area encompassing approximately 50m by 30m (Figs 2 and 6) in advance of the spreading of silts excavated from the lake along with a number of plots locating the probable position of the original lake edge and heights relating to the boathouse and the lake outlet. The survey was undertaken using a Leica System 1200 survey grade and all points were surveyed and related to Ordnance Survey National Grid. Readings were taken at a maximum of 1.0m intervals. Tops and bottoms of slopes were plotted along with spot heights across the investigation area in order to generate a contour plot.

The area of the earthwork survey, looking towards the lake: Fig 6

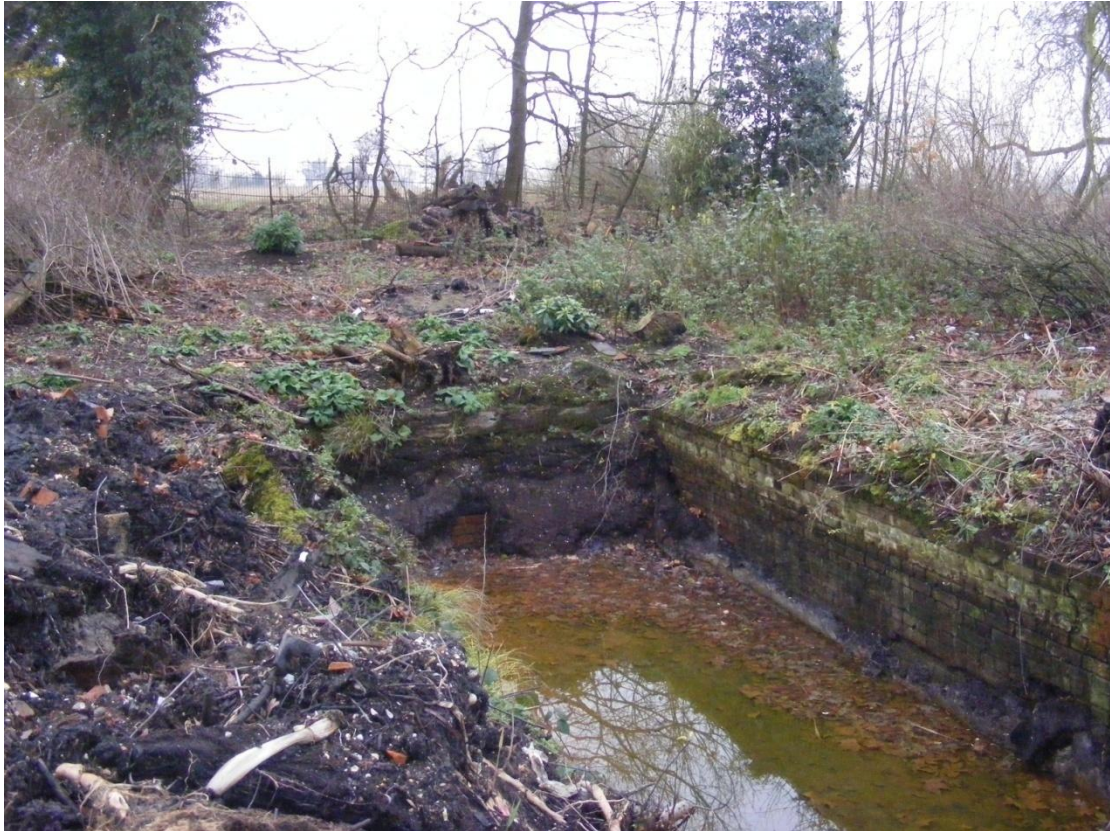
The boathouse was cleared of rubbish and rubble and the interior was washed out (Figs 7 and 9). A level 1 photographic survey was then undertaken. The objectives of the building recording were to:

The boathouse after initial cleaning: Fig 7

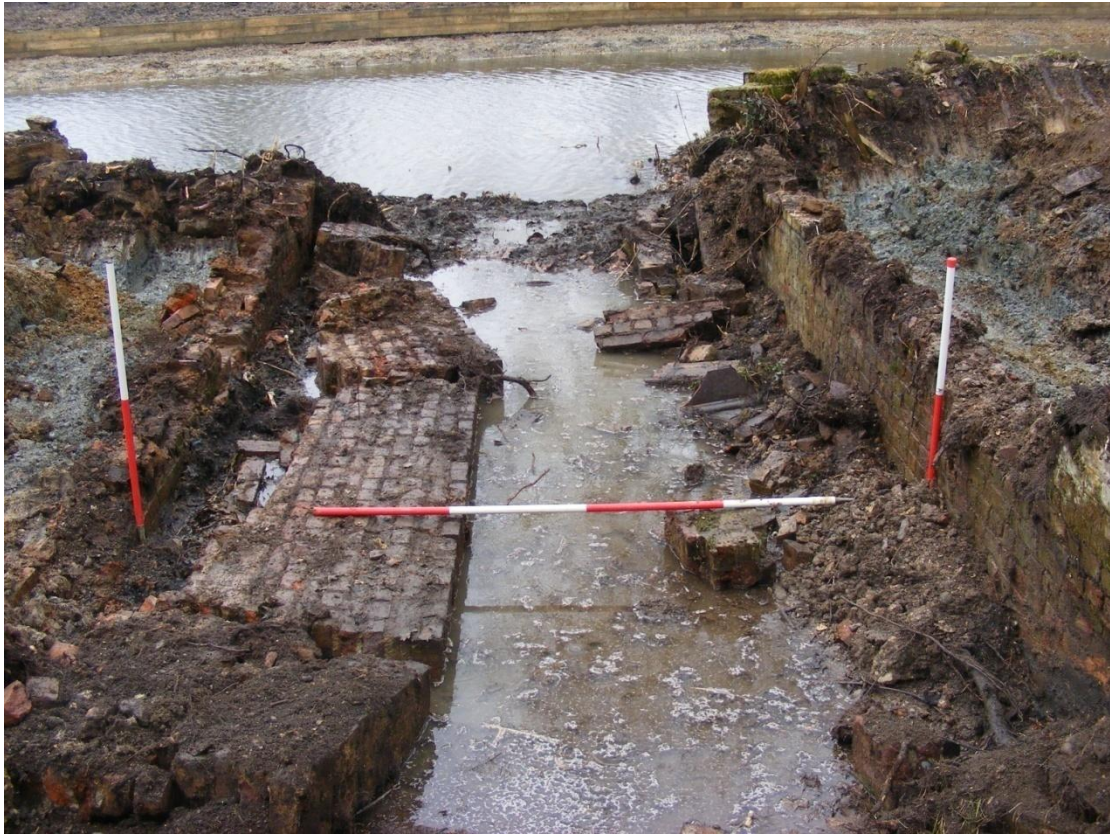
The boathouse is located on the north-eastern bank at the northern end of the lake approximately 250m west of Langley Park House. At the time of the survey the boathouse was in a ruinous state having suffered some collapse of masonry due to root activity (Fig 8). The boathouse measured approximately 10.0m long by 3.42m wide, the highest section of the surviving masonry stood approximately 1.0m high. It was constructed of red bricks each measuring approximately 220mm long by 110mm wide and 70mm thick bonded together with grey/white Portland Cement. The walls of the boathouse were constructed using English Garden Wall Bond (Figs 11 and 12) whilst the floor was of Stretcher Bond, sloping down to the centre approximately 0.10m (Fig 10).

The boathouse after the collapse of the walls: Fig 8

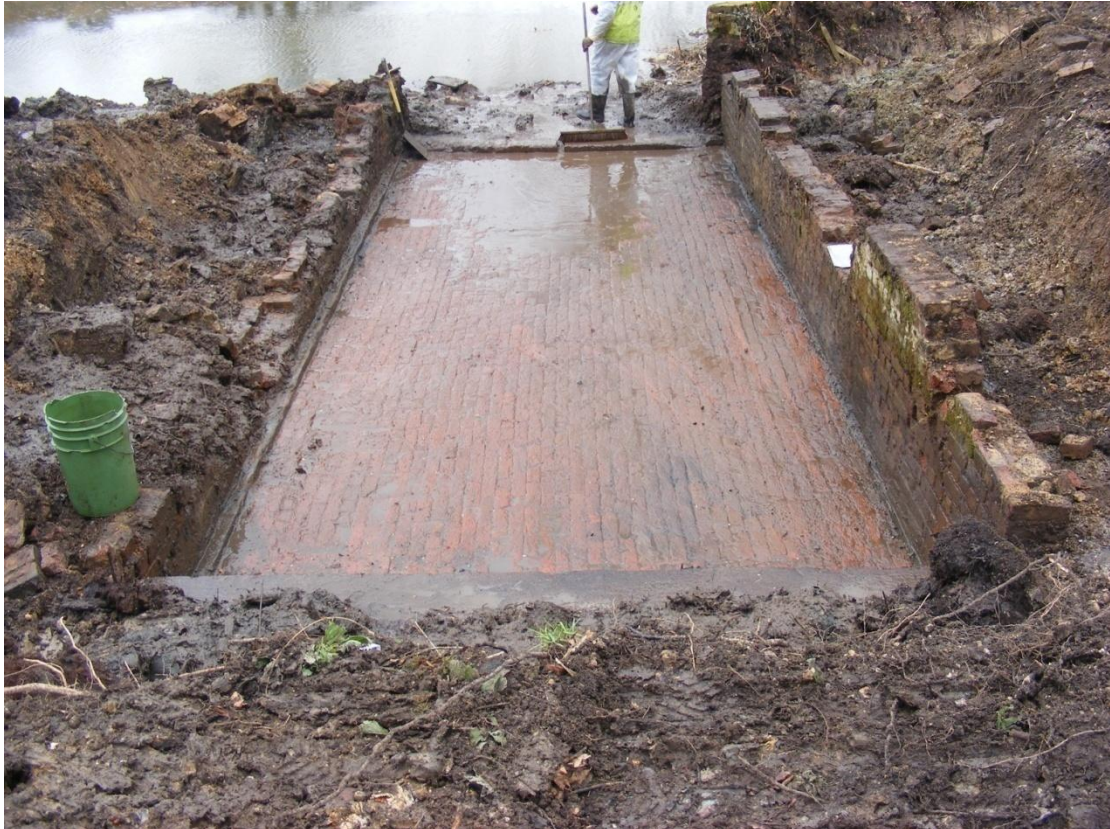
The boathouse after initial cleaning: Fig 9

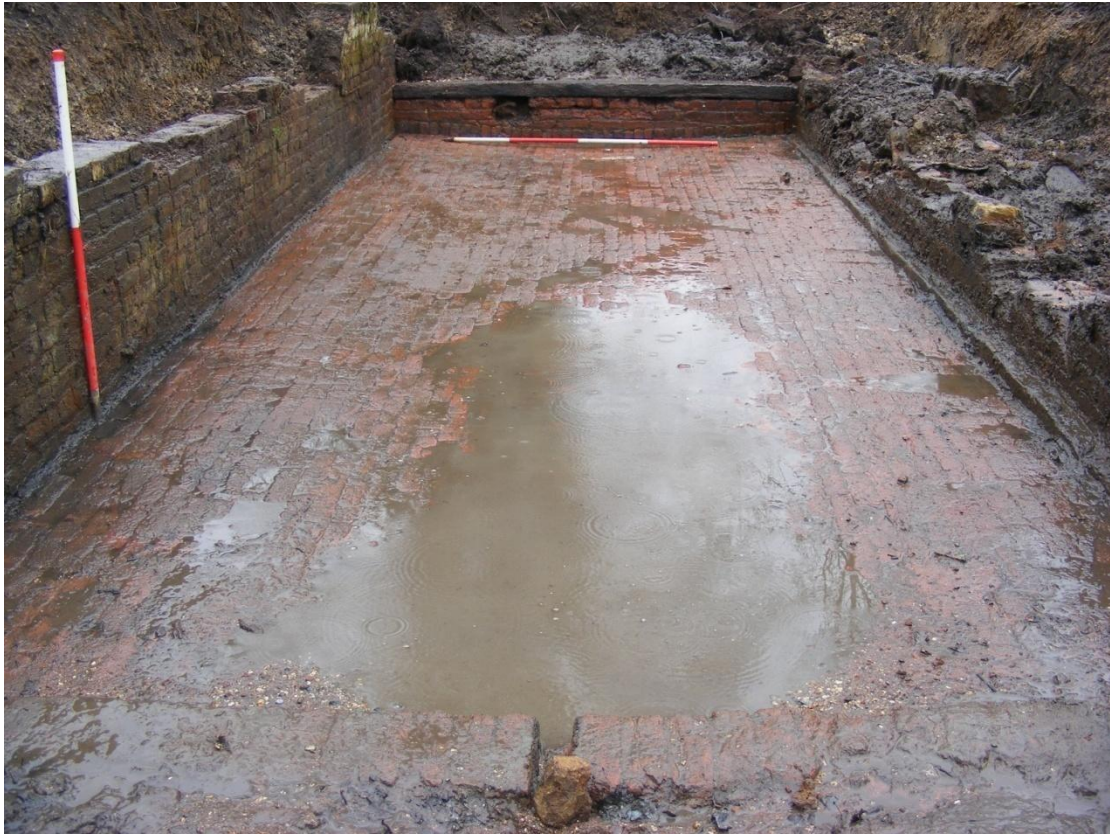
The floor of the boathouse: Fig 10

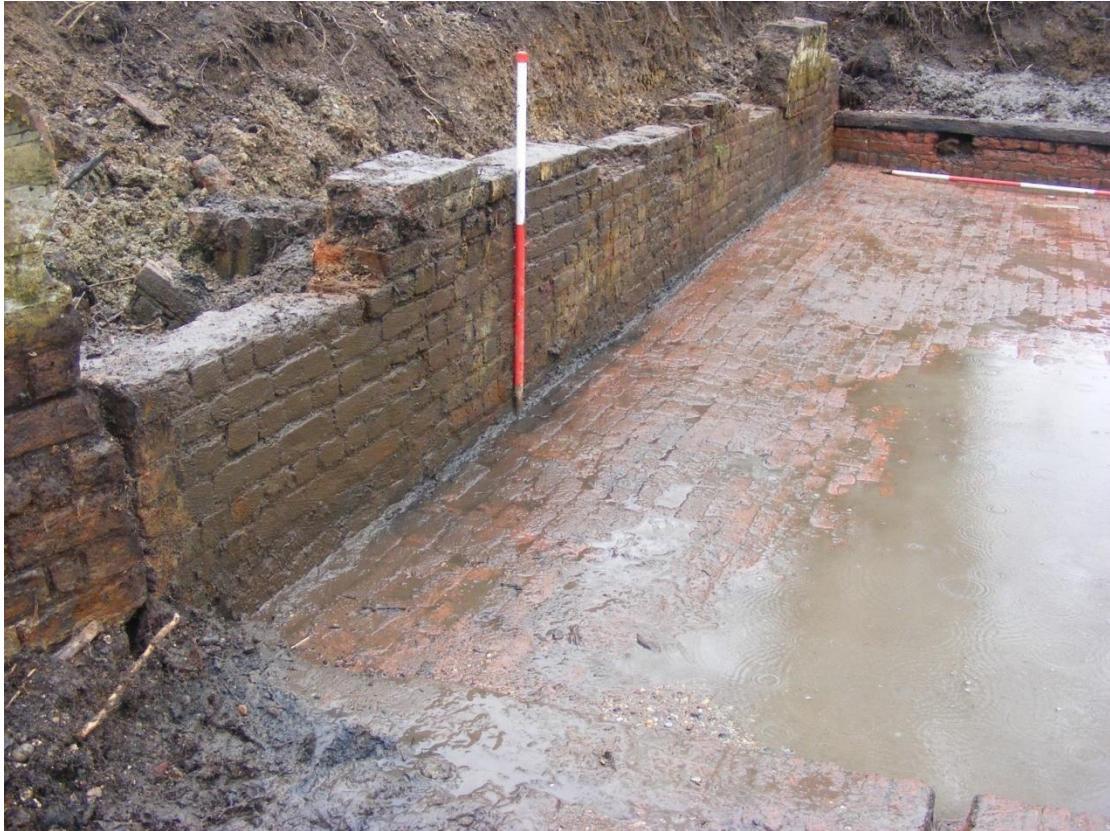
The north wall of the boathouse: Fig 11

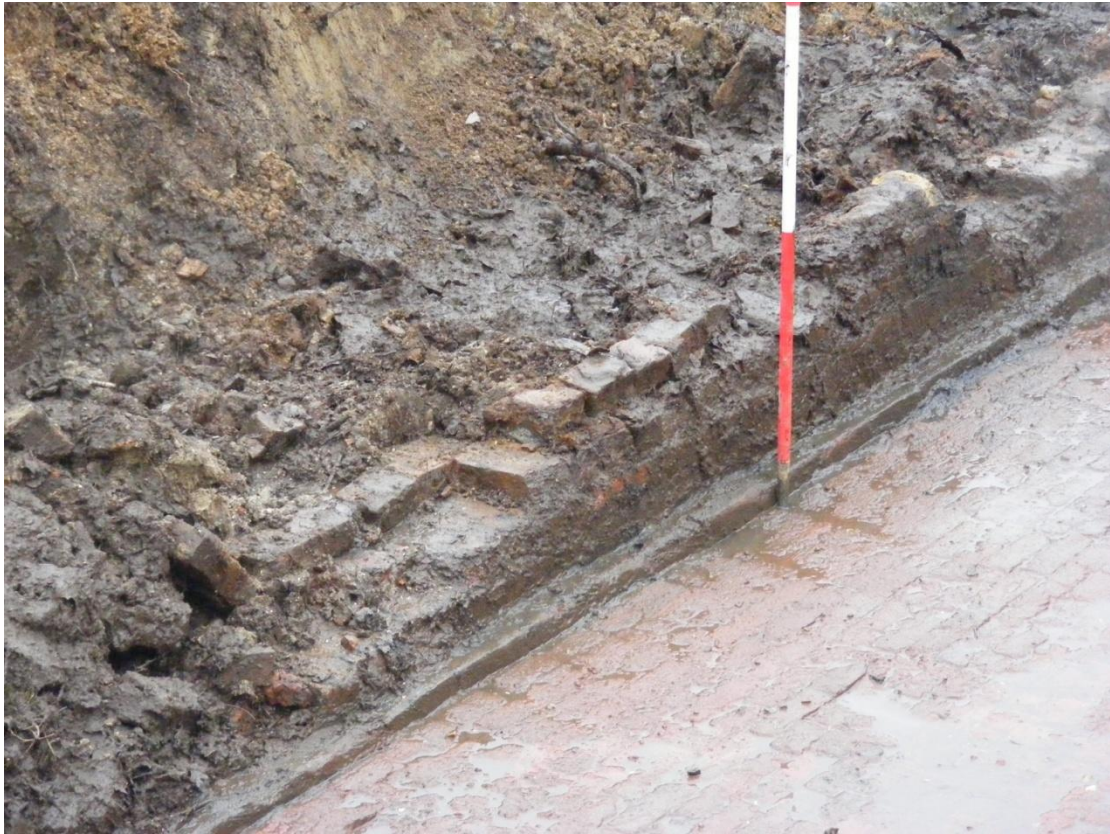
The south wall of the boathouse: Fig 12

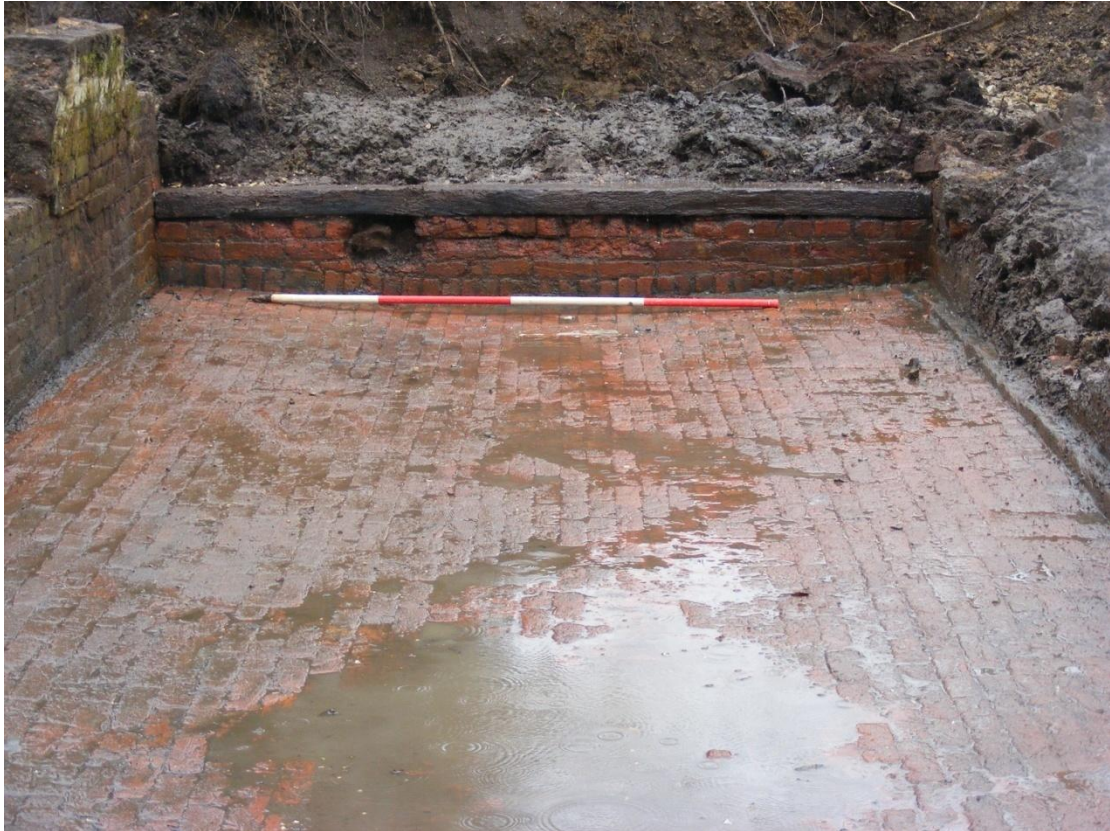
An oak sill beam 3.02m long by 0.2m wide and 0.10m thick, extended across the full width of the rear of the boathouse (Fig 13). The beam lay approximately 0.36m above the floor. Directly below the beam was a roughly square aperture in the brickwork. This measured approximately 0.20m deep by 0.27m wide, and may have been an inlet for water from the drainage ditch behind the boathouse. Levels taken on the floor suggest that the maximum depth of water in the structure was 0.72m.

The rear wall of the boathouse: Fig 13

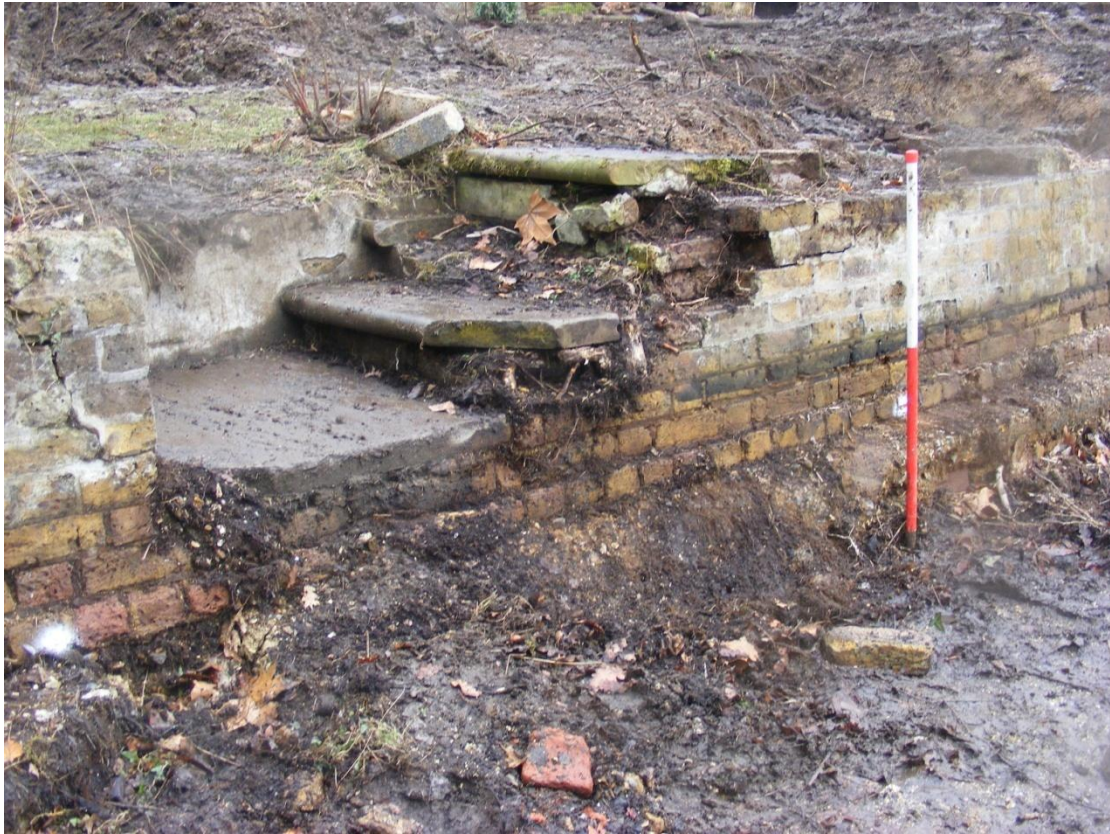
A brick-built retaining wall extended from the western side of the boathouse up towards the northern end of the lake. This was constructed in English Garden Wall Bond using bricks similar to those used in the boathouse. The wall was of double brick thickness approximately 0.22m thick and was a maximum of 1.0m high. Adjacent to the boathouse four stone built steps were set into the wall, the lowest being 31.89m aOD, approximately 0.09m above the water level in the lake (Figs 2, 14 and 15).

The retaining wall and steps adjacent to the boathouse: Fig 14

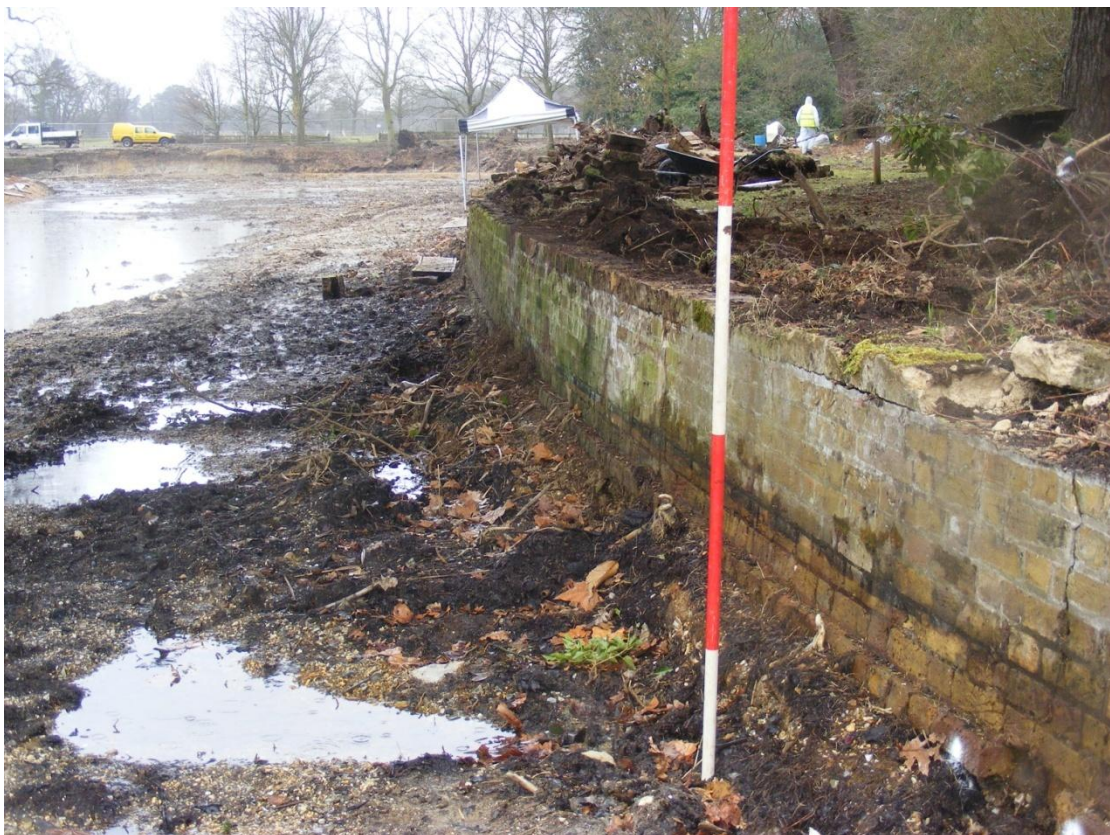
The retaining wall, looking to the north: Fig 15

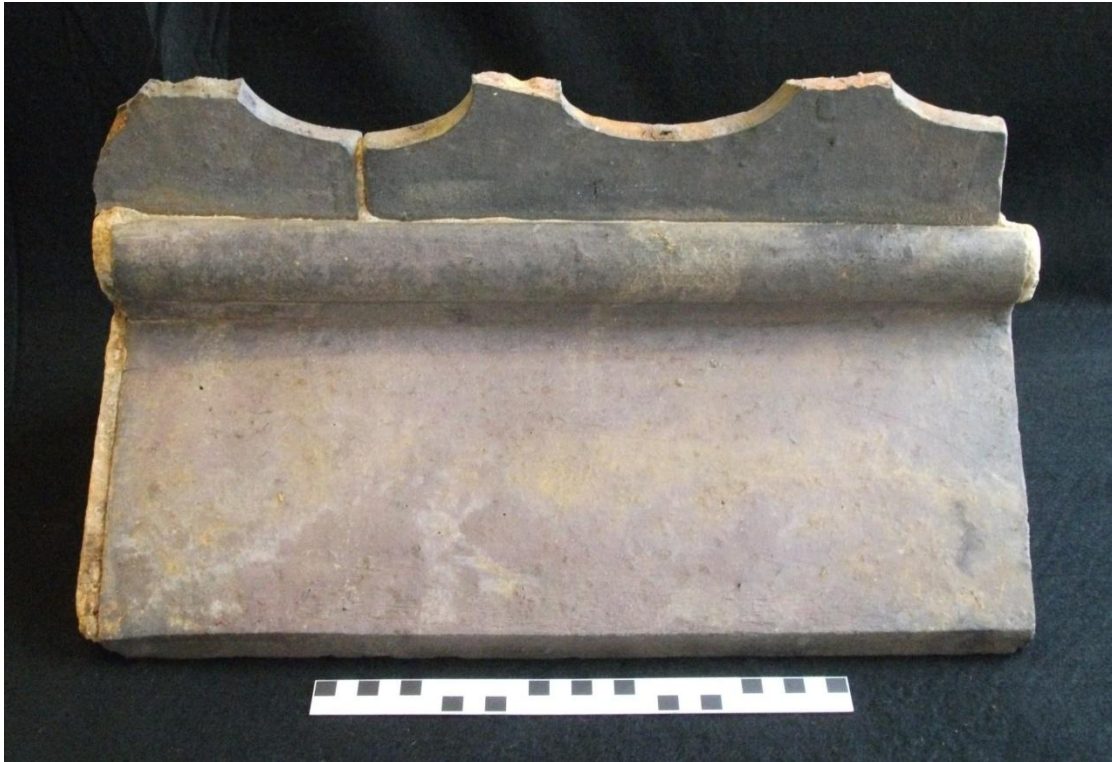
The ridge is an almost complete angle open roll top ridge tile, with the crest tops broken off (Fig 16). It is made from mauve-brown clay fired to a blue-black surface. The basic ridge is 450mm long, 260mm wide at the base and 100mm high internally from base to apex and 17mm thick (17<sup>3</sup>/<sub>4</sub> x 10<sup>1</sup>/<sub>4</sub> x 4 inches x <sup>5</sup>/<sub>8</sub> inches) the angle of the apex being 105°. Above the apex of the ridge is the open roll top, 50mm (2 inches) in diameter, with a 17mm wide opening along the top into which the length of decorated crest, made separately, was slotted and cemented in. The complete crest is 310mm (12<sup>1</sup>/<sub>4</sub> inches) long, about two-thirds of the length of the ridge tile, comprising two peaks separated by a shallow concave curve and surviving to 60mm (2<sup>3</sup>/<sub>8</sub> inches) high. Only the part of the next crest survives, to the edge of the tile.

The tiles collected from the boathouse are of 19<sup>th</sup>-century date and of a standard form, however, the ridge tile has the interesting feature of having an open roll in order to insert the decorative crest of choice.

The ridge tile: Fig 16

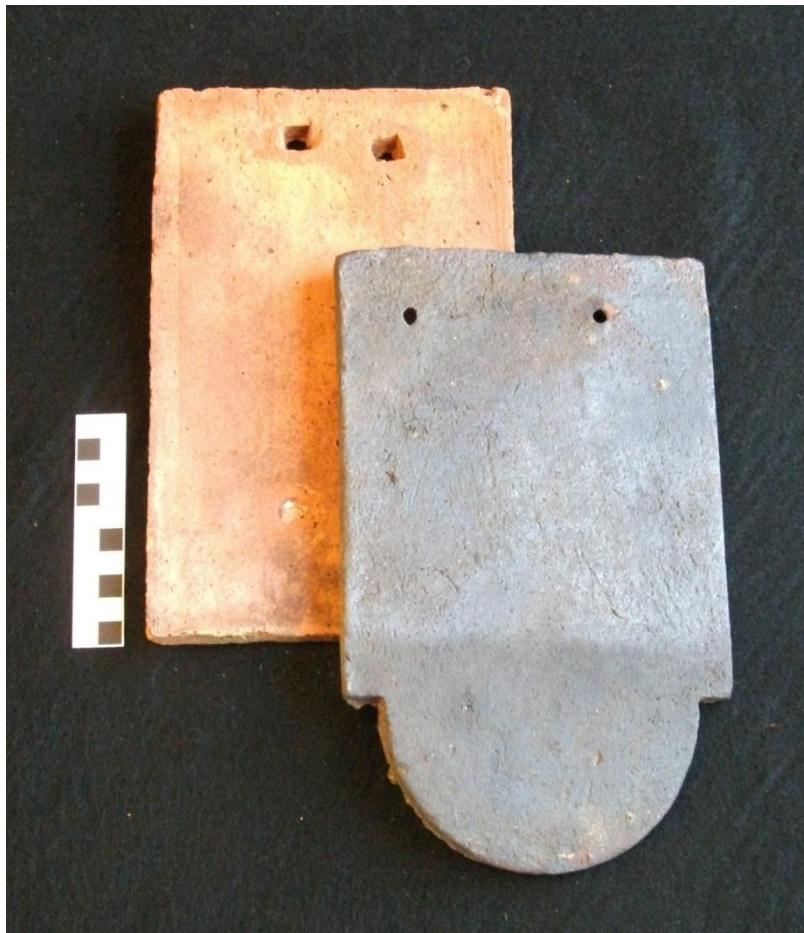
The flat tiles comprise one plain and one decorative (Fig 17). The plain tile is made from hard coarse sandy orange clay with occasional calcareous inclusions. It measures 245 x 155 x 12mm (9<sup>5</sup>/<sub>8</sub> x 6<sup>1</sup>/<sub>8</sub> x <sup>1</sup>/<sub>2</sub> inches) and has two closely spaced

slightly offset 12mm square peg-holes. The decorative tile has been cut as a fish scale and has been fired to blue-black, similar to the ridge tile. The tile is longer and wider than the plain tile, but thinner, measuring 260 x 160 x 10mm, though the scale is 68mm of that length and 130 wide (10¼ x 6¼ x ¾ inches; scale 2⅝ x 5⅛ inches). There are two oval peg-holes 10 x 15mm, but there are also three nibs, equally spaced, which have been sheared off. This type of tile began to be used during the 19th century, when the introduction of machinery greatly increased output, and tiles could be cut to order, surviving catalogues show these as part of their selection (van Lemmen 2003, 9-11).

The flat roof tiles: Fig 17
