Archaeological building recording at Yew Tree House and Yew Tree Cottage Biddulph, Staffordshire

Report 10/32

February 2010

**ARCHAEOLOGICAL BUILDING RECORDING AT
YEW TREE HOUSE AND YEW TREE COTTAGE
BIDDULPH, STAFFORDSHIRE
DECEMBER 2009**

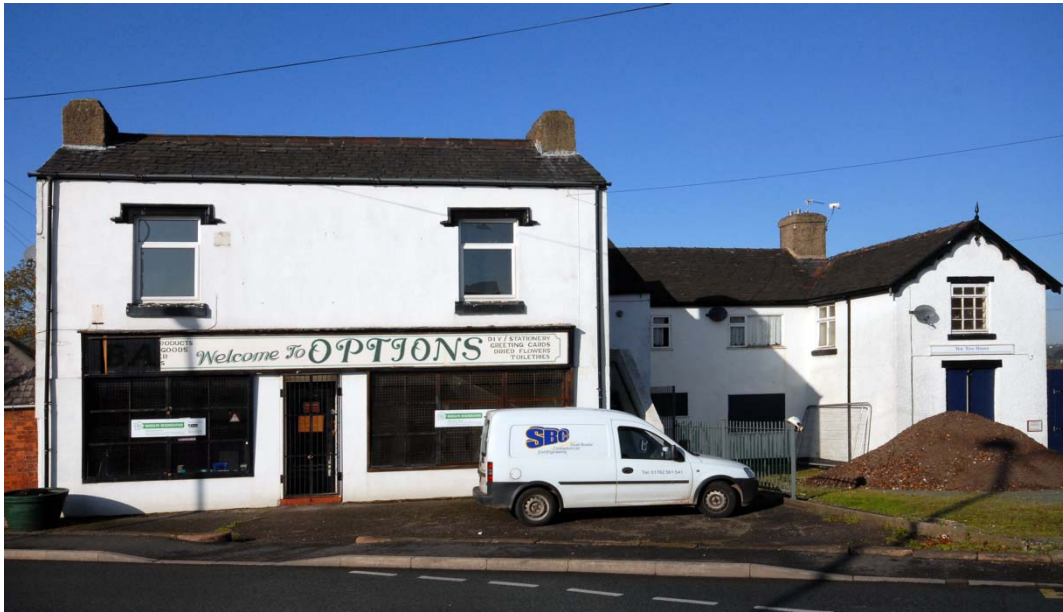
0011 The Wharf Road frontage of Yew Tree House Fig 3

The earliest extant building appears to be constructed of coursed or roughly-coursed local limestone and brick beneath a slate roof and comprised a simple, two-cell cottage which at the time of recording formed the front entrance spaces of a recently-vacated hardware shop (G1 and G2; Fig 3). All former division between the two rooms had been removed (Fig 4). A difference in the interior proportions of these rooms suggests that formerly stairs may have lain at the back of G1. Neither room contained any historic features, the whole having been ripped out to form the sales-space, although there was evidence that both rooms were once heated by a fireplace in each of the gable ends, in the form of corbels inserted to support bedroom fireplaces above. At first floor level the forward-facing windows had original stone drip-mouldings above them.

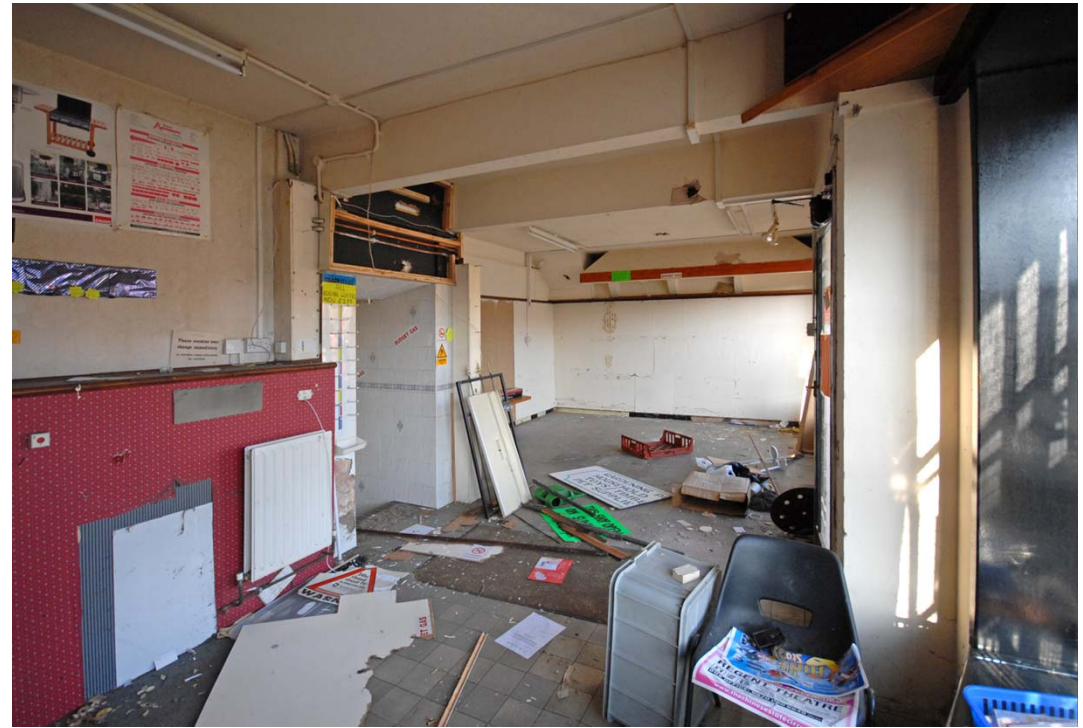
0053 The former shop interior Fig 4

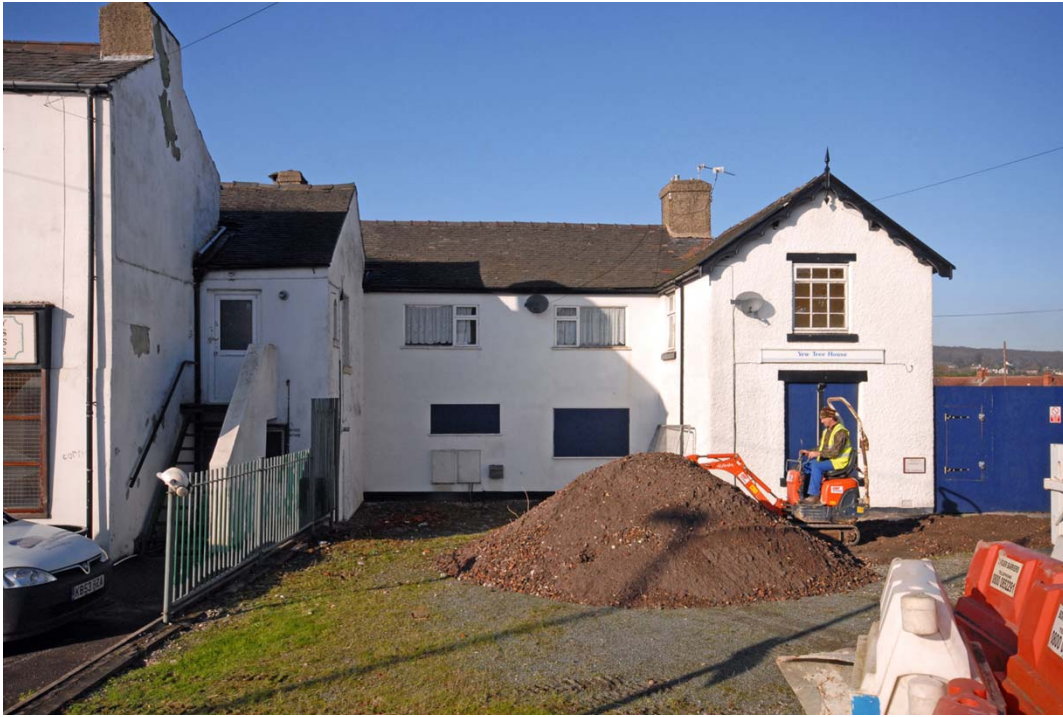
0012 The domestic front of Yew Tree House Fig 5

It seems that that at about the same time or a while after, a second property was constructed to the north-east, hereafter referred to as the north-eastern property (Fig 5). This appears to have consisted of a building with an L-shaped plan, which at the time of recording was fitted out as parts of two separate homes. No interior historic fixtures or fittings survived; all the interiors here were modern (G3, G4, G5 and G6). Of note, however are the ornamented exterior bargeboards on the gable end above G4, which are unlikely to post-date the Victorian period. It also had a single chimney at the centre of the ensemble, in the east wall of G6. This building is felt, therefore, to be of 19th century origin. It had been extended and split in recent times to become parts of two domestic dwellings, G3, G4 and G5 going together, with G6 being allied to spaces of another dwelling further south-west.

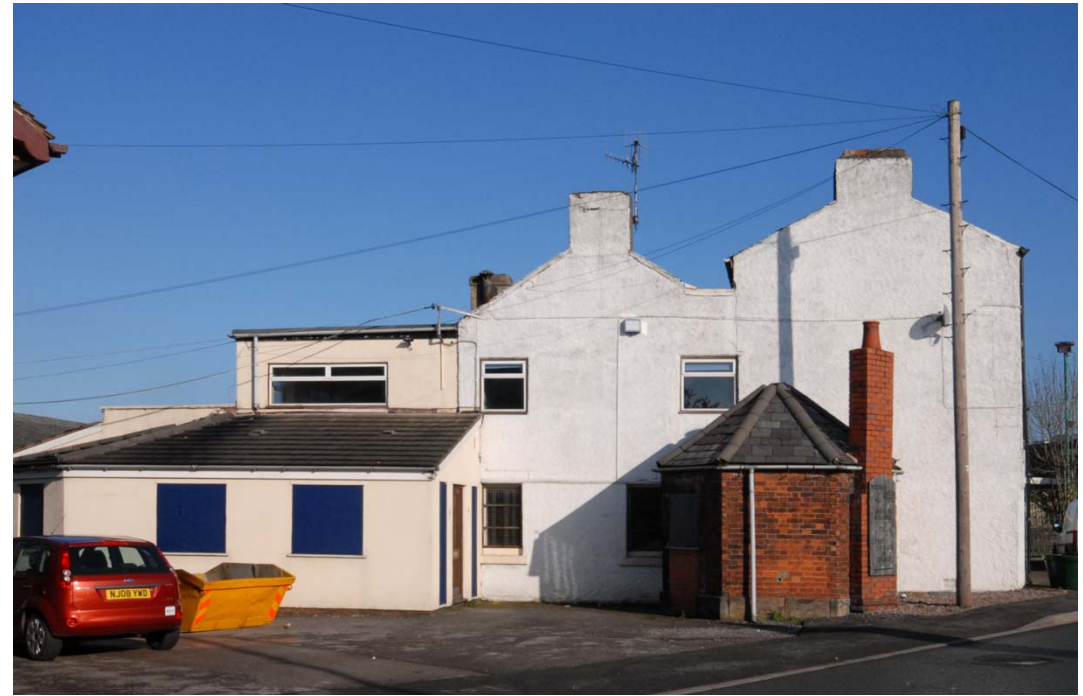
0007 Side view of Yew Tree House Fig 6

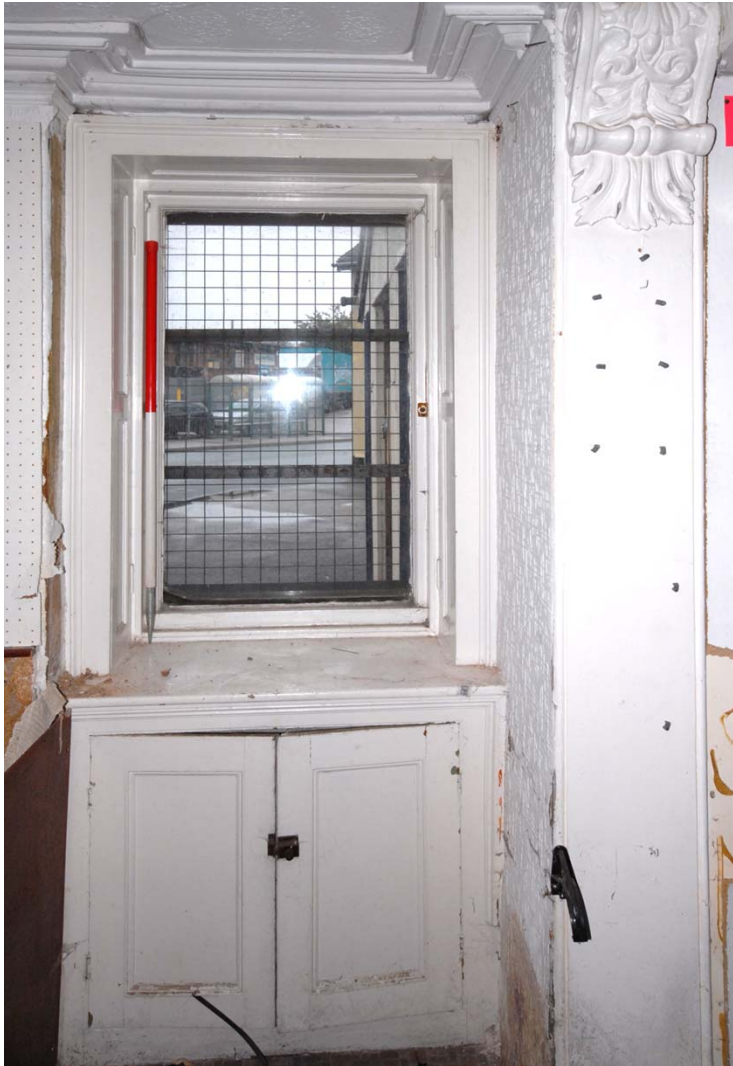
0089 Cupboard window and decorative plasterwork in Best Room G7 Fig 7

Behind G1 and G2 was built the first of a number of extensions (G7 and G8). Their addition may have taken place in such a way as to leave the functioning of G1 and G2 almost unaffected since the new work comprised a similar, but larger pair of rooms with their own free-standing gables, simply added eaves-to eaves, with an awkward roof-valley thus running between them (Fig 6). In room G7 lay the only historic features noted anywhere in the property, comprising neatly-slotted in cupboards either side of the south-western gable fireplace (Fig 7). To the rear was an arch with some decorative plaster consoles or brackets (Figs 7 and 8). The entire room also contained a relatively

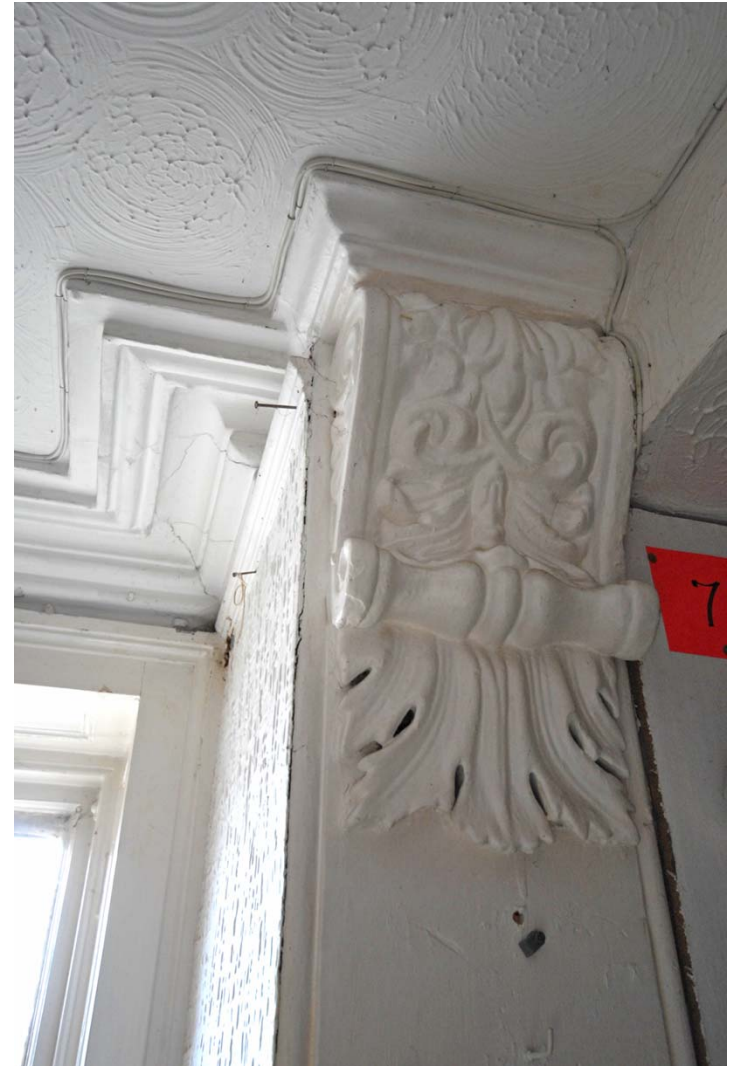
0056 Detail of plaster console bracket and cornice in G7 Fig 8

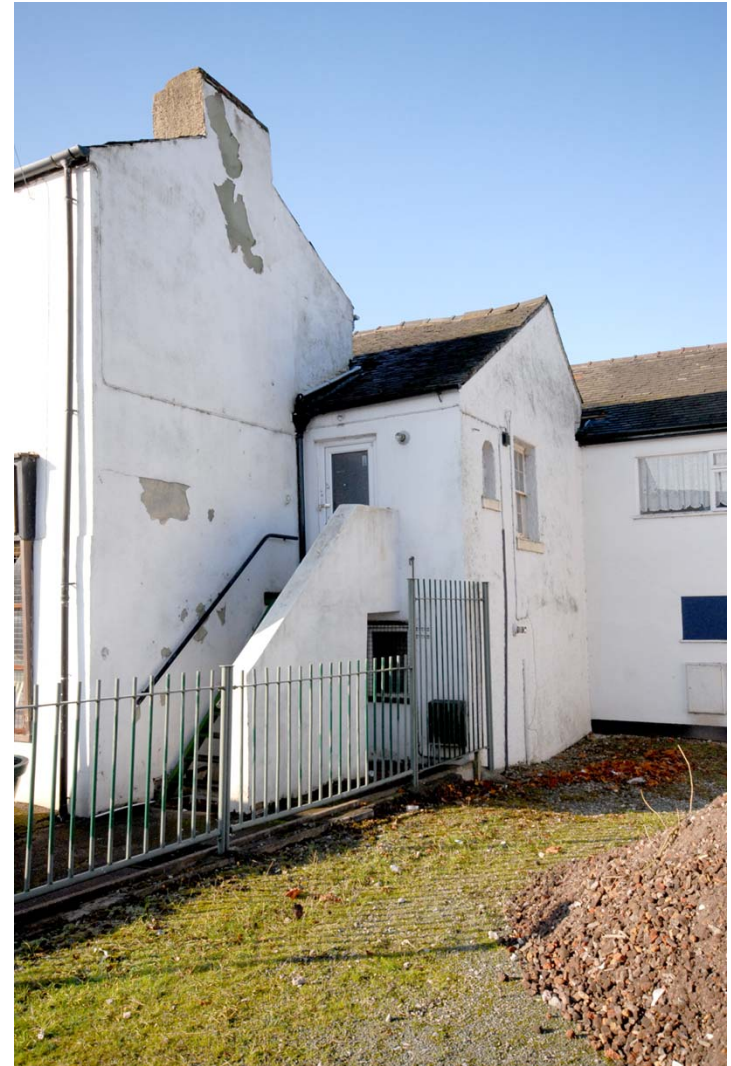
0013 Stair to upper floor flat Fig 10

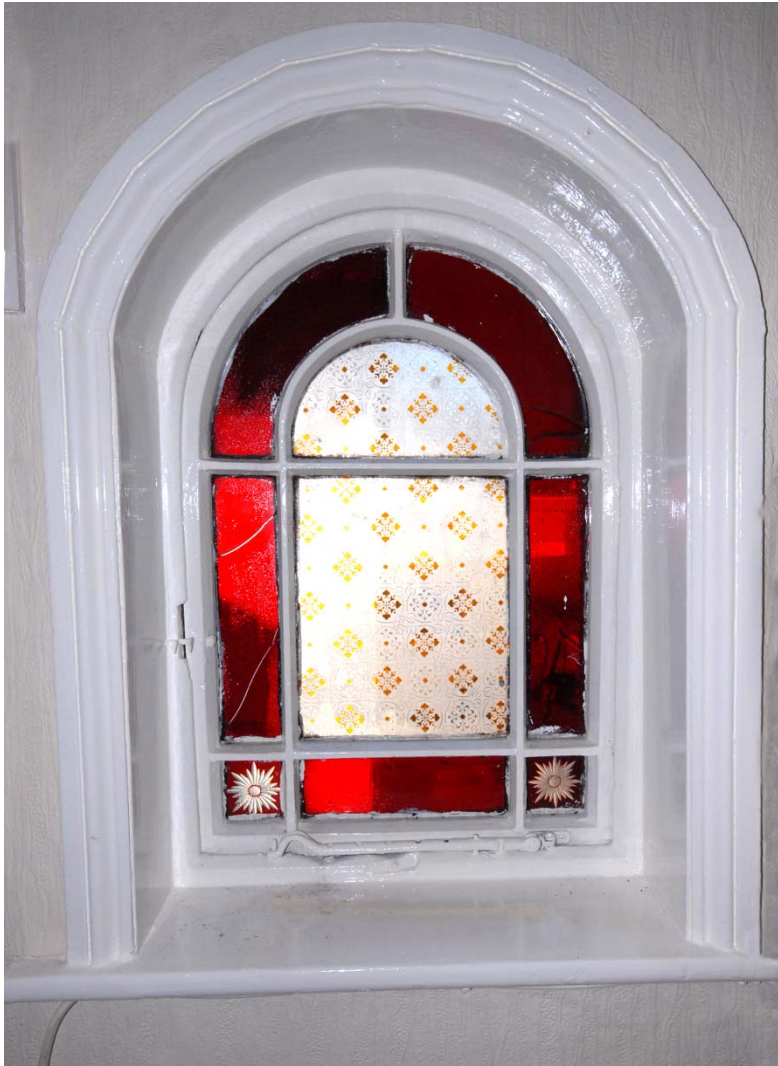
0040 Late Victorian window at top of stairs Fig 11

The abovementioned showroom function which took in the first extension of G7 and G8, was in fact twice as large as both of those rooms, incorporating also room G9. This doubled as a store and was two-storeyed, of brick but lined on the inside with block-work and beneath an asphalt flat roof (Fig 9). The flat roof may have been a later alteration, since it appears stylistically in keeping only with the 1970s or 1980s outfitting of the interiors and little else, but structurally this was unclear. To the north-west once looked four windows on either side of the northern rear doorway. These were subsequently blocked. This huge space was otherwise featureless. Possibly contemporary was a store to the north-east (G10) with a WC at one end. This appears to have once framed a large doorway in the east wall, later blocked and the first floor was accessed by an external flight of stairs, still in use since the first floor had been converted into a self-contained dwelling independent of the shop below (Fig 10). At the entrance to the first floor was a single window of perhaps c1900, with a round-arched head and both etched and stained glass (Fig 11).

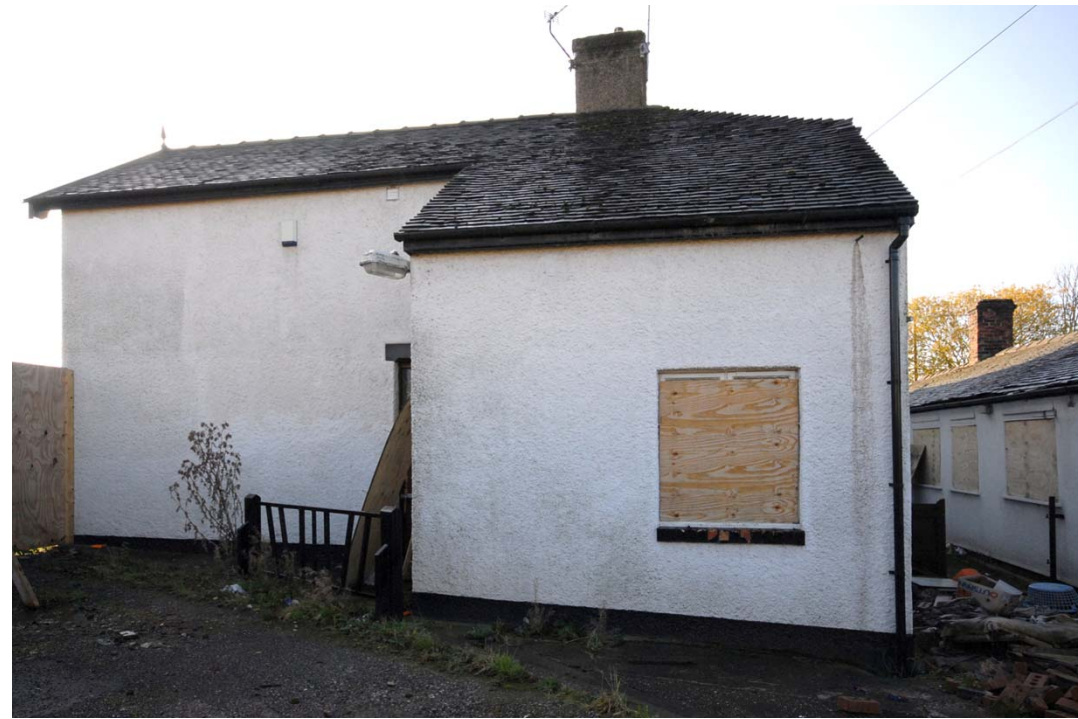
0016 Outshut to form kitchen G5 Fig 12

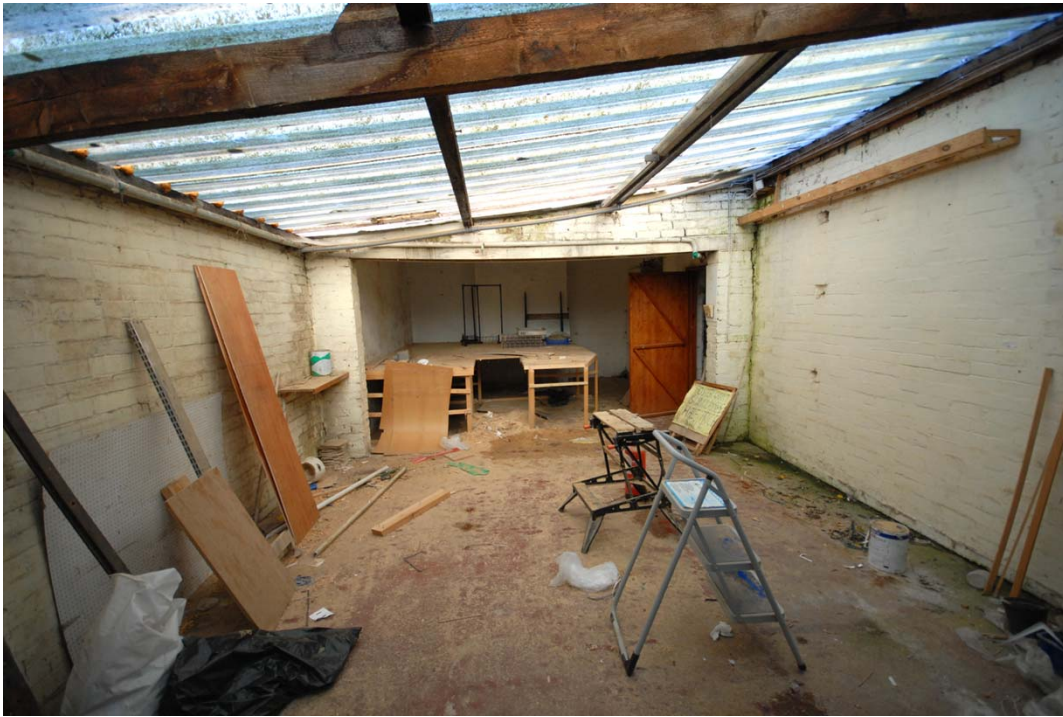
0058 View along workshop G12 (foreground) and 12a (background) Fig 15

second, former opening directly opposite this within G12 once looked into the yard (Fig 15).

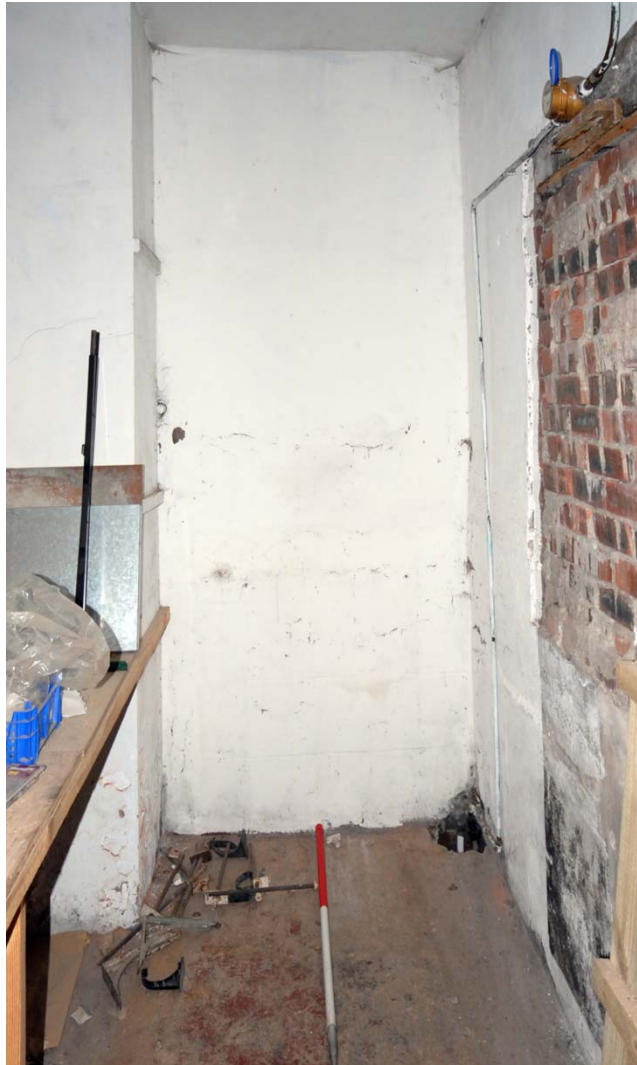
0090 Location of possible former copper in G12a, blocked window...

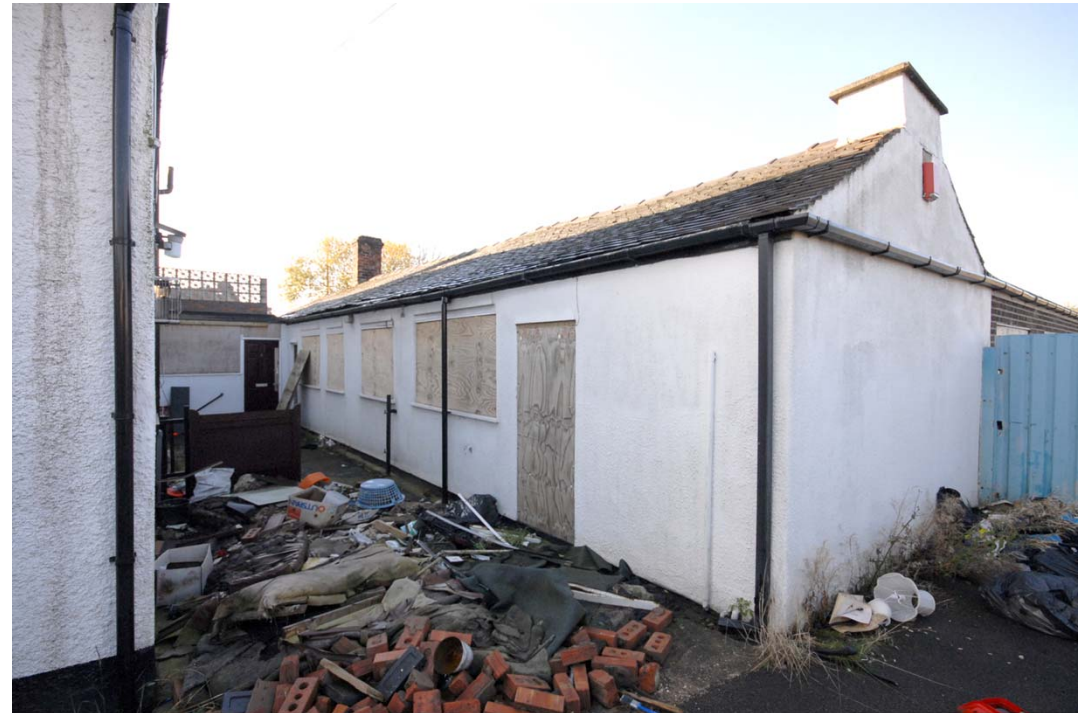
0019 Workshops G14 exterior from east Fig 16

The eastern end of the range consisted of a second ancillary building of five unequal bays (G14; Fig 16). At each end stood a small chimney, which on the west had hacked into the back of the fireplace in G12a and borrowed its chimney stack. A series of windows in wide niches punctuated the south wall. The whole building was formerly used as a garage but the proportions and layout are redolent of a stable-block (Fig 17). Further, modern garage workshops open out off its northern side at the east end (beyond the area of recording).

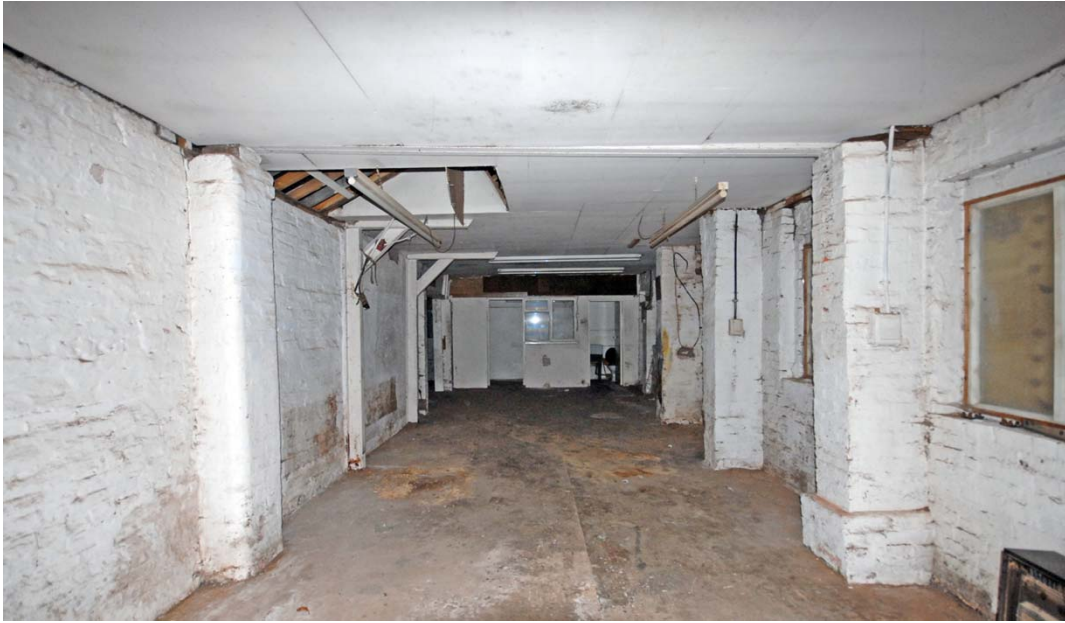
0024 Workshops G14, interior Fig 17

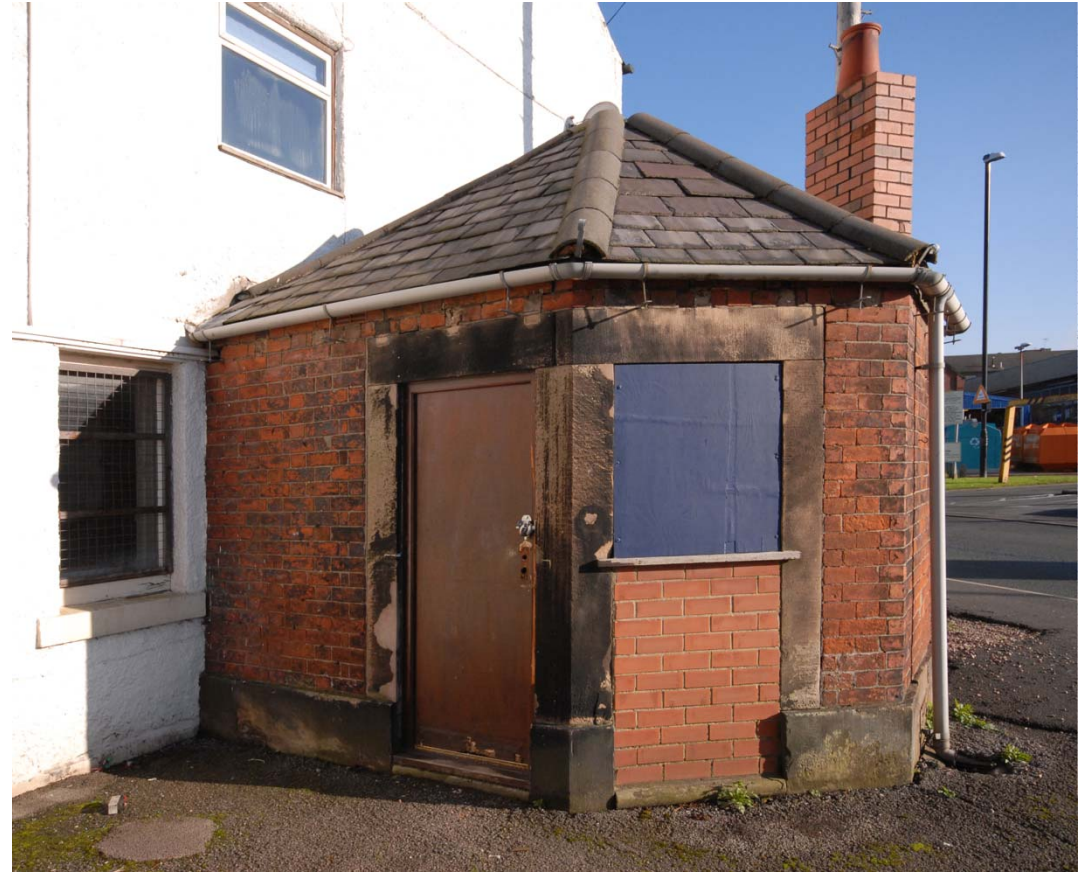
0050 Multiangular watch-office G15 Fig 18

To the far south west corner of the whole complex, probably at around c1900 or soon after, was added a multangular smooth-faced brick structure under a slate roof (G15; Fig 18). It is the only building in the entire ensemble not to have been rendered. It originally connected with the interior of G7 via a doorway, but this was later blocked up. It formerly had a single window facing north-west and a fireplace in the south-west angle. It seems to have served as a watch-office, probably relating to the former haulage business which worked out of the yards and sheds behind the complex; it still contained numerous keys on the wall. Its interior had been fully stripped of any historic features and was boarded out.

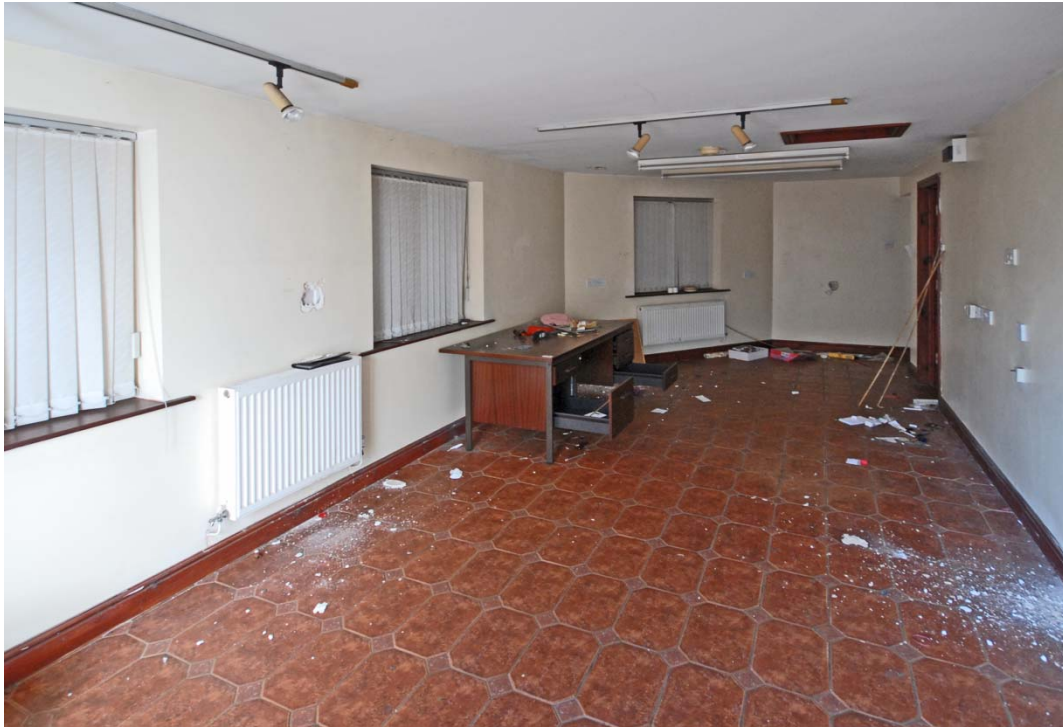
0043 Office G17, interior Fig 19

On the west side of the buildings was a long low building with a distinctive forty-five degree angle at its northern end (G17; Fig 9). This may be of the 1930s although very little of its brick was visible under a 90-percent modern render. A former doorway had been blocked in its west wall using Staffordshire blue engineering bricks. The interior comprised a modern office, store, kitchen and WC (Fig 19).

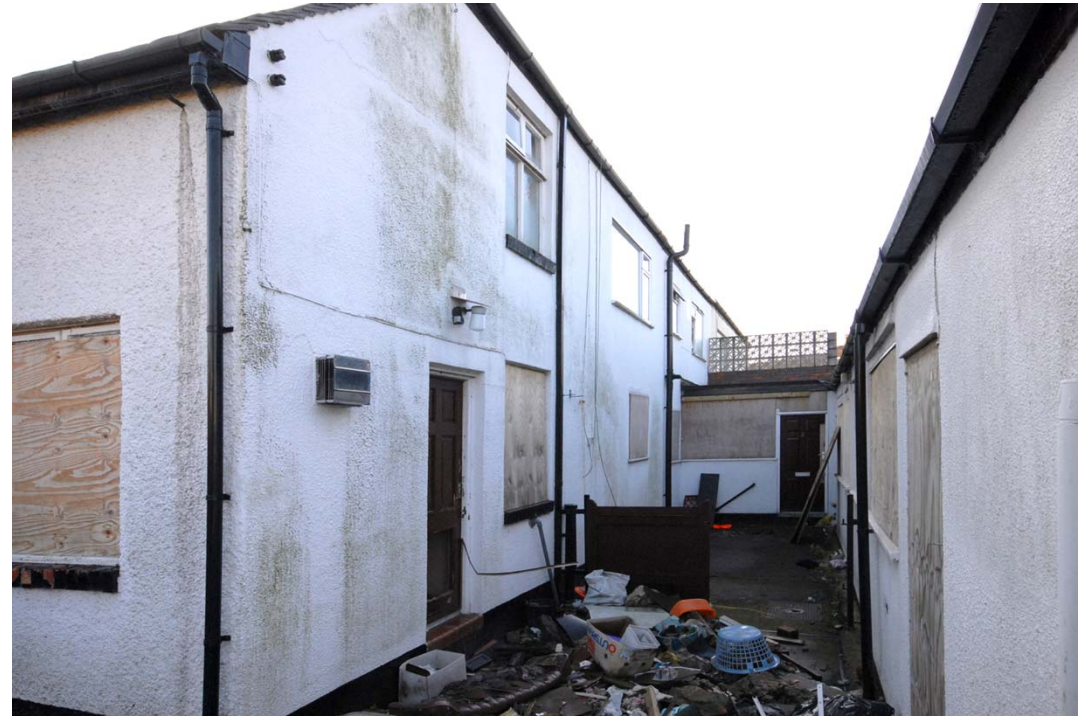
0017 View west between house (G5) on left and workshops (G14) on right Fig 20

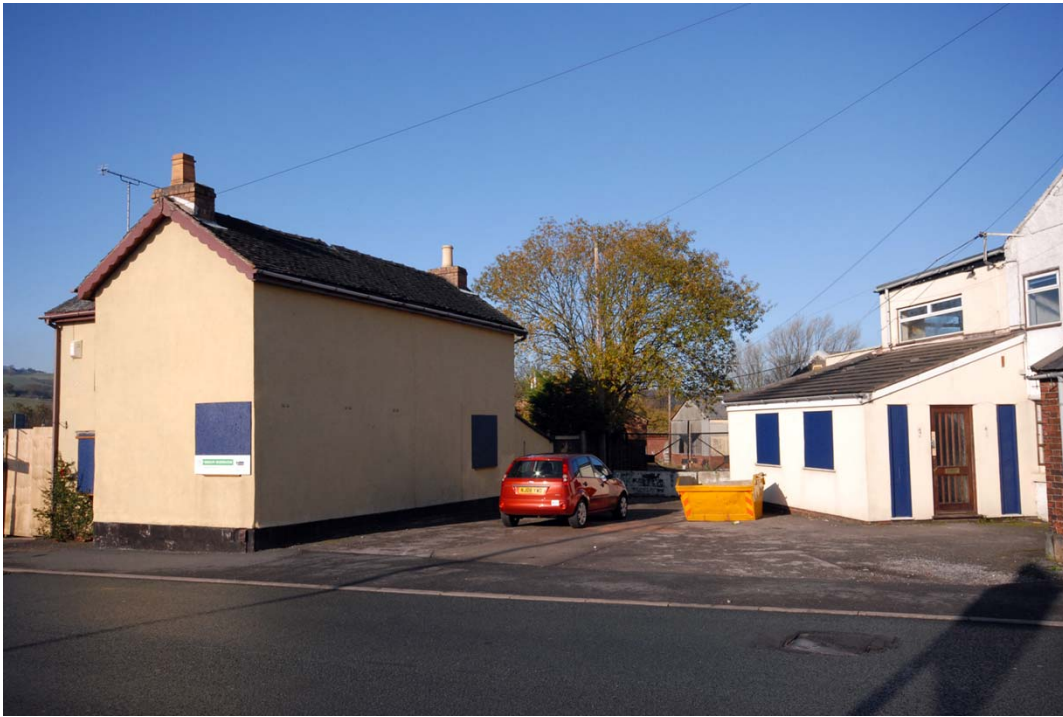
0009 Yew Tree Cottage from across Wharf Road; note distance and angle from Yew Tree House on right Fig 22

Yew Tree Cottage stood a short distance from its larger neighbour and was always separate (Fig 22). It seems to have begun life as a brick building, T-shaped in plan, which downstairs comprised four rooms. All survived as simple spaces but not without total interior reworking, so that no historic features, fixtures or décor had survived. Upstairs two bedrooms and a bathroom, probably in their original layout, were similarly

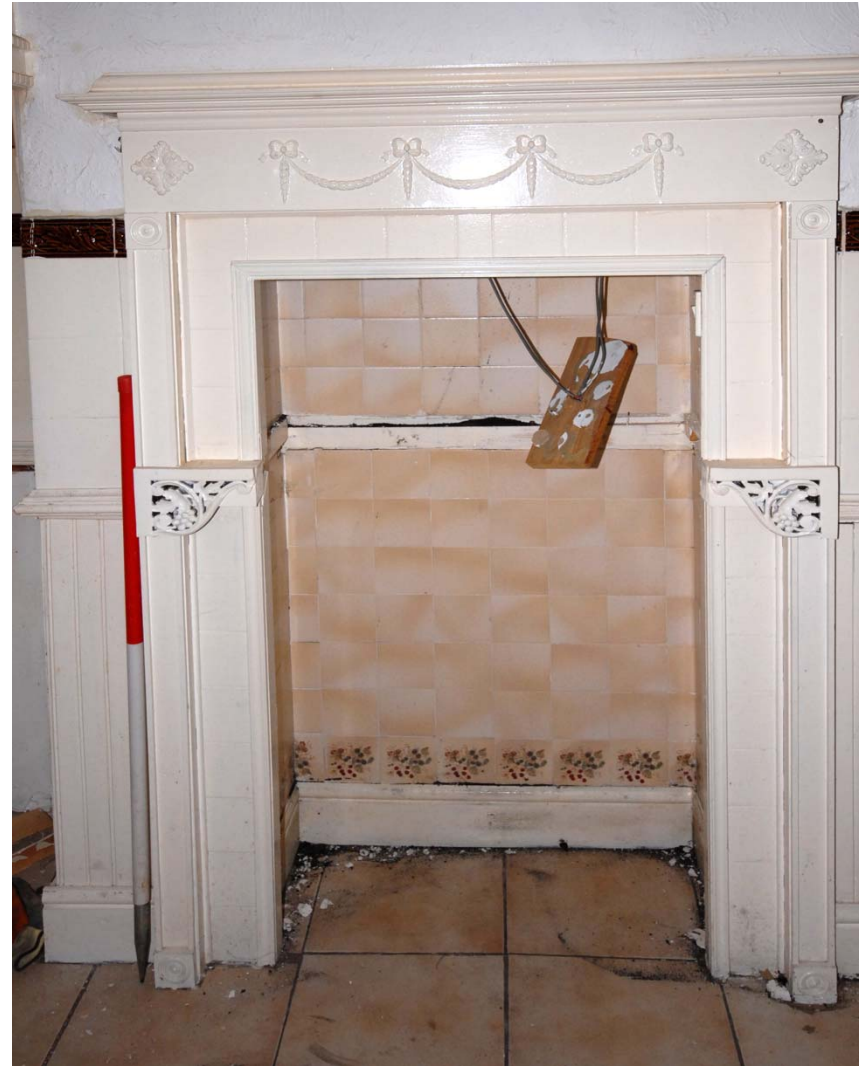
0091 Yew Tree Cottage: mock victoriana fireplace in kitchen G2 Fig 23

devoid of historic features. In fact the only 'character feature' comprised a faux- or mock-Victorian fireplace surround in the kitchen proper (G2; Fig 23).

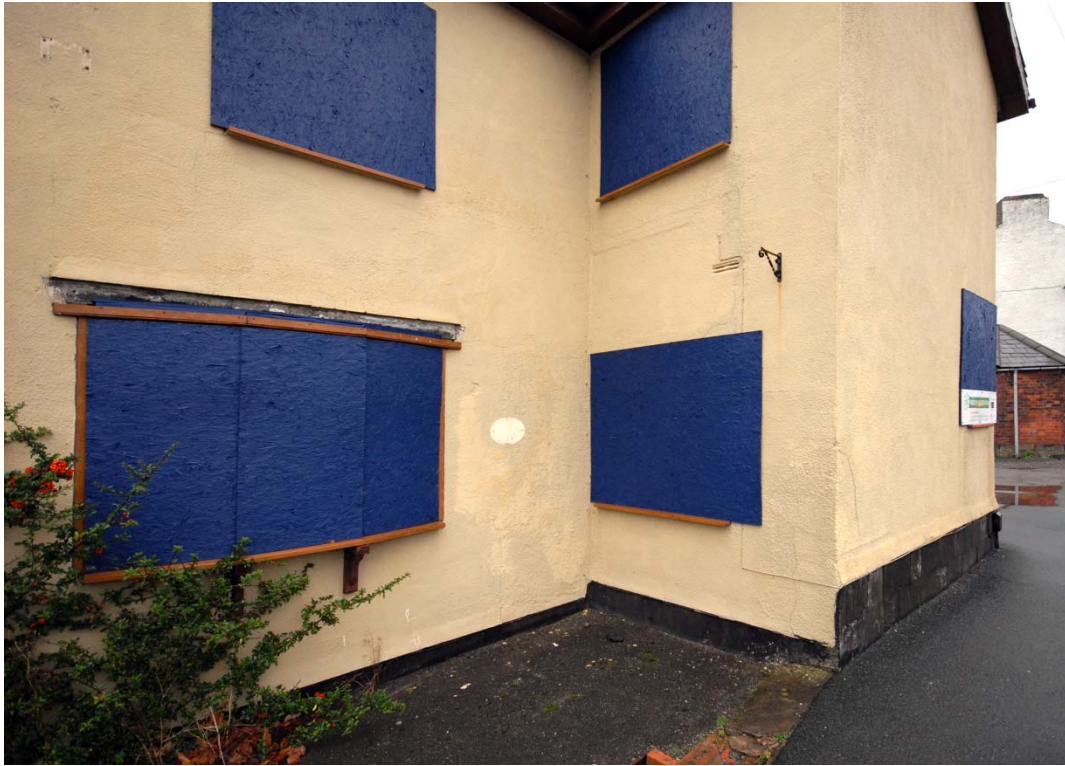
0086 Wharf road frontage; central location of former porch and entrance Fig 26

While the doorway through the porch was at the time of recording the only way into the building, above it cracked render and a canopy scar in the front angle of the building's gables denote the former presence of a front entrance (Fig 26)

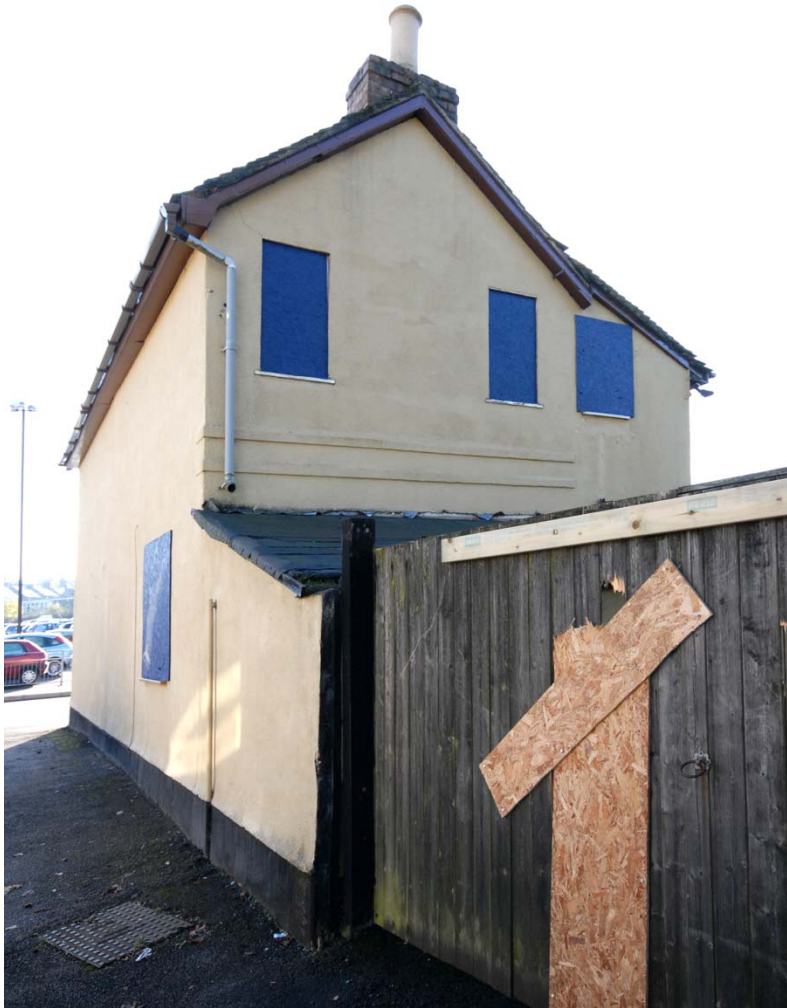
0045 Yew Tree Cottage from rear, not outshut in centre Fig 24

The building had been extended by the addition of a single-storey outshut on the north-west (G5; Fig 24). Originally lit by two windows, one of these had subsequently been blocked.

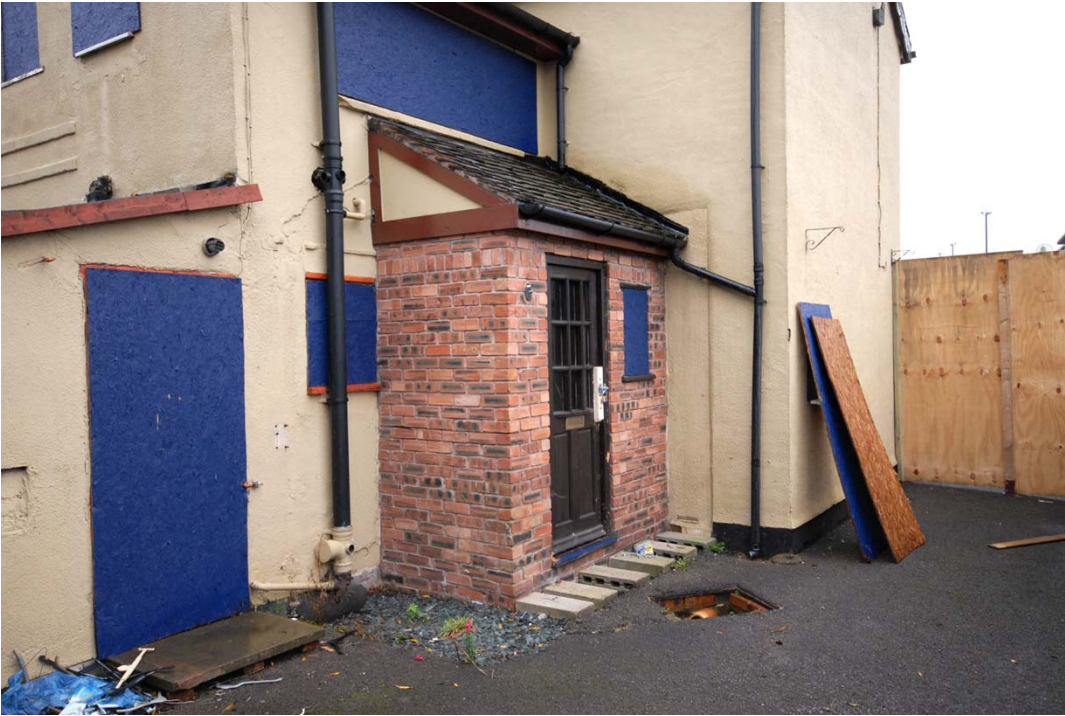
0087 The existing porch and the scars of its larger predecessor Fig 25

The entrance to the building on the south-west side, had originally been by a large porch with a pitched roof of its own. This had been demolished leaving reduced foundations at ground level and a roof scar above the doorway to the kitchen annexe. It was, however, being replaced by a smaller brick porch which was still unfinished at the time of the building's dereliction (Fig 25).
