Archaeological evaluation (Phase 1) at Bury Ground, Bury, Greater Manchester

Report 10/28

February 2010

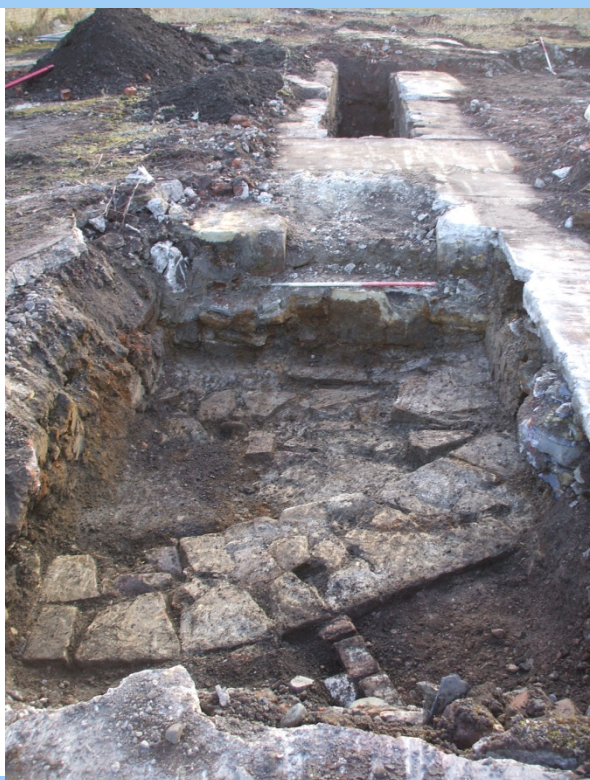
Cover: View of Trench 1, looking south

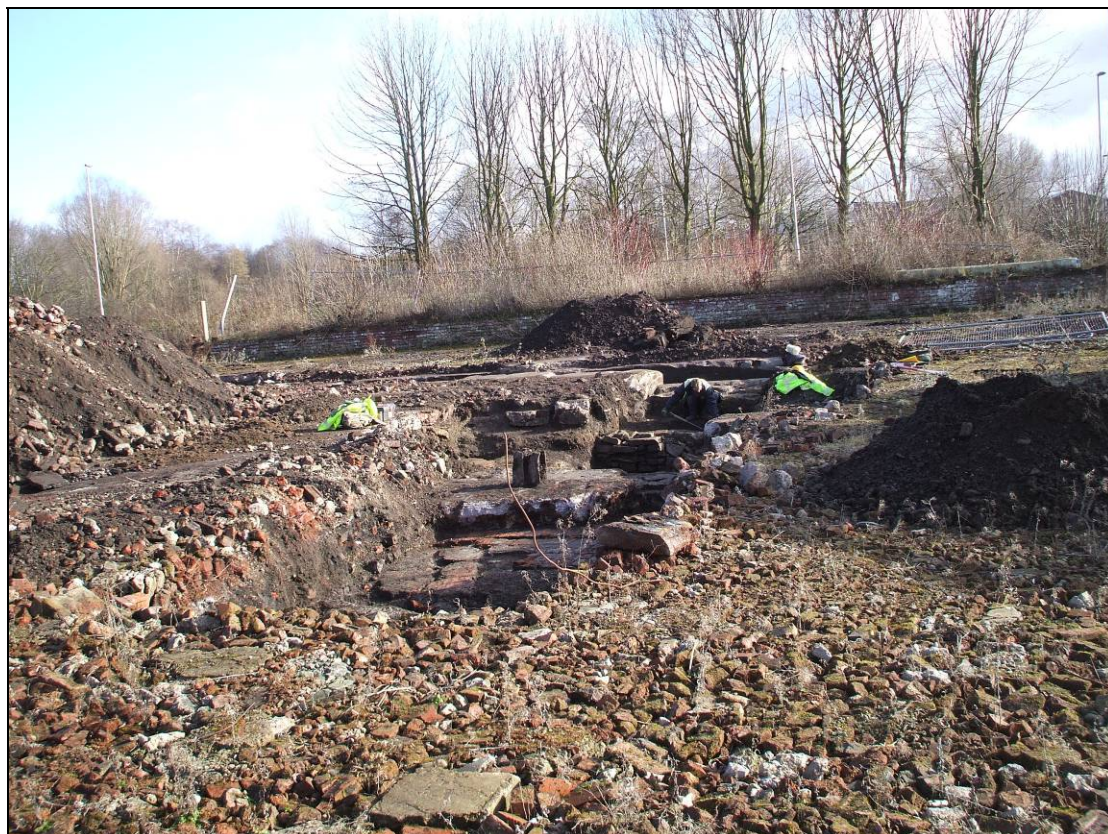
The Bury Ground site lies c 0.5km north-west of the centre of Bury. It is bounded by parkland to the north, the A58 to the south, a construction site for a new police station to the east and the River Irwell to the west. The development area (c 2.3ha) is currently a levelled demolition site with most of the existing ground surface comprised of brick rubble (Fig 3).

View of northern development area, looking east Fig 3

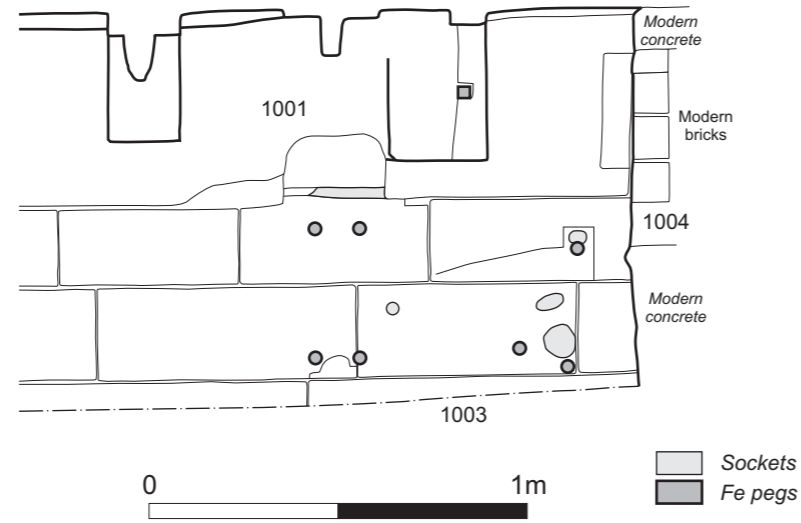
Section 1
S N

Elevation showing the interior of culvert [1001] with iron pegs and housings cut into the stonework

Iron pegs protruding at intervals from rectangular slots cut into the face of the culvert's walls suggest that something, perhaps machinery or brackets, were originally housed within the channel (Figs 4, Section 1; 8 and 9). Circular, square and rectangular sockets were also cut into the tops and sides of the walls - some had lead linings.

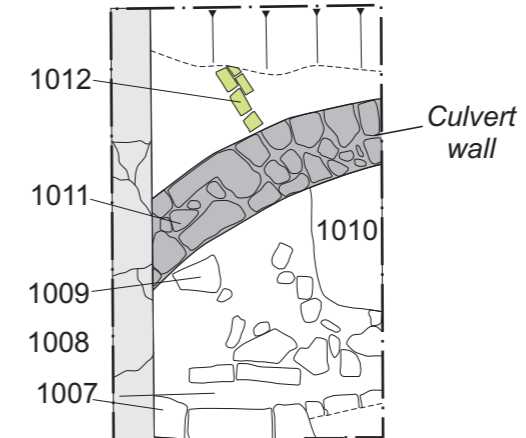
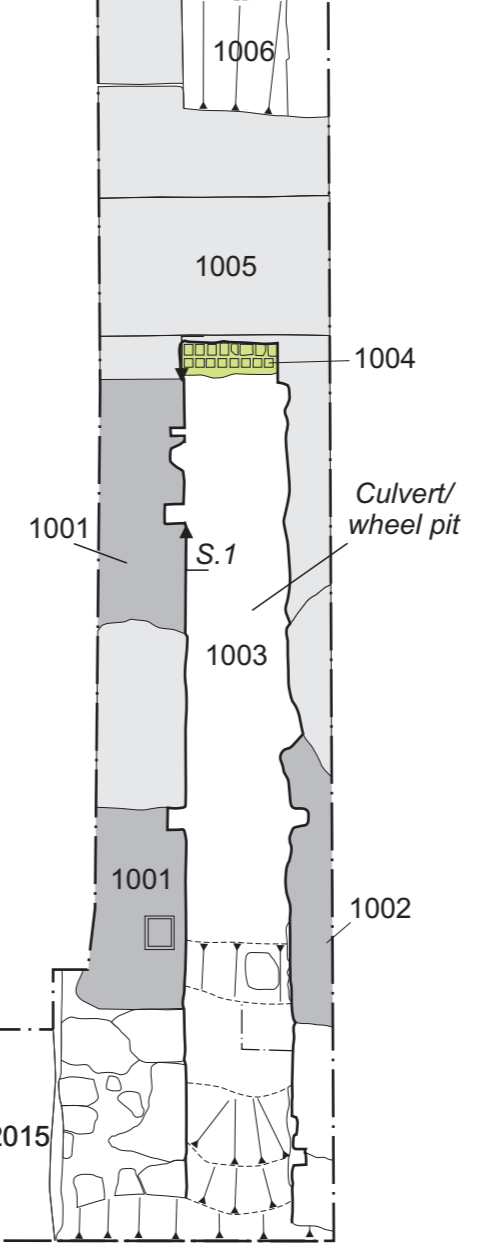
Plan of Trenches 1 and 2 and elevation of culvert/wheel pit Fig 4

Trench 1 (15m x 2.1m; Fig 4) was aligned north to south and was located to evaluate a channel associated with the goit and to assess the potential for survival at the northern end of the site (Archaeo-Environment 2008, 50).

Trench 1

Trench 2

Trench 2 (15m x 2.1m with a 1.8m x 4.5m extension to north; Fig 4) was aligned east to west and had been located to evaluate remains associated with the northern end of the linear workshop and a water channel aligned south-west to north-east across the northern part of the site (Archaeo-Environment 2008, 50).

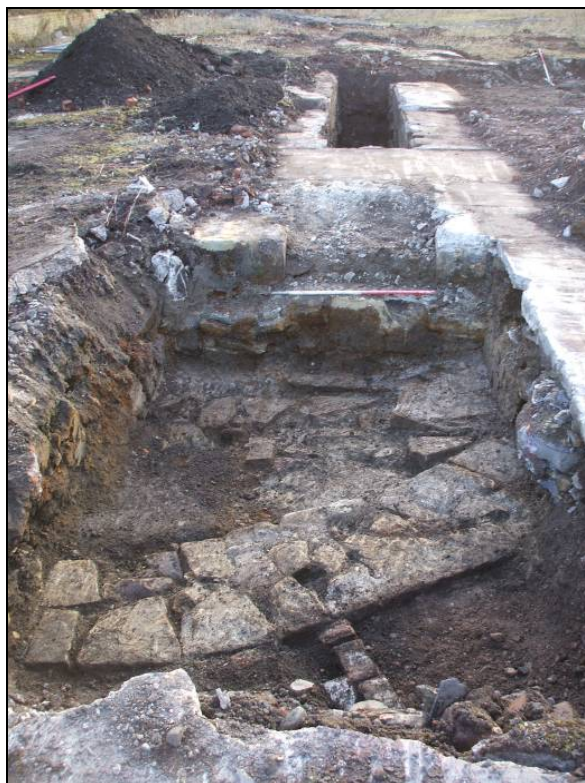
The earliest feature was a section of wall foundation [1011] that curved south-west to north-east in the extreme northern end of the trench (Fig 5). It was 0.75m wide and constructed from roughly-hewn blocks of yellow sandstone bonded with off-white lime mortar. To the north, and of later date, a single row of bricks [1012] abutted the foundation. To the south, and clearly associated with the earlier feature, was a crude surface of irregularly-shaped, flat sandstones (1009). Together these probably represent the severely truncated remains of the water channel first depicted on the Elton Tithe Map of c 1820 (ibid, fig 5).

Wall foundation [1011] for an early 19th-century culvert,
looking south Fig 5

The earliest identifiable remains appear to be related to leats or culverts first depicted on the Elton Tithe Map of 1820 (Archaeo-Environment 2008, fig 6). In Trench 1 the location and alignment of a curving wall foundation corresponds with a watercourse that projects westwards from the goit. Similarly, a substantial sandstone wall in Trench 2 corresponds with a watercourse that adjoined the River Irwell to the north of a building, annotated as 'Millwright's Shop' on the Ordnance Survey map of 1847 (ibid, fig 8). Both

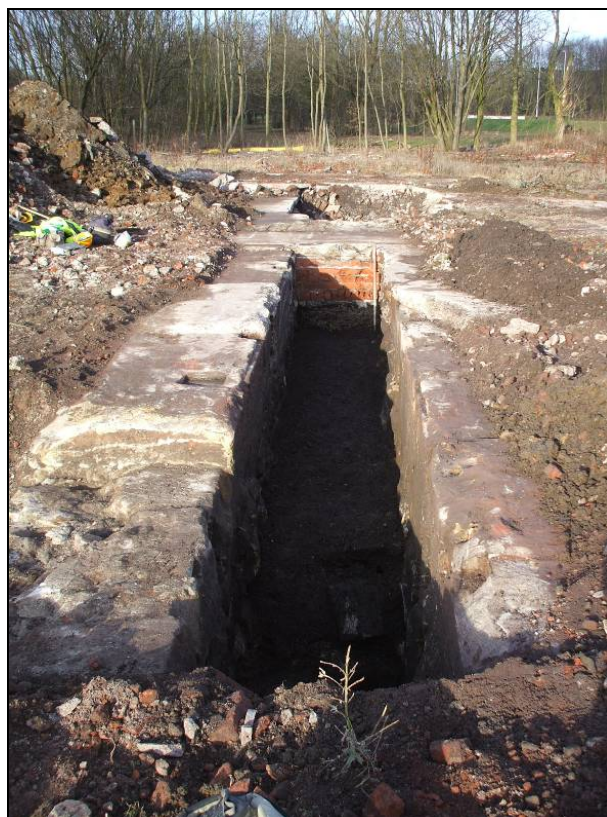
Culvert/wheel pit in Trench 1, looking north Fig 6

The culvert, or wheel pit, comprised a pair of parallel north to south walls [1001/1002] constructed from massive yellow sandstone blocks [1001/1002] measuring up to 2.0m x 1.2m x 0.50m and enclosing a 1.0m-wide channel (Fig 6). The channel was filled with a homogenous loose dark grey clinker and loam (1003) - probably imported to backfill the feature when redundant. This was excavated to a depth in excess of 2m without reaching the base of the feature (Fig 7).

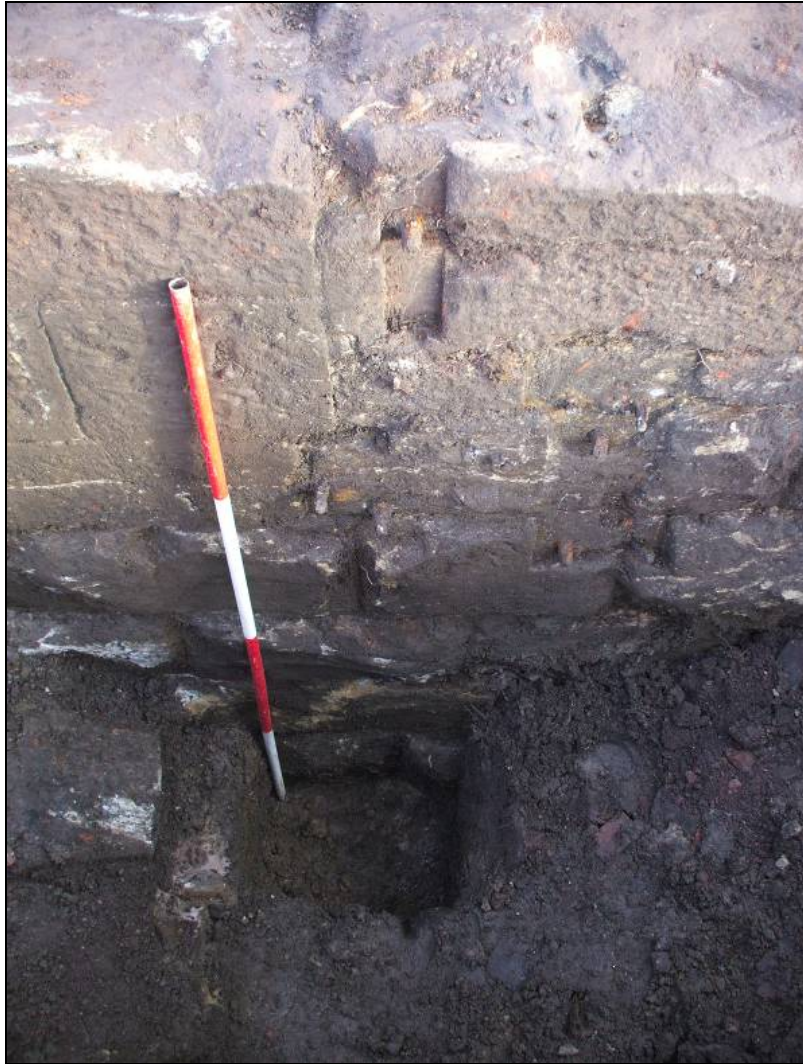
Elevation of east wall [1002] of culvert/wheel pit Fig 7

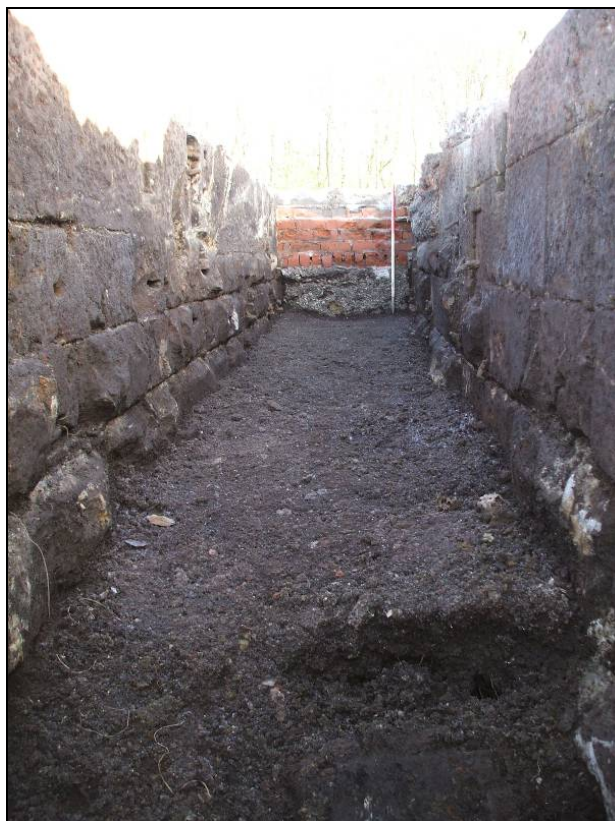
The northern end of the culvert was either truncated, or perhaps capped, by a massive concrete slab [1005] and brickwork [1004] that most probably relate to the factory rebuilds of the 1930s and 1950s.

View of culvert/wheel pit, looking north Fig 8

Although this feature resembles a wheel pit, the presence of iron pegs and slots along its interior face suggest that a number of brackets were attached to its interior, perhaps to hold calico 'ropes' - sheets of the fabric rolled lengthways to resist tearing during the bleaching and dyeing process (ibid, 24). As such the culvert could have carried water or any one of a number of liquid solutions used by the industry; or perhaps acted as a drain to remove waste products.

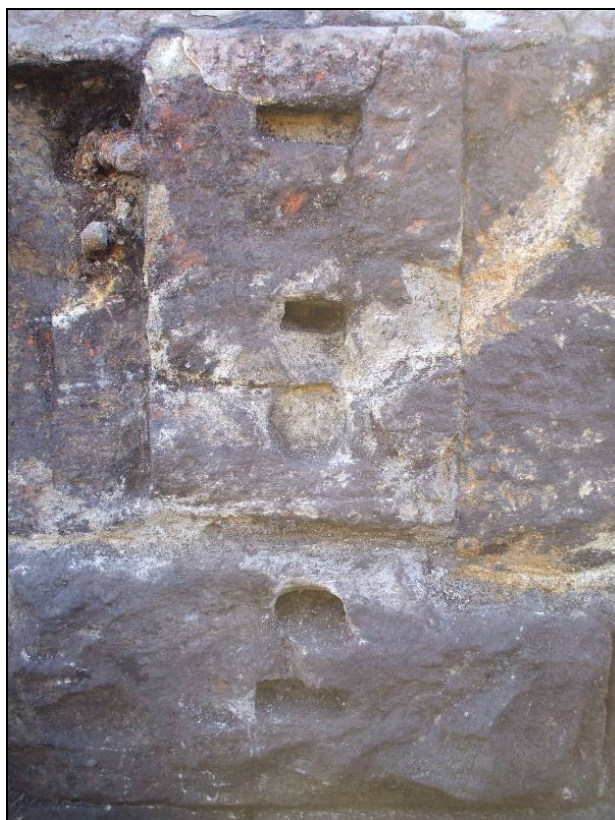
Iron pegs and sockets in west face of culvert/wheel pit wall [1001] Fig 9

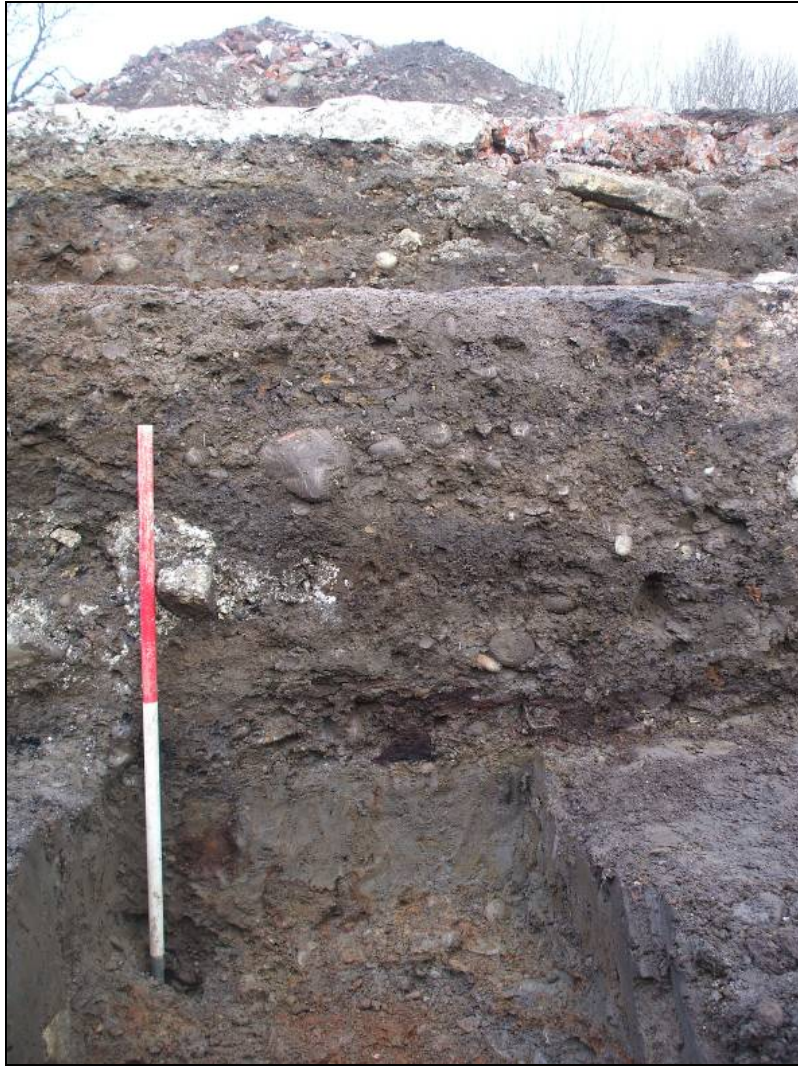
The geology, a coarse orange-brown sand and gravel (2010), was revealed in a machine-cut sondage in the centre of the trench (Fig 10). It lay at c 78.03m OD and was overlain by a 0.30m-thick layer of mid-grey alluvium (2025).

Geological and alluvial deposits observed in Trench 2, looking north Fig 10

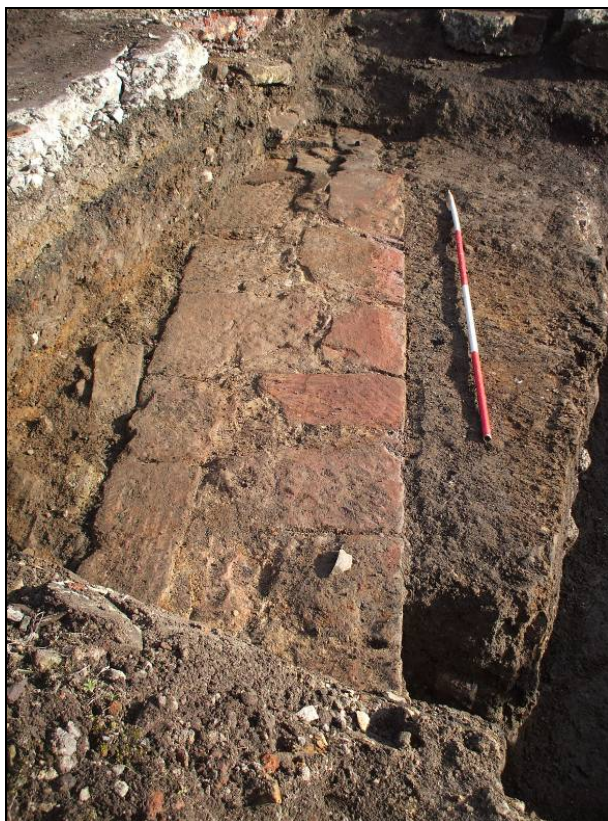
The principal feature exposed was a south-west to north-east aligned culvert wall [2011] constructed from large red sandstone blocks (up to 0.45m x 0.40m x 0.16m) bonded with a loose lime mortar (Fig 11). Its alignment and position appear to correlate with one of the water channels depicted on historic mapping of the early 19th century. The best preserved section of this culvert wall was revealed in the northerly extension of the trench where the top course of stonework sat at c 79.40m OD. Here, four courses overlay a 'kicker' that projected c 0.10m from the southern face of the wall at c 78.75m OD (Fig 12). Excavation did not proceed below this depth but it is assumed that the base of the wall foundation would have extended to the level of the geology.

Culvert wall [2011], looking east Fig 11

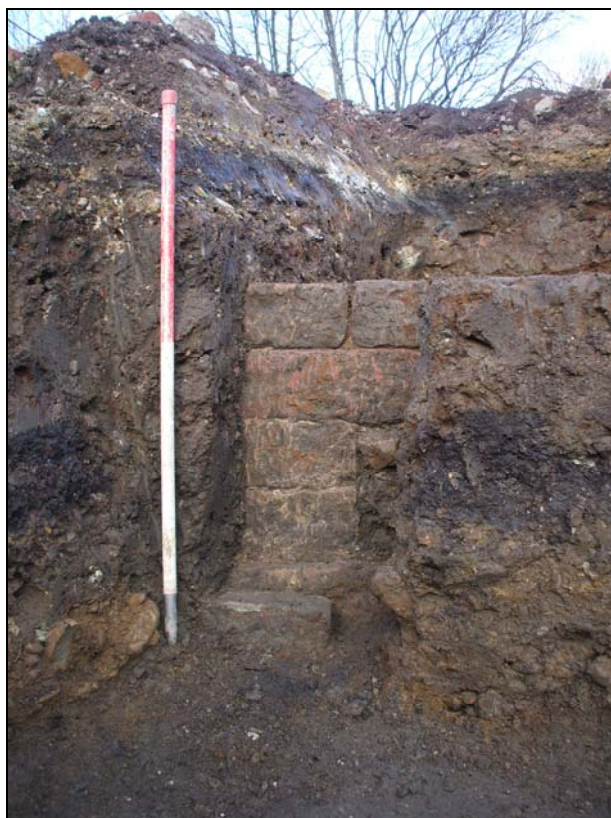
Southern face of culvert wall [2011], looking north Fig 12

On the basis of the cartographic evidence it would appear that this was the southern wall of the channel, however, the archaeological evidence is equivocal. To the south, overlying the alluvium (2025) and abutting the face of the wall, was a 0.75m-deep deposit of greyish-brown loam (2009) containing pebbles, fragments of sandstone, fragmented brick and mortar and lenses of clinker, sand and decomposing timber. This could either be the backfill of the construction trench for the culvert or the material infilling the redundant channel. A similar material (2008) overlay the wall and appeared to abut its northern face.

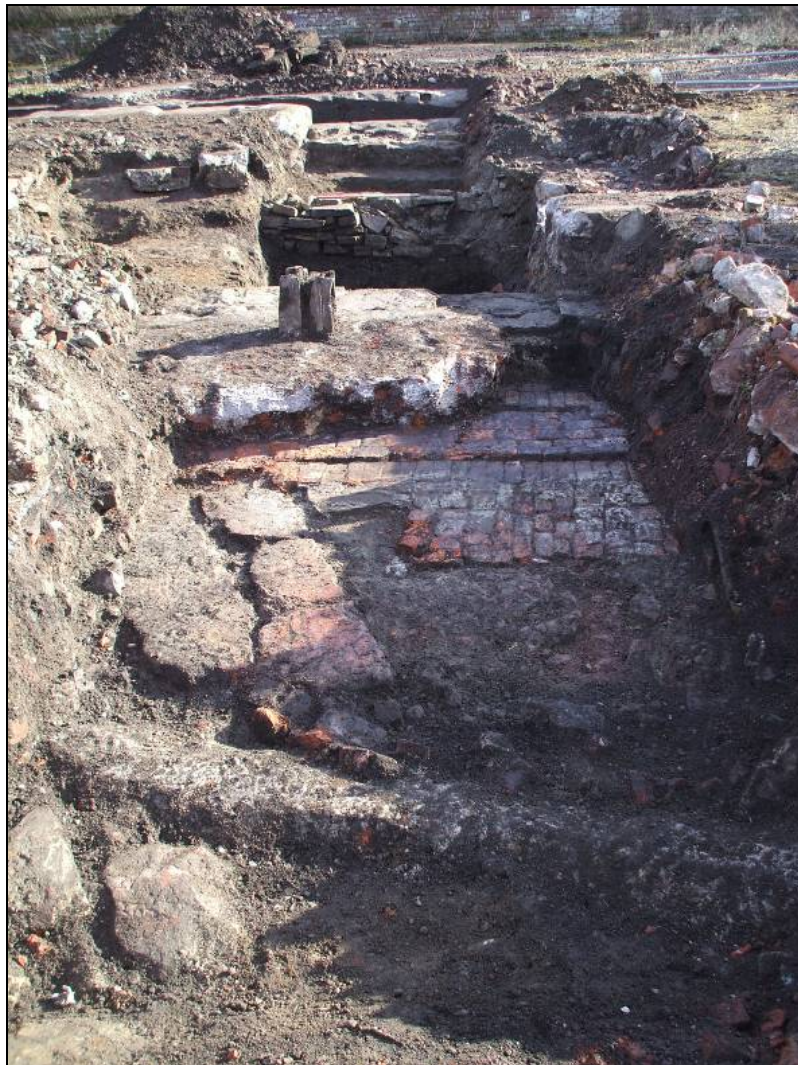
At the western end of the trench another short section of the same culvert wall was exposed (Fig 13). Here it was truncated to the west by a trench [2017] containing a concrete duct [2018] and to the east by a brick surface (2016) which was, in turn, truncated by a concrete stanchion base [2020] partially overlain with sandstone flags (2012). These features are assumed to be remnants of later 19th- and 20th-century industrial buildings.

Culvert wall [2011] (centre left), brick surface (2016) (centre) and concrete stanchion base [2020] in western end of Trench 2, looking east Fig 13

The water channel uncovered in Trench 2 last appears on the Ordnance Survey map of 1893 (ibid, fig 6) after which it was probably in-filled and built over in the 1930s. The brick surface, stanchion base and concrete duct located in the western end of Trench 2 relate to this, or later phases of development.

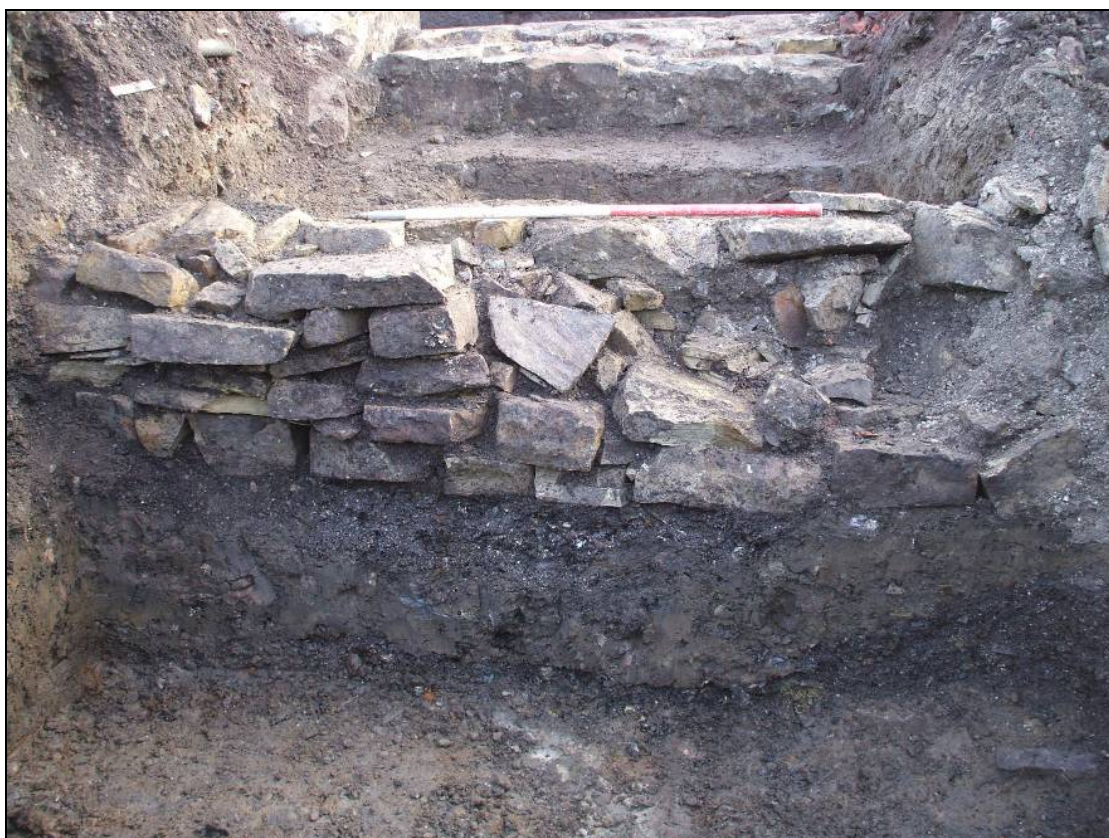
Towards the eastern end of the trench and cutting backfill deposit (2009) was a north to south aligned construction trench [2023] for a 0.65m-wide sandstone foundation [2013] packed in a deposit of loam and clinker (2014/2024) (Fig 14). This may be the foundation for the west wall of the north to south factory block that first appears on Benson's Map of c 1832 (ibid, fig 6). Abutting this foundation to the east was a 0.20m-thick layer of clay (2015) which may have been a levelling or bedding layer for a floor surface.

Foundation [2013] for west wall of early 19th-century (?) factory building, looking east Fig 14
