Archaeological excavation at Bury Ground, Bury, Greater Manchester March – April 2010

Paul Mason Report 10/79 May 2010

ARCHAEOLOGICAL EXCAVATION AT BURY GROUND, BURY,

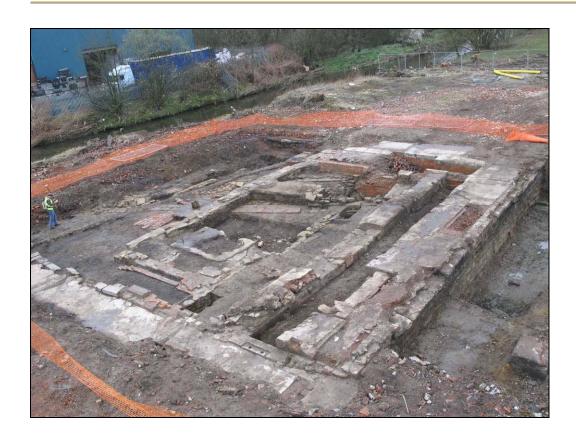
View of excavated features, looking north-west Fig 10

Following consultation with GMAU, a 25m-long trial trench was excavated to the east of the goit in order to ascertain that the building footprint hereabouts fell wholly within the reservoir fill (Fig 8). When it became apparent that this was the case, this area was written off and subsequent excavations focused on the factory remains and the goit itself (Figs 9 and 10).

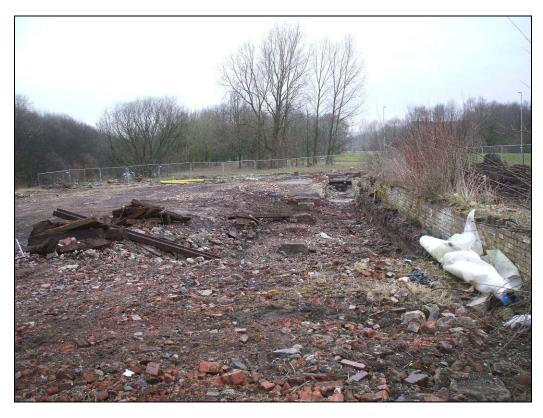
Pre-excavation ground works exposing upper level of goit, looking north Fig 11

Prior to the start of the excavation, groundwork contractors had partially excavated the upper fill of the goit, removing a number of timbers and steel joists that probably supported the floor of early 20th-century factory buildings (Fig 11). These structural elements are put into context below.

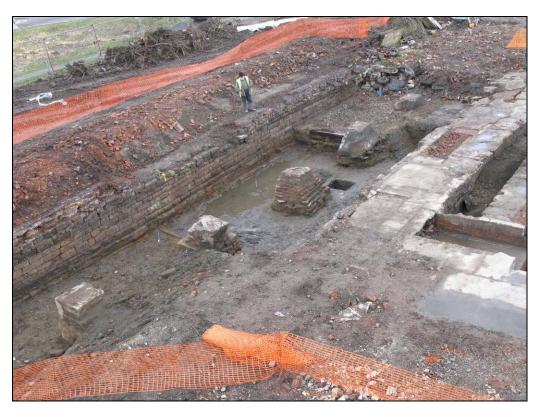
View of goit, looking south-east Fig 12

A 20m-long section of the goit was aligned north to south along the eastern edge of the excavated area (Figs 9 and 12). A c 6.75m-wide channel was defined by substantial walls, [3001] and [3002], constructed from roughly-hewn, un-bonded blocks of coarse yellow-brown sandstone. The walls were c 0.50m thick, evenly coursed, and each had an intermittent off-set course, or 'kicker', built into the inner face, nine courses down (c 1.60m) from the top.

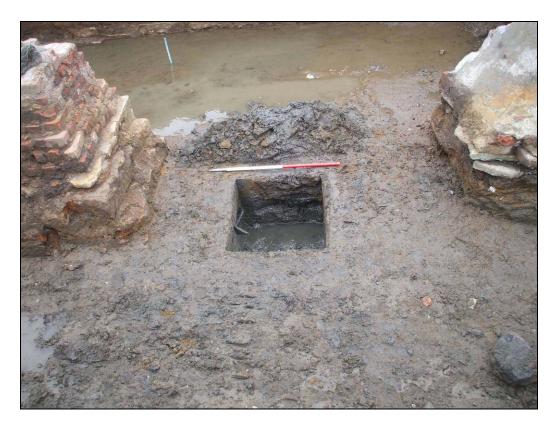
Accumulation of silt in the base of the goit, looking east, showing hand-dug test pit Fig 13

Within the goit, the natural gravels (3008) were exposed at c 77.80m OD in a hand-dug test pit located close to its centre (Fig 13). This was overlain by a 0.55m-thick layer of dark grey silty clay (3010) – an alluvium deposited by the water flowing through the open goit. This was sealed by an imported sand (3004) associated with the eventual in-filing of the channel in the early 20th-century (see below).

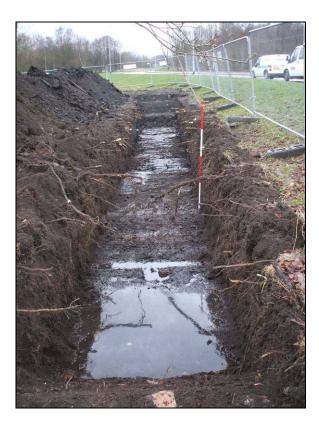
Trial excavation exposing upper level of reservoir silts, looking north Fig 14

To the east of the goit a 25m-long trench was excavated through the in-filled reservoir (Figs 8 and 14). A dark grey silt containing occasional plant fibres and roots (3007) was revealed at a depth of 1.20m below the existing ground level. This represented the upper horizon of *in situ* silting within the reservoir. It was overlain by a 0.80m deep deposit of imported backfill material (3006) comprising dark grey sandy loam with inclusions of fragmented brick, mortar and concrete. This was sealed by 0.30-0.40m of dark grey sandy loam topsoil (3005).

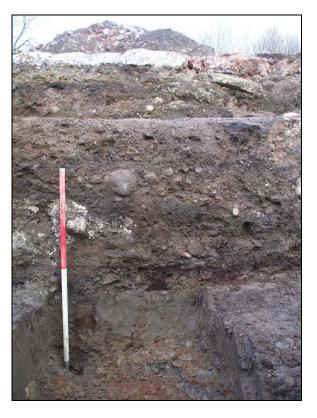
Made ground overlying alluvium, observed in Trial Trench 2, looking north Fig 15

Prior to the construction of the late 18th-century works, alluvial deposits in this part of the site appear to have been consolidated with imported material. Layer (2009), excavated during the evaluation, overlay the alluvium (2025) and contained fragmented sandstone, brick, mortar, lenses of clinker and decaying timber (Fig 15). The same deposit was encountered during the excavation (3070), producing sherds of 18th-century pottery dating through to the period c 1740-1760. This was overlain by a 0.15m-thick layer of gravel which was cut by a wall foundation [2013] — which may relate to the east wall of the dog-legged structure depicted in the Earl of Derby Estate map (Fig 4a).

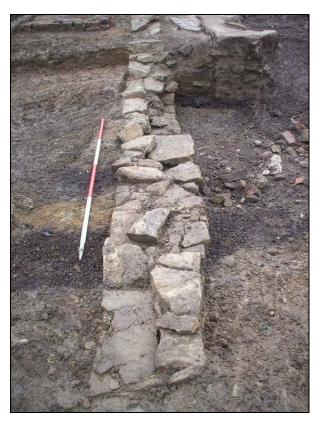
Late 18th-century foundation [2013] for calico-printing works, looking south Fig 16

The wall foundation was constructed from un-bonded slabs of yellow sandstone aligned north to south some 6m west of the goit [3002] (Figs 9 and 16), whose alignment it closely mirrored. At its southern end the remains of an overlying wall [3056] survived to a height of c 0.40m; it was 0.40m wide and constructed from uncoursed, roughly-hewn blocks of yellow sandstone bonded with a loose, charcoal-flecked greyish-white lime mortar (Fig 17). The wall/foundation was truncated at either end by later structural elements (see below).

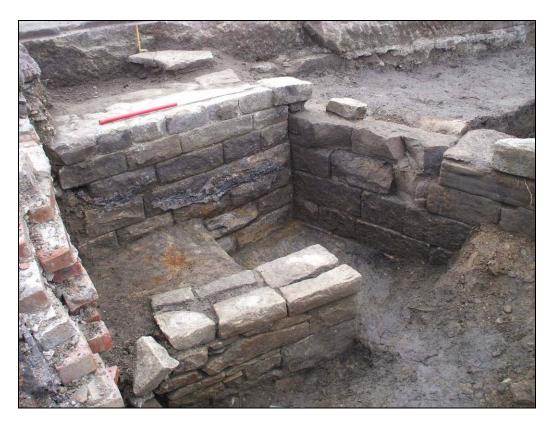
Late 18th-/early 19th century leat wall [3026] (foreground), looking south-east Fig 18

To the north, a shorter section of wall [3026] was exposed in the base of a later culvert (Figs 9 and 18). Although it appeared to be aligned with wall [3056] and was constructed in the same manner, its level was much lower than the remains to the south. It is possible that this wall section instead relates to the curving wall foundation [1011] observed at the northern end of evaluation Trench 1 (Figs 9 and 19) and that they form part of a leat first depicted on the Tithe map of 1820 (Fig 4b), but perhaps more closely contemporary in date with the structures mapped in 1783.

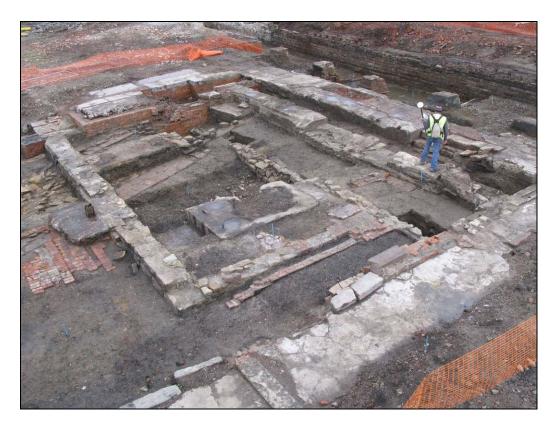
North wall [3048] of late 18th-/early 19th-century machine room (foreground), looking north-east Fig 20

A 12m-long section of wall [3048] was aligned east to west in the southern part of the excavation (Fig 20). Its location corresponded with the north wall of a 'new' building depicted on the Tithe map of c 1820 (Fig 4b) and later identified as 'Machine Room' on the Ordnance Survey map of 1847 (Fig 5b). In contrast to the earlier wall [3056], which it clearly cut (Fig 17), this wall was constructed using red sandstone ashlar bonded with a medium-hard, off-white lime mortar. It was soundly-built, 0.55m wide, with dressed stonework (typically measuring 0.40m x 0.30m x 0.20m) extending to foundation level. The eastern end of the wall appeared to abut the west wall of the goit [3002] and, to the west, a southerly return [3051] formed the north-west corner of the c 11.30m-wide building. Here, however, much of the original fabric had been robbed away and replaced in brick.

A 1.60m-wide brick-filled aperture in the northern wall of the machine room may indicate the position of a doorway [3049]. The interior of the room was floored in a bluish-grey concrete (3050) – most probably poured over an earlier floor.

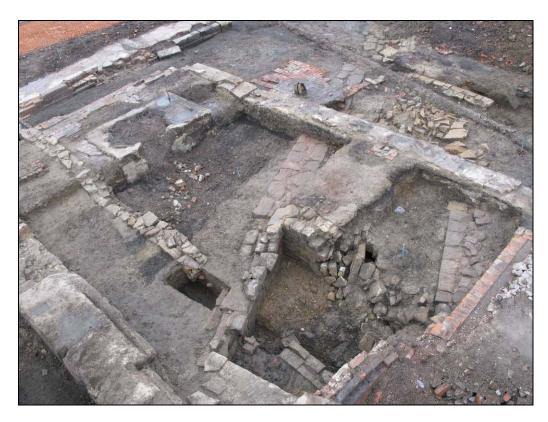
Late 18th-/early 19th-century leat (to right), looking south-west Fig 21

This leat was 3.40m wide with substantial red sandstone walls, [2011] and [3022] (Fig 21). The southern wall [2011], previously exposed in evaluation Trench 1, was built into a foundation trench [3064], which truncated the northern end of wall [2013] (Fig 22). The backfill of this trench (3065) contained sherds of pottery dating to the latter half of the 18th century, suggesting that it was built soon after the original factory buildings.

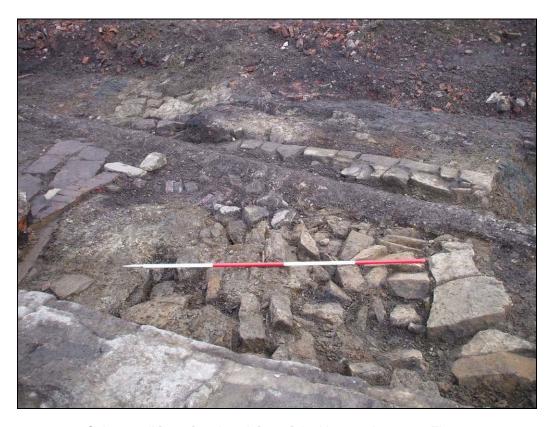
Culvert wall [3032] and vault [3024], looking south-west Fig 23

The point at which the leat entered the culvert was located just within the western part of the excavated area. Here, wall [3032] (Fig 23) was constructed from roughly-hewn yellow sandstone blocks and had a barrel-vaulted opening built into it (later altered when the leat to the west was also culverted -see below). Pottery retrieved from the fills, (3078) and (3081), of the wall's construction trench [3076] again dates to the latter half of the 18th century. To the east of wall [3032] the sandstone-rubble packing over the vault was revealed (3024).

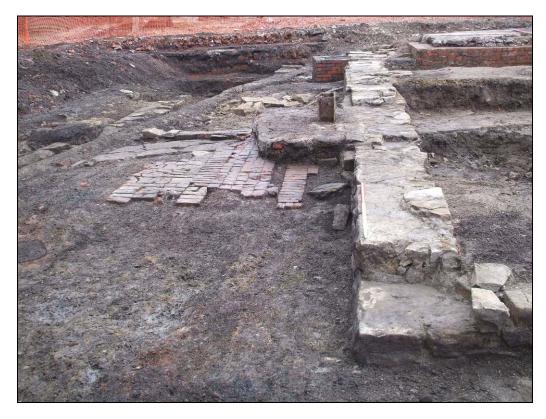
South-west corner of New Machine Room (right foreground), looking north, showing wall [3033] Fig 24

To the north of the machine room were a series of heavily-truncated walls and surfaces which were clearly the remnants of the building identified as the 'New Machine Room' on the Ordnance Survey map of 1847 (Fig 5b). This structure appears to have been partially constructed using sizeable yellow sandstone ashlars, which could be seen at its south-west corner [3038] (Fig 24) and, in a shorter section, in its west wall [3033]. However, where the west wall crossed the culverted leat, a much lighter construction of lime-mortared sandstone rubble was used [2012]. A doorway was probably present in the southern wall where stonework gave way to later brickwork [3039].

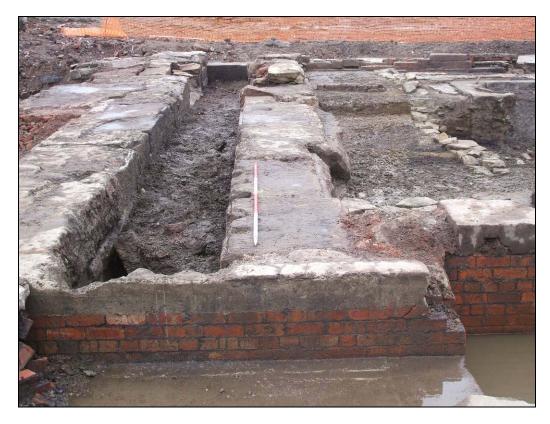
Stone-lined trough [1001/1002], looking south, truncated in foreground by later wall [1005] Fig 25

A significant proportion of the new building's internal space was occupied by a massive stone-lined trough aligned north to south towards its eastern side (Fig 25). Most of this feature had previously been exposed in evaluation Trench 1. Its edges were defined by huge yellow sandstone blocks, [1001] and [1002], measuring up to $2.0 \, \text{m} \times 1.2 \, \text{m} \times 0.50 \, \text{m}$ and defining a $1.0 \, \text{m}$ -wide channel. The southern end of this feature had been inserted into the north wall of the original machine room. Here, a $2 \, \text{m}$ -long block of sandstone [3021] had been drilled with two circular housings ($80 \, \text{mm}$ in diameter) set within a sunken rectangular area whose edge was stained with oxidised iron; clearly this was built to house a piece of machinery (Fig 26). Approximately $14 \, \text{m}$ to the north the trough was truncated by a massive concrete tank dating to the mid- $20 \, \text{m}$ to the north and beyond this was its northern end [1007], allowing its total length to be established at $c \, 17 \, \text{m}$.

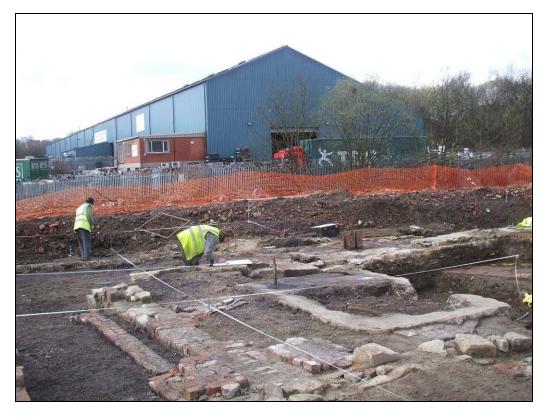
Concrete machine base [3041] (centre right) within New Machine Room, looking north-west Fig 29

Cut through the brick floor, but perhaps loosely contemporary, was a large concrete machine base [3041] measuring $c 3m \times 2m \times 0.8m +$ (Fig 29). In each corner was a 40mm-diameter steel bar upon which machinery, or even a steam engine, may have sat.

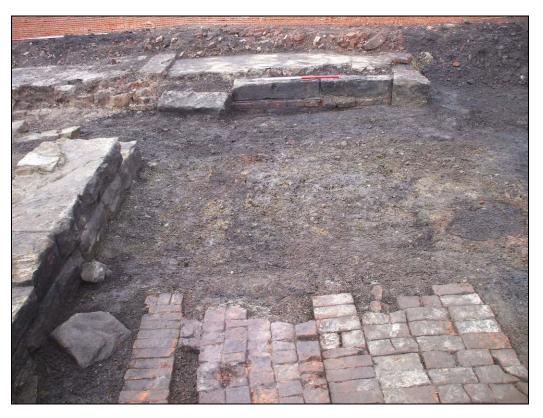
Late 19th-/early 20th-century bleach works extension, wall [3052] (background), looking south Fig 31

The western side of the original machine room was extended towards the river to respect a distinctive north-east to south-west building line. Within the excavated area, this extension was evidenced by a 0.40m-wide wall [3052] which abutted the original west wall of the block [3051] (Fig 31). It was constructed from large yellow brown sandstone ashlars, presumably salvaged from the pre-existing machine room, incorporated with brickwork and bonded with a grey-hued lime mortar. Aligned east to west for a distance of 2.60m and returning to the south-west at an angle of c 100 degrees, wall [3052] formed the north-west corner of the modified structure. The interior was floored in concrete (3072).

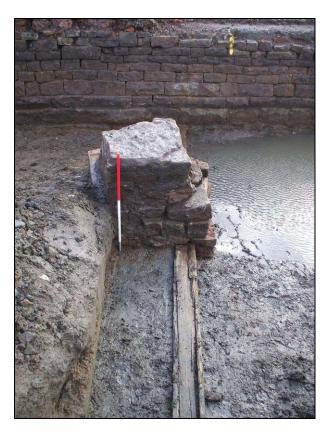
Late 19th-/early 20th-century bleach works extension across the goit, showing timber beam [3011] and pier [3012], looking east Fig 32

The pre-existing buildings were also extended eastwards, over the goit. To achieve this, a series of piers, constructed predominantly in brick, were built along the centre of the channel [3013], [3015], [3017], [3018] (Fig 12). They stood on brick and sandstone foundations [3012], [3014], [3016]. The most northerly of the pier foundations [3012] was constructed over a large timber beam [3011] that had probably been laid across the soft silt to enable access (Fig 32). Subsequently, a 0.80m-deep deposit of yellow sand (3004), lain in a series of lenses, had been used to backfill the goit to just above the level of the pier foundations. Pottery and glass bottles dating to the late 19th and first decade of the 20th century were found in association. The timbers and reinforced steel joists that supported the floor of the works lay over this sand, only one of which [3019] was found *in situ*. The eastern wall of the extended factory [3020] was built in brick over the east wall of the goit.
