Archaeological walkover survey and earthwork survey at Bedford Purlieus Wood, Thornaugh Peterborough

Report 10/113

July 2010

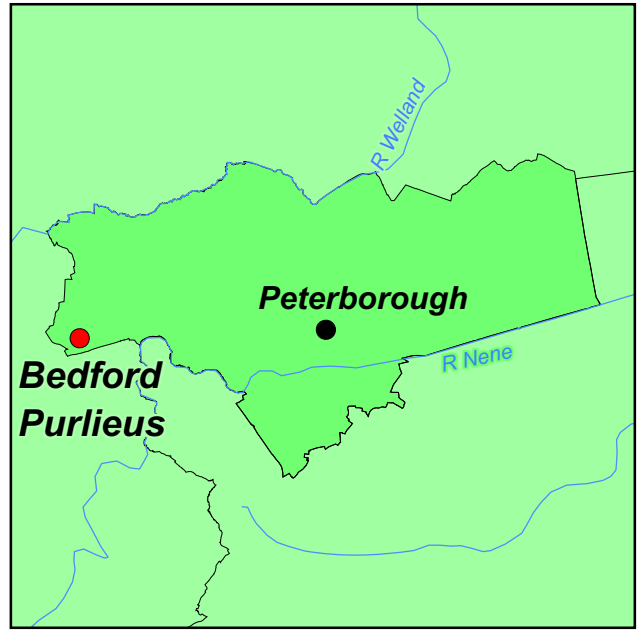
Site Location Fig 1

Bedford Purlieus is a designated Ancient Woodland and National Nature Reserve and lies upon an area of high ground situated between the Rivers Nene to the south and east and Welland to the north (Fig 1). It lies at an approximate height of 58-75m above Ordnance Datum (AOD) and encompasses 223ha. Generally the site is situated upon a rolling landscape with the ground sloping from west to east.

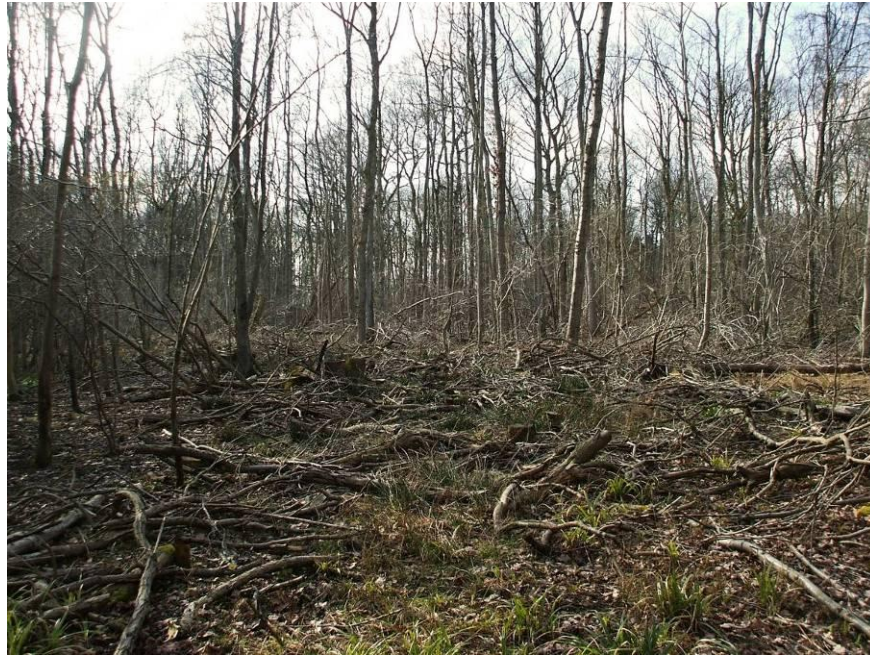
General view of the southern part of Area 3, looking north Fig 3

By contrast the conditions for Area 3 were fair to poor with areas obscured by fallen or felled trees (Figs 3 and 4). The ground was covered with grasses and leaf-mould making any ephemeral features difficult to see.

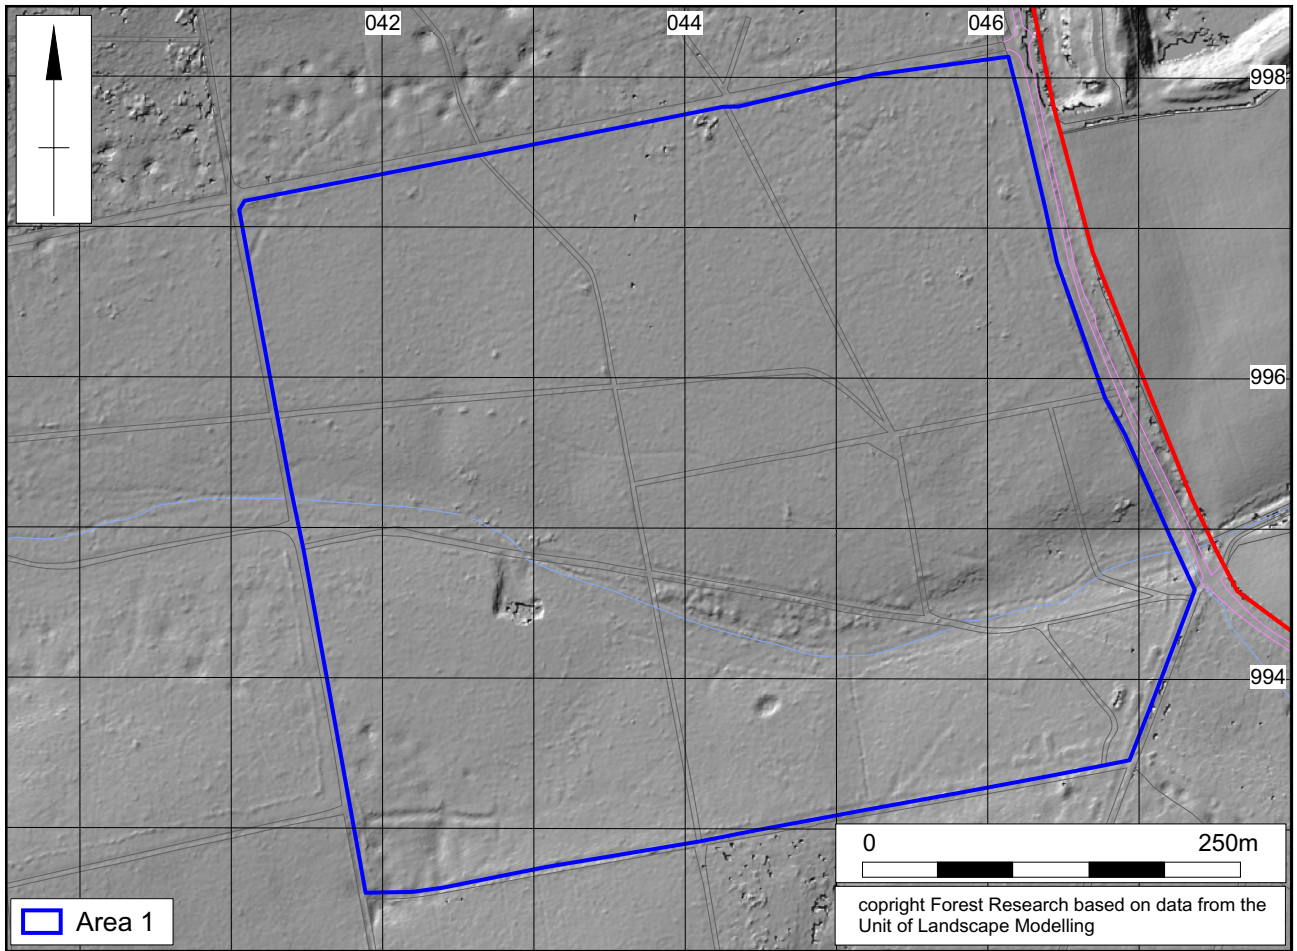
Area 1, LiDAR and walkover survey results Fig 5

Of the seven linear earthworks, six are in Area 1 (F1-3, 5, 10 and 11; Fig 5).

During the survey of Area 1 the location of two square depressions were recorded, one of which had a modern plastic pipe within it. It is likely that these are drainage sumps (Fig 5).

David Hall identified an area of Second World War features in the south-eastern corner of Area 1 (Fig 5). The features, which are easily visible from the adjacent track, were seen on the LiDAR as a set of rectangular blocks (Fig 5 top). The field survey confirmed the survival of eight platforms and a sub-ground structure.

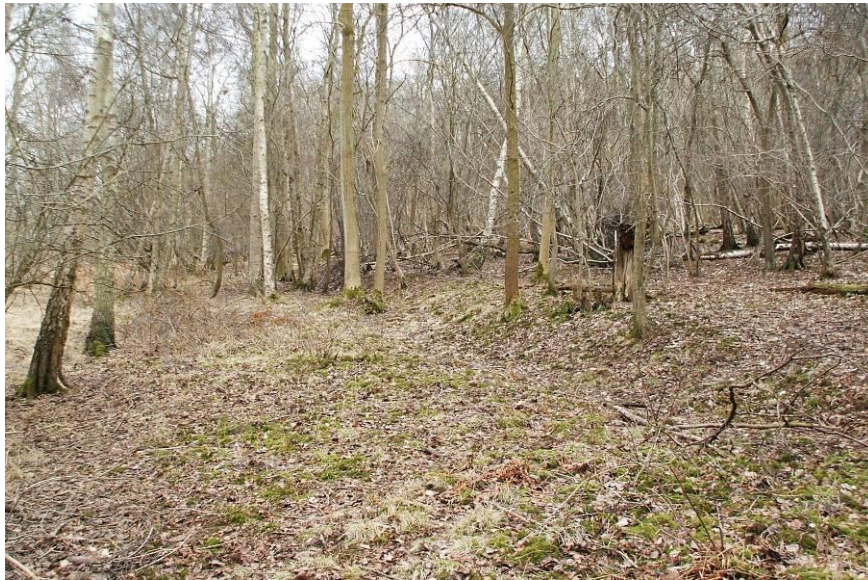
The woodland earthwork bank and ditch F2 in Area 1, looking east Fig 7

Feature F2 is an earthwork ditch and bank which is aligned parallel with the stream at the base of the valley. It comprises a clearly defined bank (to the right in Fig 7) with gradual sloping sides and a rounded top. The ditch is located to the north of the bank, with well defined gradual slopes and a flat base. The earthwork is 400m long and 7m wide. The bank is up to 0.3m high and the ditch is 0.2m deep.

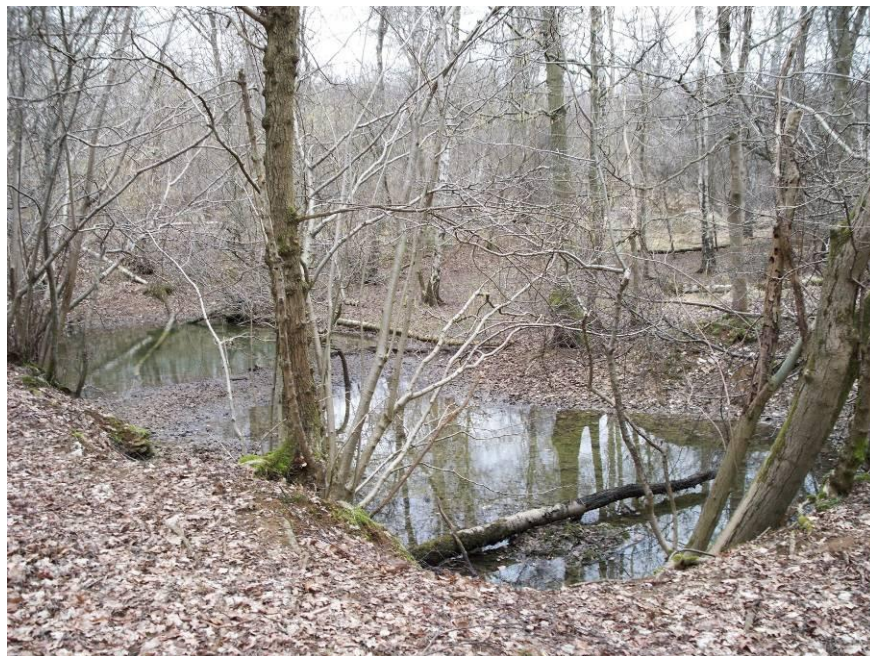
General view of the extraction pit Q1 in Area 1, looking north-west Fig 8

Pit Q1 was excavated into the side of the slope overlooking the stream below and may be seen on the LiDAR survey. It comprises a rectangular pit with vertical sides and a flattish base, partly filled with water at the time of survey. A shallow access hollow approaches the pit from the north and is defined by gradual sloping sides and a wide flat base. The pit measures 34m long, 16m wide and is approximately 3m deep, whilst the access hollow is 20m long, 10m wide and up to 1m deep.

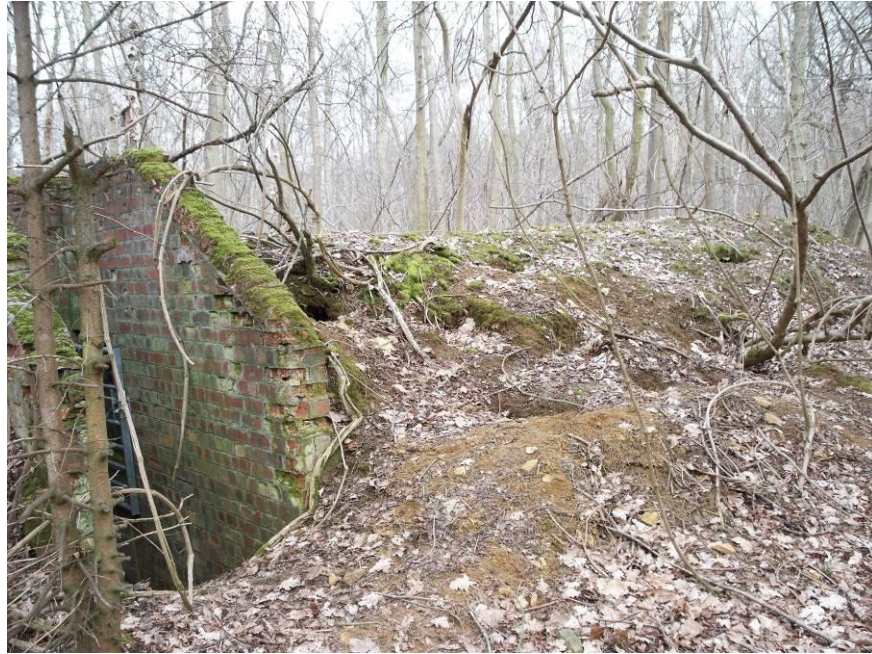
A view of the underground structure located in Area 1, looking north-west Fig 9

One of the features comprises a underground structure covered with corrugated sheeting and earth over (Figs 9 and 10). The base within the interior of the structure was lower than the floor level by approximately 1m. An arched roof of corrugated iron with metal rivets is supported by a breeze-block wall at the north-eastern end and by a brick wall at the south-west. The interior housed four low brick and mortar walls.

The structure was accessed from the outside by a set of descending steps and through a doorway (now barred by a gate). The corrugated metal structure is covered by a layer of earth, in poor condition. It measures 15m long, 8m wide and the outside brick walls are up to 3m high (from the base of the steps). The earthwork mound is up to 1.8m high and is in poor condition with indications of animal burrowing.

Military remains dating from the 20th century are often an undervalued resource. The identified remains within Bedford Purlieus would benefit from documentary survey as well as a more detailed character and regular condition survey. The main thrust of the research would need to put the remains into the context of movement of troops and supplies. It should be noted that the known Second World War sites in Bedford Purlieus are all adjacent to rides or tracks (Fig 2). Whether the sites were placed at those locations due to the ease of access is unclear. Comparative sites may be found in Salcey Forest and Yardley Chase in Northamptonshire (Simmonds 2007).

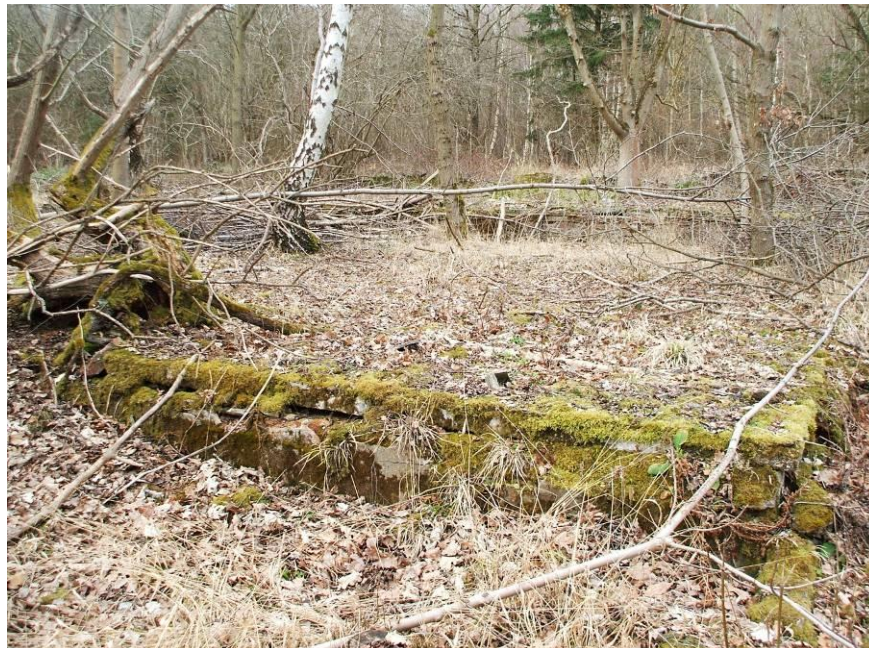
General view of the descending platforms (F6) in Area 3, looking north Fig 11

Feature F6 comprises a set of descending platforms of mortared brick and concrete which are aligned north to south (Fig 11). Immediately to the south of the track a concrete plinth angles down to a flat concrete platform supported by a mortared brick wall (Fig 11 to the back of the frame). The plinth measures 25m long and 2m wide. The platform below measures approximately 21m long 9m wide and stands approximately 0.3m high. Below this there is another concrete platform supported by a mortared brick wall (Fig 11, foreground). This platform measures approximately 16m long 12m wide and is 0.3m high. A further brick wall lies 2.5m to the south of this platform and this is 2m wide and up to 0.4m high. The gap between the platform and the wall suggest a stairwell or entry-port to the structure.

The concrete and brick walls are clear to see but are covered in moss and leaf-mould which obscures the condition of the structure. It is possible that there may have been temporary sheds and huts built on the platforms.

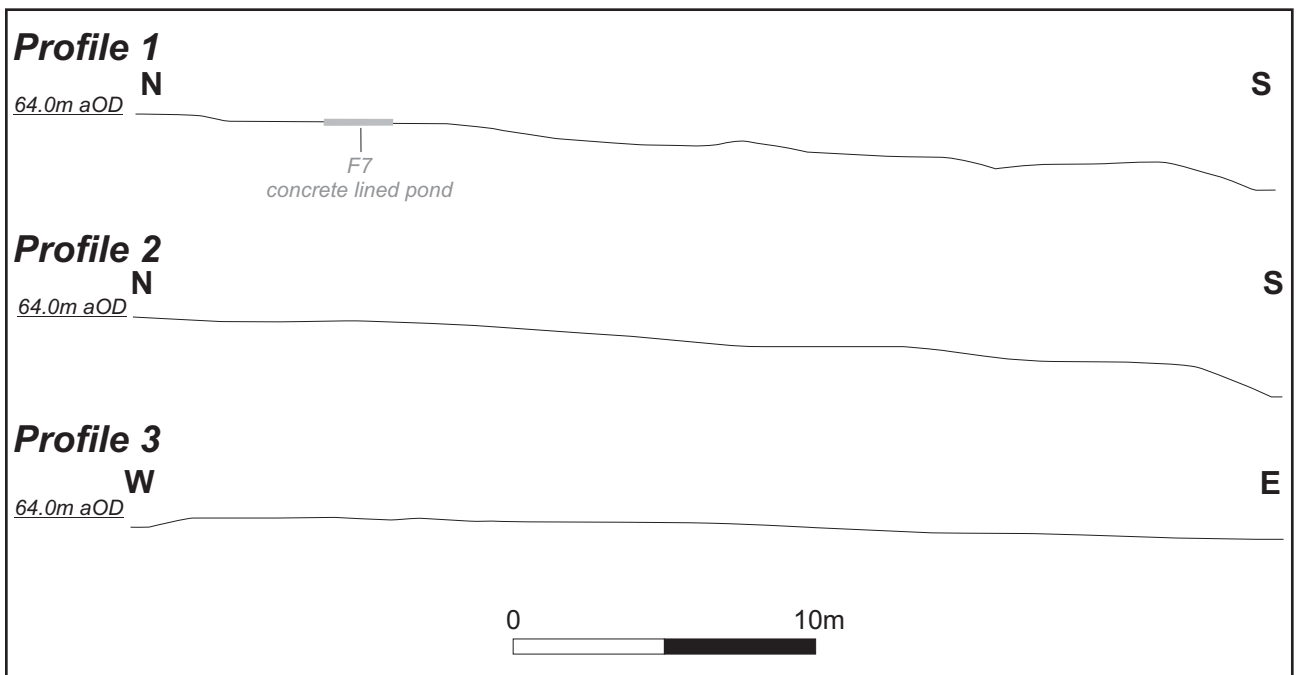
Platform F8, Profiles 1 - 3 Fig 13

The platform (F8) is defined by a slope on three sides which is gradual to the west and becomes steeper and higher to the south and east. The surface of the platform is largely flat, the exception being the eastern part of the platform which undulates. This may be seen clearly in Profile 1 (Fig 13) which illustrates the ground sloping down to the south and the varying profile of the topography. In Profiles 1 and 2 (Fig 13) the southern edge of the platform is distinct with a gradient of approximately 45 degrees and 1m high. This is to be compared with the western side of the platform where the slope is not as high (0.5m) or as clear (Fig 13, Profile 3). The platform measures 56m long by 55m wide.

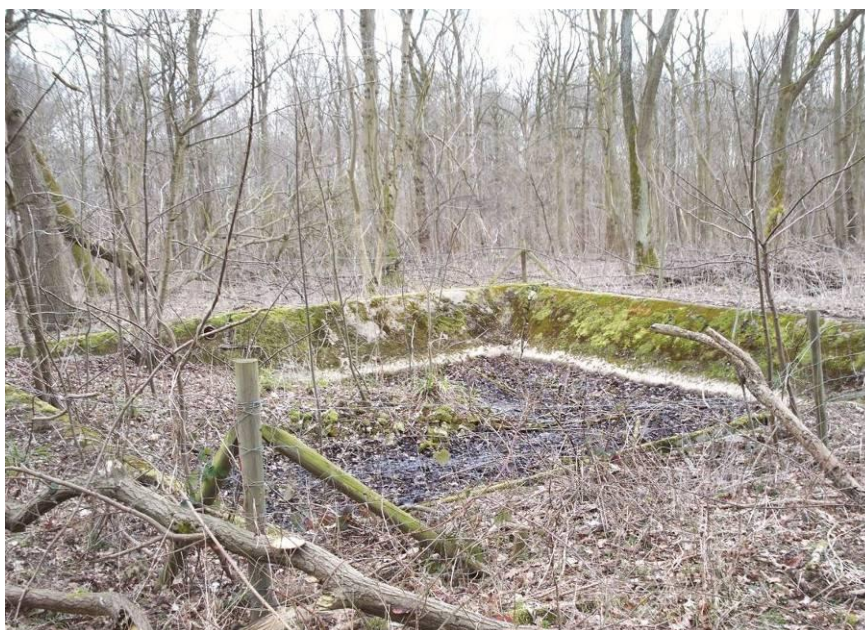
General view of the concrete-lined pond (F7) in Area 3, looking south Fig 14

The pond is rectangular in plan and is aligned north-west to south-east. It comprises a moss-covered concrete-lined depression flanked by a concrete kerb. The eastern corner of the pond has been infilled with stone debris, perhaps to allow easier access to the base of the pond (Fig 14). Leaf-mould and debris cover the base of the pond masking its true depth. It measures 11.5m long 10m wide and is 1.2m deep. A modern wood post and metal wire fence surround the pond.
