## Archaeological trial trenching on land at Swallowfield Park, Swallowfield, Berkshire

Report 10/146

November 2010

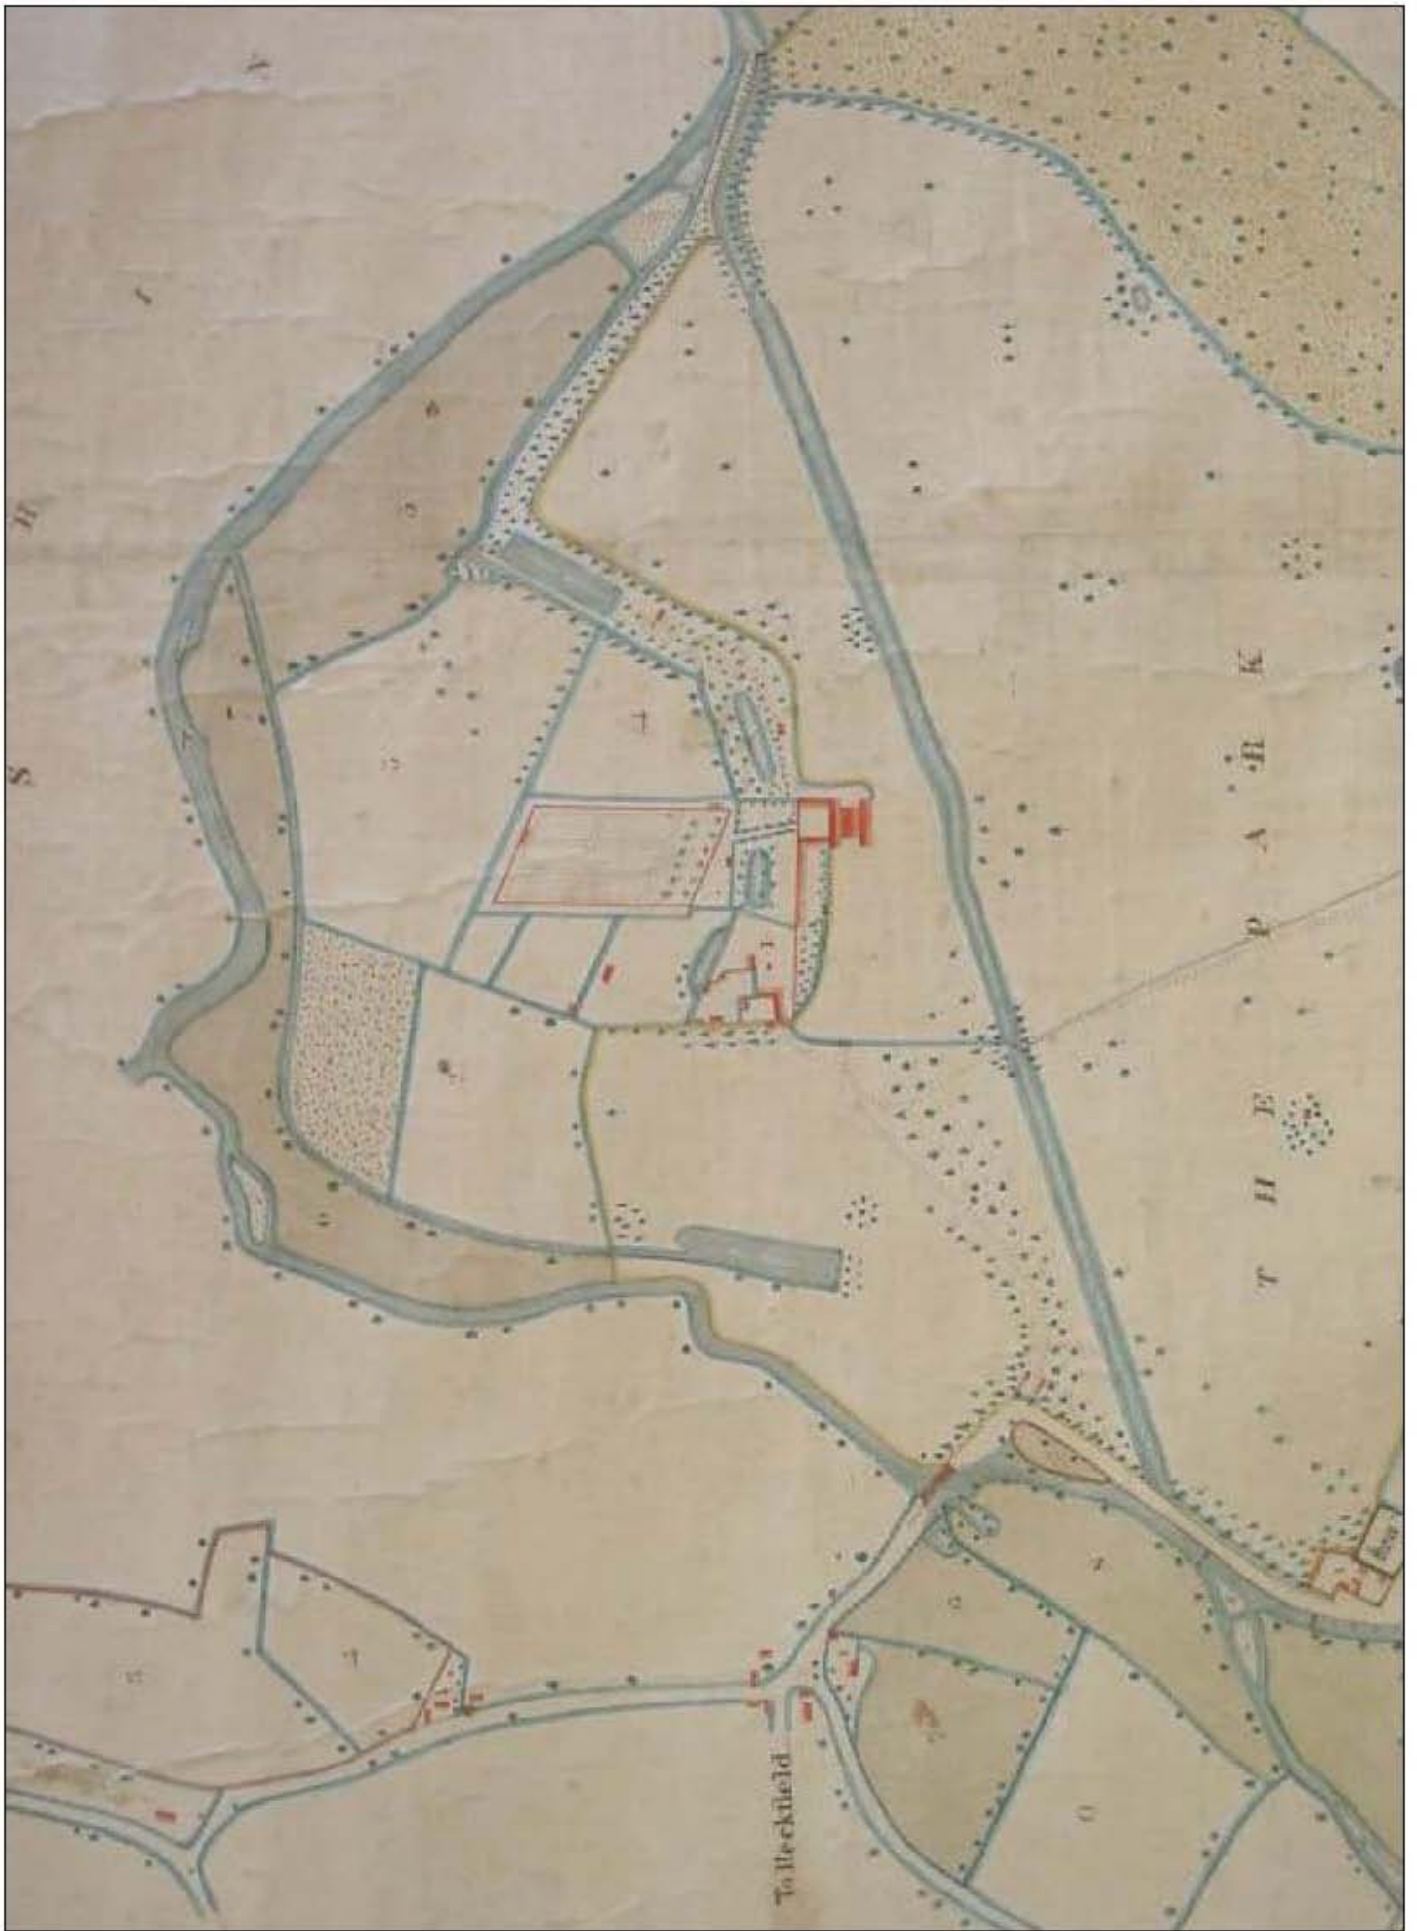
1809 estate map Fig 2

A documentary reference to a canal was made by John Evelyn, a visitor to Swallowfield, in 1685. However, the canal is first shown pictorially on Rocque's map of Berkshire of 1761. It is then depicted on a succession of maps up to the Enclosure map of 1817 and on an engraving of the house in 1820. On these maps the canal appears as a tri-partite feature, with narrowing 'pinch points' marking each division (Fig 2). On the 1817 map, these divisions are specifically labelled as *Upper*, *Middle* and *Lower Canal* and possibly weirs and/or bridges are shown at the pinch points (Fig 3).

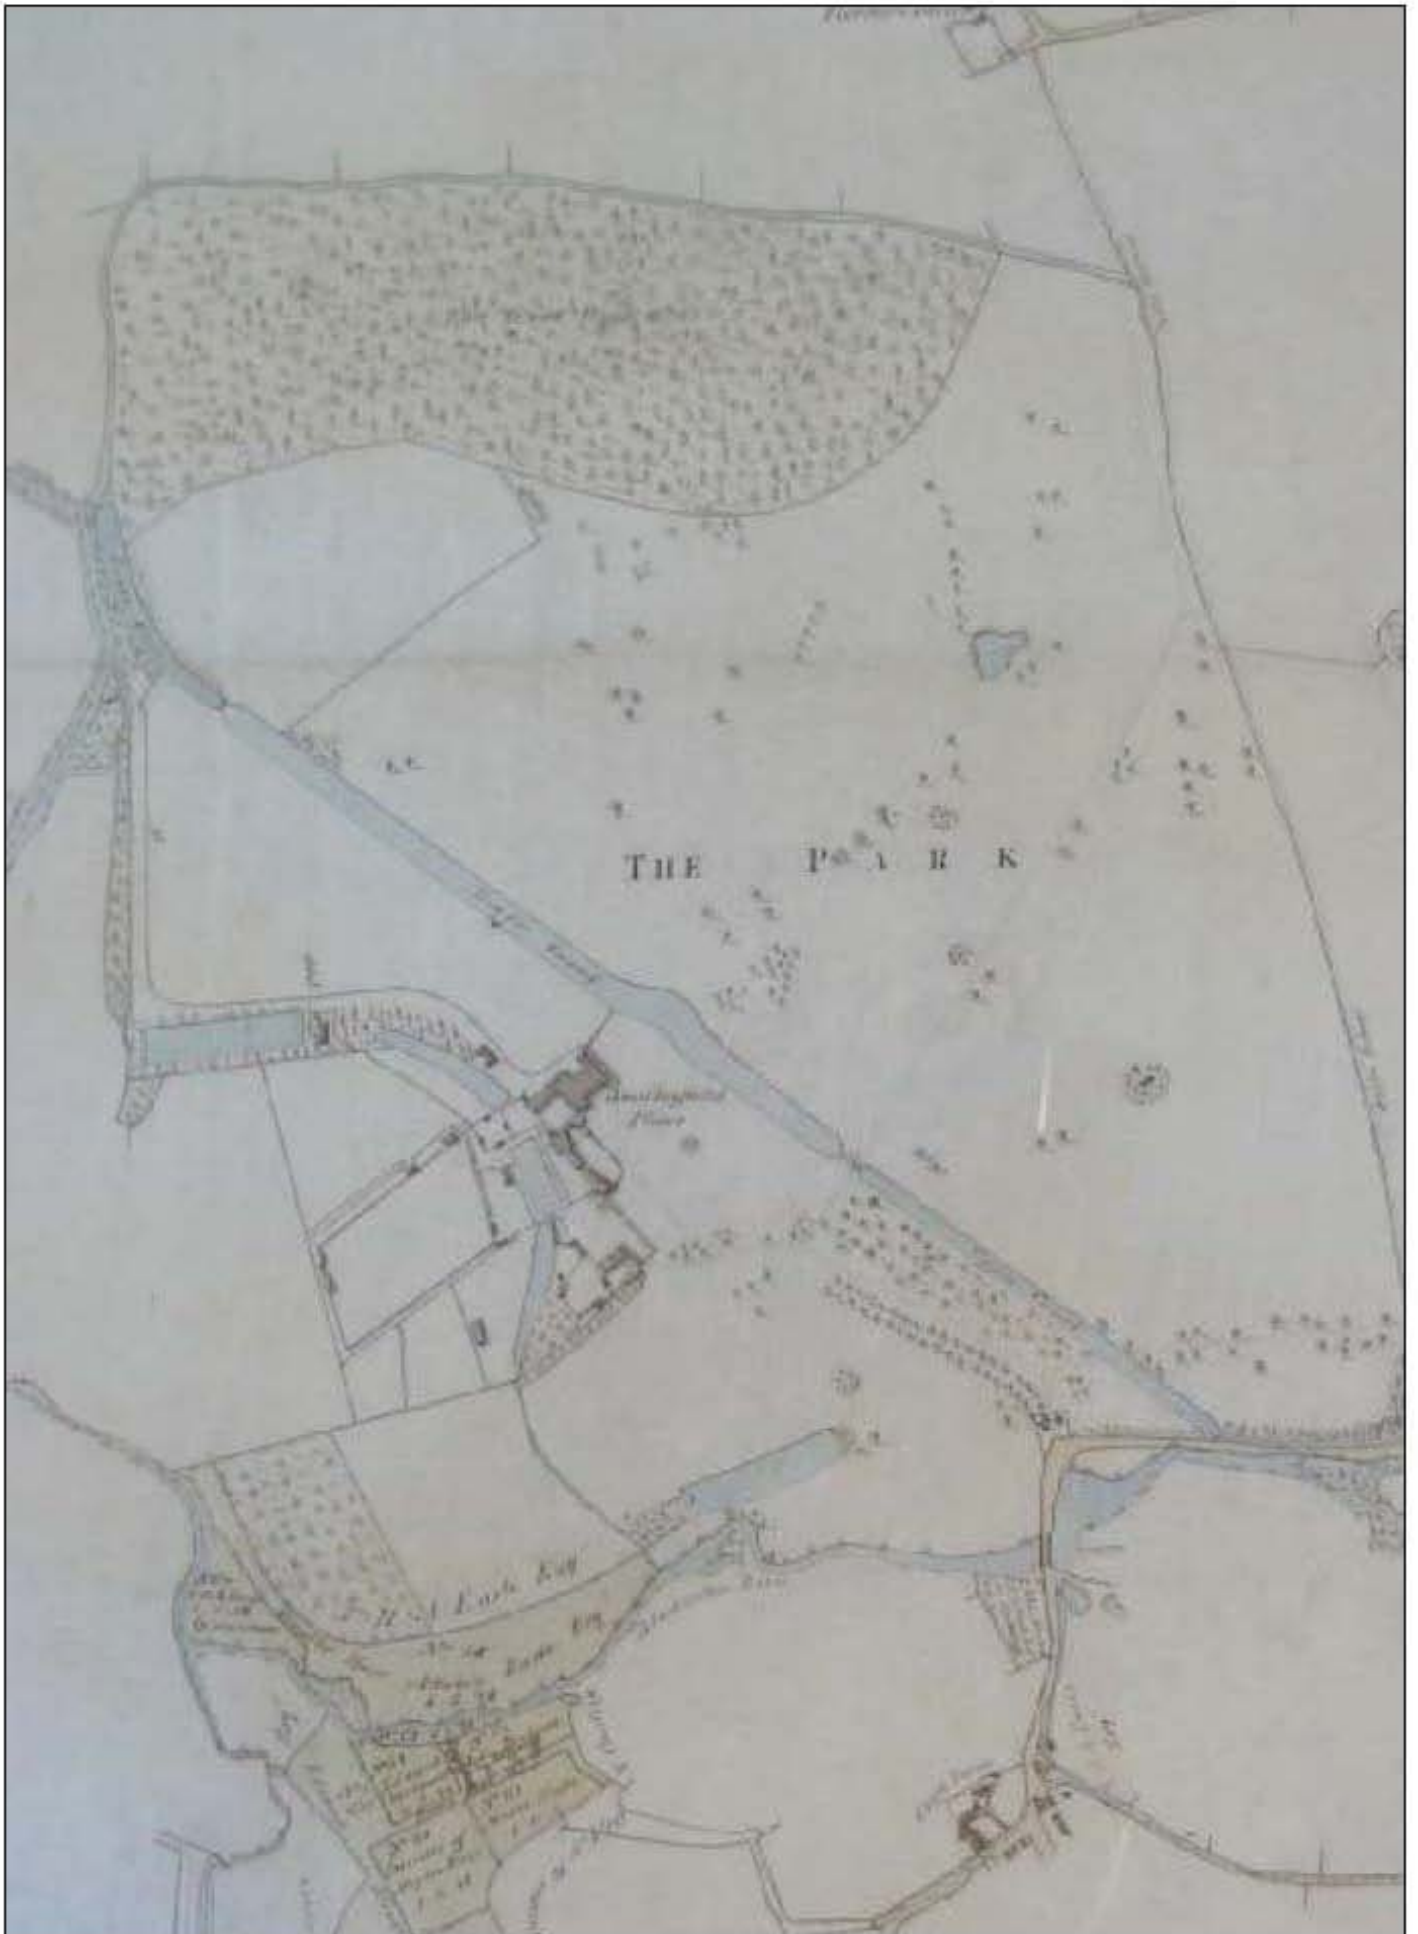
1817 Enclosure map Fig 3

The geophysical survey was deemed only partially successful since the geology of the area was adjudged not to be fully conducive to a gradiometer survey. However, the line of the canal was located and it was concluded that its infilling was probably quite 'clean' in that it did not contain much in the way of brick rubble or similar material. Also, it was concluded that there was no clear evidence for any internal features such as a brick built culvert in the areas examined. However, strong anomalies towards the northern end of the canal indicated the presence of a below ground structure in the area where the enclosure map of 1817 showed a possible weir or bridge (Fig 3).

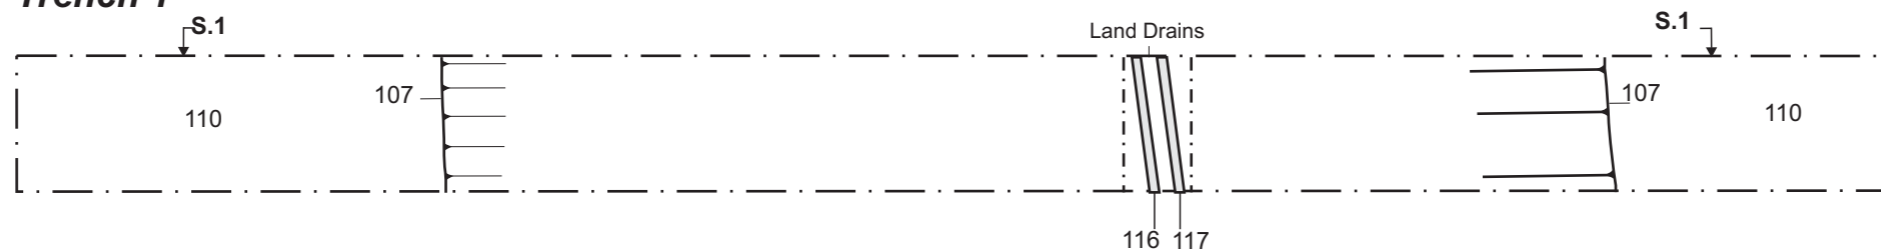
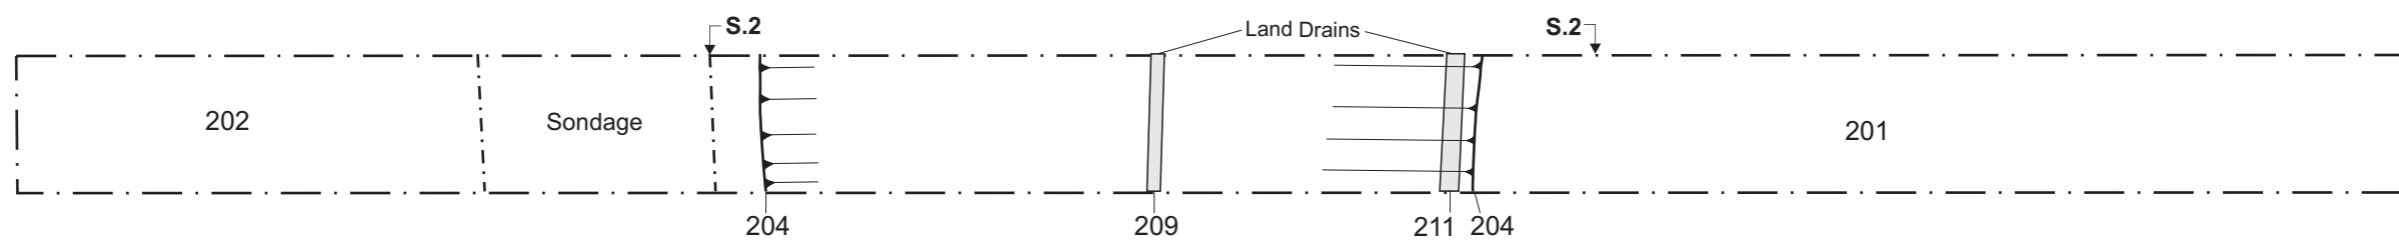
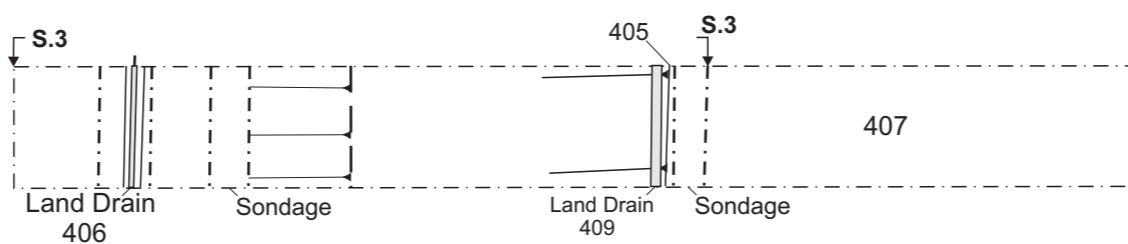
**3.3 Trench descriptions*****Trench 1*** (Figs 5 and 6)

**Trench 2** (Figs 5 and 10)

**Trench 4** (Figs 5 and 10)

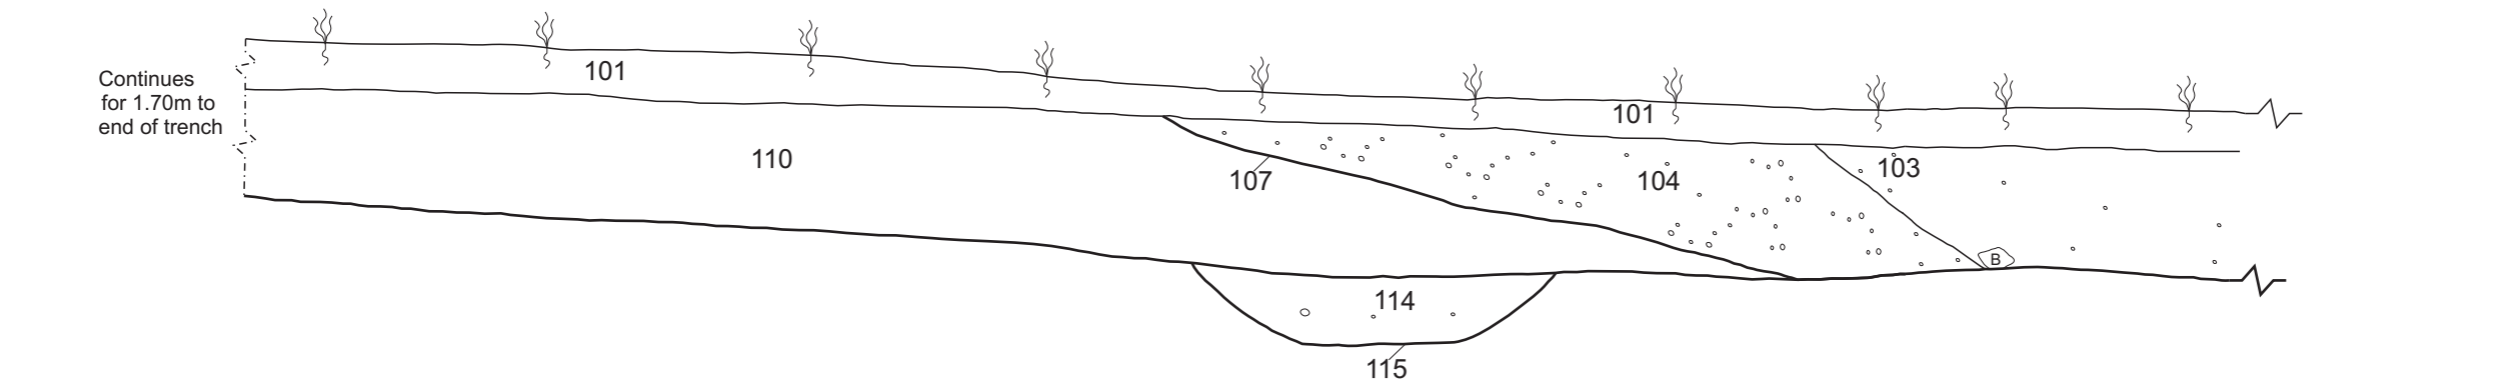
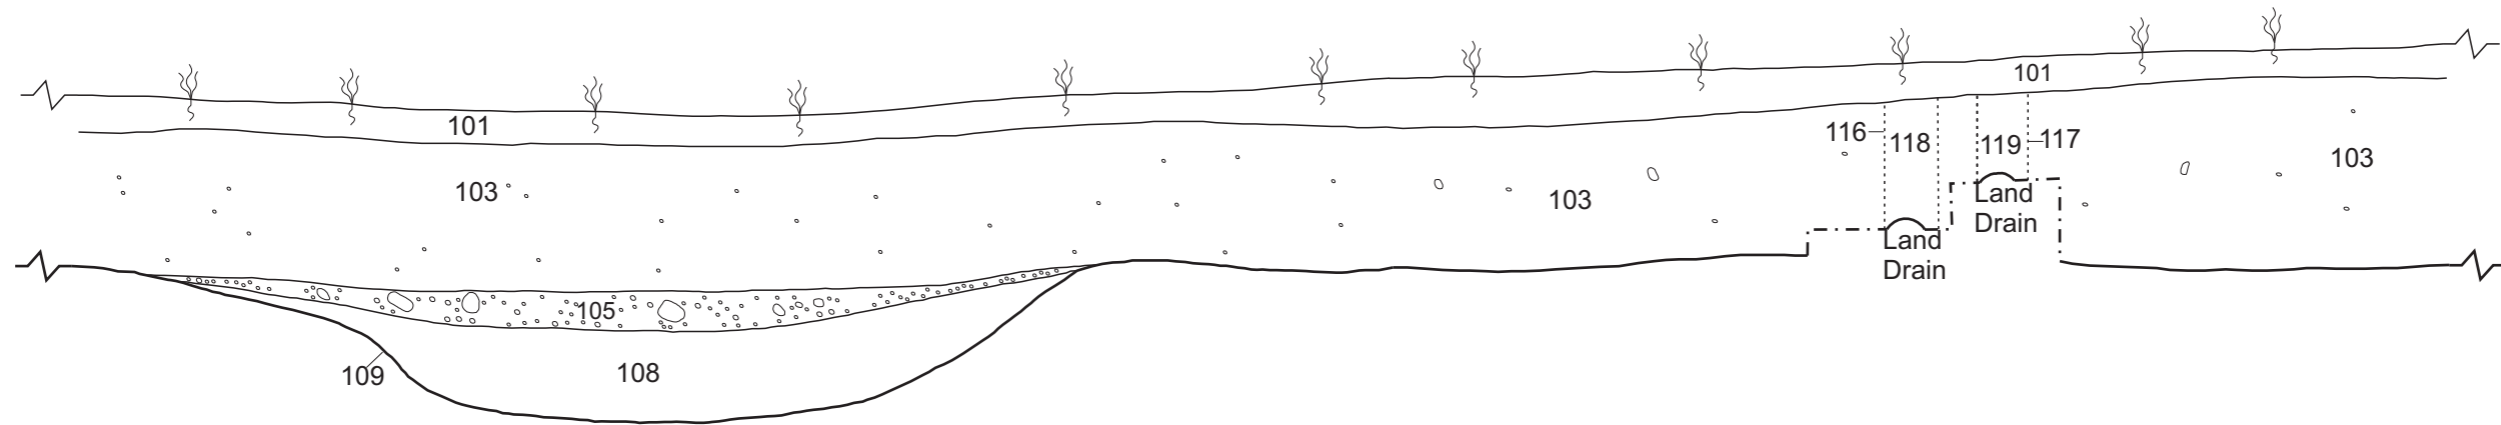
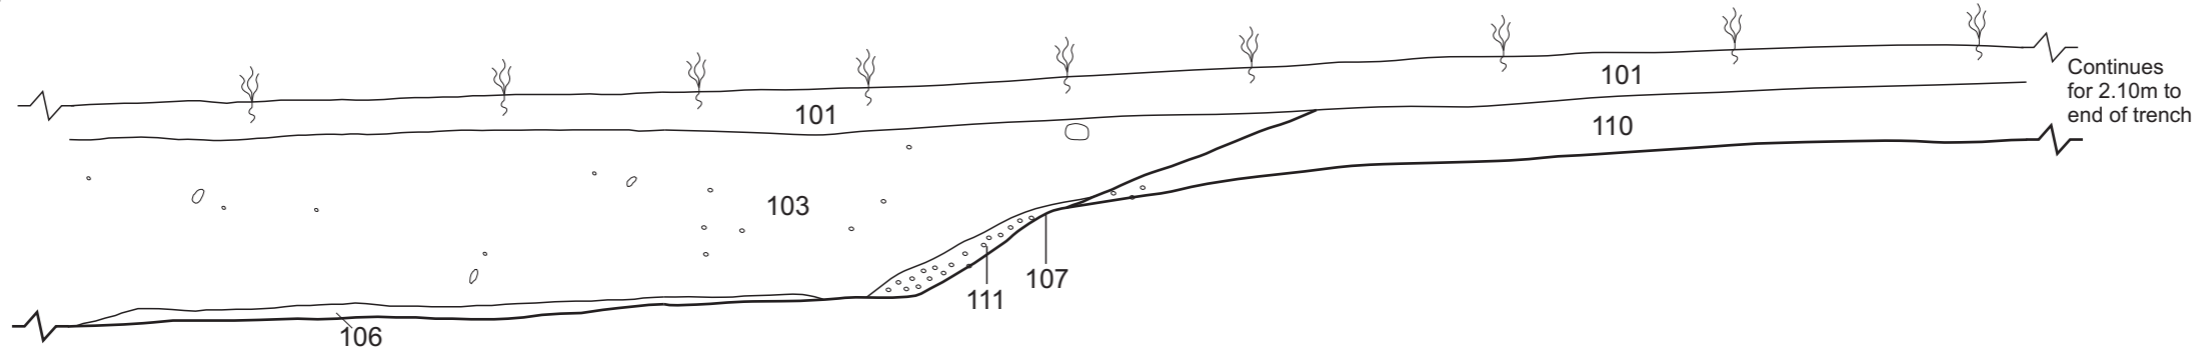
# Trench 1, S1

Two ditches were present which pre-dated the canal [109] [115] (Fig 6 Section 1). Both contained silty fills which had either been waterlogged or were water-derived. It is possible that one of the ditches [109] may have been a pre-cursor to the later canal or represent the line of pre-existing watercourse that was broadened to form the canal. Alternatively, the ditches may be earlier, unrelated features possibly connected with the conjectured site of the deserted medieval settlement of Swallowfield, presumed to be nearby (Parklands Consortium 2009, 93).

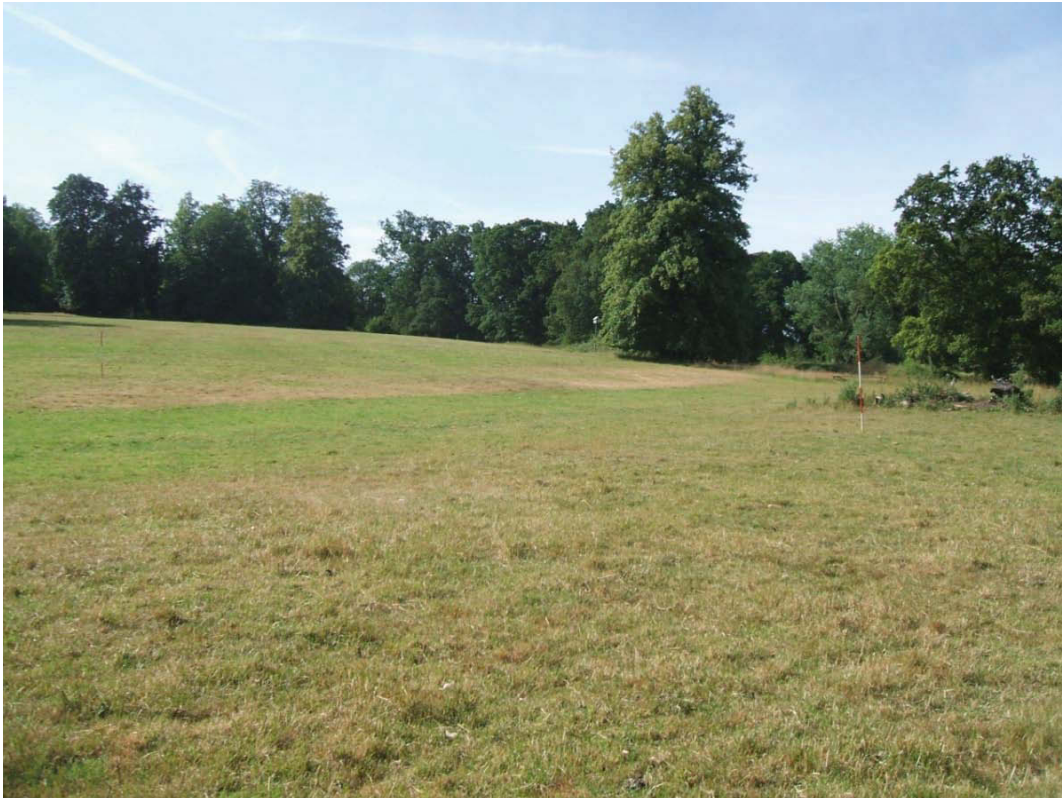
Southern end of canal earthwork, prior to excavation of Trench 1, looking south Fig 7

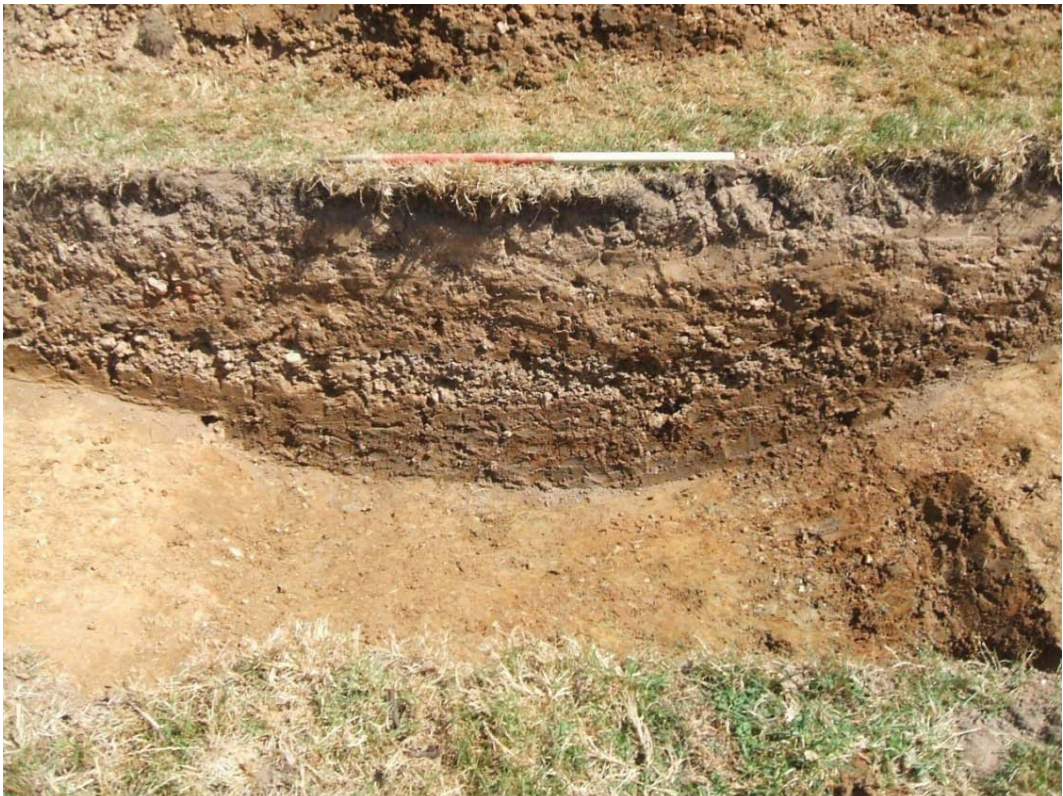
Fig 8

Ditch [109] looking north-east

It had a broad U – shaped profile and survived to a depth of 0.45m and 3.00m wide. It cut into the underlying clay natural (112) and had itself been truncated by the overlying canal [107]. The primary fill (108) was grey clay silt, with orange brown staining which appeared to be water-derived. The secondary fill (105) was grey sandy silt with very frequent gravel inclusions. This may have acted as a ‘sealing’ or capping layer for what would have been an otherwise wet or boggy feature. No dating evidence was present.

Ditch [109] was aligned north-east to south-west and ran across the width of the trench (Fig 8).

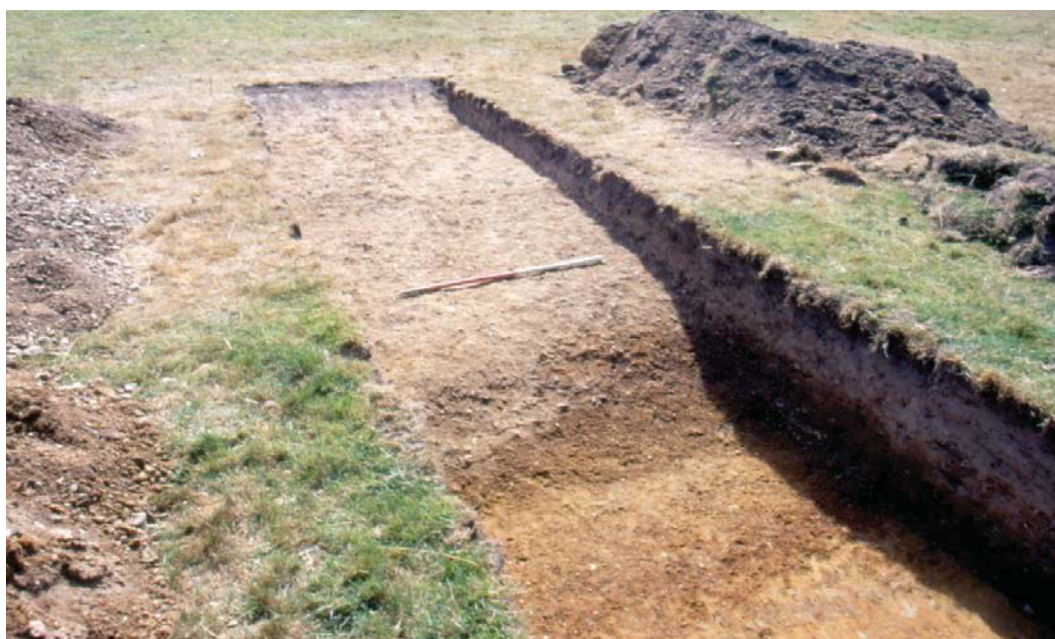
Fig 9

The canal was aligned north-east to south-west. It was 15.65m wide and up to 0.65m deep, at its deepest point. It had been cut into the alluvial subsoil (110) and through into the natural underlying gravels (113) which formed its sides and base in the southern half of the trench. At the northern end of the trench, these gravels gave way to the natural clay geology (112).

The southern side of the canal sloped down at approximately 30° and met the flat base relatively sharply. The northern side appeared to have a gentler angle, sloping down at around 20°.

Southern edge of canal [107], looking south

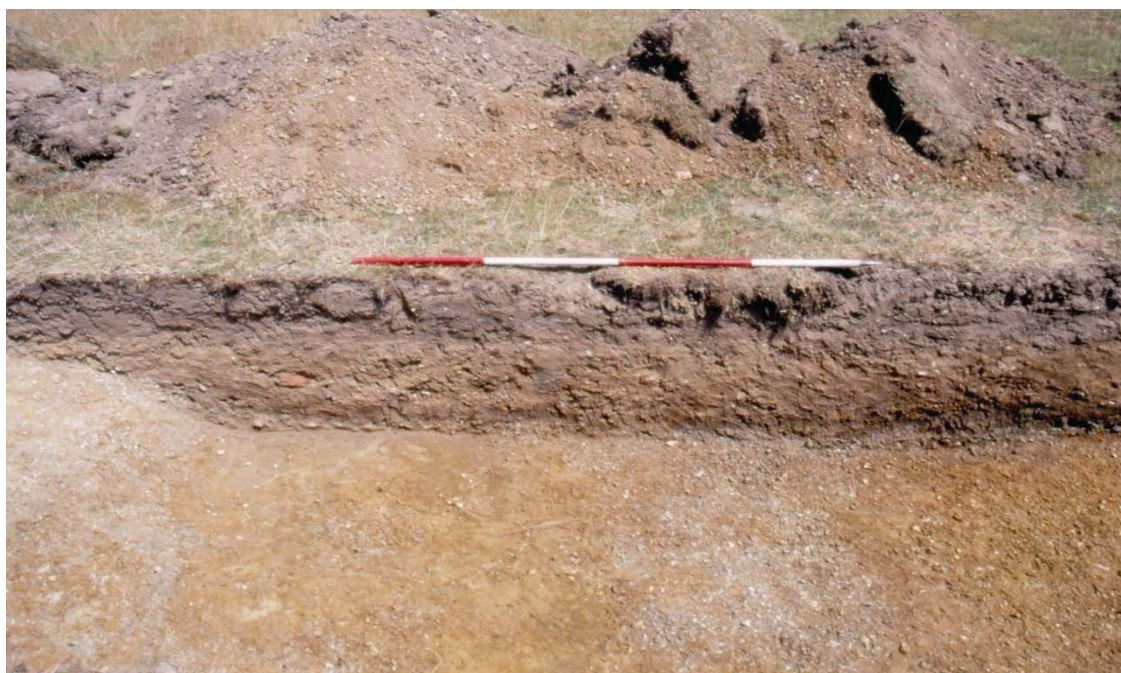
Fig 11

The canal was aligned north-east to south-west. It was 9.50m wide and 0.75m deep at its deepest point. Its southern side was relatively shallow, sloping down at approximately 20° whilst its northern side was steeper, sloping down at approximately 35°.

Northern edge of canal [204], looking north-east

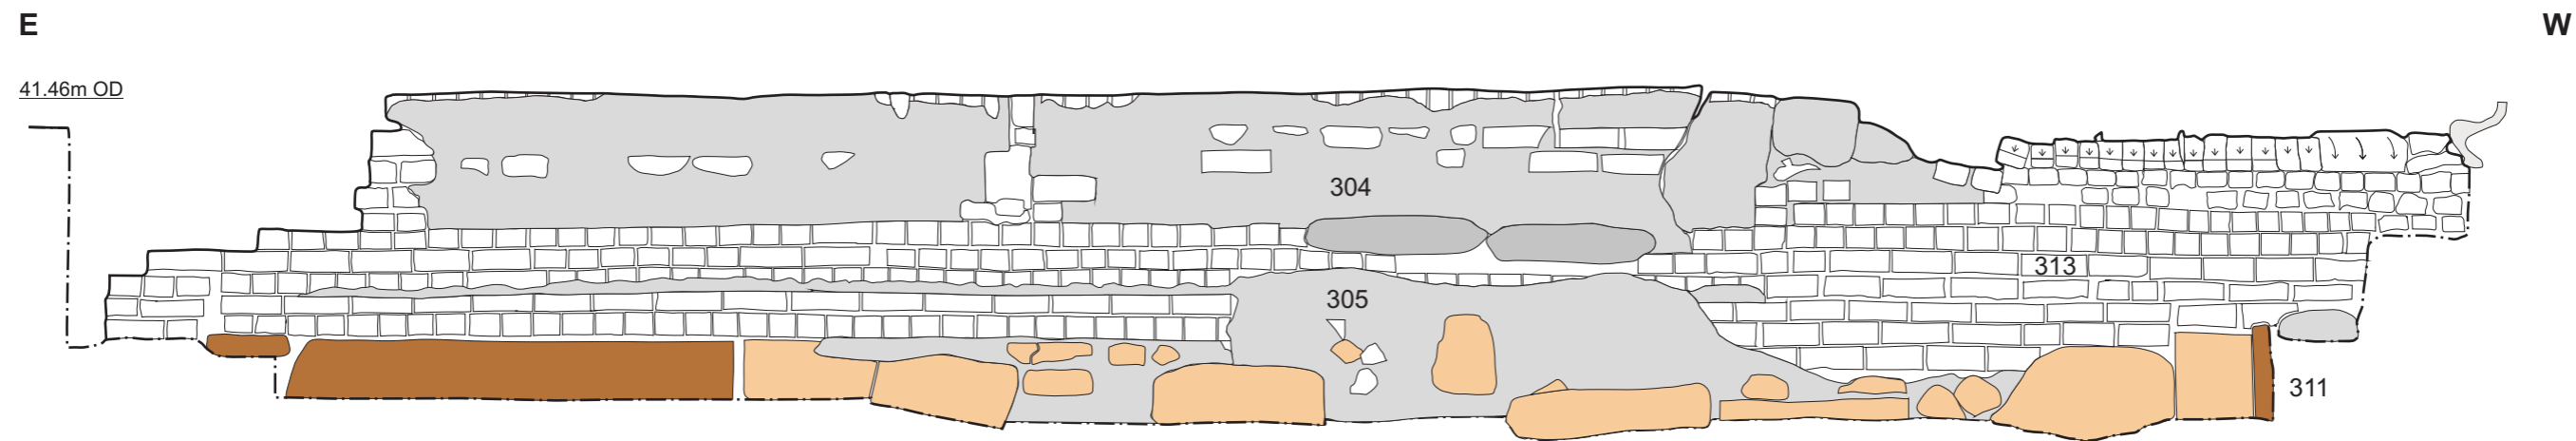
**Fig 12 Trench 3, north facing elevation of weir [305] S.4**

The brick wall [304] proved to be a later 20th century addition or repair set on earlier foundations [305]. The continued use of the weir into the 20th century is probably due to the flooding that occurs when the river is in spate. This was evidenced through repairs to the extreme eastern [303] and western sides [313] of the weir which indicated that the weir had been breached at these two points. Context [313] comprised reconstructed brickwork (Figs 12 and 13). Context [303] comprised plastic soil filled sacks and rubble removed as part of the excavation process (not illustrated).

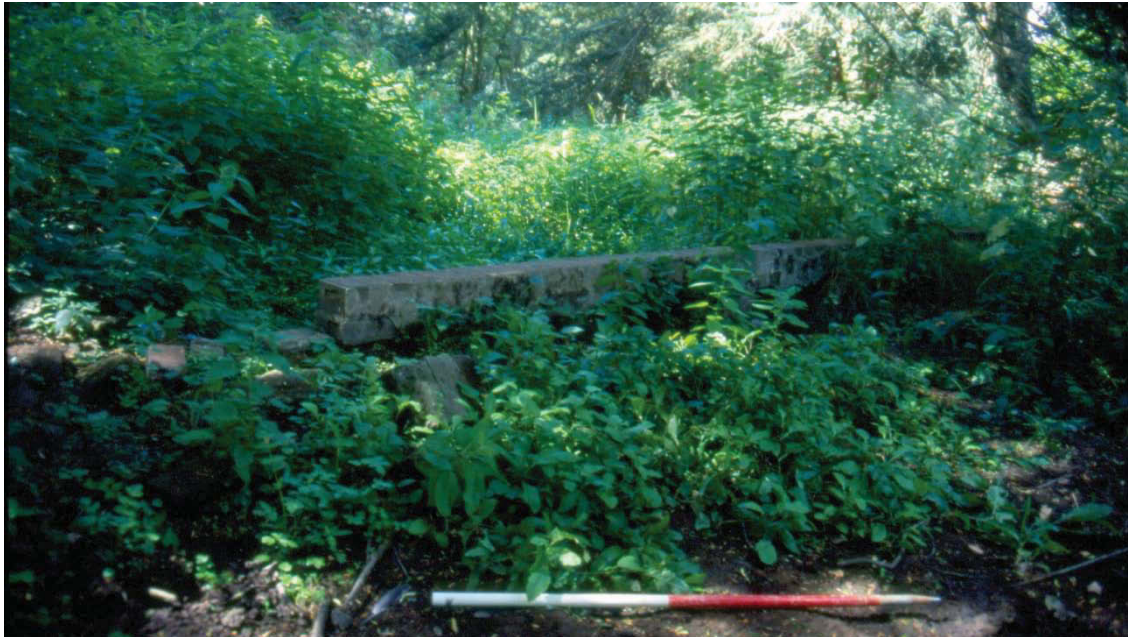
Fig 14

Trench 3, wall [304] prior to excavation, looking south-west

Trench 3 was located in dense woodland, at the junction of the canal and the River Loddon. A low brick wall, thought to be part of a weir, crosses the former canal at this point and hand excavation was undertaken around the structure to expose and record the remains (Figs 14 and 15).

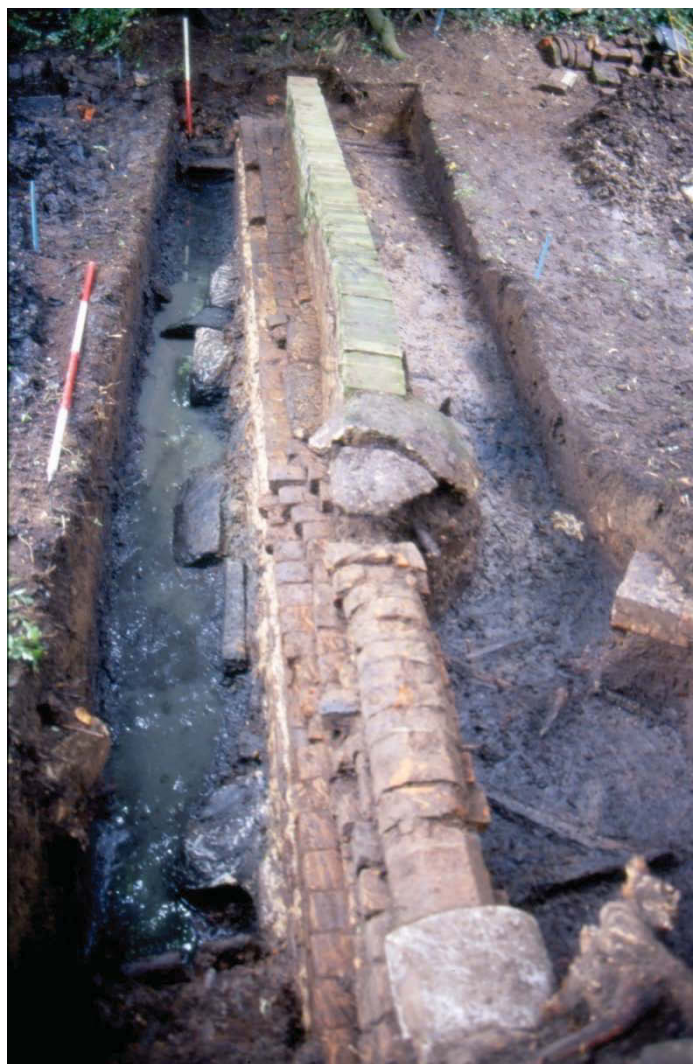
Fig 15

Trench 3, after excavation looking east

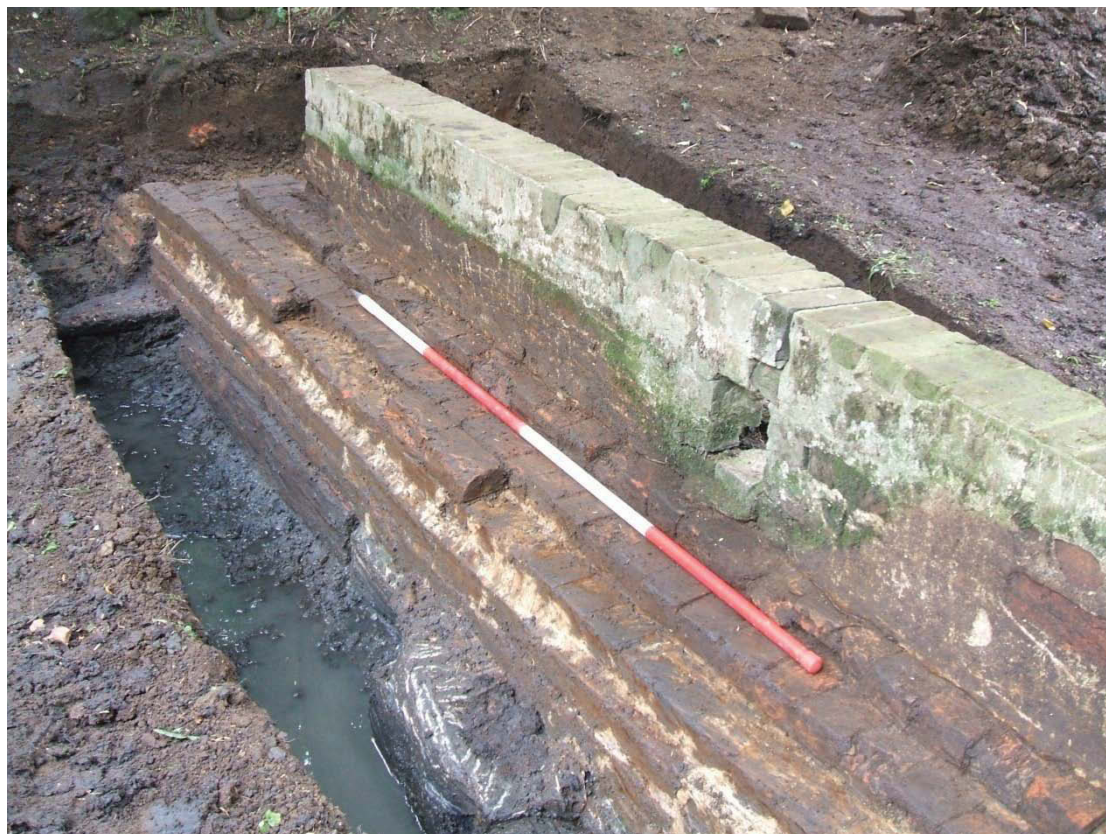
Fig 16

A raft comprising blocks of stone and wooden beams c0.20m thick had been laid down and brick foundations built on top (Fig 16). The foundations comprised five courses of red brick set in English bond to a height of 0.40m. The unfrosted bricks measured 220mm x 110mm x 70mm (8.75" x 4.25" x 2.5") although there did appear to be some variations amongst the brick sizes. They were bonded with a white mortar. The foundations had been stepped back into the underlying natural gravels, with a height difference of 0.30m between bases on the northern and southern sides.

Trench 3, detail of weir foundations [305] looking south-west

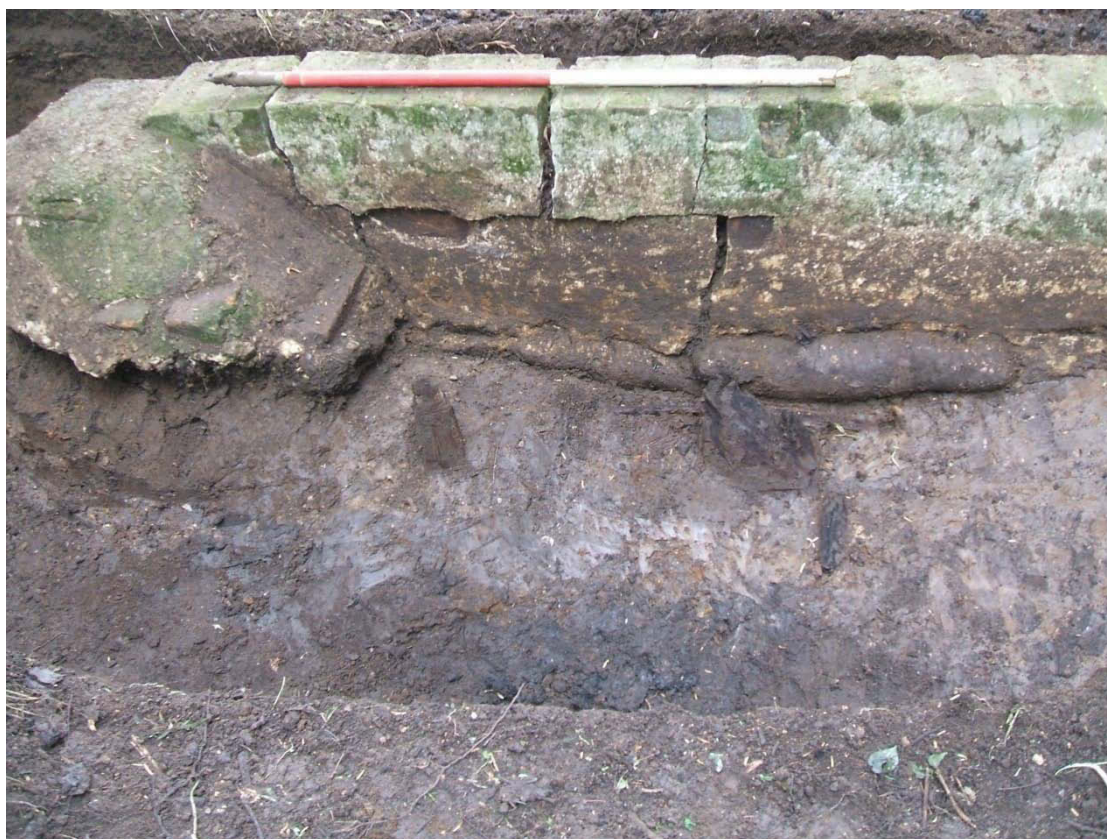
On the southern side of the wall, a wooden structure [306] was identified (Fig 17). This comprised the tops of two upright posts, of differing dimensions, and the remnants of a thin plank aligned parallel to the weir. Immediately to the south of these wooden members was a semi-circular hollow [307] measuring 1.10m long by 0.55m wide. It was 0.30m deep and extended beyond the edge of excavation. The collection of features may represent the location of a former sluice gate. The subsidence and cracks in the later wall [304] immediately adjacent to [306] may indicate that the wall is overlying further elements of the structure at this point (Fig 17).

Trench 3, wooden features [306], hollow [307] and later wall [304] looking north Fig 17

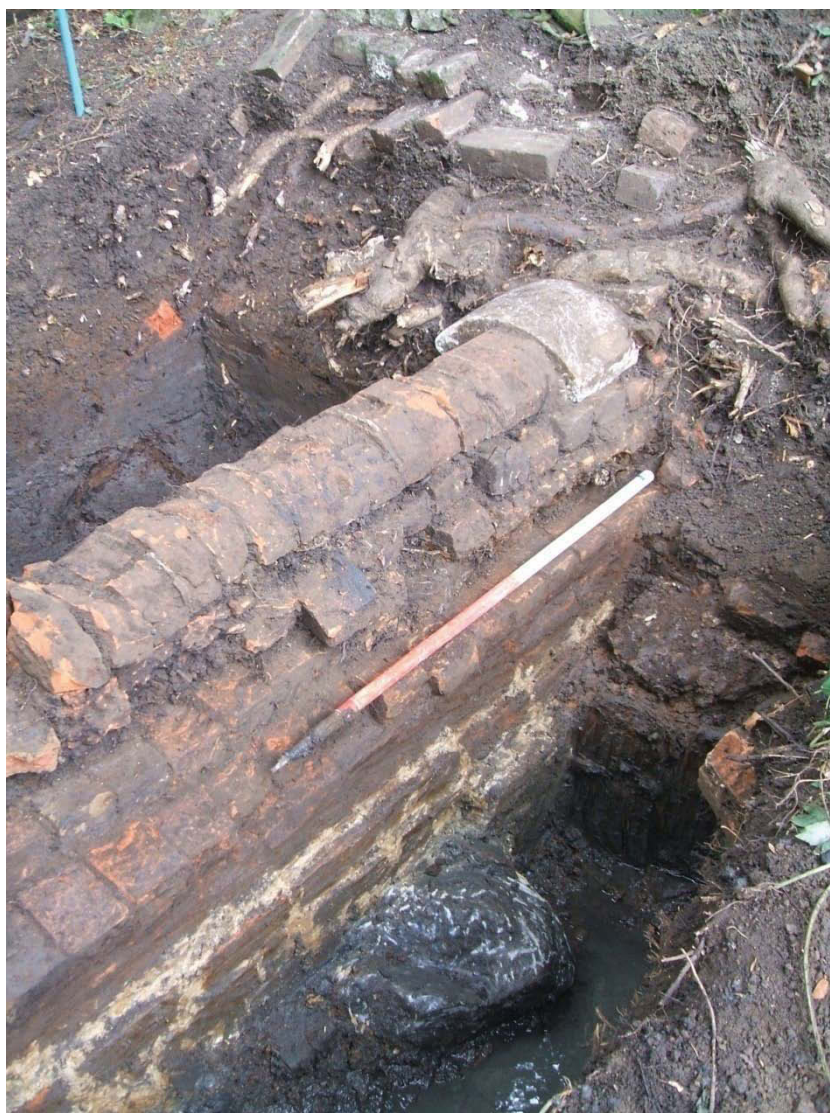
Fig 18

At the western side of the weir, the superstructure comprised an irregular red brick wall [313] sitting on the underlying brick foundations (Fig 18). It ran for c2.50m before joining with later brick wall [304]. Four courses were laid in header bond to a height of 0.36m. The lowest course sat flush with the underlying foundations [305] but the higher courses were disturbed and very irregular. The disturbance may have been due to tree root action but the courses did not appear to be bonded in any way and individual bricks varied in size and type. This would suggest that the wall was not original or at least had been rebuilt. It was topped with a layer of double cant bricks. Some of these appeared to be in situ, whilst others had obviously been replaced. Many had been worn down with water so that the Portland cement stood proud. The use of Portland cement would suggest a date after 1824 for these bricks. At the extreme northern end of the wall, was a large semi-circular white coping stone that appeared out of character with the otherwise brick construction.

Wall [313] looking south-west

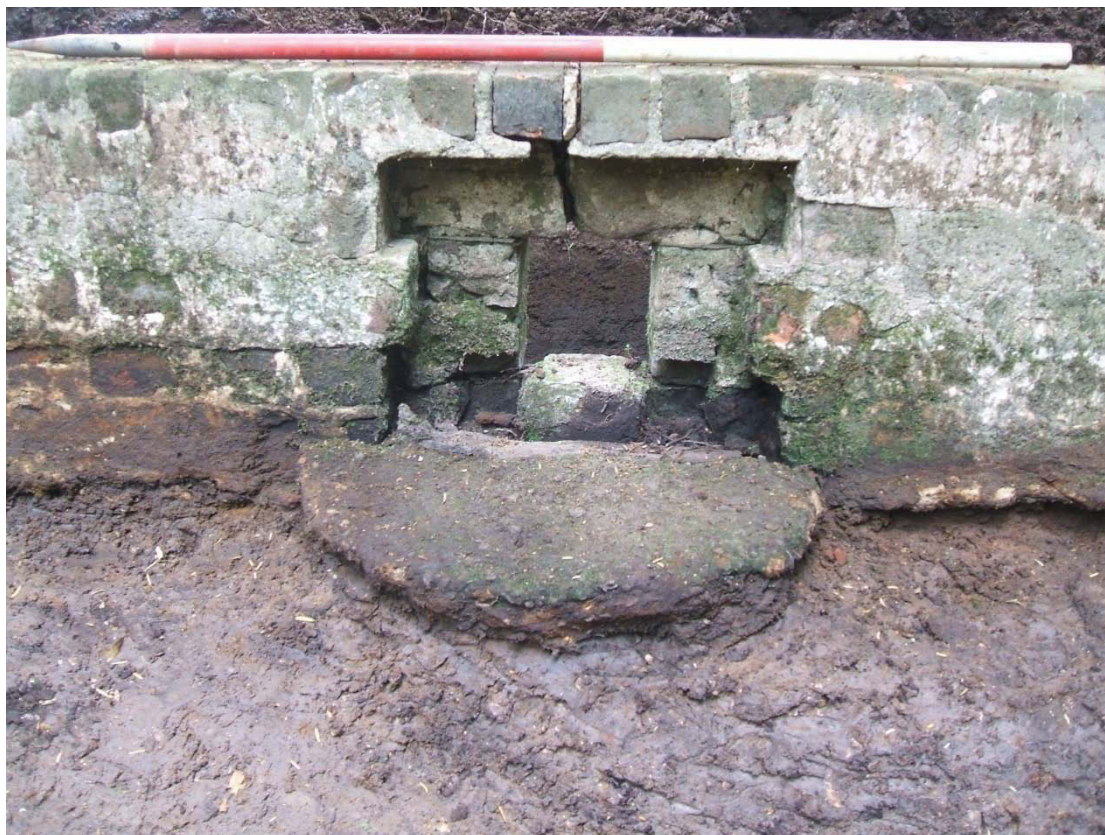
Fig 19

In the centre of the wall was an opening [Fig 19]. On the north facing side of the wall the gap measured 0.17m x 0.20m and would appear contemporary with the wall, rather than being a later insertion. On the south facing side the gap was larger due to the removal of bricks. This may have been to insert a wooden lintel in the base, the vestiges of which still survived. The presence of rusted bolts associated with the lintel possibly suggests that the opening held a sluice gate to control the flow of water. A semi-circular concrete pad [315] 0.57m x 0.27m is situated directly under the hole on the southern side of the wall and is presumably related.

Trench 3, opening in wall [304] and concrete pad, looking north

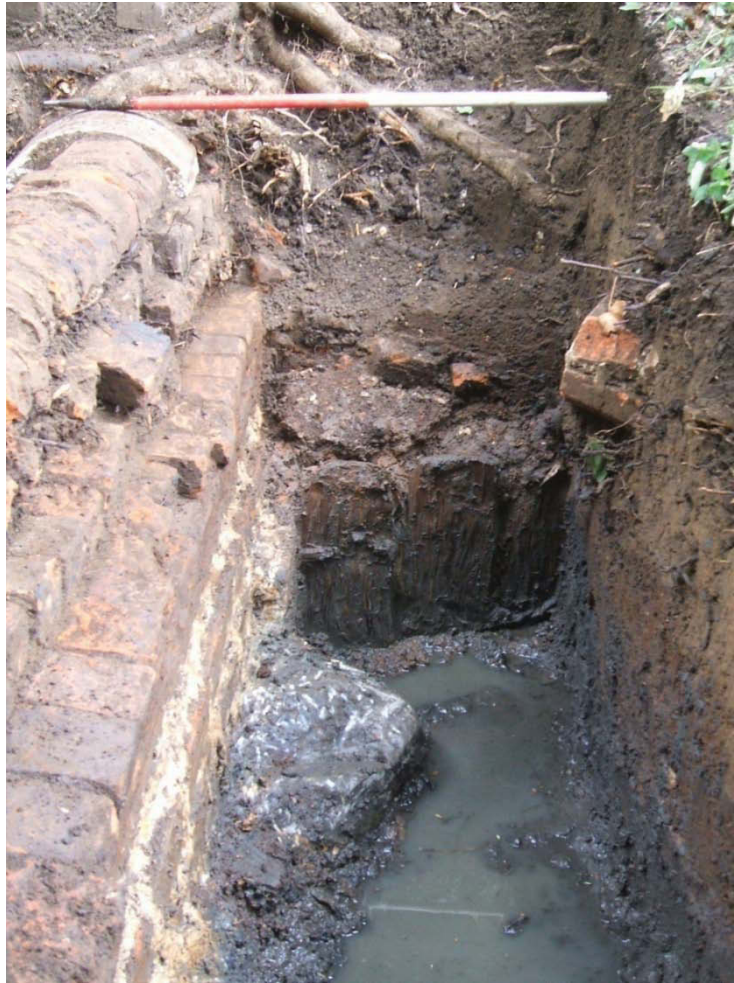
At the western side of the canal, on the northern side of the weir, the canal bank had been revetted with sawn planks that had been driven into the natural gravels (Fig 20). Each plank was 0.17m wide x 0.05m thick (6" x 2"). The space behind the planks had been packed with soft clay and concreted material. Similar clay packing was observed on the southern side of the canal on its eastern bank. However, no vertical timbers were observed here, instead timber beams laid long-ways may have formed the revetting (Fig 21).

Trench 3, timber revetting on western edge of canal Fig 20

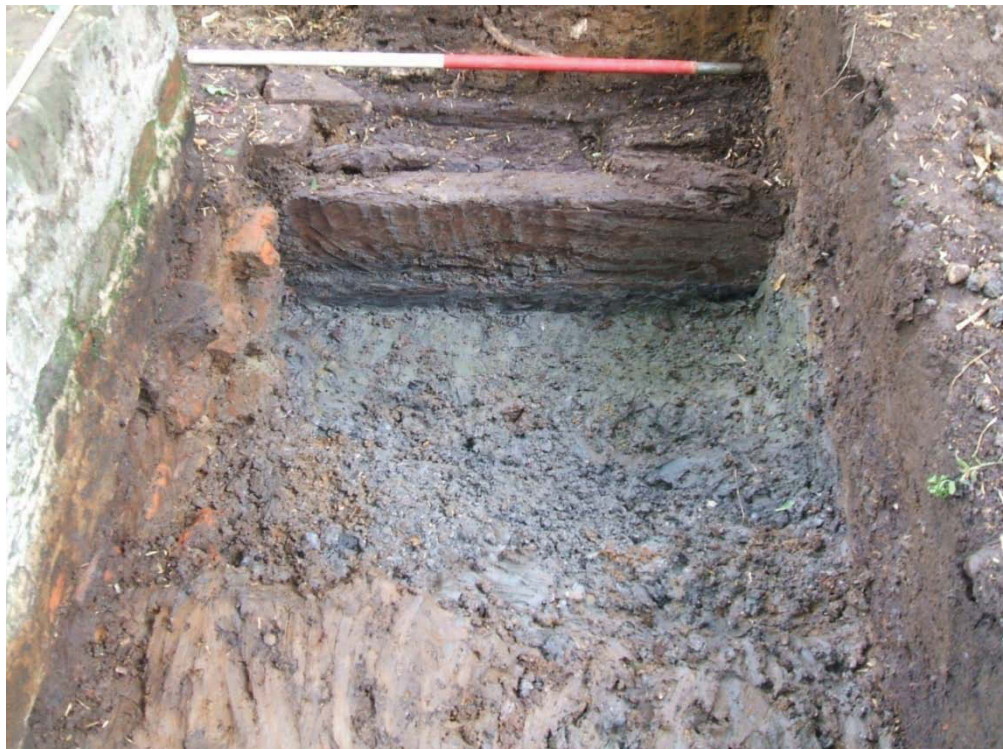
Trench 3, revetting on east side of the canal looking east Fig 21
