## Archaeological trial trenching on land at Swallowfield Park, Swallowfield, Berkshire

Report 10/146

November 2010

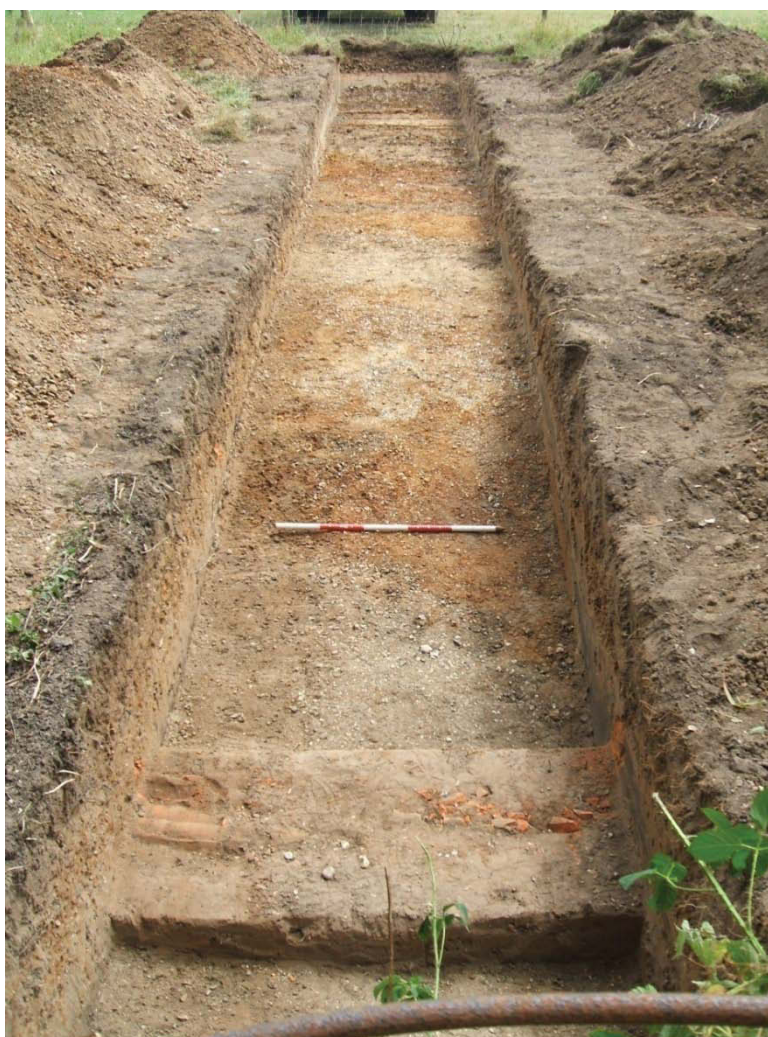
Fig 22

Trench 4 was 15m long at cut across the southern half of the line of the canal (Fig 22). The western half of the canal lay within the grounds of Swallowfield House itself and therefore could not be excavated.

Trench 4, looking south-east

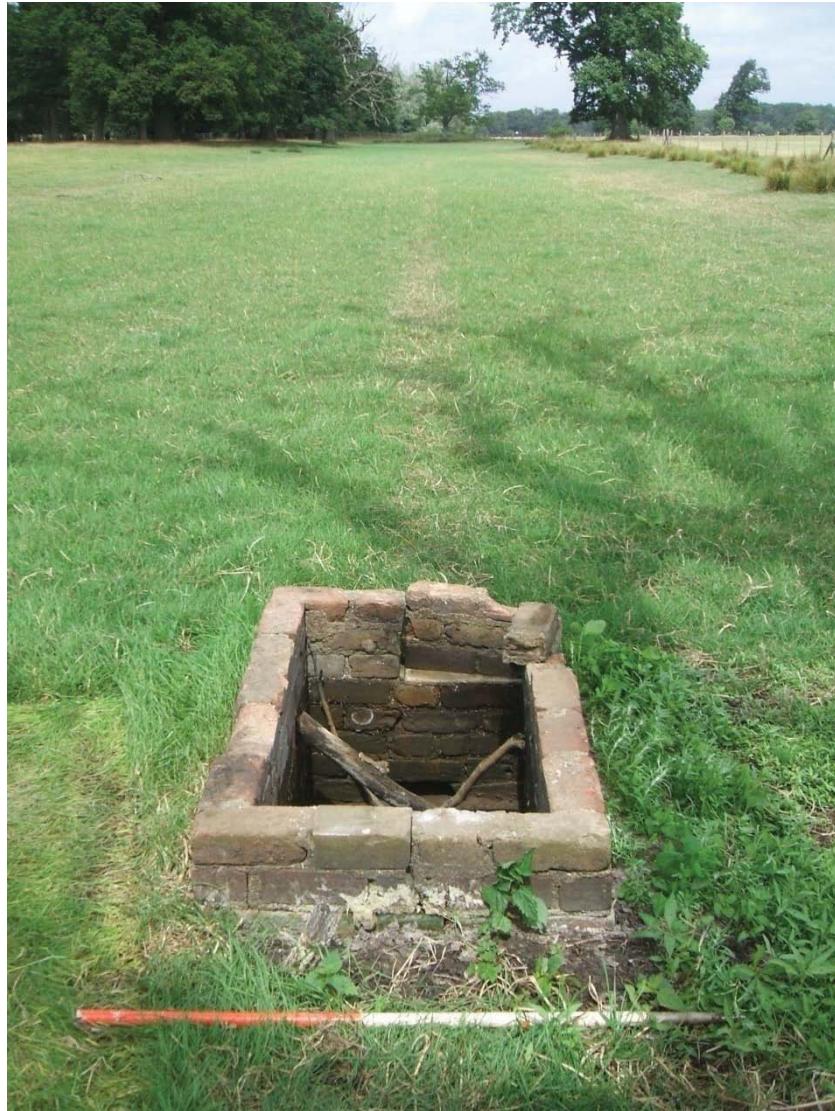
After the canal had become filled, land drains were inserted. Their size would preclude them being used to channel the canal waters underground and they would simply have been used in an attempt to drain the wet ground. There was no evidence for a brick-built culvert. However, in the stretch of canal immediately north of the track leading from the church, there is a brick built inspection hatch located in the middle of the canal (Figs 4 and 23). A linear parch mark stretches from this through to the entrance of the next field. It is therefore possible that a more substantial conduit exists at this point.

Brick inspection hatch and parchmark looking north-east Fig 23
