An archaeological desk-based assessment,
building recording survey and trial trench evaluation
at Wistaria Farm, Maxey, Peterborough

Report 10/21

February 2010

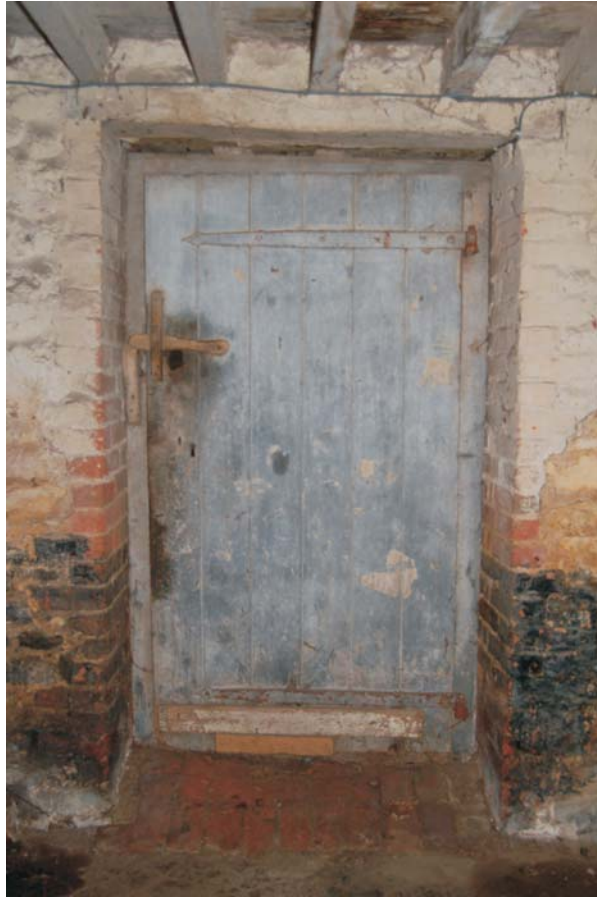
Door in east wall of store barn Fig 13

The east gable wall is constructed in the same way as the north and south sides, it has a central pedestrian doorway inserted when the range to the east was added (Fig 13). The door jambs are built of red brick, the lintel is pine. The doorway is fitted with a vertically boarded plank door, ledged but not braced. It has a simple wooden drop latch. There is a slight ramp constructed of red brick leading up to the door sill from the floor of the store barn since the room to the east (the Loose Box) is at a higher level. There are two rows of two splayed slit vents in the wall, each with an oak lintel.

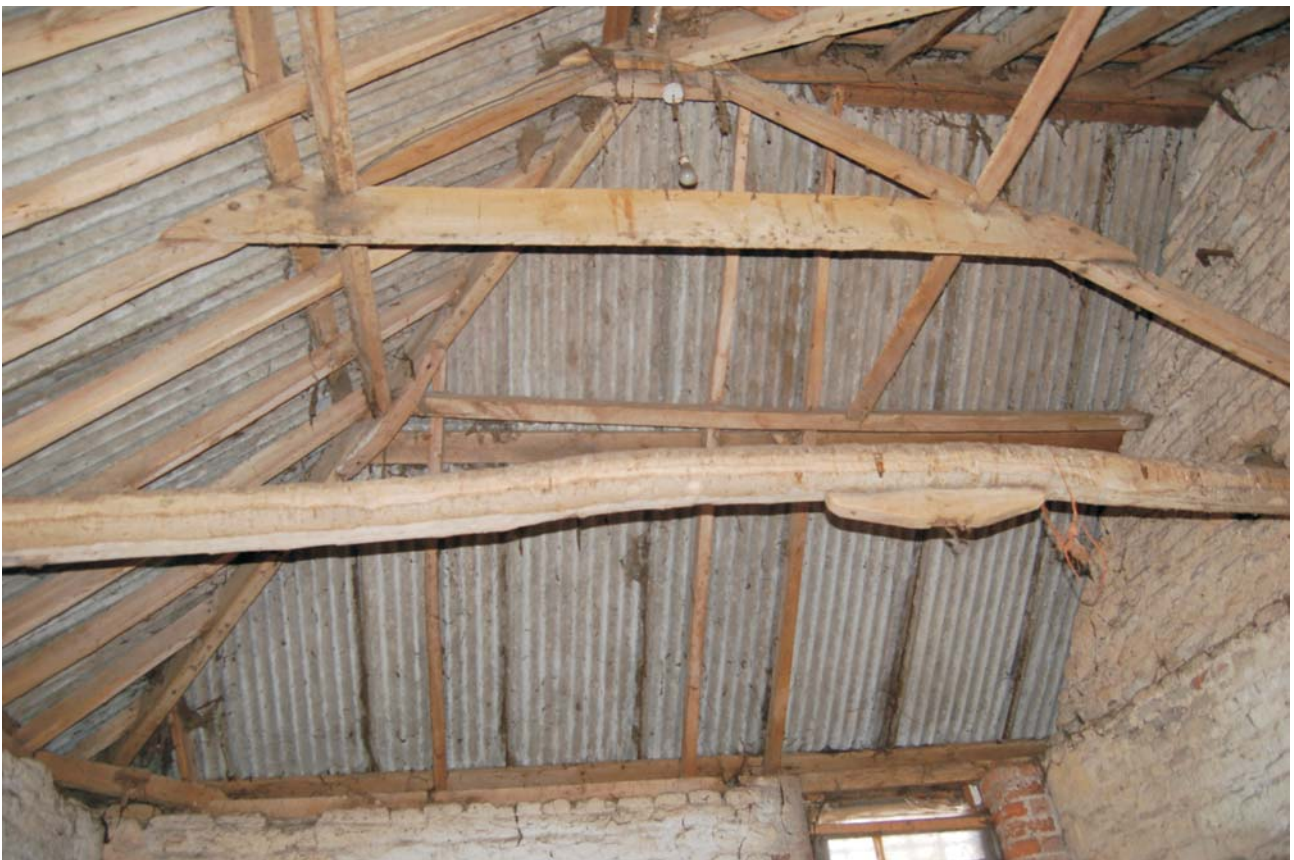
Roof of loose box, looking east Fig 18

The roof is constructed in hipped fashion and all of the framing is of machine sawn pine, somewhat irregularly made, perhaps suggesting piecemeal repair (Fig 18). It is covered with corrugated asbestos. The floor was originally of stone slabs, now mostly overlain with concrete.

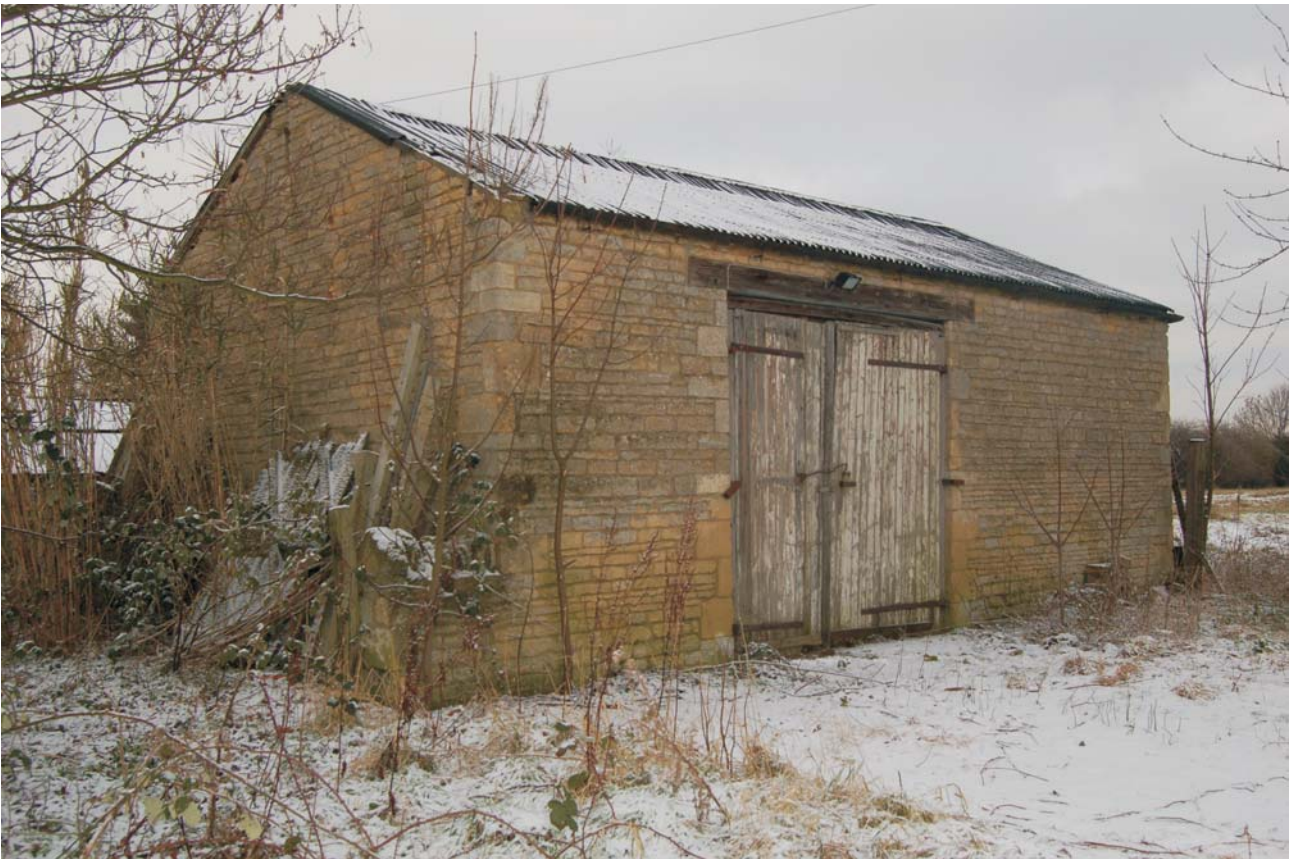
Detached barn, looking north-west Fig 28

A rectangular barn to the north of the main group, built of coursed and dressed limestone with ashlar quoins bonded in lime mortar, its long axis aligned north-south (Fig 28). It had two doors, one each in the east and west sides. That in the east side rises to the full height of the wall and has a chamfered pine door frame, fitted with what appear to be modern replacement doors of unequal size. Both leaves are of vertical pine planks and both are ledged and braced. They have modern locks and hinges. The doorway in the west wall was both narrower and lower and retains its chamfered door frame but has been infilled with a Crittal-style window set over a timber boarded lower half. In the south gable end there is a single vertical slit vent high up beneath the ridge. In the north gable end there is a window comprising a single sheet of glass within the frame, the lintel of which is chamfered externally (type of timber unknown). This opening was originally fitted with doors as hinges remain *in situ* on the west side of the frame. It must therefore have served as a hayloft door though there is no evidence that the barn was ever floored and would have been used simply to fill the upper section of the barn to the roof.

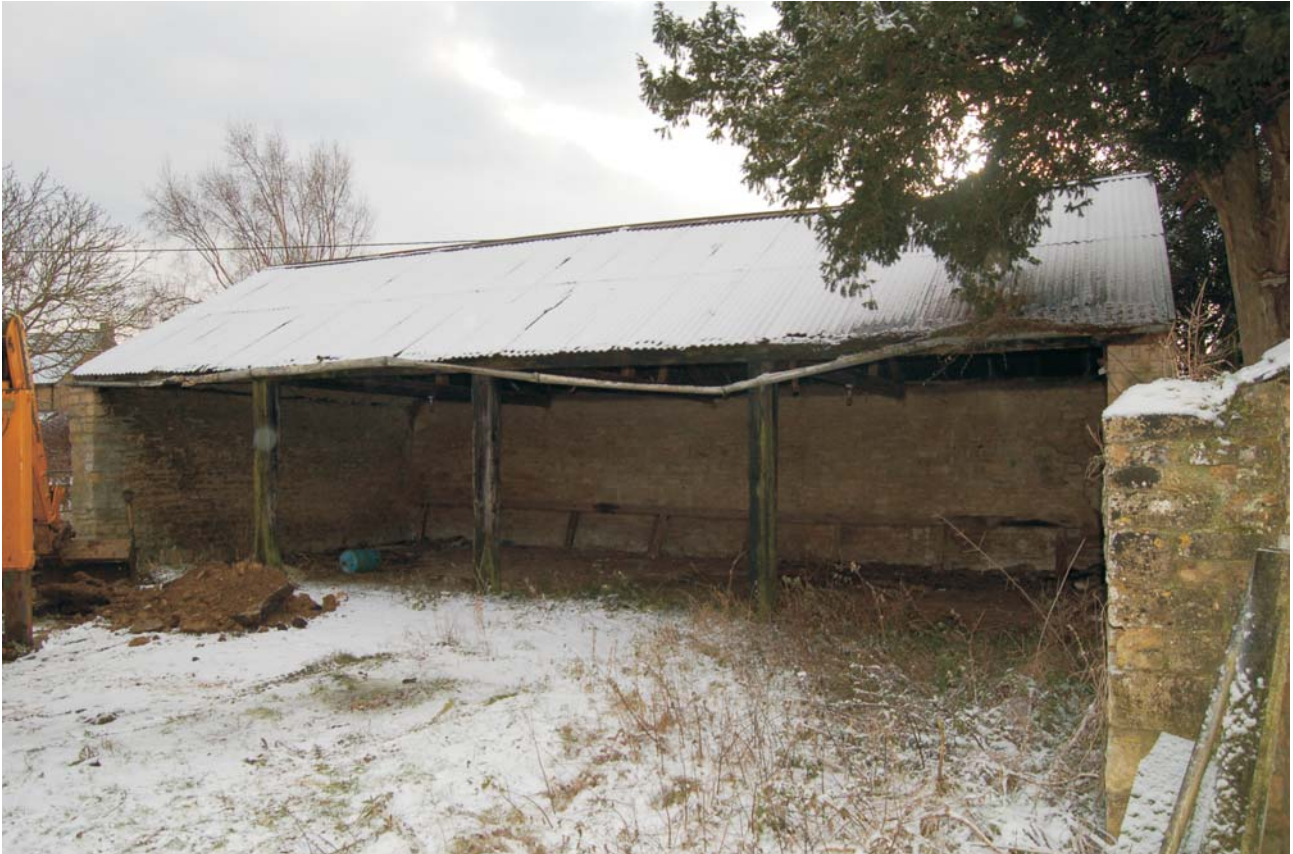
Cart hovel, looking south-east Fig 31

A four bay cart hovel adjacent to the road on the east side of the main group of buildings (Fig 31). Constructed of coursed limestone on the east, south and west sides with the north side open and supported on three pine posts. There is an oak bump rail against the internal south wall to prevent carts being damaged by collision with that wall (Fig 32). The roof is of three pine trusses of king post construction with raking struts covered in corrugated metal sheeting (Fig 32). Cart hovels traditionally face north or north east to keep the carts in the shade to prevent them from excessive drying out by the sun. The floor is of rammed earth.

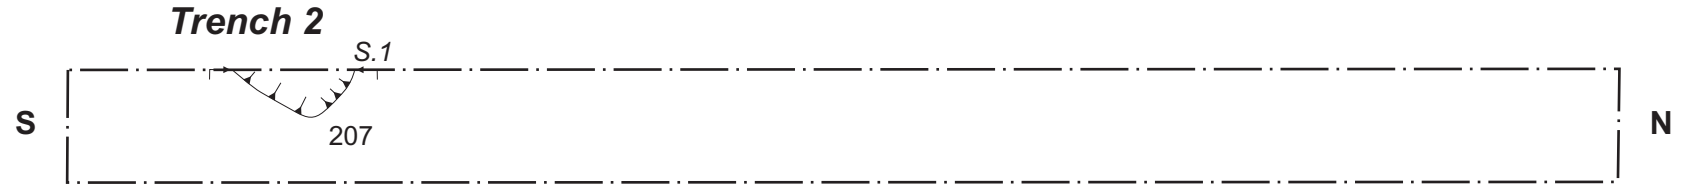
Plans of trenches 2, 3, 8 and 9 Fig 34

Archaeological features were found in Trenches 2, 3, 8 and 9, dated to the late Saxon and medieval periods and included ditches and pits. No archaeology was encountered in Trenches 1 and 4-7.

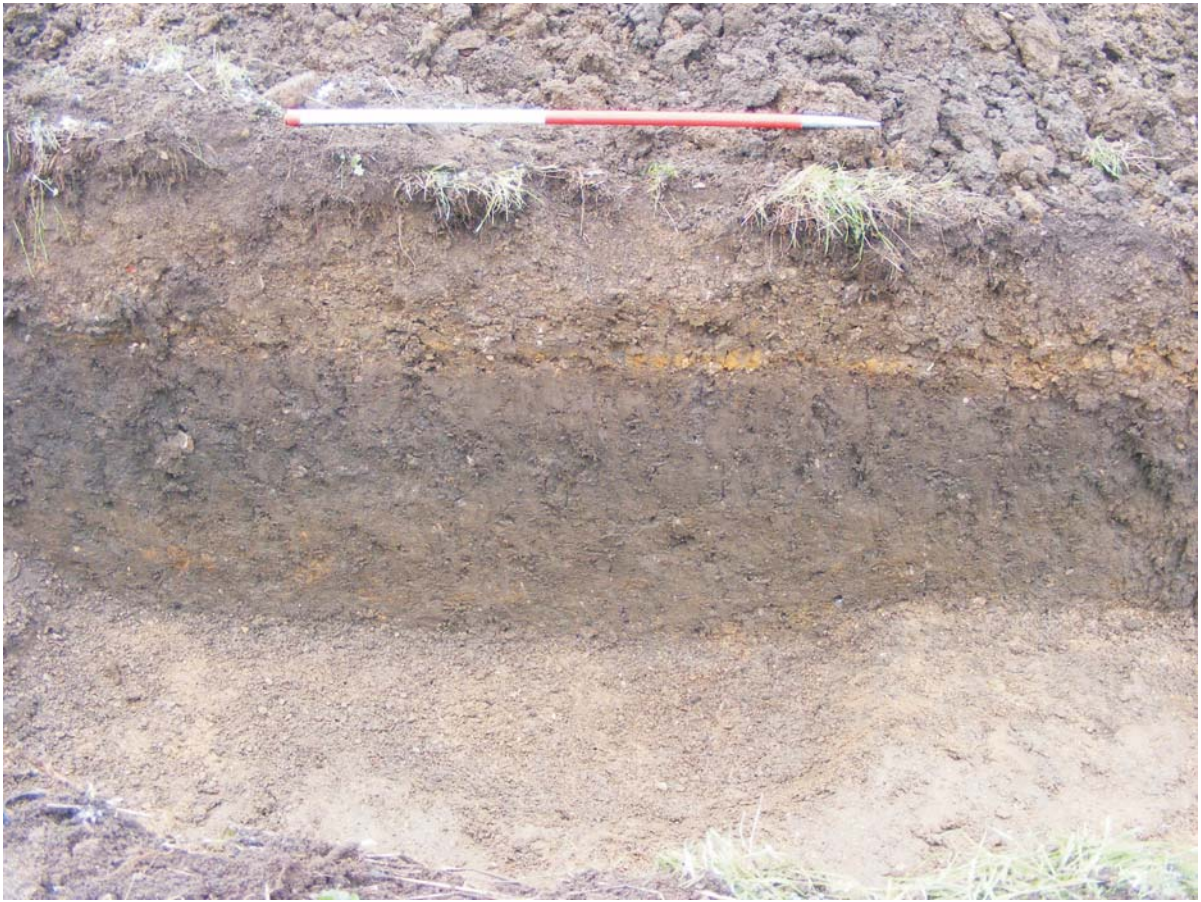
Pit [207], looking west Fig 36

The natural gravels were encountered 1m deep. In the southern part of the trench was part of a sub-square feature, 1.60m long, 0.60m wide and 0.34m deep, with fairly steep sides and a wide, flat base, [207]. The dark grey-brown silty clay fill contained evenly distributed fragments of charcoal, small chippings of limestone and occasional gravel (Figs 34, 35, Section 1 and 36). One sherd of South Lincolnshire Oolitic ware and a sherd of 19th century pancheon ware were found in the feature.

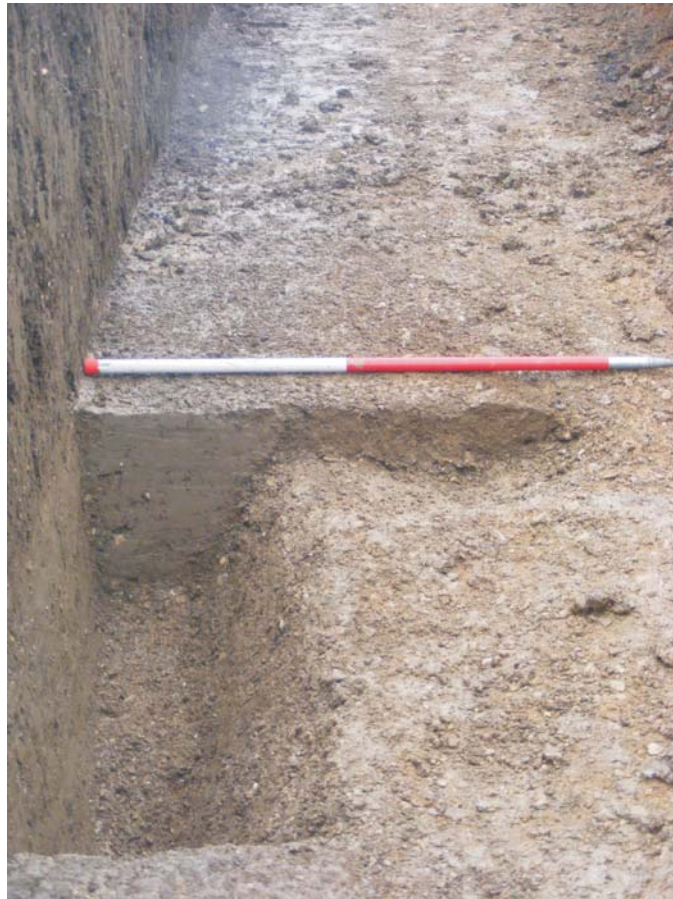
Posthole [310] and ditch [308], looking north Fig 37

A single posthole, [310], at least 0.54m in diameter and 0.12m deep, with a shallow dish-like profile, cut the natural (Figs 34, 35, Section 2 and 37). The single fill was greyish brown silty sand. This was truncated by a straight ditch, at least 0.39m wide and 0.40m deep, which followed the same alignment as the trench [308] (Figs 34, 35, Section 2 and 37). The single, homogeneous fill was grey-brown silt with gravel and sandstone chippings throughout. A number of sherds of Late Saxon and medieval pottery were found in the base of the ditch. It may represent a former property boundary.

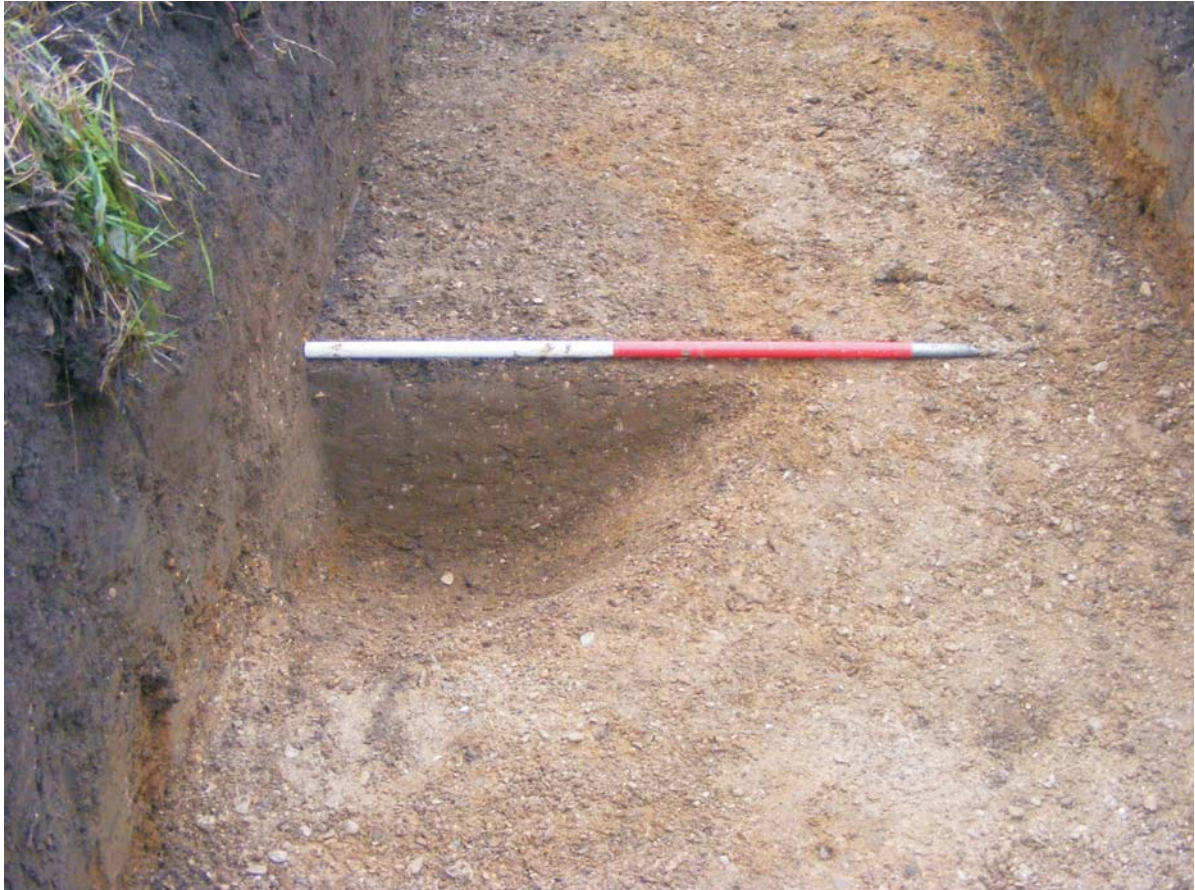
Possible pit [908], looking north Fig 39

A sub-circular feature, at least 0.70m in diameter and 0.34m deep, was filled with mid brown-grey silty sandy clay with fragments of charcoal [908] (Figs 34, 35, Section 8 and 39). A single sherd of South Lincolnshire Oolitic ware pottery was found within the fill.
