An archaeological watching brief during water main
replacement works in Gold Street, Northampton
January – April 2009

David J. Leigh
Report 10/17
March 2010

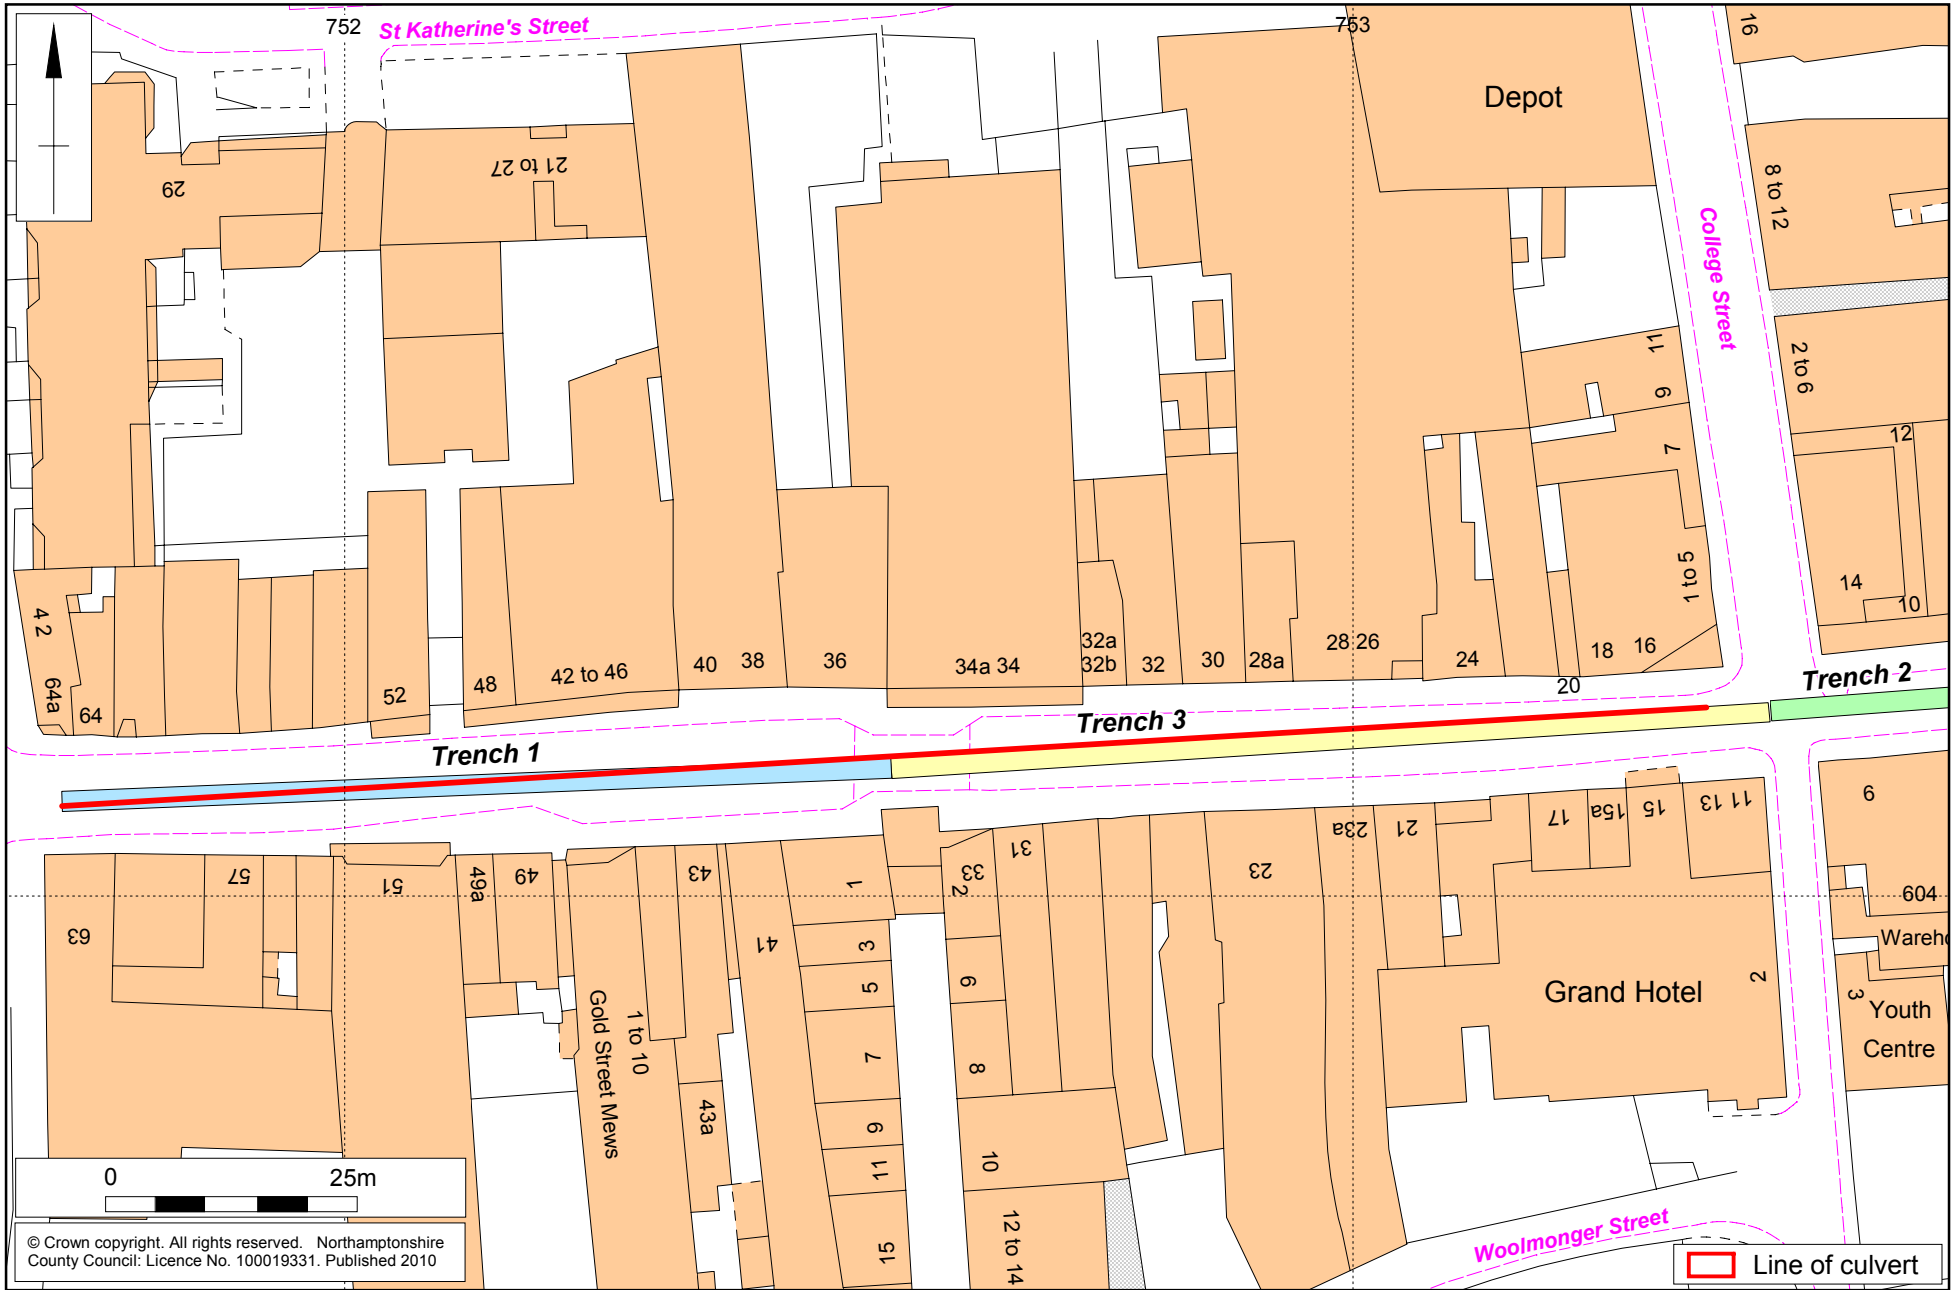
Line of culvert in Trenches 1 and 3 Fig 5

Running along the length of the trench was a brick-built culvert (Figs 13, 14 & 24). This cut the clay layers and was set just above the level of the possible early cobbled road. It ran slightly obliquely to the trench line, entering from the centre of the western section at c65.4m aOD then crossing through the centre of the trench, exiting into the northern section of trench 3 at c69.5m aOD. This amounted to a fall of approximately 4.10m east to west, the corresponding fall of the street level over the same distance amounts to approximately 3.0m.

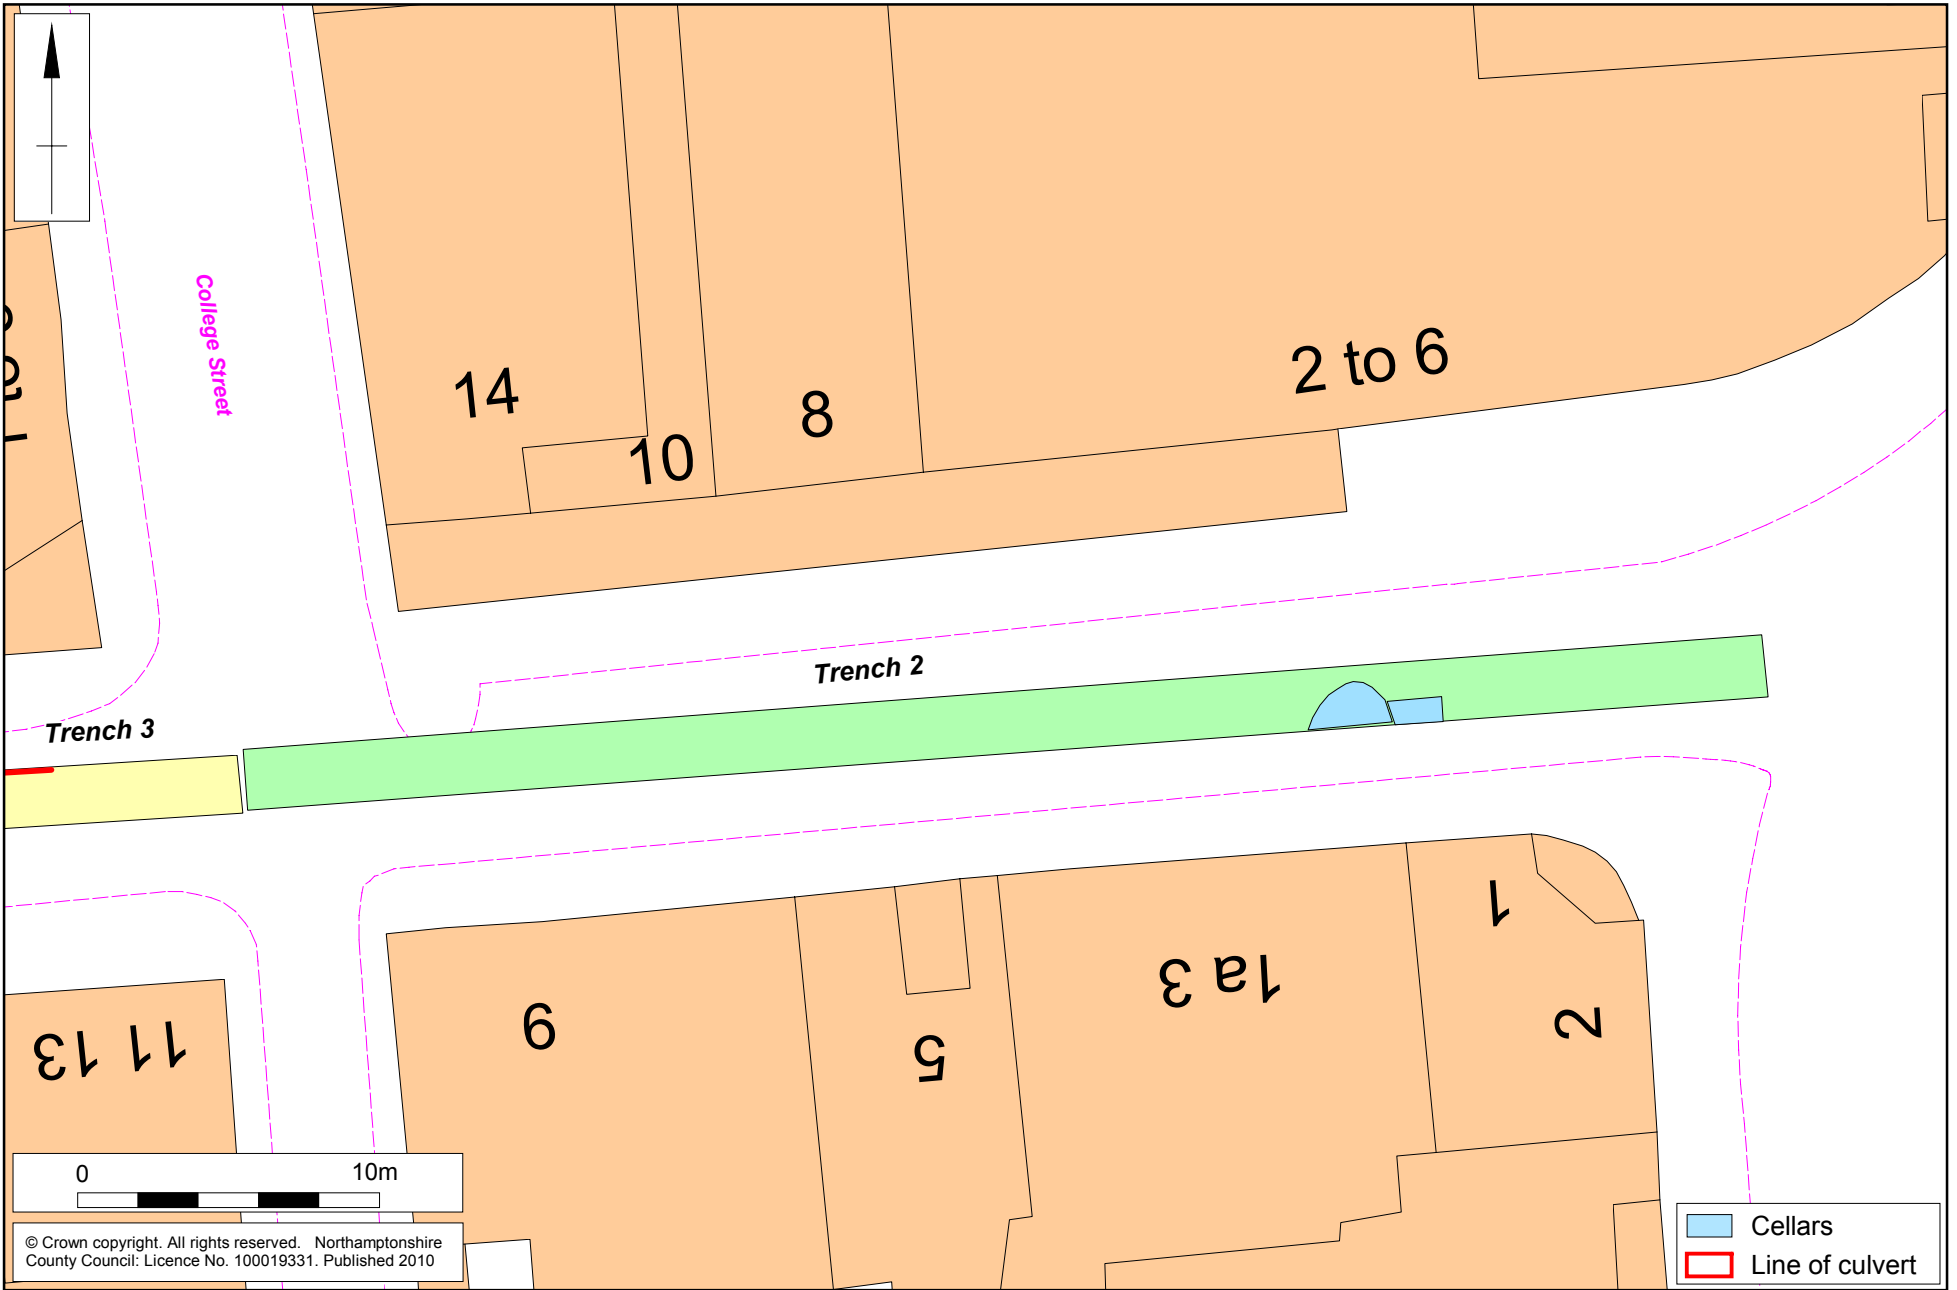
Fig 6

Two apsidal-ended cellars were encountered side by side (Figs 6, 17 & 18) approximately 15m from the eastern end of the trench. They extended 0.72m into the trench from the southern section, approximately 4.5m from the frontage of the present buildings. They had been constructed of roughly cut limestone blocks bonded together with off-white mortar, the interior of the western cellar retaining a covering of whitewash. The upper part of each cellar had been rebuilt relatively recently using modern red bricks bonded with hard grey/white Portland cement. The apsidal end of the eastern cellar had been truncated and the cellar blocked off by a wall of modern red bricks. Each cellar was 1.40m wide and had been cut through by the existing cast iron water main. As the new water main is to pass through the line of the cellar limited demolition and reconstruction of the western cellar was undertaken. The western cellar currently functions as a store for a hairdressing business and the access remains open, whilst the eastern cellar belongs to a Jewellers.

Trench 2 and the location of the cellars

The cellars revealed at the eastern end of Gold Street would appear to be evidence of the widening of Gold Street that took place during the early 20th century. The cellars, which would have once been located beneath the tenements, now extend some way out from the frontage of the present buildings into the line of the modern road. Full recording of the cellars was outside the remit of the watching brief, however, a medieval vaulted cellar is still extant just to the south of All Saints in George Row and a future comparison with this may provide some indication as to the date of the Gold Street cellars.

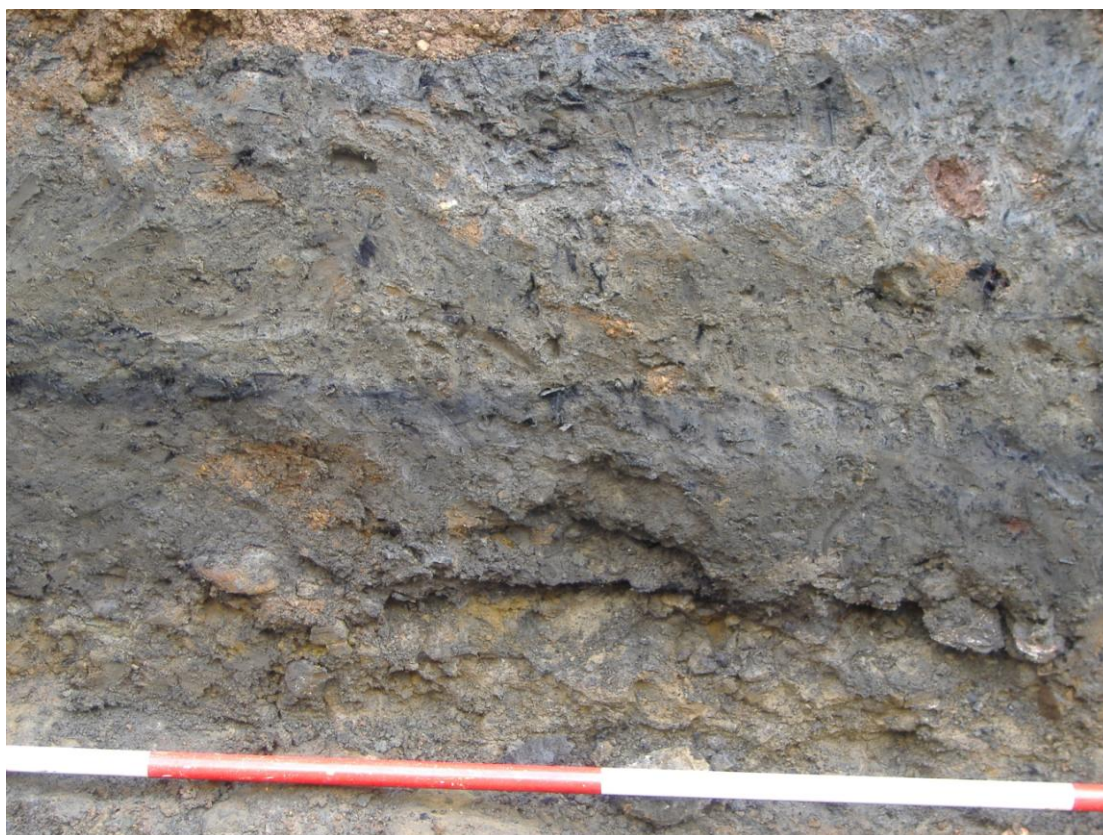
The road surface in Trench 1, with the clay above Fig 12

thick, made up of irregular fragments of ironstone, up to 150mm in diameter, with occasional small fragments of limestone (Fig 12). This was present throughout the trench, although cut through in several areas by modern deposits. A band of fragmentary river worn cobble stones, each a maximum of up to 100mm in diameter, mixed with an equal amount of irregular ironstone fragments lay above this. This deposit was a maximum of 110mm thick. These deposits can be interpreted as the truncated remains of a road surface.

A compact ironstone/limestone deposit, perhaps a remnant of a former road surface was recorded during the course of the watching brief. However, no secure dating evidence was present. Lying directly above was a thin layer of fragmented cobble stones, which may be attributed to a subsequent resurfacing of the road.

Similar road construction was recorded during excavations at Green Street (Chapman 1998-99), which were datable to the late Saxon/Norman period. This comprised “two layers of heavily worn road metalling” constructed of small fragments of limestone and cobbles with an upper surface of larger ironstone and limestone fragments.

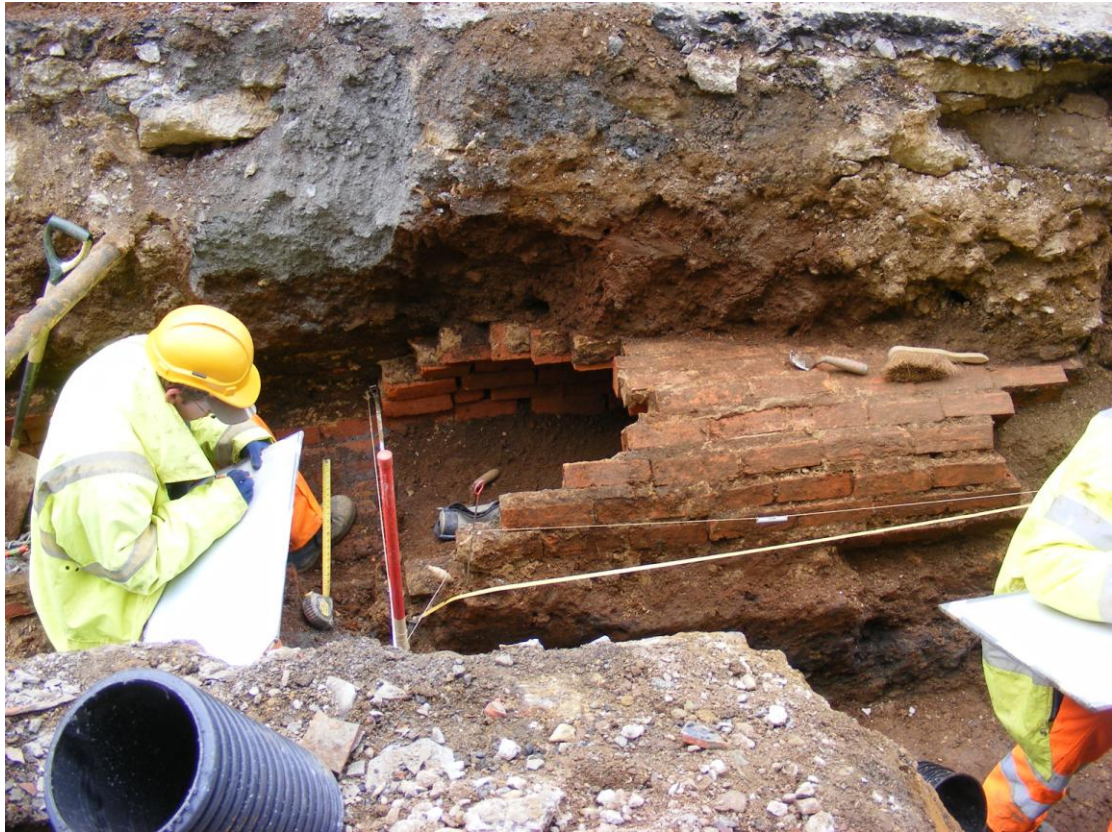
General view of the culvert during recording Fig 13

The culvert was constructed of red brick bonded with firm grey/white mortar. It had suffered some distortion in its form as a result of ground pressure and modern service groundwork and appeared to have been deliberately collapsed or dismantled for much of its length, as several stretches had been disassembled and the bricks stacked up within the void left by the culvert. A number of inlets comprising ceramic pipes, approximately 250mm in diameter, were noted entering the culvert at varying intervals.

The interior diameter along the horizontal axis was approximately 0.65m, while the vertical axis measured a maximum of 0.75m. Within the culvert at its eastern end, was a shallow fill of grey-brown silt loam (3002), up to 50mm thick. This was overlain by another shallow fill of pale grey/brown silt loam (3003), up to 50mm thick, containing occasional items of modern rubbish including plastic bottle tops and cigarette packets. Within the culvert at the western end of the trench was a grey-brown silt loam, up to 50mm thick, containing occasional small fragments of modern ceramic building material.

At the request of local independent historian Alan Clark a section of the culvert was saved for future research each brick being individually numbered to allow for reconstruction should it be so required.

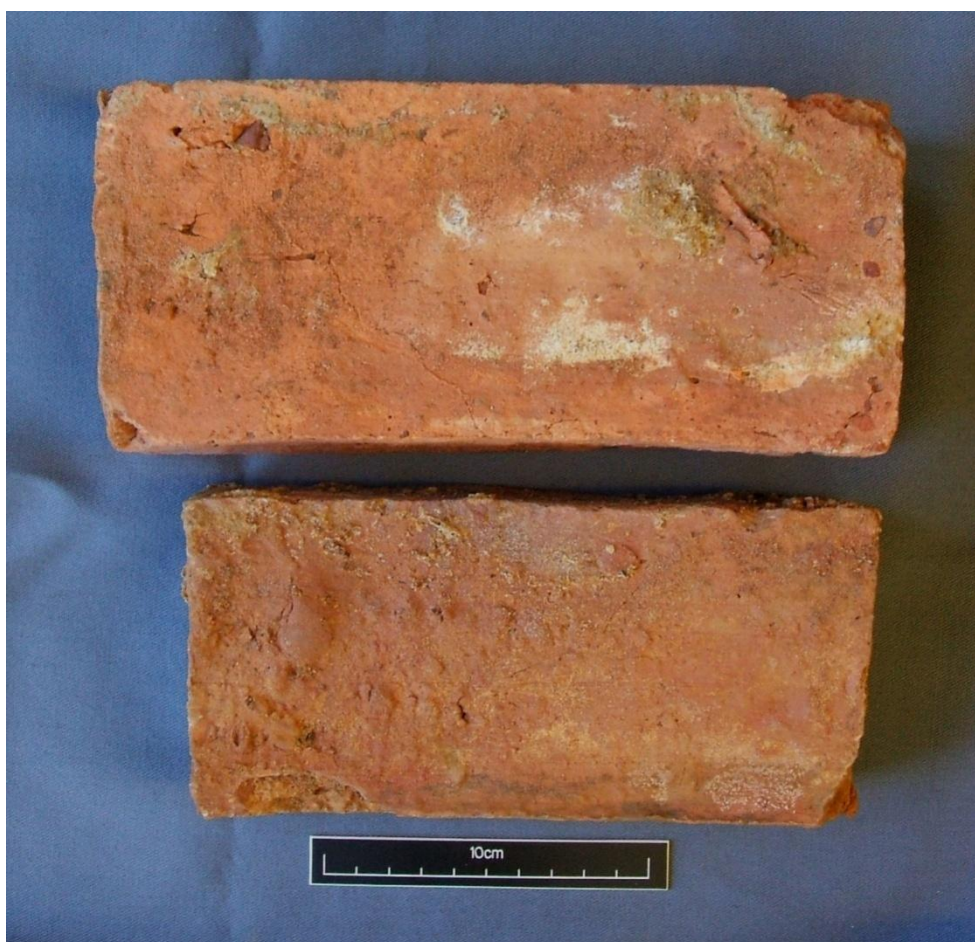
The brick samples Fig 21

A total of 108 bricks were collected from a length of the culvert which was fully dismantled, and 105 of these have been examined. Two types of brick are present, distinct in length and width; a smaller reddish brick comprising just under a quarter of the assemblage and a larger brick more orange-brown in colour (Fig 21).

The 22 smaller bricks are typically orange-red-brown or mauve-brown in colour and generally better made. These bricks measure 190-195mm long by 90-95mm wide and 55-60mm thick (7½-7¾ inches x 3½-3¾ inches x 2⅛ - 2⅜ inches). This group includes one brick with a glazed finish on one surface (Fig 22) and a header. This brick could either have been a reuse from a demolished building or a discard from over-firing, as it is slightly distorted.

The remaining, slightly larger bricks are orange-brown in colour, varying in hue, often with large pieces of ironstone in the clay. These bricks are 200-225mm ($7\frac{7}{8}$ - $8\frac{5}{8}$ inches) long and 95-100mm ($3\frac{3}{4}$ -4 inches) wide. The thickness, at 55-60mm ($2\frac{1}{8}$ - $2\frac{3}{8}$ inches), is the same as the smaller brick. Both types are a little smaller than the typical bricks of the 18th and 19th centuries (Harley 1974, 76), perhaps an indication of local traditions in brick-making.

The bricks taken from the fabric of the culvert revealed two distinct types. The smaller of the two would appear to be of probable 18th-century date whilst the larger would appear to date from the 19th century. This would suggest that the culvert is of 19th-century date re-using a percentage of earlier bricks in the construction, with the use of Portland Cement suggesting that this occurred no earlier than the mid-19th century.

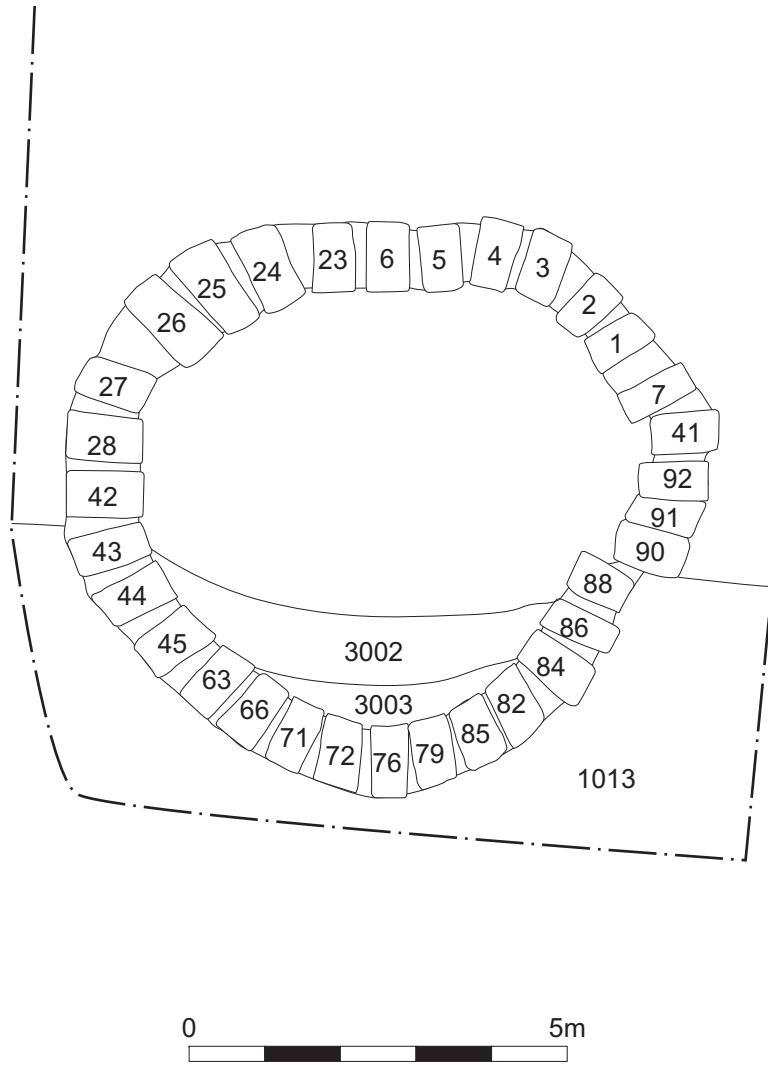
Documentary sources held by the Northampton Record Office appear to support a late 19th century date. Borough Engineer records include thirteen specifications for drainage replacement works in the town between 1866 and 1891. Whilst none of the specifications refer directly to Gold Street an indication of the design of the new culvert is illustrated in the contract for that to be constructed in Freehold Street in 1884 reads "The contractor to take up the existing 18" barrel culvert in the street. The bricks of which if sound and good may after being well cleaned be re-used in the new culvert (no old pipe bricks will be allowed to be re-used)". It further goes on to state ..."The new culvert...oval in shape 3 feet in height 2 feet in width of a single brick ring 4½ inches wide set in lias lime mortar and cemented with Portland cement ¾ inches in thickness..". A further record survives which records an announcement issued on March 2nd 1779, regarding a meeting to be held at the Guildhall in Northampton to determine whether a tunnel or common sewer is required in Gold Street (Fig 25).

When the documentary sources are considered with the archaeological evidence, it is probable that the culvert recorded during the course of the watching brief was constructed during the 1866-91 drainage works in the town. As stated in the engineers schedule, two types of mortar were employed in its construction and whilst the dimensions recorded do not correspond exactly to that in the specification, the surviving sections of the culvert have been subject to some distortion due to the passage of time. Further, the smaller 18th-century bricks incorporated within the

construction would most likely have been re-used from the earlier culvert referred to in the 1779 document.
