The churchyard wall at St Lawrence's Church Long Buckby, Northamptonshire

Report 10/213

December 2010

THE CHURCHYARD WALL AT ST LAWRENCE'S CHURCH, LONG BUCKBY, NORTHAMPTONSHIRE

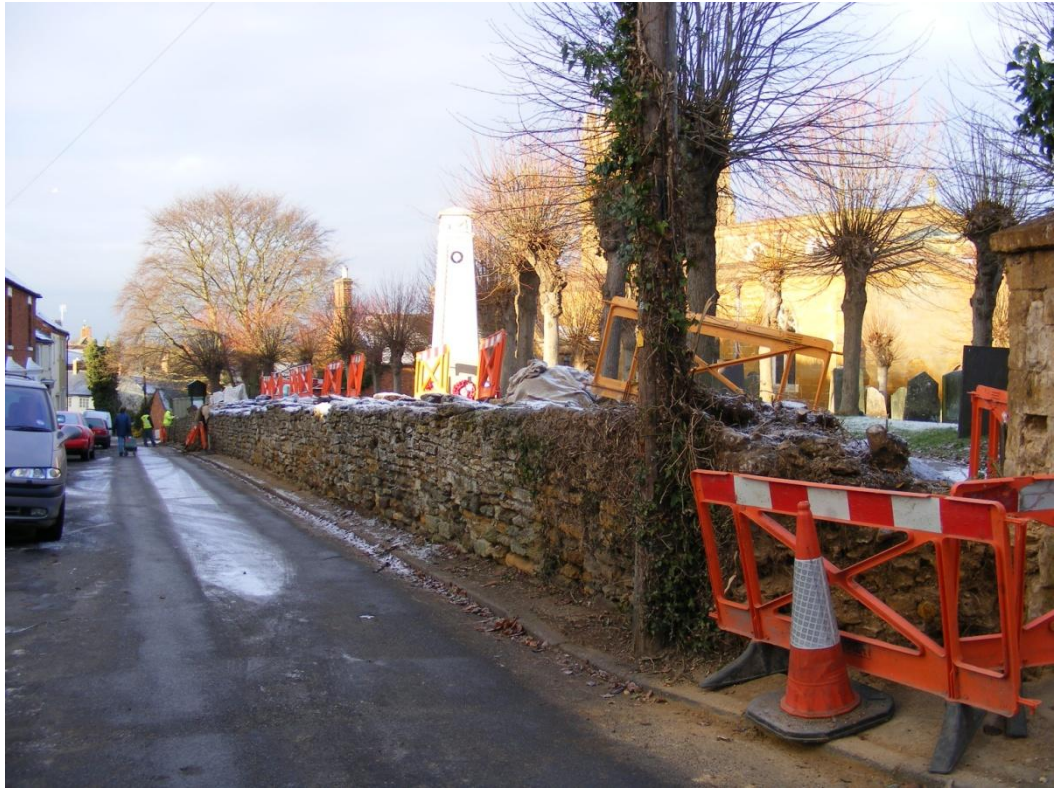
Church Street, looking north-west Fig 2

The retaining wall of the churchyard forms the southern boundary with Church Street (Fig 2). It has an entrance into the churchyard at its east end. The wall is 1.4m high and the ground upon its north side is approximately level with the coping stones. In recent years a section of the wall had become unstable and started to bulge. This section was the subject of the present repairs together with a small portion next to the gateway. The entire length was also being raked out and repointed.

A section of the outer face of the retaining wall that was 5m long was dismantled along the Church Street footpath and a smaller section 1.5m long was dismantled at the east end, next to the churchyard gateway (Figs 2-3). The locations were recorded in relation to the Ordnance Survey using measurements to fixed points along the wall.

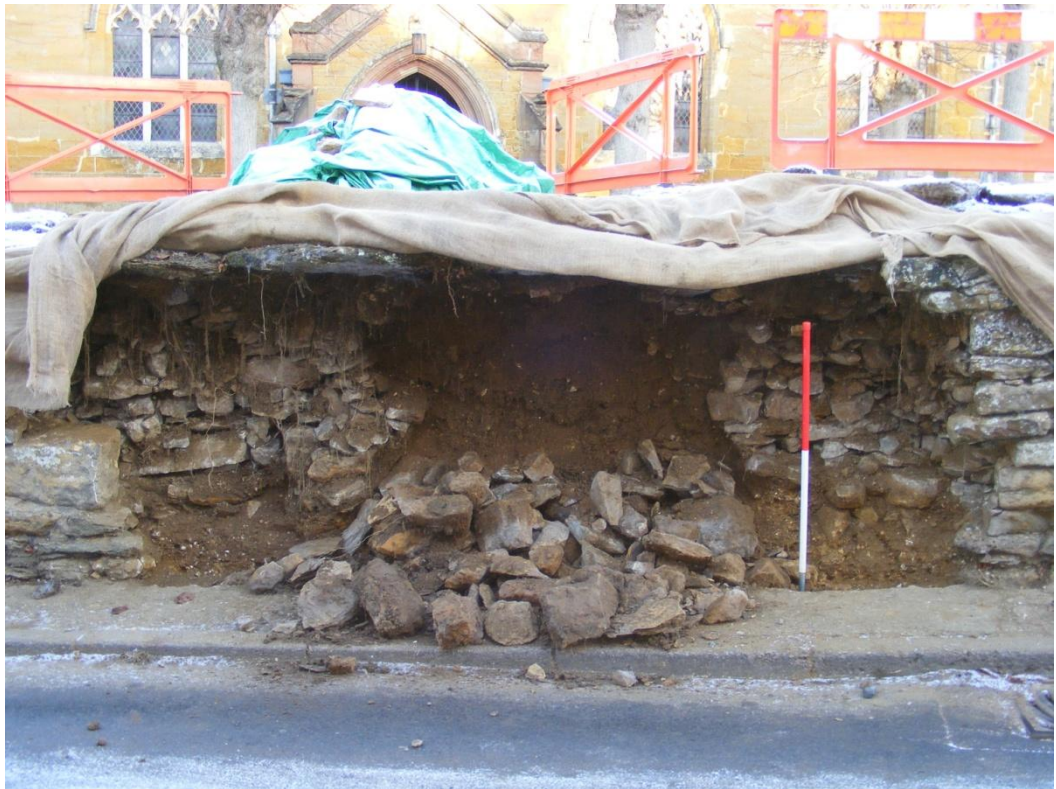
Collapsed retaining wall, looking north Fig 3

The outer face of the wall was dismantled by J Tomlinson Ltd during which the inner face collapsed outwards of its own accord. The cross-section of the stonework was cleaned and examined sufficiently to characterise, record its extent and construction. The cross-section was drawn to scale on permatrace. The frozen retained earth was examined and no artefacts or variations in soil context were present.

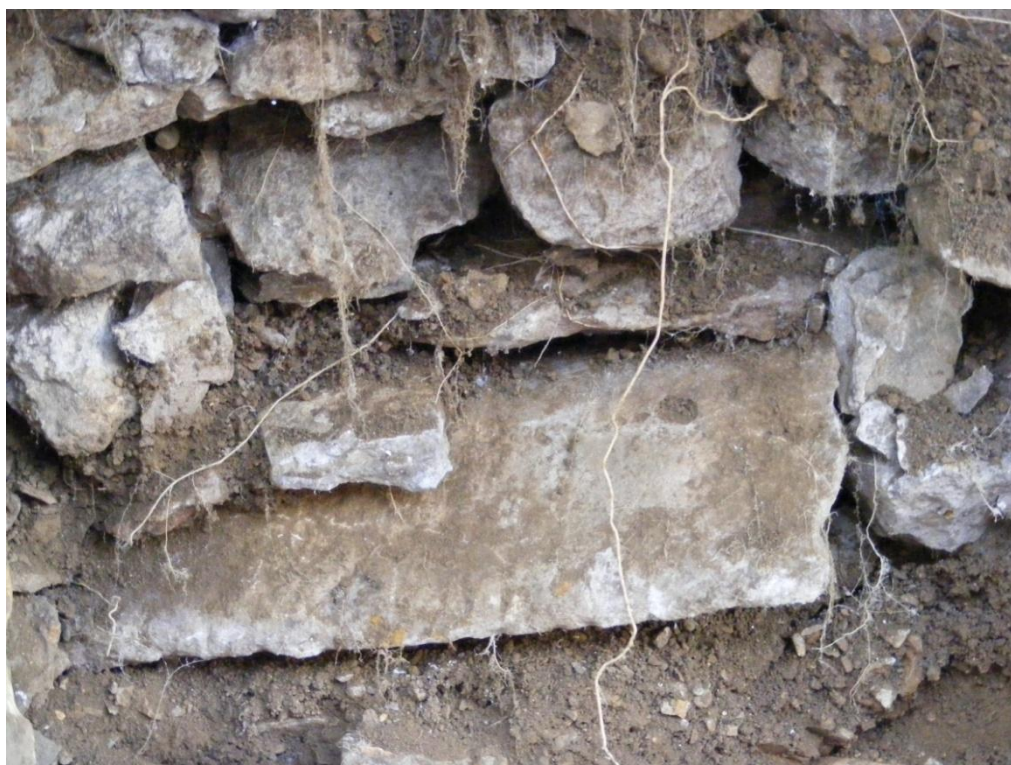
Former coping stone built into retaining wall Fig 4

No visible substrate was exposed during the works and no artefacts or human remains were present. Homogeneous grave earth lay behind the retaining wall on its north side. The wall was built in front of it upon a coarse crushed ironstone bedding layer (105) with the larger cut blocks forming the base of the wall face (102) and the uncoursed rubble ironstone (103) filling the area behind (Fig 5). Amongst the construction rubble fill (103), behind the facing stones was a former coping stone, reused from elsewhere (Fig 4). Some coping stones remain in position on top of the wall, but many are missing.

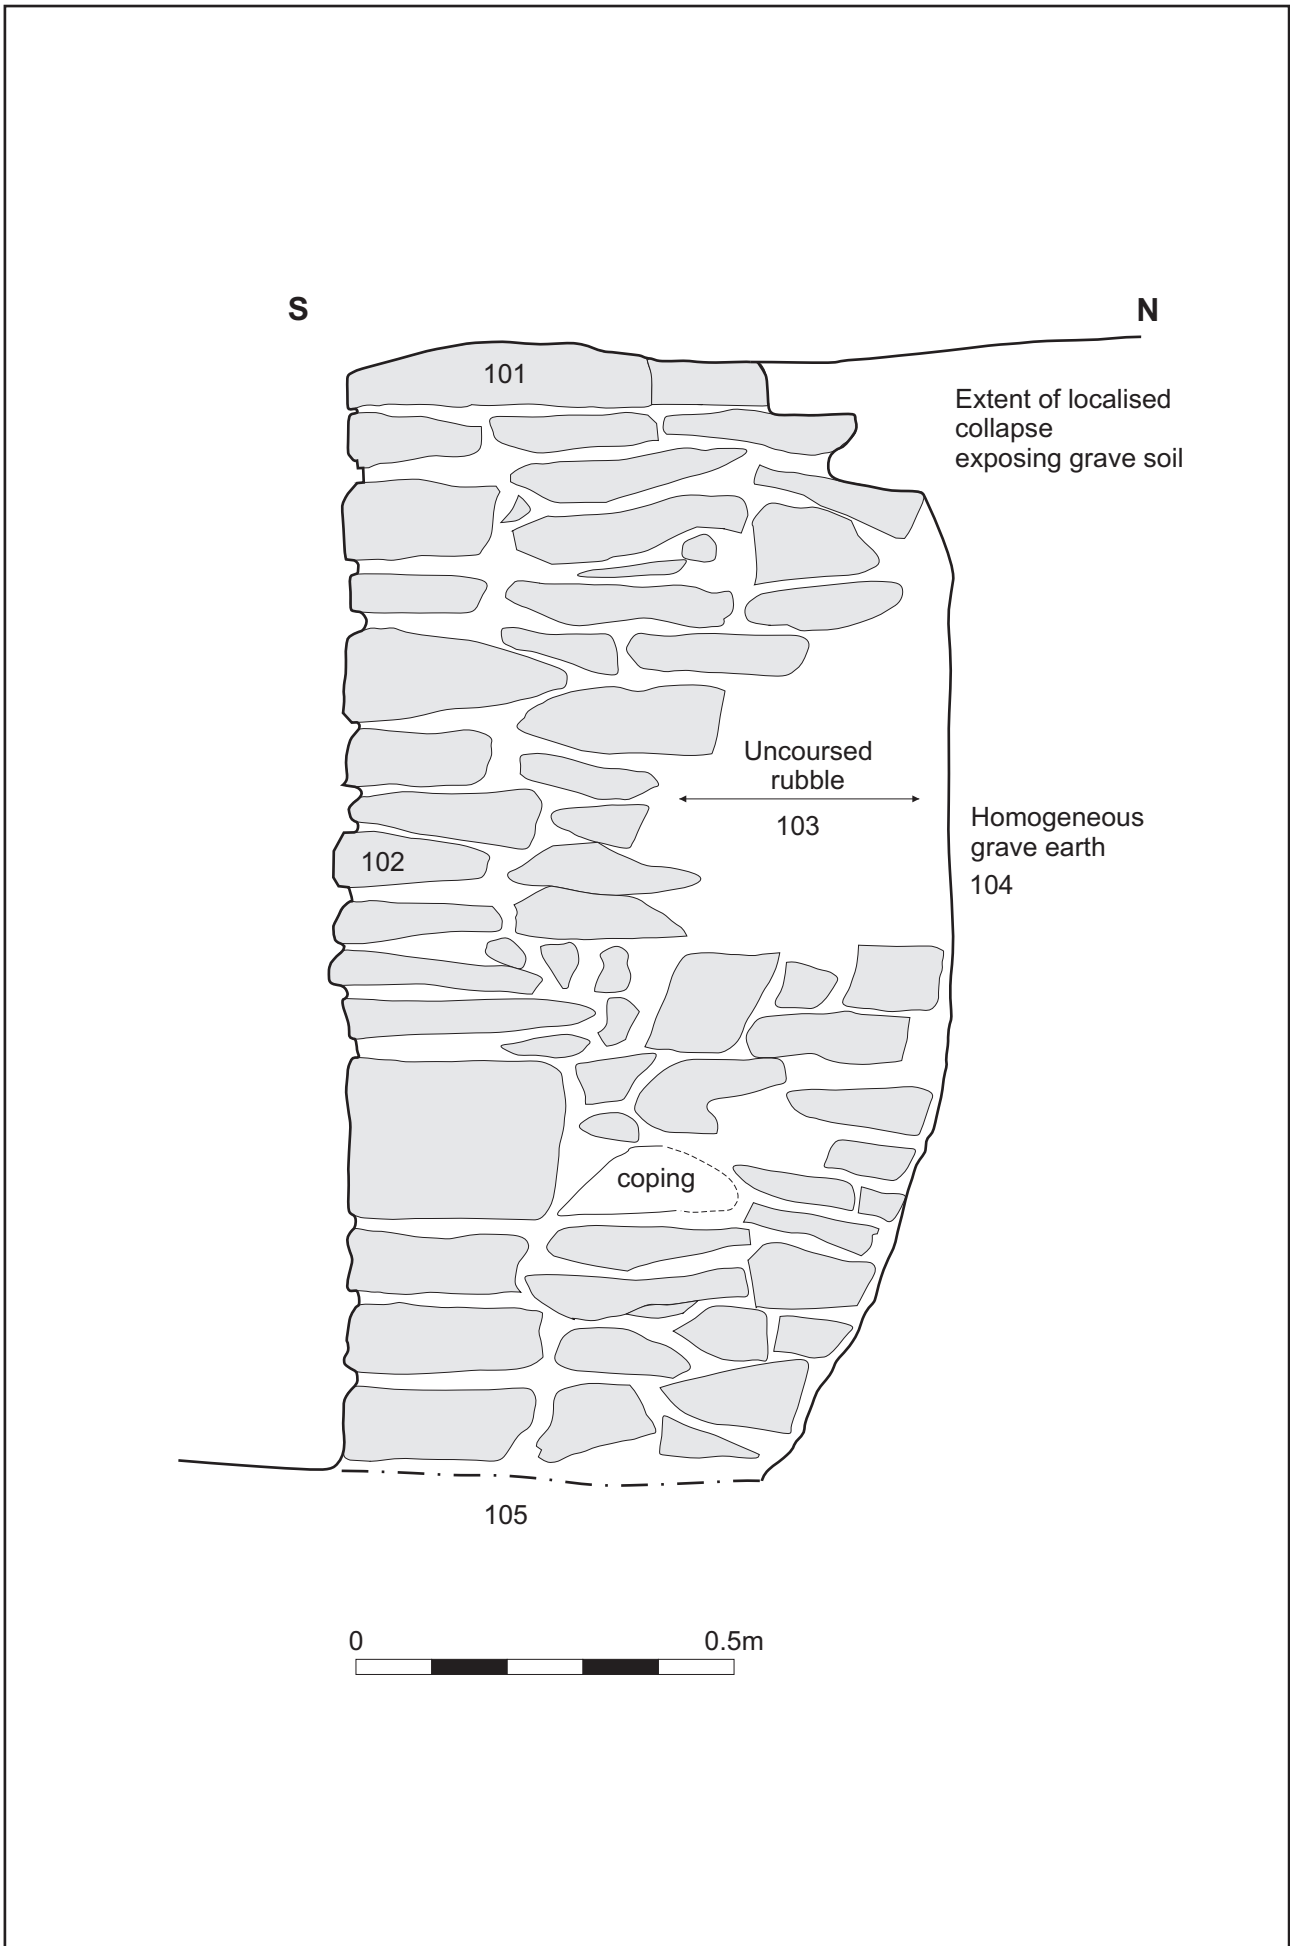
Section of churchyard retaining wall, looking west Fig 5

All contexts are listed in Table 1, below (Fig 5).

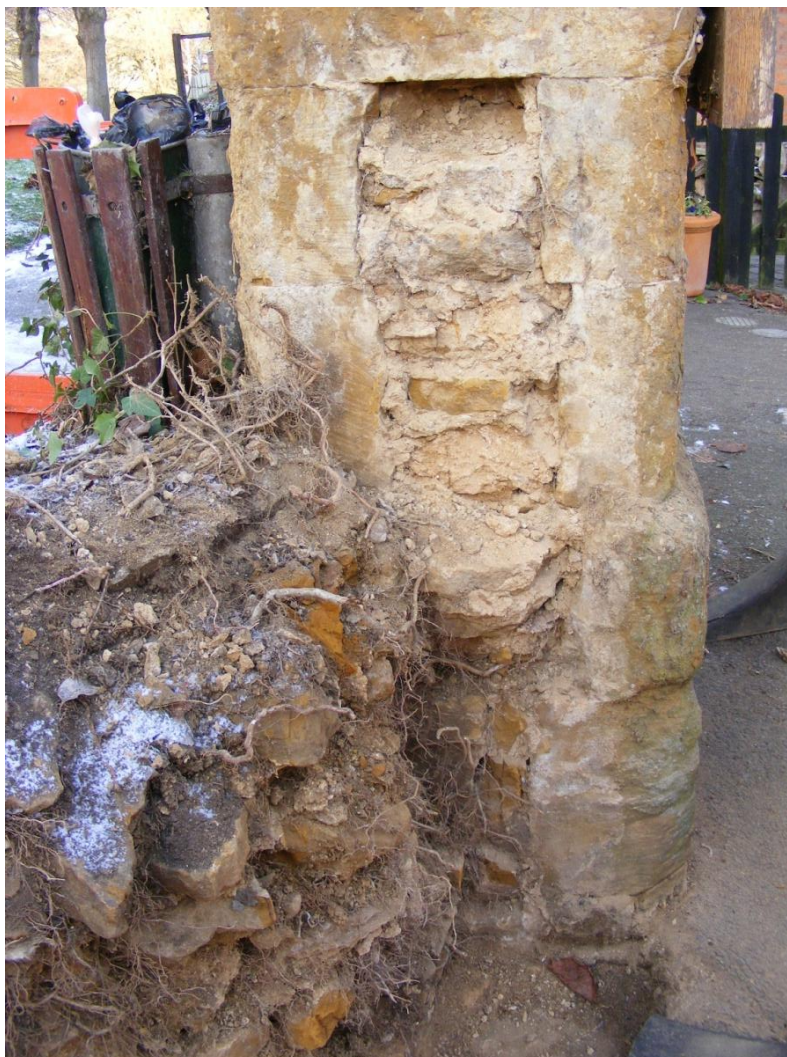
Join of wall to the gate pillar, looking north-east Fig 6

The smaller 1.5m wide section of repair, adjoining the gate pillars, demonstrated how the retaining wall had been tied into the stonework (Fig 6). It did not, however, provide further information concerning the date or construction of the principal wall.
