## Archaeological evaluation at South Quay Hayle Harbour, Cornwall August 2010

Report 10/142

# ARCHAEOLOGICAL EVALUATION AT SOUTH QUAY

## HAYLE HARBOUR, CORNWALL

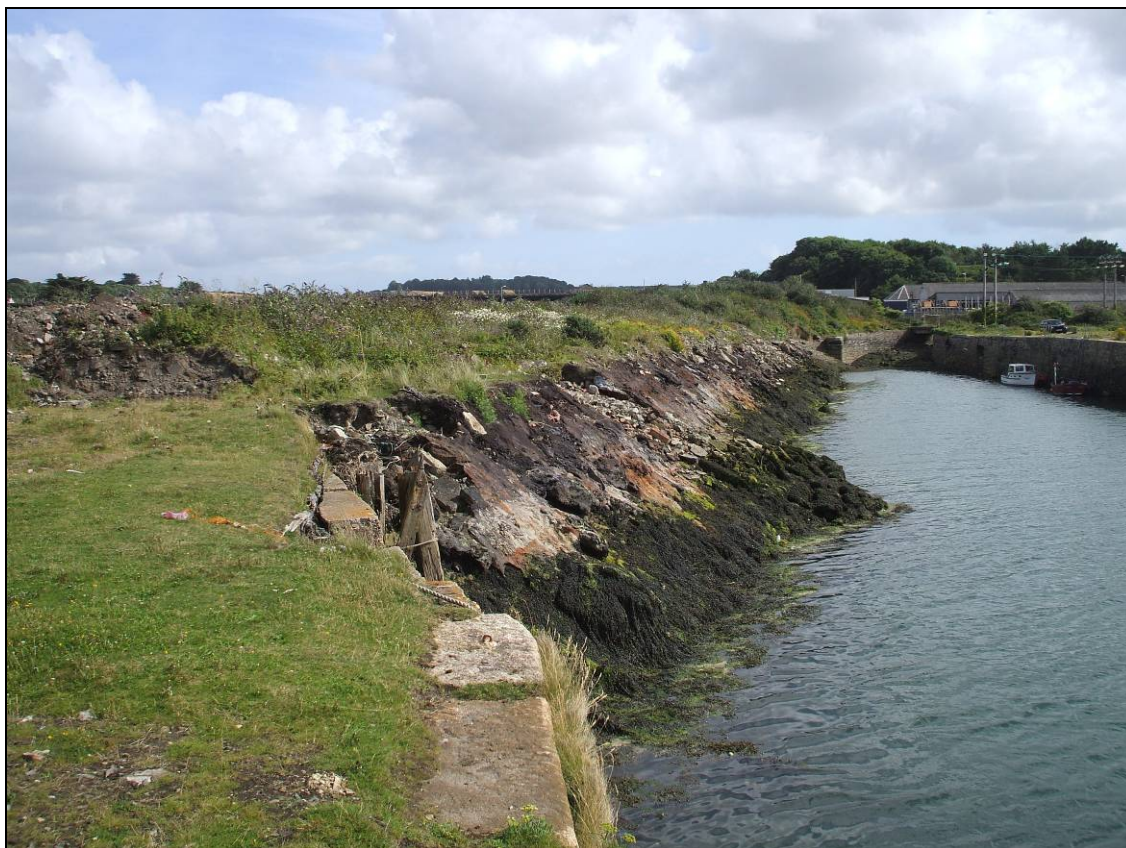
A view of the material in-filling South Quay and Carnsew Channel, looking south Fig 3

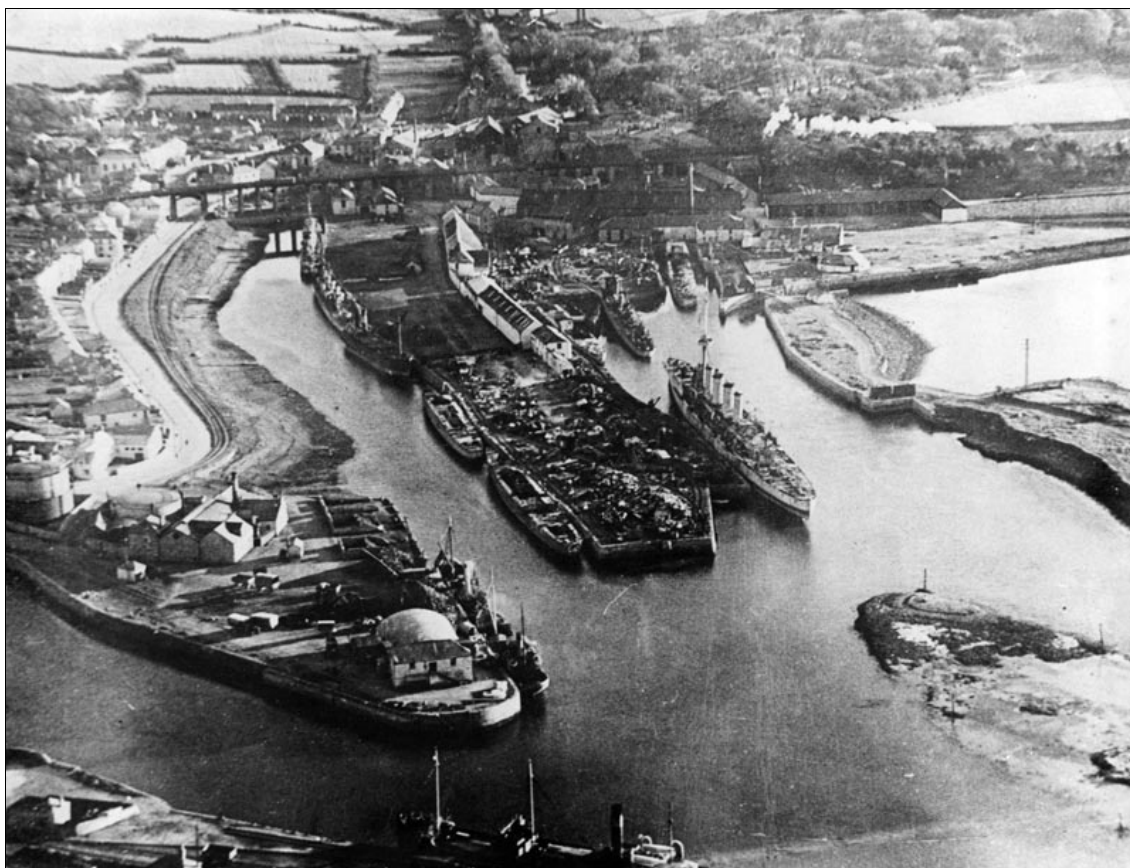
Hayle Harbour, 1931 Fig 15

This oblique aerial shot is taken from the north and shows a large vessel moored at South Quay together with smaller ships pulled up on the three slipways at the head of the Carnsew Channel. The linear block of buildings lines the south-western part of the quayside and goods, or perhaps piles of fuel, occupy the northern end of the wharf. Ships, including what appear to be barges, are also moored on the eastern (Penpol) side of South Quay.

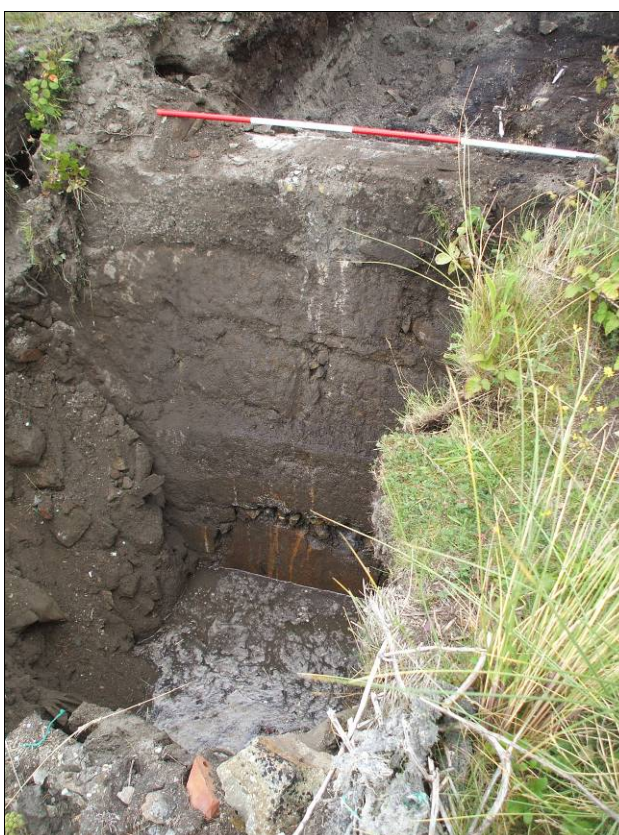
Trench 1 (8.50m x 1.8m; Fig 2, Fig 20) was aligned north-east to south-west, just south of the point where the existing granite wall of the quayside emerges from the consolidated in-fill material. The top of the wall [1003] was revealed c 0.55m below the existing ground level at c 4.0mOD (Fig 21). It was constructed from large, rectangular, evenly-coursed granite blocks overlain by a single course of 0.55m-wide concrete blocks – in the same manner as the section of wall to the north (Fig 22). Five courses of the wall were exposed to a depth of c 3m before the base of the trench began to flood. The in-fill material (1002) abutting the wall was largely comprised of brick and concrete rubble in a loam matrix. Other debris, including fragments of timber and sections of fishing net and rope, was also present.

Quay wall [1003], Trench 1, looking north-east Fig 21

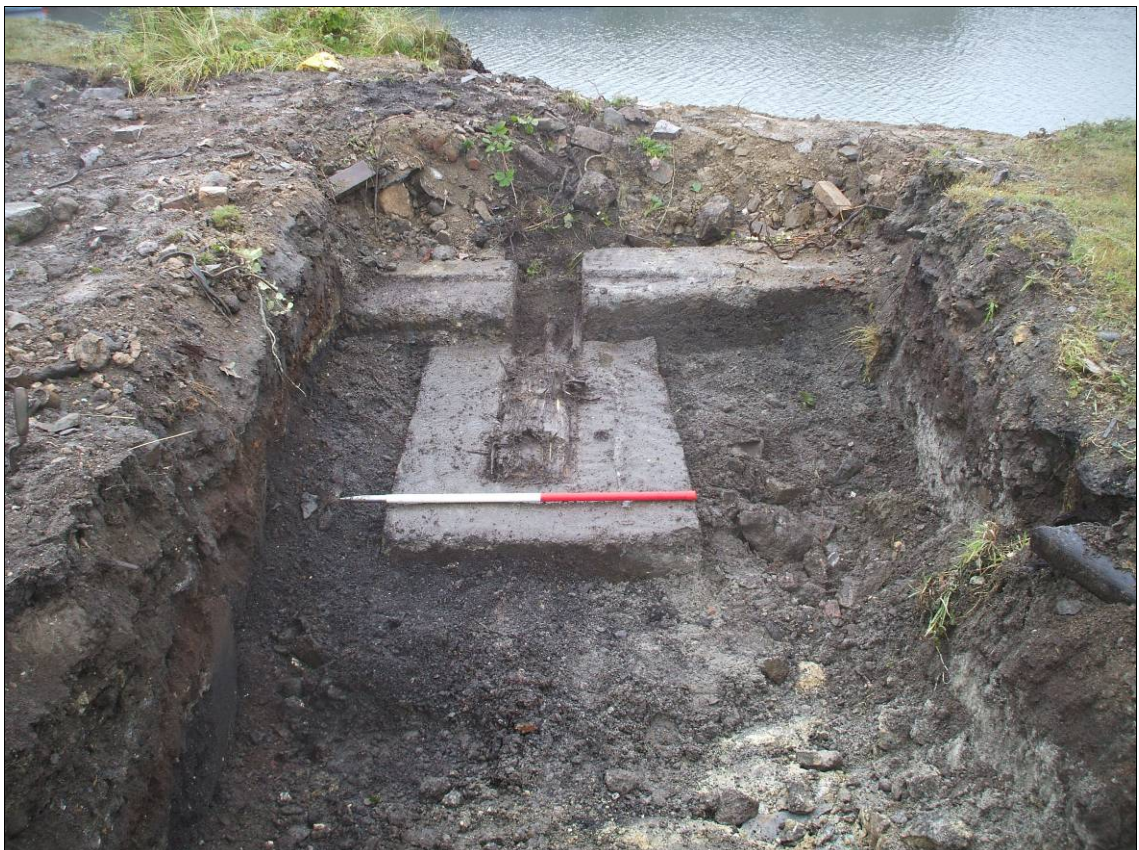
The upper (concrete) course of the wall had a 0.30m-wide slot built into it housing a timber beam [1010], perhaps part of a former jetty. These slots were also observed at regular intervals along the upper edge of the exposed wall to the north. In the eastern, landward, end of the trench, the beam was tied into a 1mx1.90m rectangular concrete block [1009], set into a thick layer of dark grey ironworking debris and clinker (1008) lying c 0.80m below the ground surface (Fig 23). Similar deposits were observed in the landward sections of the other trenches and would appear to be part of the quay construction.

Timber beam [1010] tied into concrete base [1009] and passing through quay wall, Trench 1, looking west Fig 23

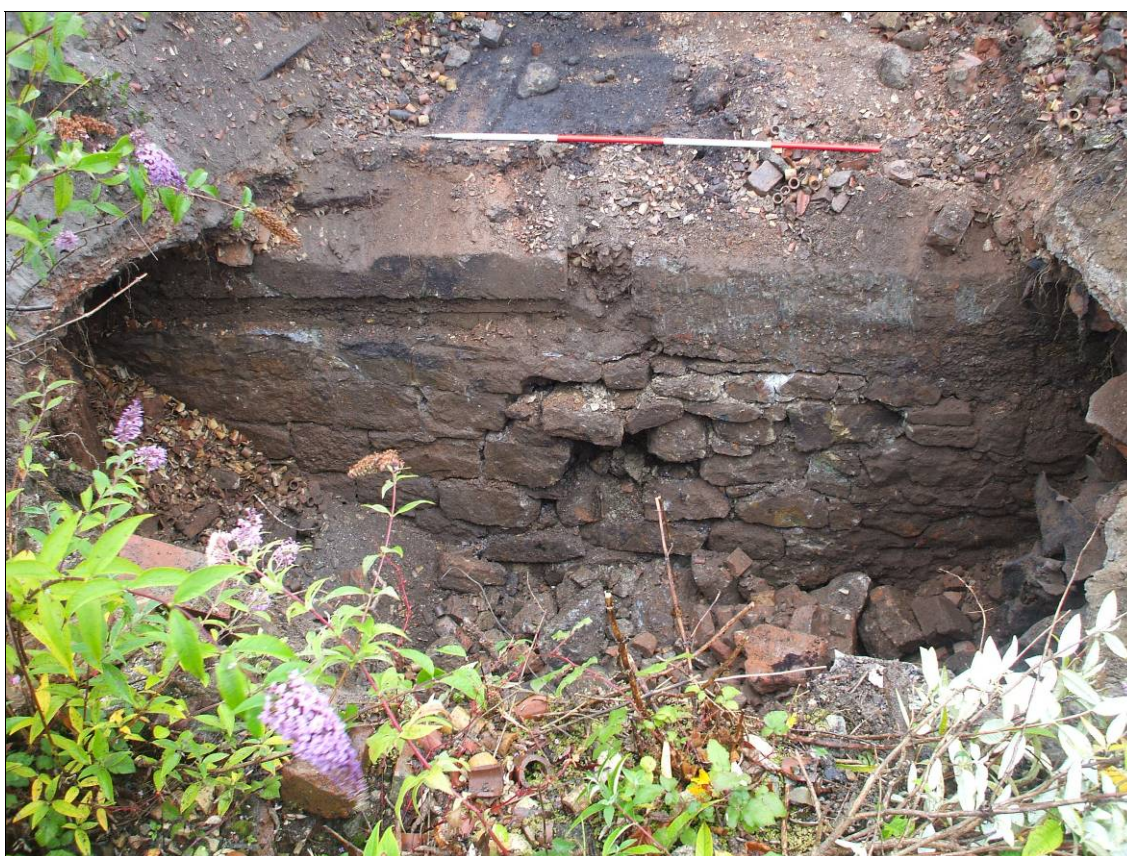
Trench 2 (7m x 1.8m; Fig 2) was aligned north-east to south-west locate the quayside to the south of Trench 1. Here the top of the quayside wall [2004] was located at c 3.90mOD, c 1.5m below the level of the local ground level (which hereabouts comprised of fly-tipped 'mound' material). As observed in Trench 1, the upper course of the wall comprised of concrete blocks (Fig 24). These overlay a wall of more irregular-shaped, unevenly coursed granite blocks similar in appearance the quayside wall visible on the western side of the Carnsew Channel (Fig 25). They appeared to be bonded with a loose lime mortar.

Quay wall [2004], Trench 2, looking east Fig 24

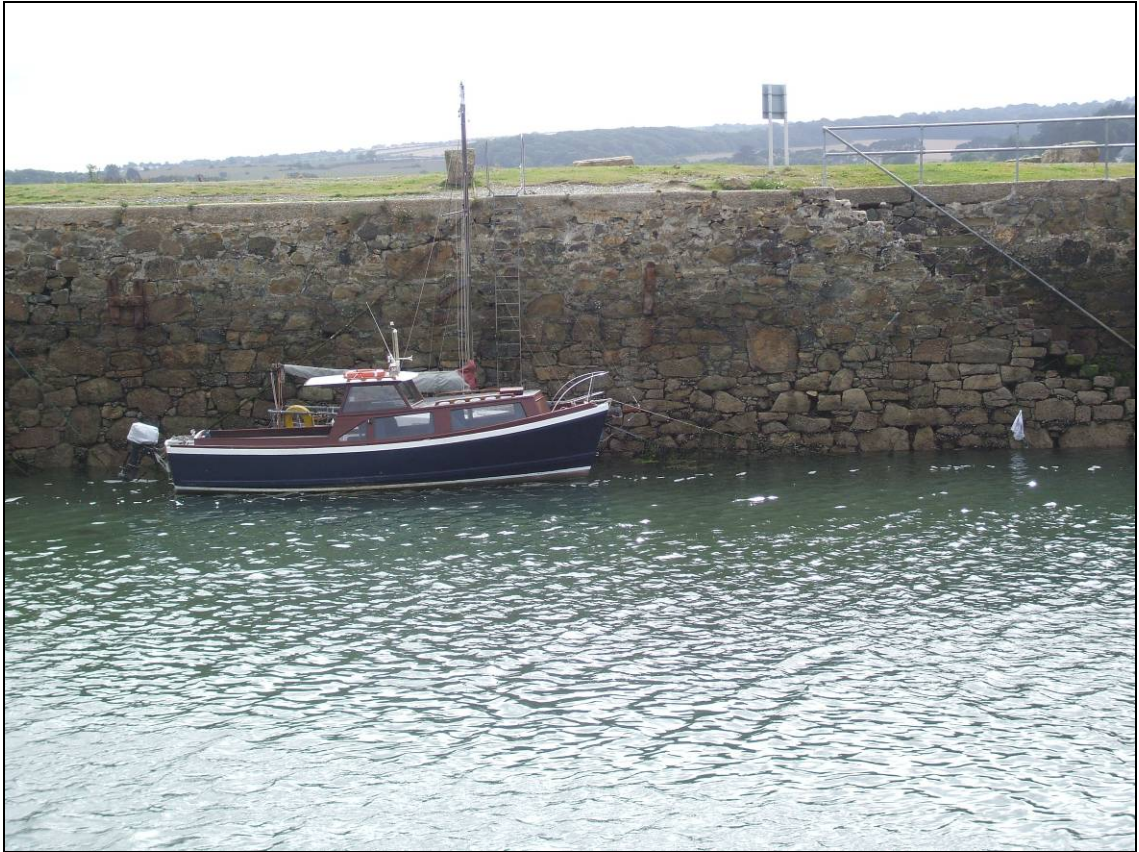
Fig 25

Granite construction of Carnsew Quay, looking west

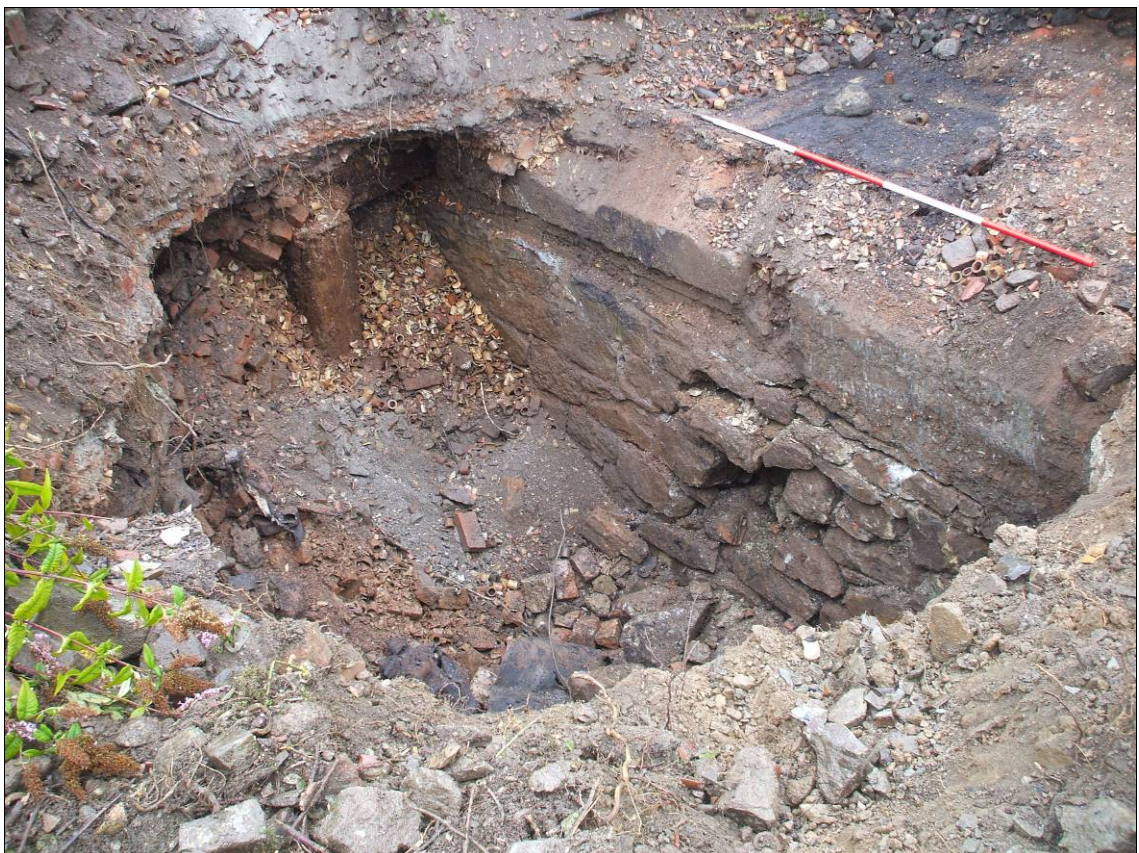
Fig 26

The slots in the upper (concrete) course of the wall were also present here and, in the northern edge of the trench, an *in situ* timber beam [2005] could be seen projecting c 1m out from the face of the wall towards a substantial vertical post [2006] (Fig 26). The physical relationship between these two timbers, however, could not be ascertained.

Timber structure [2005/2006] built into quay wall, Trench 2, looking north-east

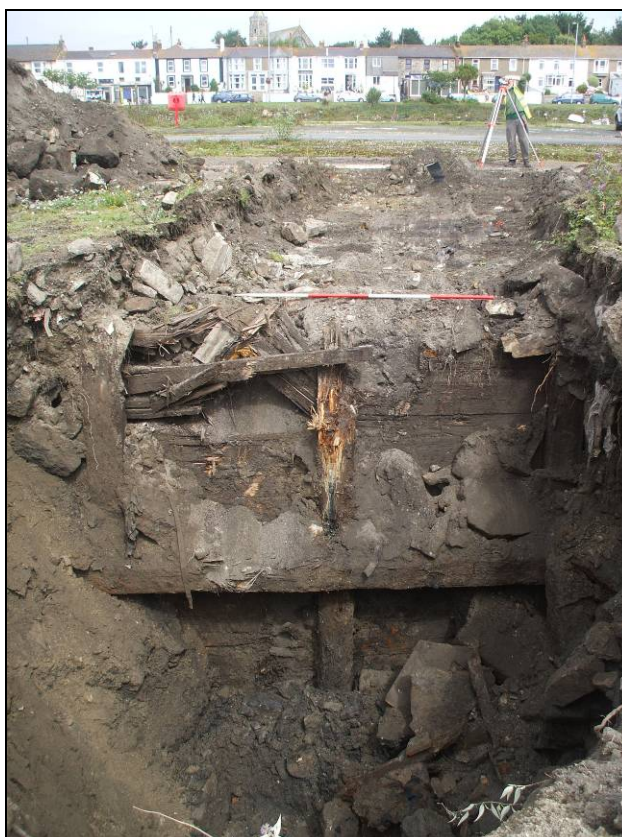
Trench 3 (7m x 1.8m; Fig 2) was aligned north-east to south-west to locate the quayside to the south of Trench 2. Its surveyed position lay 6m south-east of its pre-agreed location due to the presence of a pile of shattered asbestos sheeting. A timber revetment, rather than a stone wall, was duly located (Fig 27) c 0.90m below the existing ground level (4.10mOD), thus corroborating the evidence of photographs taken prior to the in-filling of the quay and slipway (Figs 12-13). The revetment was built using 70mm-thick timber planks retained behind vertical (pine?) posts, spaced at c 1.60m intervals and braced by cross-beams. The revetment was at least 4m deep and extended downwards, beyond the reach of the mechanical digger, into charcoal grey, gritty sand (3003). It was abutted by the in-fill of the quay, which here comprised concrete, bricks, granite blocks and miscellaneous detritus (3002).

Timber revetment [3004], Trench 3, looking east Fig 27

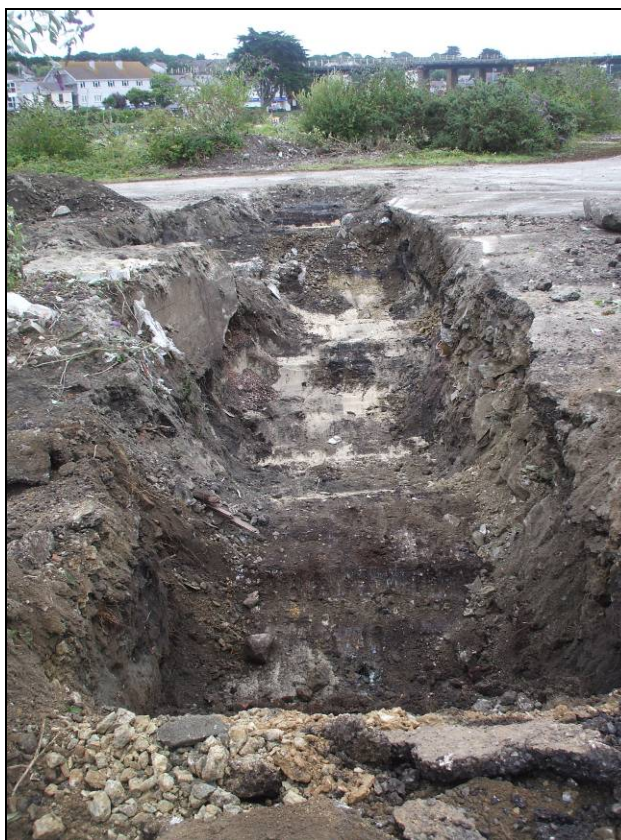
A layer of pale yellow sand (4005), similar to that identified in Trench 3 lay 1.30-1.40m below the current ground surface. In the centre of the trench it was overlain by a 60mm-thick layer of compacted iron slag (4003), again similar to the quayside stratigraphy observed in Trench 3. This layer, however, could conceivably have been the truncated surface of the slipway – if so, the projection for its timber revetment would lie to the east rather than the west (Fig 2).

Trench 4, looking south-east Fig 28

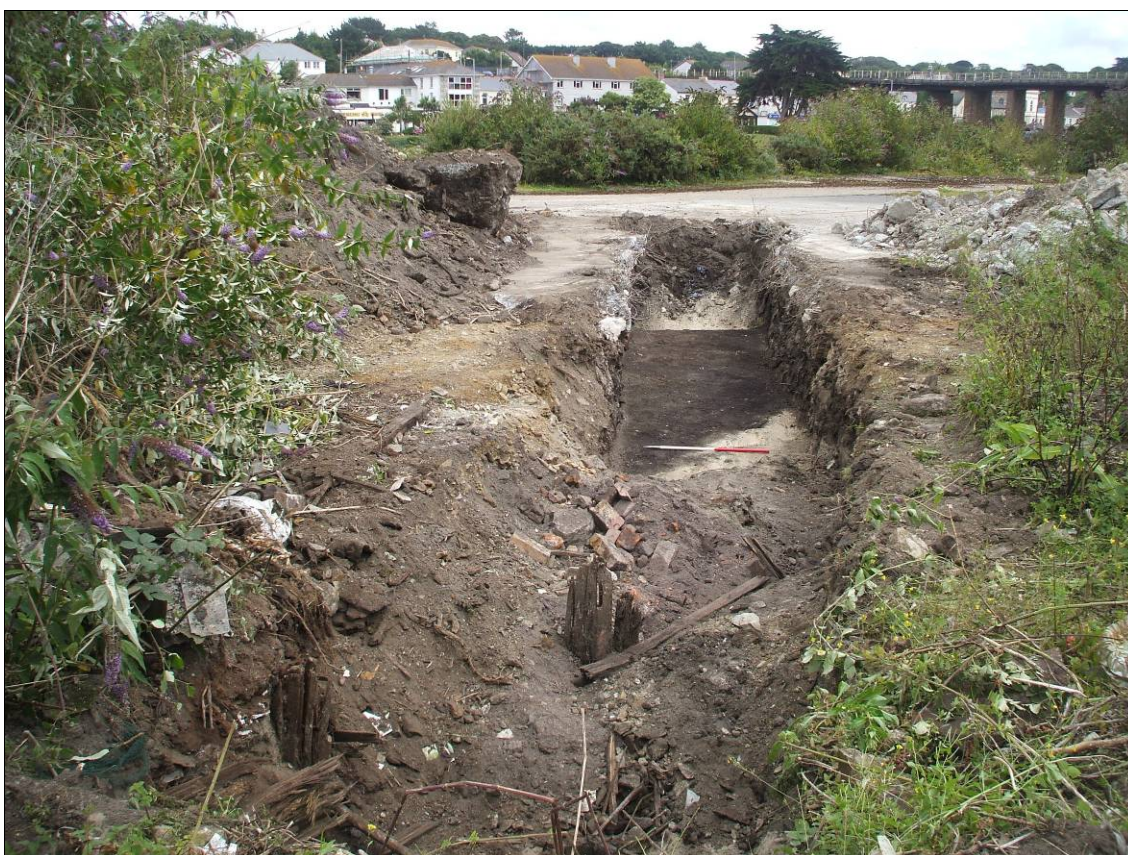
Trench 5 (18m x 1.8m; Fig 2, Fig 20) was aligned north-west to south-east to locate the south-western corner of the slipway. The top of a 6.5m-long section of timber revetment [5013] was aligned north-west to south-east in the northern end of the trench c 0.50m below the existing ground level (c 4.70mOD) (Fig 29). It was constructed in the same manner as that observed in Trench 3, however here, an iron tie-rod was connected to the back of one of the upright posts, presumably securing it to a stay located somewhere beyond the north-western corner of the trench. Abutting the post and extending into the slipway, was a timber plank whose function remains obscure. It may have been used to retain loose material during the in-filling process or be part of the shipbuilding scaffolding depicted on early photographs (Fig 12). To the south of this, the revetment was cut by a substantial service trench containing a ceramic drain.

Slipway timbers [5013] (foreground) and compacted iron-slag slip (5007), Trench 5, looking south-east Fig 29

Within the slipway the deeper parts of the trench exposed clean yellow sand (5009). Above this the base of the slipway was compacted iron slag (5007) overlying clay and siltstone (5008) (Fig 29, background). Typically only 60mm deep, the slag exhibited a marked north-west slope, falling 0.30m within the southern part of the trench (from 3.65-3.35mOD). At the southern end of the trench the sequence of slipway in-fill was evident; a 0.15m-thick later of loose slag and clinker (5006) was overlain by a 0.20m-thick layer of loam and building debris (5005) sealed by another thin deposit of clinker (5004). This was overlain with a 0.35m-thick layer of demolition rubble (5003) sealed by a formation layer of re-deposited natural clay and siltstone (5002) used to bed the existing tarmac surface of the quay (5001) which lay at c 4.70mOD.

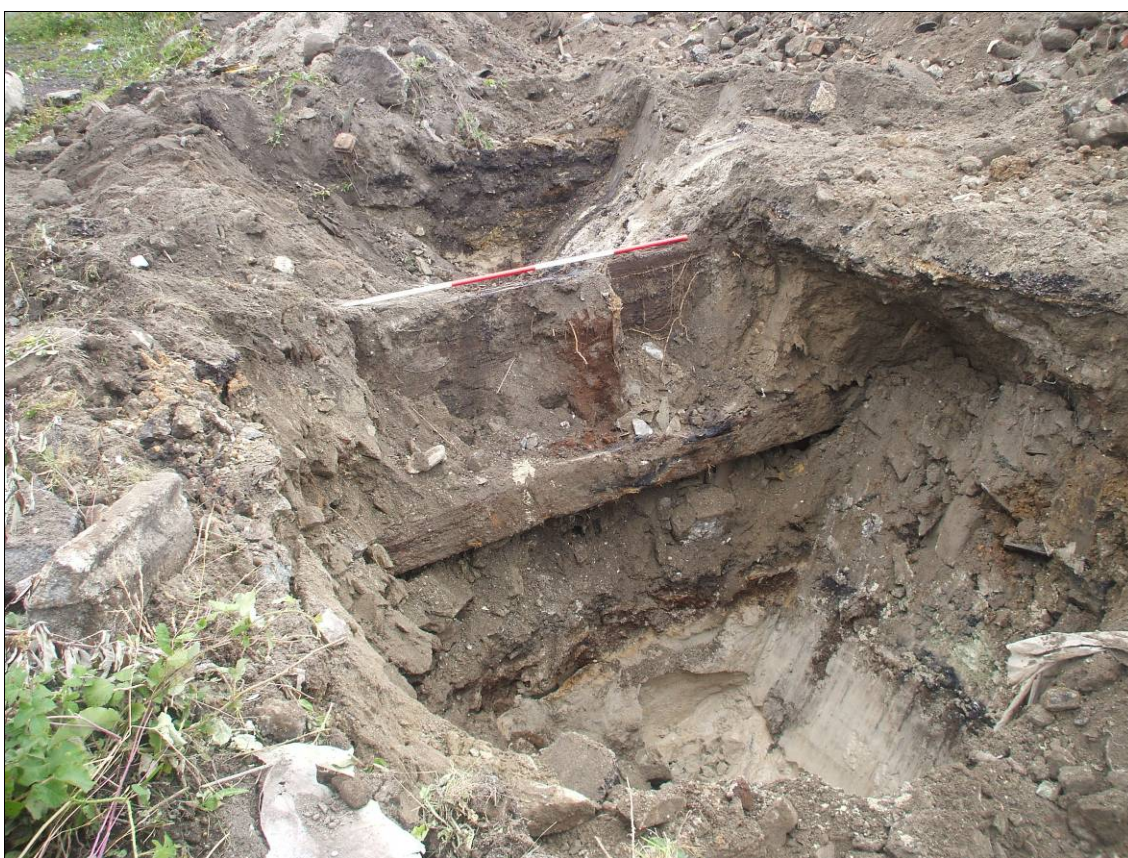
Trench 6 (25m x 1.8m; Fig 2) was aligned east north-east to west south-west across the projected width of the slipway to locate both of its sides and search for evidence of an apocryphal ship, buried within the in-fill. Timber quayside revetments [6004] and [6011] were duly revealed towards the west and east ends of the trench respectively (Figs 30-32) at depths of as little as 0.40m below the existing ground surface (at c 4.30mOD). They defined a slipway of some 14.80m width.

Timber revetment [6004], west side of slipway, Trench 6, looking north-west Fig 30

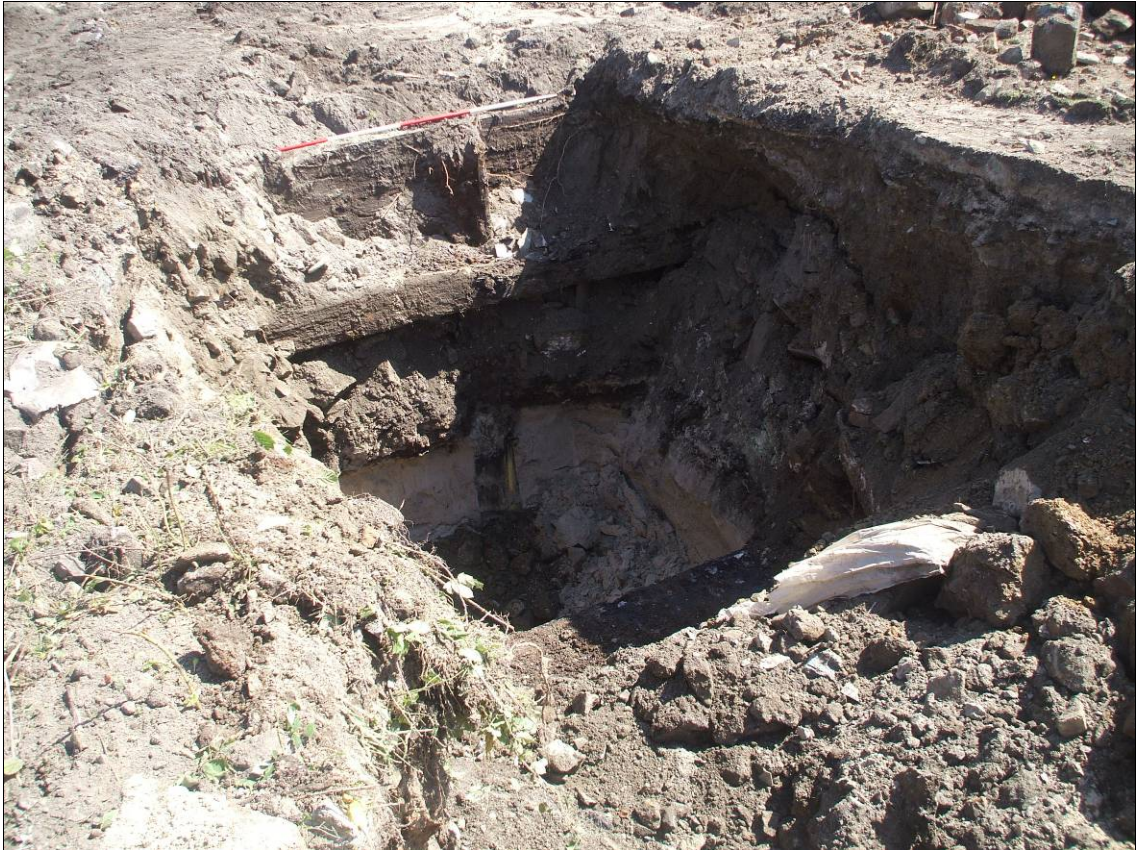
The revetments were constructed in the same manner as those observed in Trenches 3 and 5, and, as in the latter trench, an iron tie-rod (6014) was connected to one of the upright posts on the eastern side of the slipway (Fig 33). The base of the slipway appeared, as in Trench 5, to be formed from compacted iron slag (6006) (Fig 32; foreground). Here it survived c 2m below the top of the timber revetment at 2.40mOD, over a c 1m-deep deposit of clean pale yellow sand (6007). Below the sand were black silts (6013).

Timber revetment [6011], east side of slipway and compacted iron-slag slip (6006; foreground), Trench 6, looking south-east Fig 31

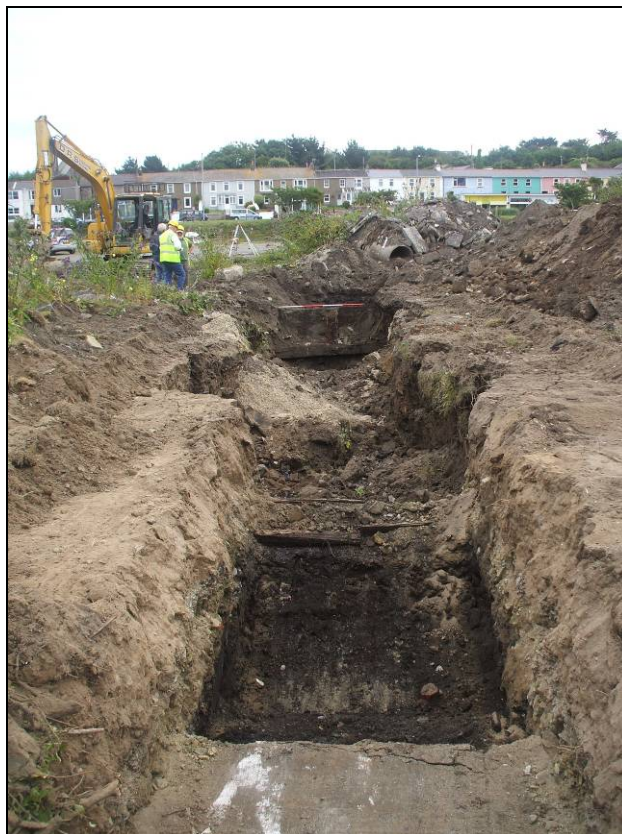
View of Trench 6, showing timbers and collapsed edges, looking east Fig 32

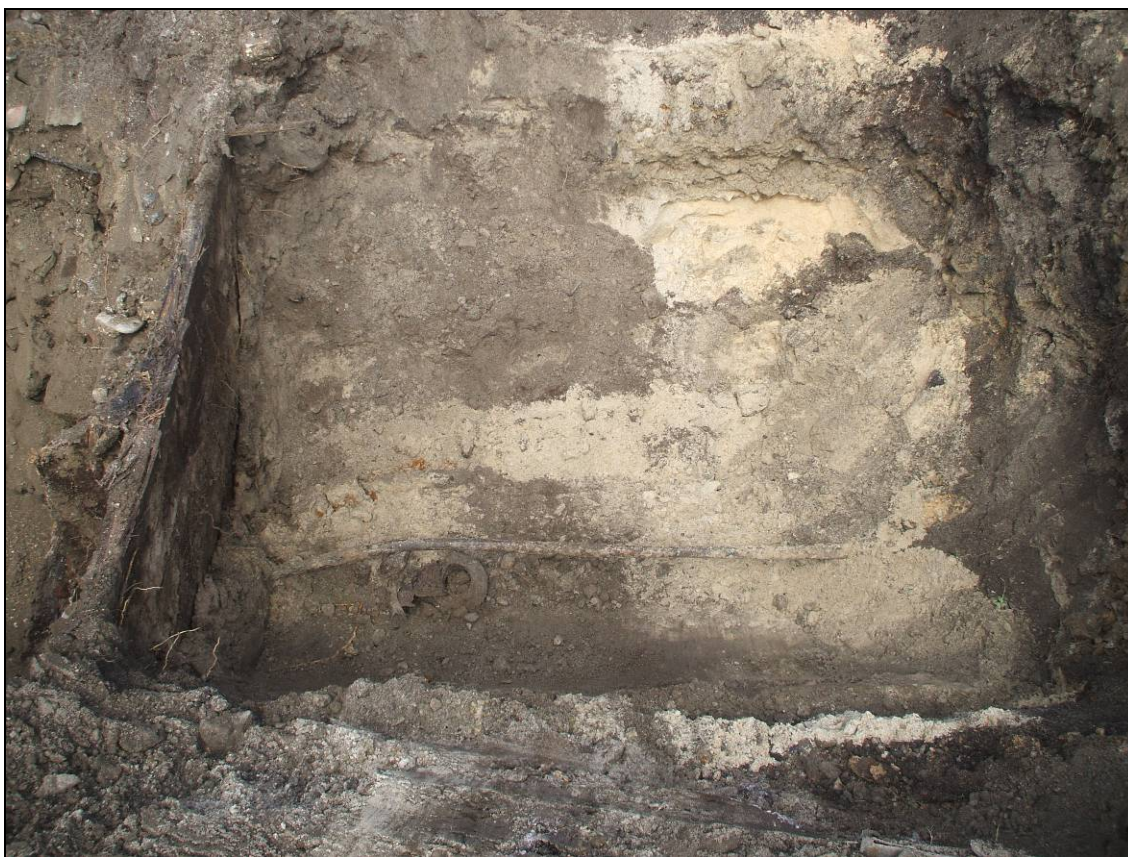
Iron tie-rod (6014), Trench 6 (east), looking north Fig 33

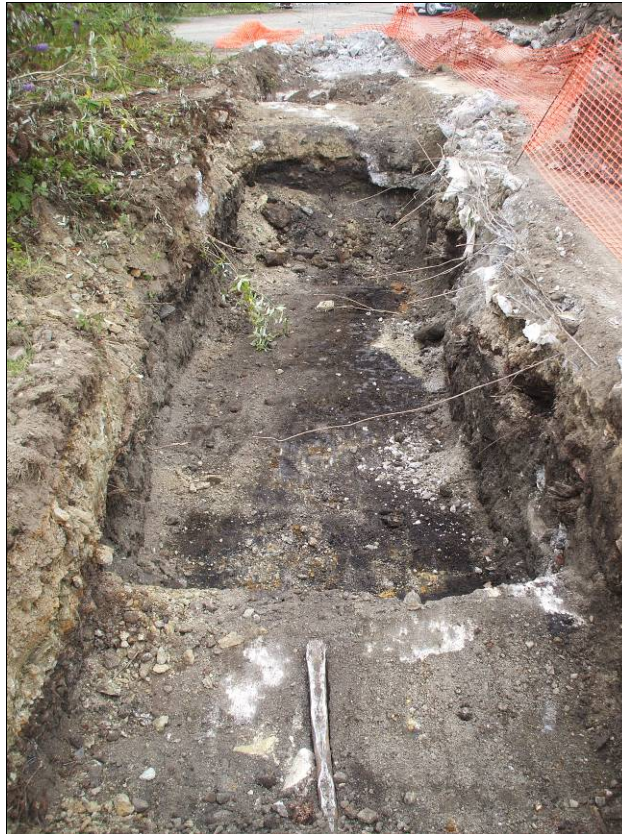
Trench 7 (18m x 1.8m; Figs 2 and 34) was aligned north to south towards the south of the proposed development area and located to intercept the south-east corner of the middle slipway. The trench was excavated to a depth of up to 1.30m deep without encountering walls or revetments.

Modern concrete bases and foundations in Trench 7, looking north-east Fig 34

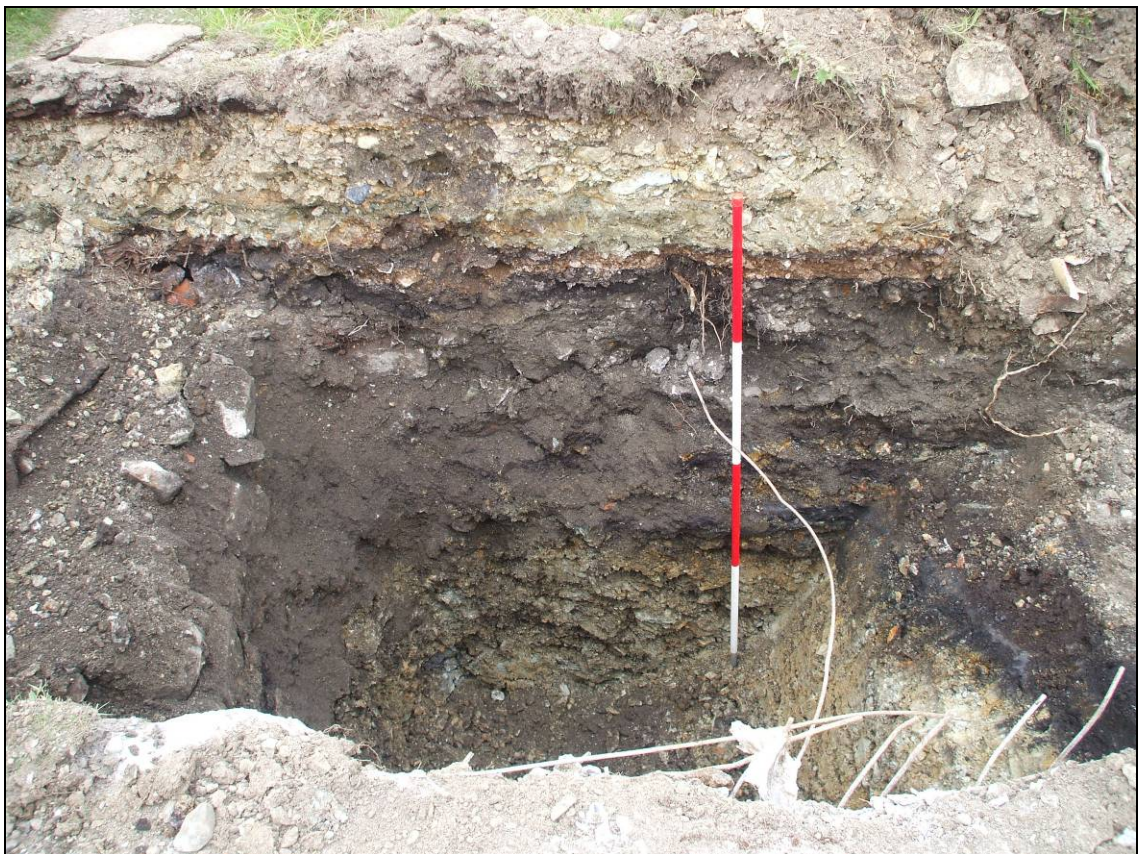
At the southern end of the trench the top of a deposit of mottled yellow/blue/brown clay and stone (7010), possibly an outcrop of *in situ* geology, was revealed 1.30m below the modern ground surface at c 3.40mOD (Fig 35). This was overlain by a series of layers of industrial debris commencing with a 0.10m-thick layer of compacted clinker (7009). Above lay another compact layer of stone, clinker and slag (7008), a lens of fine ash and charcoal (7007) and an orange-brown deposit of slag and stone (7005) sandwiched between fine layers of ash and clinker (7006) and (7004). Sealing this was a re-

Quay formation layers and modern overburden, Trench 7, looking west Fig 35

deposited geology layer (7003) similar to (7010). Crushed stone (7002) underlay the soil surface (7001) on the western side of the trench and a concrete hardstanding (7011) on the east (at c 4.8mOD).
