An archaeological evaluation of boundary walls at Towles Pastures, Castle Donington Leicestershire

Report 10/125

July 2010

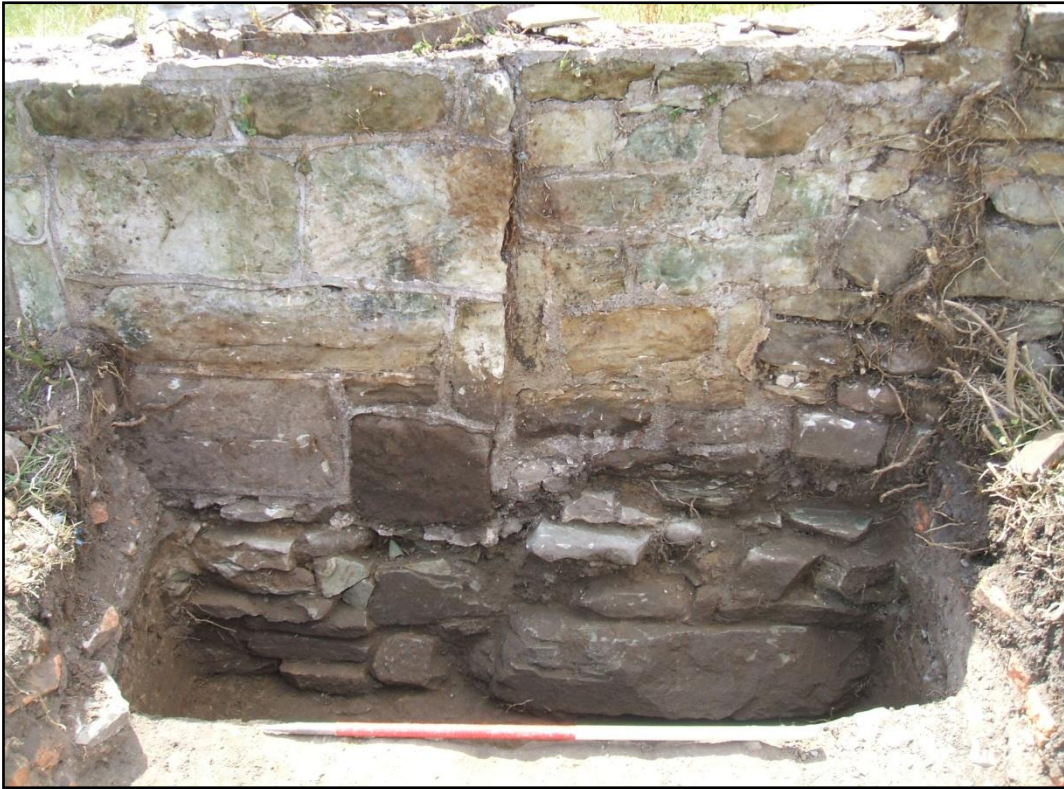
Test Pit 1 was positioned on one of the joints apparent on the northern side of the wall (Figs 2 and 4). The joint's location is thought to coincide with the junction between the boundary wall and the side wall of a now-demolished building, shown in roughly this location on Ordnance Survey maps up to the 1960s.

The foundations of the wall lay 0.75m below ground level on the northern side of the wall; ground level was approximately 0.35m lower on its southern side. There was no clear evidence for a foundation trench at this point in the wall and the foundations rested on sandstone bedrock. The joint in the wall extended down to the base of the foundations and different construction techniques were evident on either side of the joint. On the east side of the joint the foundation courses were constructed of sandstone rubble; to the west the first course consisted of large sandstone slabs or blocks, on which the rubble courses were built. The latter technique was noted in the other test pits and the machine-excavated trench. There was no evidence of any walls associated with the former building.

The wall foundations exposed in Test Pit 1, looking south Fig 4

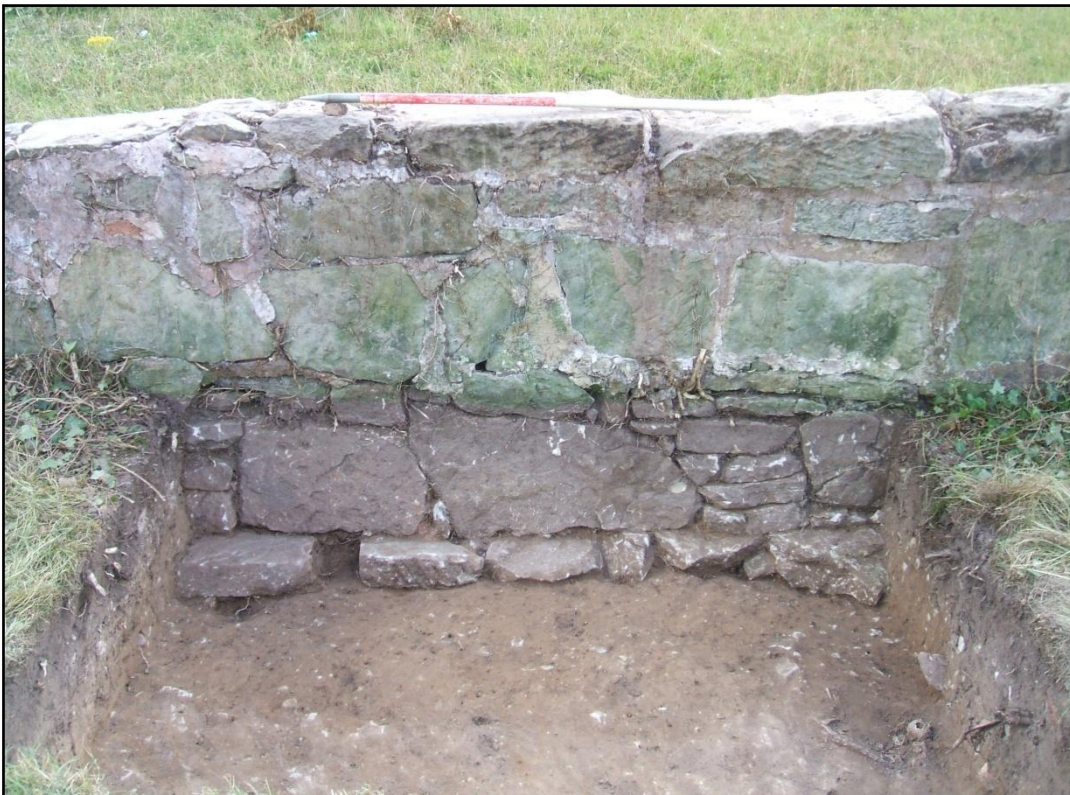
Positioned on the northern side of the wall, Test Pit 2 was located approximately half way between the site of the former building and the western end of the wall (Figs 2 and 5). The base of the foundations was encountered at a depth of 0.50m below the ground surface, resting directly on the bedrock, which comprised sandstone and gritty mid yellowish-brown clay (203). The first course consisted of large sandstone slabs or blocks, which protruded approximately 0.2m from the upper courses of the wall. The upper foundation courses consisted of three to four courses of sandstone rubble, on top of which the main body of the wall was constructed.

The wall had been patched and repaired on many occasions over the years, with more recent repairs bonded with cement (Fig 5). Extensive re-pointing of the wall also possibly obscures the date of construction of parts of the wall. The wall was patched with several types of brick, measuring 0.10m by 0.22m or 0.06m by 0.20m; the brick may have been re-used from the now demolished building that had once abutted the northern side of the wall.

The wall foundations exposed in Test Pit 2, looking south Fig 5

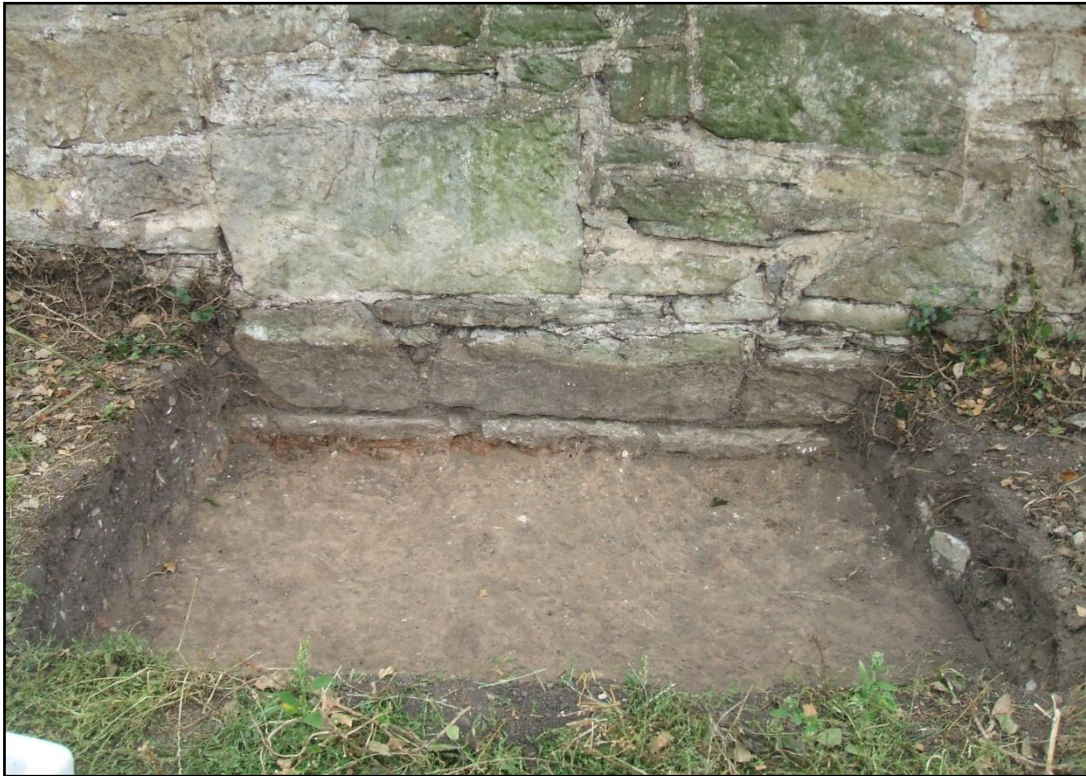
Test Pit 3 was excavated against the south side of the wall, towards its eastern end. The base of the foundations lay 0.38m below the ground surface and rested on a deposit of reddish-brown sandy clay (304) that appeared to fill a shallow construction trench [305], similar to that encountered in Trench 1 (see Section 4.4 below). The construction of the foundation courses was identical to that encountered in Test Pit 2, although the slabs forming the first course were flush with the upper courses of the wall on this side.

The assessment of the north and west walls revealed that the west wall and dividing wall are of one construction (Fig 6). The general nature of the walls is similar, having been constructed of sandstone with occasional brick repairs.

The wall foundations exposed in Test Pit 3, looking north Fig 6

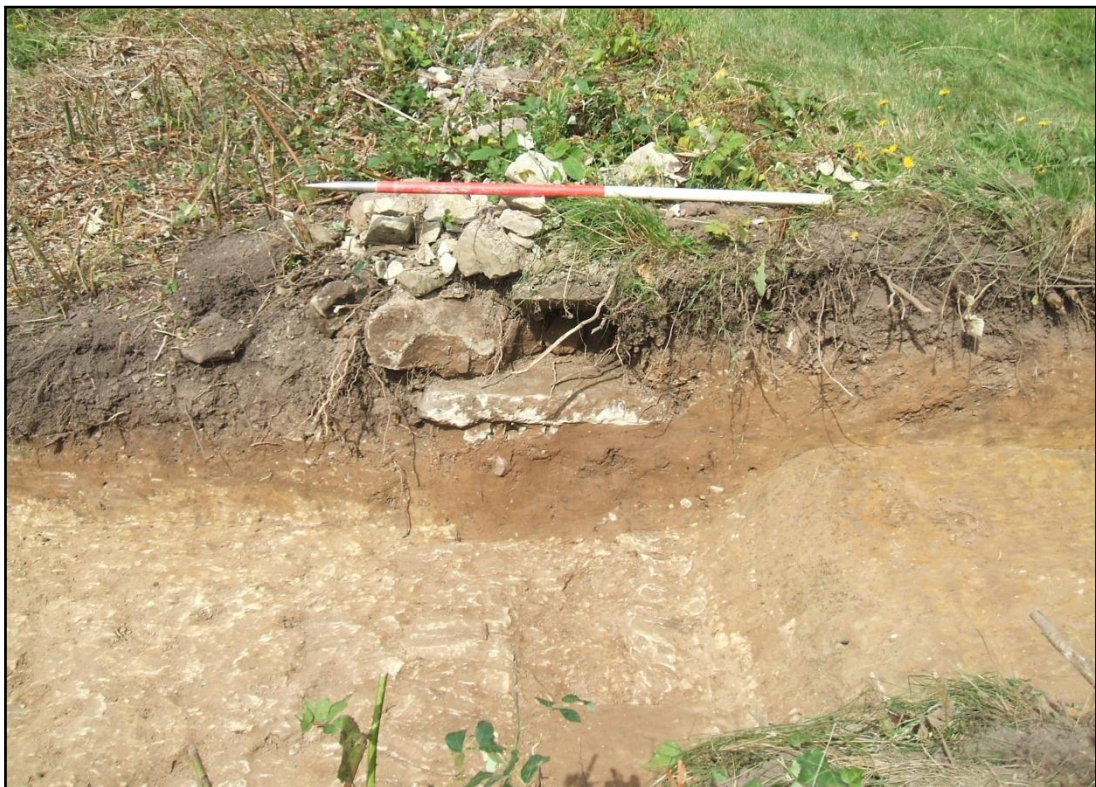
The trench was excavated across the line of the boundary wall at its western end (Fig 2 and 7).

Overlying the natural substrate was subsoil, comprising mid orangey-brown sandy clay (402) with frequent sandstone pebbles (Fig 3, Section 3). On the south side of the wall this was c 0.10m thick, on the north side c 0.18m thick. The subsoil was cut by the foundation trench for the wall, [406]; this was 0.6m wide and 0.3m deep and had vertical sides and a flat base. It was packed with clean reddish-brown sandy clay (405) and contained occasional sandstone pebbles and small cobbles. The foundation courses of the wall, 409, comprising large stone slabs overlain by rubble courses, lay directly on top of this deposit.

Trench 1, base of wall and foundation trench [406], looking west Fig 7

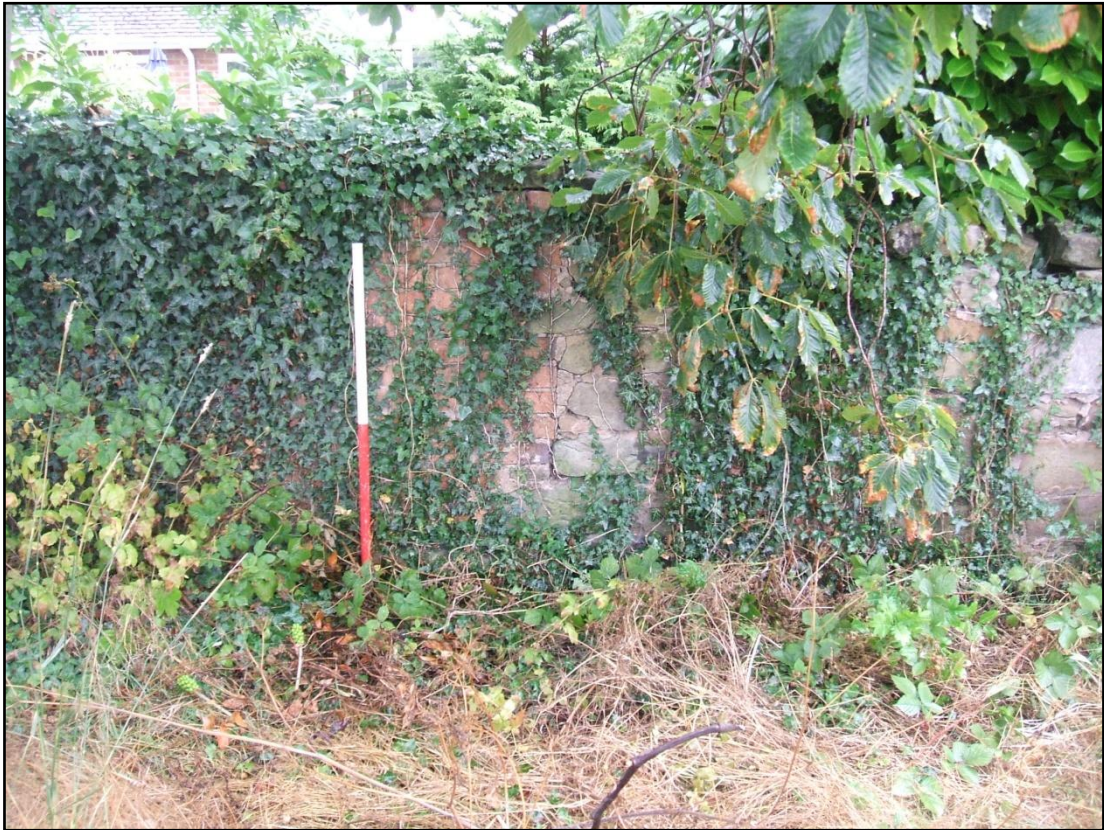
The north wall is largely of brick construction, with a part of it having been replaced by a wooden fence. The wall reverts to stone and mortar near Key House and its construction is very similar to the central dividing wall, with similar coping stones.

Change of brick to stone in northern wall, looking north Fig 8

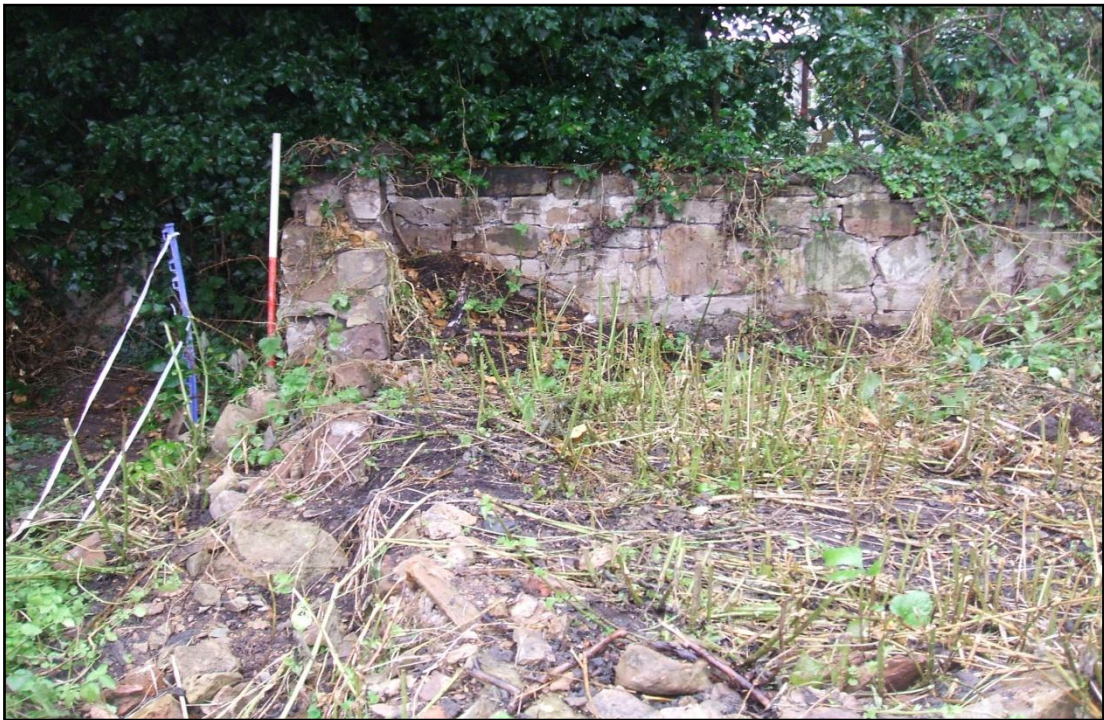
Corner of central and western boundary wall, looking west Fig 9
