## Archaeological building recording at The Summerhouse, Forty Hall, Enfield

Report 10/129

September 2010

*Northamptonshire Archaeology undertook archaeological building recording at The Summerhouse, Forty Hall, Enfield. The former building, thought to date from the eighteenth century, is built of red brick and was deliberately demolished in c1951. It appears to have been constructed in one phase with potentially additional alterations and embellishments. The purpose of the recording action was to record the remains of the structure prior to works to stabilise the walls and prevent further deterioration.*

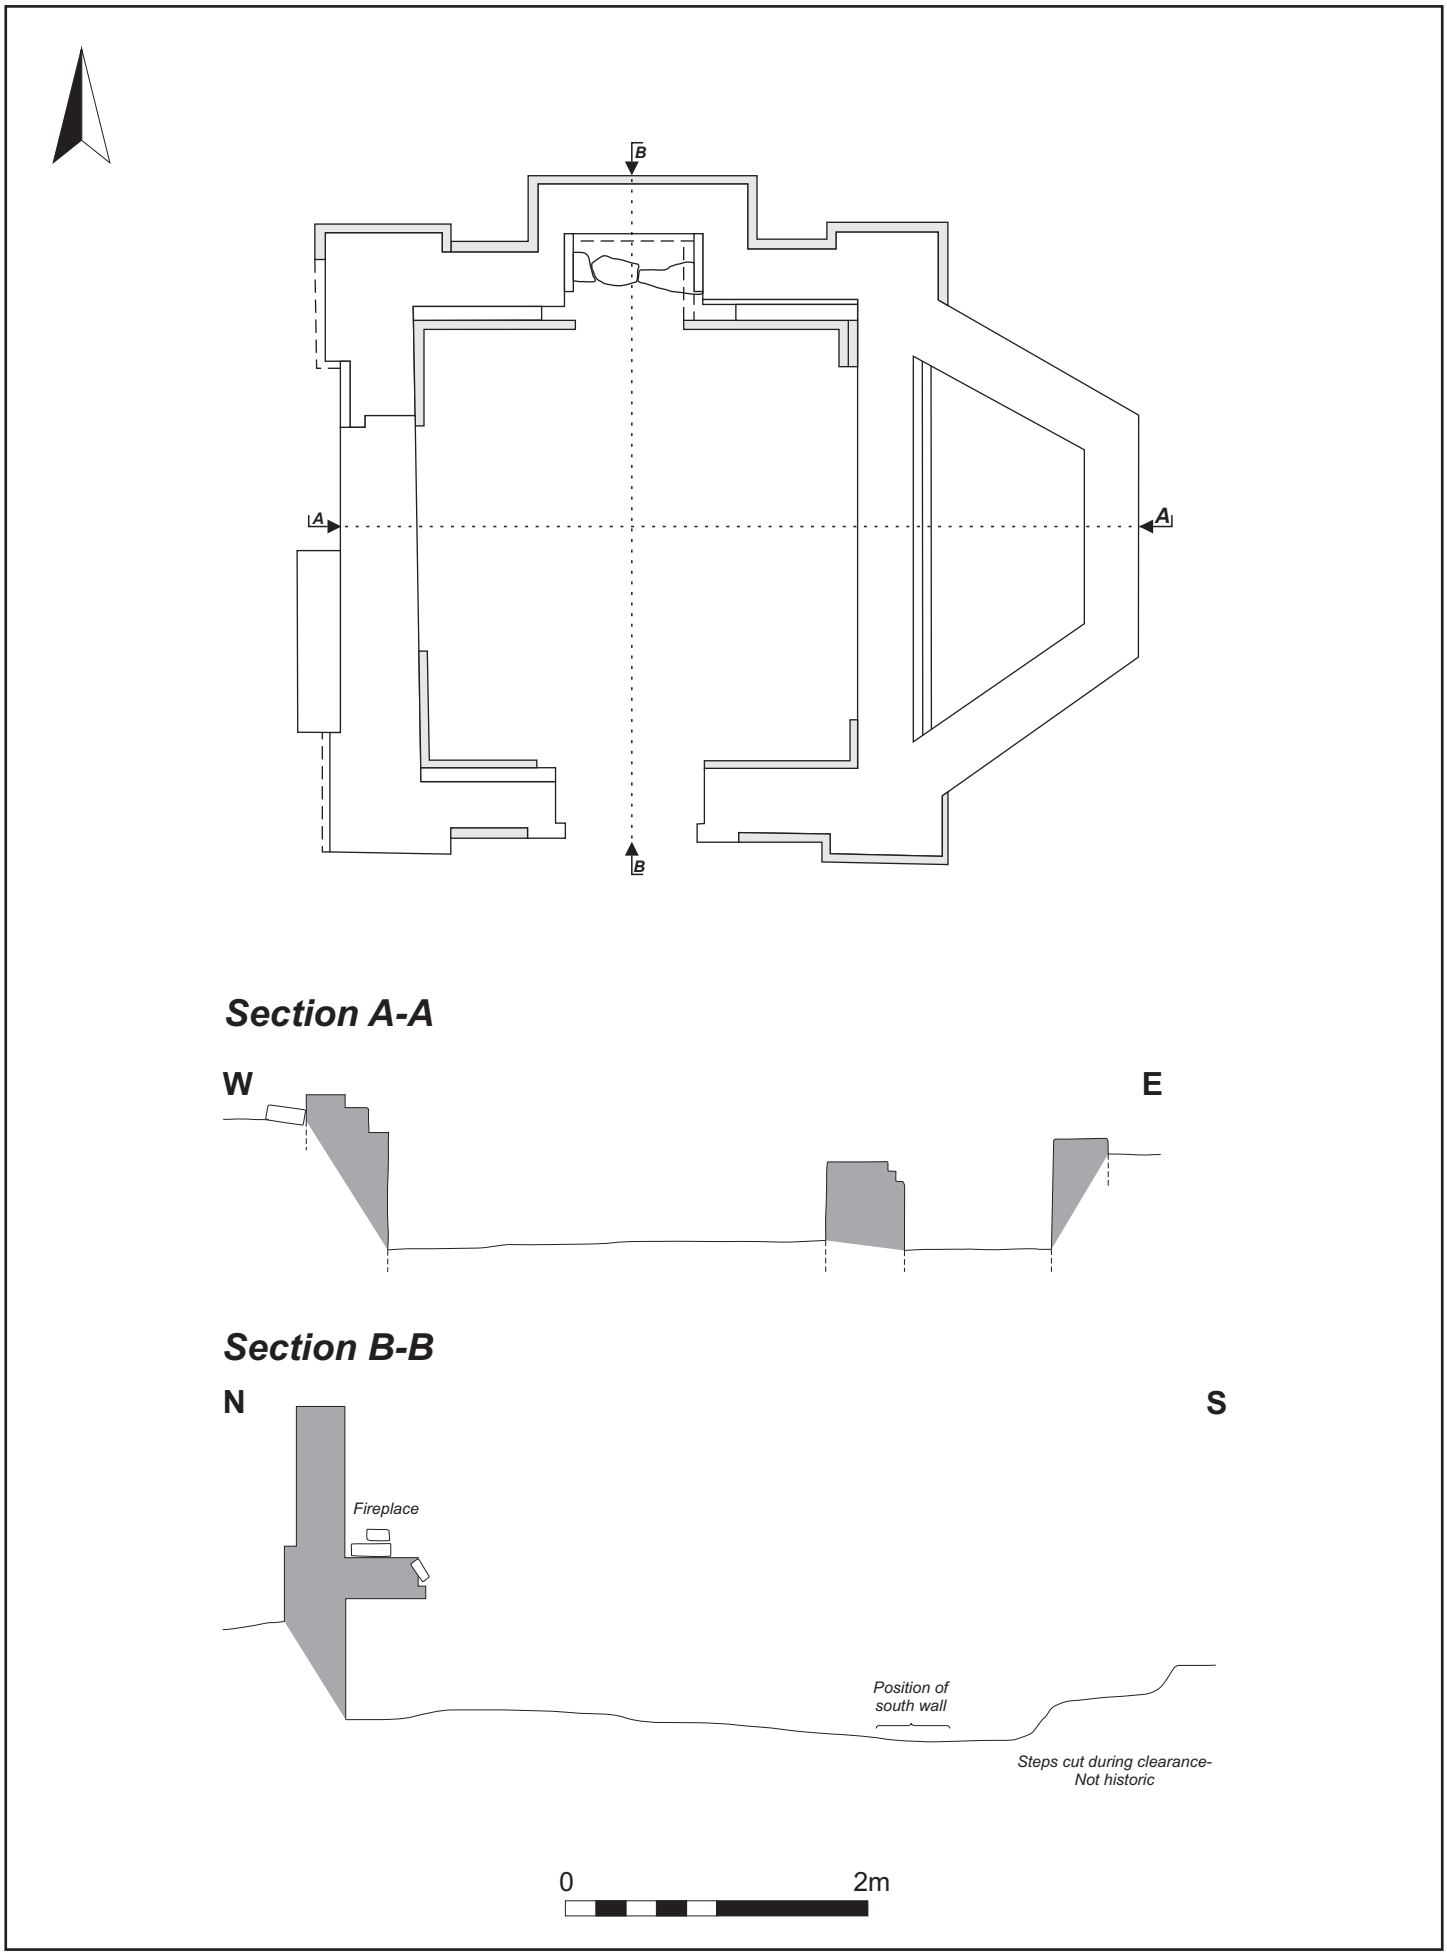
Plan of the Summerhouse with sections A-A, B-B Fig 4

The structure was built of brick, 4.0m square in plan externally not including the thickened corners, and 2.80m square internally, with the four sides facing almost exactly the four cardinal points. A canted bay is present on the eastern side adding a further 1.50m externally but only 1.0m wide internally (Fig 4). The bricks are, in general, poorly made and fired to varying degrees resulting in a wide range of colour, texture and

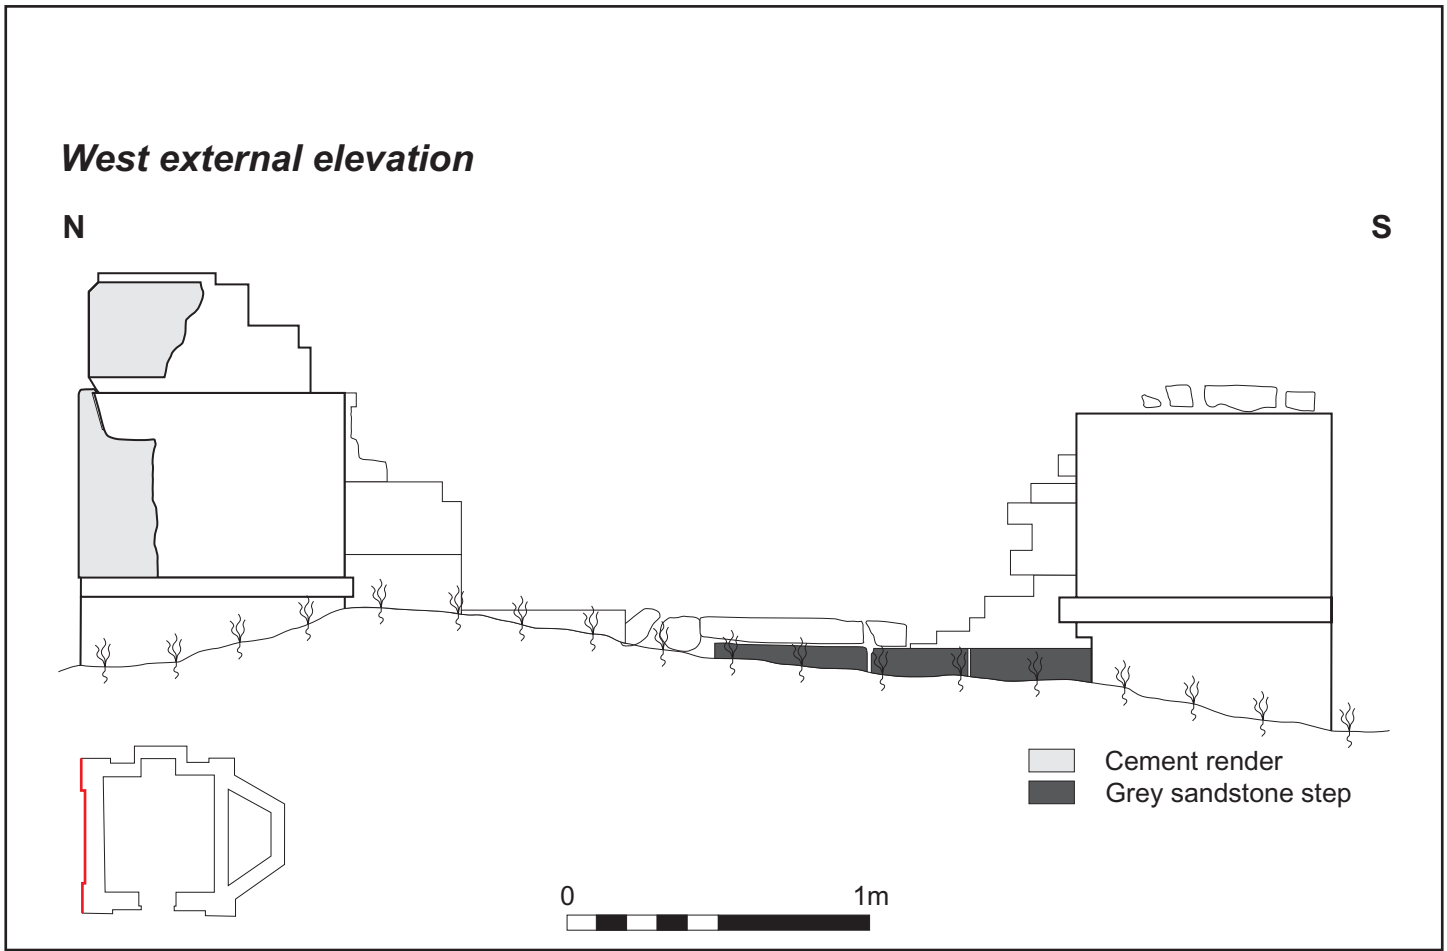
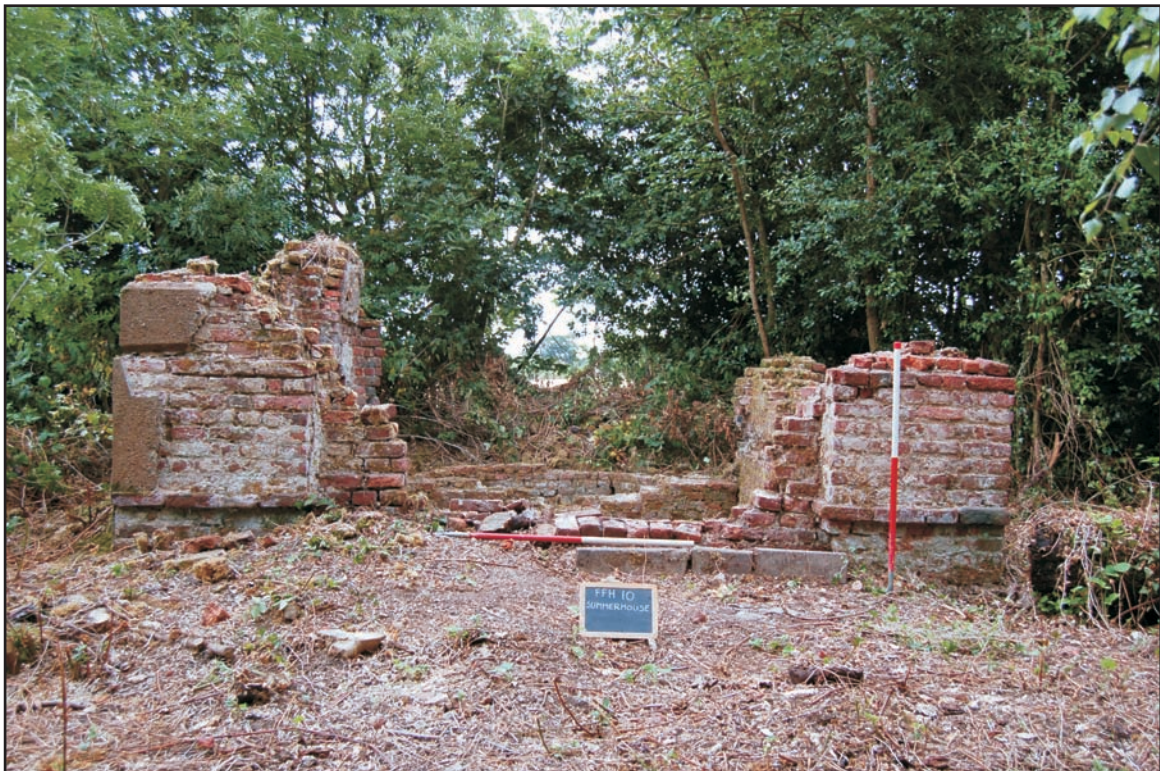
West external elevation and rusticated corner Fig 5

This elevation faces the pond to the west and retains fragmentary evidence of a single door jamb towards the north end of the wall. The jamb appears to have had a rebate on the internal surface which most likely held a timber post for a door frame, and if this opening is original suggests that it held double doors as it is too wide for a single leaf door. No evidence survives on the southern side of the jamb as the wall has been demolished in this location. There is no surviving indication that this door opening has been altered.

At the north and south corners the wall is thickened giving the appearance of clasped buttresses which have, predominantly on the north corner, remains of cement render fashioned to give the appearance of quoins in the form of smooth chamfered rustication to imitate the appearance of blocks of ashlar masonry (Fig 5). It is likely that this was part of the original design and was originally faced with lime mortar, the surviving cement render being the latest surviving phase of repair. The surface render is positioned both above and below a projecting string comprising a single course of brick set out from the wall surface by c50mm. No render remains above this level on the southern corner though *ex situ* fragments were noted lying close by, and what appear to be the upper surfaces of broken render were visible close to the wall plane at soil level.

A broken slab of fine grained grey sandstone may represent the topmost section of a flight of steps leading to the former entrance, although it is not clear if further steps, or evidence for them, remains buried (Fig 4, section A-A; Fig 5). The positioning of the fragment suggests that the full width of the west front between the two projecting corners was surfaced with slabs. If not the uppermost step of a flight, it must have acted as a single step and the remainder of the slope leading westwards from it may have been gravelled since a grass surface this close to the building would not have withstood the wear and tear even of a few family members if used often.

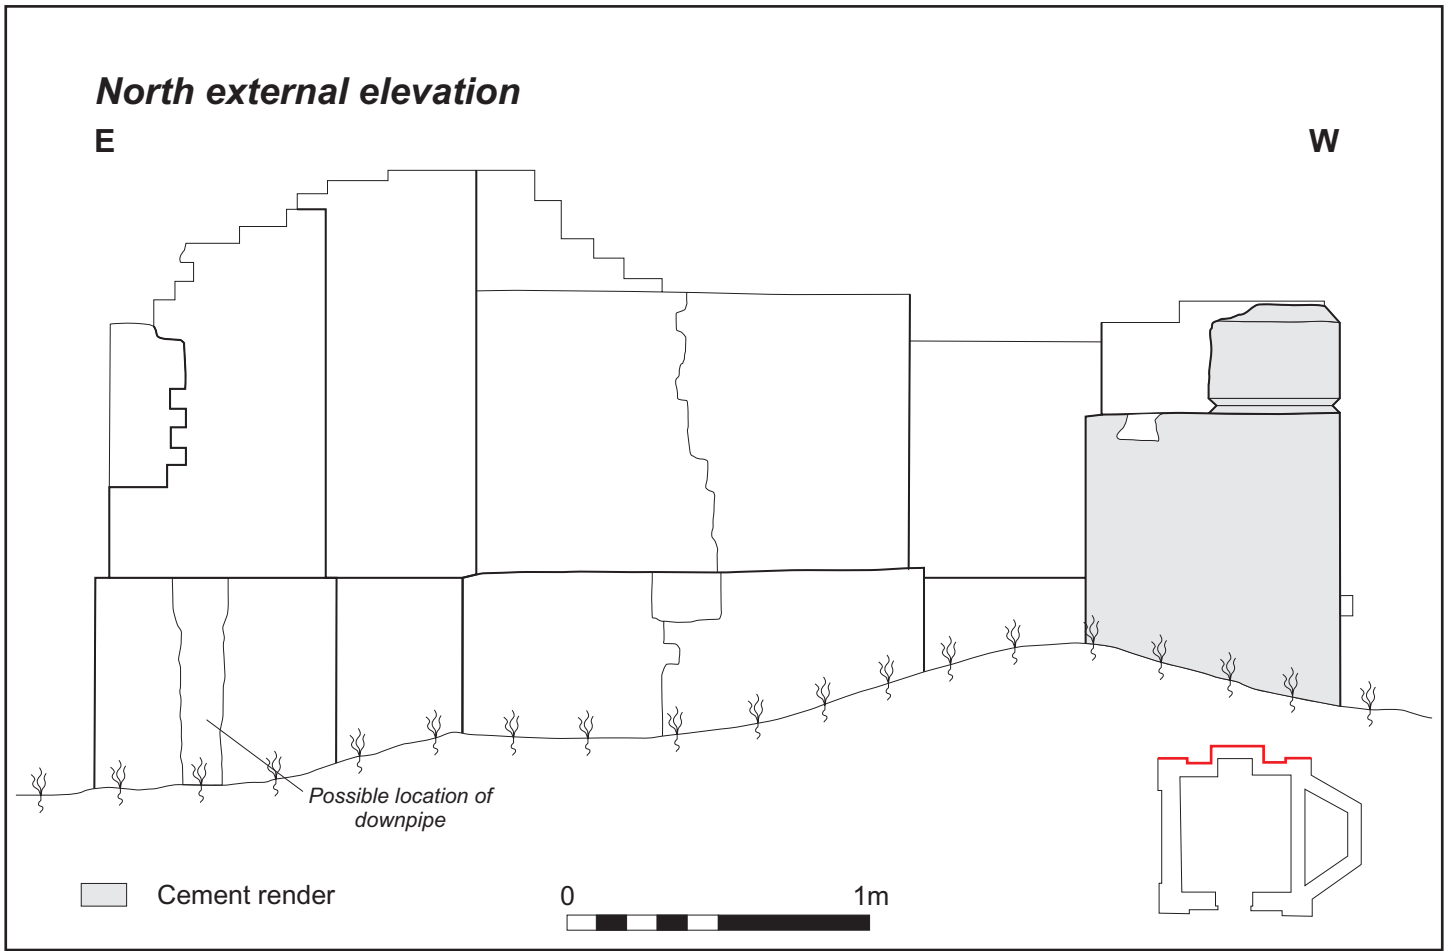
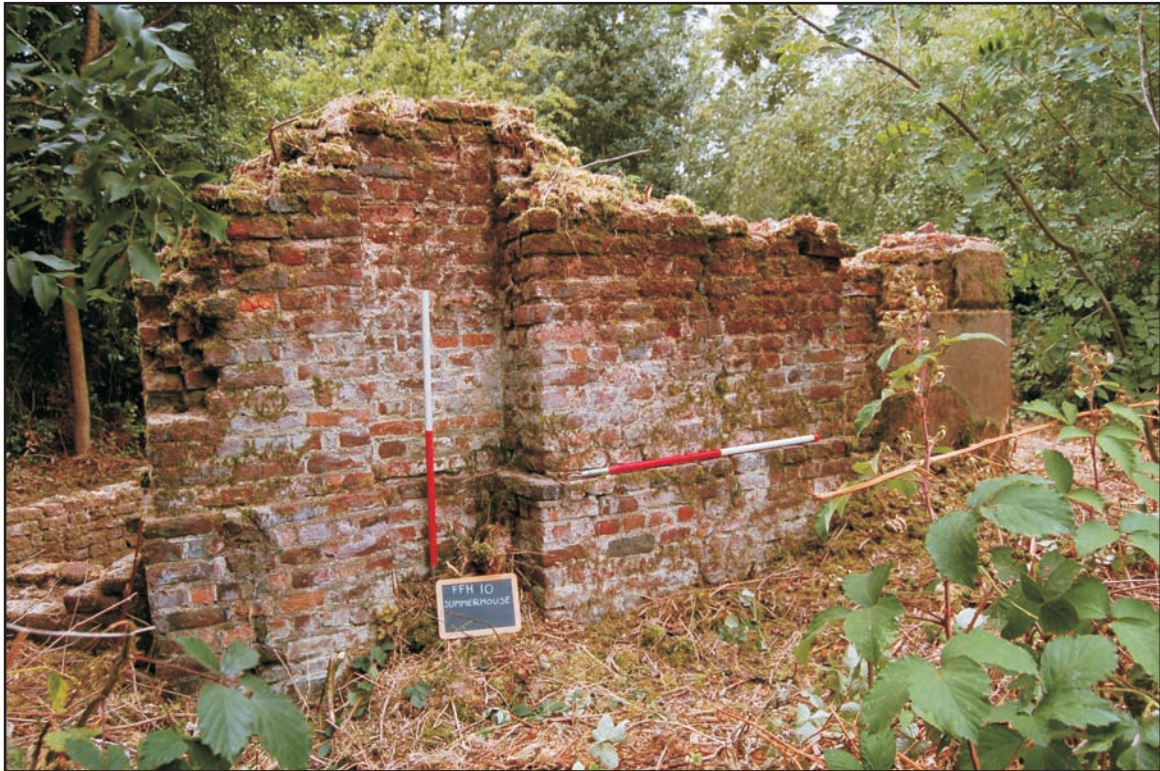
North external elevation with chimney stack Fig 6

This is the most complete surviving section of wall. It is built above a simple, stepped plinth which is not present on the clasped buttress itself, but begins from its eastern face and continues to the north-east corner. The most recent rendering has been applied to give the appearance of chamfered rustication. Apart from the rendering on the clasped buttress of the north-west corner there are no indications that the other surfaces were similarly covered, the join of the present rendering is cleanly finished in the angle between the buttress and the north face of the building. The bricks are predominantly laid in English bond (alternate courses of headers and stretchers) though there are areas where this bond is less regular, most likely due to the relatively short lengths of walling.

In the centre of the north wall is the rear projection of the chimney stack and at the north-west corner the wall again thickens giving the appearance of a clasped buttress, but there is currently no indication of any rendering duplicating the appearance of quoins present at the north-west corner. The upper surface of the surviving section comprises loose bricks with almost no adhering mortar, and for a few courses below this level the mortar is largely or completely weathered out. At the north-east corner there is a section of the external angle missing. On the north side of the north-east clasped buttress is a patch of cement pointing to the brickwork which, though irregular, might indicate the former location of a downpipe, and perhaps is present due to a repair following a leak; there are not any clear indications of brackets or holes for the attachment of any downpipe, however, and this repair may be coincidental and unrelated.

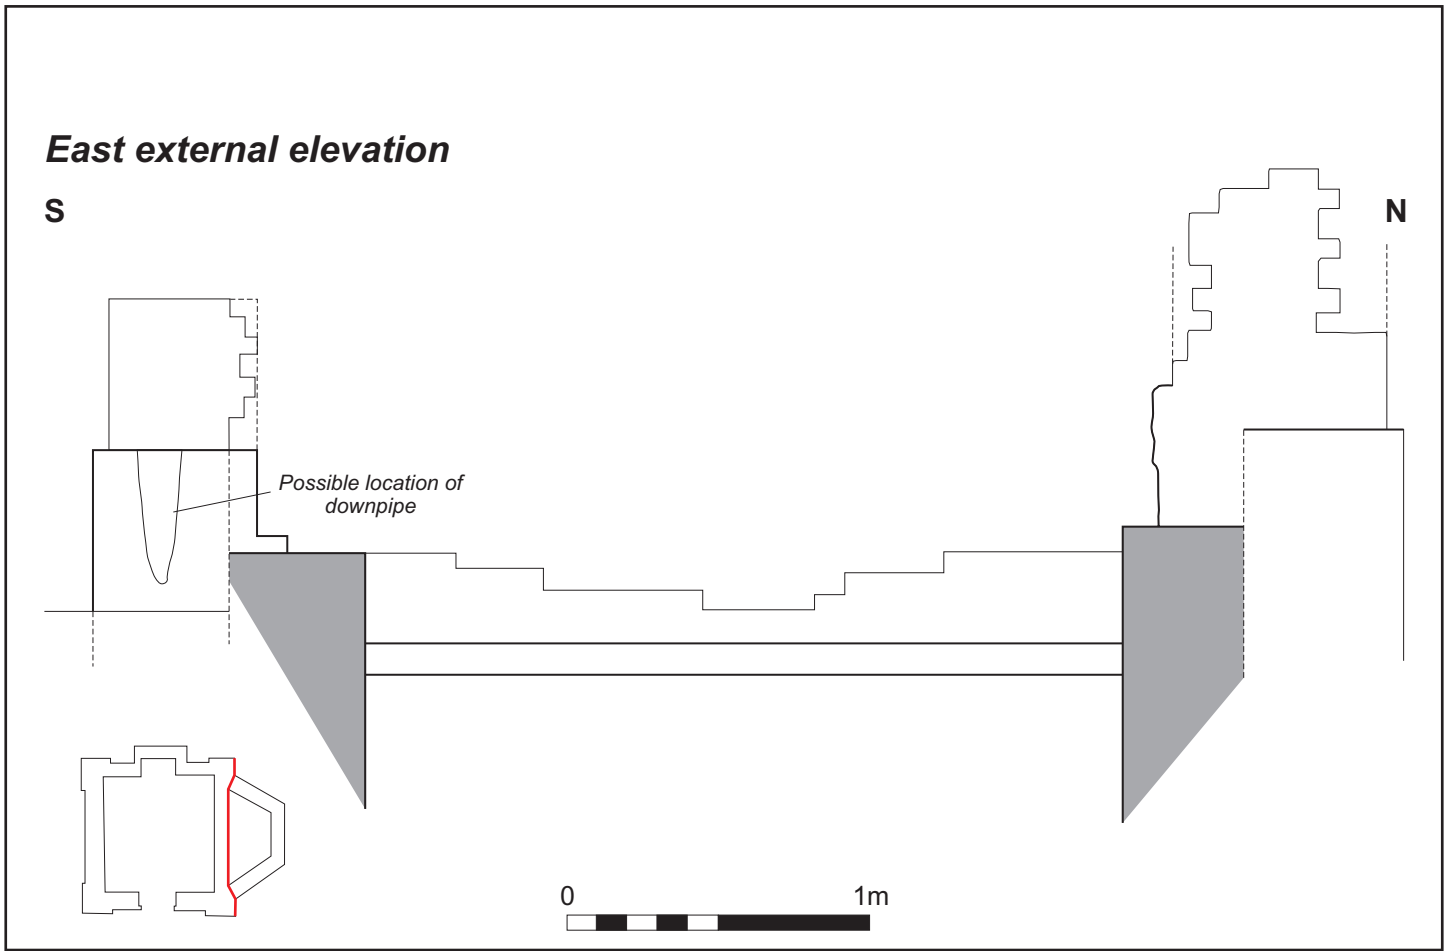
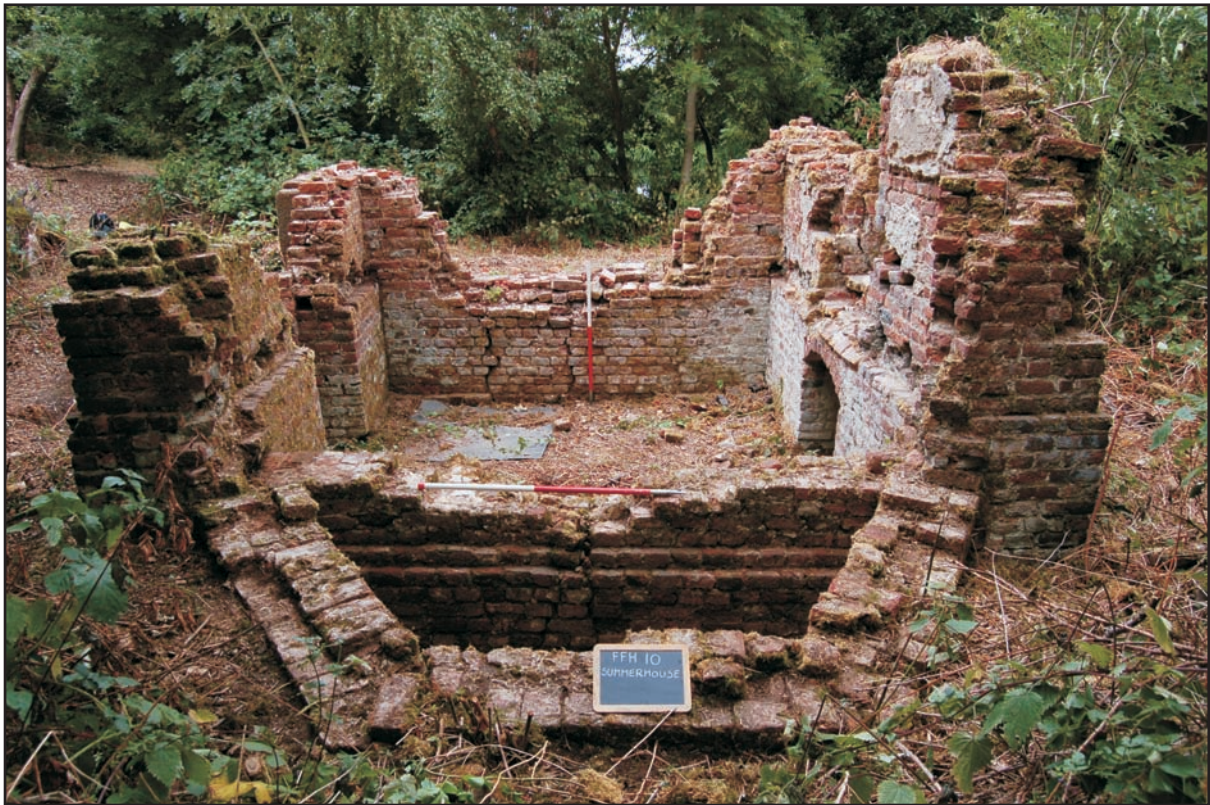
East external elevation showing canted bay in foreground Fig 7

Very little of this elevation survives above ground apart from sections of the north-west and south-west corner. The entire central section in between is only present below ground level, and indeed this section would have been open to allow access into the space within the canted bay. It has been suggested that the canted bay is a later addition, however, the evidence for this is not entirely clear. As it survives, the bond between the straight section of the east wall and the junction where the angle of the canted section projects from it displays no clear indication of a section being chopped out of a straight face and the angled bricks being set into it. There is no obvious change in coursing, bond or mortar, and the fact that carefully shaped birdsmouth bricks are present suggest that if this is a later insertion, unusual care was taken at that stage to make specially angled bricks for the addition. Also the external plane of the east face of wall which is present between the north-east and south-east corners is set further back from the clasped buttresses of the corners than on other faces; if this was originally the external eastern face it seems curious that this be set-out and built in a different way to the other three sides where the set-back is consistent. Below ground level there is a double off-set well below ground level where the foundation wall thickens; it is not known if this configuration is present elsewhere, though it is not on the exposed face of the south wall (Figs 4 and 7, see below).

There is no indication how the canted bay was finished above ground level; whether each face was filled entirely with windows or if there were brick piers at each angle against which timber frames were set. By the same token it is not clear how the floor was configured, though it would make most sense to have the joists aligned north-south as they were in the main building since then the floorboards would be aligned consistently at right angles (ie east-west) into the bay and on the long axis of the interior, as one would expect in a space of this kind.

The reason for the north-south eastern wall (present only below floor level if this theory is correct) appears therefore to be a simple constructional device which would tie the north and south walls together more rigidly. If the canted bay is a later addition, the care with which it was added is considerable and it must be assumed that prior to its addition the east side would have probably had a centrally placed window overlooking the park. Since so little of the east wall survives, nothing else can be said of its original configuration or decoration.

On the east face of the southern clasped buttress is a slightly eroded area below the level of the plinth which might indicate water damage, perhaps from a leaky downpipe. As on the north elevation, there are no indications of any fixing holes or remains of brackets if this was the case.

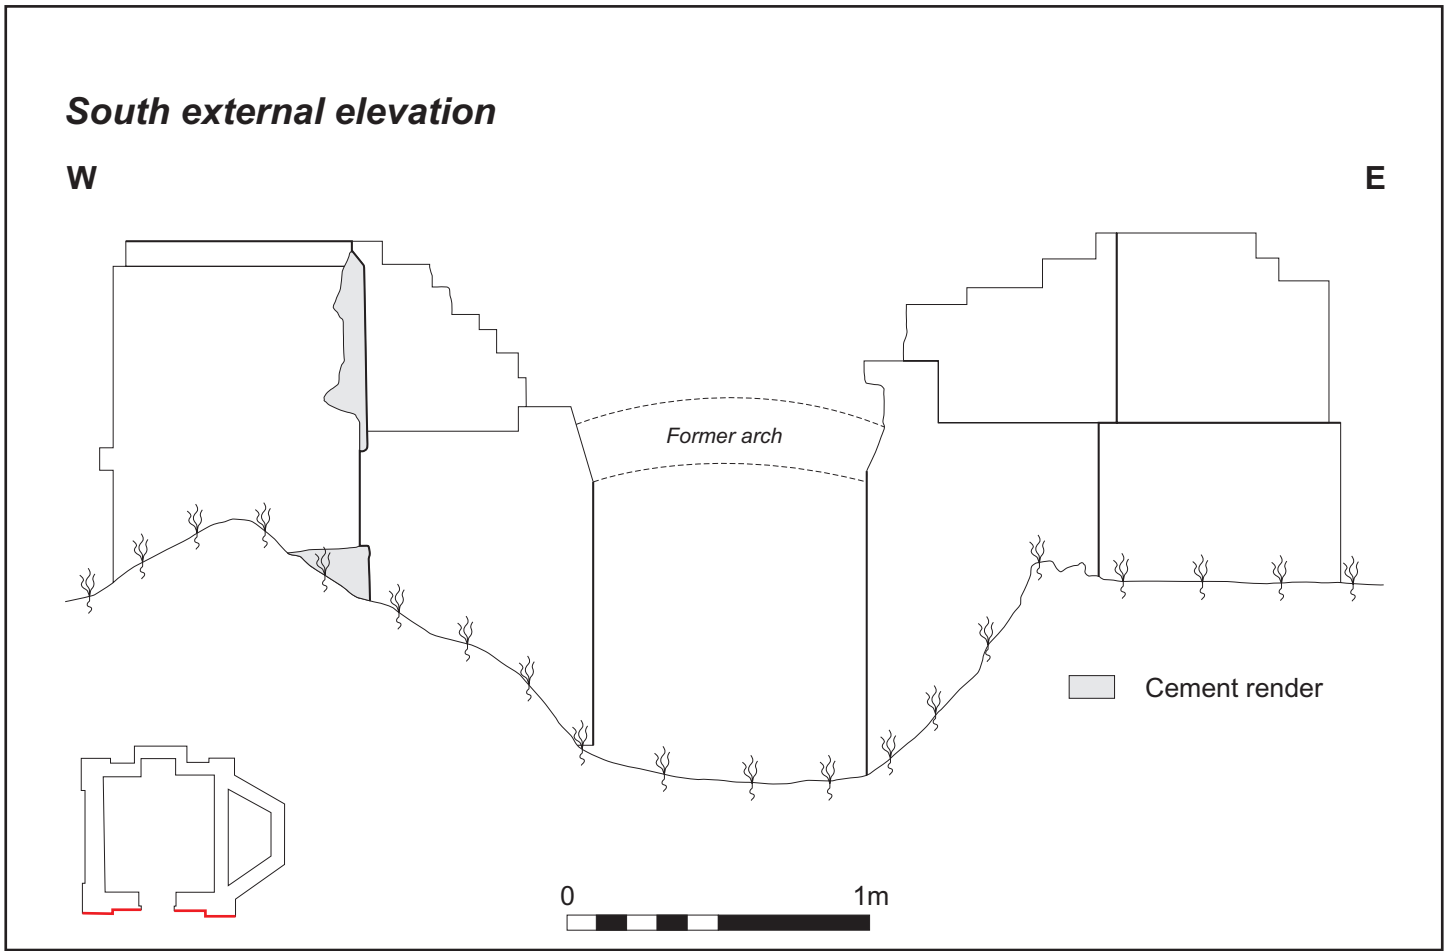
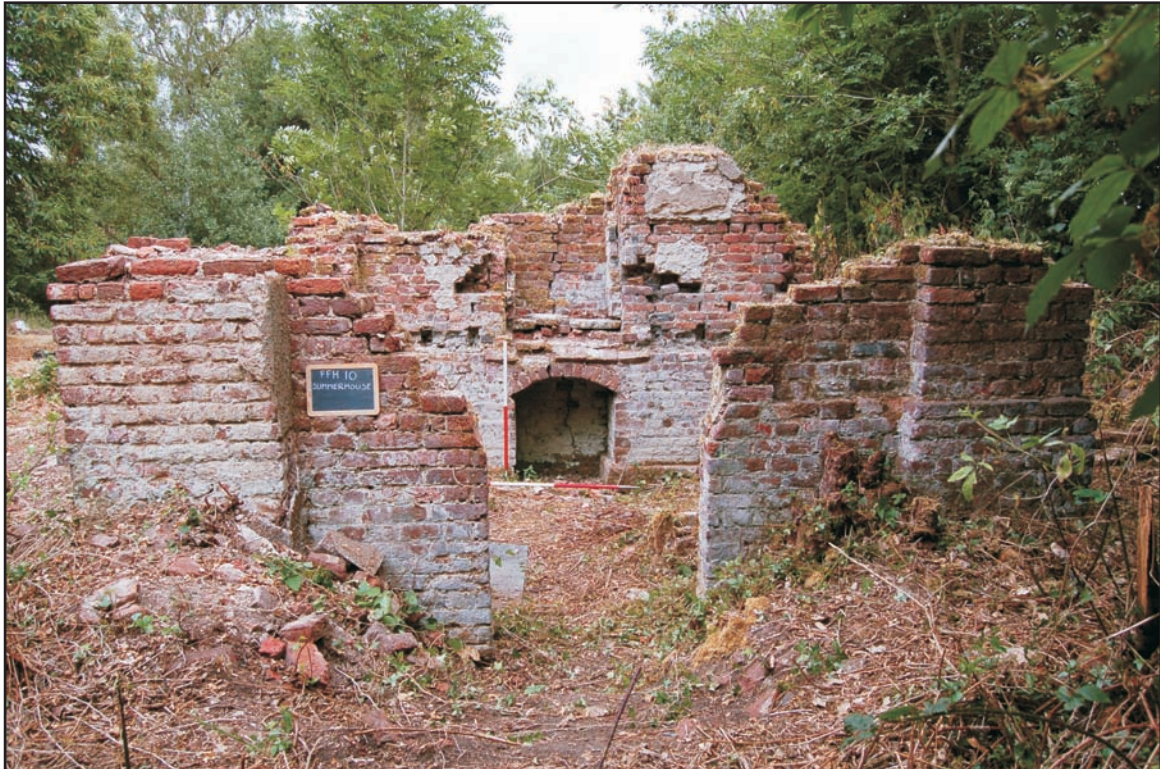
South external elevation showing door to basement Fig 8

This wall was constructed in the same way as the other walls, with a plinth and clasped buttress corners. It has a doorway placed centrally at basement level which gave access to that space. In its current state, the doorway survives only to the level of the former arch, with the cut-back bricks for the springing of the arch surviving on both sides. The length of the angle cut-back into three courses of brickwork indicates that the arch consisted of bricks laid lengthwise (stretchers), or perhaps more likely alternately headers and stretchers. It is assumed that the arch was of segmental form as is present beneath the fireplace in the north internal wall (see below). Above, and to either side of the remains of the arch the brickwork thickens to the same depth as that of the wall below the plinth to allow for the height of the arch beneath. It is assumed that the plinth therefore rose to either side, then passed above the arch at a slightly higher level than is present on the remainder of the building. At the south-west corner the clasped buttress has no plinth on the south side but does retain small areas of cement render on the east face with evidence of more render below ground level. The render appears to have only been applied to the buttress, as on the north-west corner, and there are no indications that it continued further.

The doorway into the basement is plainly finished on the exterior. There is no visible sill, but the report produced in 1999 when the site was cleared reports that a threshold of reused bricks was revealed (Gillam 1999). This covered an area of roughly 3 feet square. No mention is made of any external paving to the doorway, or of steps leading down to this entrance so the form of entry is unclear at present.

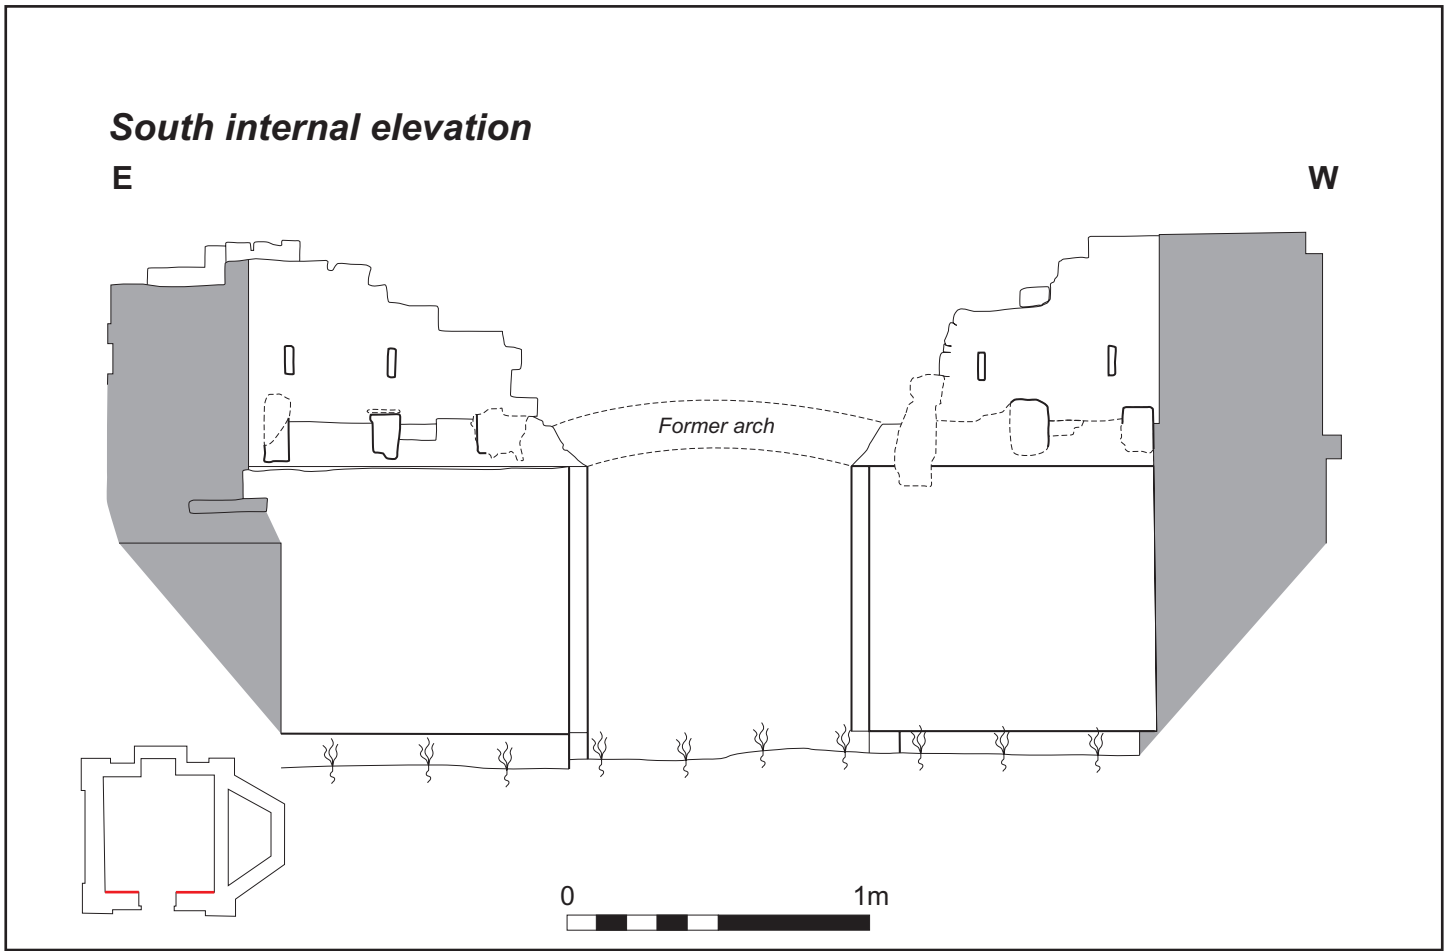
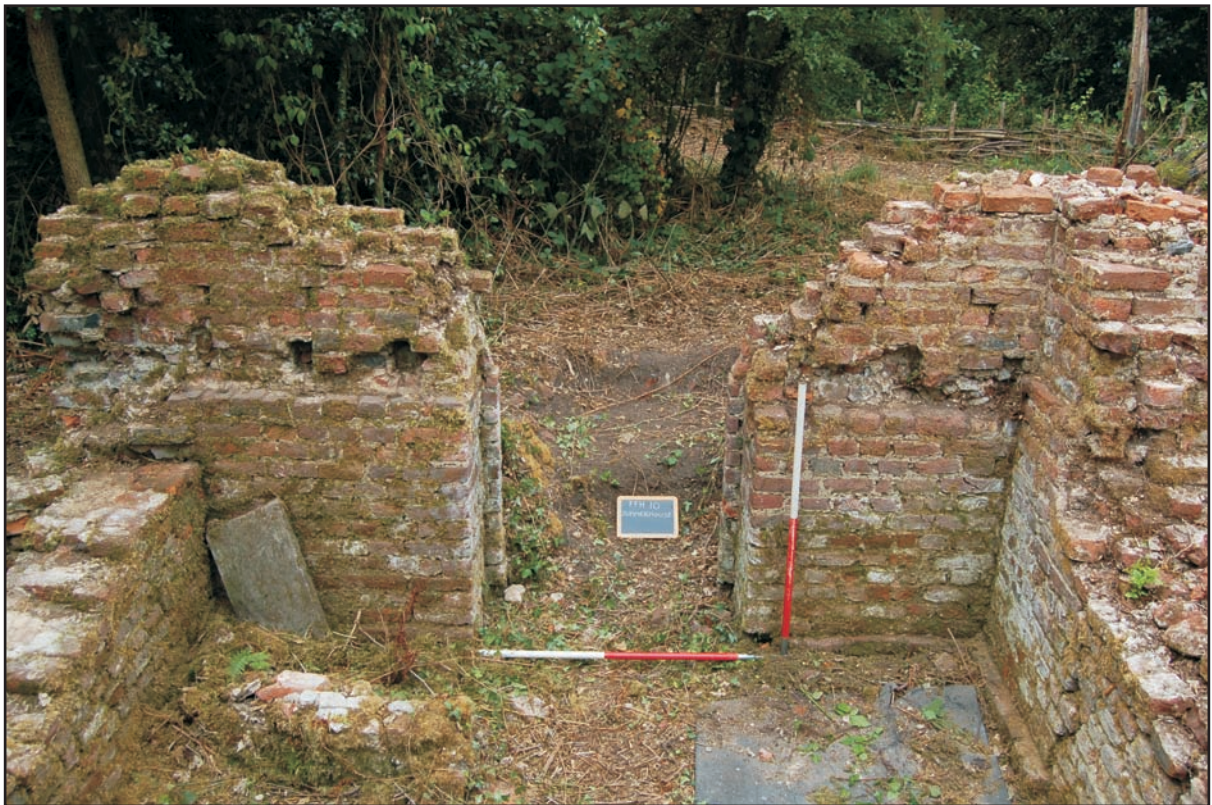
South internal elevation Fig 9

On entering the basement the first impression is of how limited this space must have been, and that it could never have served as a fully usable space as such, but merely as storage, perhaps more useful here given the distance from the main house. The wall is constructed as on the exterior, of neatly laid red brick in white lime mortar, mostly, but not exclusively laid in English bond.

The doorway has a rebate on the interior for the fitting of timber door posts, the jambs are square set and not splayed. On either side of the doorway at the base of the exposed wall is an offset, or plinth, presumably the upper surface of a thickening of the foundations as it serves no obvious purpose, and does not appear to represent the floor surface which seems to lie at a lower level. Level with the base of the springing of the arch is an internal ledge on which rested the lower edges of the joists for the floor to the room above; the ends of the joists were set into the south wall spaced roughly at between 250mm and 300mm intervals, three on either side of the doorway. The joists themselves appear to have been approximately 100mm in width and 220mm in depth, set into the wall approximately 50-60mm. None now survive so it is not possible to determine if they were of hard or soft wood. Above the level of the upper surface of the joists are two small slots on each side of the door between headers in a single course. It is thought that these empty slots originally held wooden packing which may have been used to fix either skirting boards or the lower edge of wainscoting.

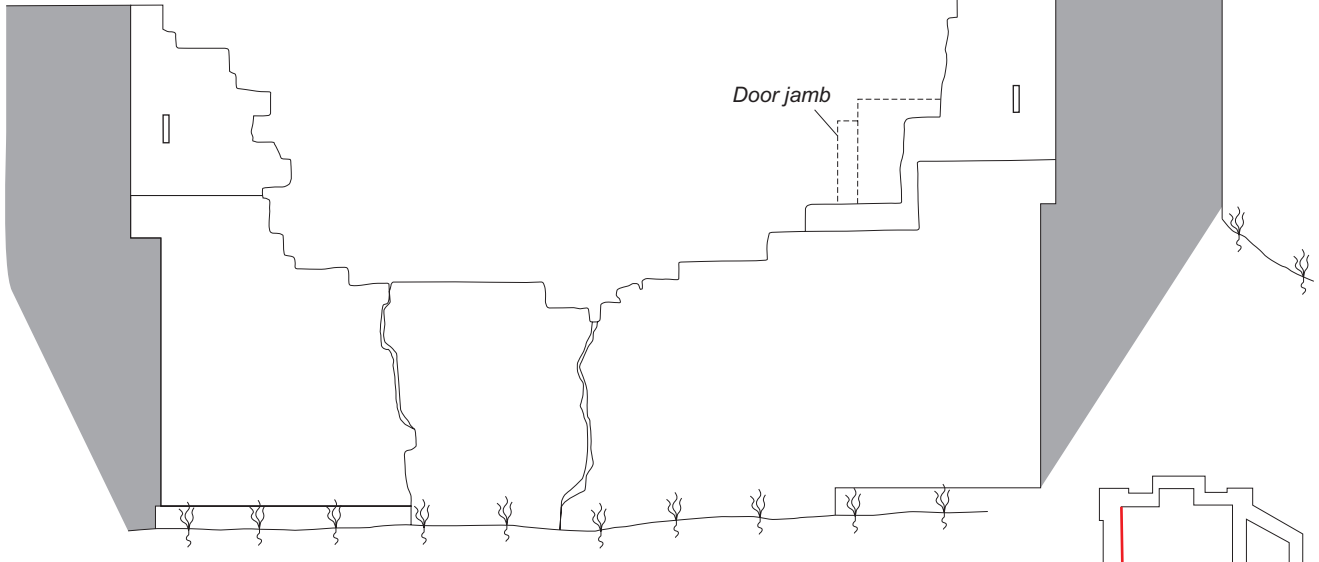
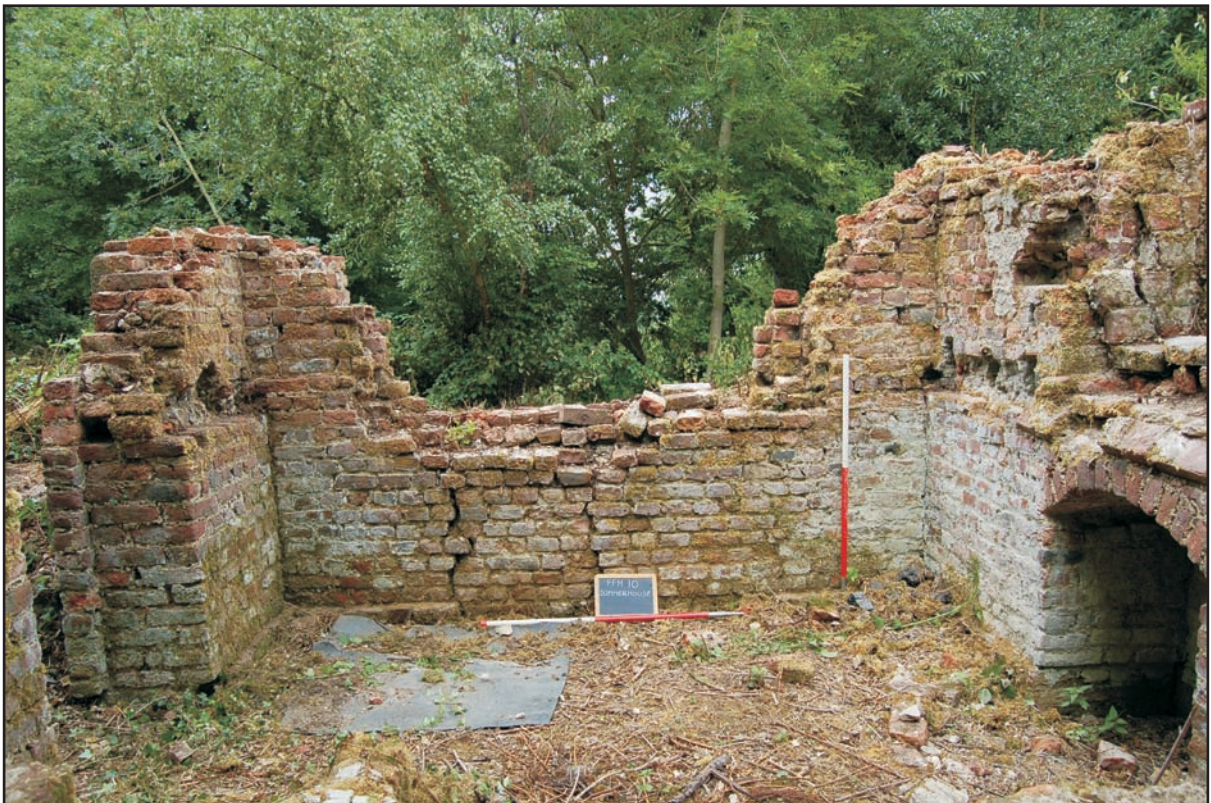
West internal elevation Fig 10

A plain elevation with a partial off-set at present ground level at both north and south ends, but not continuing the entire length of the wall; this presumably represents widening of the wall foundation where greater loads were carried either side of the door opening, confirming that it was originally of the width implied by the surviving jamb for a pair of double doors. There is no ledge on this side at the level of that on the south side

as the joists would have been laid parallel to the wall plane and therefore did not need to be seated on it. There is, however, a slight off-set at just over half way up the side of the joist which would have allowed the ends of the floor boards, laid at right angles, to oversail the joist and perhaps therefore make a closer fit to the west wall. A single slot is visible on either side of the former doorway between the edges of bricks at the same level as those observed on the south wall, and appear to have served the same function, ie for the attachment of skirting or wainscoting.

At the northern end of the wall where the brickwork remains above external ground level there is evidence for the inner jamb of the doorway; it has a simple rebate similar to that of the half-basement door comprising of a single brick set back from the external wall plane. No evidence for a sill remains, so it is unclear if this was of timber or stone.

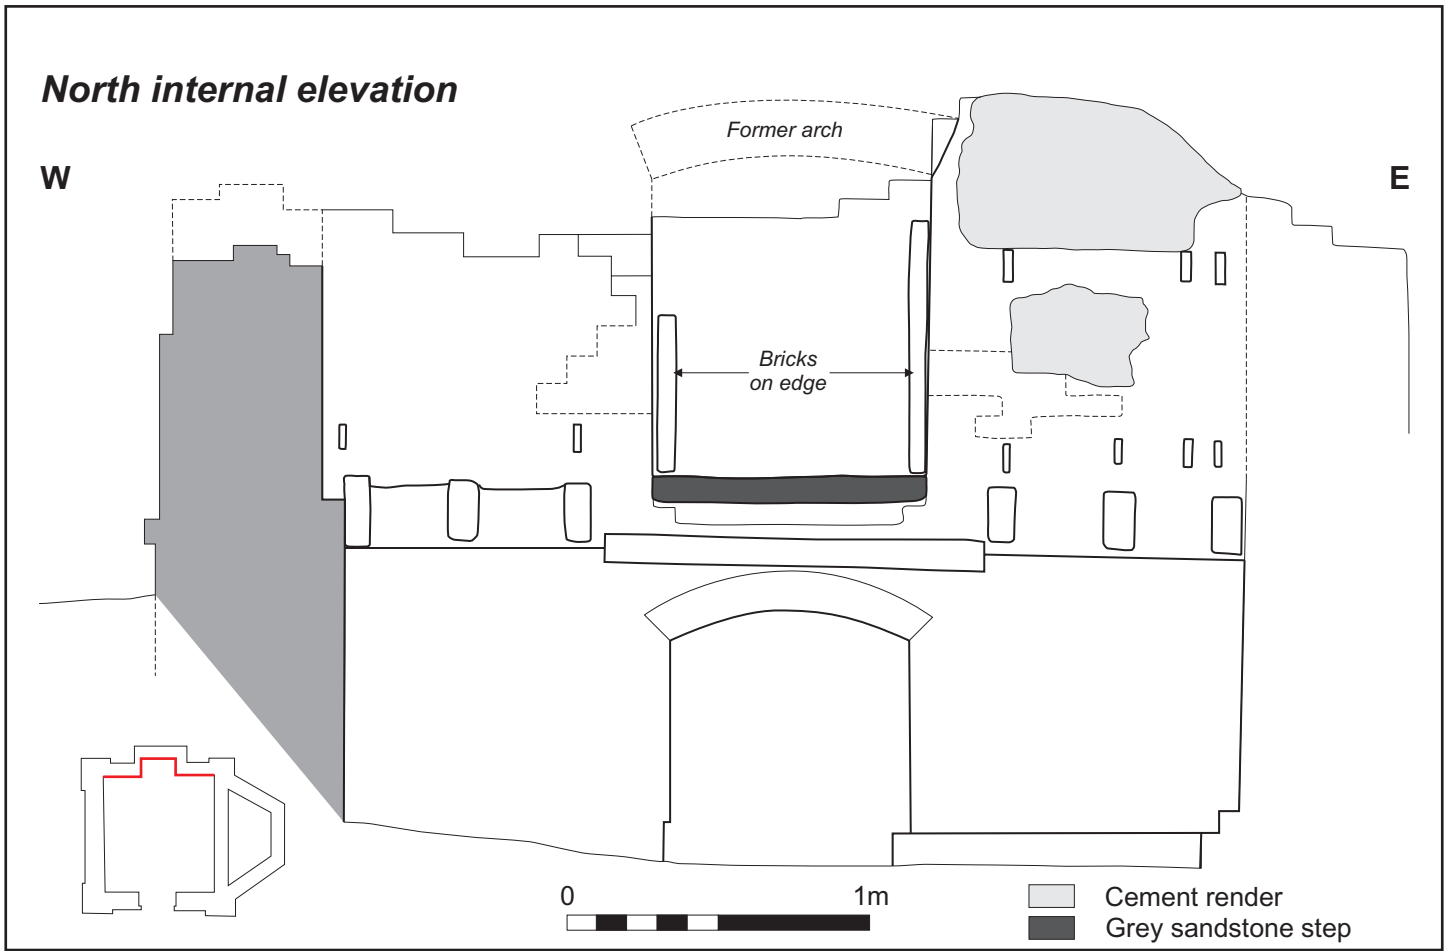
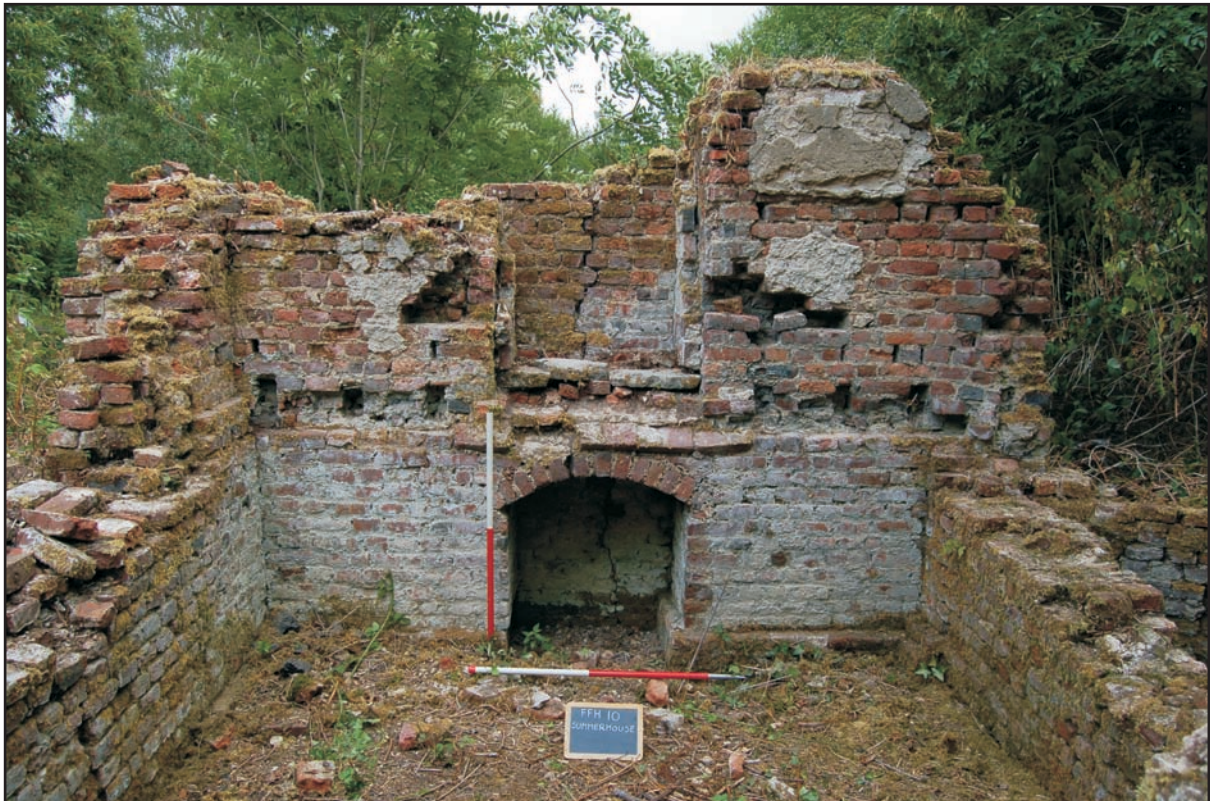
North internal elevation showing fireplace Fig 11

This elevation contains not only the remains of the fireplace and chimney breast which heated the upper room, but also a structural arch beneath (Fig 4, section B-B). At basement level the wall retains an offset along the full length of the wall to either side of the arch. The arch recess contains a similar sized off-set on its eastern side, but not on its western. The arch is constructed of edge-set bricks and is laid flush with the internal wall plane. Immediately above are the remains of a second, shallow arch set at right angles to the wall plane which would have sprung from the north wall to a trimmer between the adjoining joists; this would have supported a stone hearth slab. The few remaining bricks of that arch are also laid on edge.

The fireplace opening is essentially of the same dimensions as the arch beneath and has undergone some changes. The most obvious is the insertion of a new hearth slab within the fireplace, presumably since this area would be subject to the most intense heat, and the east and west sides of the fireplace have had linings of edge-laid bricks set within the embrasure. The bricks sit on top of the stone hearth slab and are therefore later than it, but in reality most likely is part of the same alteration. There is currently no sign that the back of the fireplace was re-lined and it shows little heat damage, perhaps suggesting the presence of a cast-iron fireback (the 1999 excavation report mentions fragments of fireback). The narrowing might have taken place at the time a new grate was added, fragments of a cast-iron grate were also reported in the 1999 clearing exercise, though the size and configuration are unknown (Gillam 1999). Though the arch of the fireplace opening is now missing, its height can be deduced from the cut-back bricks on the east side where the sloping profile indicates a similar segmental arch to that above the basement door, and of the same configuration. It is reported in the summary of the 1999 excavation that fragments of decorative plaster surround were retrieved, though it is not known what style these pieces display, and so no date is given here for that feature.

On either side of the lower arch and at the same level as the ledge on the south wall is a similar ledge to support the floor joists, there are also three empty sockets for those joists to either side of the fireplace of the same dimensions as previously described. Above these there are similar empty joints for skirting or wainscoting, on this wall the latter seems more likely since, given the higher survival of this section of wall, these slots can be seen at a higher level. However, there are also remnants of wall plaster adhering to the bricks on either side of the fireplace; it is not clear if these pre-or post-date the possible wainscoting, however, the remaining section to the east of the fireplace appears to respect the level of the two upper slots suggesting that that section at least was present when the lower portion of the wall was panelled. There is no indication that the north wall contained any windows.
