## Archaeological building recording at The Summerhouse, Forty Hall, Enfield

Report 10/129

September 2010

*Northamptonshire Archaeology undertook archaeological building recording at The Summerhouse, Forty Hall, Enfield. The former building, thought to date from the eighteenth century, is built of red brick and was deliberately demolished in c1951. It appears to have been constructed in one phase with potentially additional alterations and embellishments. The purpose of the recording action was to record the remains of the structure prior to works to stabilise the walls and prevent further deterioration.*

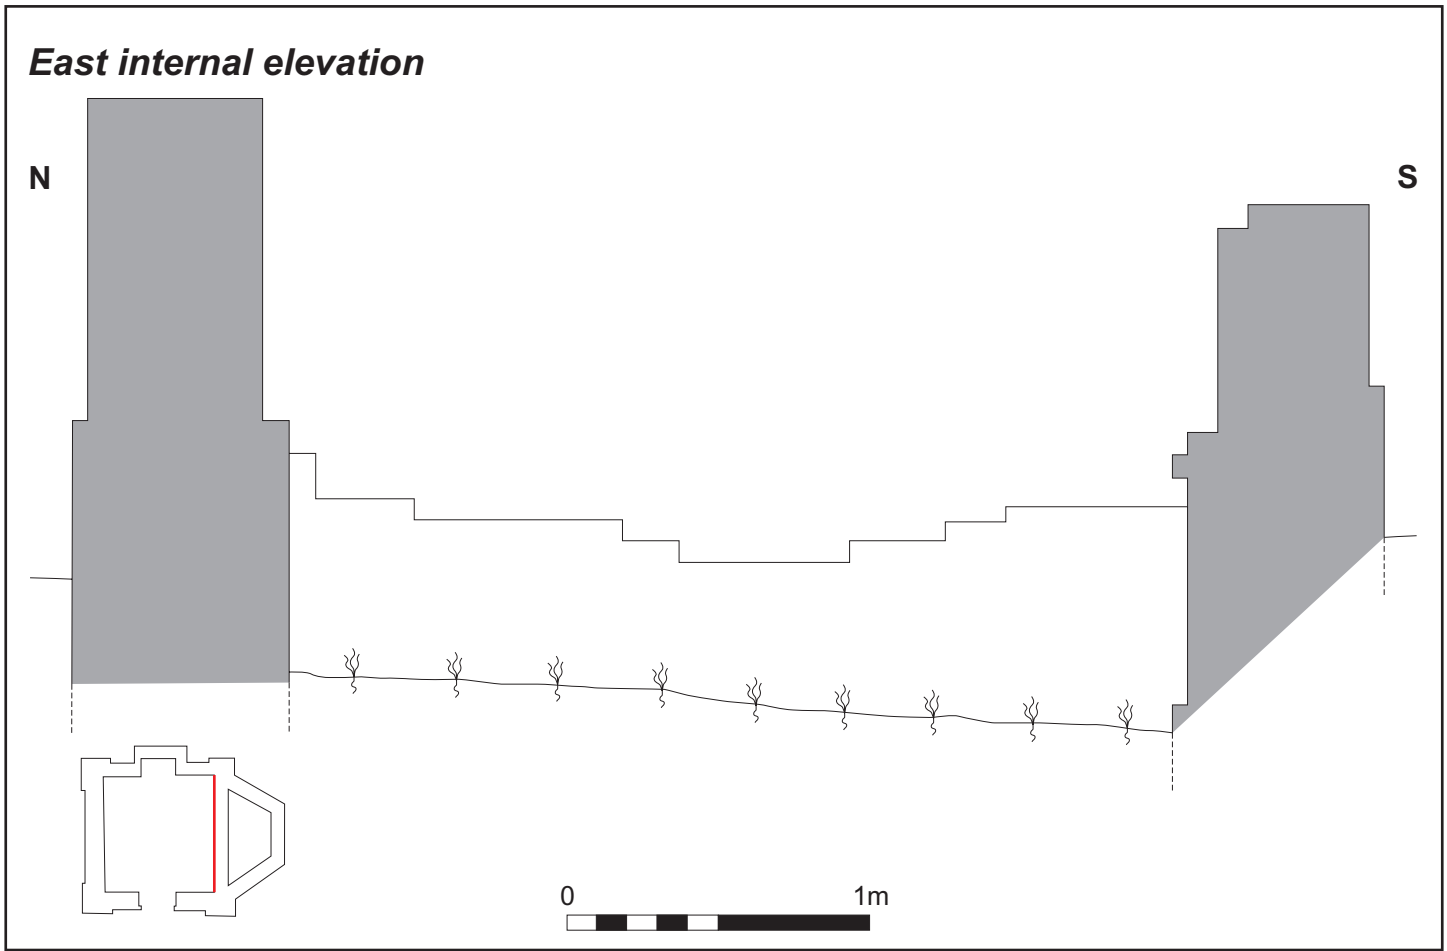
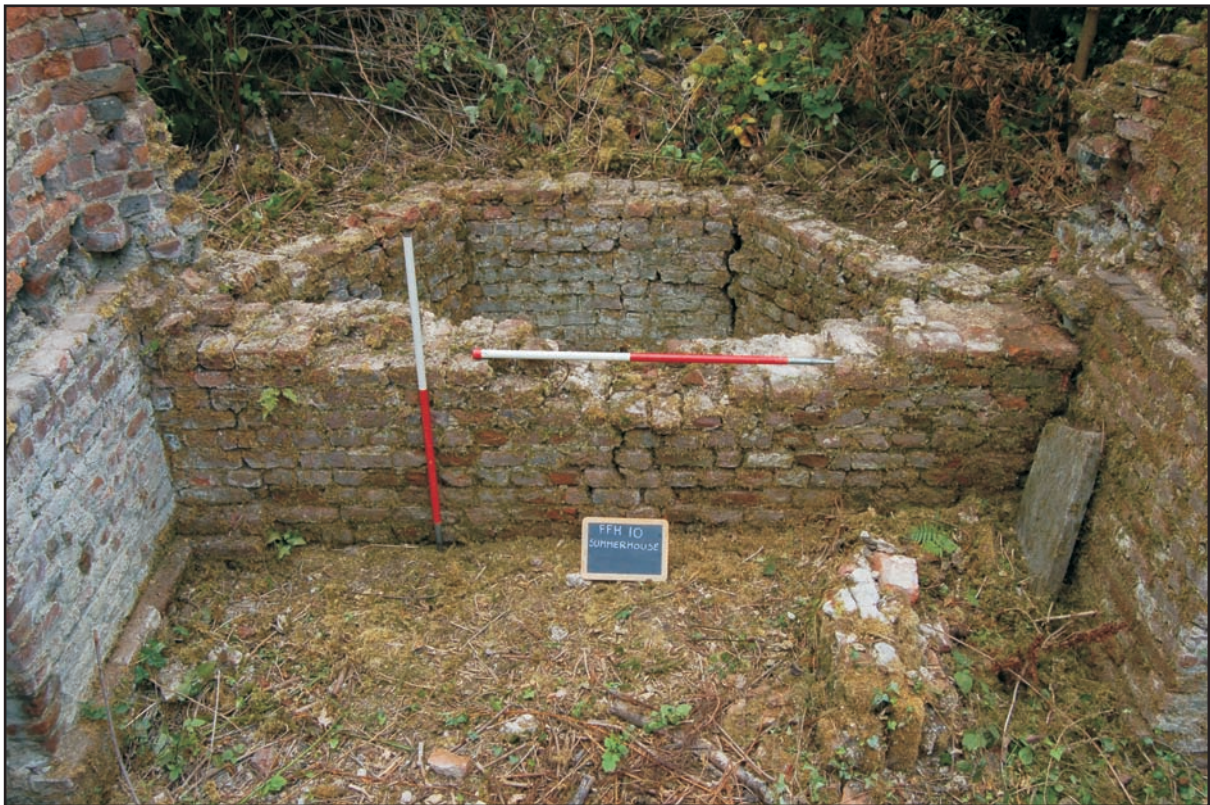
East internal elevation looking into canted bay Fig 12

Almost nothing survives of the east wall above basement level, and here too it does not survive even to the level of the former floor. Of the north-south aligned wall which forms the east side of the square section of the building little can be said; it has a small off-set section at the north end comprising two courses of brick, whilst at the southern end of the wall a similar length is of one course only.

Of the internal faces of the canted bay little too can be said, the bricks are of the same size and composition as in the remainder of the building, bonded in a similar way. The wall does not survive to a sufficient height to retain any evidence of internal fittings.
