Archaeological evaluation at Torrington Avenue, Coventry

Report 10/18

February 2010

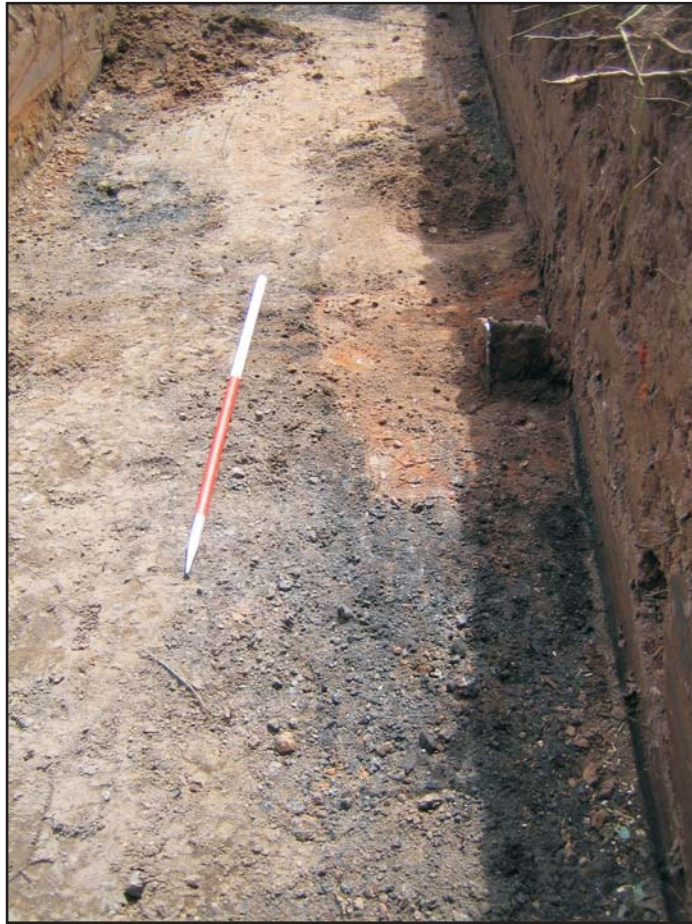
Trench 6, clinker surface, concrete base and steel stanchion, looking north Fig 16

At about 7m from the north end of the trench, a foundation trench [606] aligned west-east cut across the full width of the trench and extended 20m to the south. It had sloping sides to a flat base roughly 0.25m deep. Cutting the natural within this pit were two smaller pits, [608] and [610]. Both were sub-rectangular, roughly 1m long and 0.8m wide and exposed up to 0.5m deep. Both pits contained concrete bases retaining steel 'H' beam stanchions (609) and (610). In both cases the steel beam had been cut off just above the concrete base. Filling the trench and packed around the two concrete stanchion supports was a layer of dark grey-black ash and clinker (607) forming a compact surface across the whole area (Fig 12).

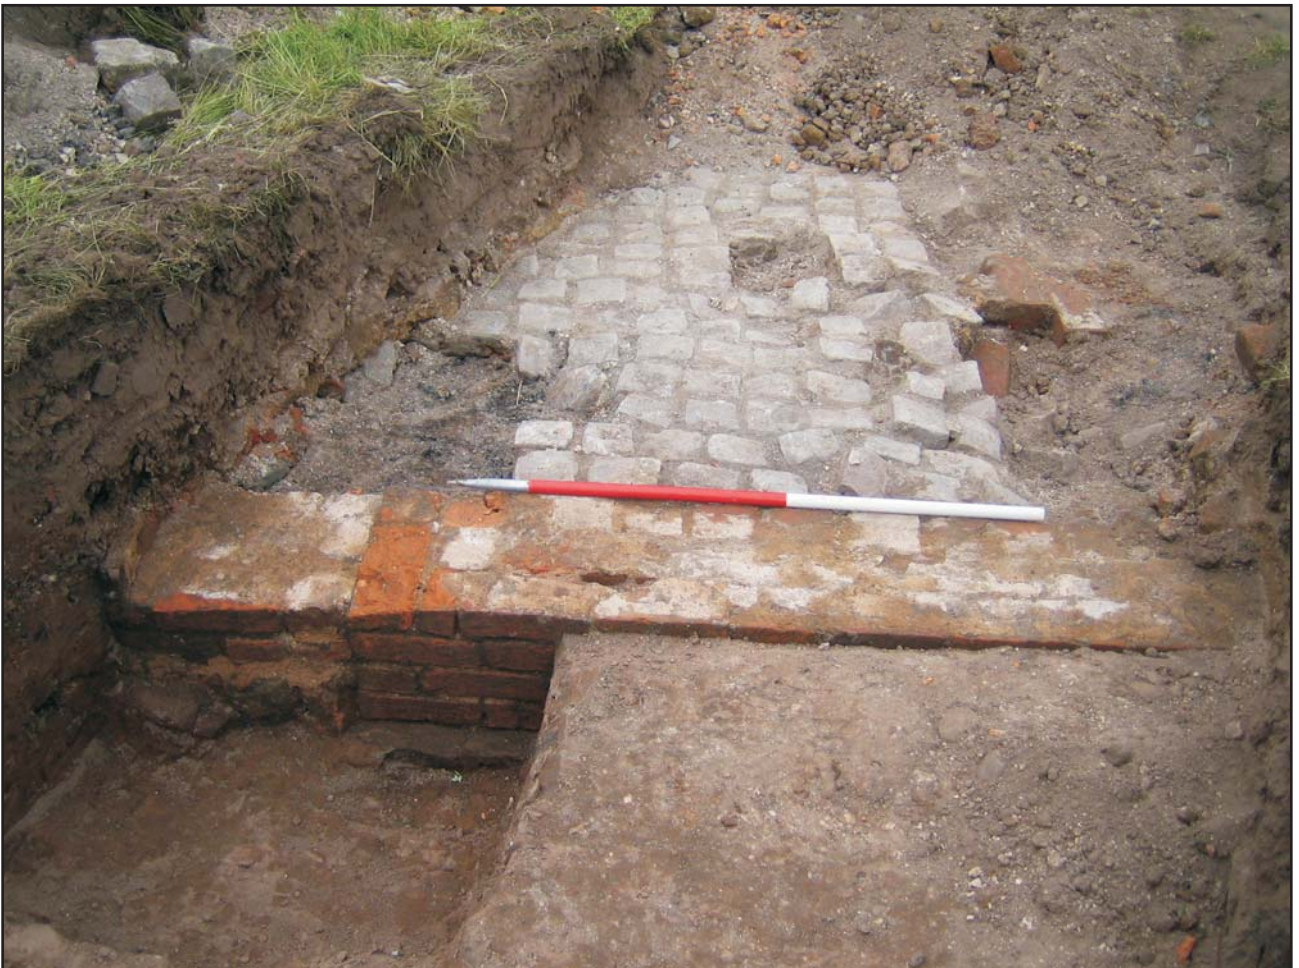
Trench 7, partially exposed walls and cobbled surface (724) looking east Fig 17

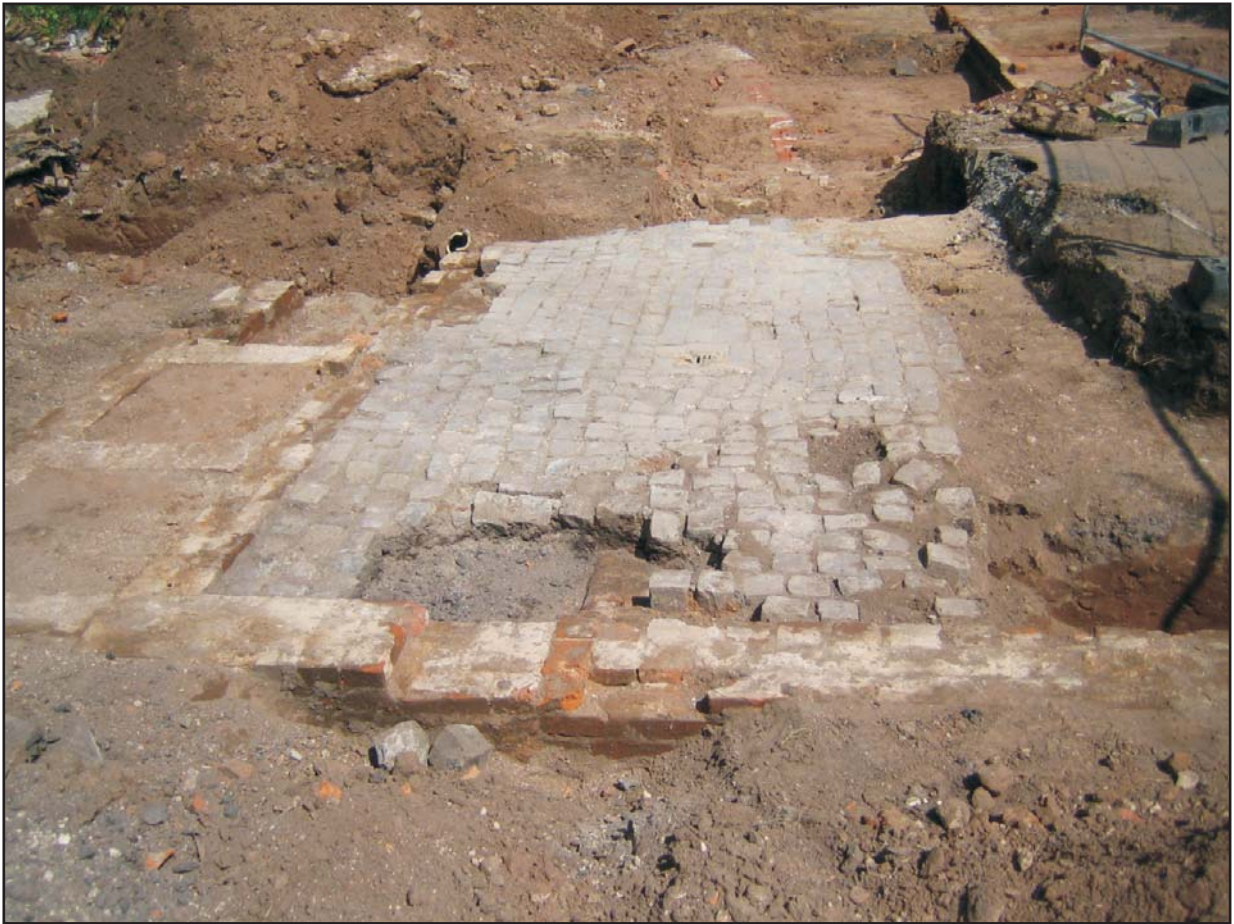
Trench 10, walls and cobbled surface (724) looking east Fig 19

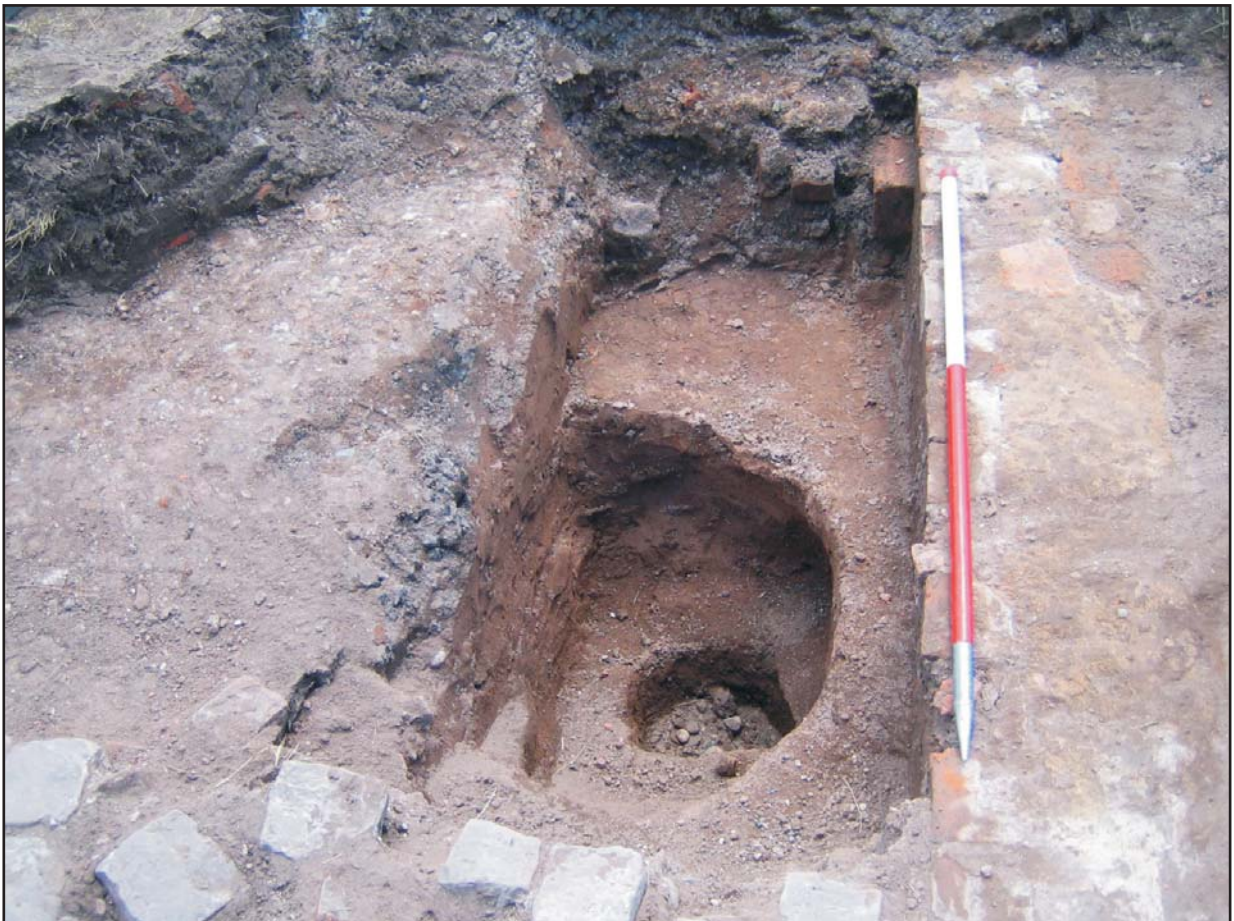
Trench 10, well [1056] below cobbled surface, looking south Fig 20

It was filled with mixed brown sandy clay (1057) containing broken brick, roofing tile, ash and clinker. Cutting the base of the well and slightly offset to the south and west was a smaller sub-rectangular pit [1059] 0.35m long, 0.3m wide and excavated 0.4m deep. It was filled with brown sandy clay (1060) containing the rusted remains of a 50mm (2") iron pipe set vertically in the lower part of the pit (Fig 16).

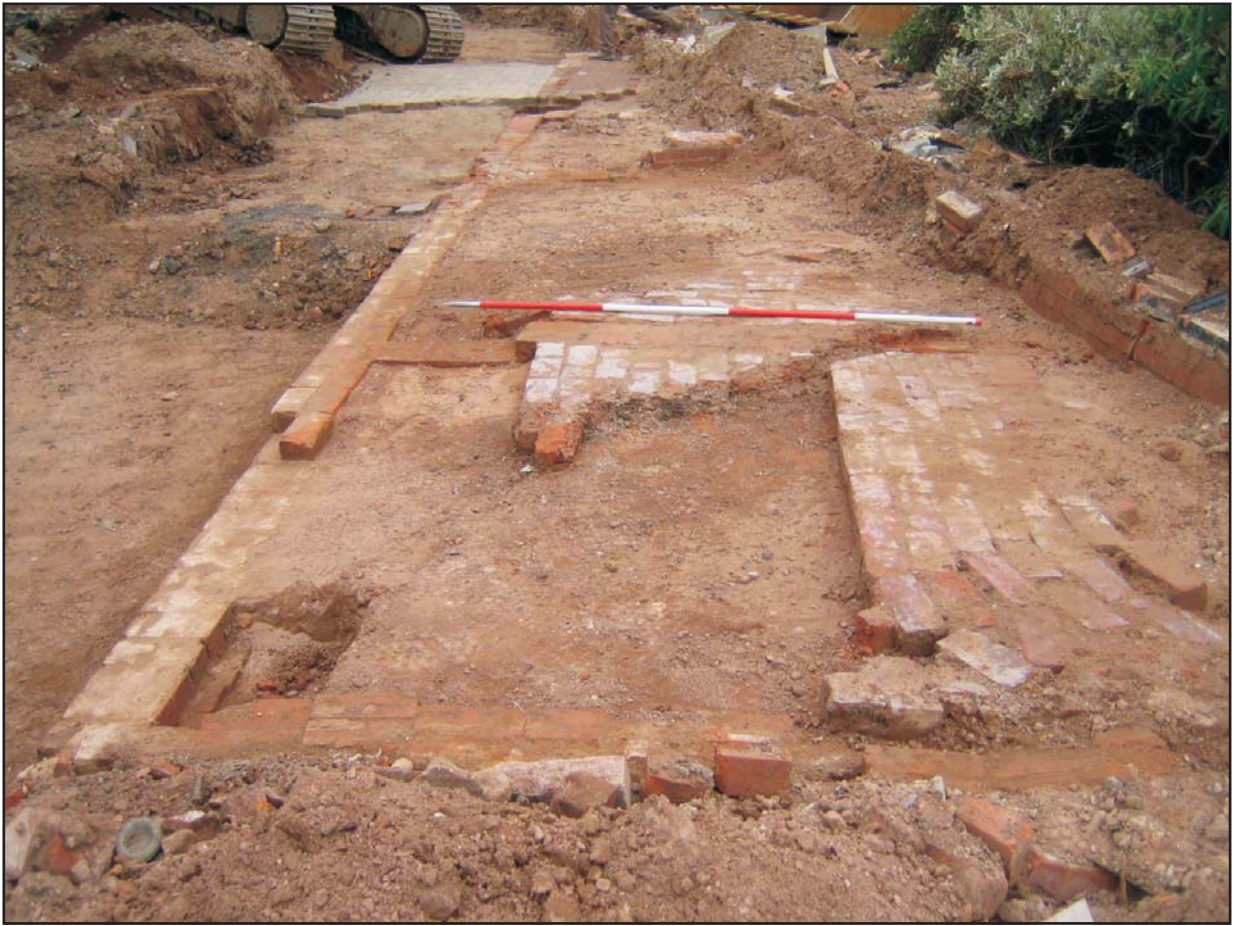
Trench 10, walls and brick surfaces, looking east Fig 21

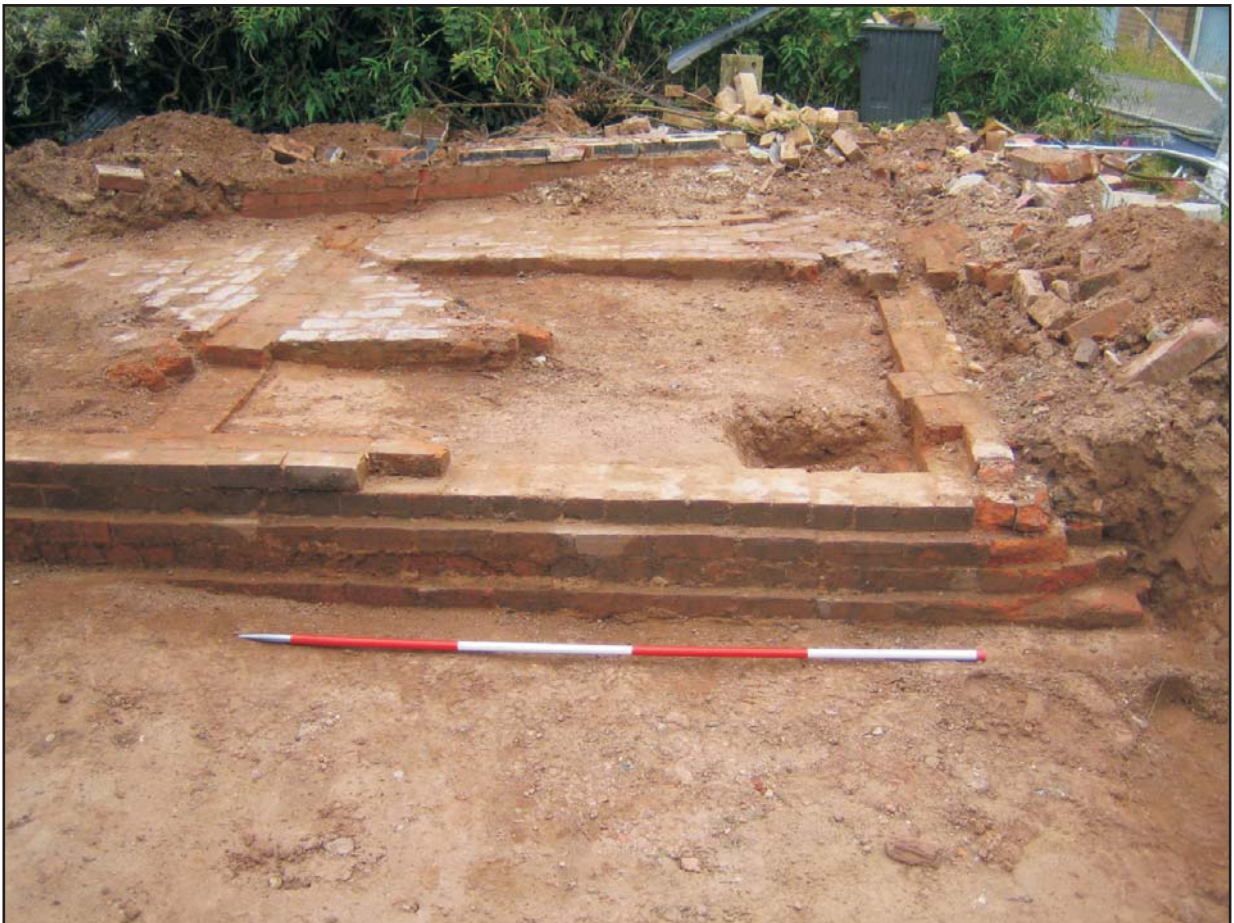
Trench 10, foundation, walls and brick floor, looking south Fig 22

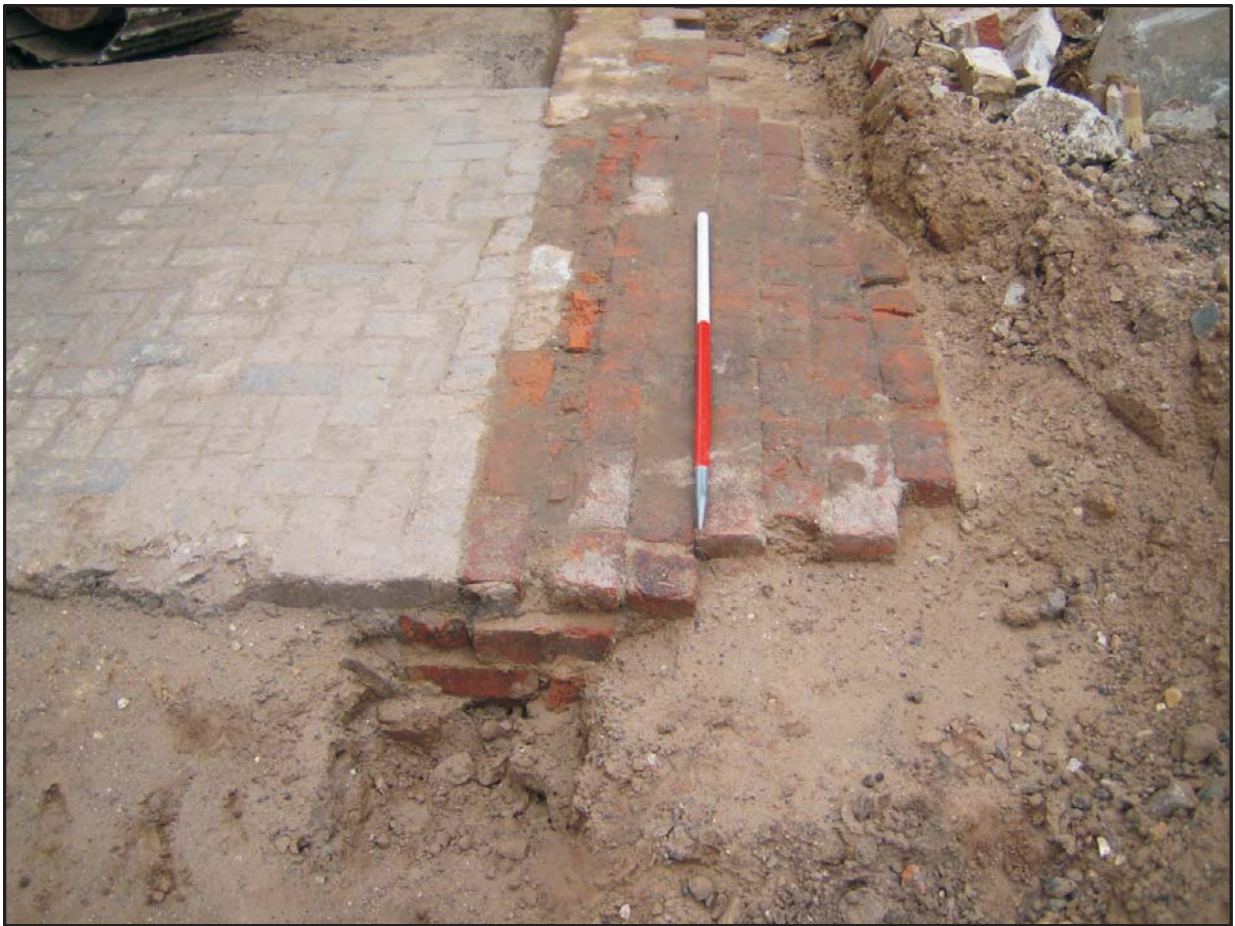
Trench 10, external brick access, threshold and internal floor, looking east Fig 23

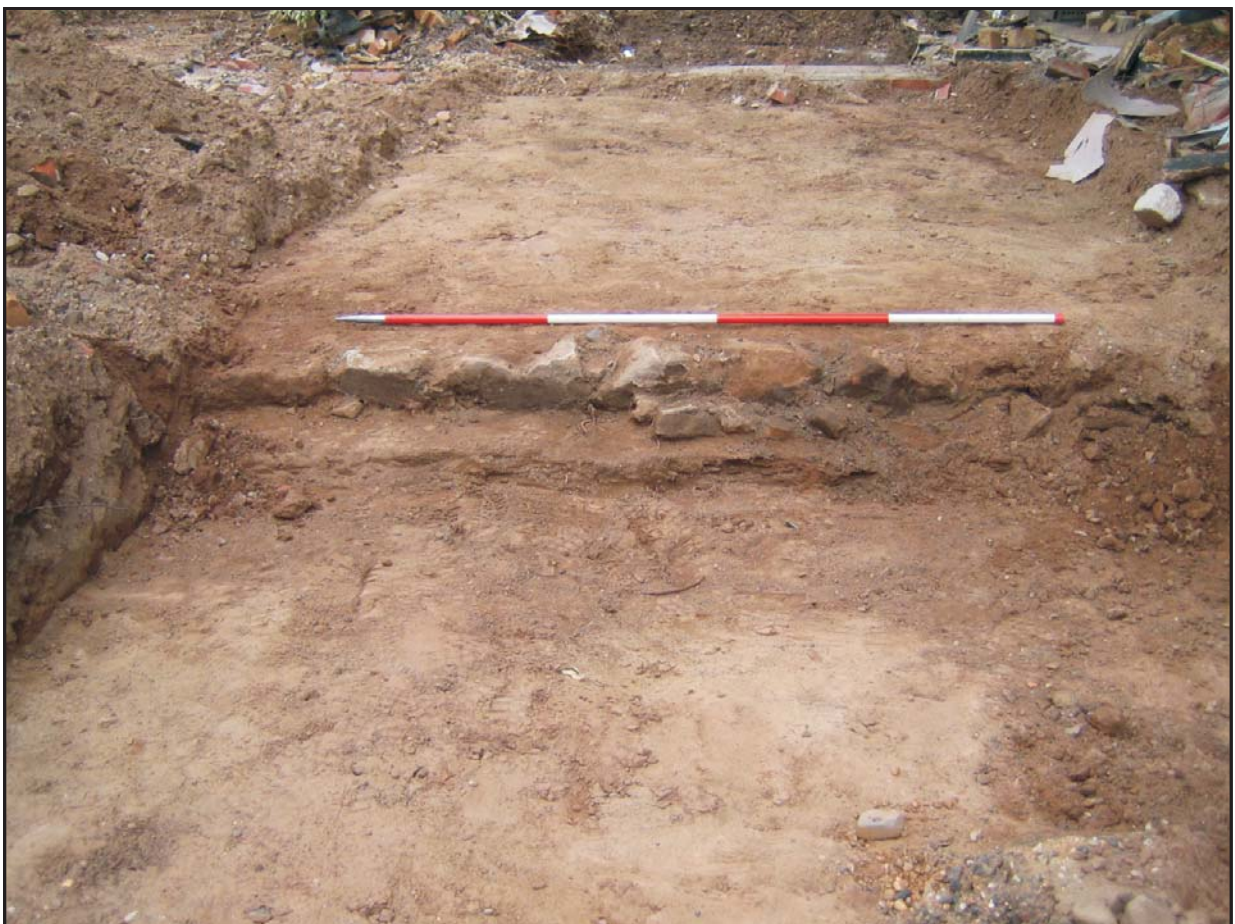
Trench 10, sandstone wall foundation on sandstone bedrock, looking east Fig 24

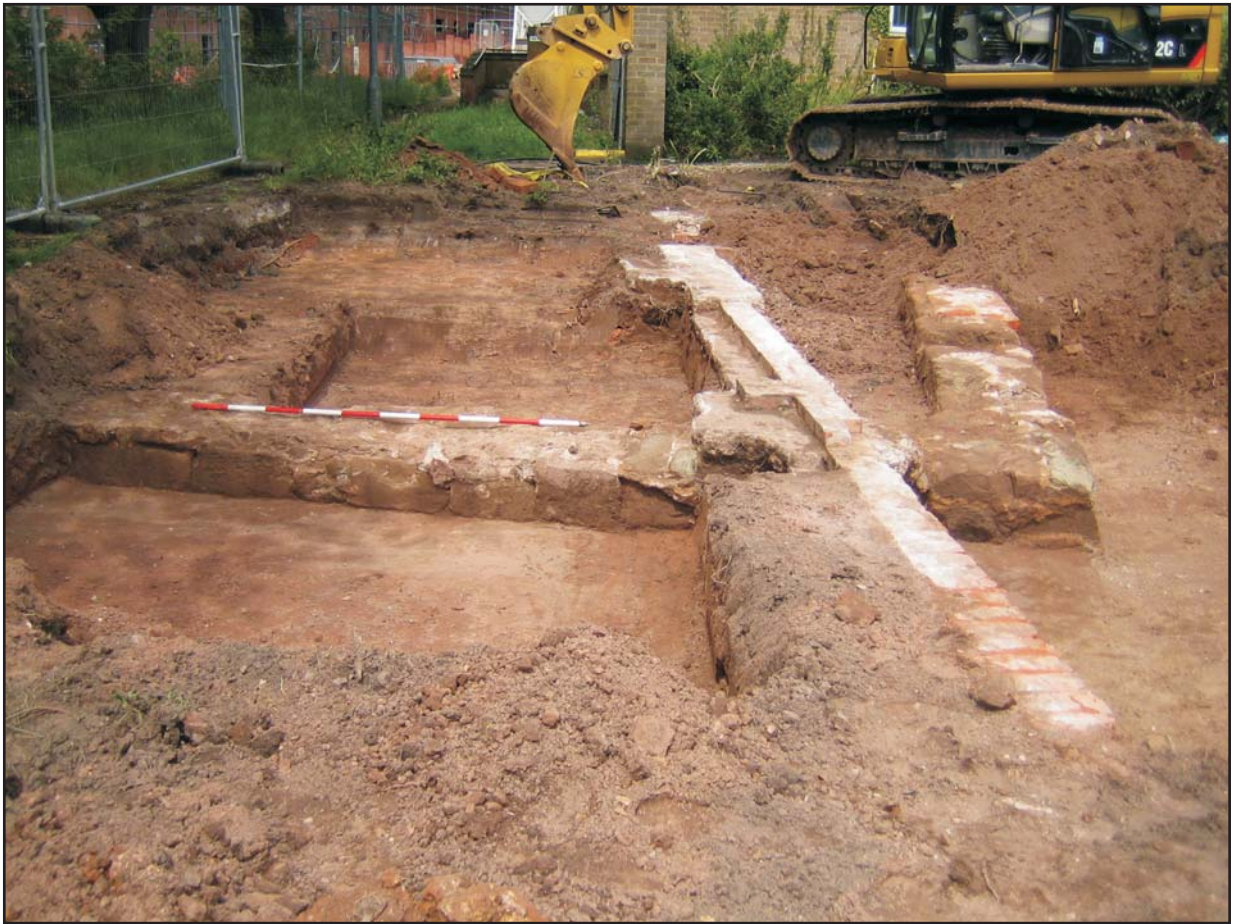
Trench 12, sandstone wall foundation, looking north Fig 26

The trench was filled with roughly shaped and faced but randomly sized sandstone blocks (1210) up to 0.6m long and bonded with yellow lime mortar. These formed two rough courses filling the foundation trench, with mortar extruding from between the blocks filling the gaps between stonework and the sides of the construction trench (Fig 22).

This foundation was up to 0.6m high and supported a 0.45m (18") red brick wall (1211) constructed of two bricks laid as headers. Mortar scarring on the upper surface of the surviving course of brickwork indicates the bricks were laid in stretcher fashion for the next course.

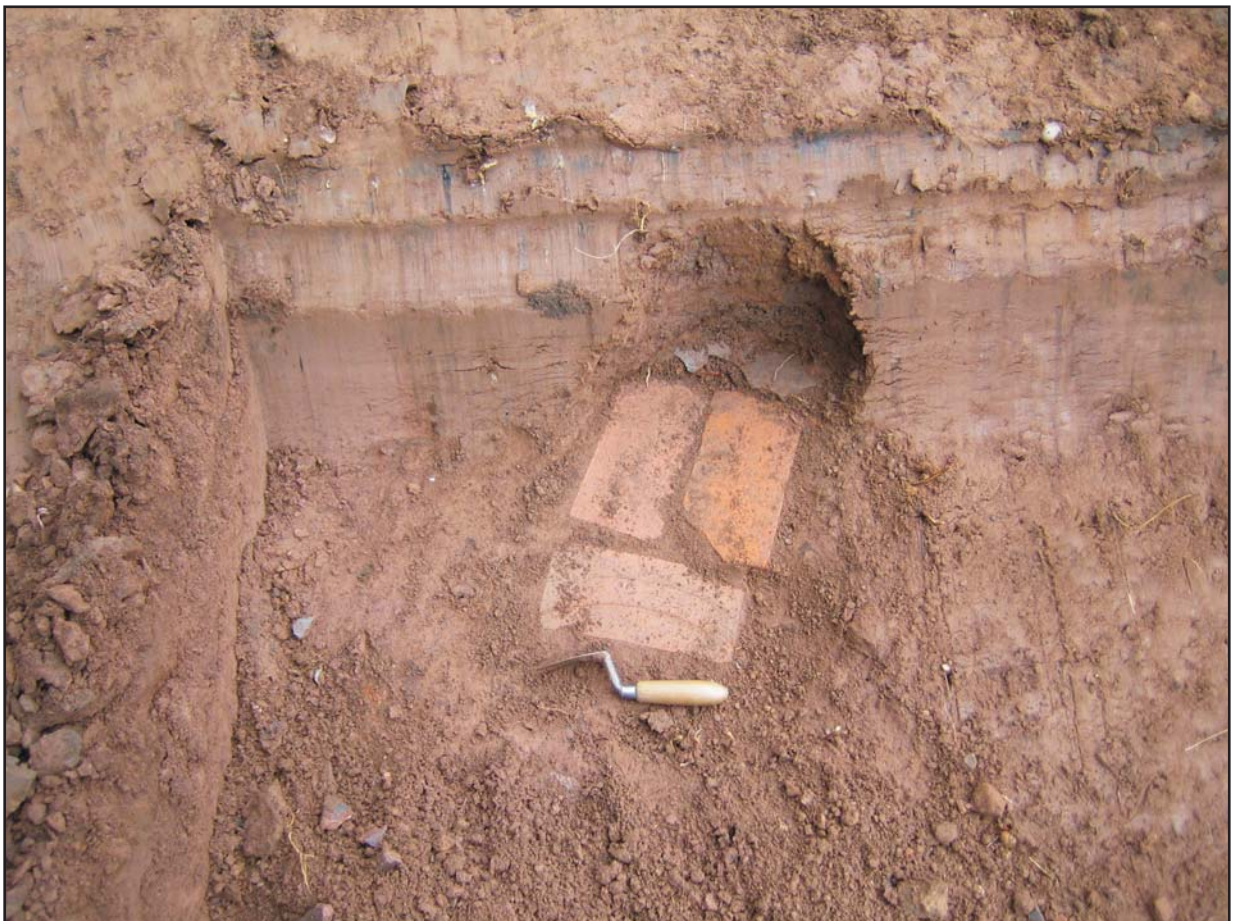
Trench 12, post base and post pipe, looking north Fig 27
