Northamptonshire Archaeology

Archaeological watching brief on land adjacent to the Congregational Church, Welford Road, South Kilworth Leicestershire March 2010 Accession Number X.A19.2010

Jason Clarke Report 10/50 March 2010

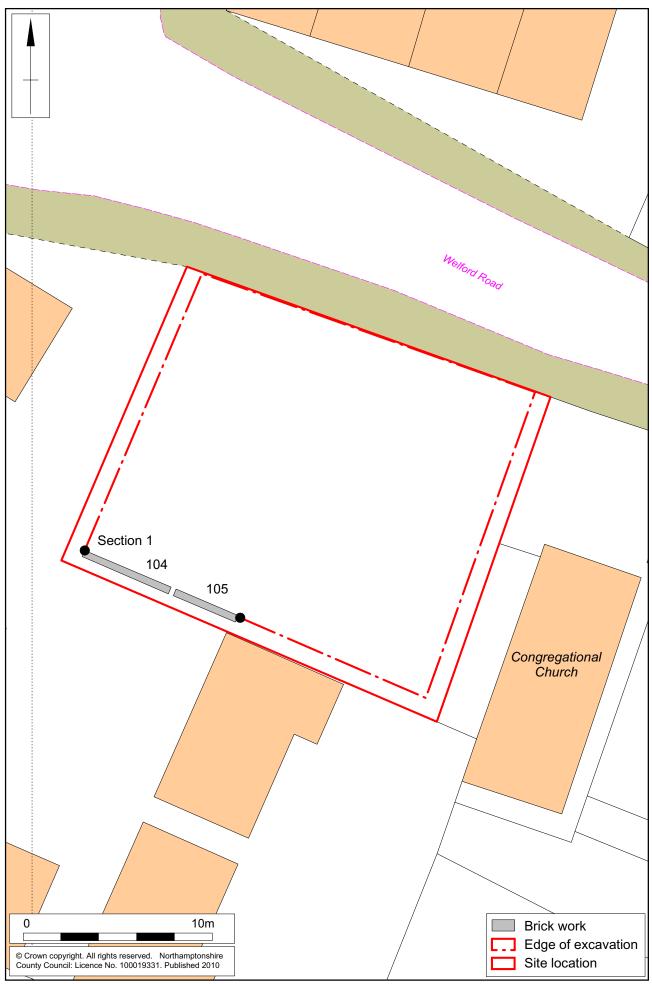
Aligned north-west to south-east, 5.0m long and 0.30m high. The wall comprised three courses; the two lower courses were roughly worked ironstone and river worn stones, bonded by clay. The upper course was unfrogged, handmade bricks, bonded by lime mortar. No dating evidence was recovered from the wall (Figs 2 and 3).

Aligned north-west to south-east, 3.5m long and 1.25m high. The wall comprised ten courses of brick laid in English Bond. The bricks were unfrogged, handmade and bonded by lime mortar. A frequent amount of 19th-century pottery within the topsoil and subsoil around the location of the wall was noted but discarded.

A small section of wall [105] was removed by the machine during groundworks due to its instability. The section of wall was bonded to wall [104] and was a truncated return, aligned north-east to south-west.

The walls appear to be the remains of a cellared building [105] and boundary wall [105]. A building is shown here on the Ordnance Survey maps between 1892 and 1952, suggesting the building was demolished during the latter half of the 20th century.

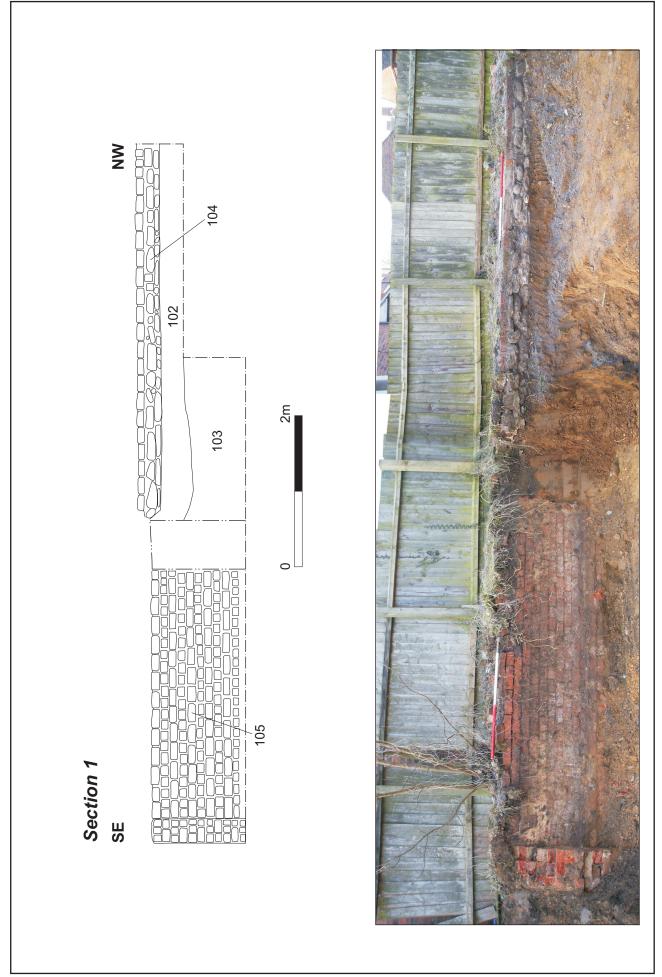
The underlying geology was glacial till, which was encountered between 0.50,-0.70m below the modern ground surface throughout the site. This occurred as mid orange to brown sand and gravel with occasional rounded to sub-angular flint pebbles. The subsoil was mid orangey-brown silty clay and the topsoil was dark greyish-black slightly clayey silt, both soils containing occasional flint pebbles (102, 103; Fig 3).

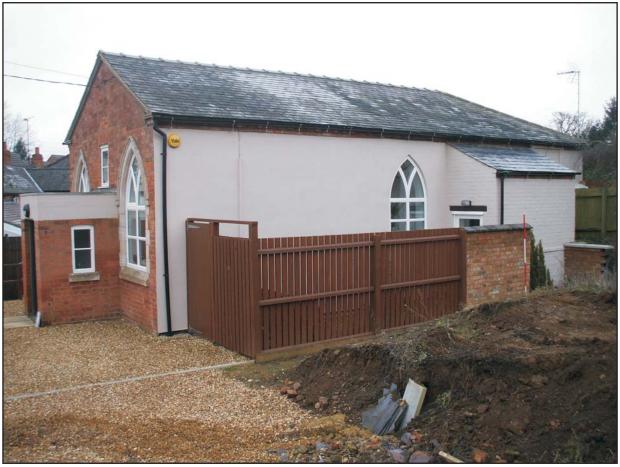
The Congregational Church, looking south-east Fig 4

The record comprises general photographs of the exterior and setting of the building including the boundary wall. They carry a 2m ranging rod for scale. Oblique views show external elevations of the structure where the new dwelling will obscure this view at a later date (Figs 4-8).

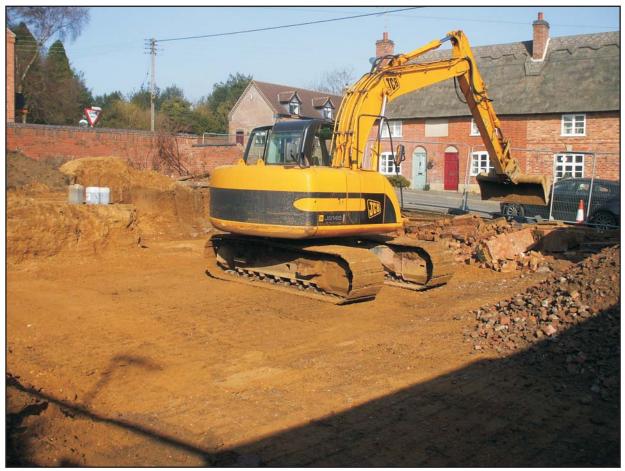
View of the development area, post excavation, looking north Fig 9

No other archaeology was present on site. The excavation revealed truncation, possibly from landscaping for the nearby buildings (Fig 9).
