An archaeological watching brief during the water main  
replacement at Belchford to Nab Hill, Lincolnshire  
November to December 2010

Site Code: BNH10  
Accession No: LCNCC: 2010.153  
NGR: TF 3019 7472 to 3096 7404

Report 10/204

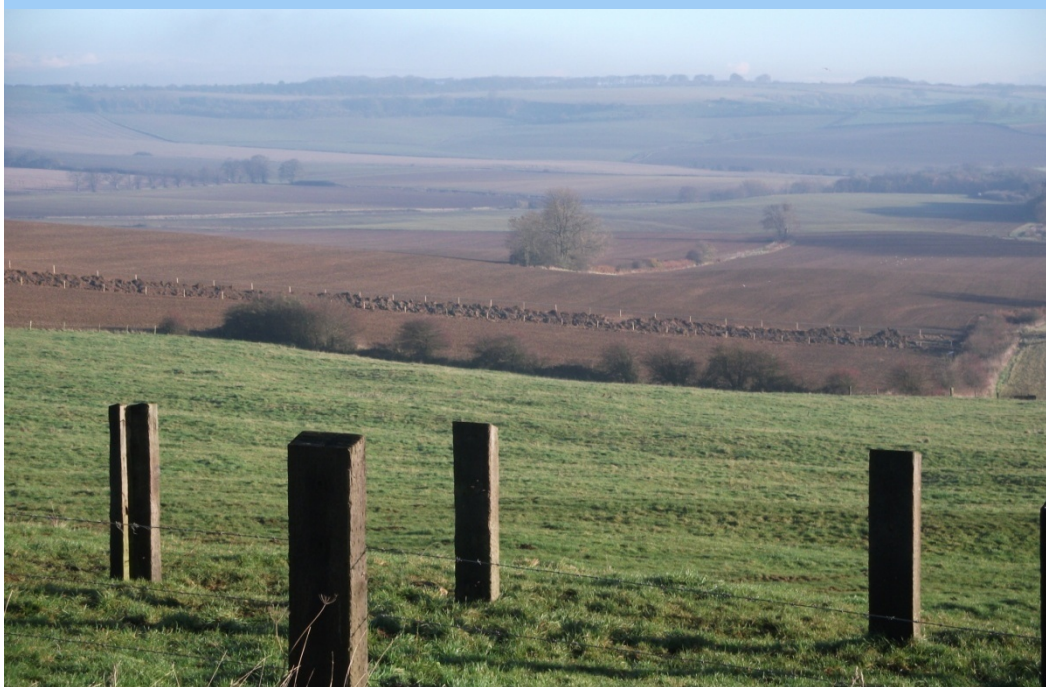
Front cover: View of the pipeline in Field 3, taken from Furlongs Lane

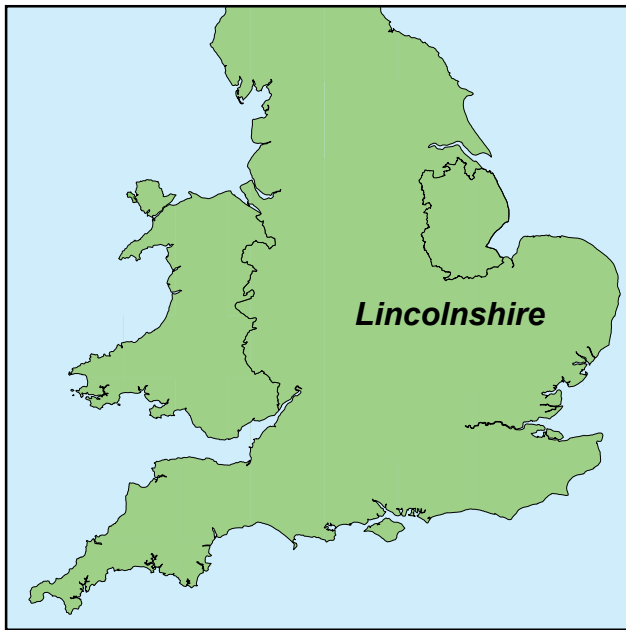
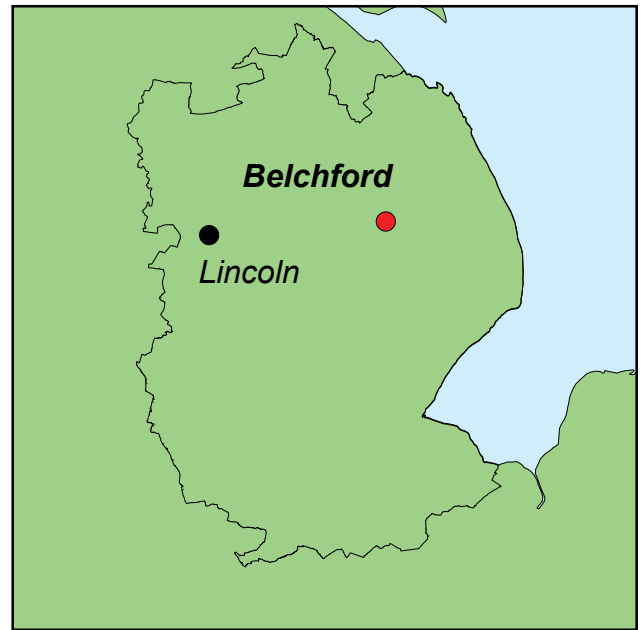
Fig 1

Site location showing selected Historic Environment Record information

The Historic Environment Record (HER) for Lincolnshire, consulted via the Heritage Gateway ( [www.heritagegateway.org.uk](http://www.heritagegateway.org.uk) ), indicates that there are a number of sites in the vicinity of the mains replacement scheme dating to the prehistoric, Roman and medieval periods (Fig 1).

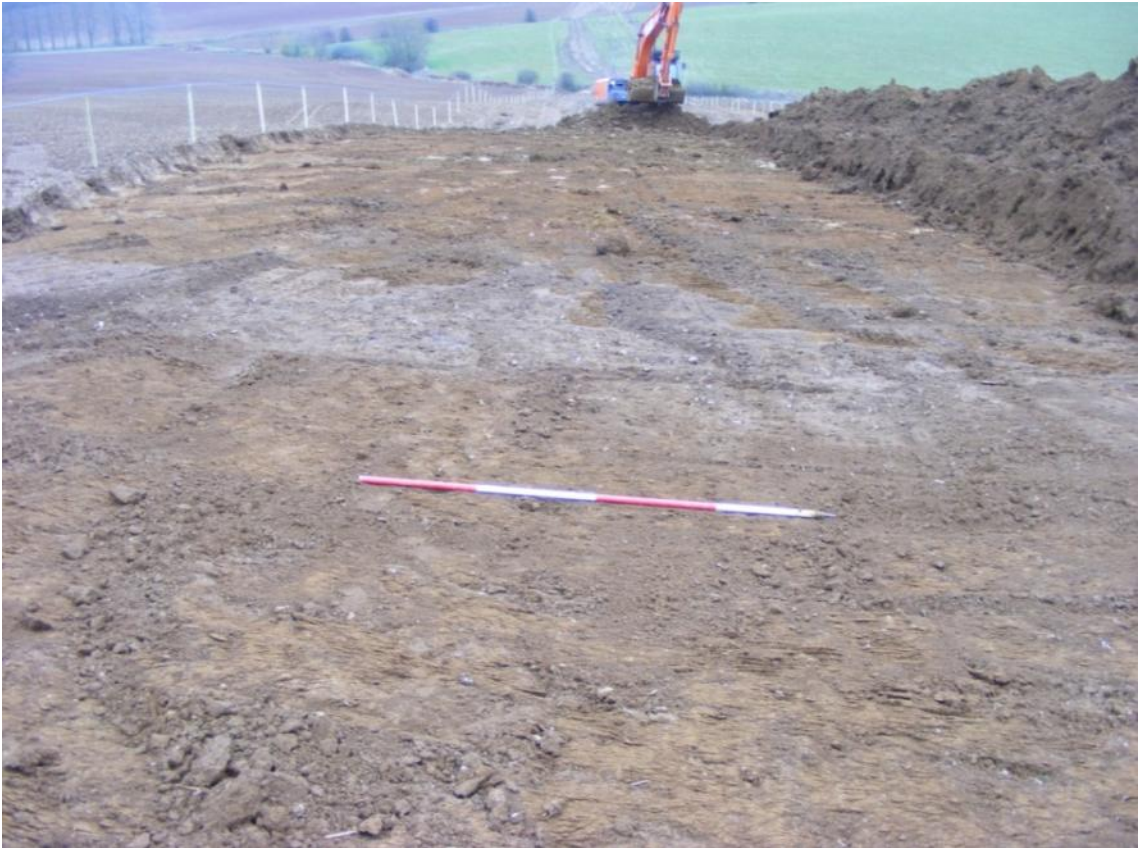
Field 2, looking south east, showing the modern ditch      Fig 3

Only one ditch was observed during the topsoil stripping, running approximately north-east to south-west between the escarpment in Field 2 and the derelict house; the fill contained modern building rubbish, including late-20th century aerated concrete blocks (Fig 3.)

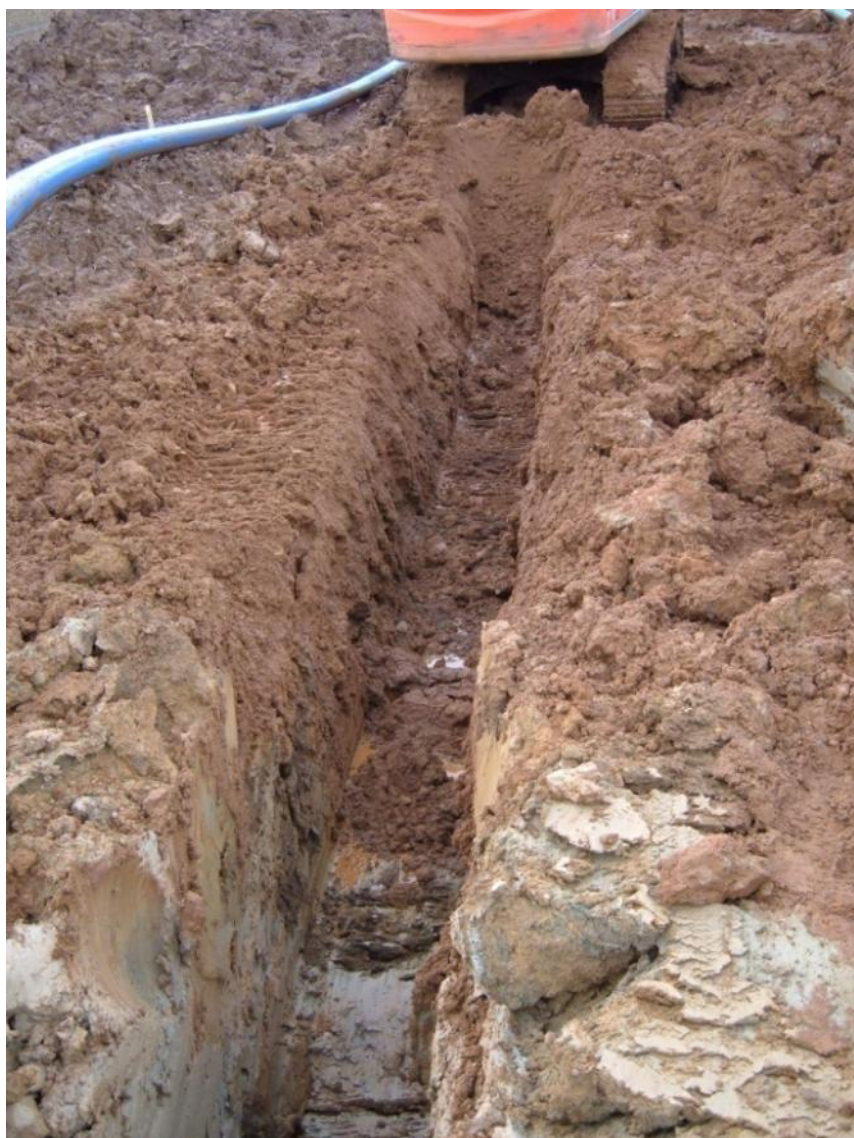
Pipe trench during excavation, also showing the changes in geology Fig 4

The pipe trench was excavated using a 400mm toothless bucket, to an approximate depth of 1.3m. The natural geology was cut into along the entire length of the trench. No archaeological features or finds were observed (Fig 4). Frequent land drains were observed in the fields and in the road side verges, where disturbance from the existing water main was also apparent (Fig 5).

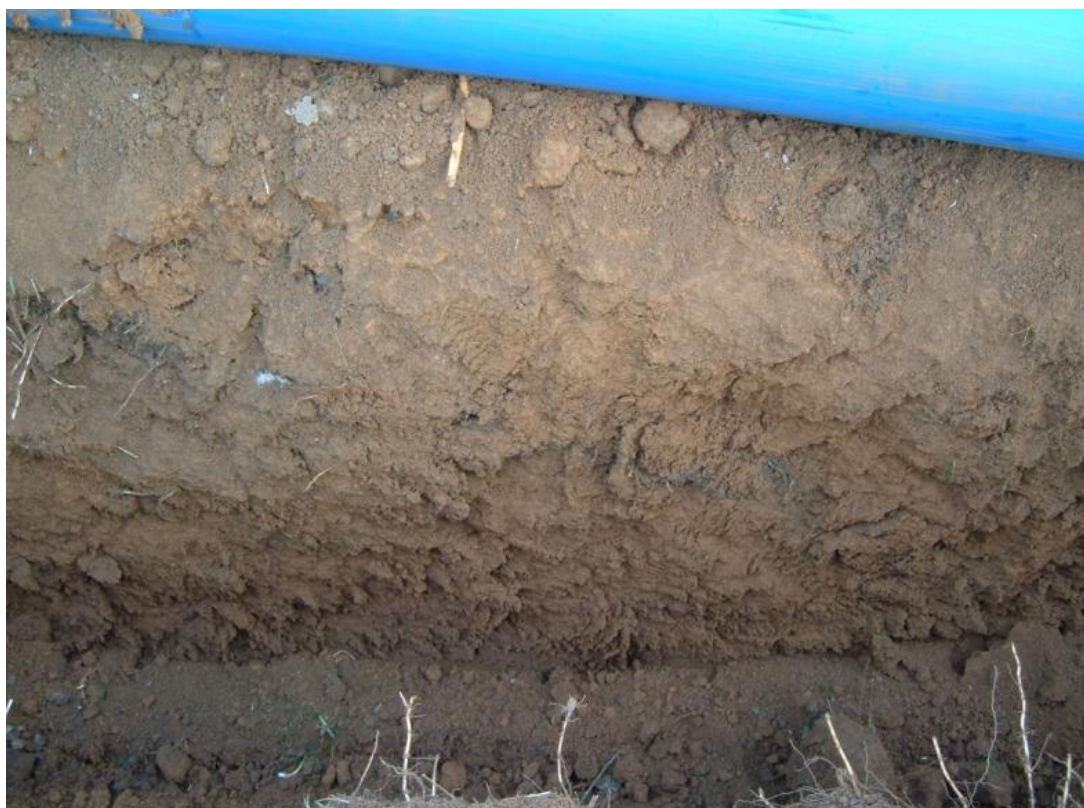
A section of backfill of the existing pipe trench Fig 5
