Archaeological desk-based and building
assessment with trial excavation in the walled
garden at Rockingham Castle, Northamptonshire

Report 11/34

February 2011

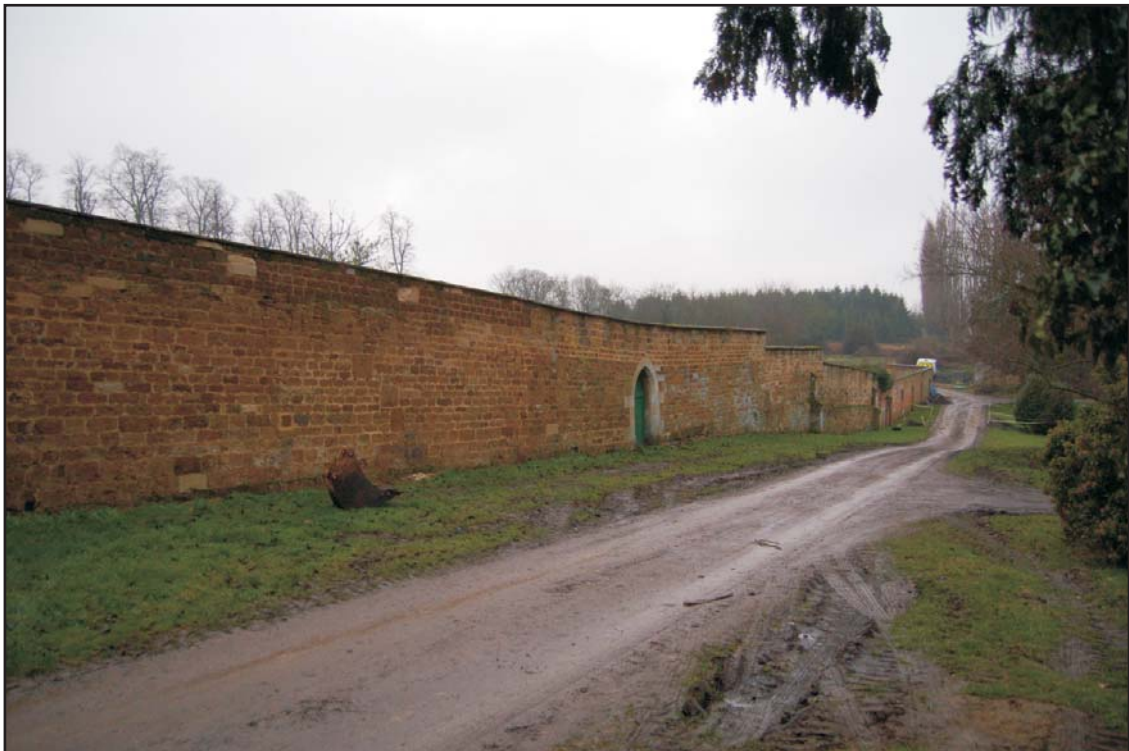
The north ironstone face of the original, larger, walled garden, looking south-west Plate 2

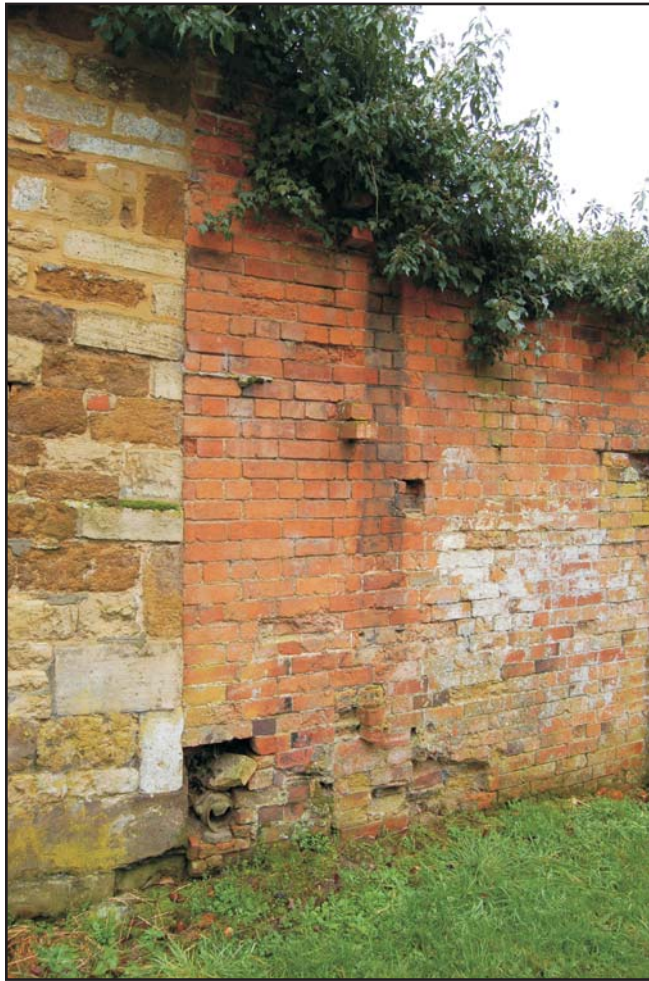
Join of the earlier ironstone faced walled garden, and the later, brick addition, looking south-west Plate 3

involved. By the time of the First Edition Ordnance Survey map of 1880 the southern compartment is present indicating that it was added between 1856 and 1880 (Figs 6 and 7). The junction of the two phases of wall can be most clearly seen on the north side where the brick of the later, smaller compartment abuts the ironstone of the earlier wall (Plate 3).

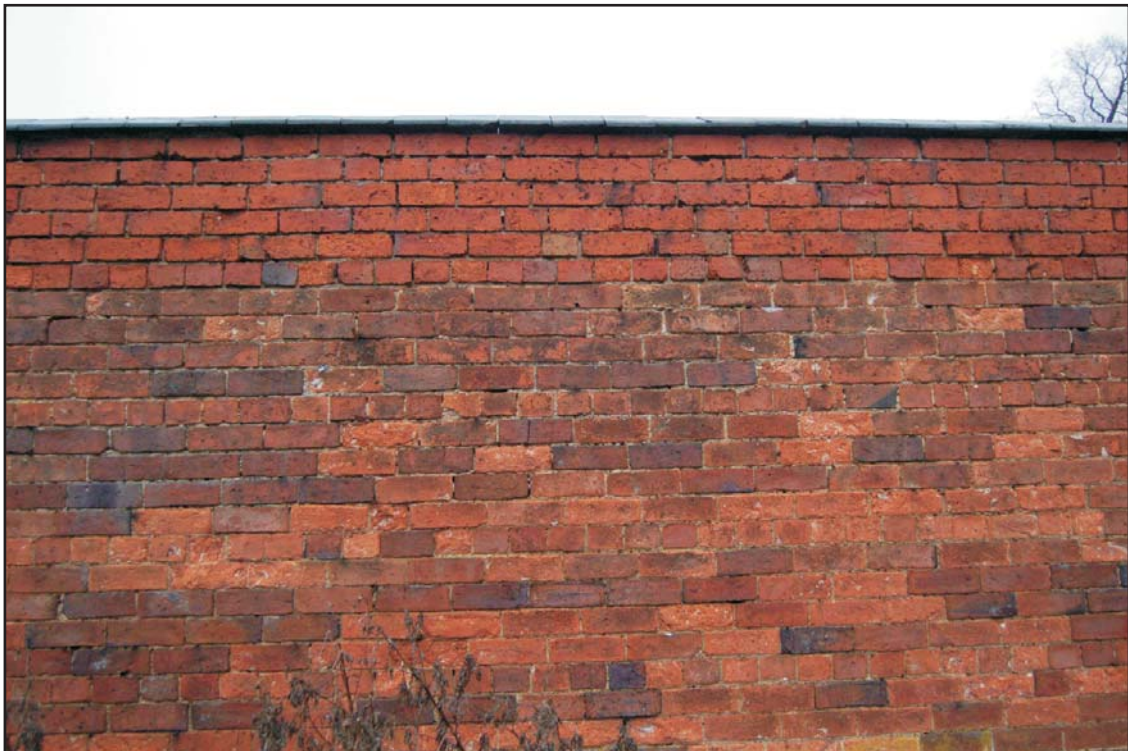
The configuration of the wall- English Garden Wall Bond Plate 4

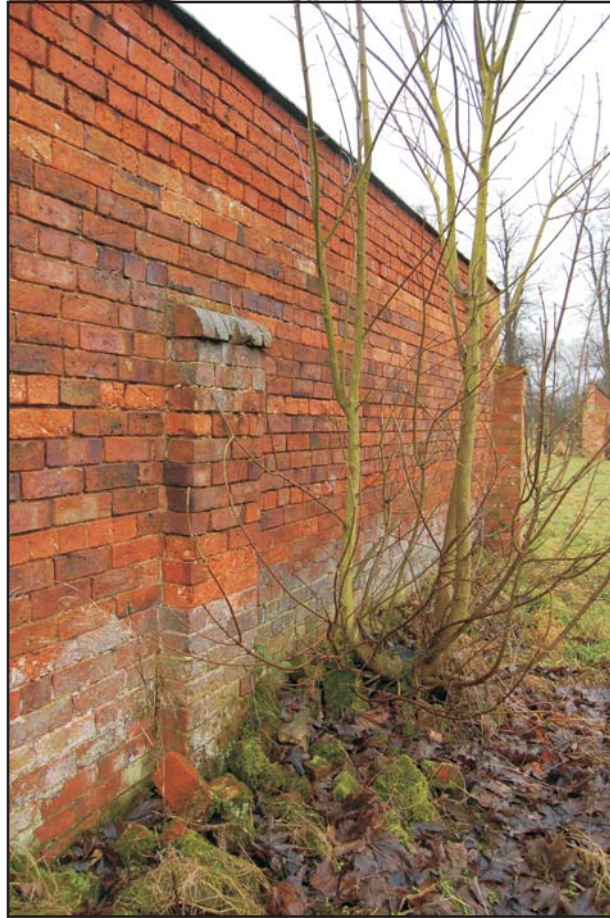
Wall buttress with capping of bullnose bricks laid on edge Plate 5

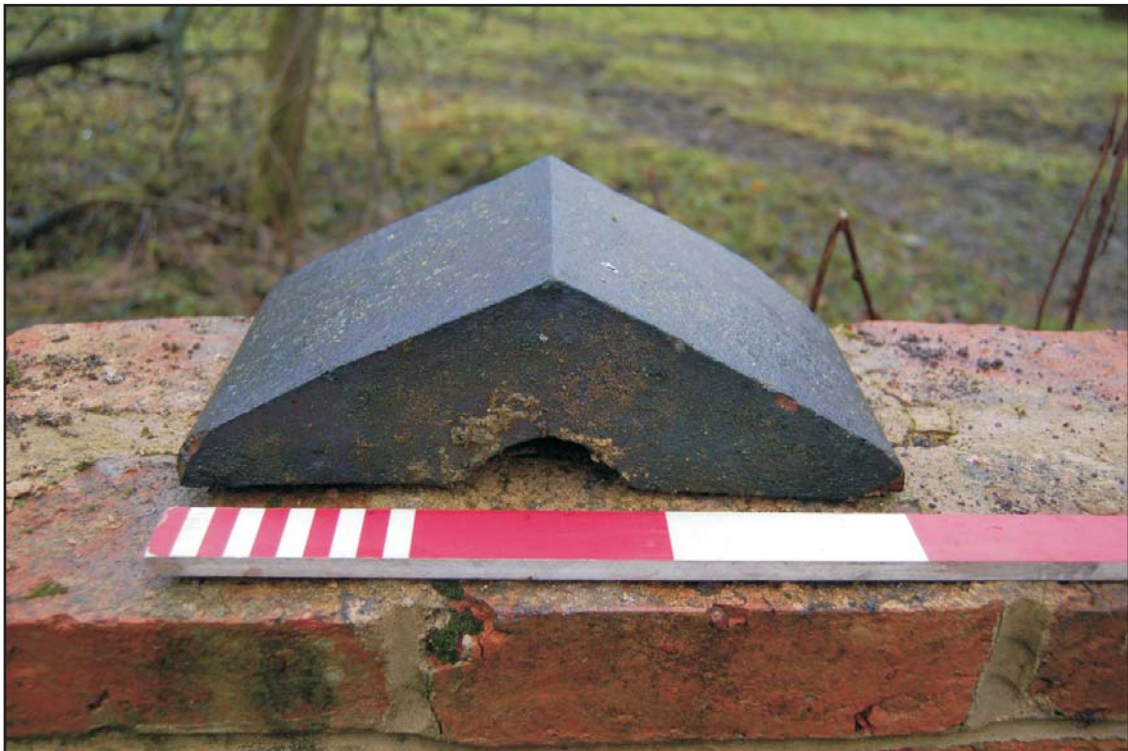
Staffordshire blue ceramic saddleback coping block, scale in centimetres Plate 6

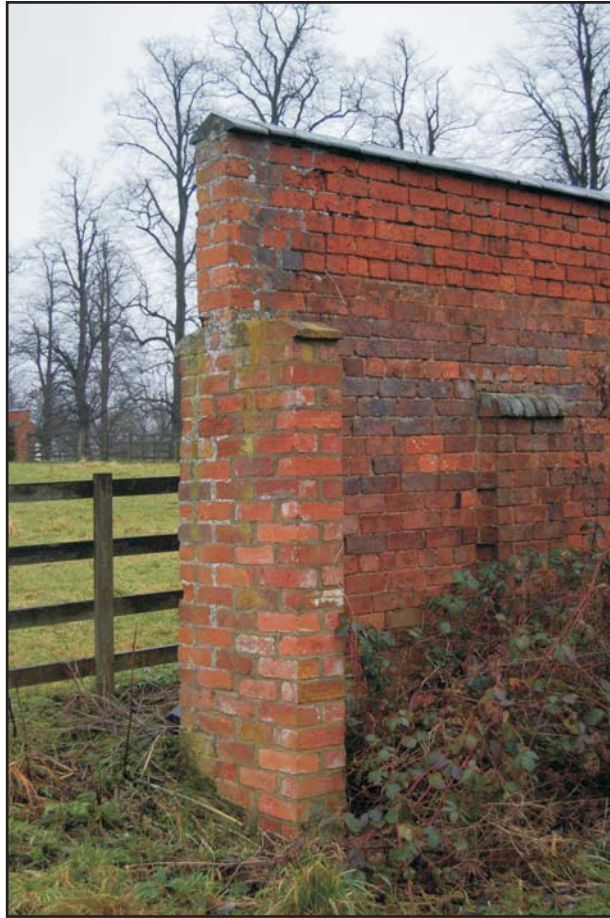
The central section of the east side is missing, though both stub ends of the walls have been re-built with narrower buttresses capped with plinth headers to throw the water off (Plate 7). The date of the re-build to the stub ends is not known, but the use of cement rather than lime mortar indicates a modern date. This length of wall appears to have been raised, the upper six courses are distinctly different from those below and are of a more orange-red colour though laid in the same way as the lower courses (Plate 4). This raising of the wall may have occurred when the glasshouse was added at the northern end, though why it was continued for the whole length is unclear.

Re-built ends of the east wall with terminal buttresses, looking south-east Plate 7

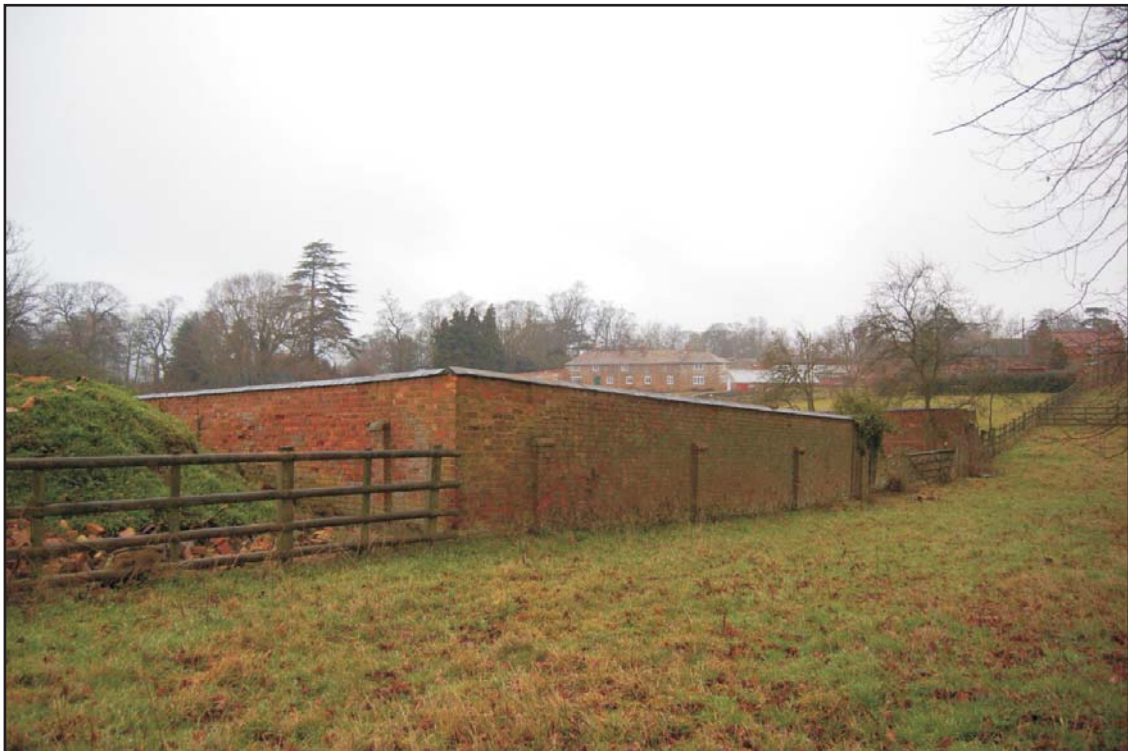
The south wall has fallen at the eastern end where it joined with the east wall of the larger compartment (Plate 8). This loss was apparently caused when the Top Moat, situated to the south, overflowed and caused a significant build-up of water against the outside of the wall. The pressure of water eventually caused the wall to collapse sending bricks almost the entire length of the garden (pers. comm. Richard Stibbly, castle gardener). The date of this collapse is not entirely certain, but is thought to have occurred during the 1960s.

Collapsed section of the south wall (right of photo) from the south-west Plate 8

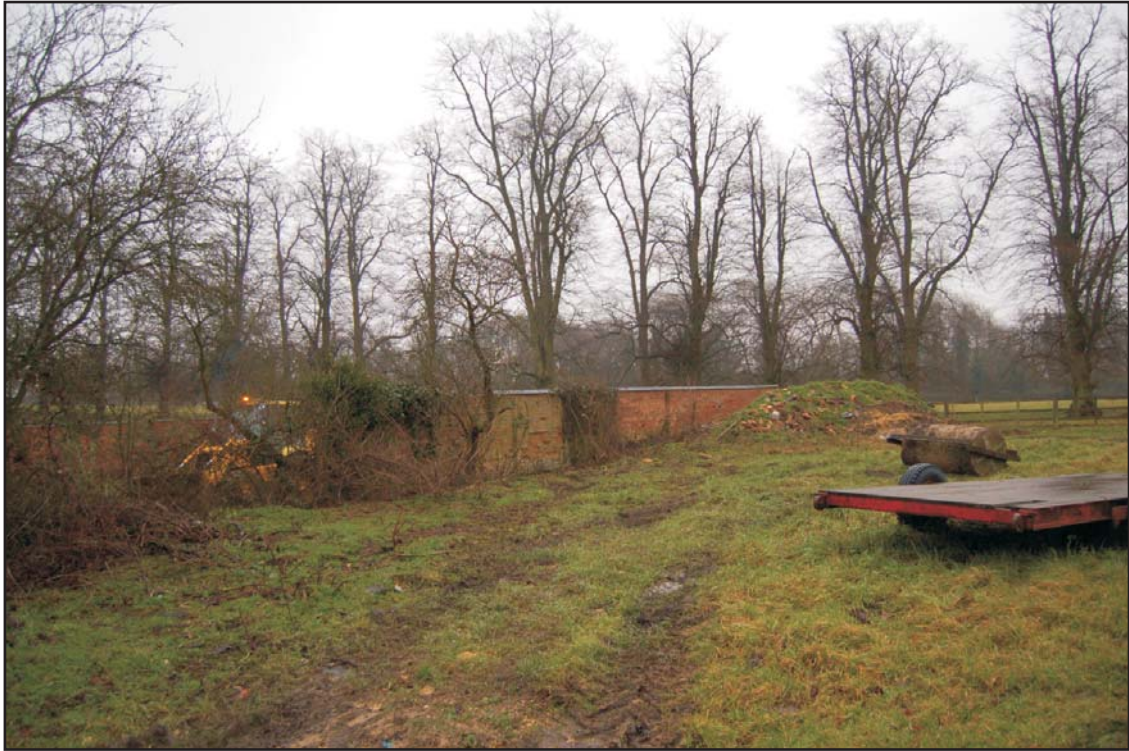
The west side of the garden is the least intact with the majority of it missing, and only about 25m standing at the southern end (Fig 8, Plate 9). A very short section stands at the northern end close to the corner with the north wall, about 4m of full height wall, a slightly longer section of lower wall not to full height and then a modern pedestal or double buttress at the south end (Plate 10).

South end of the collapsed west side of the garden, looking south-east Plate 9

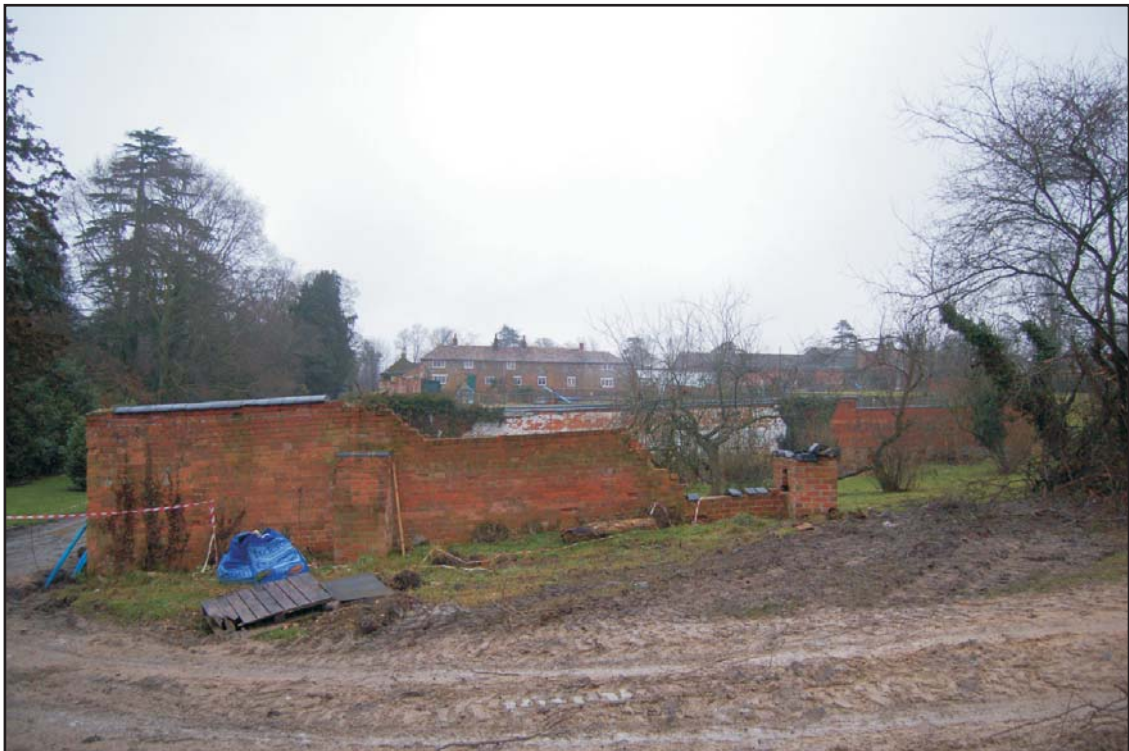
North end of the west side of the garden, looking east Plate 10

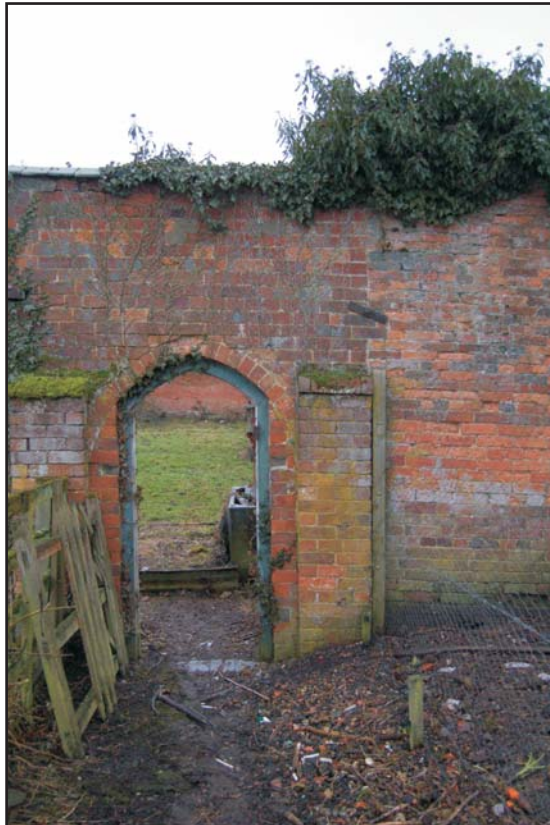
flanked and partly obscured by buttresses on both faces of the wall, the doorway in the east wall is of a similar shape and size but has only a single row of edge-laid bricks which form the arch (Plates 11 and 12). The doorway here is narrower, the jambs to either side partly infilled with brickwork and fitted with a timber frame, though the door is now missing. The doorway in the north wall retains its timber frame and door which comprises horizontal planks on the interior and vertical planks on the exterior. These are fitted to a shaped frame with a further horizontal external brace, integral to the frame (which is simply moulded), at the level from which the arch springs. The door is hinged on the inner face with simple iron strap hinges which are almost the full width of the door. There is evidence that the door could be locked from both sides, though what is not clear is whether the visible locks/bolts are original.

North side of the door in the north wall of the garden, looking south Plate 11

East side of the doorway between the larger and smaller compartments of the walled garden, looking west Plate 12

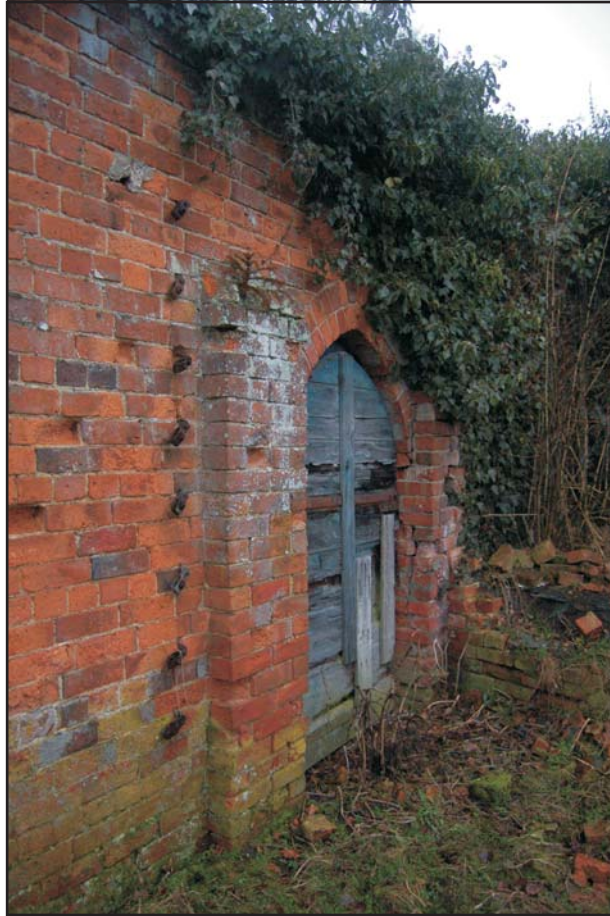
- 4.5 There is evidence on the majority of the standing walls to indicate that plants had been grown against them. The north and east walls retain plain galvanised iron bars driven horizontally into the mortar between bricks, (three bricks apart) each bar with a single hole at the outer end to retain a wire. These wires were anchored in straining bolts placed at either end of the wall so the wires could be tightened, and trees grown close to the walls with their branches trained along these wires in cordons (Plate 13). This form of permanent cordon was recommended by William Robinson, and is thought to derive from a French style of growing (Campbell 2005). In 1868 he wrote that this was longer lasting 'whereas nails had to be cut and shreds (pieces of cloth used to tie the branches on) cut, annually'. Whilst there are also a large number of nails around the garden walls, the author of this report does not consider them to be worthy of further attention; they simply represent the positioning of nails into the walls when and where a branch needed tying in.

Straining bolts for the cordon wires on the south side of the north wall of the gardens, looking east Plate 13

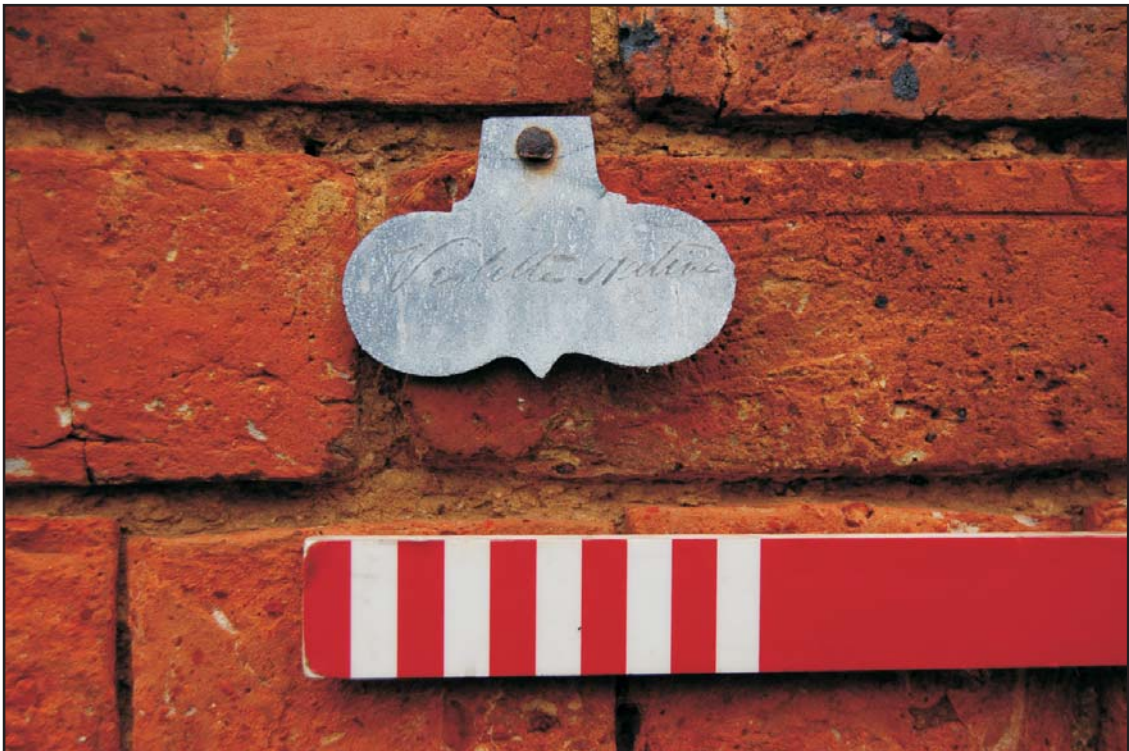
Plant label *Violette Hâtive*, scale in centimetres Plate 14

Three galvanised metal or zinc plant labels remain, of a classic, elegant, shape (Fig 8). Two are legible, the third is not. The two legible labels are both on the east wall, facing west (in reality, south-west). The one closest to the former glasshouse bears the (pencil?) inscription *Violette Hâtive* (Plate 14). This is a variety of nectarine, roundish and of medium size, yellowish-green to purplish-red in colour which ripens in early September (Watson 1933). The second inscribed label, to the eastern end of the same wall bears the name *Imperatrice* (Plate 15). This appears to be most likely a plum, *Ickworth Impératrice*, a dessert fruit with a bright purple bloom and greenish-amber flesh ready in early October (Watson 1933). The location of these label ties, on the south-west facing wall, corresponds with general walled garden planting where the hottest walls are those that get the most sun and therefore are most suitable for more tender varieties. The shorter walls would perhaps have had pears and apples grown against them, and the west wall (north-east facing) was generally used for cherries. This is the location of the third, illegible label.

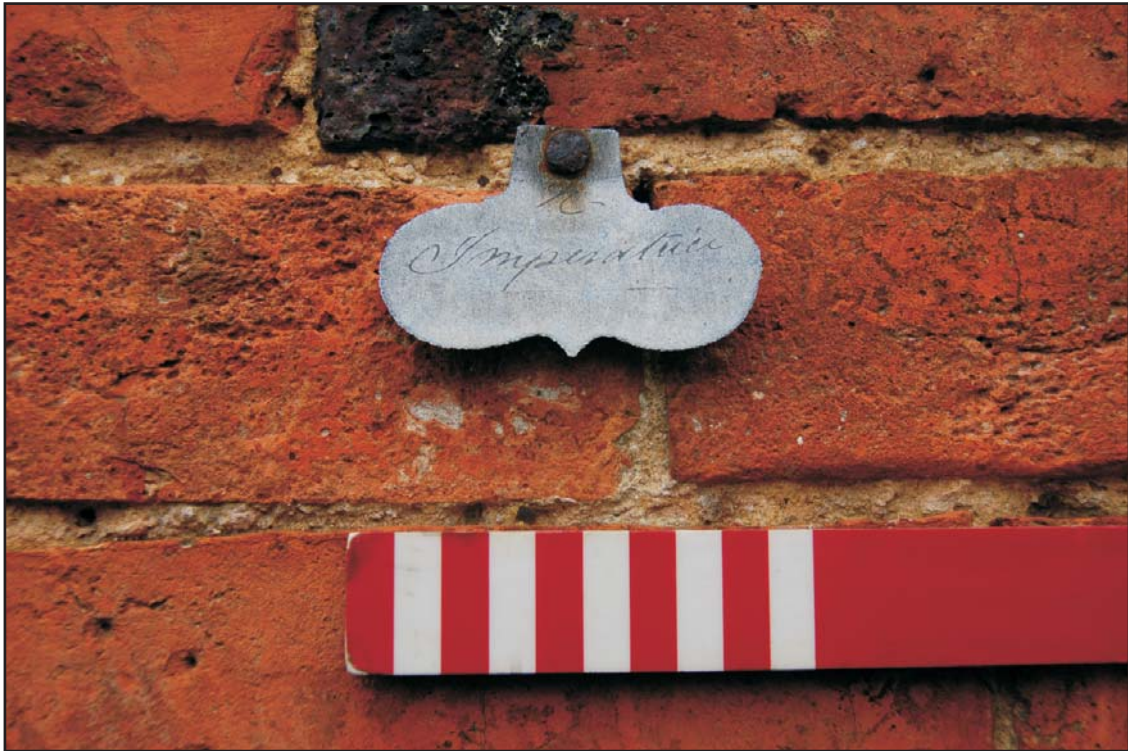
Plant label *Imperatrice*, scale in centimetres Plate 15

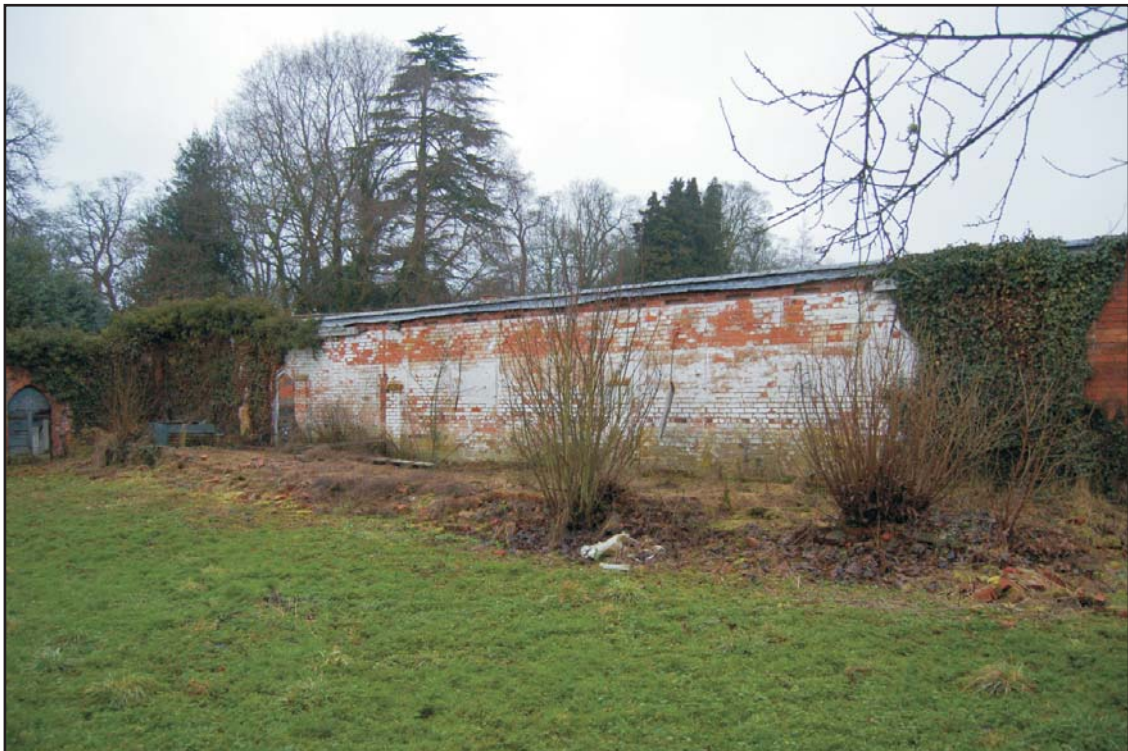
Nothing now remains of the superstructure of the glasshouse apart from a single piece of timber loosely attached to the apex of the wall towards the northern end and a line of lead flashing along the length of the former structure. It is assumed that the walls along the west and south sides were only about three feet high and above that would have been a vertical timber frame holding glass, and in the southern gable, a doorway (indicated now only by a hook attached to the east wall which would have been used to hold the door open). The remainder of the structure would have been a single pitch sloping roof maximising both light and growing space. It is possible that there were racks or shelves along the west side either in part or all of the glasshouse, but given that it was divided into three, it seems likely that each section was for different plants and growing conditions. The glasshouse was heated since there is remaining *in situ* a short section of cast iron pipe which can be seen from the north side of the north wall, to the east of the doorway there (Plate 18). There was a small boiler house here (pers. comm. Richard Stibbley) where the hot water or steam was heated, and the scar of the flue can be seen on the face of the north wall, however, this boiler house is not shown on the First Edition Ordnance Survey map of 1880.

Former glasshouse, looking north-east Plate 16

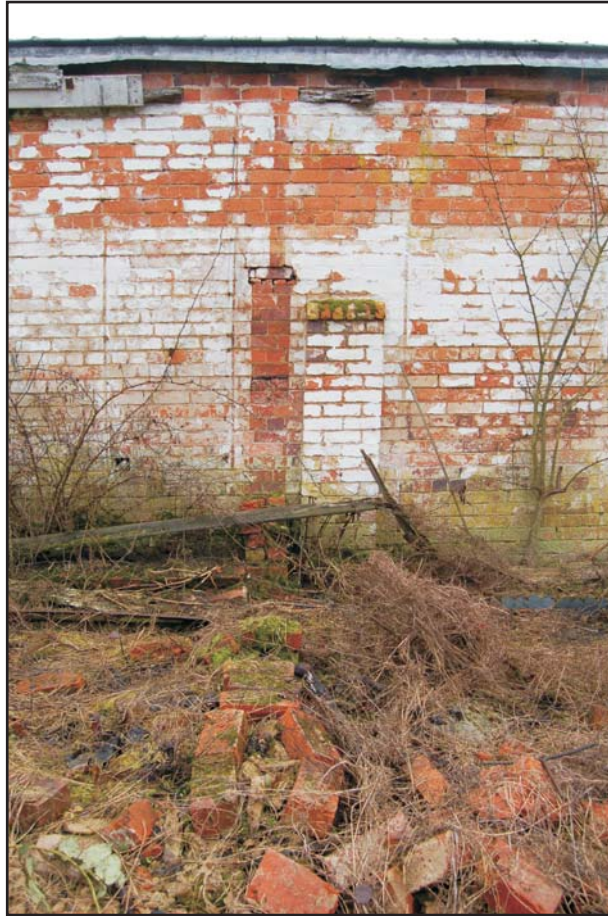
Scar of middle internal dividing wall within the glasshouse, looking east Plate 17

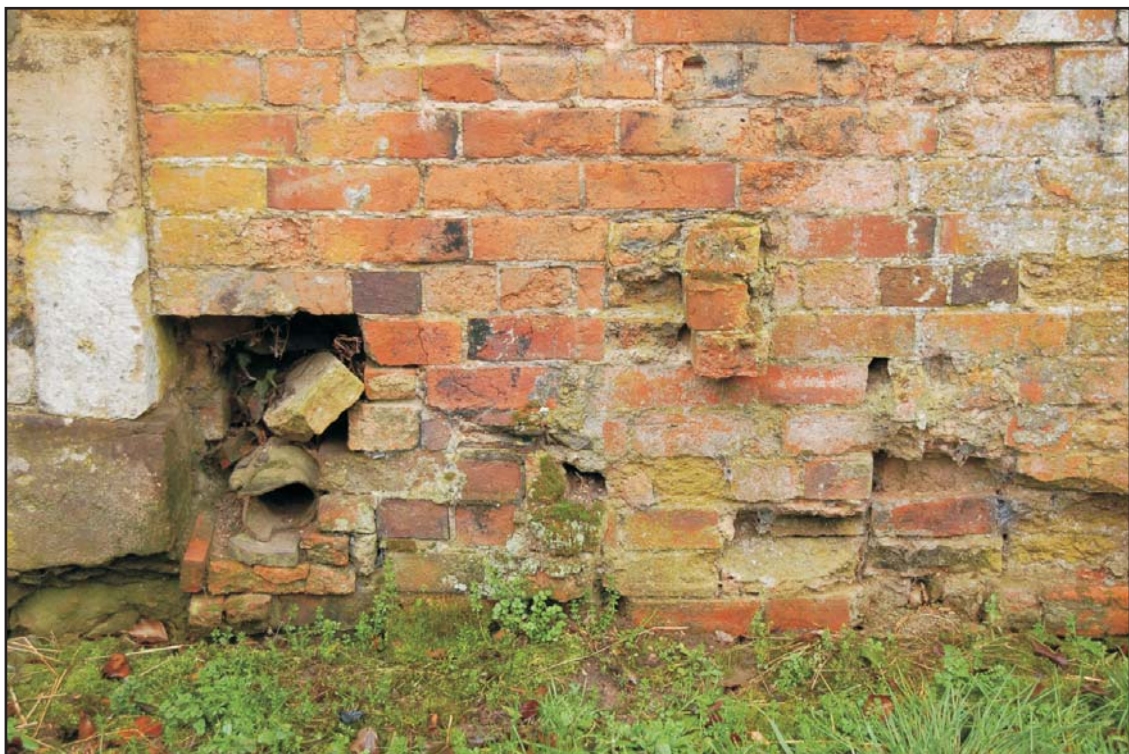
Remnant of cast iron heating pipe within duct from demolished boiler house on north side (foreground) of the garden, looking south Plate 18

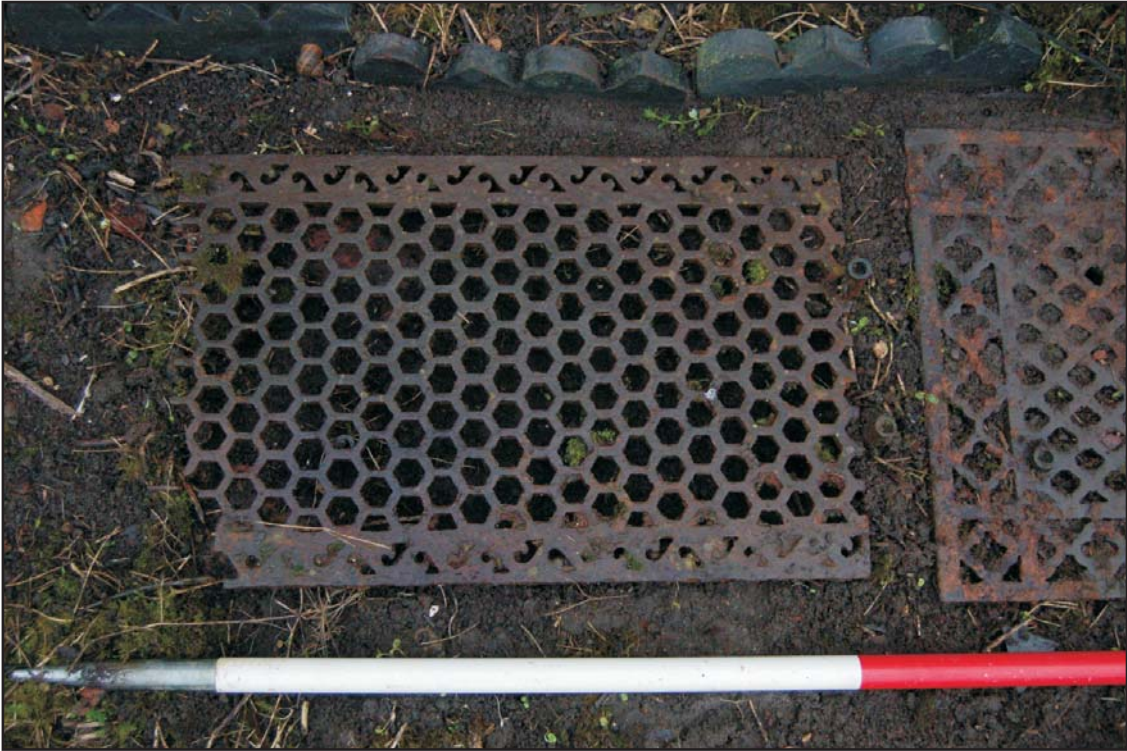
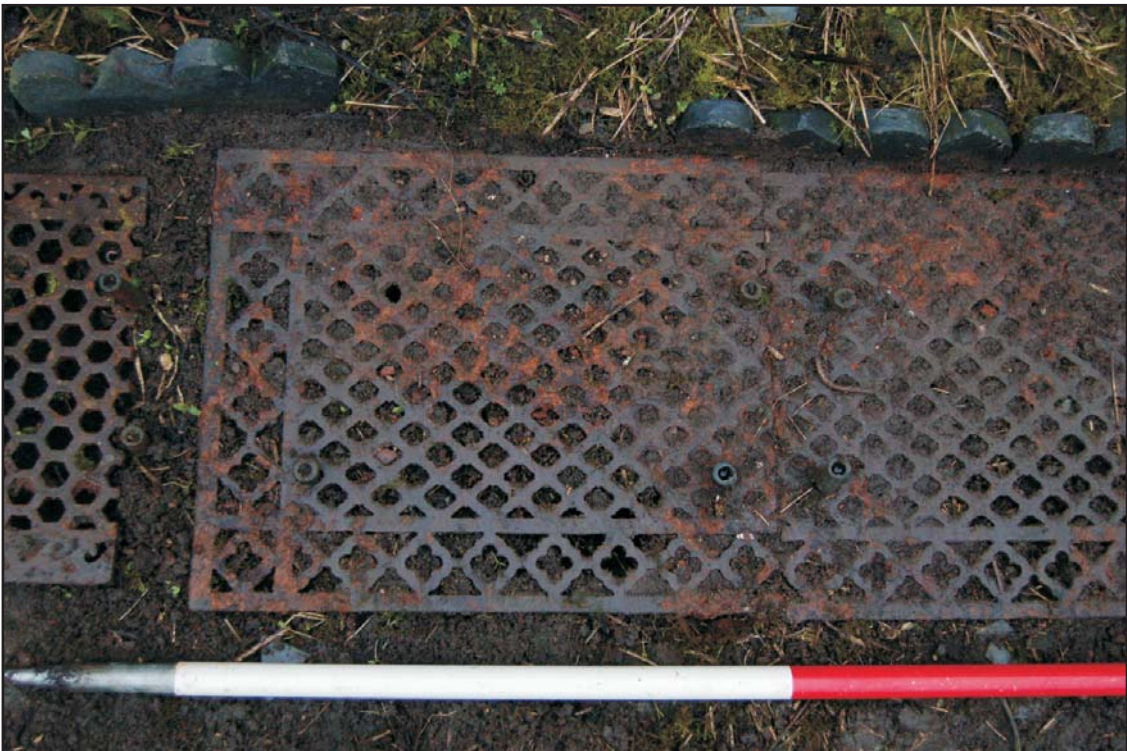
There remain various lengths of cast iron floor grilles which would have originally been positioned over the heated pipes in the floor though they are not now in their original positions and appear to have been re-used as pathways and pegged to the ground with metal spikes. Their original locations are unknown, and the use of two different patterns and widths might indicate at least two phases of construction or repair. One is 360mm wide although the original length is unknown since no complete sections were seen. It has a central pierced panel with an octagonal honeycomb pattern and a border of a stylised floral motif (Plate 19). The other panels are slightly wider, 410mm wide, and similarly incomplete in length. Their central panel is of a diamond reticulated pattern with a border of pierced quatrefoils (Plate 20).

Heating grille, scale 0.5m Plate 19

Heating grille, scale 0.5m Plate 20

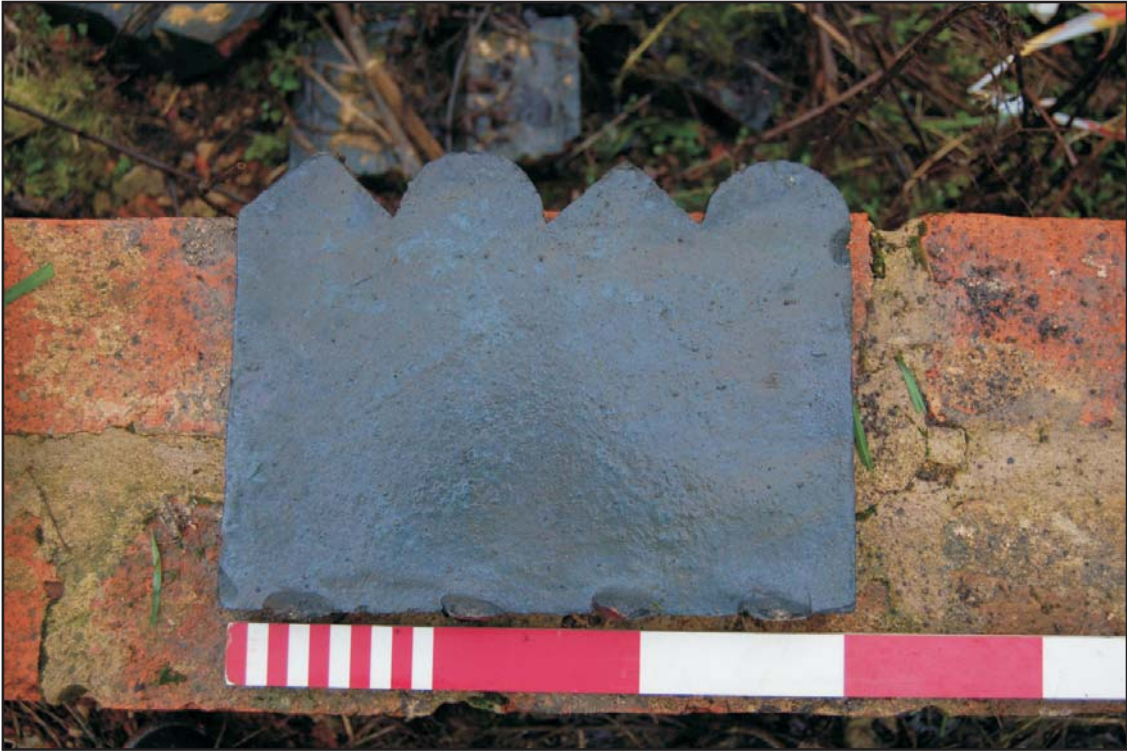
Staffordshire blue ceramic path edging tile, scale in centimetres Plate 21

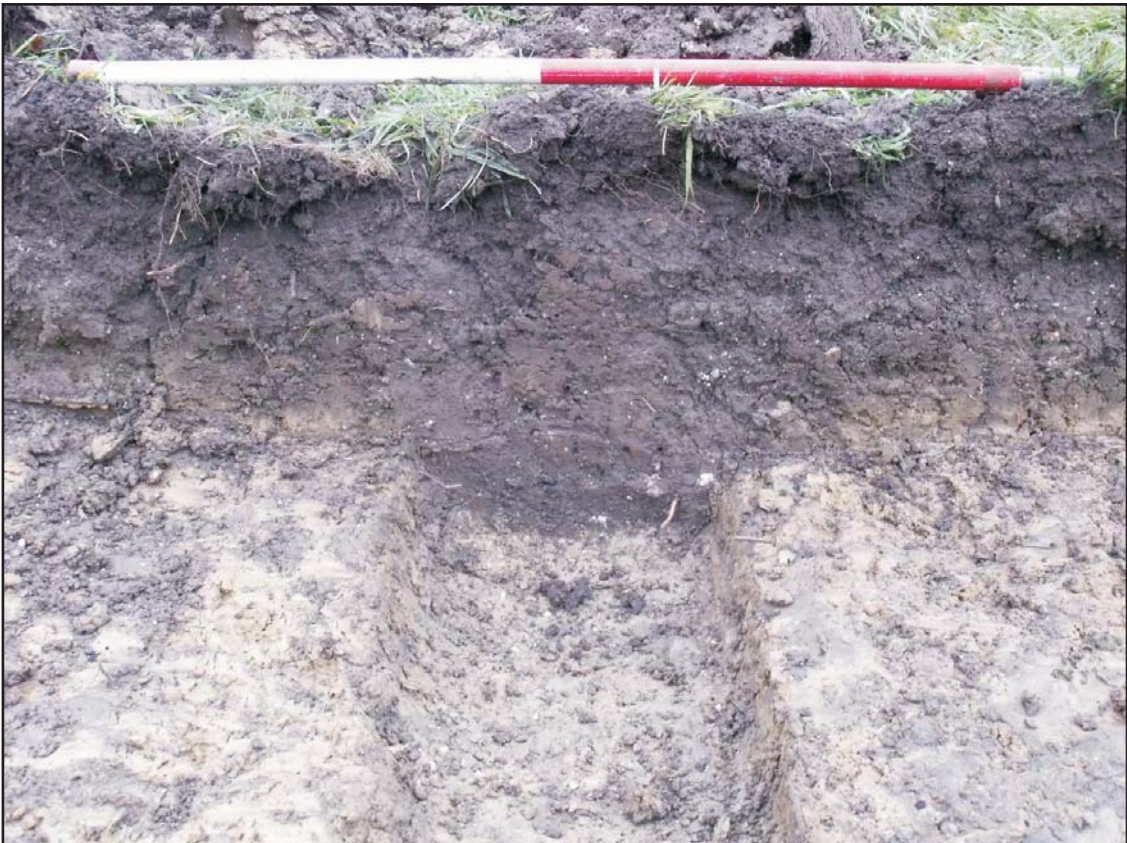
The natural buff coloured boulder clay (103) was exposed at a depth of c0.3m below present ground surface. Three narrow loam filled gullies (c0.7m wide and 0.25m deep) were observed cutting the subsoil (102), a light grey to brown clay loam and the natural (103). At the north-western end of the trench the limestone hardcore surface of a 1.5m wide path was exposed (110). All of the features in the trench were aligned north-east to south-west and were therefore parallel to the short south side of the garden, and perpendicular to the long west side. None were dated by finds but it is known that prior to the garden becoming an orchard in the 1960s that this part of the garden was used for a commercial crop of runner beans (pers. comm. Richard Stibbly) and the features are likely to be the planting trenches for these or a similar crop (Fig 9, Plate 22).

Planting trench 105, looking west Plate 22

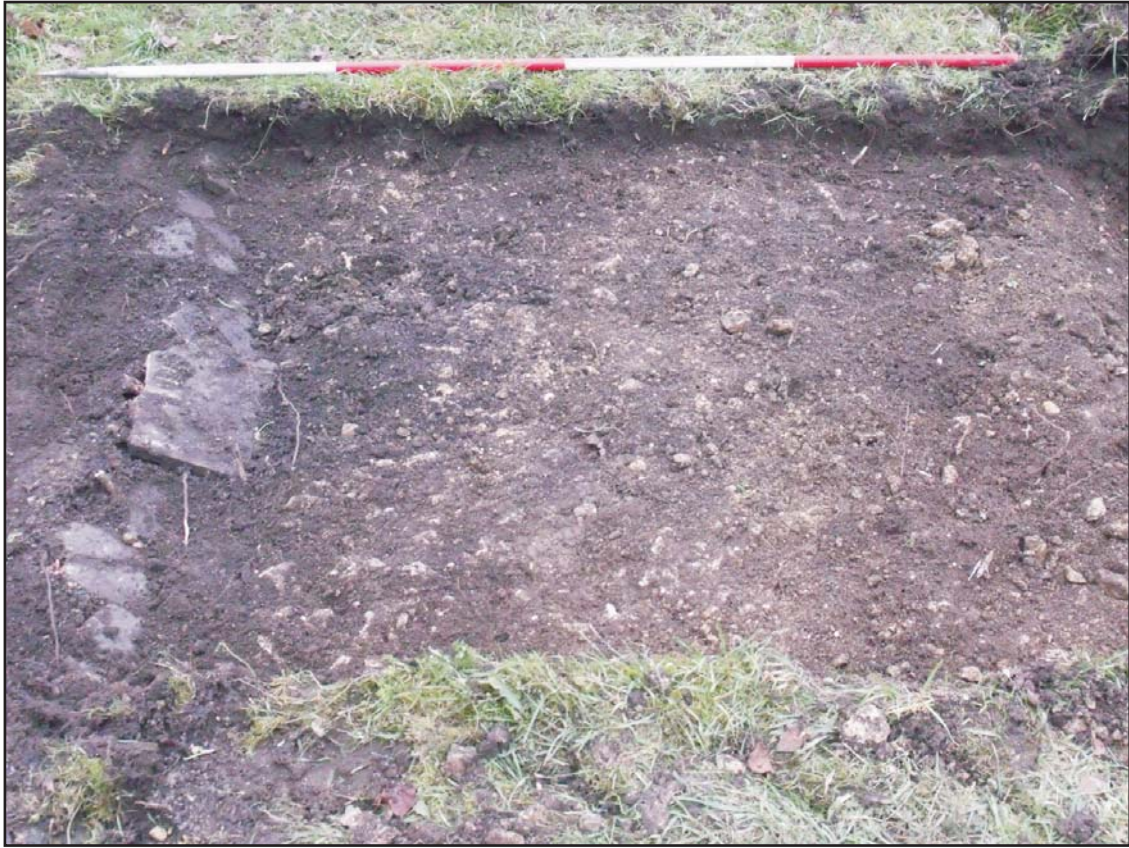
The path was aligned north-east to south-west and corresponds with that shown bordering the garden on the First Edition Ordnance Survey map. The loose nature and depth of the path makeup would perhaps suggest that it had a secondary purpose acting as a drain for the lowest part of the garden, obviating the need for a piped drain lying as it does, at the northern end of the garden at the lowest point. The path was overlain by between c0.2m and c0.4m of mid grey brown clay loam topsoil (201).

Garden path (110) in Trench 1 with collapsed and broken path edging tiles, looking east Plate 23

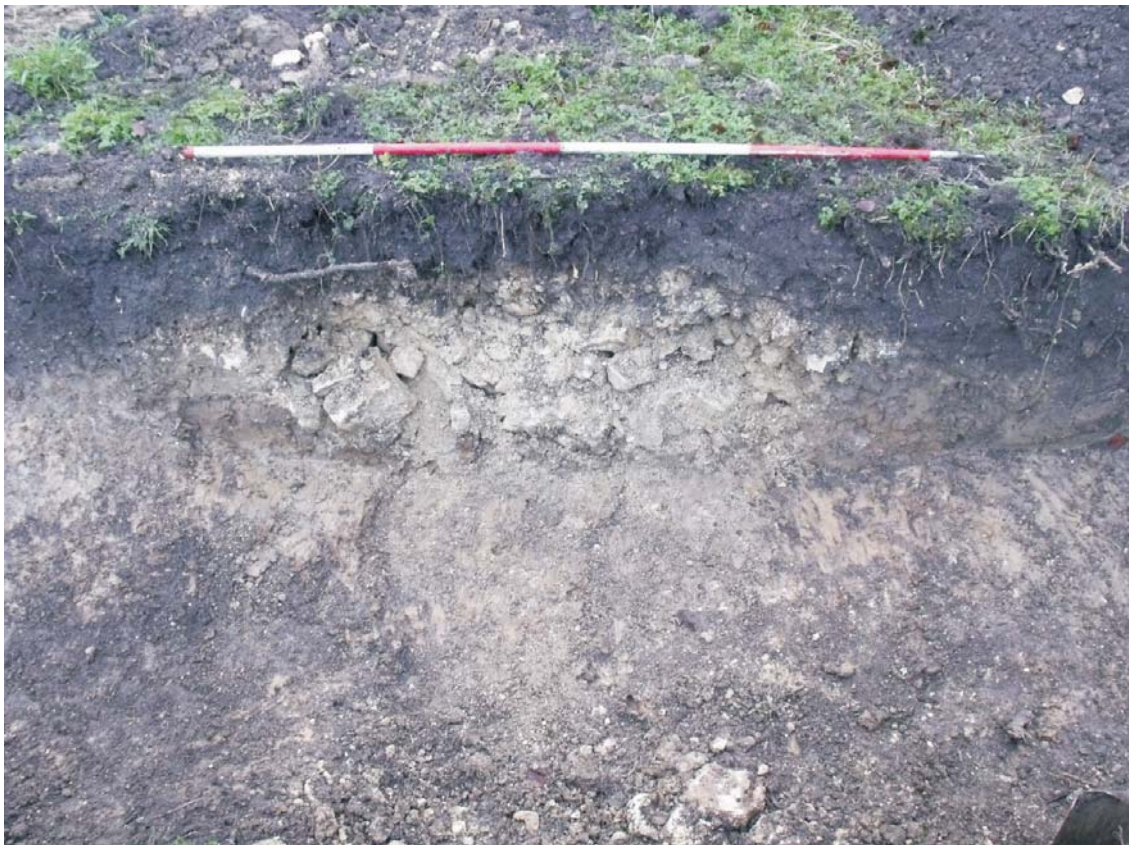
From the hardcore path base a broken brick was observed, the height and width are the same dimensions as those of the surrounding walls, the length is unknown since it is incomplete. It is assumed to be a broken fragment from that structure, and of the same date. It was not retained.

Path base (204) in Trench 2, looking west Plate 24
