Archaeological building assessment of the Old Smithy, Apethorpe, Northamptonshire

Report 11/21

February 2011

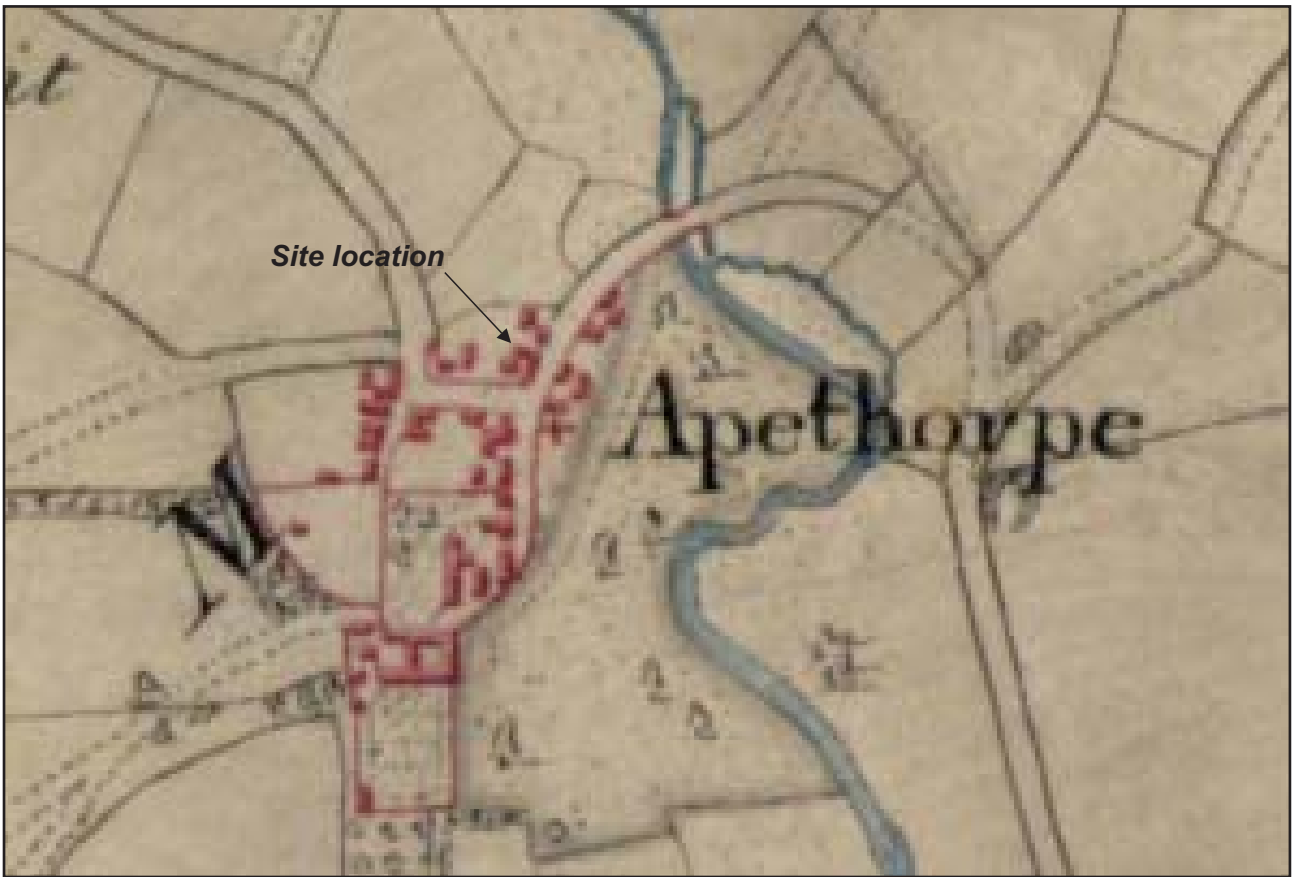
Extract from 1810 Ordnance Survey preparatory map Fig 2

- 3.1 No particularly early maps have been assessed for this project though the 1810 Ordnance Survey Preparatory Map held in digital format by NA was referred to (Fig 2). This shows little detail but is sufficiently clear to show that the present barn, along with the demolished eastern range, is not shown. The Ordnance Survey map of 1880 shows the village in more detail, and a building on the site of the present barn is clearly indicated (Fig 3). This shows the L-shaped range with the western arm, now demolished, in place. There is no indication that it was used at the time as a smithy; generally these are indicated as such. The complete L-shaped range is present on the 1950 Ordnance Survey map (not reproduced here).

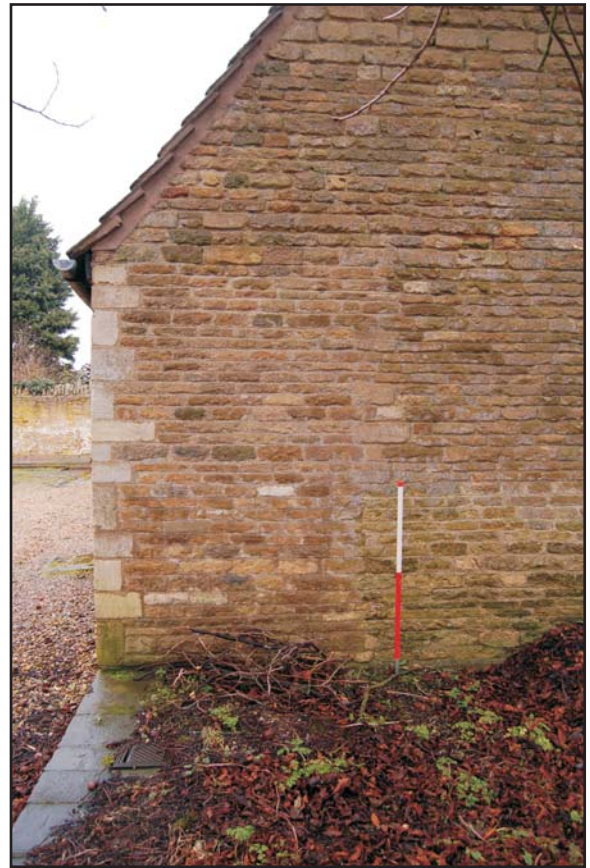
Plate 1

Join in east wall exterior; original section to the right (north), extended section to the left (south)

The east side of the building is externally of coursed limestone, entirely so in the northern section and of Fletton brick internally with a brick skin on the southern section. A clear join is visible in the east external face with large quoins marking the former south-east corner, partially obscured by a plastic downpipe (Plate 1). The north external face (north hipped end) was not observed since it lies within the garden of an adjacent property, the south gable is limestone externally with a Fletton inner skin. This gable end previously contained a narrow doorway which has subsequently been blocked (Plate 2).

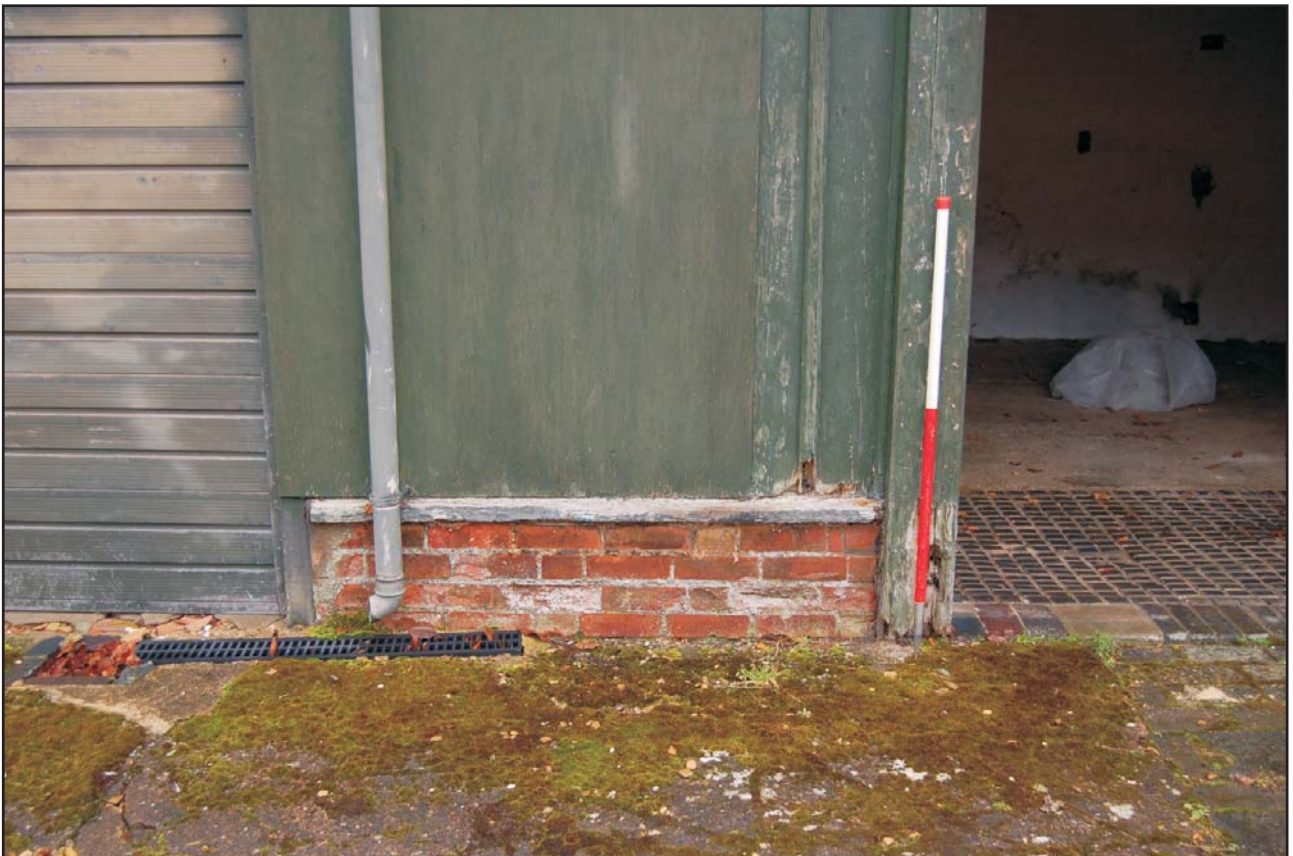
Plate 2

Blocked doorway in the south gable and exterior, looking north

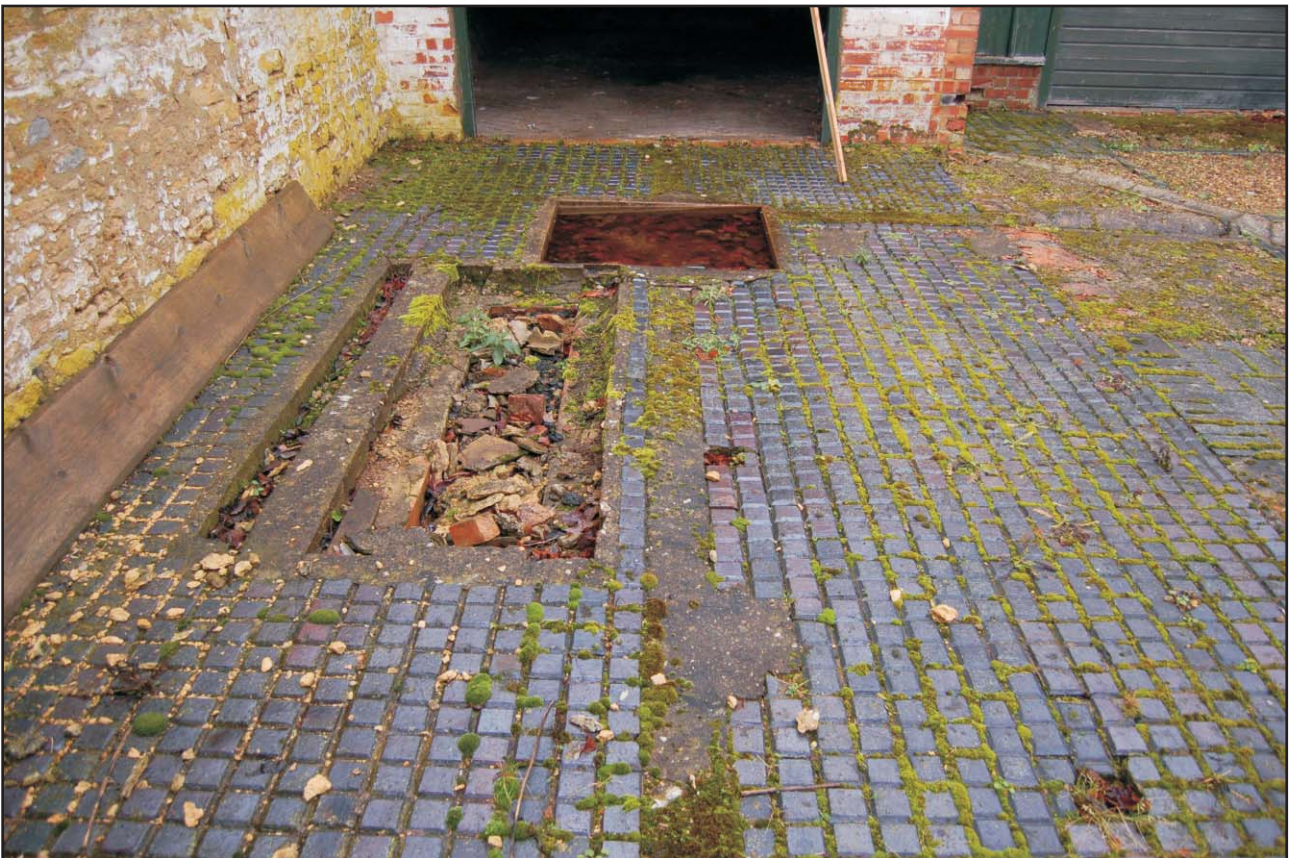
Former doorway in west range, looking south Plate 6

This demolished section is present on the 1880 First Edition Ordnance Survey map but no detail is present to determine how, or if, it was subdivided. The north wall is of coursed limestone and appears to have been an existing wall. The Staffordshire blue paviers do not suggest that there was any internal division but there is an indication that there was a central doorway in the south wall (Plate 6). The south wall was constructed of frogged Fletton brick, and it is assumed that this was only a dwarf wall like that which survives in the eastern arm of the building, though this cannot be certain. On either side of the former doorway stone blocks indicate the position of uprights which were presumably timber, the centre of each stone has a small hole in it, perhaps to take a dowel fixed into the base of the post. A line of standard blue bricks is laid on their sides across the opening to form a sill and externally the same bricks are laid flat to form a path to the doorway.

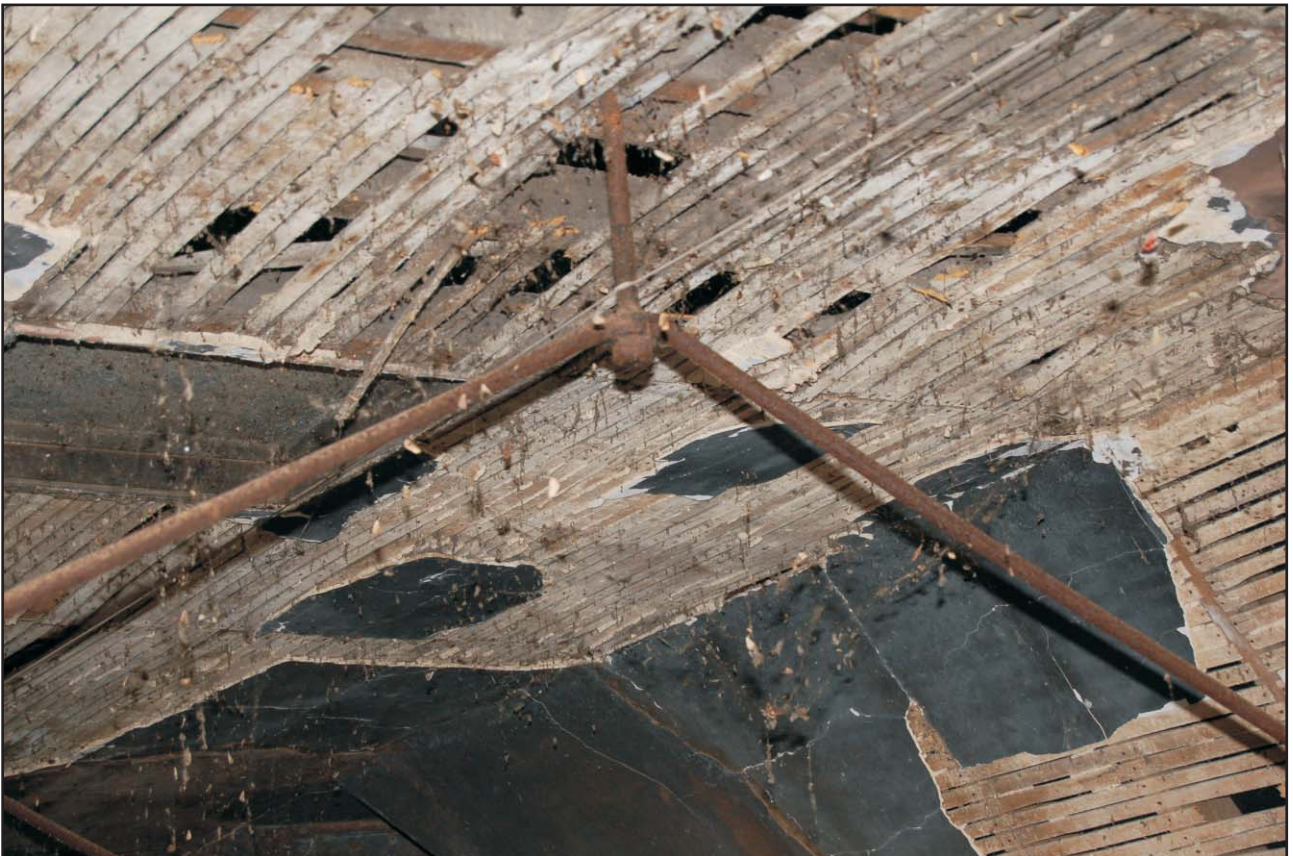
The ceiling of the eastern range, looking south Plate 13

Internally the space accessed by the three garage doors is a single room, all of the walls are heavily limewashed, the northern end of the east wall is of stone, the remainder of the east side and the south gable is Fletton internally. All walls extend only to eaves level above which the ceiling is plastered at an angle to the height of the collar where it becomes flat (Plate 13).

The ceiling construction is the same as in the room at the north-east corner, i.e. limewashed plaster over sawn laths. Four iron tie rods comprising raking struts with a vertical post from the apex additionally strengthen the roof (Plates 13 and 14). They appear to be original as the plaster ceiling is clearly fitted around them. An almost identical roof section is illustrated in Newlands book of 1880 which is a book of contemporary architectural drawings including farm buildings (Fig 7, Newlands 1880). Along the centre of the flat section are five square vents, each edged with fillets of timber and the squares fitted with a pierced sheet of either galvanised metal or zinc (Plate 15). This would have allowed air to circulate up from the room into the enclosed space above the plastered ceiling and below the roof to vent through the louvres at either end and the central raised four sided louvre at ridge height.

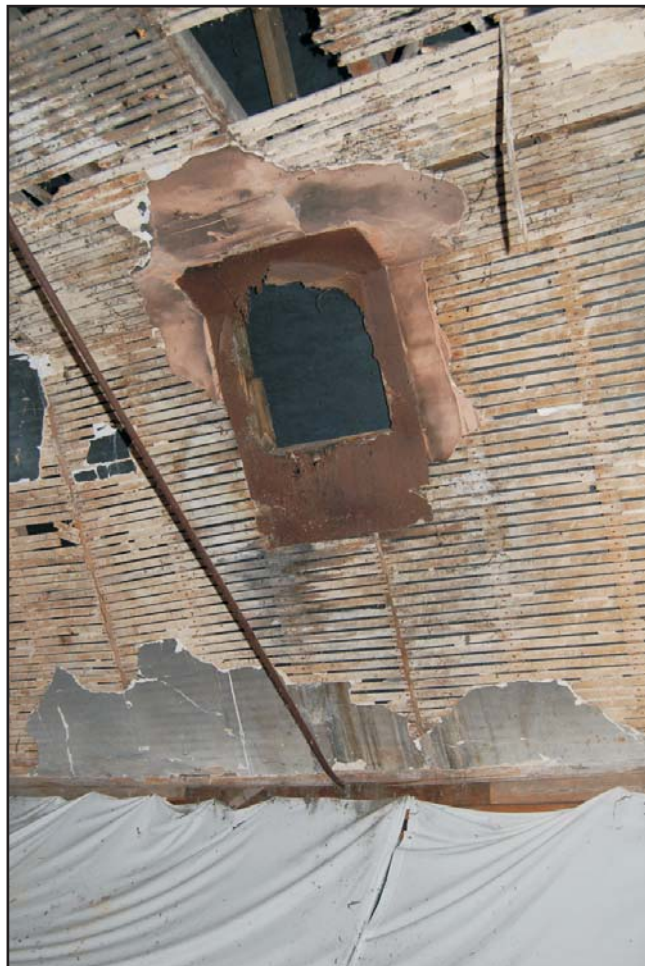
Mesh filled ceiling vent Plate 15
