Archaeological evaluation at South Quay Hayle Harbour, Cornwall June-July 2011

Report 11/164

August 2011

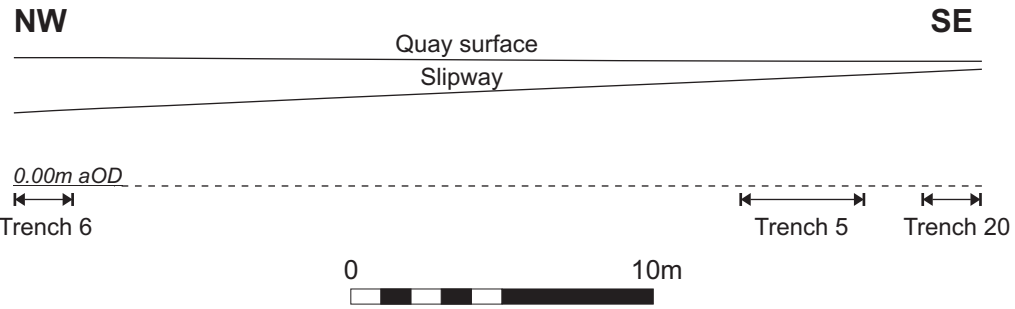
Profile of eastern slipway between Trenches 6 and 20

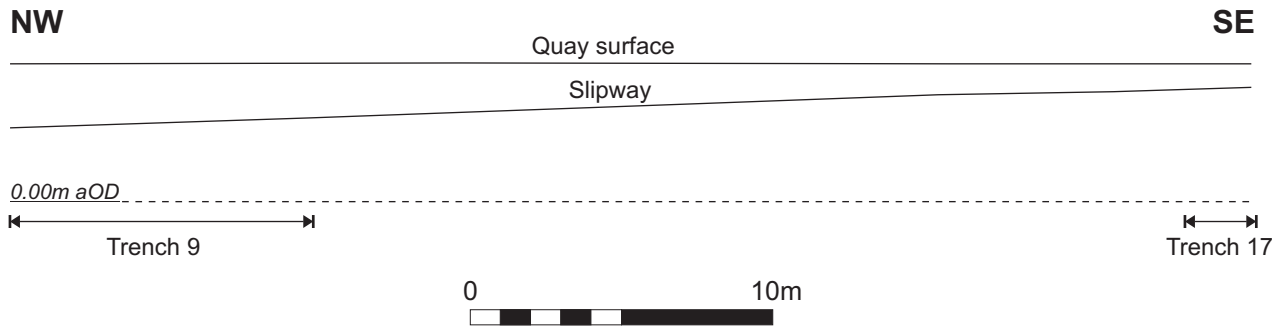
Profile 2

Profile of middle slipway between Trenches 9 and 17
