Archaeological watching brief during work on the
north side of the Eleven Acre Lake at Stowe,
Buckinghamshire

Report 11/60

**AN ARCHAEOLOGICAL WATCHING BRIEF DURING WORK
ON THE NORTH SIDE OF THE ELEVEN ACRE LAKE AT
STOWE, BUCKINGHAMSHIRE
SEPTEMBER 2010**

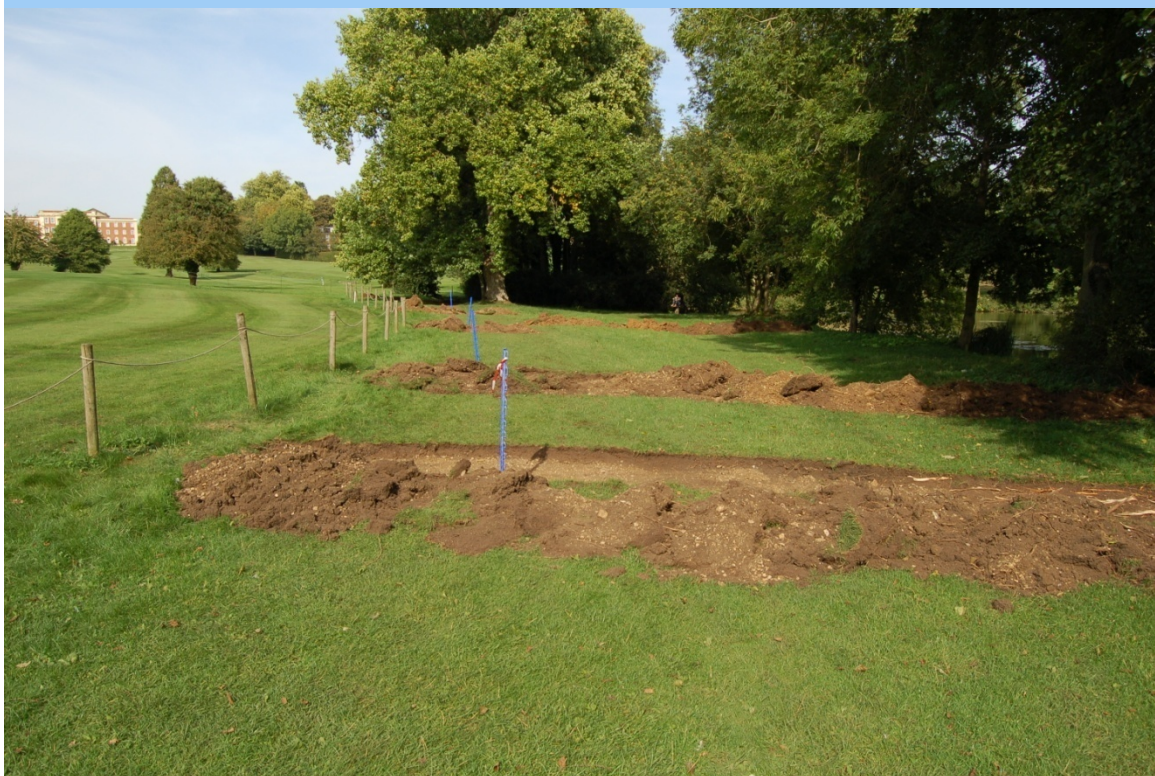
Report cover: Trenches 1180-1185 looking north-east

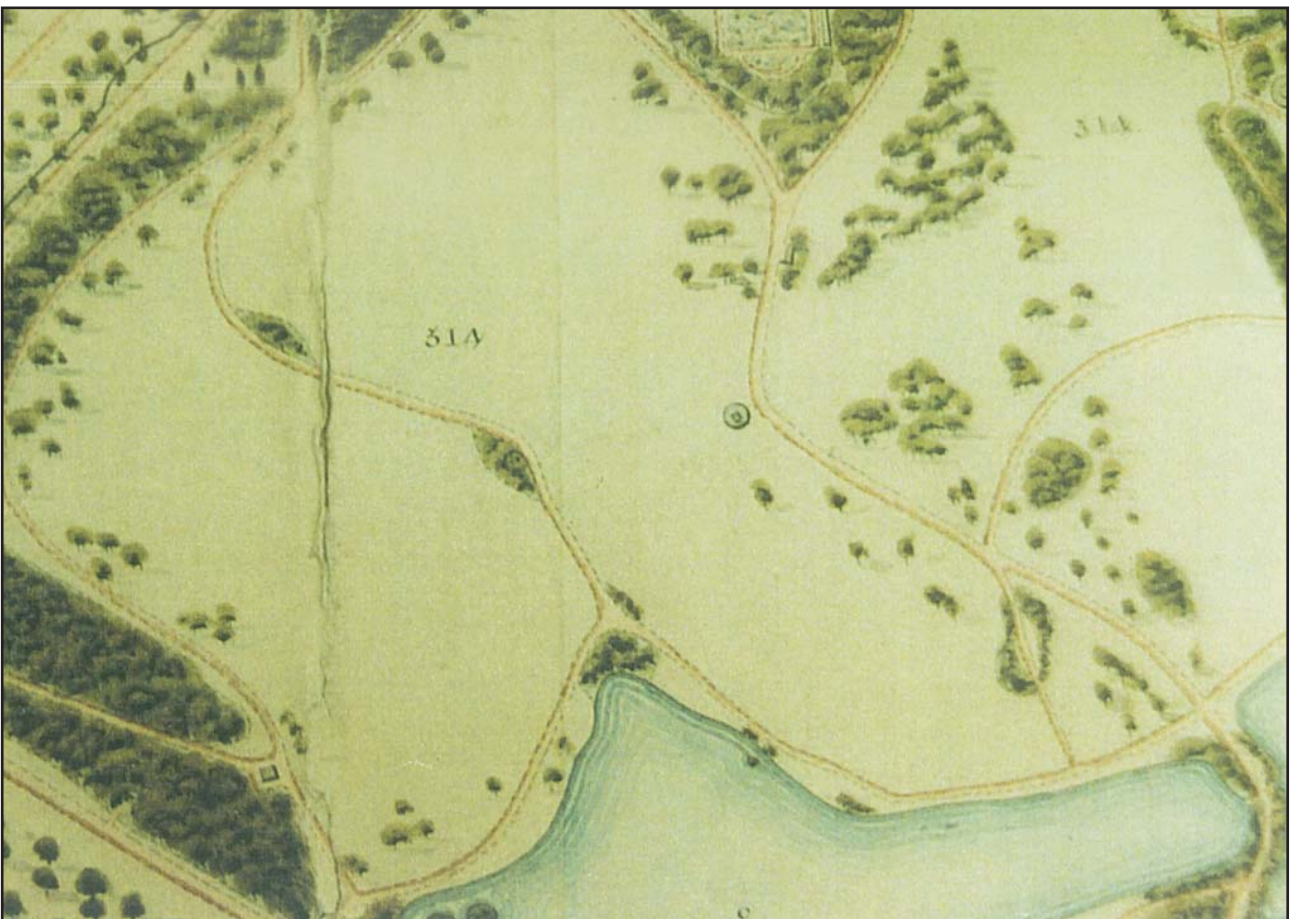
1843 plan by Henry Howard Fig 5

A slightly later 1843 plan by Henry Howard shows essentially the same configuration apart from a spur leading north-westwards from near the eastern end on the north side through a grove of trees in the direction of the path (Gurnets Walk) which leads from the dam between the two lakes to the Rotondo (Fig 5).

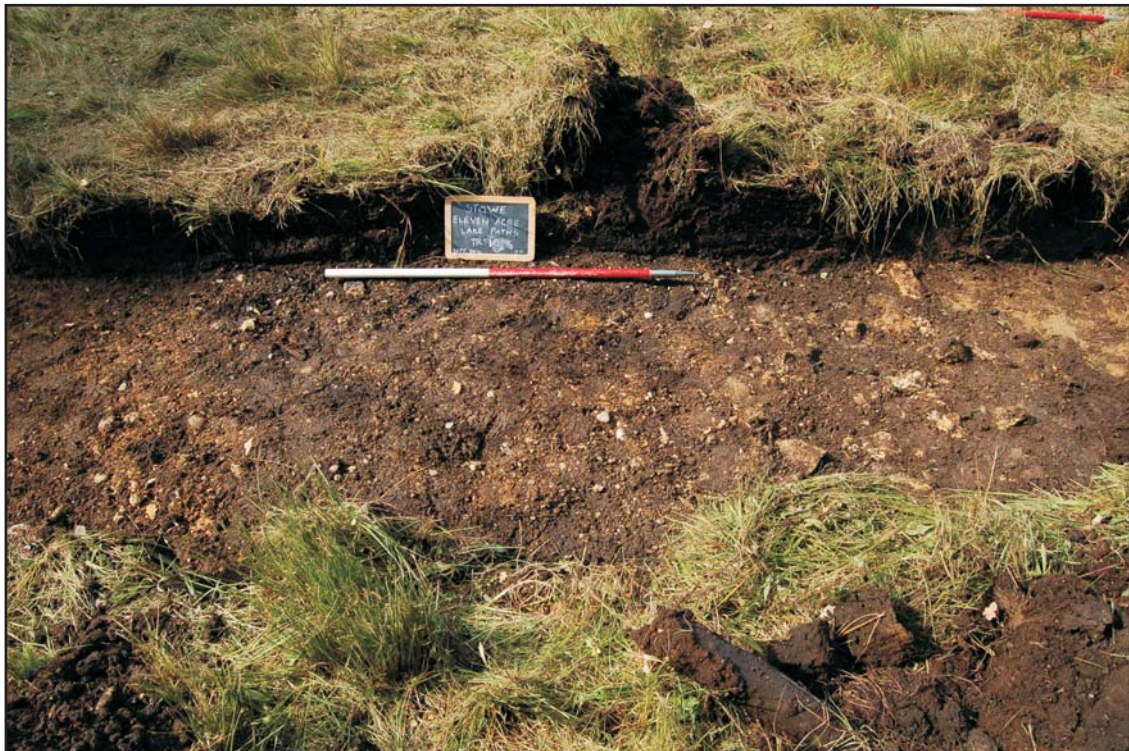
Plate 2

However, this wet area was clearly also wet at the time the path was constructed as there were large pieces of limestone, particularly along the northern edge, presumably in an attempt to provide a firmer foundation and perhaps even raise the path slightly above the wet subsoil (Plate 2). No distinct edging was observed, but rather an irregular dump of stones up to 250mm-300mm in size, all undressed. The remainder of the path within the edges of the larger stones was as observed elsewhere.

Trench 1191 (Trench 16), looking north-west showing limestone blocks with black organic soils

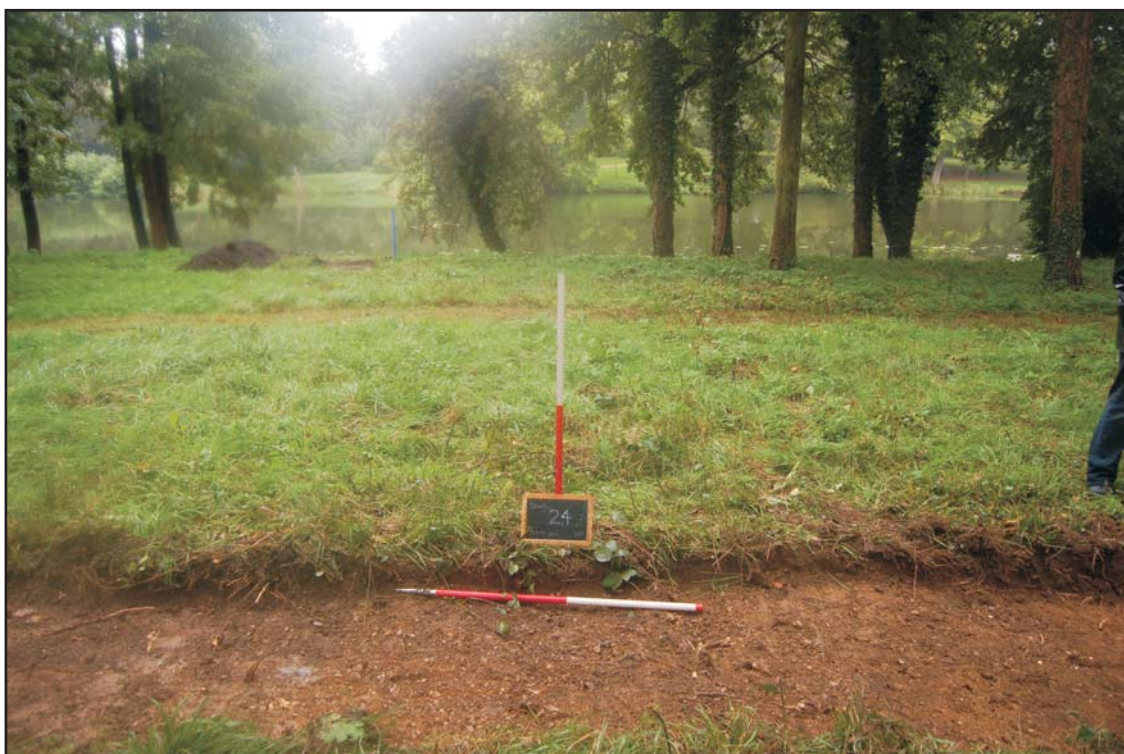
Trench 1199 (Trench 24), looking south Plate 4

Only one trench revealed evidence which was thought likely to be evidence of the former path (Fig 6). The natural subsoil was varied and comprised a mixture of clays and gravels. Two areas of higher level gravel were thought might represent the former gravel path, one at the eastern end of the trench and another at the western. Both comprised a clearly delineated band of sand and gravel aligned north-south across the trench, and both appeared to have a camber which was thought was not likely to be a feature of the natural underlying subsoil. However, when the 1843 Howard map was overlaid onto the modern survey it was found that the westernmost of the two possible paths was located in almost exactly the position indicated (Plate 4). It is therefore thought that this represents the 1843 period path, and whilst the gravel area to the east may be simply a natural gravel outcrop, it might indicate the position of another path of unknown date, since none are indicated on any historic maps in this area.
