Archaeological building assessment at 13 Bridge Street, Olney, Buckinghamshire

Joe Prentice
Report 11/78
March 2011

**ARCHAEOLOGICAL BUILDING ASSESSMENT AT
13 BRIDGE STREET, OLNEY, BUCKINGHAMSHIRE
MARCH 2011**

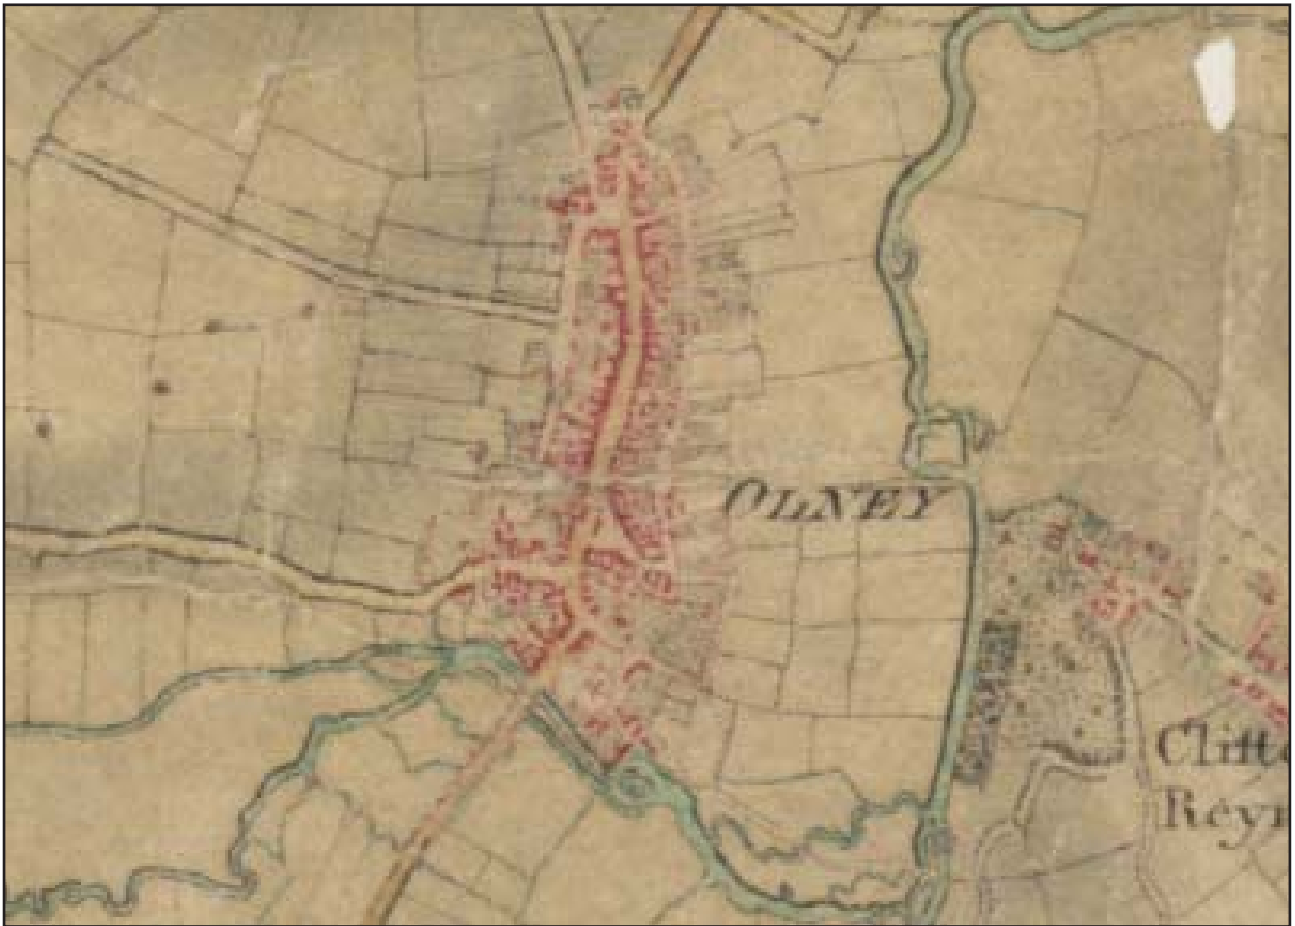
1810 Ordnance Survey preparatory map Fig 2

The scale of this map makes the identification of individual properties difficult when they are in such close proximity to one another in a built-up area such as Olney. Whilst it is clear that there is a row of buildings along the west side of Bridge Street it is not possible to distinguish the separate buildings. Therefore, it is not clear from this map whether or not the existing property was shown at this date.

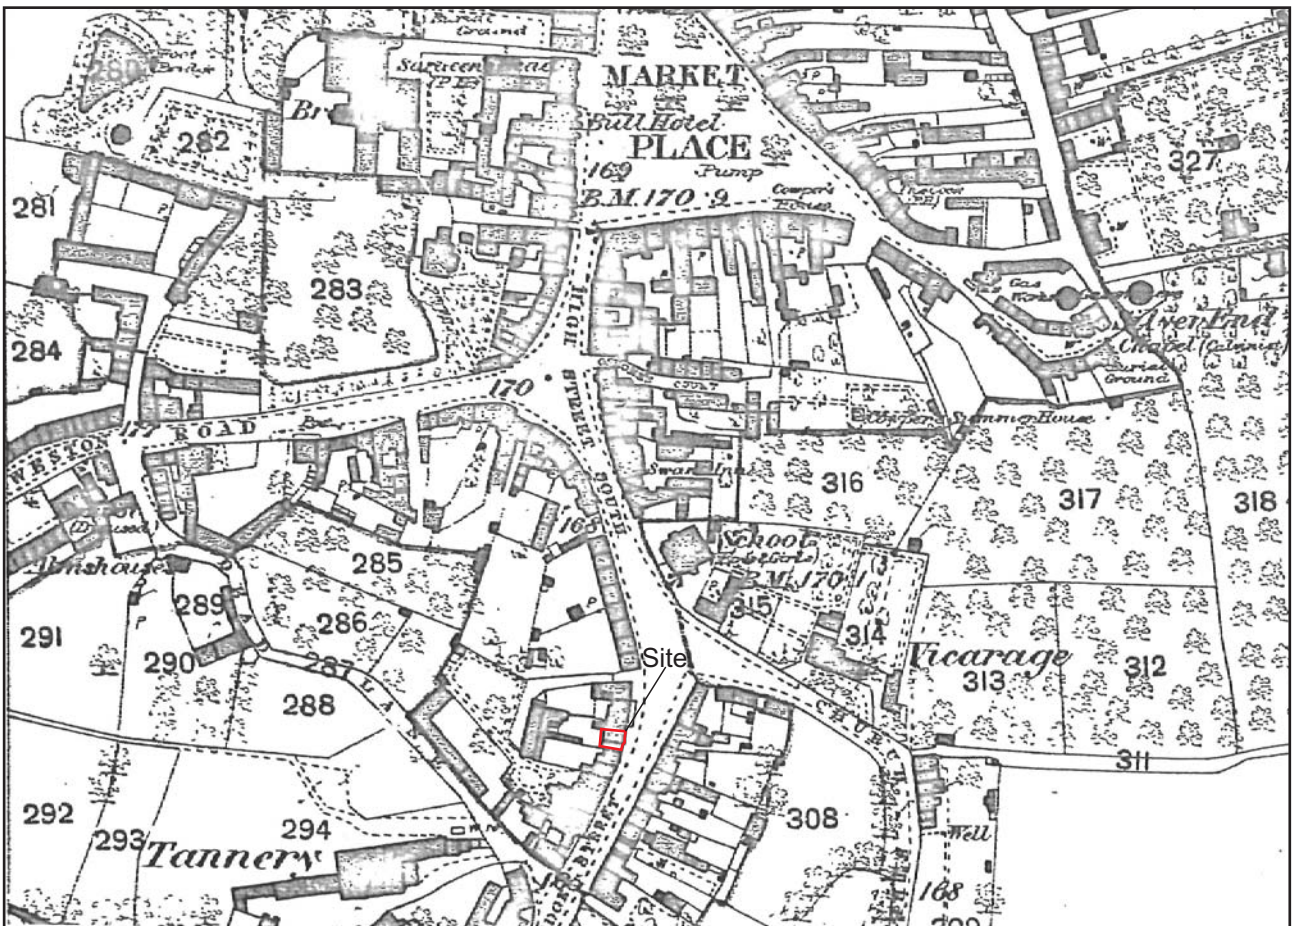
1882 Ordnance Survey First Edition map Fig 3

The map shows the property apparently divided into two parts, the northernmost section being part of the adjacent property to the north (number 15 Bridge Street). This confirms the comments of the present owners who also understood that this part of the building

was at one time part of that property. The building to the south (number 11) appears to have occupied the footprint on which it remains today although what can be seen now is in fact a modern re-build after that property fell down. It was re-built in its current form in 1983 (pers comm Mrs Scheepers).

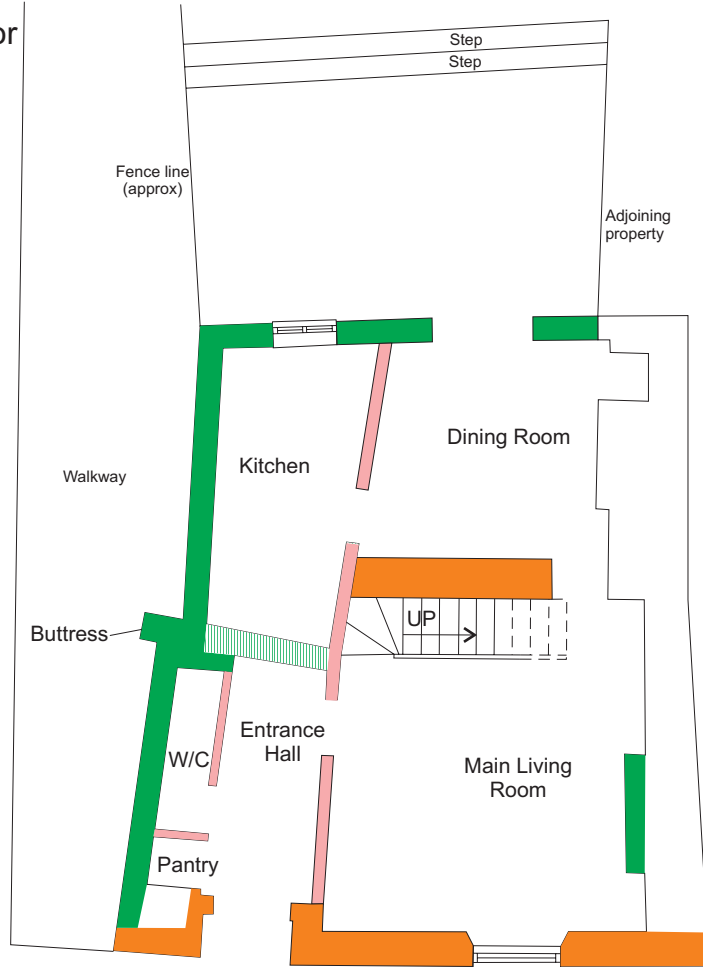
Ground and First floor plans Fig 4

The rear of the house is similarly of two bays and two storeys but narrower, since the building tapers in plan towards the west (Fig 4). The west elevation is entirely of brick, now painted a cream colour; the lower portion of the wall is rendered (Fig 5, Plate 2). The ground floor has a pair of French doors and two single pane casement windows (set within a single frame), both fitted within modern timber frames with sealed unit double glazed panels of modern date. Both the French doors and the kitchen window are set beneath concrete lintels. The kitchen window appears to be a replacement of another window since vertical scars can be seen where the original opening was at one time wider, which probably explains the thickness of the lintel which would have had to span the much wider opening (Plate 3). The sill of this earlier window cannot be seen since the lower portion of the wall has been rendered.

The plan of the ground floor indicates that there have been considerable changes with the south end in particular having an unorthodox layout with internal walls at angles to the exterior. Since it is difficult to determine the exact nature and date of those changes, the most obvious explanation is that this side of the building was affected by the loss of the building to the south and has been re-built. Stud and plaster walls are indicated on figure 4. The thick, stone, north-south aligned spine wall to the west of the stairs appears to be an original feature. This seems to be the only original internal wall. There are two fireplaces against the north wall of each downstairs room; that in the front (east) room is built of brick since the inner faces of the fire opening have been exposed. The rear fireplace opening is entirely plastered. All floors are either carpeted or tiled (in the kitchen) and appear to be concrete.

On the first floor the configuration is similar although all of the internal walls appear to be of studwork. There are exposed timber (pine) beams at ceiling height in the bedrooms, two of which bear paper labels, only one of which can be clearly seen, nailed to the north face of the beam in the front master bedroom (Fig 4). It has a hand-written pencil date, name and address on it which can only partly be deciphered (Plate 5). It appears to read:

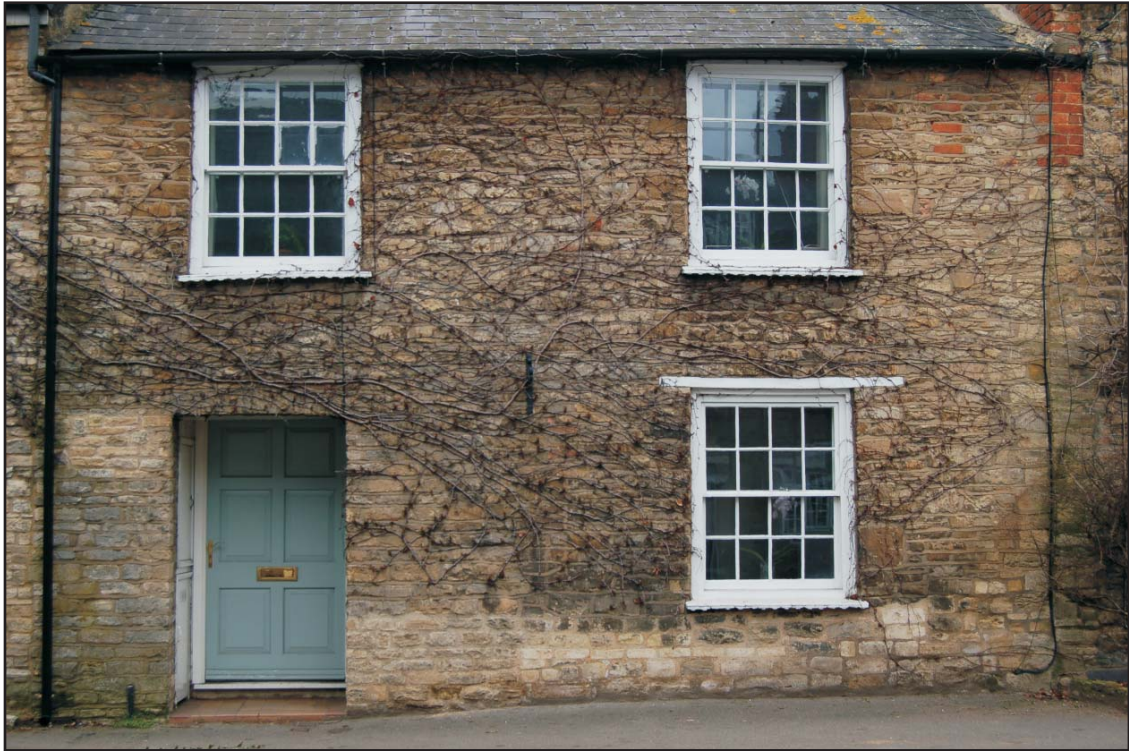
The east elevation, looking west Plate 1

The upper section of wall of the house has probably been raised; the evidence for this can most clearly be seen on the northern side of the east facade where the top section at the north side is built of red brick directly over the south wall of the building to the north (Plate 1).

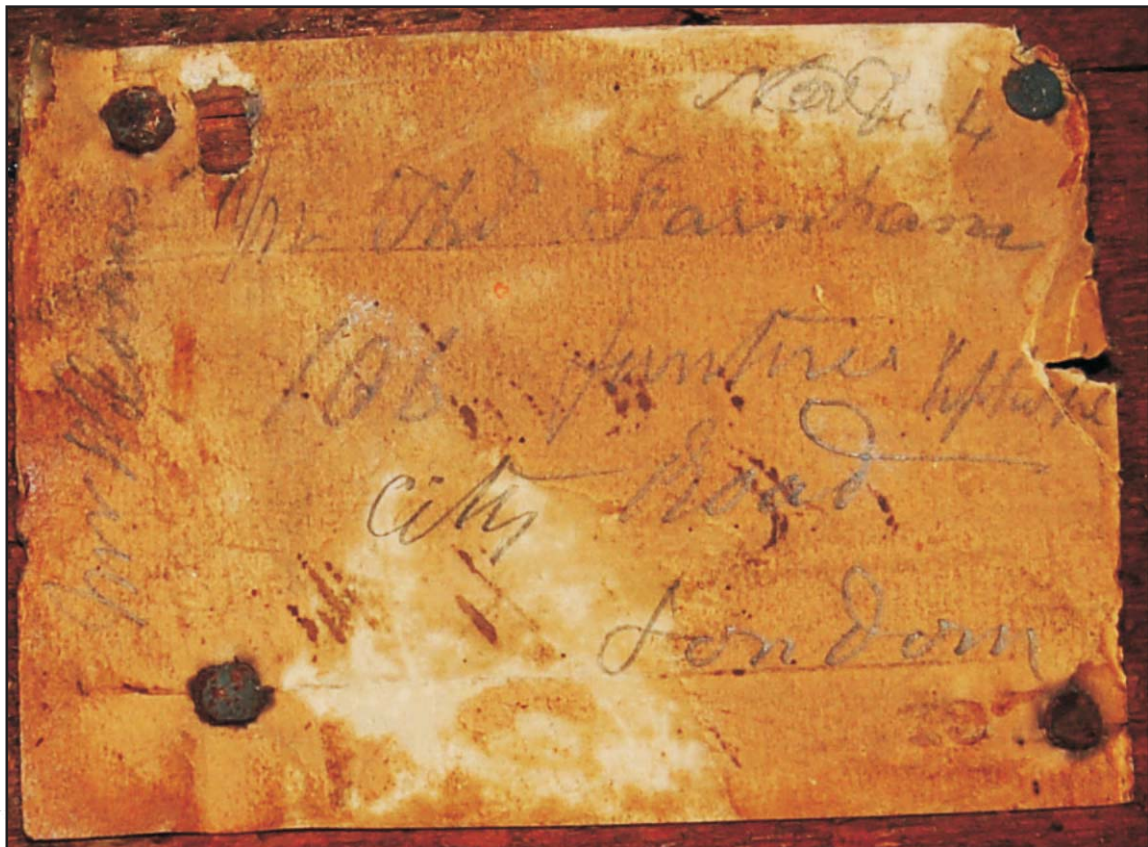
It is uncertain why this label is nailed to the beam, especially with what is clearly a London address written on it. Though it is possible that the timber came from there, this seems most unlikely since it is hardly an unusual type of wood and it is unlikely that timber would be sourced from so far away. An internet search reveals a Mr Thomas Farnham living at 106, City Road in a 'Supplement to the London Gazette, February 27, 1863'. His occupation is listed as Esquire. Whether this is the same Mr Farnham, and if

Paper label on the north side of the beam in the master bedroom & extract from the London Gazette

so, why his name and address are written on a label attached to a beam in a small house in Olney is unclear. The current owners are keen to retain the label *in situ*.

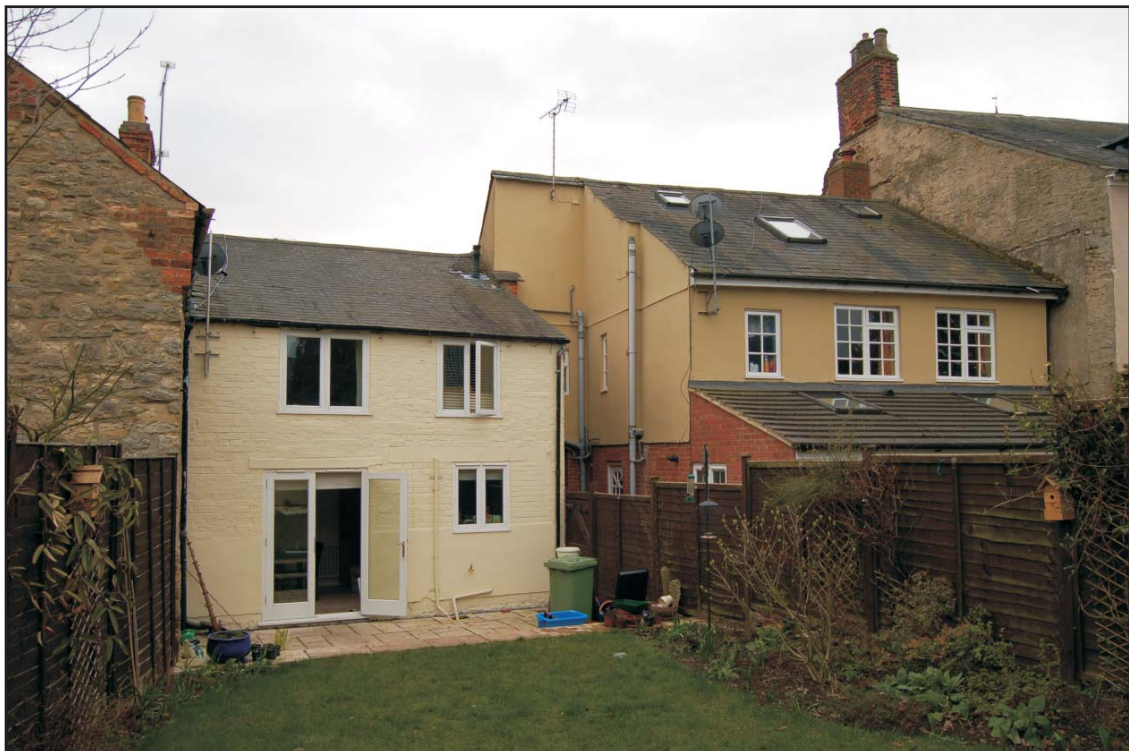
The rear elevation of number 13 and adjoining properties, looking south-east Plate 7
