Archaeological Building Recording at The Last Straw, Great Brington Northamptonshire March 2011

Report 11/99

April 2011

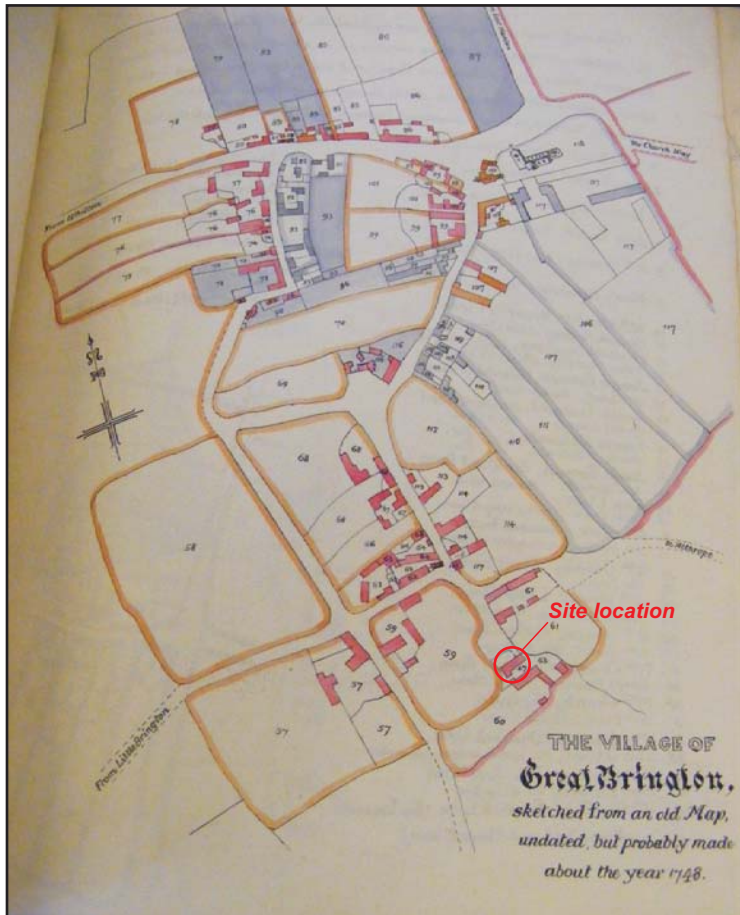
Fig 4

Plan of Great Brington, c1748
 (courtesy of Northampton Record Office; S0X413/1)

The village of Great Brington sketched from an old map, undated, but probably made about the year 1748 (NRO: SOX413/1; Fig 4)

This is the earliest extant map of the village. The house is L-shaped in plan and labelled 47 with a further range of buildings to the rear labelled 63. Although there was no accompanying schedule to the map when it was copied the numbers were found to correspond to those in a rent roll of 1743-4 of John Spencer's New Enclosed Estate in Great and Little Brington. Unfortunately, 47 is not mentioned but 63 is listed as Budgeway Farm occupied by John Jakeman (also known as Ridgeway Farm in other documents). The single number for the house suggests that it is a single dwelling at this time.

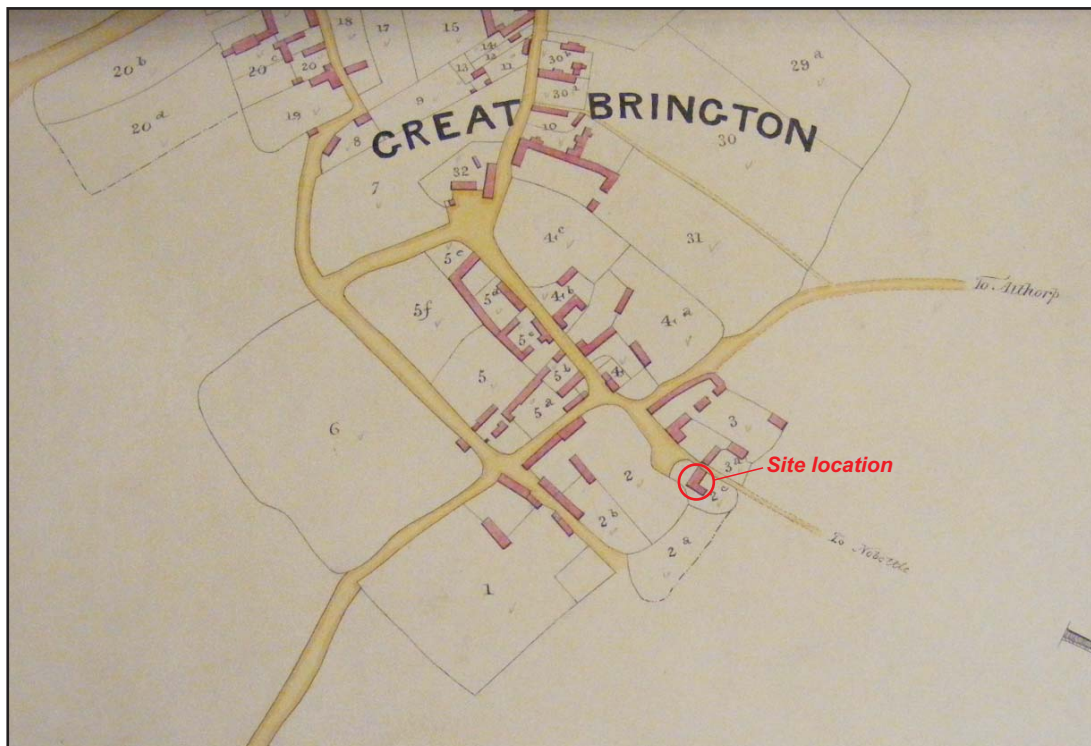
Fig 5

Great Brington Tithe map 1840
 (courtesy of Northampton Record Office; map T.176)

Great Brington Tithe Map, 1840 (NRO: T176; Fig 5)

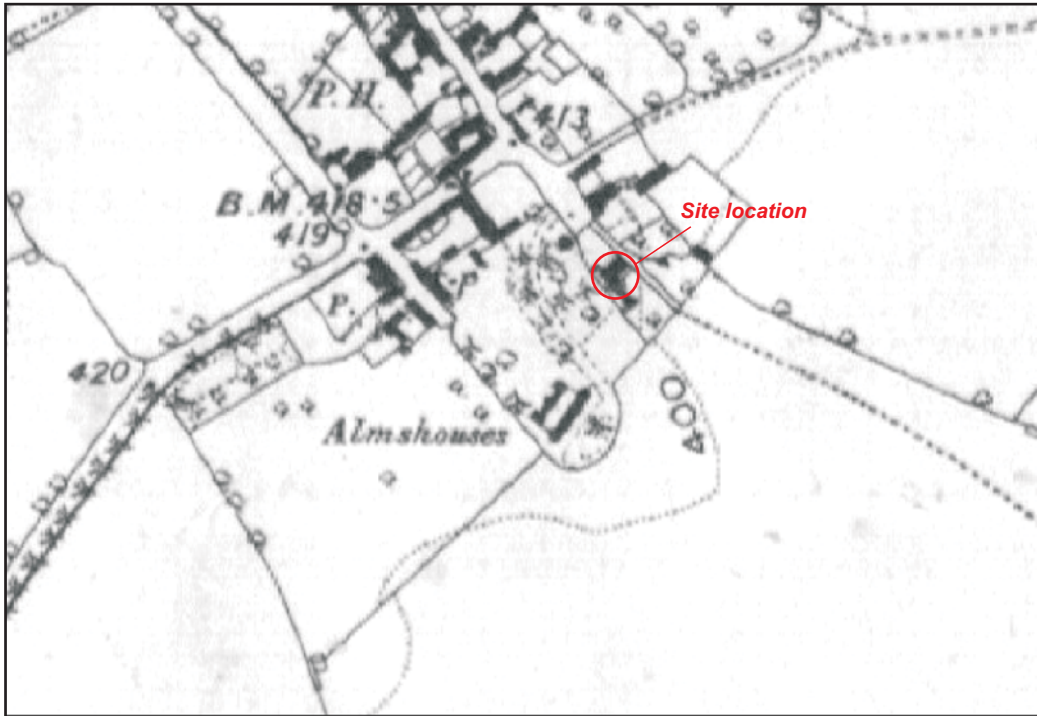
Fig 6

First Edition Ordnance Survey map, 1887

First Edition Ordnance Survey map, 1887 (Fig 6)

The First Edition Ordnance Survey map indicates that the rear wing of the house has been extended to the south and has been divided into separate cottages (not visible on illustration). The tenement shown on the 1840 map on the opposite side of Tebbits Lane has been pulled down and replaced by a small building or barn.

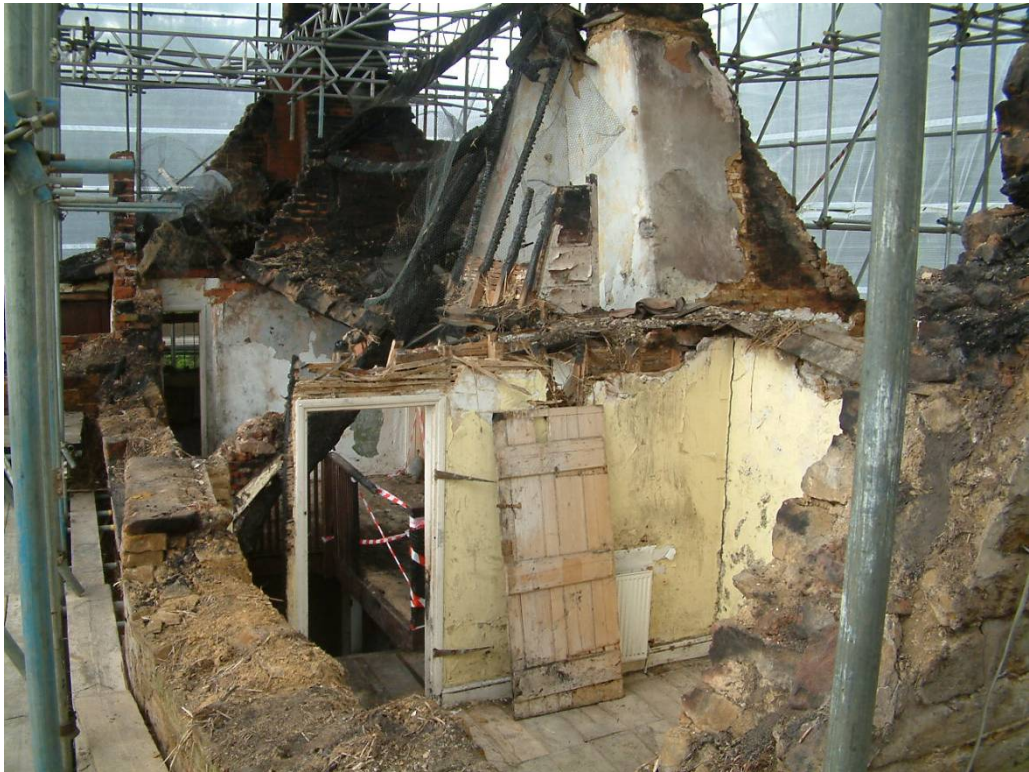
First floor, looking west Fig 8

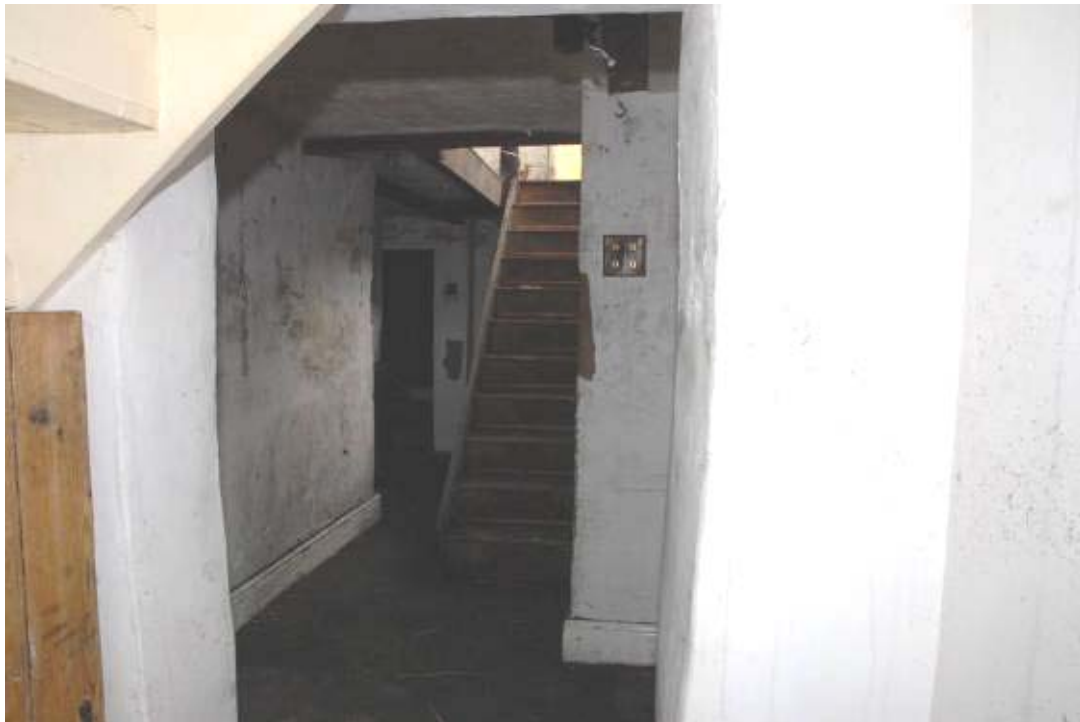
Hallway, looking east Fig 10

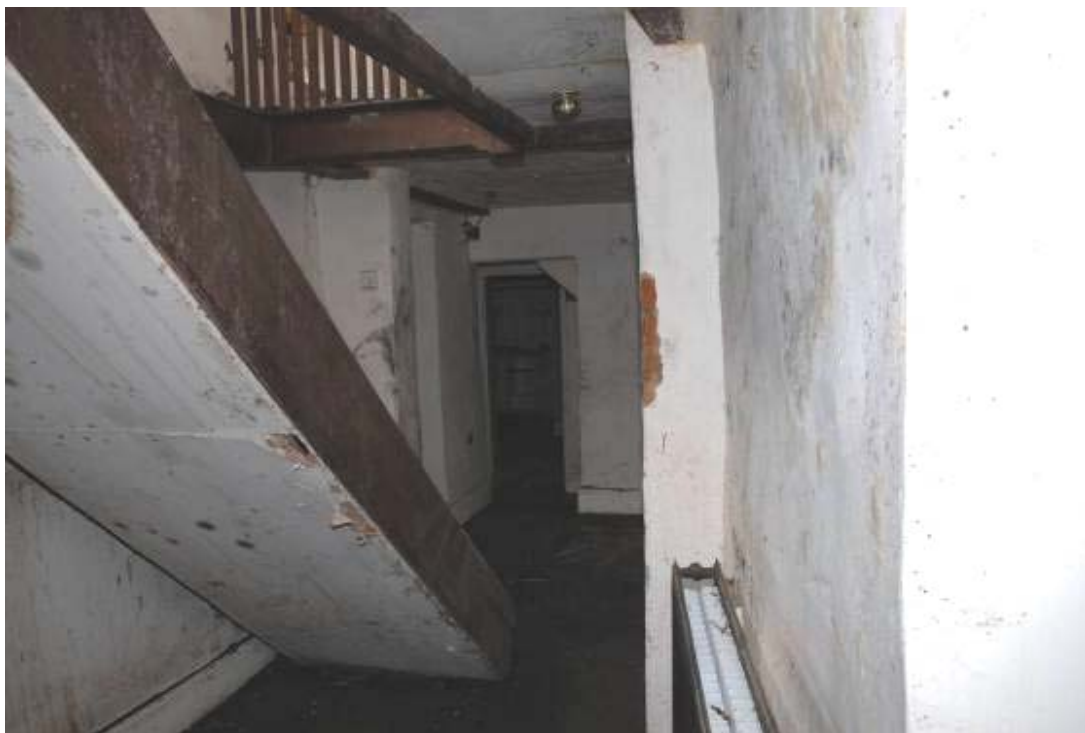
Hallway, looking west Fig 11

The ceiling is 2.1m high and clad with lath and plaster. The floor is re-laid stone flags bedded with cement mortar.

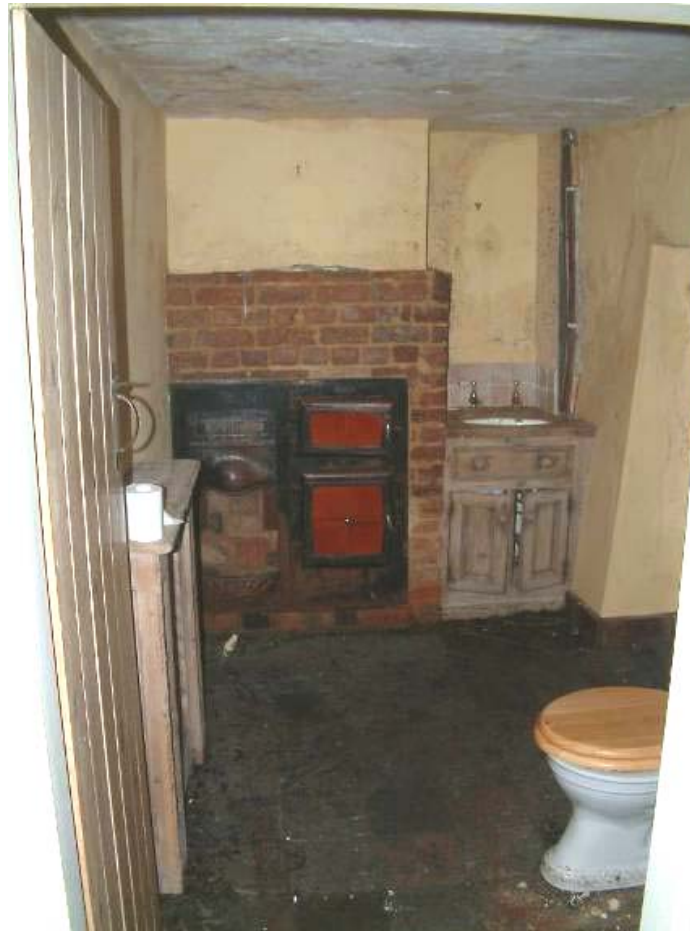
The north end of the east wall has a chimney breast 1.06m wide and 0.4m deep, faced with single thickness brick cladding up to 1.1m high. This contains a cast iron range, 0.96m square 'Foresigat' range, comprising an open fire grate and adjoining ovens. The oven doors are metal hinged and faced with four, red, square ceramic tiles in each door. Immediately to the south of the range was a wooden cupboard supporting a worktop with an inset sink.

Cloakroom, looking east Fig 12

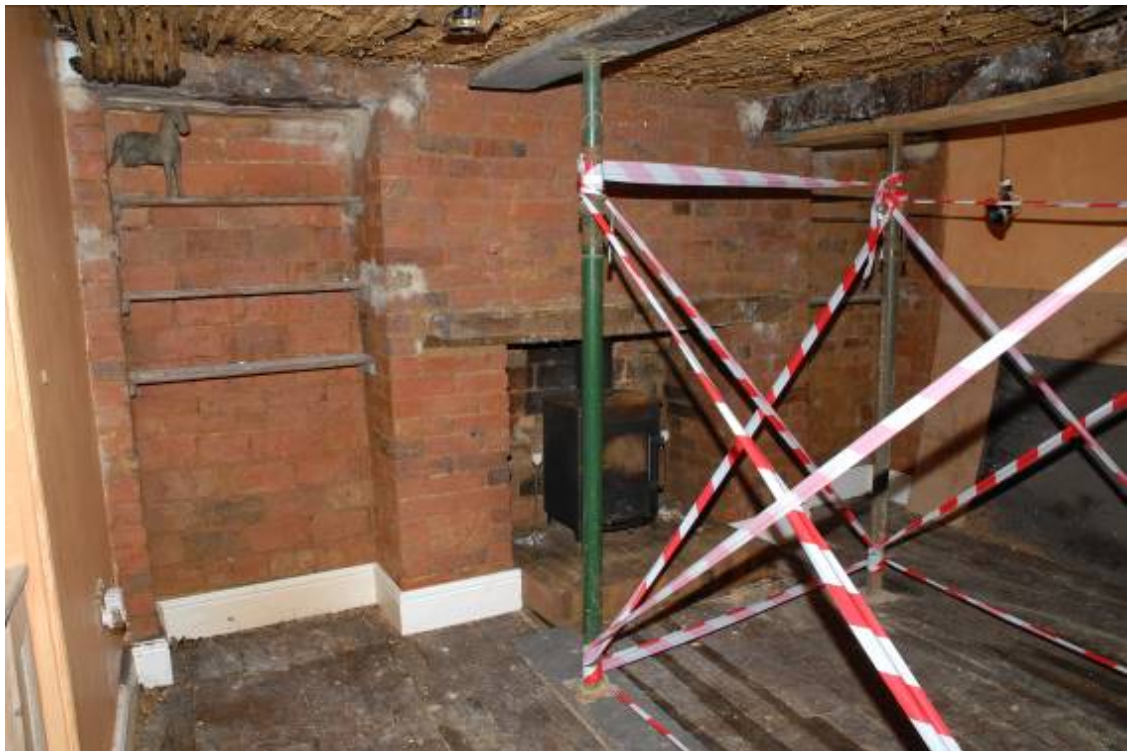
Dining room, looking south-east Fig 14

The east wall of the room had been clad full height with a single brick cladding that extended 0.37m along both the north and south walls, into the recesses at each side of and around the central chimney breast itself. A brick hearth 1m wide extends 0.3m forward of the fireplace which contains a modern metal solid fuel stove. The two side recesses carry wooden shelves supported on wooden batons.

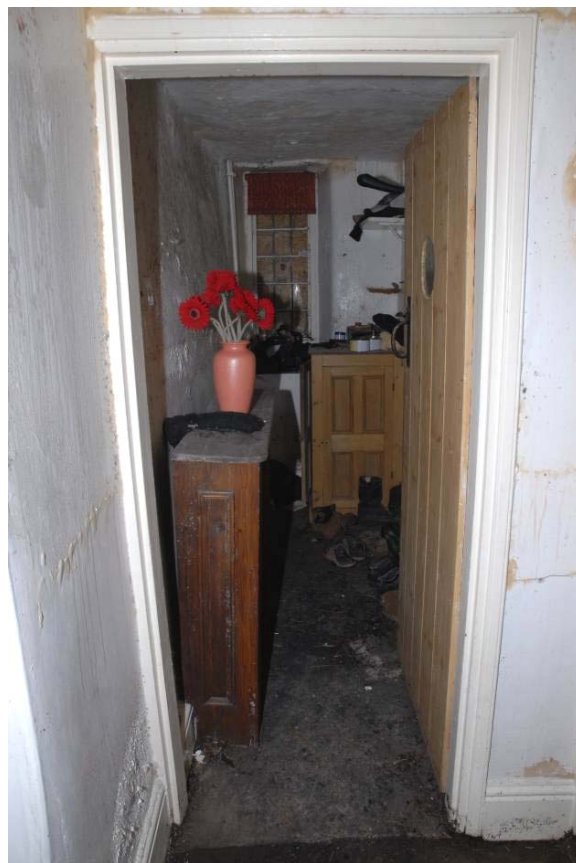
The storeroom, looking north Fig 15

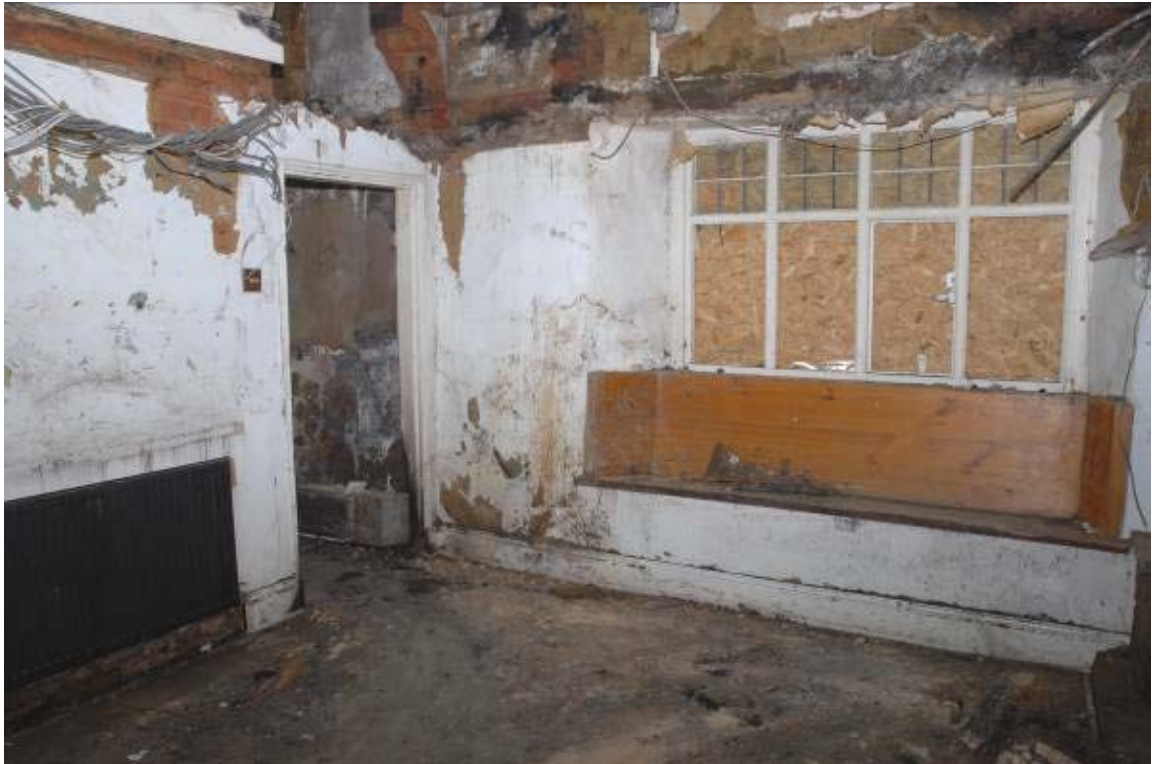
The north wall contains the only window, 1.84m wide at the window frame splaying to 2.2m wide at the inner edge of the wall. The window opening was 1.1m high and contains a soft wood frame divided into four casements, each with a fixed transom over. All the windows were fixed except for a single opening casement east of centre.

All the transoms have a single saddle bar supporting two registers of three leaded lights, each held in lead window cames. The casements originally had wrought iron frames, each with four saddle bars supporting five registers of three leaded lights all held in lead window cames. The opening casement is secured with a revolving turnbuckle catch with a metal back plate, on the external side of the frame there is a plain quadrant stay. A timber-lined window seat lies directly below the window.

Lounge, looking north-west Fig 17

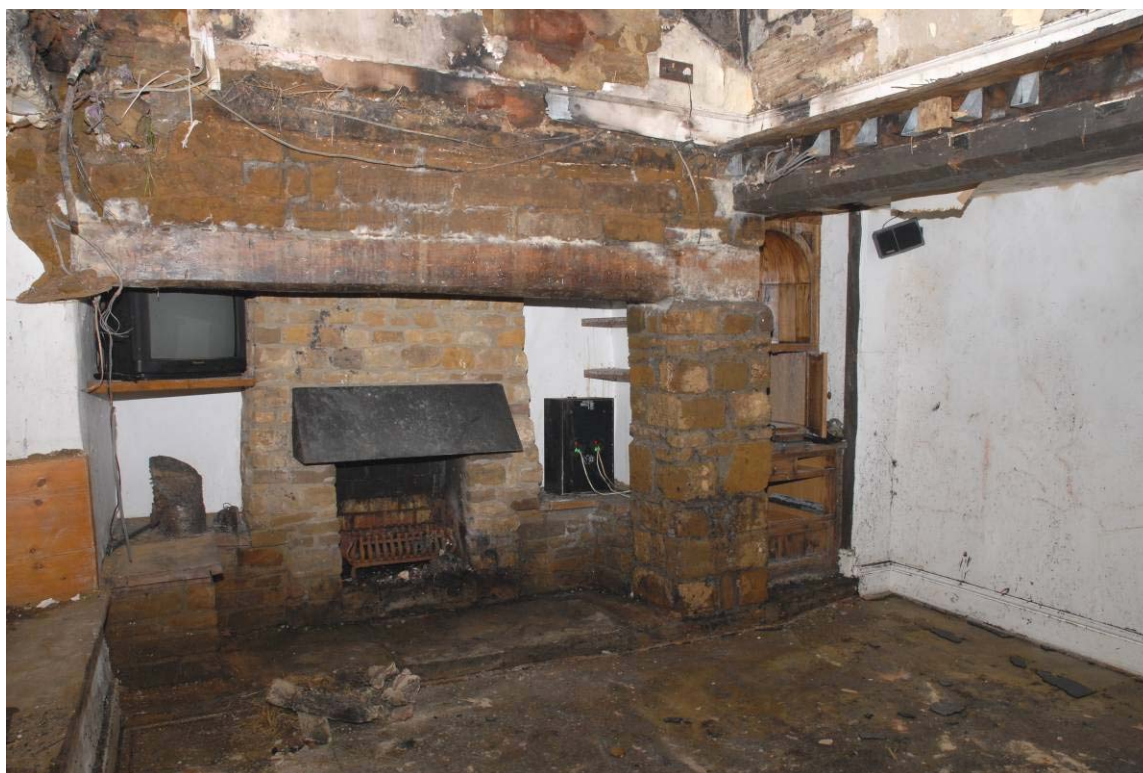
The east wall was formed from a large stone built chimney breast containing an inglenook fireplace. To the south of the fireplace, a recess contains a wooden cupboard.

A decorative modern metal smoke hood is mounted on the front of the fireplace above the grate. At each side, low level stone walls carry wooden covers forming storage and/or seating either side of the fireplace. The entire floor area within the inglenook is raised 0.1m above the remainder of the room floor.

Lounge, looking south-east Fig 18

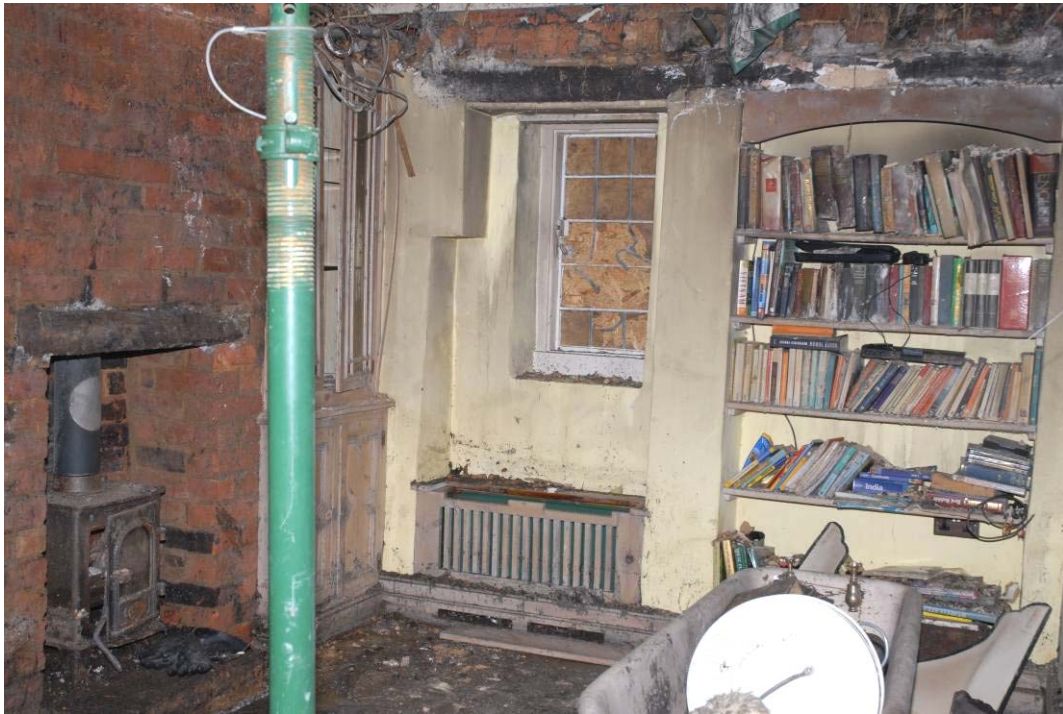
In the west wall, a doorway has been blocked on the outside and the internal recess used for book shelving. The window recess is 0.77m wide stepping in to 0.55m at the window frame. The softwood window frame is 0.9m high with a single wrought iron framed opening casement with four saddle bars supporting five registers of three leaded lights. It is hung on iron pintles and secured with a revolving turnbuckle catch with metal backing plate.

Snug, looking south-west Fig 19

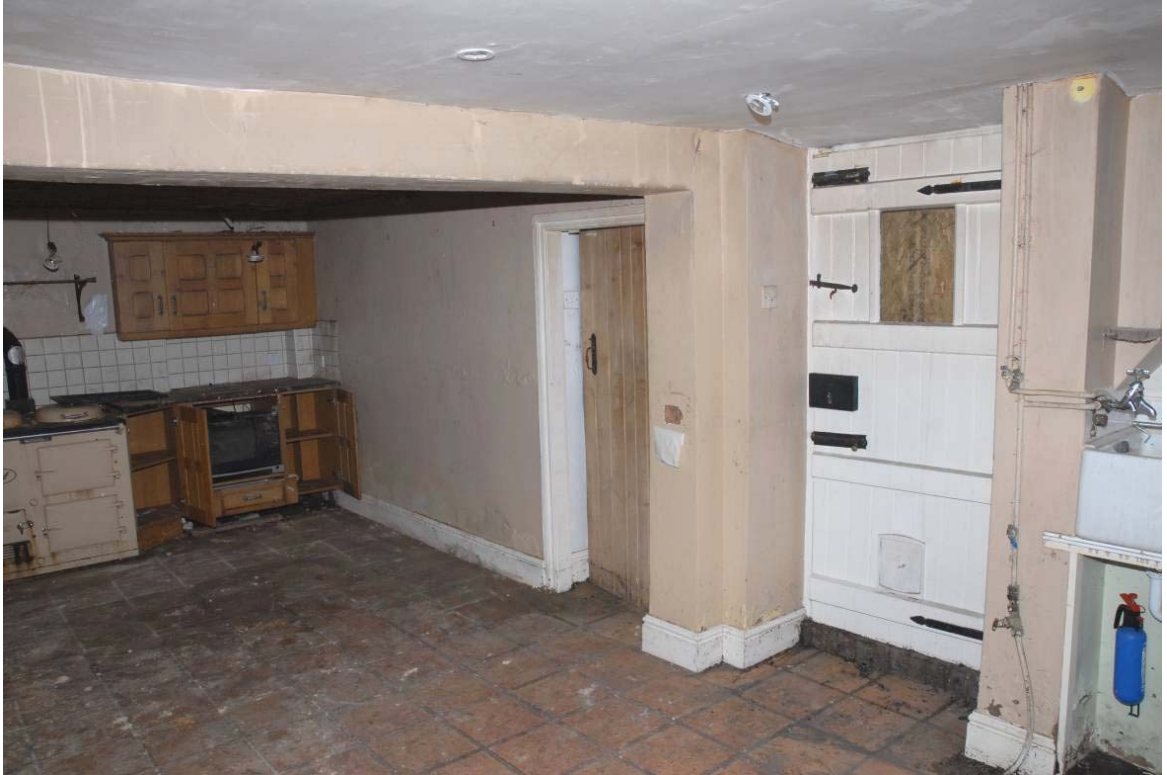
Kitchen, looking south-west Fig 20

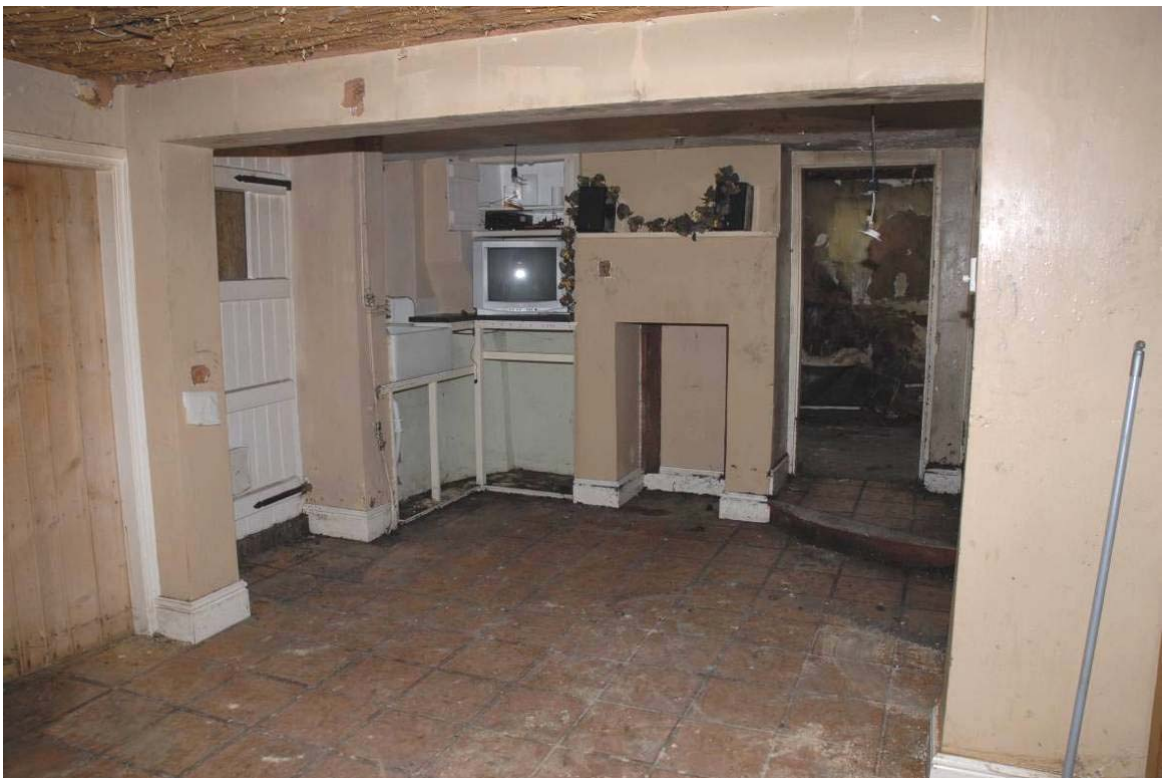
Kitchen, looking north-west Fig 21

The north wall of the kitchen contains a chimney breast, 1.18m wide with a mantle shelf at 1.6m high. The central fire recess is 0.96m high, 0.7m wide and 0.4m deep.

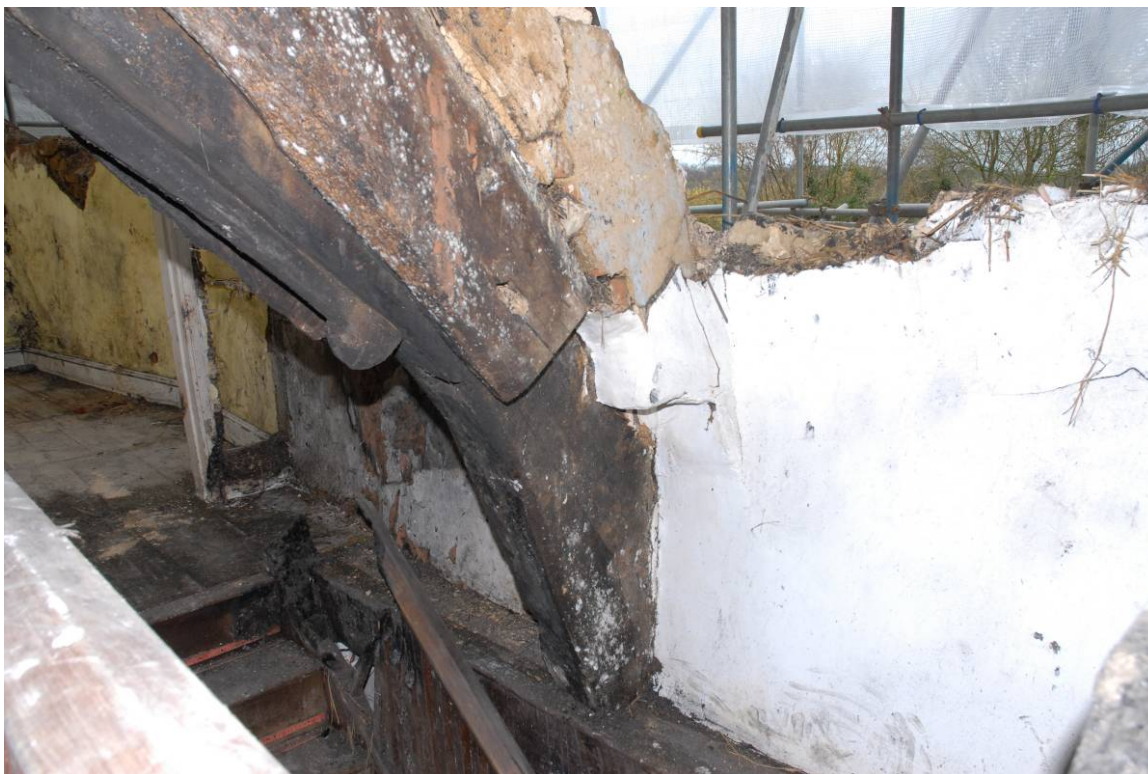
Rising from the south wall and crossing the new stairwell to the central chimney stack are the fragmentary remains of a cruck truss. The cruck blade is 0.23m wide and up to 0.4m thick with the lower part set into the south wall, curving out and over the stairwell and landing.

Cruck, looking south-east Fig 22

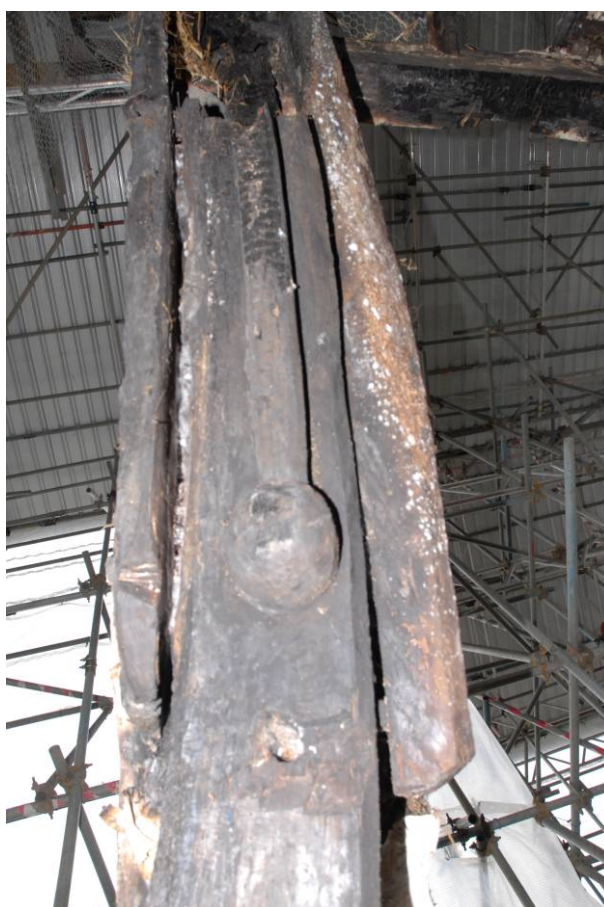
Cruck detail, looking south Fig 23

On the underside of the cruck blade there is a chamfered moulding with a carved ball stop located below what was probably a large recess or mortise, almost certainly for a missing collar beam. At about 0.6m above the landing floor, the cruck has been 'splinted' on each side by timbers up to 1.8m long, 0.35m wide and 0.1m thick. The splint timbers are clearly reused with chamfers, holes and slots cut into them. They are secured to the cruck blade by wooden dowels.

The cruck had clearly degraded in the past because at the upper end of the splints, the cruck blade has been replaced at a more acute angle by a separate timber beam up to 0.25m wide and 0.15m thick. This extended from the splints, north across the front of the central chimney stack where it was jointed into a triangular 'yoke' that supported the remains of the axial ridge beam. The corresponding beam to the north had been largely destroyed in the fire.

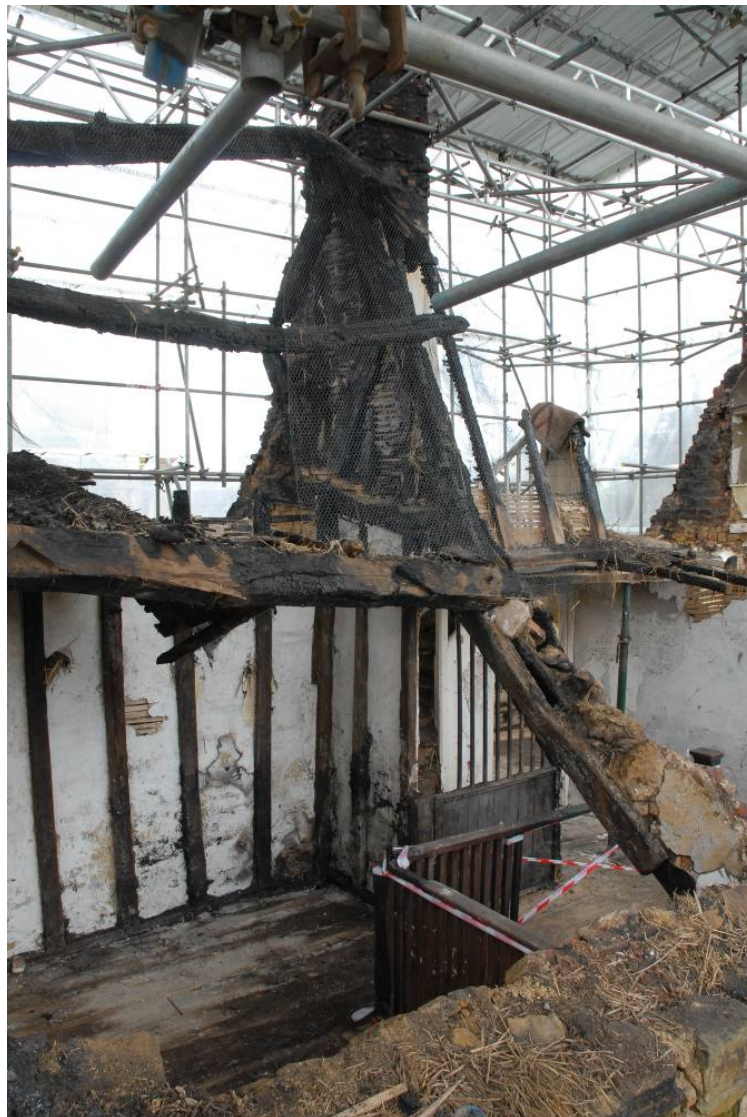
The upper beams were supported with curved braces set in a collar beam above the original ceiling height. The truss supported axial beams, of which only a fragments of one survives above the landing on the southern side of the roof. It was too badly charred to be considered for dating purposes. The upper surface is less badly affected and carries the rebates for the weather boards originally placed to help support the weight of the thatch.

Cruck, looking north-east Fig 24

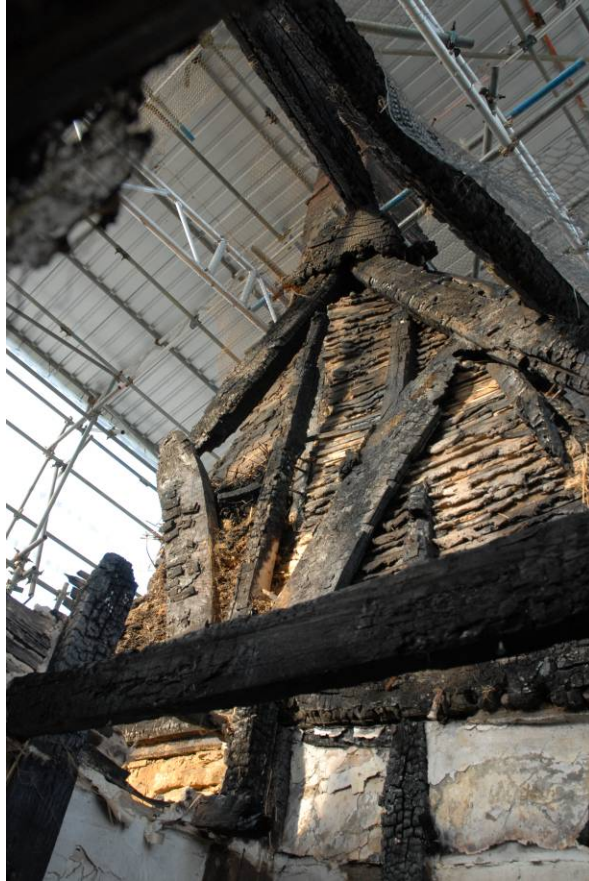
Cruck, yoke and braces, looking north-east Fig 25

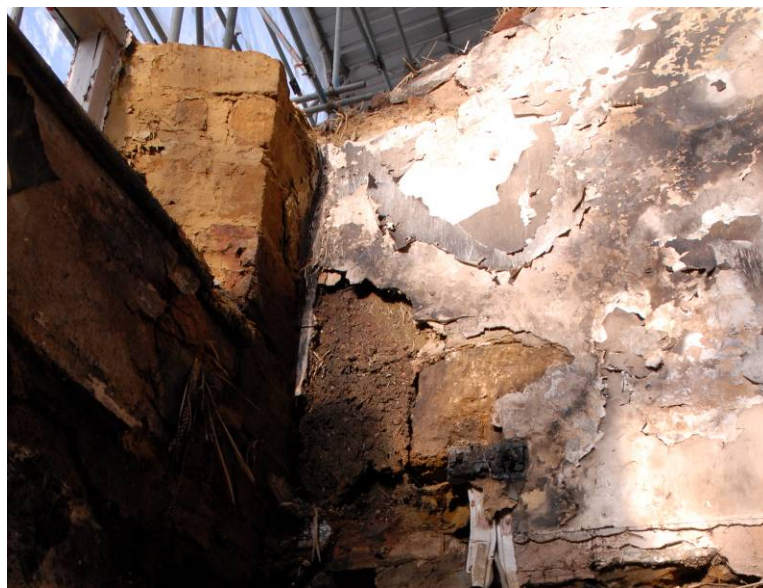
On the north wall, at its junction with the central chimney stack, there was no evidence for a corresponding cruck blade to the one on the south wall. Removal of some of the lime plaster revealed that there is a void in the stonework of the chimney stack in the appropriate place but it contains no timber cruck. At some time in the past, the void had been filled with cob and plastered.

Cob fill, looking east Fig 26

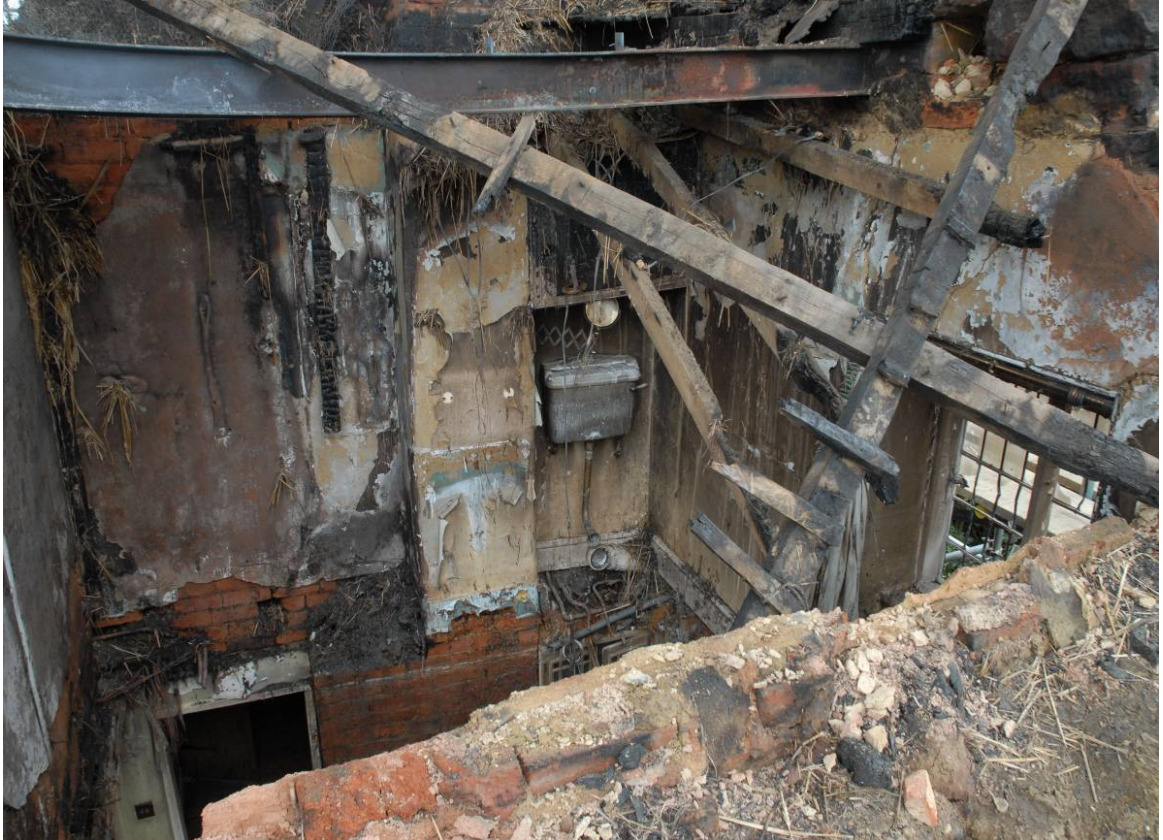
The en-suite bathroom, looking south-west Fig 29

The west doorway from Bedroom 1 gives access to the en-suite bathroom. The room measures 3.2m north to south and 2.8m east to west. It had a modern plastered ceiling 2.1m high in the centre of the building, sloping down to the wall plate on the north wall. The ceiling was hung on new wooden rafters supported by an axial steel joist.

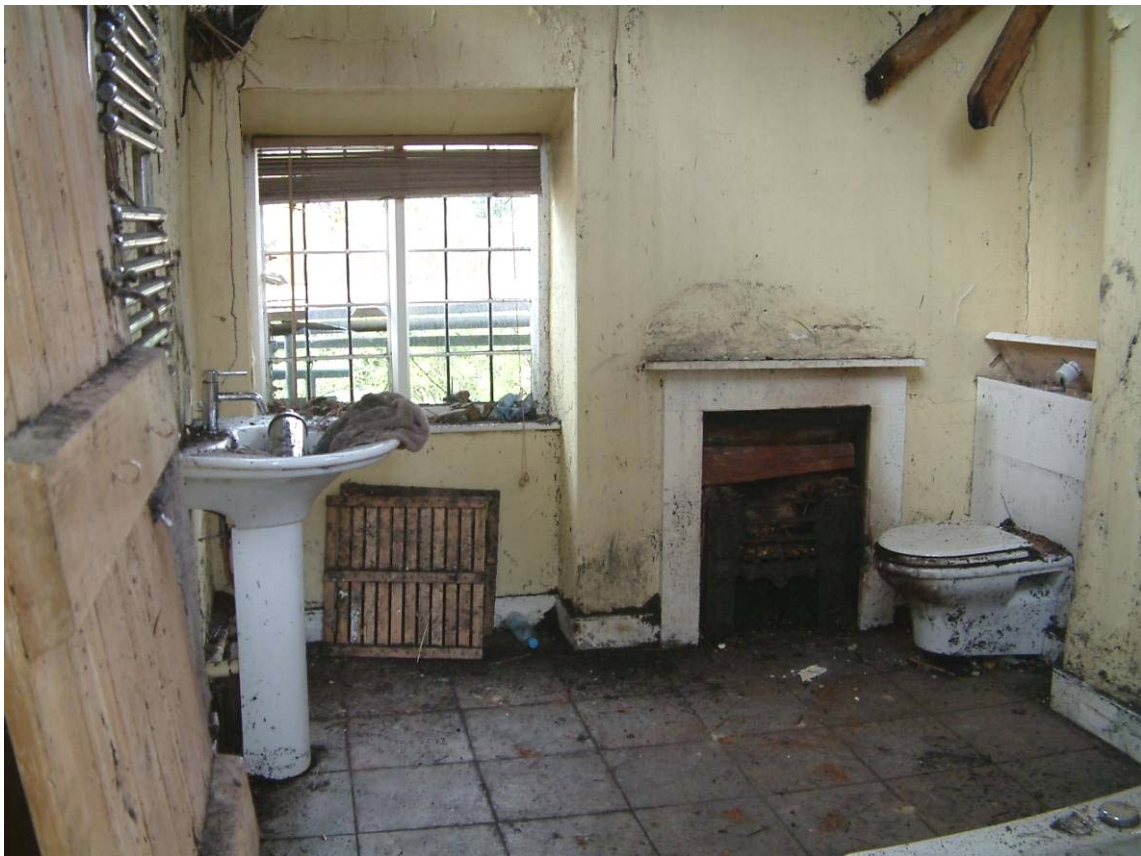
The north and east walls had been battened and plaster-boarded to allow the fixing of modern ceramic tiling around a Jacuzzi bath. A low-flush toilet is fitted in the alcove to the west of the original chimney breast. A modern stainless steel towel rail and a pedestal sink are fitted on the south wall.

Bathroom, looking west Fig 30

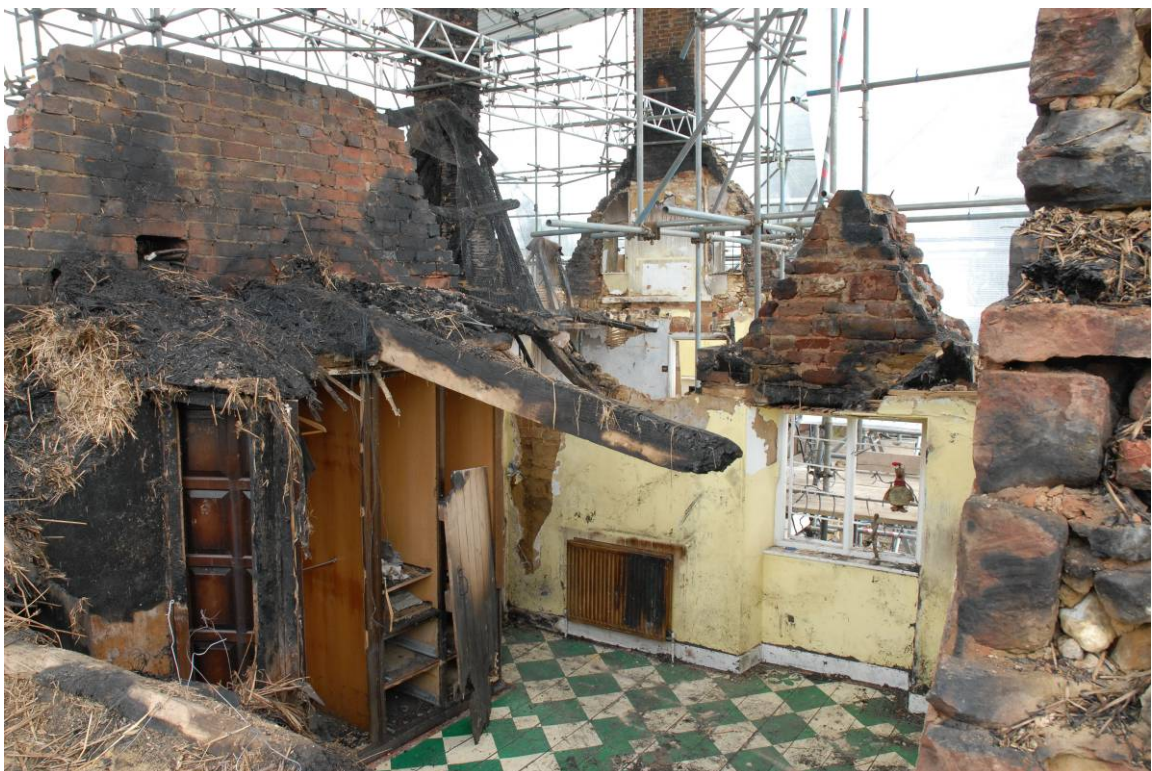
Fig 31

A modern metal expanding loft ladder lay in the ruins of the west range of wardrobes. No doubt it had given access to the roof space but there is now no indication of where it may have been located within the room.

Bedroom 2, looking north-east

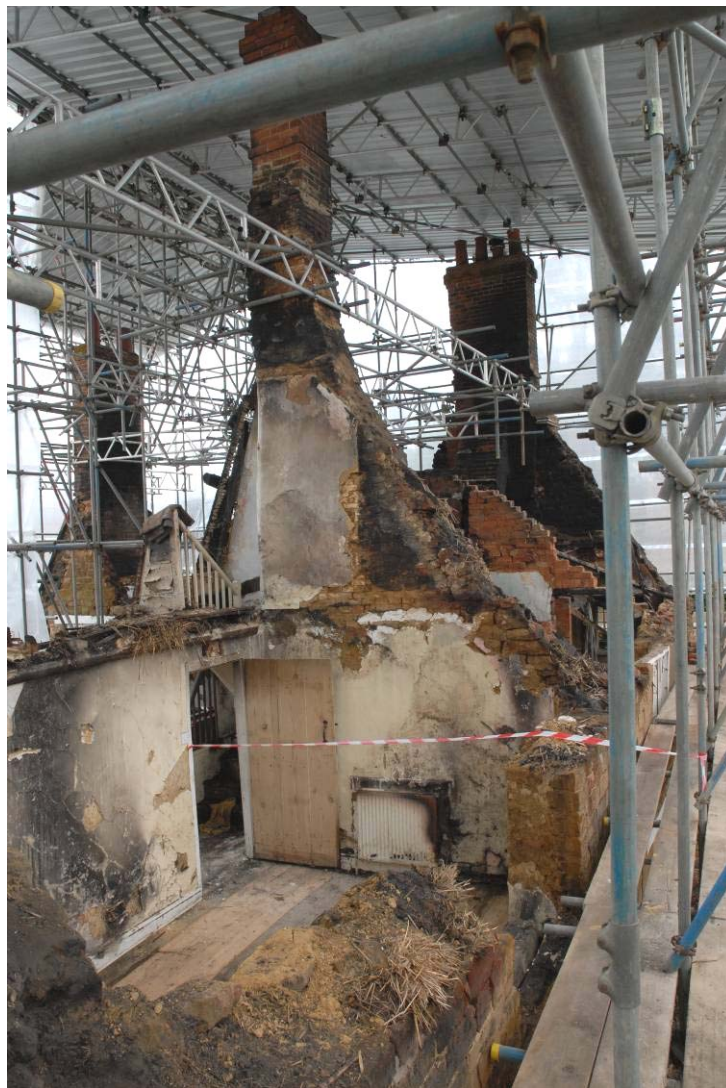
The north wall curves along its length and contains the only window. The window was 2.0m wide at the splay, 0.9m high and 0.45m to the rear of the window frame. None of the window frame survived.

Bedroom 3, looking west Fig 32

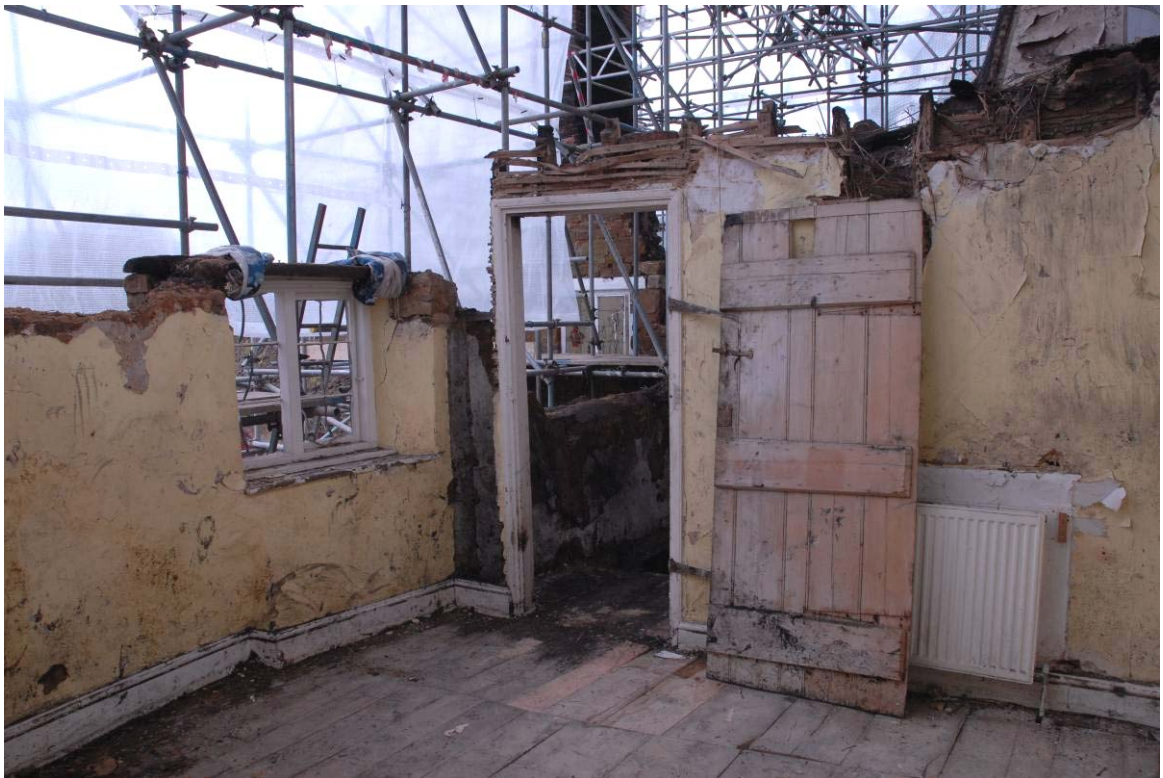
The south wall is of coursed ironstone 1.6m high rising to 1.8m over the window at the south-west of the room. Immediately below the east edge of the window, the wall 'steps' out and curves by 0.4m from the main axis of the building. To the west of the window, the wall 'steps down' in two increments to the wall plate at about 1.1m above floor level. This part of the wall was badly disturbed by the collapse of the roof timbers and exact measurements were not possible.

Bedroom 4, looking south-west Fig 33

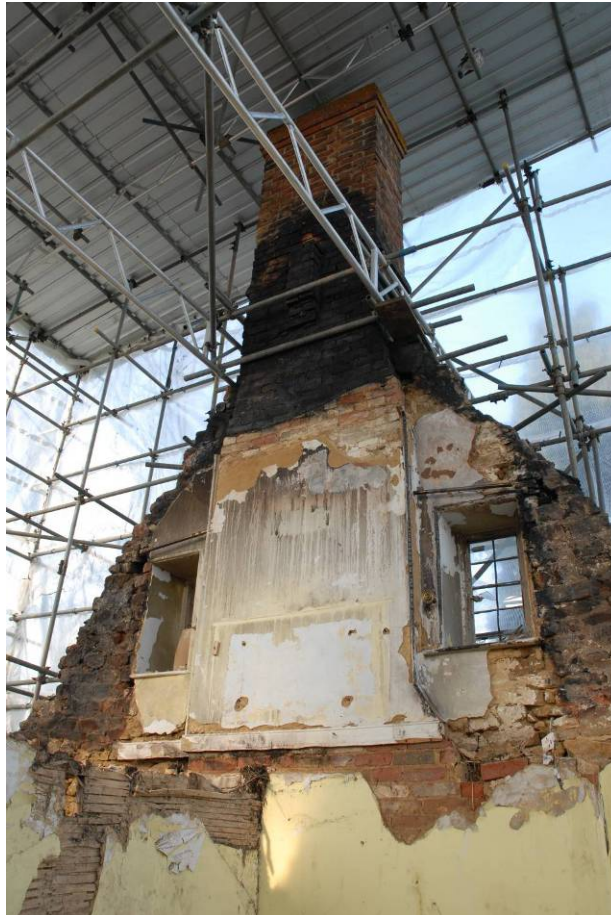
Fig 34

Bedroom 5, looking north-east
