Archaeological excavation on land
to the north of St Andrew's Church
Station Road, Abbots Ripton
Cambridgeshire
April 2011

Report 11/114

June 2011

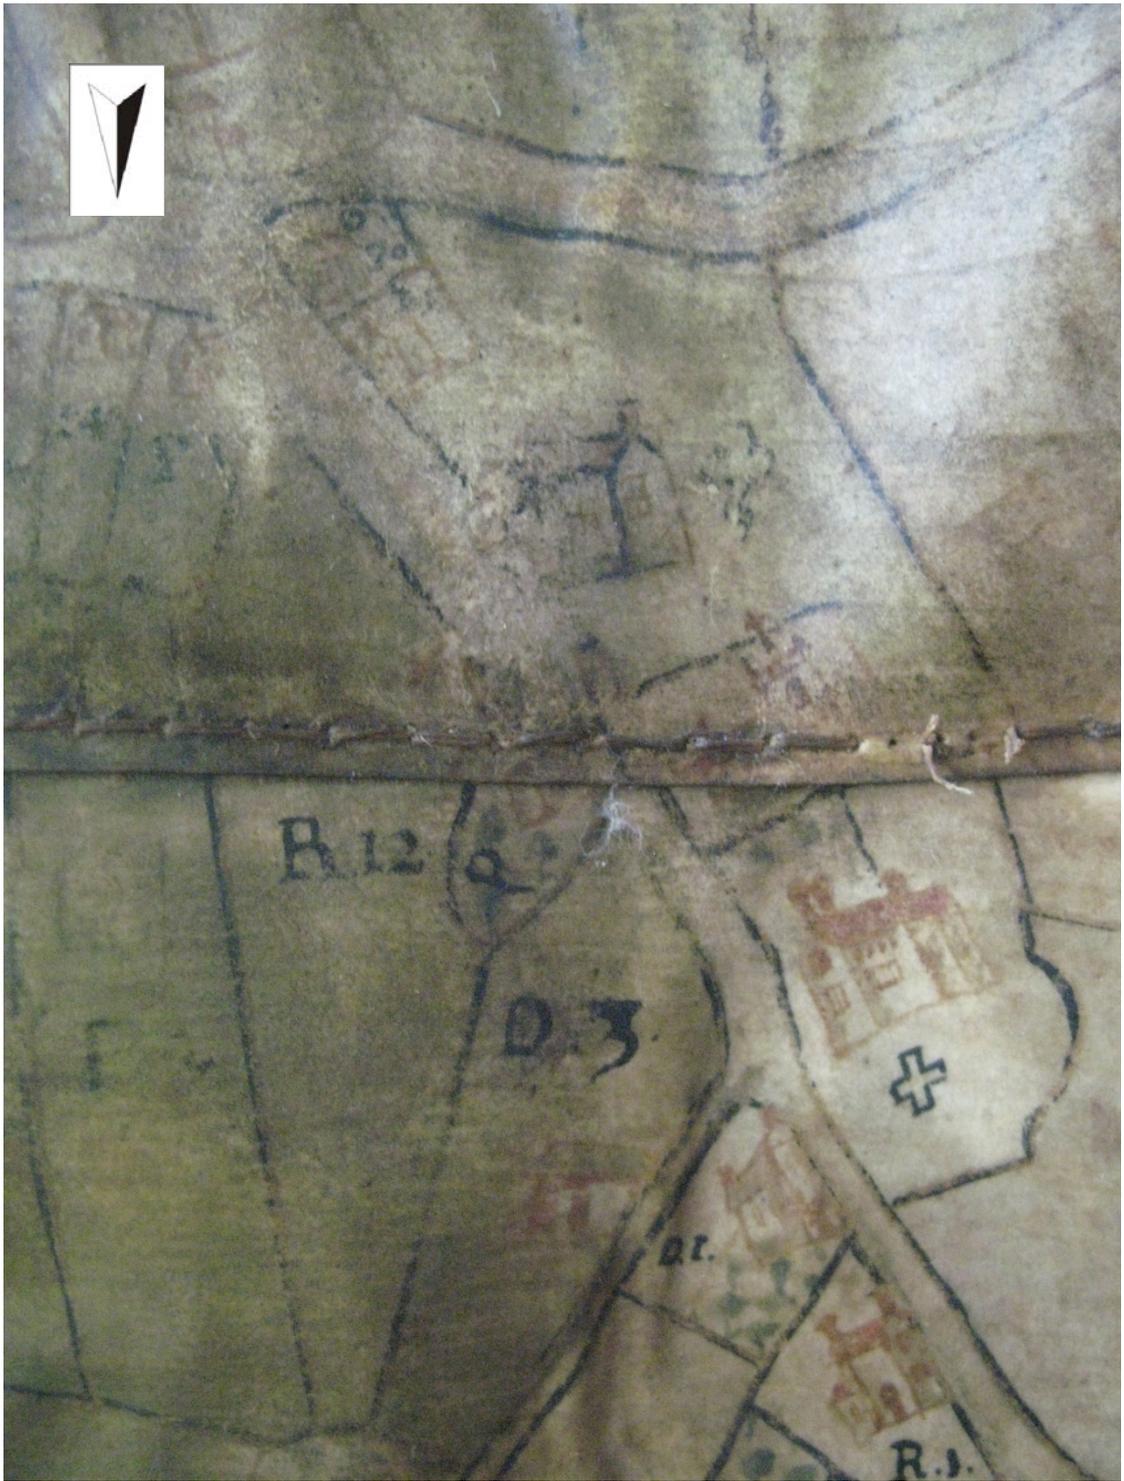
Detail of 1623 tithe map Fig 3

The investigation area, containing the parsonage and its associated buildings are depicted on two historic maps; the Tithe map of 1623, which is housed in St Andrew's Church (Fig 3), access to which was by the kind permission of Mr and Mrs Jack Crompton; and the 1773 estate map (Fig 4) which was kindly provided by Mr Robert Pickard of the Abbots Ripton Farming Company.

The maps of 1623 (Fig 3), 1773 (Fig 4) and 1847 all show a building in the approximate position to that encountered by the excavation in slightly varying forms. Although old maps cannot generally be considered reliable records of actual architectural forms of individual buildings, they would suggest in this instance that the parsonage had seen extensive alteration or rebuilding during its lifetime. This could explain the view of the north-west facing elevation, the junction of walls (105) and (109) (Fig 4) where the 18th-century bricks appeared to have been laid around and over a core of slightly smaller bricks. Between 1847 and 1880, as evidenced by the tithe map and the first edition Ordnance Survey map the parsonage was demolished and the land levelled.

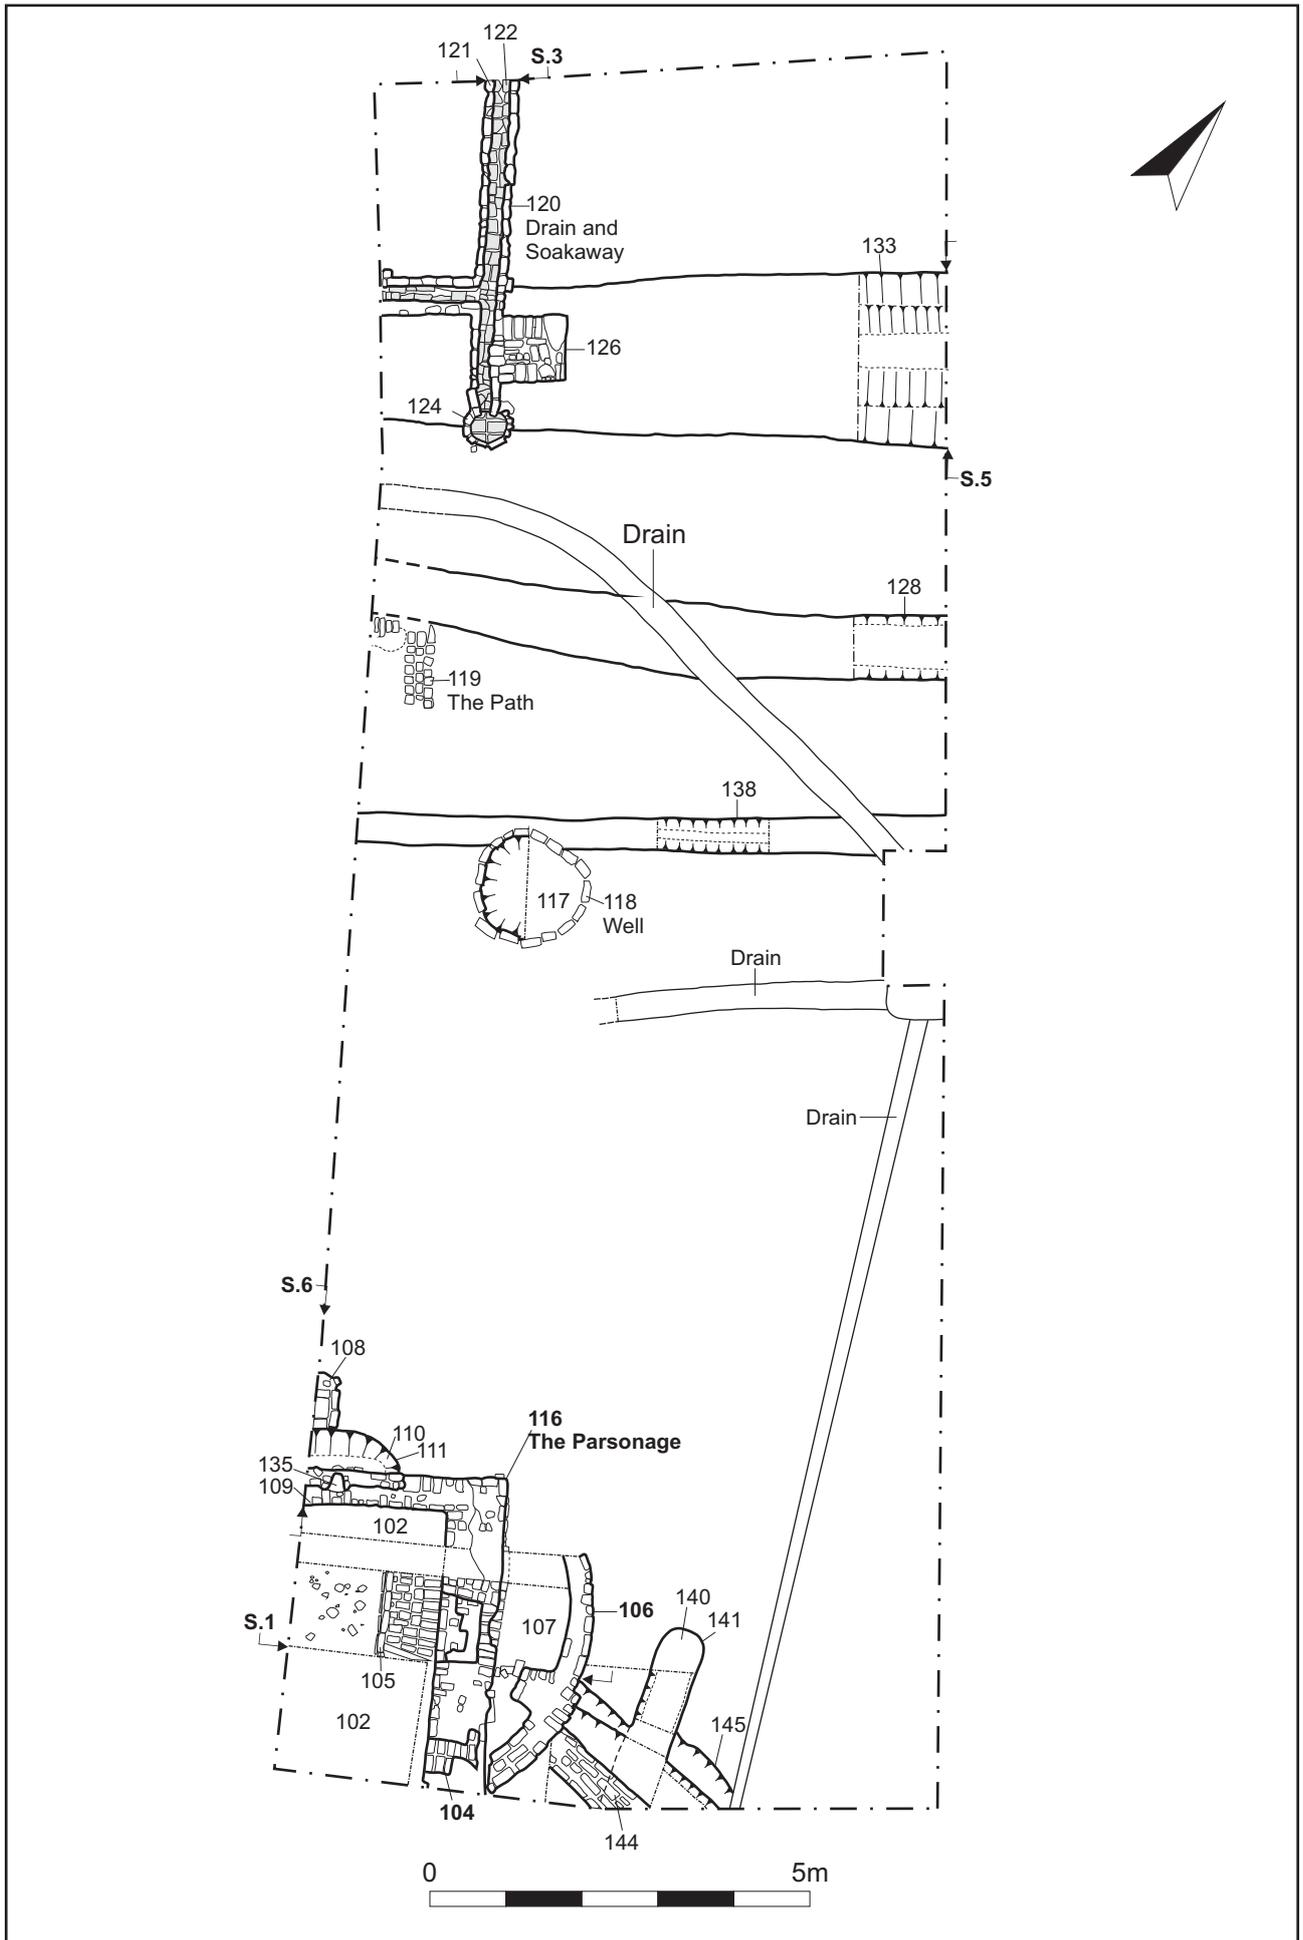
Site plan Fig 5

The natural substrate across the site comprised a firm mid brown clay with bluish-grey mottling and chalky flecks. This was overlain by a dark brown-grey silty clay subsoil, (107), which was 0.15m-0.30m thick. In the southern corner of the site this was overlain by a similar material, (102), 0.20m-0.30m thick, which contained abundant brick and mortar pieces relating to the demolition of former buildings on the site. The topsoil across the site comprised a dark brown-grey clay loam, (101), 0.15m-0.30m thick.

In the north-western part of the site there were three ditches aligned north-east to south-west (Fig 5). These are likely to represent a single boundary shifting over time, with possible medieval origins and final abandonment in the 19th-century.

On the eastern side of the building there was a curving wall, (106), which was 0.30m to 0.40m wide, 4m long and projected 1.20m from the side of the building (Fig 5). The bricks and bonding were similar to that of the main building with a higher occurrence of half bricks needed to achieve the apsidal shape. There was no foundation for the wall and the single course of surviving bricks appeared to have been laid on a thin mortar bed directly on the subsoil (Fig 7, section 1). At the southern end, it overlay the fill of the drain cut [145]. Near to the southern end of the wall there was an internal buttress, 0.30m by 0.40m which survived to two courses.

This sub-circular well was located in the middle of the excavation area and had a diameter of 1.30m and was excavated to 0.40m (Fig 5). It comprised unbonded pale yellow bricks and was filled with a dark brown-grey silty loam with frequent red brick fragments and pottery dating from the 15th to 20th centuries. The north-western edge of the well cut ditch [138].

To the south and 2.50m from the soakaway there was a small paved area, (119), 1.20m long by 0.40m wide (Fig 5). It comprised square and sub rectangular handmade bricks which were up to 105mm wide and 43mm thick (4 $\frac{1}{8}$ x 1 $\frac{5}{8}$ inches) and were worn smooth on their upper surfaces. They appeared to have been laid on a thin layer of subsoil, 0.05m thick.

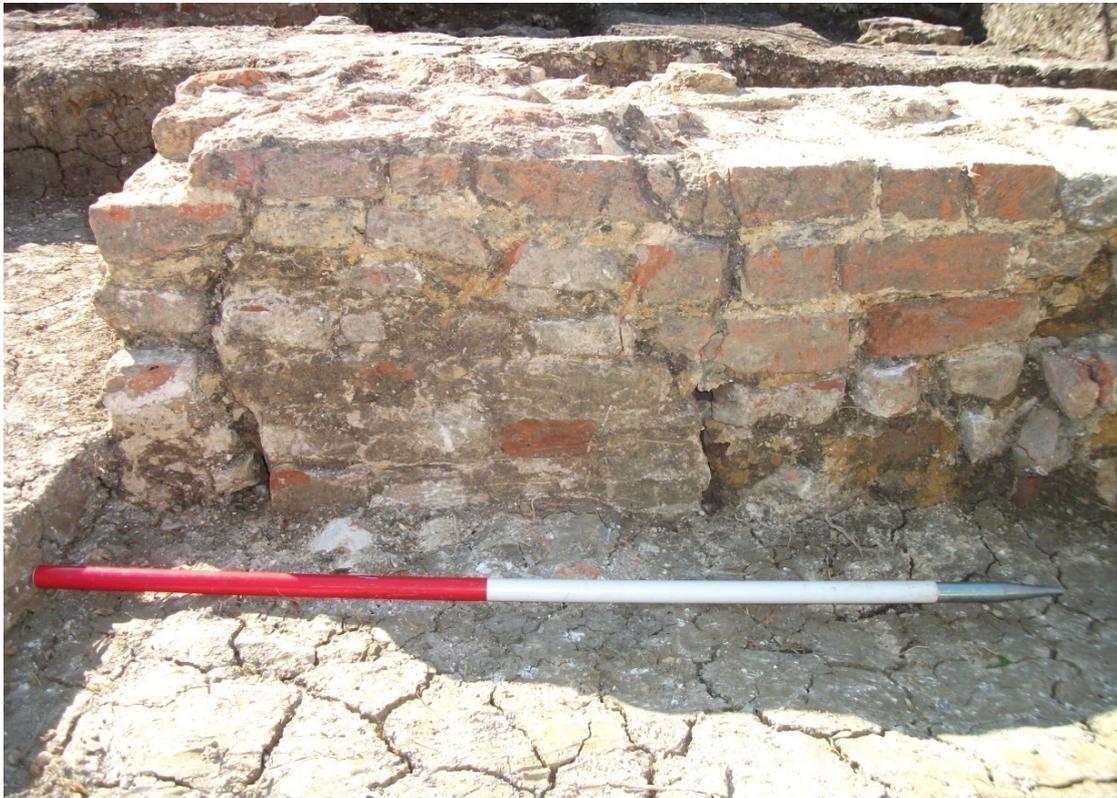
Structure 116, wall (104), north-west facing elevation Fig 6

The eastern wall, (104), was 0.80m-0.85m wide and appeared to have been built upon an earlier foundation (Fig 6).

The walls appeared to cut subsoil (107), although no foundation cut was visible so it is possible that the subsoil accumulated after the building's construction. The bricks were handmade, unfroged and generally measured 215 x 100 x 68mm (8½ x 4 x 2⅝ inches). They were predominantly orange-red in colour although there were a few that were pale yellow. The bonding comprised a soft lime mortar which ranged in colour from light to dark orange-yellow.

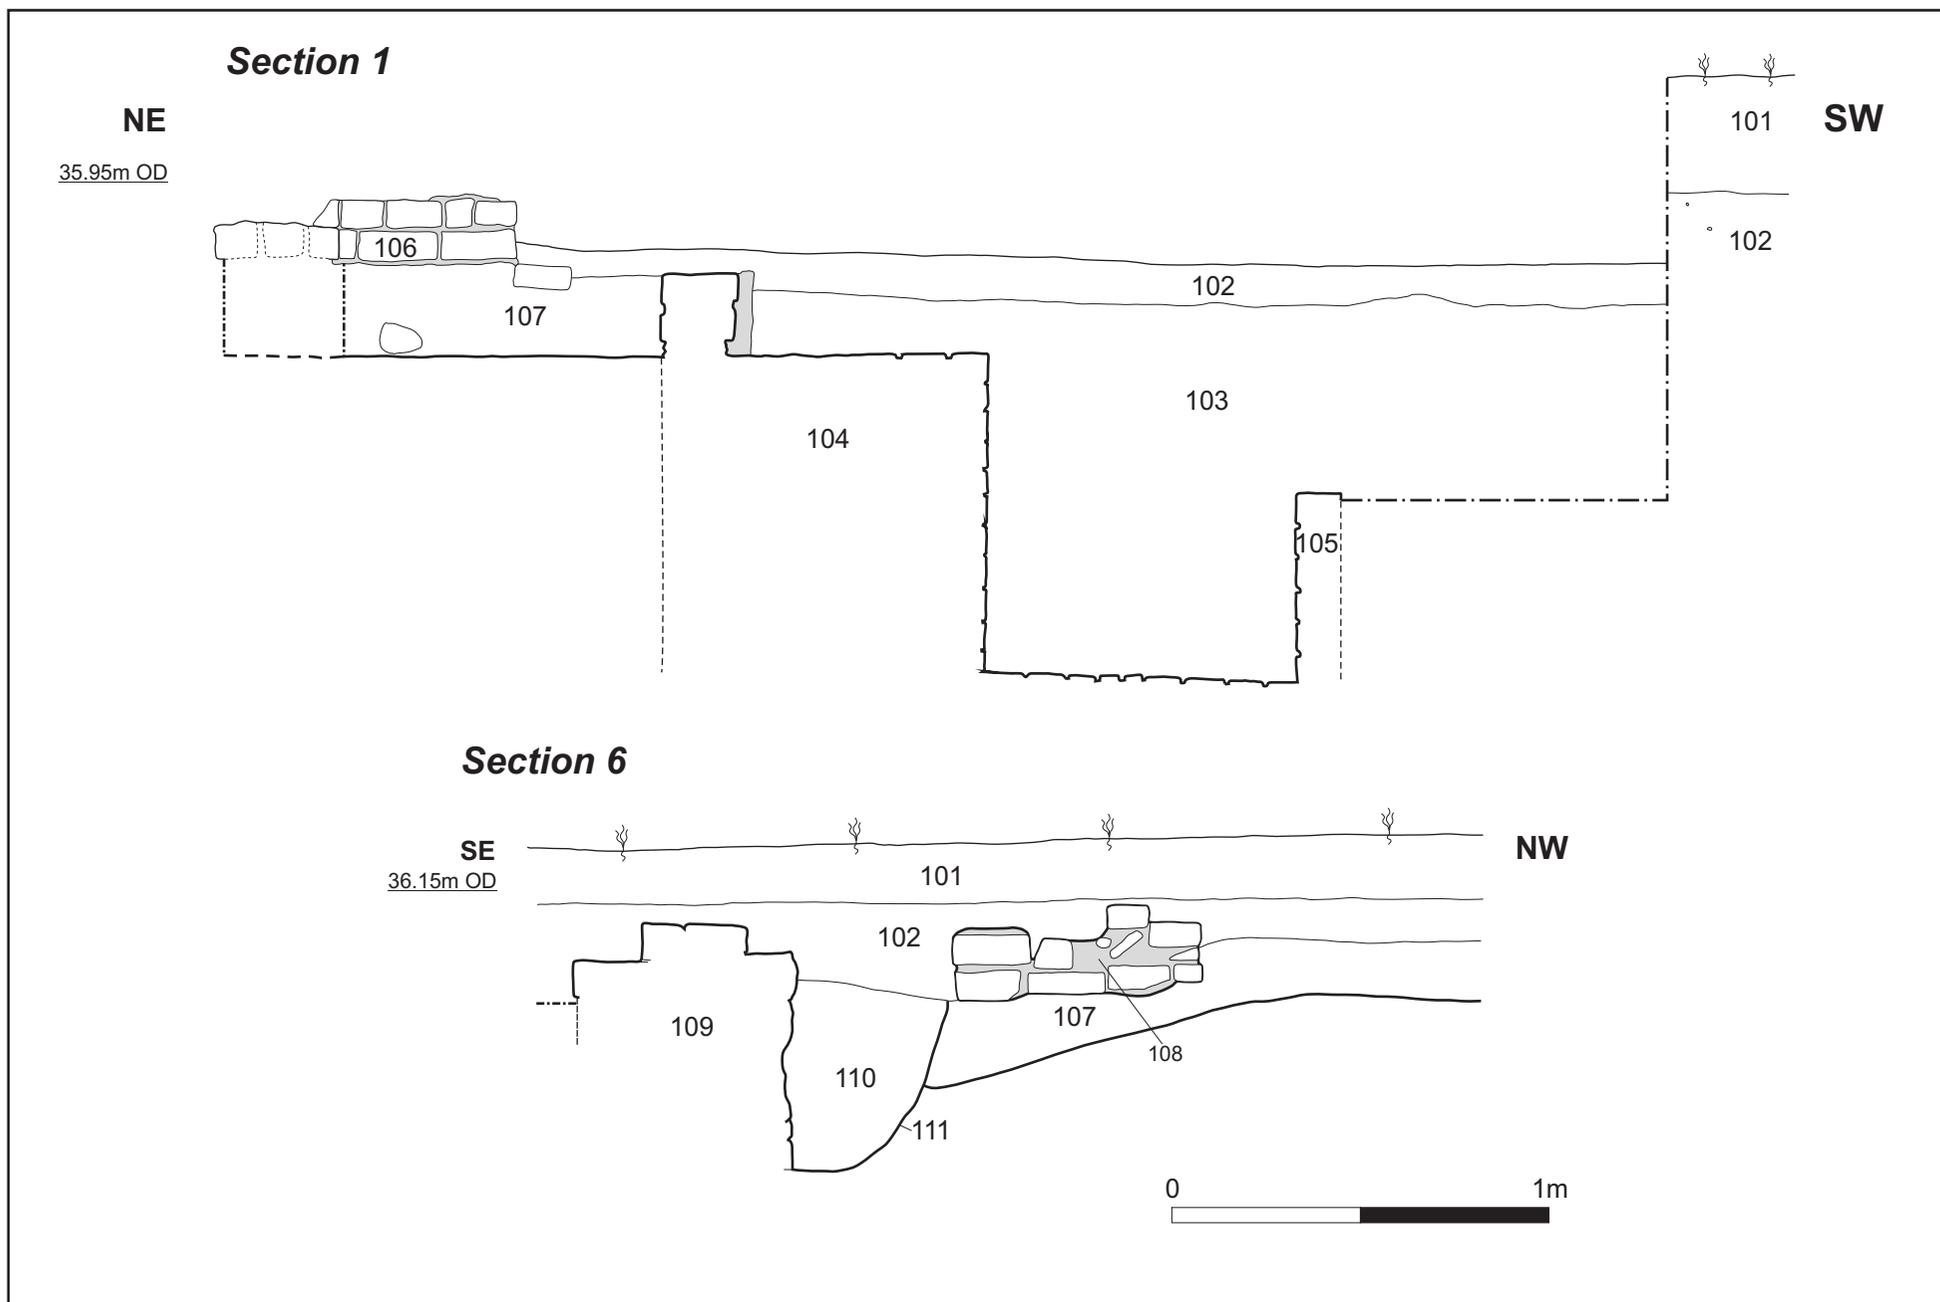
Structure 116, sections 1 and 6 Fig 7

In the middle of the exposed section of the wall there was a light well into the cellar, 1m to 0.80m wide and 0.50m deep, which had been rendered with a creamy white plaster, 0.05m thick. The outside was upstanding 0.20m (two courses) from the natural substrate whilst the inside was 1.05m (13 courses) from the top of the wall to the floor of the cellar (Fig 7, section 1).

To the north-west and 0.45m from wall (109) there was a small rectangular group of mortar bonded bricks, (108). This was only partially exposed and was at least 0.30m wide, 0.70m long and 0.20m high. It had no clear relationship to the main building and may have been truncated by pit [111] (Fig 7, section 6).

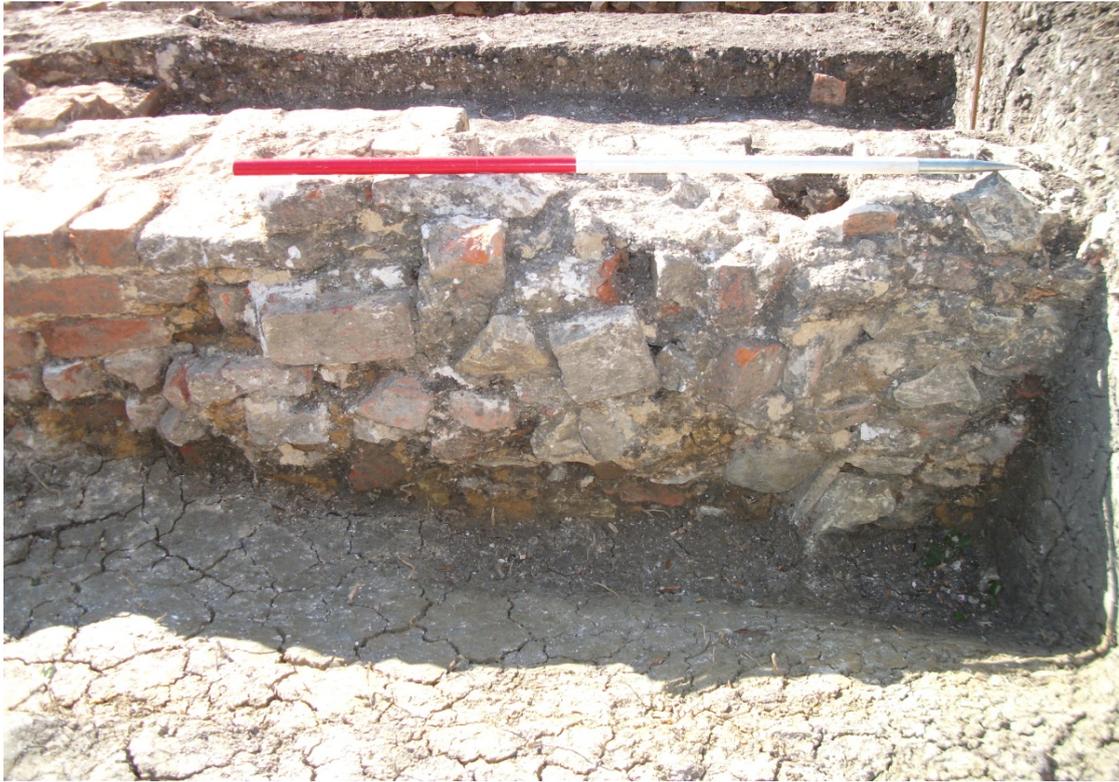
The possible repair to wall (109), looking south-east Fig 8

The northern wall, (109), was 0.45m-0.50m wide and had evidence of a possible repair approximately 1m from the corner of the building (Fig 8). The area of repair comprised a patch of randomly placed bricks, half bricks and stone fragments which had been mortared to the outside of the wall. This corresponded with a steep sided-pit, [111]/(110), which had been dug up against the side of the wall, presumably to facilitate the repair (Fig 7, section 6). There was a sub-rectangular beam slot, [135], 0.50m long, tapered from 0.50m to 0.20m wide and at least 0.45m deep with vertical sides. The fill comprised a dark brown loam with occasional brick fragments and contained a single sherd of 18th-19th-century pottery.

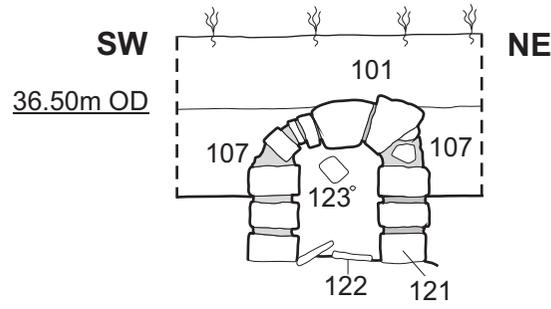
Section 3

Drain 121, section 3 and ditch 133, section 5 Fig 9

The mortar bonded brick walls of the drain (121) survived to three courses, the lower two courses were cut into the natural substrate although there was no clear foundation cut. The bricks varied in size and colour and included many half and quarter bricks, some of which had white wash or remnants of render, suggesting that they had been reused for the drain's construction. The drain had been covered by a vaulted brick and stone capping which could only be seen in the north-west edge of excavation (Fig 9, section 3).

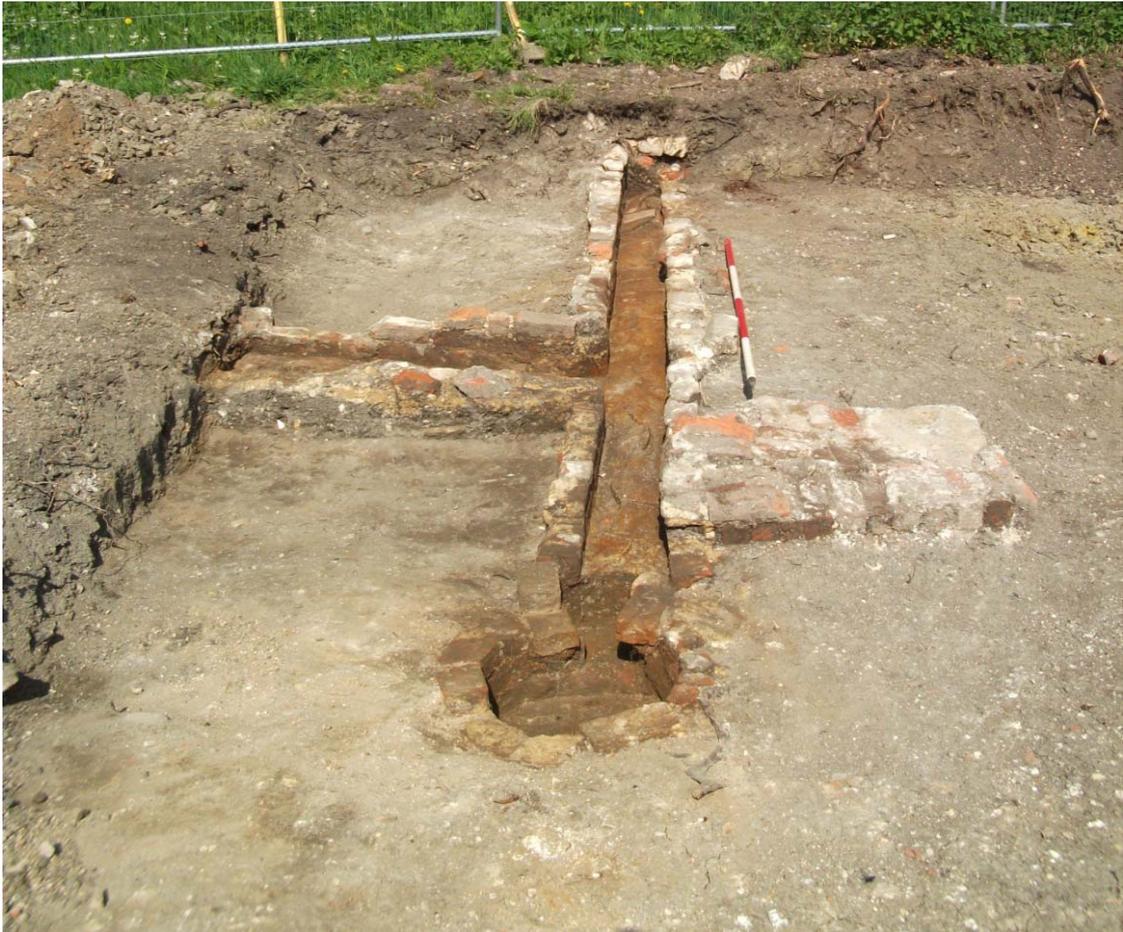
The drain and soakaway, structure 120, looking north-west Fig 10

This was situated in the north-west corner of the excavation area and comprised a drain and small circular soakaway, both of which were of brick and tile construction (Fig 10). The structure was not exposed in its entirety and its exact function was unclear, although the movement of water towards the circular element was clearly the goal of its construction. It may have been associated with an agricultural building such as a cow shed.

The exposed section of drain consisted of two arms, both extending beyond the limit of excavation. The arm aligned north-west to south-east was at least 4m long and the arm aligned north-east to south-west was at least 1.20m long and had a pronounced downward slope into the main arm. Both were 0.45m-0.50m wide and 0.25m deep.

At the south-east end of the drain there was a small, subcircular soakaway, (124) which was of the same brick and tile construction as the drain. It was 0.50m in diameter, 0.20m deep and was filled with red brick fragments, presumably intentionally placed there to aid drainage.
