A Photographic Survey of The British Red Cross Building Lower Chantry Lane, Canterbury

Report 11/126

October 2011

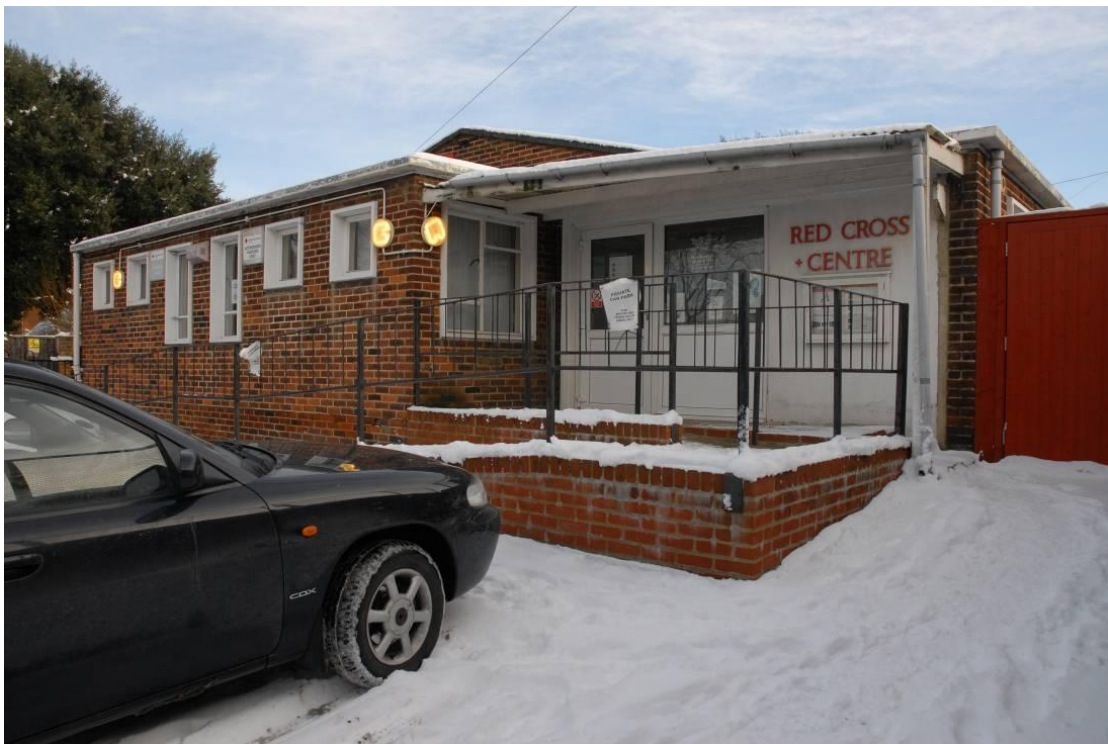
The building consists of a single-storey brick building with a felted pitched roof. Flat roofed single-storey extensions are to the front and south side of the building (Fig 4).

The front elevation of the building, looking east, showing the extensions Fig 4

Most of the original metal framed doors and windows survive with the exception of the front entrance door with adjoining window and the rear access door with adjoining window which consist of modern UPVC replacements (Figs 4-5). An original metal framed door with adjoining window survives in the kitchen (Fig 9).

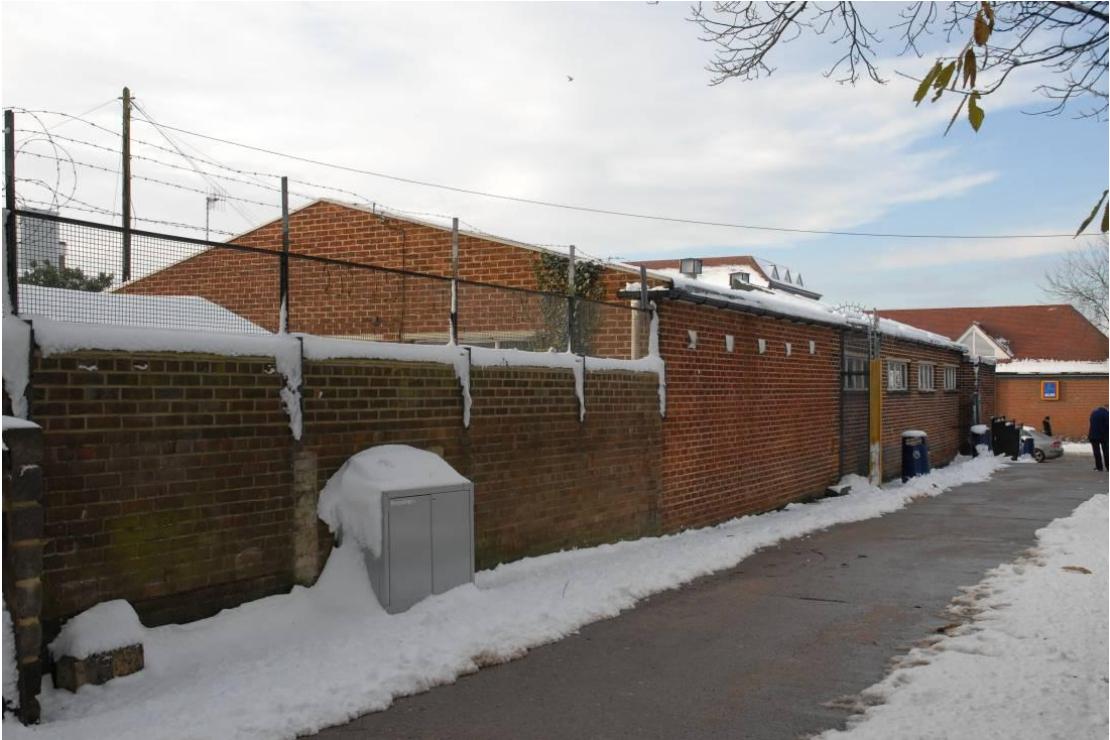
The extensions appear to consist of at least two phases of alterations as several changes in brickwork and fenestration are apparent. The main building demonstrates this towards the rear of the east elevation where the length of the main building had been extended, with the same pitched roof, and an enclosing yard wall added (Fig 5). This change of brickwork corresponds with the addition of offices at the rear of the building. In the covered area at the rear of the south-west elevation, the doorway was later enlarged to accommodate more light (Fig 6).

The north-east elevation showing a rear extension of the 1955 building Fig 5

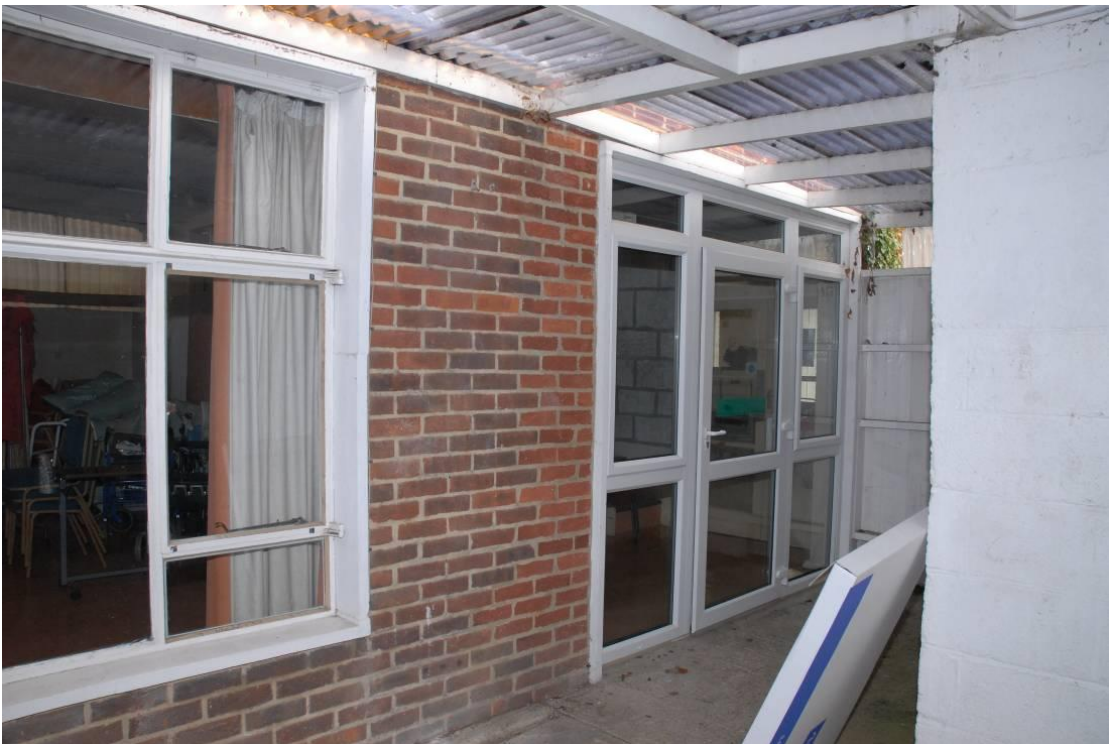
The south doorway showing the change in brickwork Fig 6

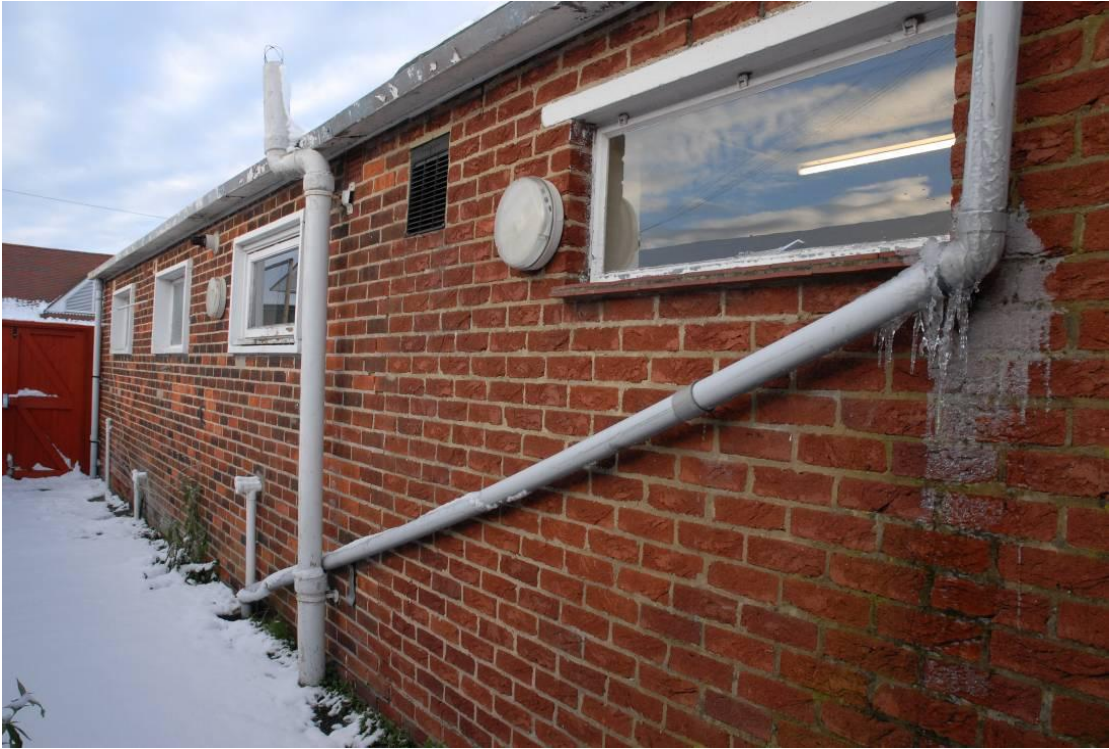
The rear half of the kitchen may be contemporary with the extension of the main building to the rear, demonstrated by the change in brickwork and fenestration (Fig 7), both of which exhibit similarities in the exposed plain concrete lintels and metal frames (Fig 8).

The kitchen extension showing the change in brickwork and fenestration Fig 7

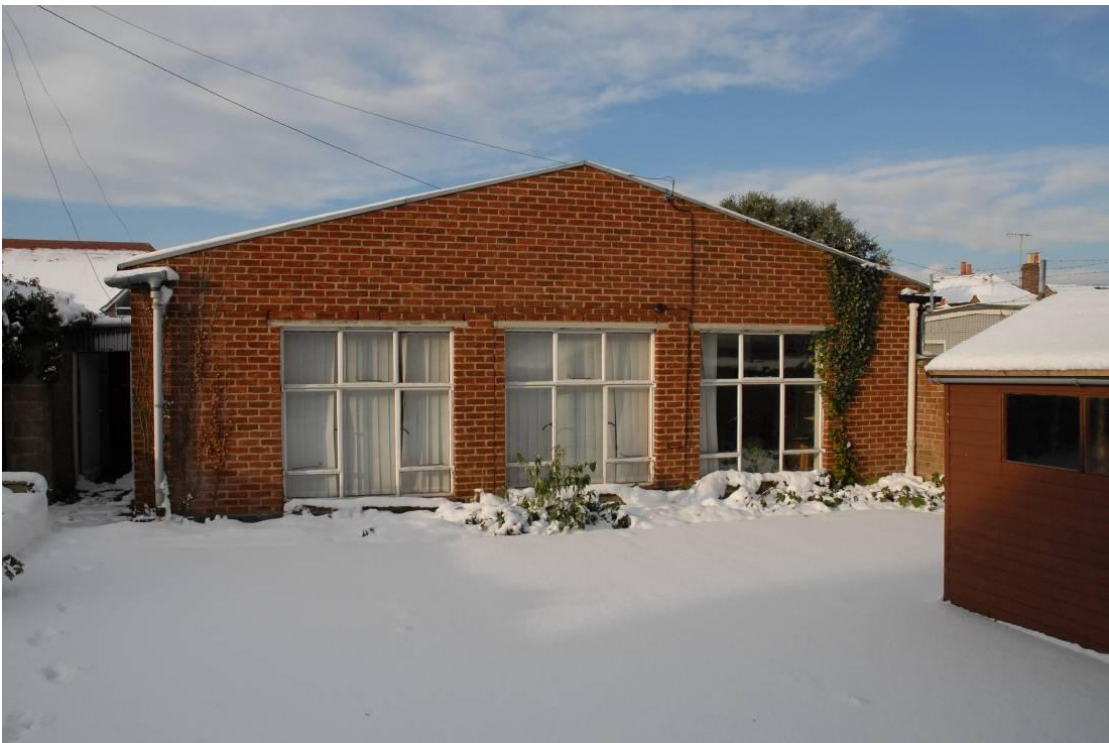
The rear elevation showing window and lintel styles Fig 8

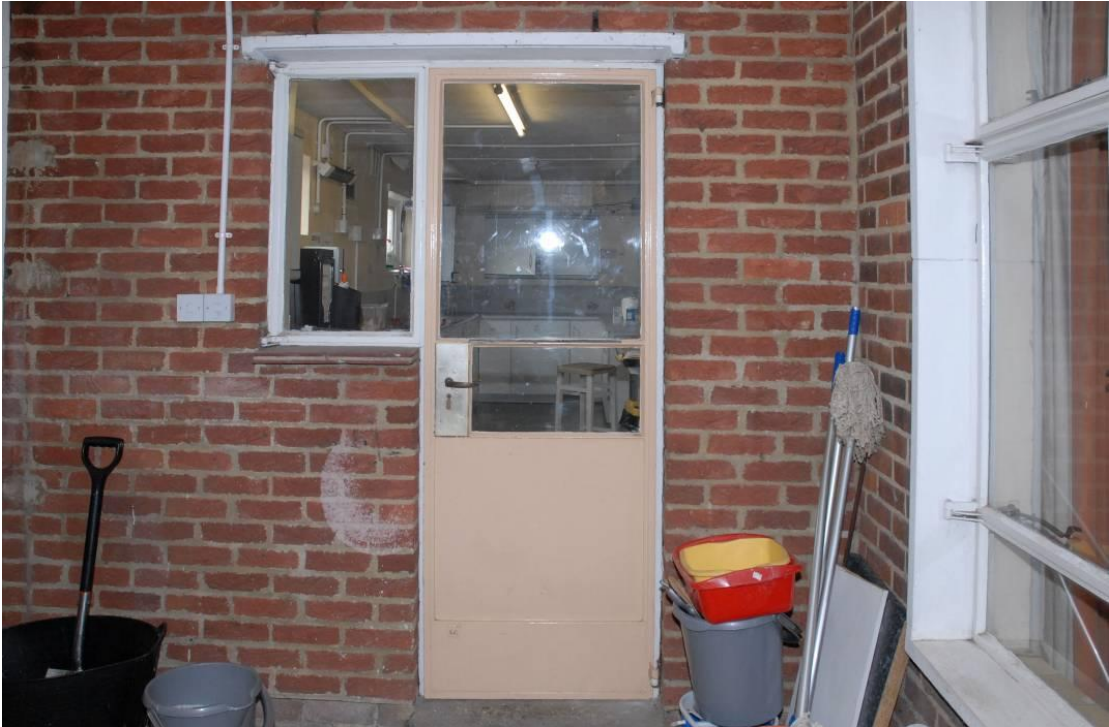
The external door to the kitchen Fig 9

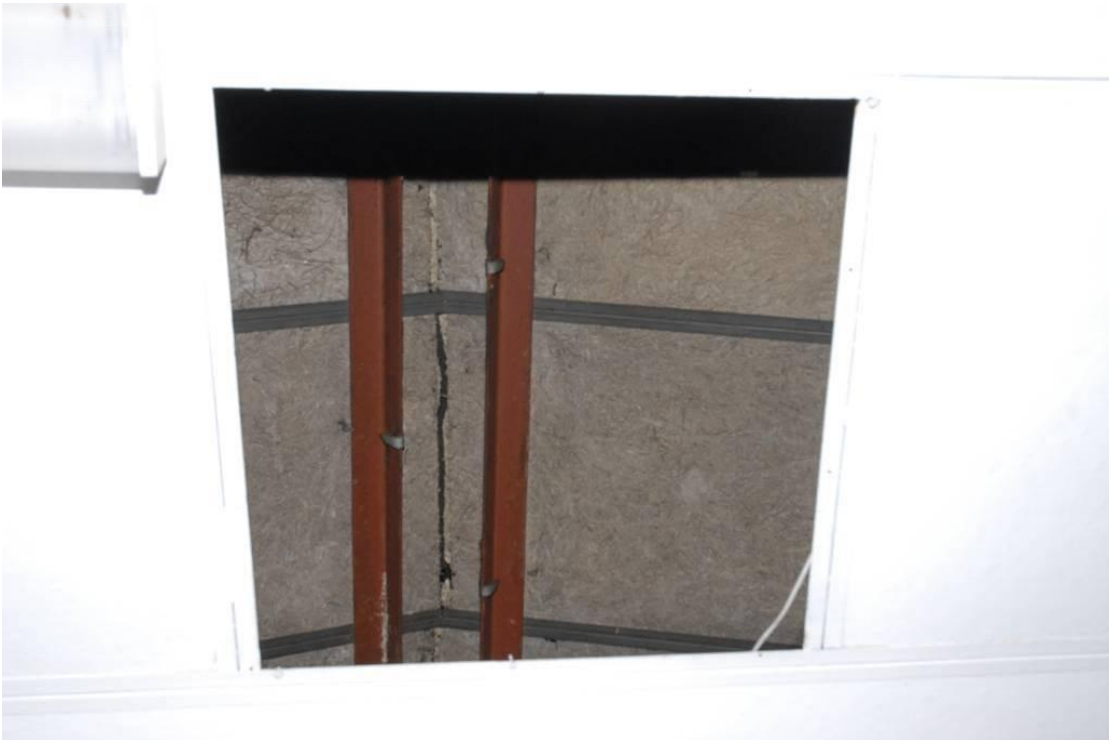
The roof was covered with snow at the time of survey, however, the internal structure, visible through the suspended ceiling, indicates that it is of a metal frame construction (Fig 10). Skylights are present along the north-east pitch.

The roof frame visible through the ceiling Fig 10

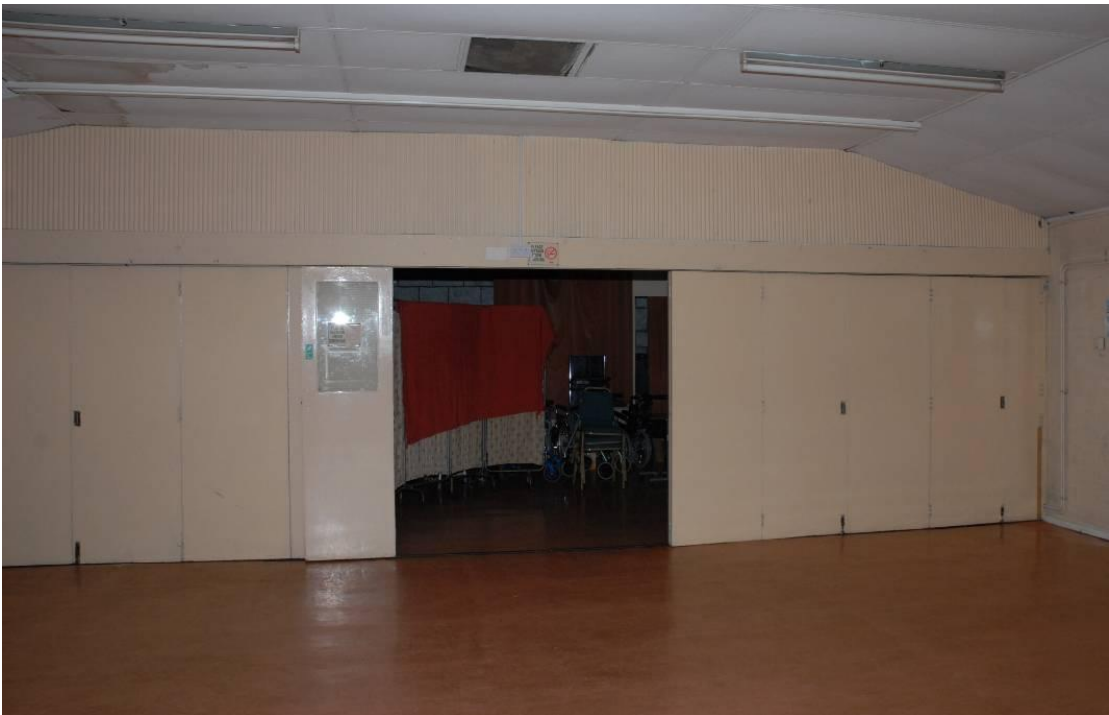
The concertina doors between the Hall and Stage rooms Fig 11

The internal walls consist of both half-brick partitions and stud wall partitions, both decorated with magnolia emulsion. The partition between the Hall and the room containing the stage consists of wooden concertina doors enabling the rooms to become one large space (Fig 11). The wall between the Kitchen and the Hall is pierced by a serving hatch with wooden doors (Fig 12). Few further internal fixtures

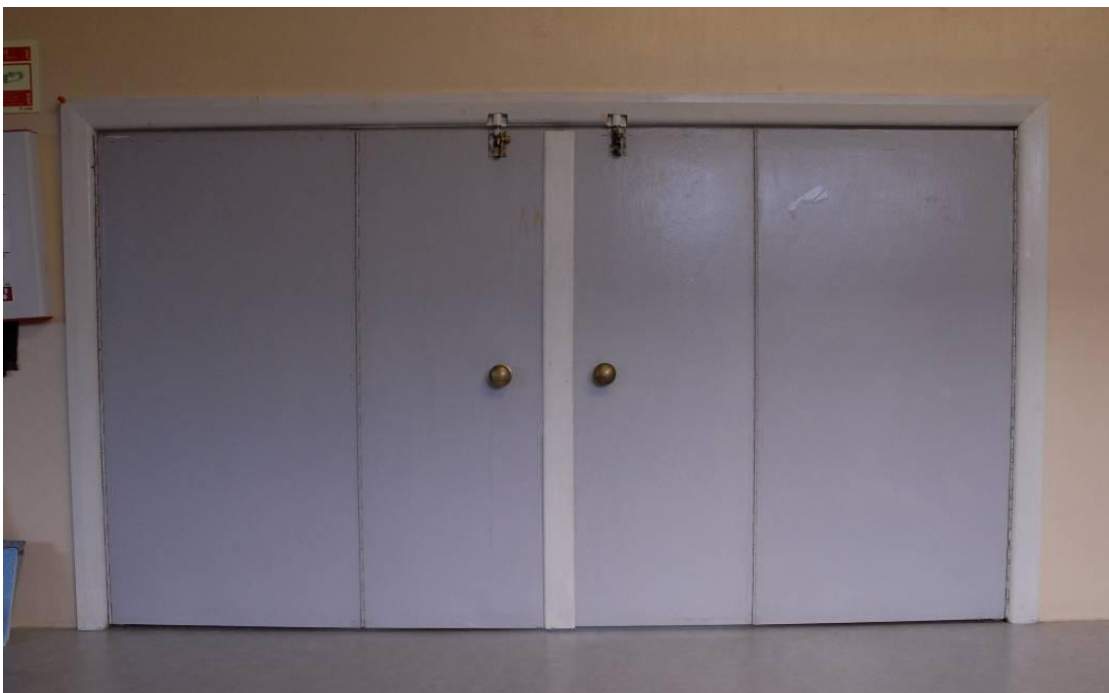
The serving hatch between the Hall and Kitchen Fig 12

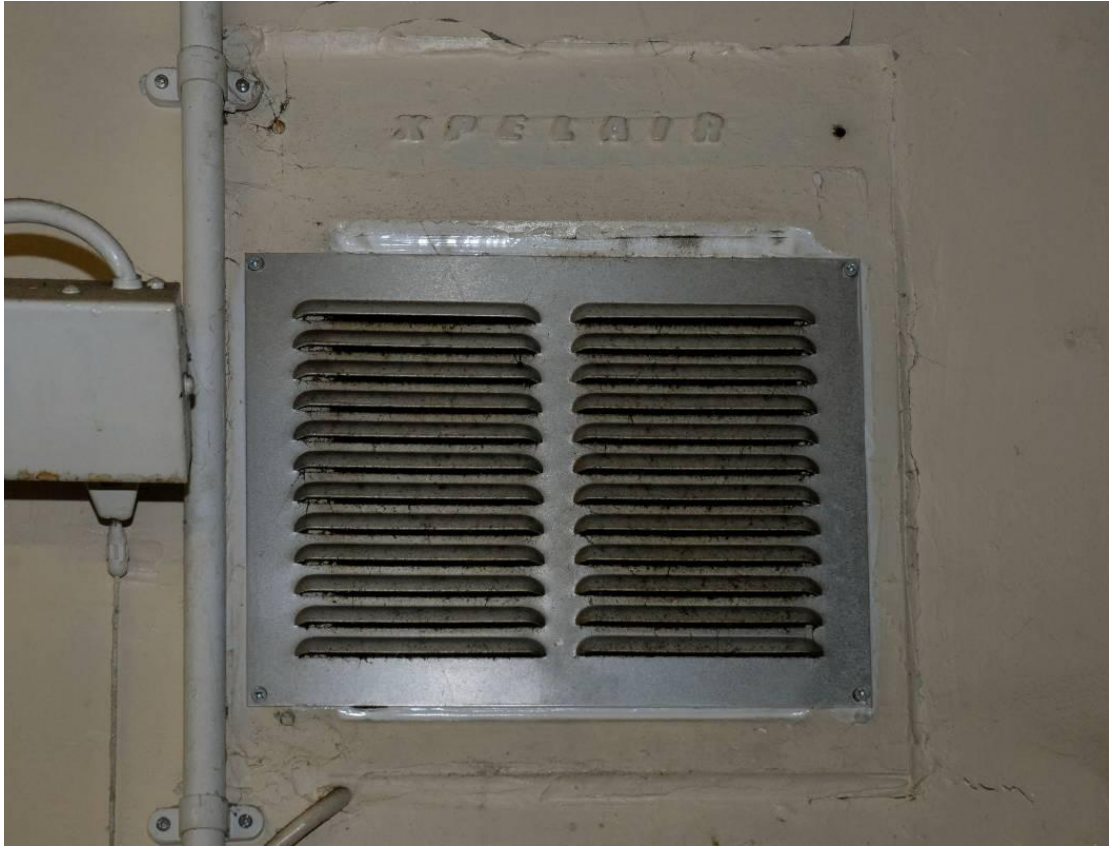
and fittings are of note. An original Xpelair extractor fan fascia is visible behind a modern ventilation cover (Fig 13).

The original Xpelair fascia in the Kitchen Fig 13
