Archaeological Building Recording during a  
Watching brief at 27 High Street, Daventry  
Northamptonshire  
April 2011

Report 11/138

**ARCHAEOLOGICAL BUILDING RECORDING DURING A WATCHING BRIEF AT  
27 HIGH STREET, DAVENTRY, NORTHAMPTONSHIRE  
APRIL 2011**

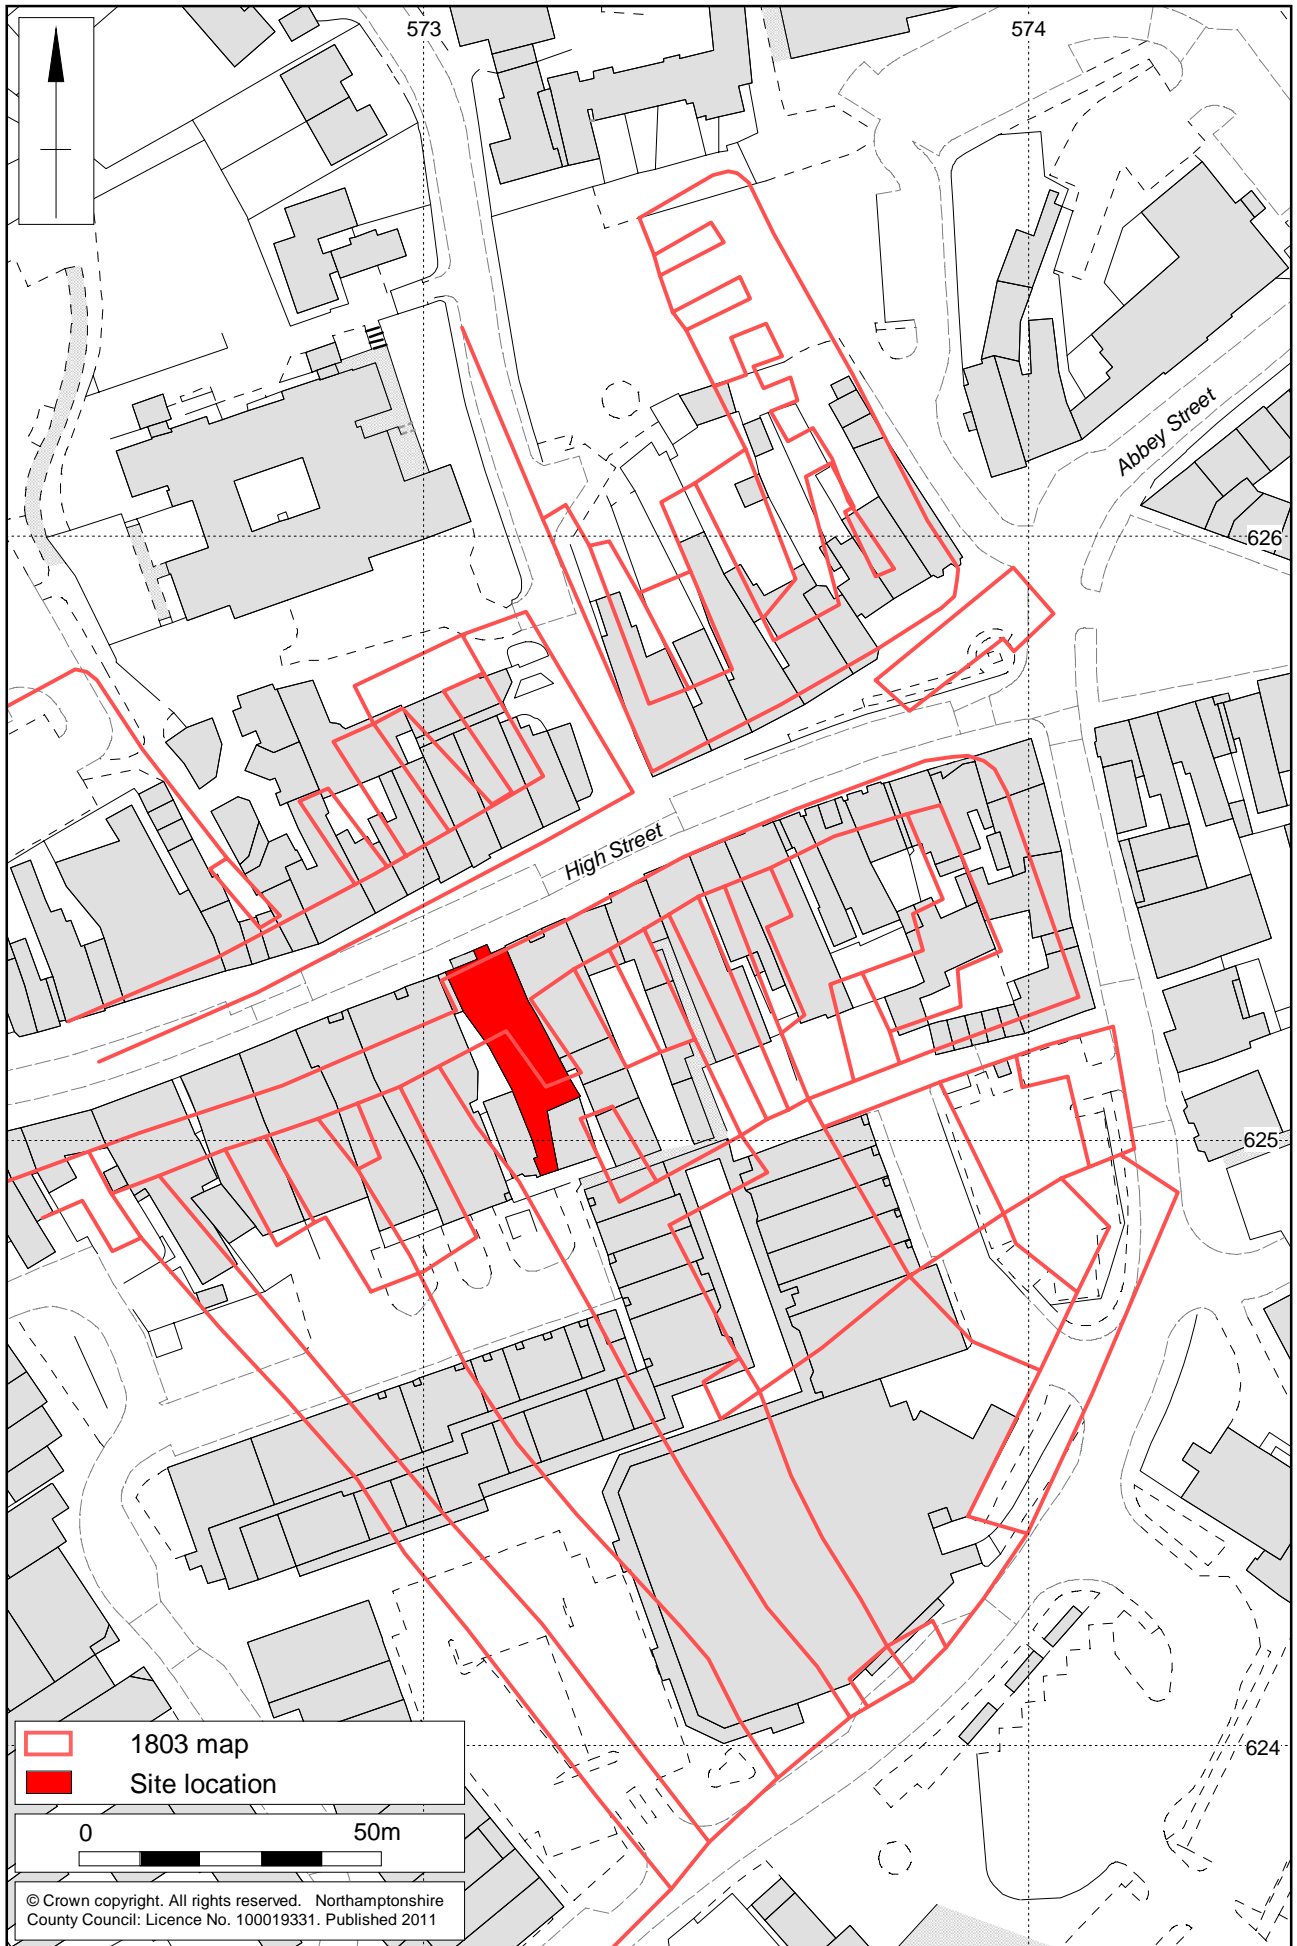
183 enclosure map on modern OS base Fig 2

This map depicts the building, albeit crudely. It is recognisable and indicated in Fig 2, overlaid on the modern Ordnance Survey base, along with the surrounding contemporary plot layout. It shows that the main property had reached almost its current layout by 1803.

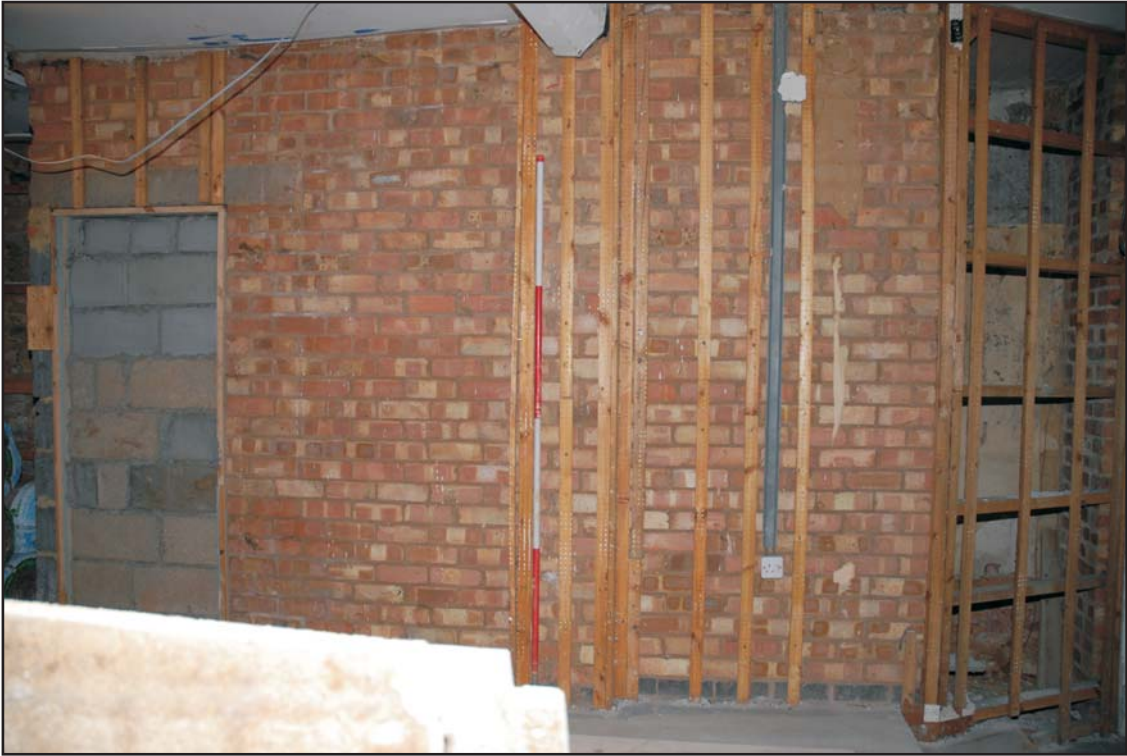
View of former stairwell in west wall Fig 4

The more northerly comprised a structure of modern Fletton-type brick with a doorway stopped up in block-work (Fig 4). This comprised a former stair connection to the first floor, now only accessible from the exterior. It is entirely modern.

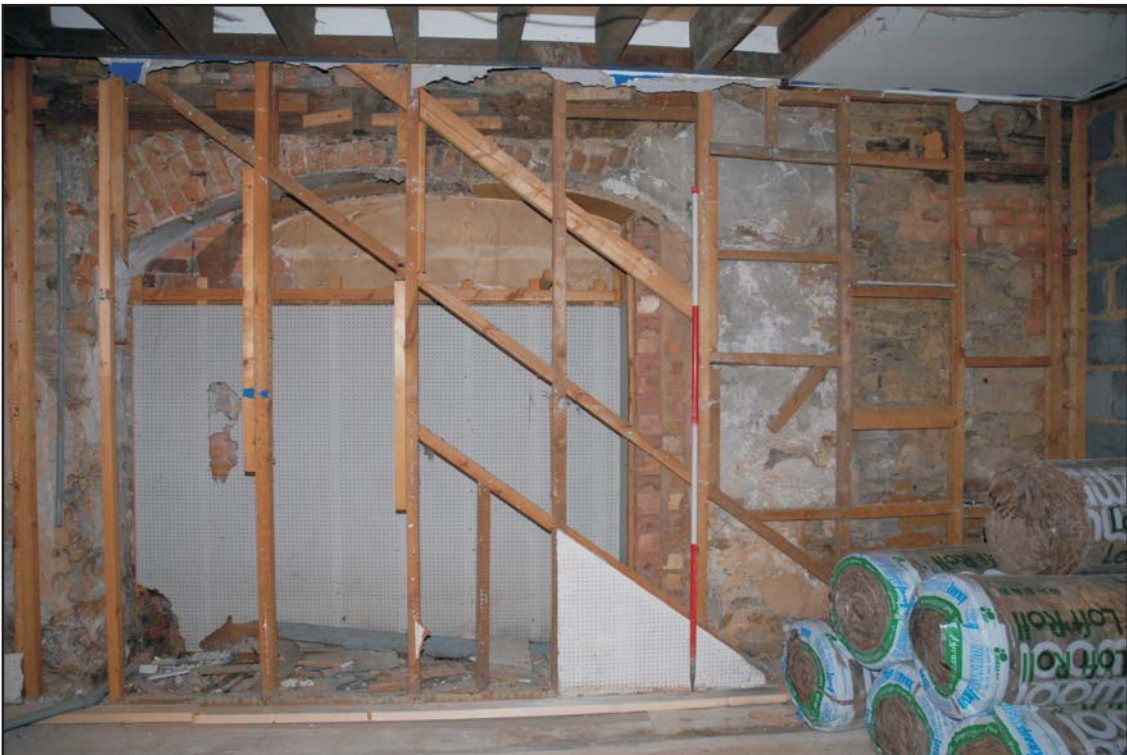
View of blocked doorway in west wall Fig 5

The southerly exposure uncovered a former wide brick arch for a doorway, which originally opened out into the passageway and yard on the west side (Fig 5). It measures 2m high at the apex x 1.8m across. On the exterior there is no visible evidence of the doorway, having been covered over in modern brickwork and render.

The opening potentially once held double doors, being too wide for an ordinary pedestrian doorway. The brickwork appeared to be of later 18th century date, using bricks smaller than the standard adopted by the brick tax in the 1780s, although they do have a capacity for re-use. The archway had been reduced once before blocking and had subsequently been propped at its northern end, using modern Flettons, reducing its span unevenly by about 300 mm. It seems to have survived in use as an alcove in an earlier shop-interior before being lost from view in the most recent shop-fit. It remains enclosed beneath the new dry-lining of the Dental Surgery.

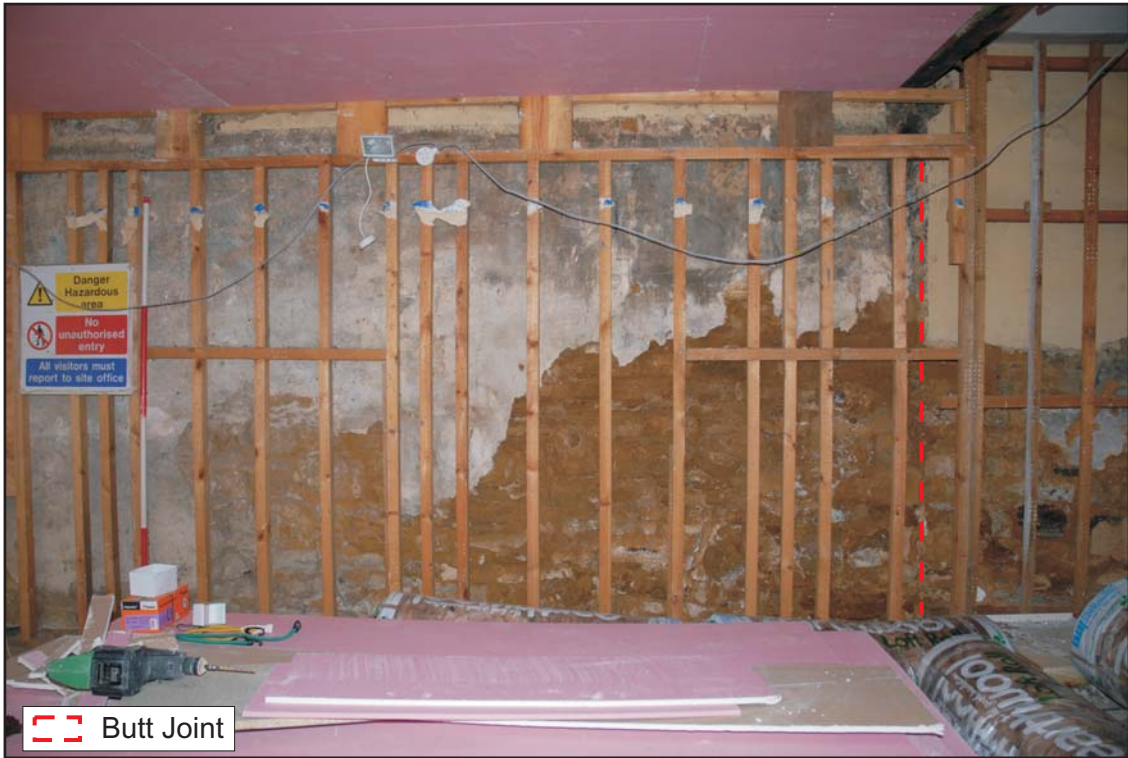
View of plain east wall, interior face. (Butt joint to the right) Fig 6

Approximately 11m of the eastern wall face was exposed for examination, still behind the old dry-lining. The wall was devoid of features and unremarkable, being of rough-coursed ironstone, bonded with lime mortar, plaster-rendered and lime-washed (Fig 6). The portion to the front of the building was an older lime-render, whereas to the rear this changed to a more recent painted, cement-render. The change took place where the line of the east wall changes very slightly and this location is a vertical butt-joint indicative of where a historic rear wing was added before 1803 (from the mapped layout of that year).

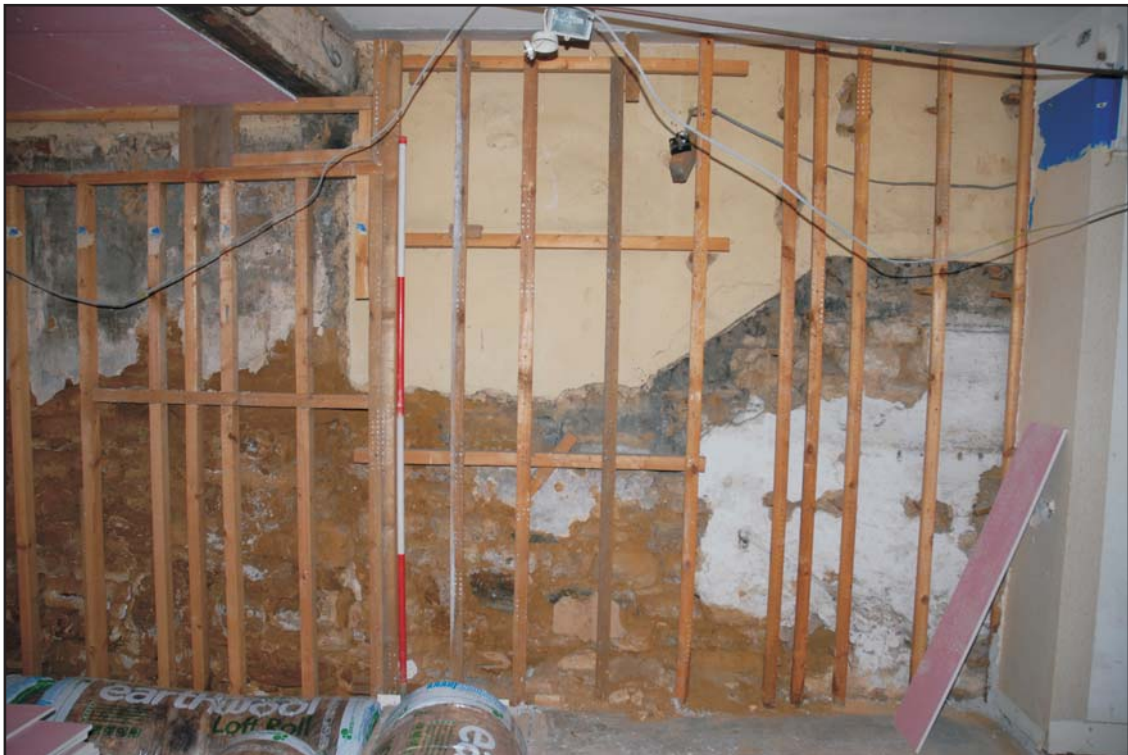
View of former stair location Fig 7

Here too an angled plaster-line strongly suggests this was the location of a former stairway to the first floor (Fig 7).
