An archaeological evaluation of land adjacent to  
Sutcliff Baptist Church, Olney, Milton Keynes  
August 2011

Report 11/191

**AN ARCHAEOLOGICAL EVALUATION OF  
LAND ADJACENT TO SUTCLIFF BAPTIST CHURCH,  
OLNEY, MILTON KEYNES  
AUGUST 2011**

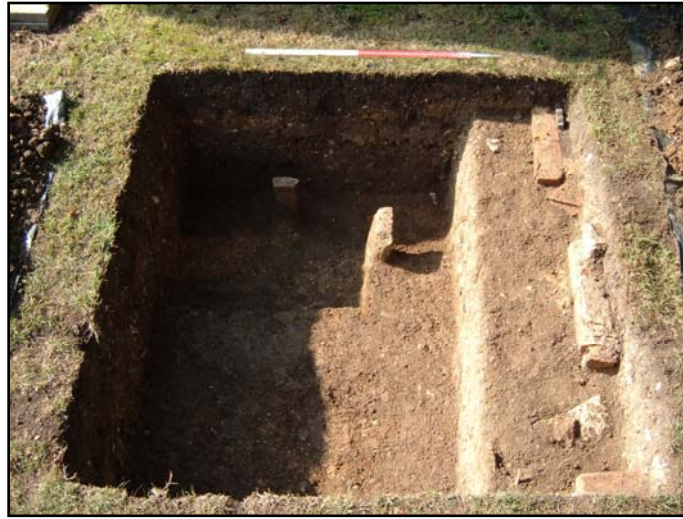
Test pit 1 showing burials [103], [104], [105], [112] and footstones, looking south Fig 3

Test pit 1 was located at the west of the development area (Fig 2). The earliest deposit was a dark brown clay loam (108) which contained abundant brick and stone fragments. This was cut by two unvaulted graves [112] and [114] which were uncovered at a depth of roughly 0.5m (Fig 3, Section 3). Grave [112] was located in the south-eastern corner of the trench. It was filled by a dark grey, clayey silt (113). Grave [114] was located in the north-eastern corner of the trench. It was filled by a mid orange-brown sandy silt (115). Both [112] and [114] were sealed by a subsoil of made ground (102). The subsoil was a mid brown, sandy clay loam with abundant brick and stone fragments and represented the artificial raising of the level of the churchyard. The footstone of an earlier burial [109] was found in the south-eastern corner of the trench. This was also sealed by (102) and belonged to the earlier phase of burials, though no grave cut was associated with it. The eroded remains of carving and the initials "IF" were visible on the stone. A second footstone [110] was found to the south east of [109], close to grave [112] though it was unclear if they were associated. Footstone [110] didn't appear to be *in situ*.

The remains of three brick-lined vaults [103], [104], [105] were present against the western edge of the trench. All three were on an east-west alignment. The tops of these were cleaned off and the trench was stepped approximately 0.2-0.3m to the east. The bricks used in the construction were handmade unfrosted, red bricks and were bound with a pale yellow-white mortar. Vault [103] also incorporated a piece of moulded Victorian path edging and pieces of broken tile into its structure. These later burials cut through the made up ground (102) and were sealed by a modern mid brown sandy clay (116). This deposit represents levelling of the churchyard after the clearance of headstones and was overlain by a topsoil of dark brown sandy clay loam (101).

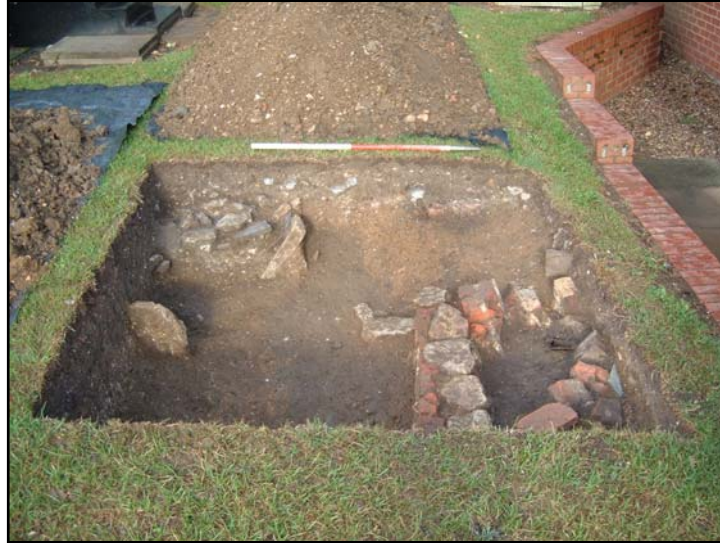
Test pit 2 showing burials [212] and [204], looking west Fig 4

Test pit 2 contained the remains of two brick-lined vaults [204] and [212] and an unvaulted burial [215] (Fig 2, Fig 7; Section 2). The excavation was stepped around the brick vaults which were not themselves excavated. Vault [212] was located in the south-west corner of the trench and contained fills (203) and (213). Fill (213) was a mid dark grey, clay silt which was deposited between the brick vault and the construction cut. The vault was constructed with red, handmade, unfrogged bricks with a pale yellow mortar bonding. The vault was filled with (203), a mid-dark grey silt containing numerous fragments of stone and brick. The whole grave was sealed by a layer of compact, sandy clay (202) containing more modern debris including brick, porcelain, nails and gravel. Layer (202) represents artificial raising of the churchyard.

Grave [204] was located in the northern half of the trench. It comprised a construction cut [204], the brick vault itself (205) and a backfill for the cut (214). The vault was constructed from red, handmade, unfrogged bricks with a pale yellow mortar bonding. The backfill of the construction cut (214), was a mid grey-brown silt. Overlying the brick vault was a fill of disturbed, dark grey sandy clay, grave soil (206) which contained 19th-century debris. The burial was sealed by a mid orange-brown sandy silt (207), which contained debris such as brick fragments, nails, rubble and pottery. Layer (207) was overlain by topsoil and partially overlies (202). This layer may have represented backfilling of the vault in order to level the ground surface.

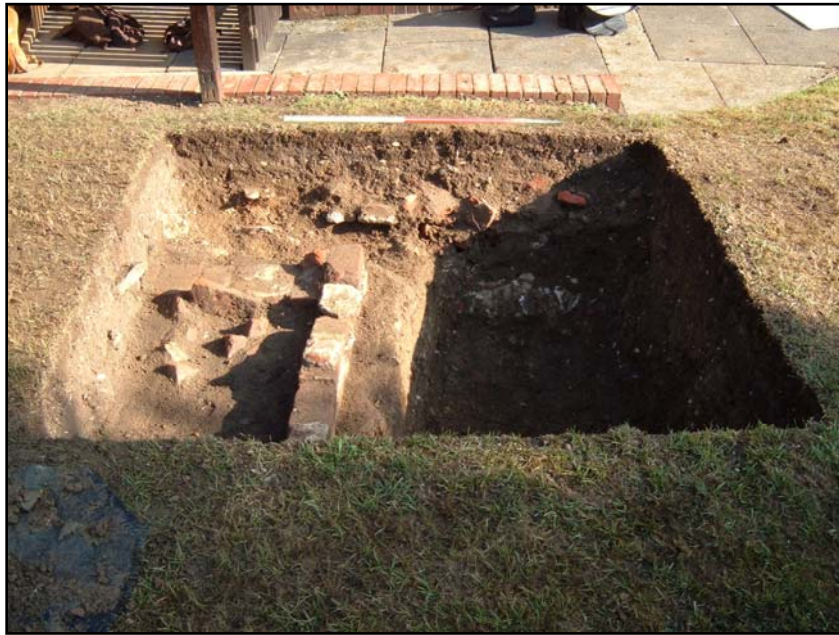
Test pit 3, burials [304] and [309], looking north Fig 5

Test pit 3 contained two brick vaults [304] and (309) and the remains of a gravel path (302) (Fig 2, Fig 7 Section 1). The earliest deposit present in the test pit was a mid-dark brown, moderately compacted clay silt (307). This was a disturbed grave soil containing numerous fragments of disarticulated human remains, fragments of animal bone and iron nails (all reinterred). This was overlain by a highly compacted make up layer (306) of sandy clay with a high concentration of gravel and occasional fragments of animal bone and nails.

Another brick vault (309) was revealed in the north section of the trench. A construction cut was not visible in section and the excavation was stepped around the vault. At least two courses of handmade, unfrosted, red bricks with a pale yellow mortar bonding were present. This was surrounded by a fill of tightly packed limestone fragments in a mid orange-brown, sandy silt matrix (311), and a mid grey brown silt (315) which contained occasional fragments of brick, rubble and animal bone.

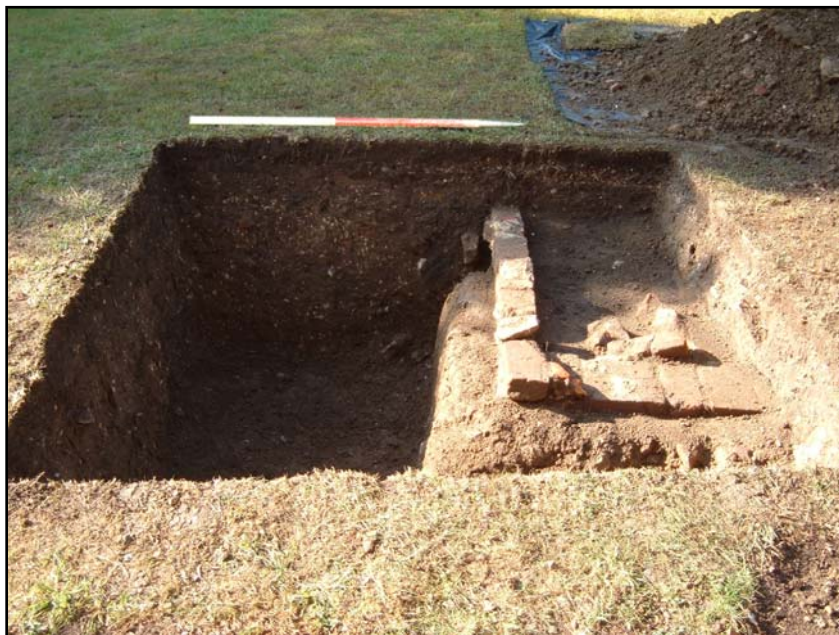
Test pit 3, burial [304], looking south Fig 6

Vault [304] was cut through both (306) and (307) and was sealed by the subsoil (303). The vault structure comprised red, handmade, unfrosted bricks [314] of which eight courses were exposed (Fig 6). The construction cut [304], was filled with a compact, yellow-brown clay (308), which was up cast natural material, and a moderately compacted, mid dark grey silt with occasional gravel inclusions (312). These were covered by a mid grey-brown sandy silt containing fragments of brick (305).

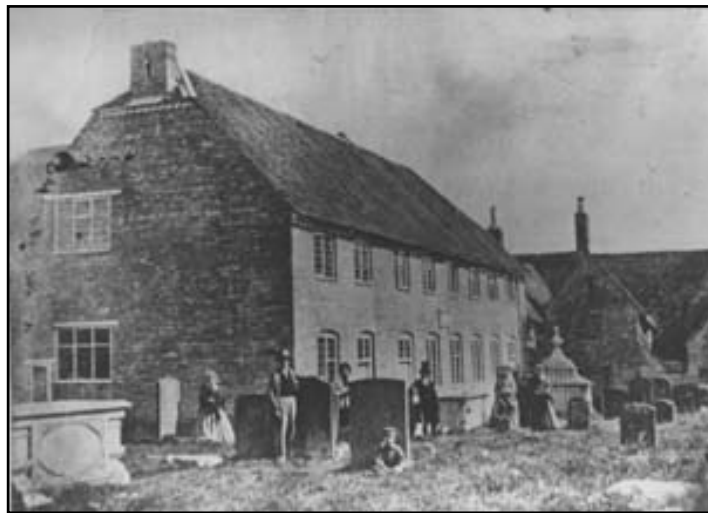
View of the churchyard with the tomb of John Sutcliff to the extreme left, date unknown Fig 8

Test pit 1 is positioned roughly over row 13. The register estimates 23 individuals are interred in row 13, distributed into eight burials. Only the tomb of John and Jane Sutcliff (1814) remains *in situ* (Figs 8 and 9). Test pit 2 roughly overlies rows 10 and 11 which contain 46 individuals between 17 graves. Test pit 3 is positioned over rows seven or eight. Row 7 contains 14 individuals in nine graves and row eight contains seven individuals in four graves.

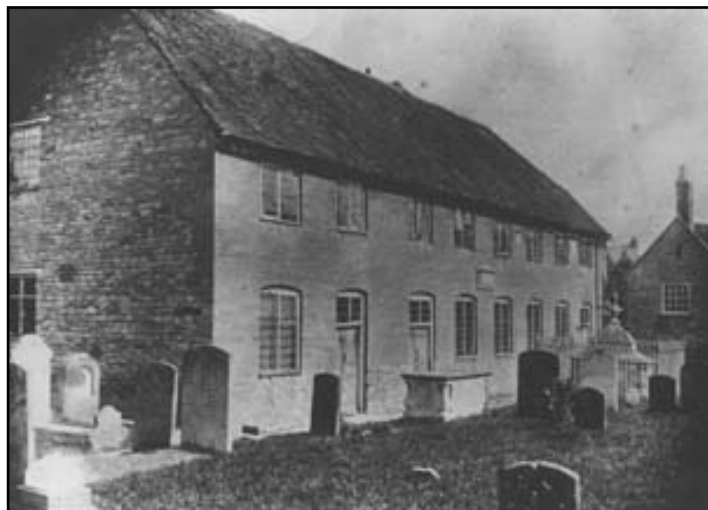
View of the churchyard, date unknown Fig 9
