An archaeological watching brief at Snibston  
Colliery, Ashby Road, Coalville, Leicestershire  
April-May 2011

Report 11/205

**ARCHAEOLOGICAL WATCHING BRIEF AT SNIBSTON COLLIERY,  
ASHBY ROAD, COALVILLE, LEICESTERSHIRE  
APRIL-MAY 2011  
X.A68.2011**

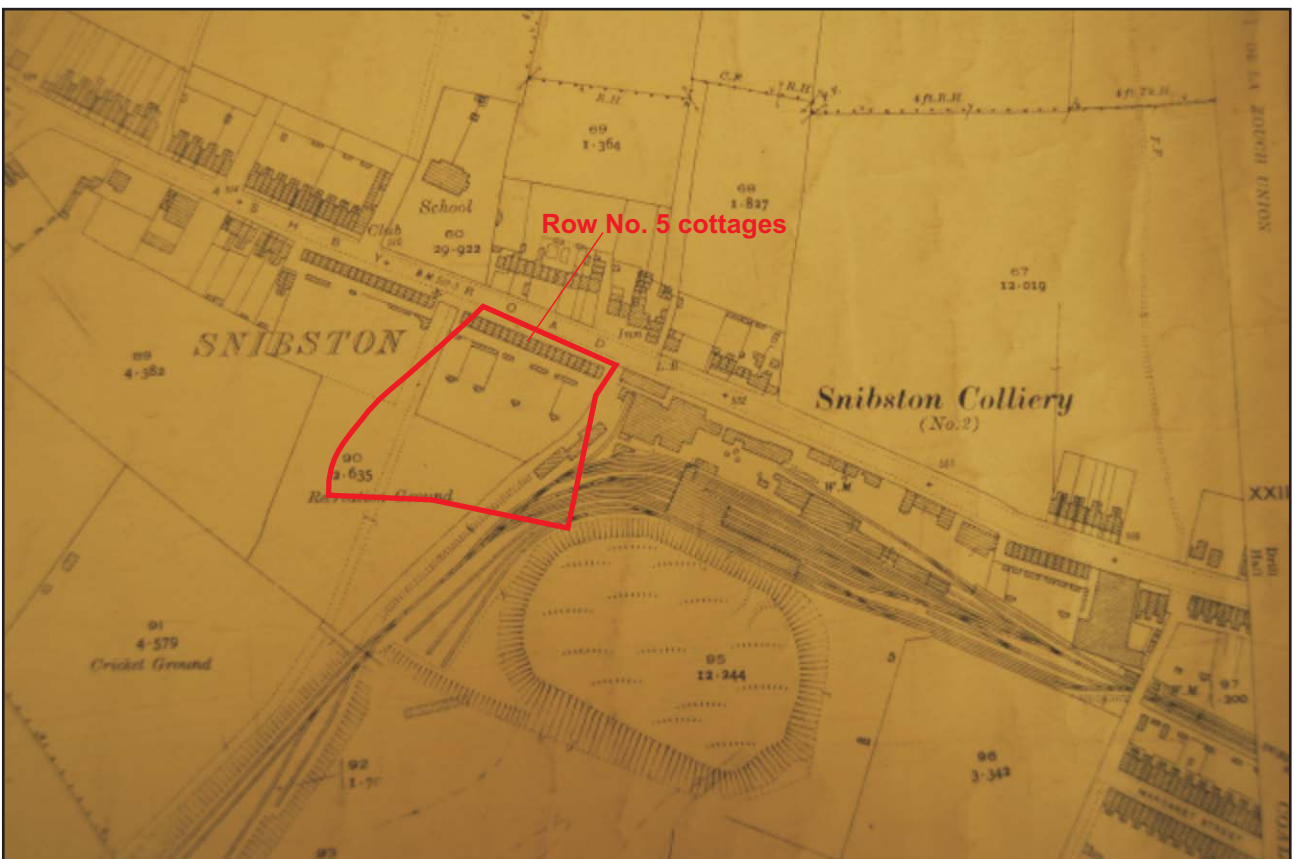
1929 Ordnance Survey map Fig 4

- 3.3 On both the 1929 and 1938 Ordnance survey maps the two rows of cottages on the south side of Ashby Road are shown, with to the south of what is thought to be row No 5 a recreation ground and beyond that a cricket ground, both indicating that welfare facilities were available, though whether or not these were provided by the coal mine is uncertain (Figs 4 and 5). To the east the buildings of the colliery are shown with a series of railway lines curving to the south-west along the eastern edge of the recreation ground.

Thought to have been built in 1833 when the colliery was first developed, these cottages are now known only from maps and some general photographs (Figs 4, 5, 6 and 7). The photograph showing the Ashby Road street frontage is undated but most likely dates from the late 1950s or 1960s given the style of the apparently concrete street lamp in the

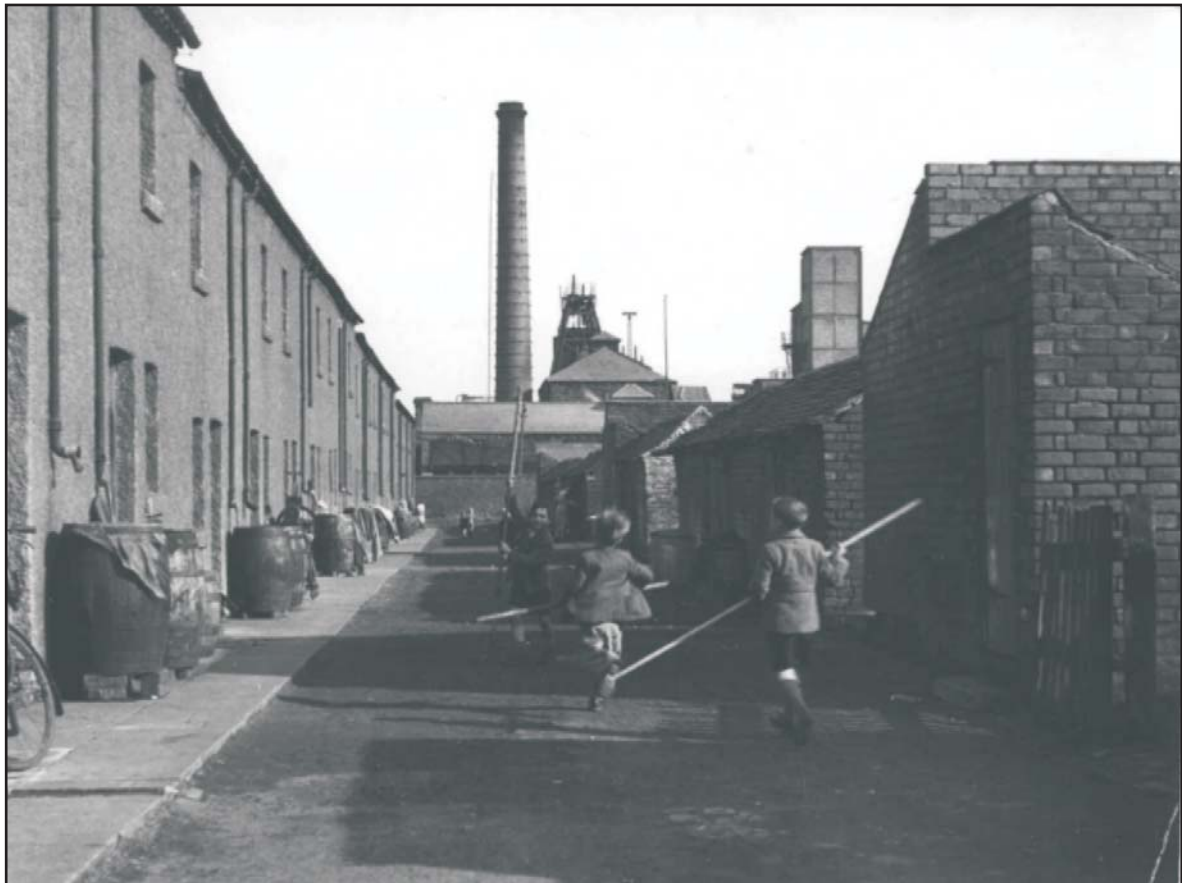
Miners from County Durham came to the area to work. By 1840 around 250 men were employed at the colliery ([www.minesofmemory](http://www.minesofmemory)). At first they were housed in tenements and later in six rows of terraced cottages on Long Lane, which it is thought was re-named as Ashby Road. The row of cottages thought to be located on the current development site was known as Row No 5, later known as Kimberly Row which lie on the south side of Ashby Road (Figs 3, 4 and 5). These cottages are thought to have been built in 1833, and, on the 1929 map appears to show a continuous row of twenty one cottages (The Coalville 150 Group, <http://scoilnet.magicstudio.co.uk>). To the rear (south) is an alleyway which separates the houses from what are probably privies and perhaps also coal sheds, as coal would have been provided for the workers (though not for free). This alleyway is shown on an undated photograph which shows the rear of the houses on the left and the outhouses on the right (Fig 6). In the background can be seen the buildings of the colliery. It is possible that further south beyond these sheds or privies the land was allocated for growing food in allotments. This row appears to almost identical to another situated immediately to the west further along Ashby Road and shown in an undated photograph of possibly the same date as that showing the rear view (it must be after 1926 when the first concrete lamp posts were introduced as one

Photograph of the rear (south) side of the cottages, looking east. Undated. Fig 6  
Copyright Leicestershire County Council

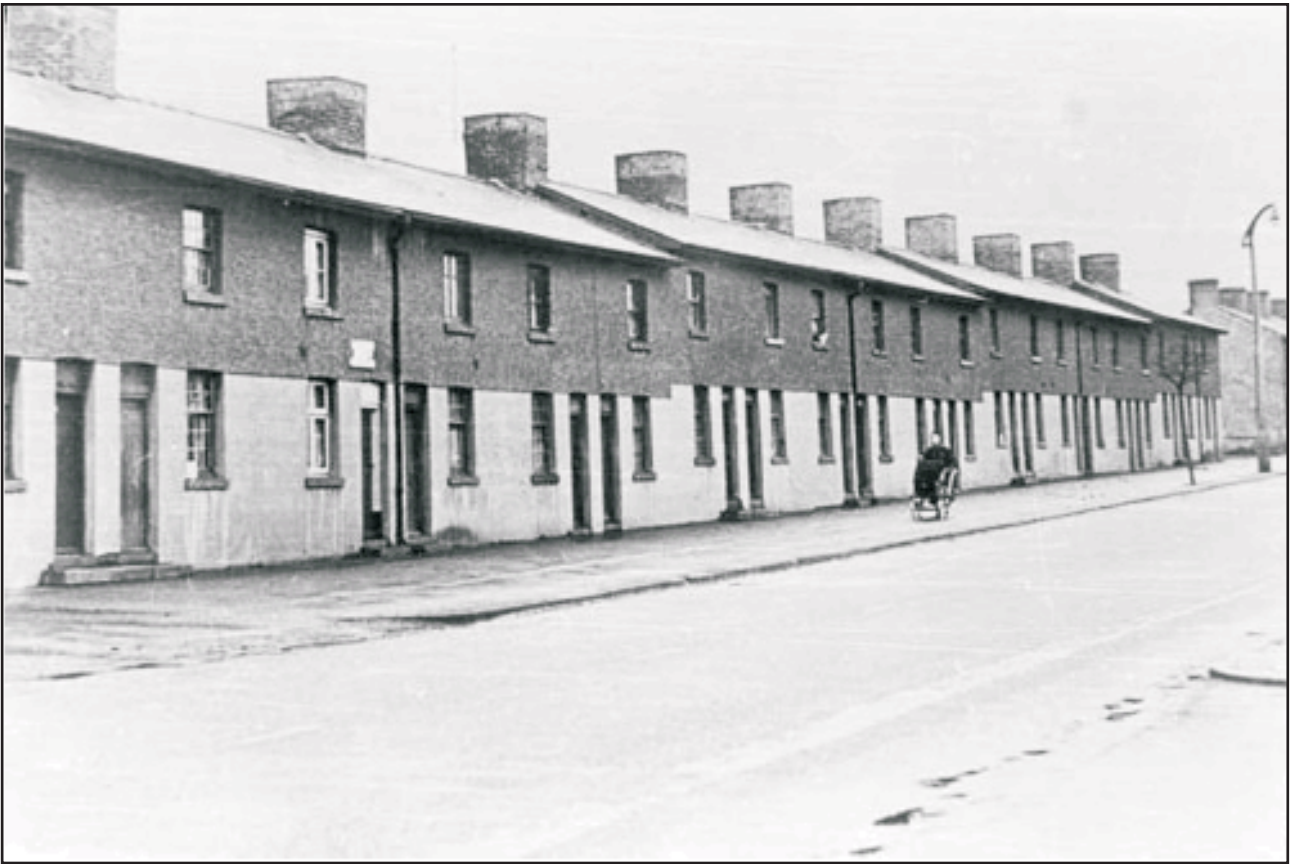
can be seen in the photograph, Fig 7). This photograph shows the Ashby Road frontage and it can be seen that each house was a simple two-up two-down structure with paired front doors and to either side a single window. The windows appear to be fitted with sash frames, probably nine over nine lights to each window. The buildings appear to be part pebble-dashed, a finish which can be seen more clearly on the photograph of the rear alleyway (Fig 6). This type of finish is not likely to be original and most likely represents an attempt to up-grade them. The row of houses displays a slightly stepped profile as the land falls gently towards the east, most clearly seen on Figure 7. Each adjacent pair shares a large, square chimney stack, though as none have any chimney pots it is not possible to determine the numbers of flues; if there were fireplaces in both downstairs and upstairs room there would be eight pots to each stack (four to each house). Given the basic nature of the houses it is possible that only the downstairs rooms were heated, but this cannot be certain. None have any front or rear gardens.

Photograph of the Ashby Road street frontage of the cottages, looking south-west. Undated Fig 7

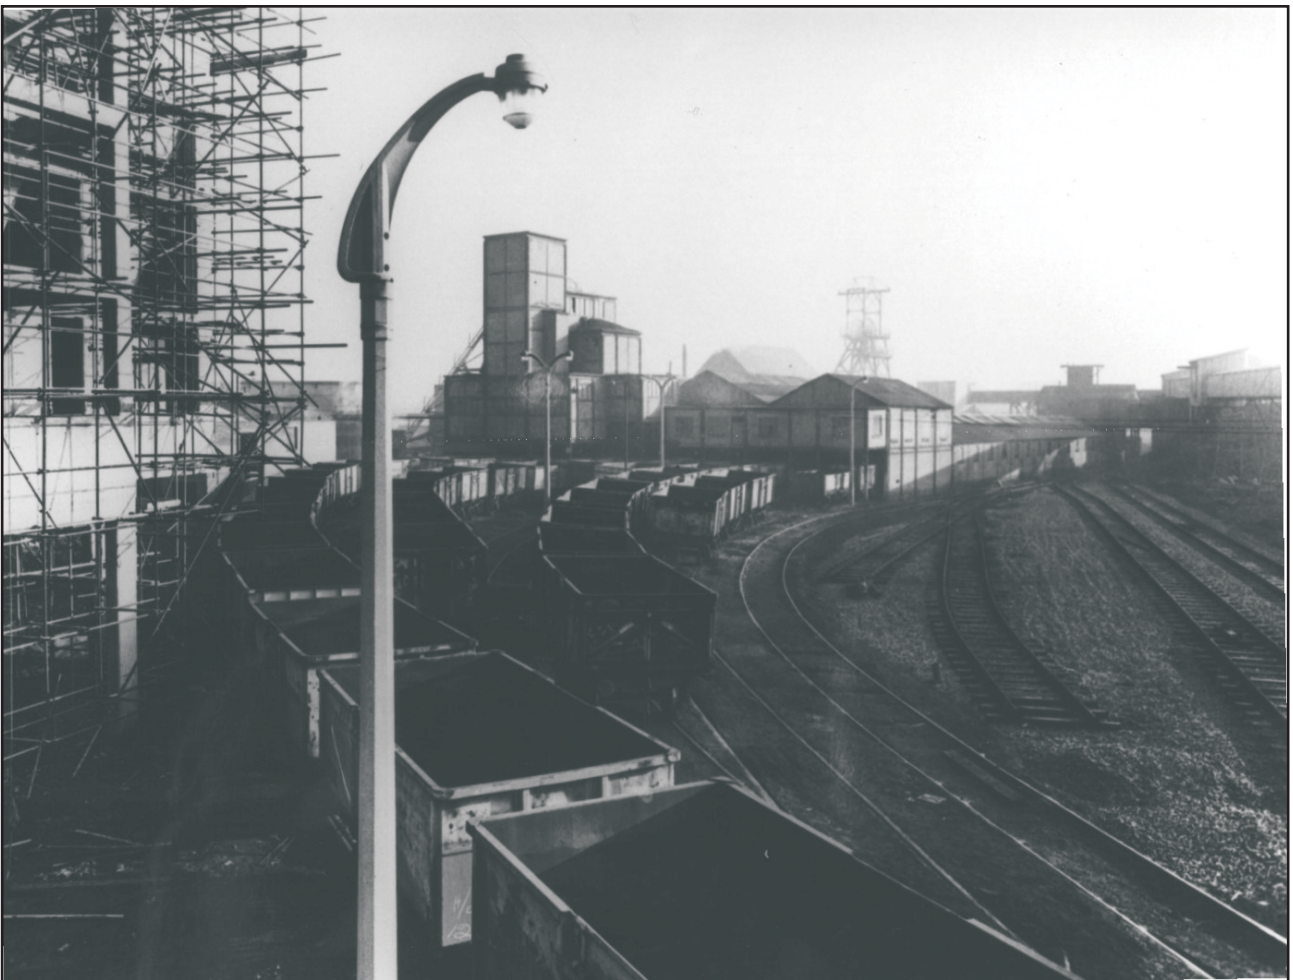
- 3.6 A series of photographs provided by Nick Pell, Curator, Mining and Transport at Snibston, shows the plant under construction and in operation (Figs 10, 11 and 12). It is

Coal preparation plant under construction, looking north-east. Undated. Copyright Leicestershire County Council Fig 10

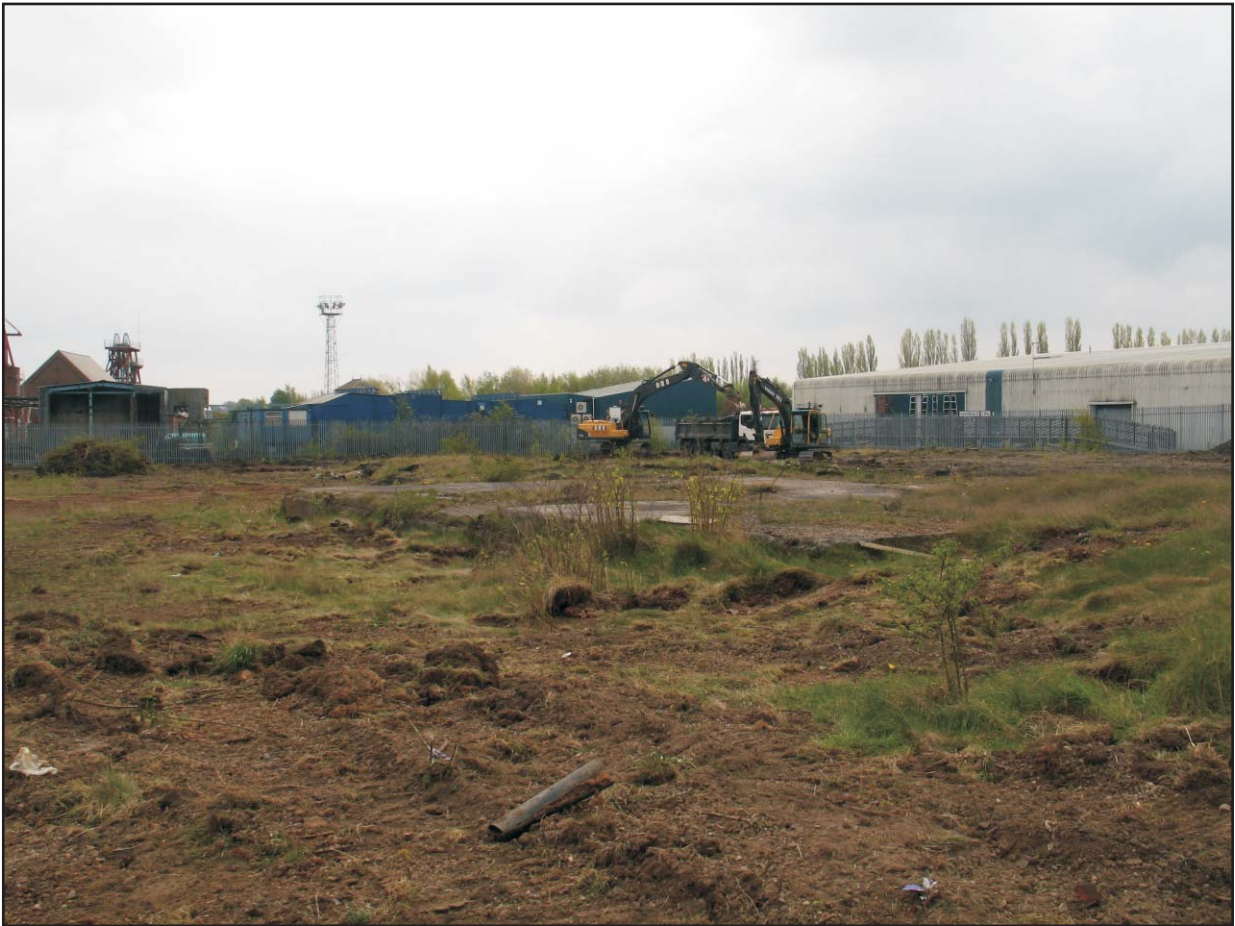
When first visited the site had been cleared of weed growth and trees which were self-set across the whole site. A number of concrete foundations and floors were visible and these were plotted using a Leica 1200 System GPS (Figs 2 and 13). Although the ground plan of these buildings was incomplete due to partial removal at the time of demolition, it is possible to locate some of these foundations to the undated plans of the site and identify the former functions of some surviving elements. Along the southern border of the site two parallel concrete footings were cleaned and recorded which do not appear on any of the plans copied at Snibston and is therefore presumed to post-date those plans. The footings were aligned approximately east-west and had along their length the stumps of upright concrete piers which had been removed above ground level although the steel reinforcing rods remained (Figs 2 and 14). This suggests that the building was probably covered or supported another level, although its function is unknown. At the eastern end of the two parallel footings a massive block of concrete was present and when that foundation was being broken-up its full depth was revealed which showed that there, at least, it was a solid block of concrete at least two metres deep (Figs 2 and 15). It retained around its exterior pieces of both plywood and polystyrene shuttering into which the concrete had been poured. The size of the footing suggests that it supported a large superstructure, although its purpose is unknown.

The former coal preparation plant site before clearance, looking south-east Fig 13

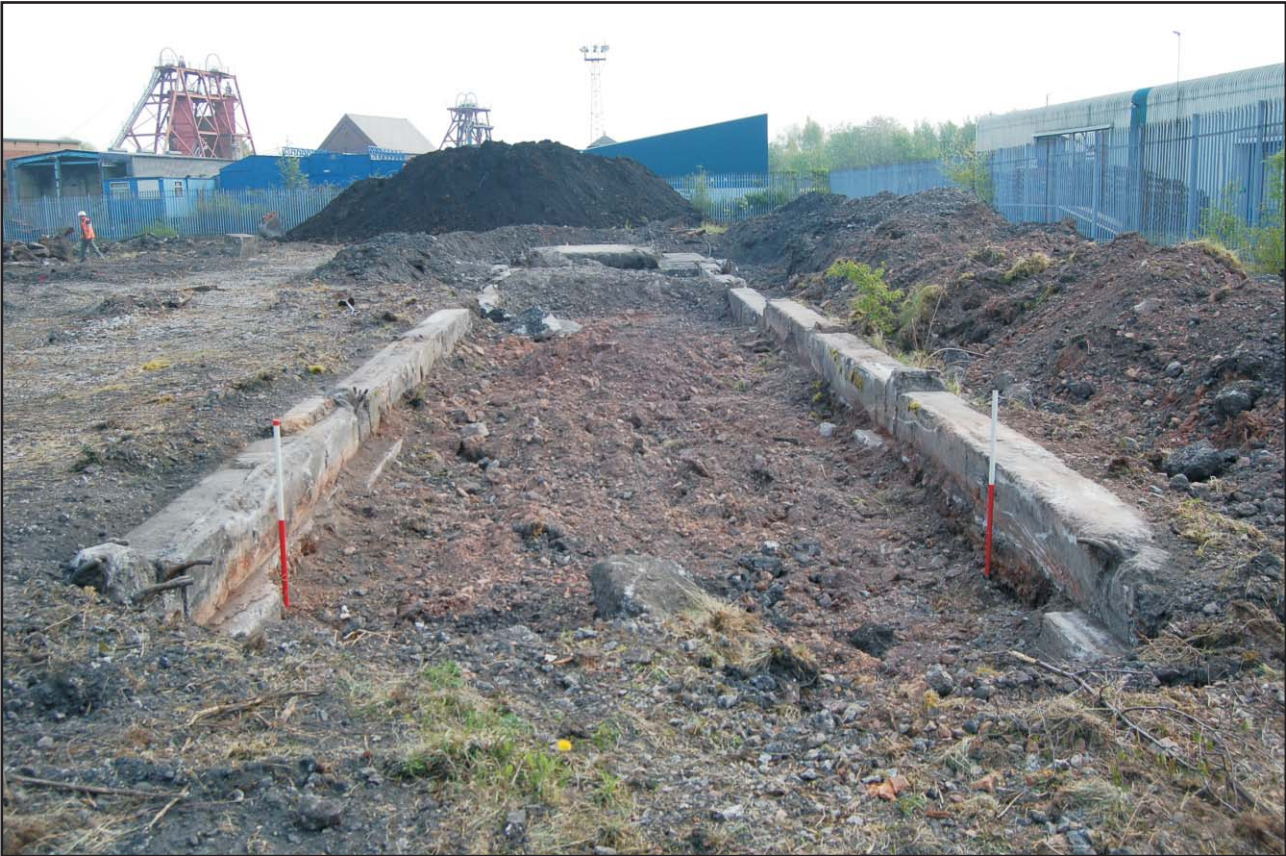
Parallel concrete foundations, looking east Fig 14

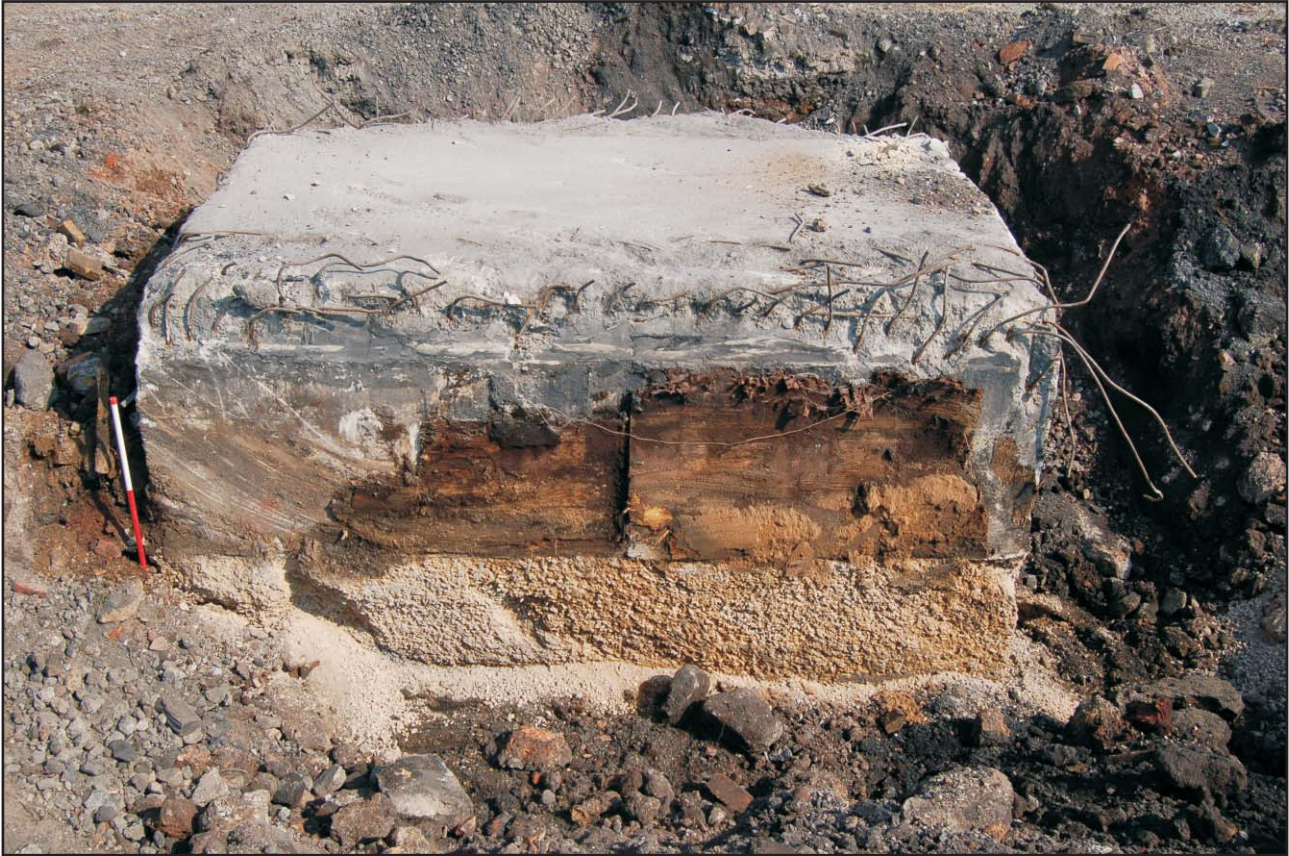
Deep concrete base, looking north Fig 15

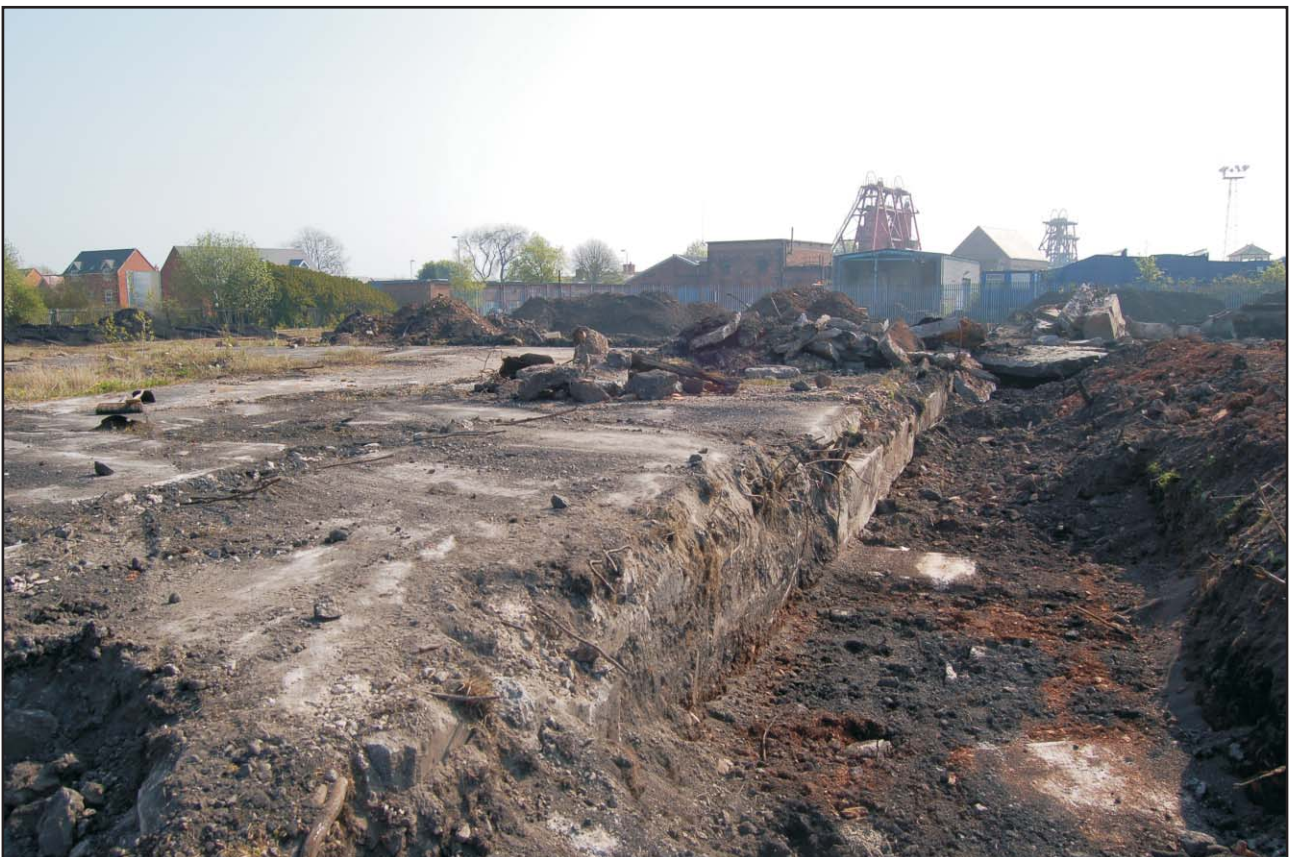
4.2 Towards the western side of the site a larger area of concrete comprising floor slabs along with the bases of vertical reinforced posts was similarly observed and planned (Figs 2 and 16). This corresponds approximately with the main group of buildings indicated on the undated plan of the plant, some of which are numbered and named on the corresponding key. Building 32 on the north side is listed simply as 'coal preparation plant', the name by which the whole complex appears to have been known. The only other element of this group which is numbered is the circular feature, not identified on the ground, which is listed as number 33 and identified as 'thickener'. The fact that this was not observed on the ground suggests that this must either have been constructed of different materials or was located above ground and had been totally removed during demolition. To the south remains of a long, north-south aligned narrow channel were also observed and recorded (Fig 2). This retained half sections of salt glazed pipes set in concrete which must have formed a channel for the carrying of waste water since it retained a hard deposit within it suggesting that at the time of demolition the channel had not been cleaned out (Fig 17). It is not labelled on the site plan.

Concrete floor slabs to coal preparation plant building, looking north east Fig 16

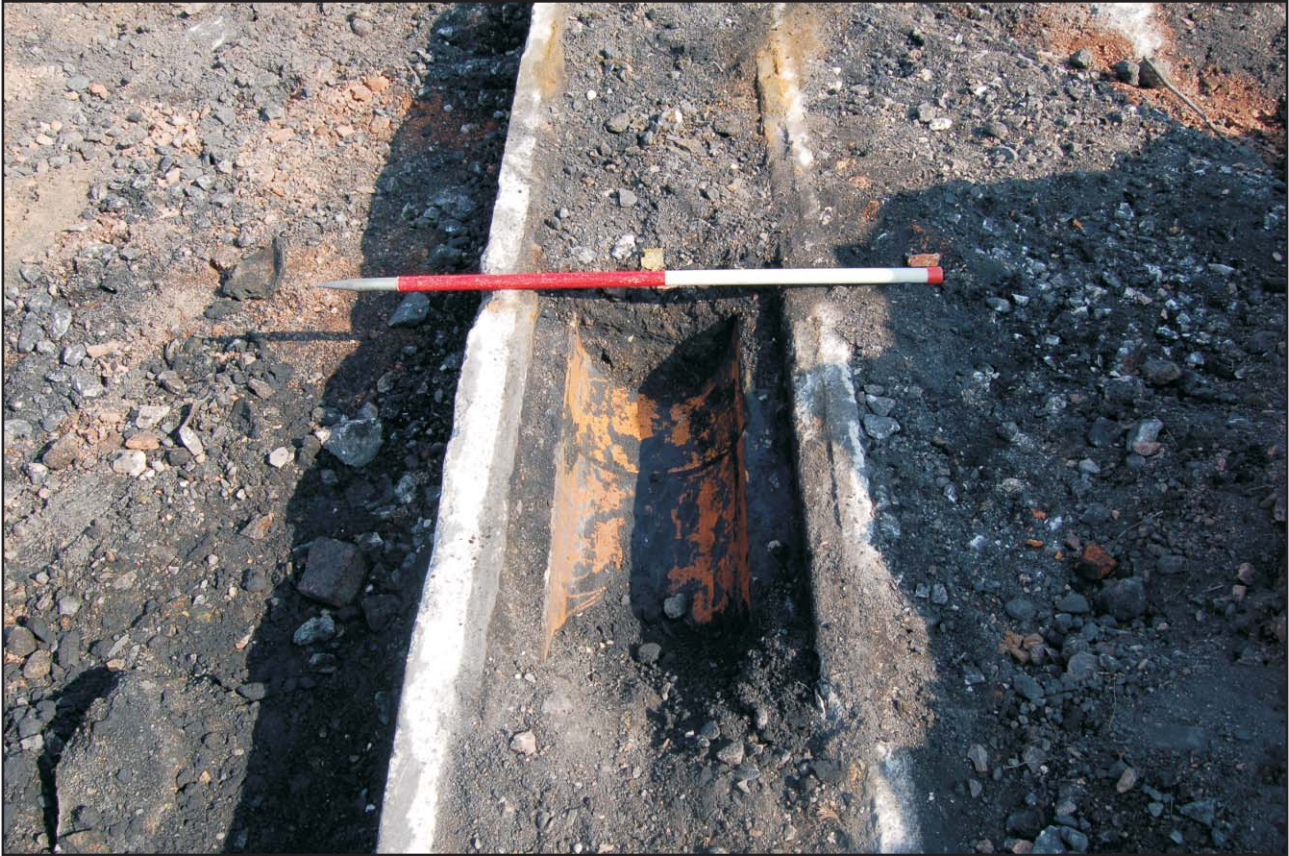
Salt glazed half pipe set in concrete channel, looking north Fig 17

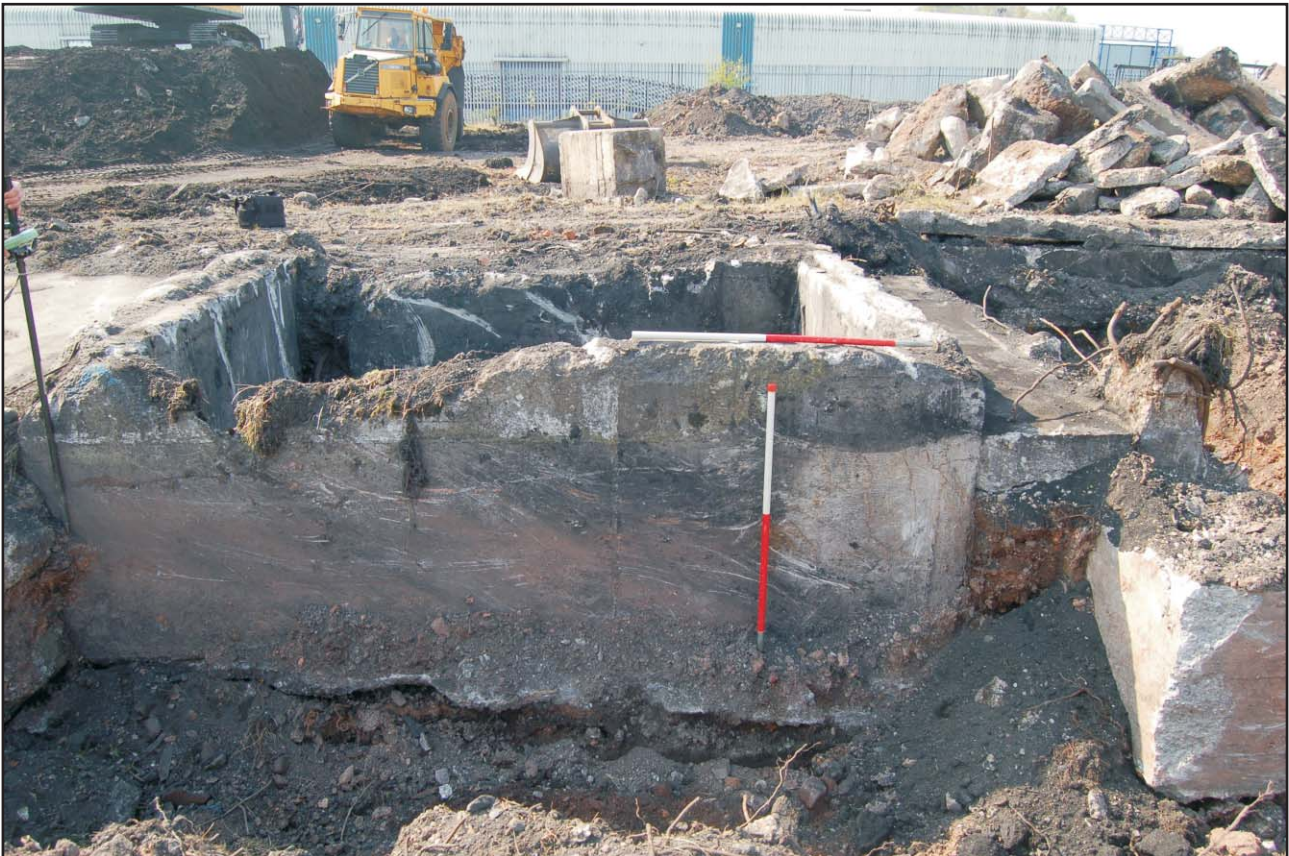
4.3 Towards the eastern side of the site two smaller areas of concrete foundation were observed, one that appeared to be a tank of some sort, the other a fragment of what appears to be the corner of an unidentified building (Figs 2 and 18). The tank may correspond with what is identified as number 30, 'blending bunkers' on the undated plan. The other fragment appeared to be the corner of a building, but the plans do not show any buildings in that area, and therefore it appears that this structure must have been added at a later date and so its purpose is unknown.

Concrete 'tank', possibly blending bunkers, looking south Fig 18

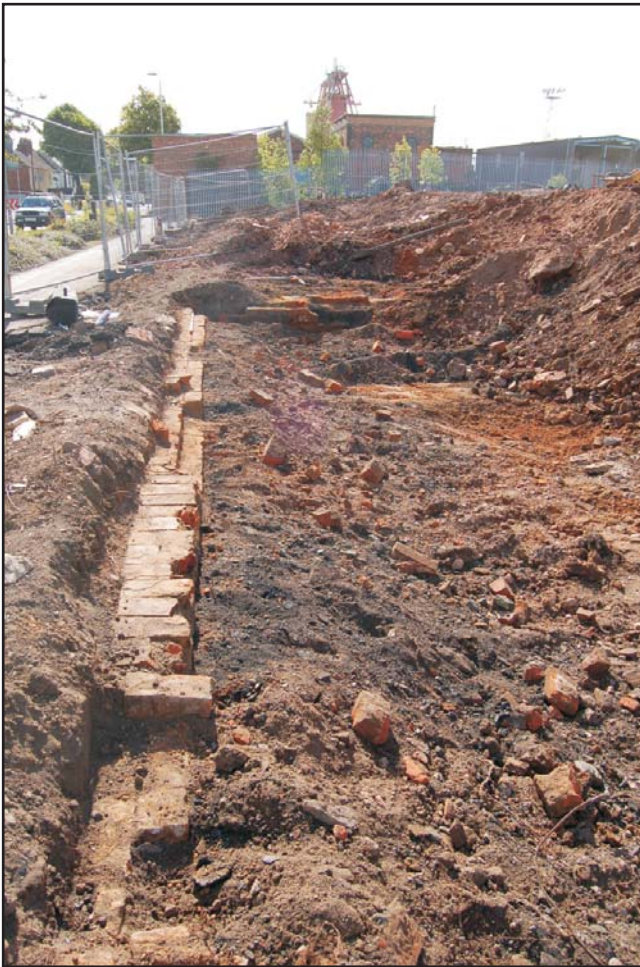
- 4.5 At the west end there was no surviving evidence of the cottages, the ground comprising clearly re-deposited rubble, thought to be associated both with the demolition of the cottages and later demolition of the coal preparation plant which superseded it. As the ground reduction proceeded eastwards the footings of the front (north) wall of the cottages was observed (Figs 2 and 19). This comprised a standard construction with bricks laid alternately lengthwise and perpendicular to the wall plane. The unfrosted bricks were 245mm x 110mm x 75mm in size (10 x 4 ½ x 3 inches), of a hard red fabric bonded in lime mortar. It was not possible to discern whether or not the bricks had been laid in a recognised bond. Perpendicular to the front (north) wall were fragments of the dividing walls between the separate cottages (Figs 2 and 20). These were more fragmentary in nature and only survived in a few places. They were fully bonded to the front wall and at the lowest level were of two bricks laid side by side, though above this, and presumably at a level above ground, were only a single brick wide. This corresponds exactly with a reference to miners cottages which mentions the thinness of the walls between adjoining properties, often being constructed of a single brick (Bailey 2007). This meanness of building was then, as now, dictated by building costs and whilst the cottages may have been relatively well appointed in some respects, they were clearly built on a budget. The photograph of the backs of the houses indicates that there were no projecting ranges, and thus the houses would only have been two rooms deep, the front room most likely a sitting room, the back room the scullery/kitchen.

The street frontage foundations of the row of cottages, looking east Fig 19

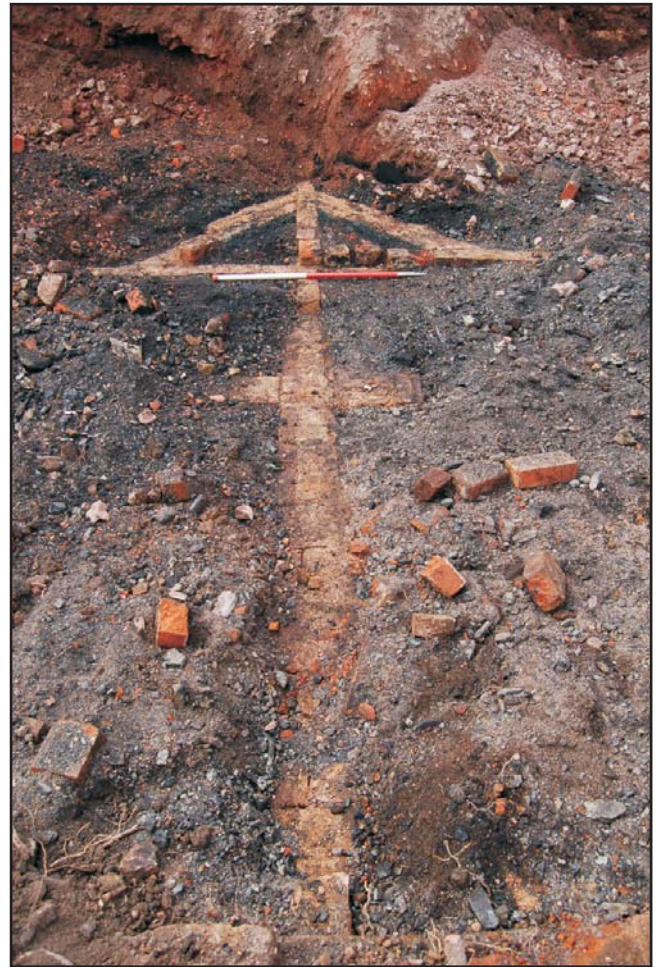
Dividing wall foundation between two cottages, looking south Fig 20

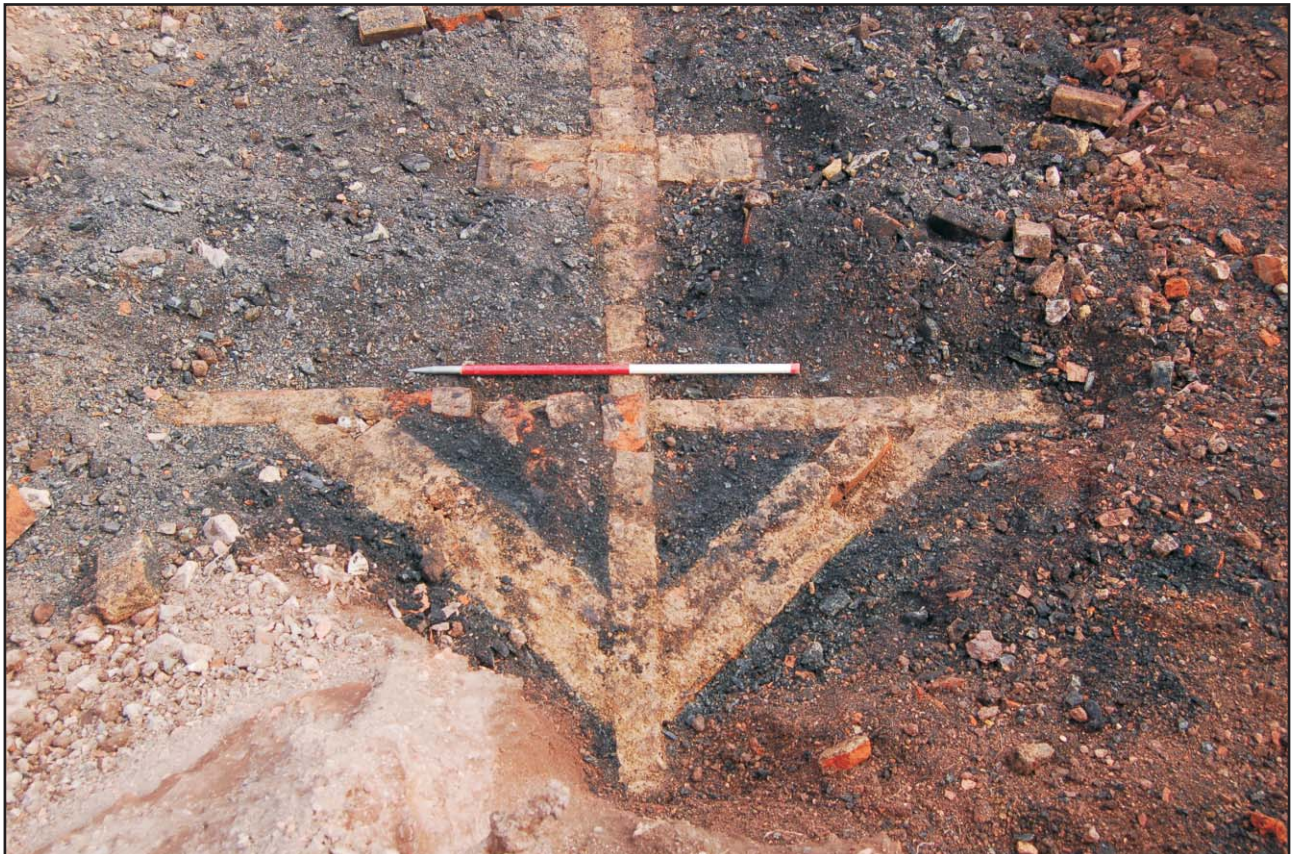
- 4.6 Projecting from every other dividing wall were remains of footings for back-to-back fireplaces, set in the angle of the south-west and south-east corners of the front rooms, and across the angles of the north-west and north-east corners of the back rooms (Fig 21). Those in the front rooms were built square to the dividing walls, those in the back rooms across the angles. Quite why this was the case is uncertain, but it does indicate that each pair of cottages would have shared a central stack, a fact confirmed by the photograph showing the row from Ashby Road (Fig 7). None of the large stacks in the photograph have chimney pots so it is uncertain how many flues each stack contained; if only two per house this would indicate that each cottage had only two fireplaces, one to each of the ground floor rooms, if four each they would have had a fireplace in each upstairs room. However, the large size of the stacks evident on the photograph and given the fact that coal would clearly be in plentiful supply, the latter might have been the case if needed, or could be afforded. The front room size was approximately 3.5m wide x 3.4m deep (11 feet 6 inches x 11 feet), the back scullery's were 3.5m wide and only 2.5m deep (11 feet 6 inches x 8 feet). Though small by modern standards, these rooms seem to have been reasonably well proportioned compared to some recorded by George Orwell in the 1930s who travelled around the south Yorkshire coalfields. He wrote of a house in Barnsley that there was a

Foundations to the corner fireplaces of the kitchen/scullery in the foreground and front room fireplaces beyond, looking north Fig 21

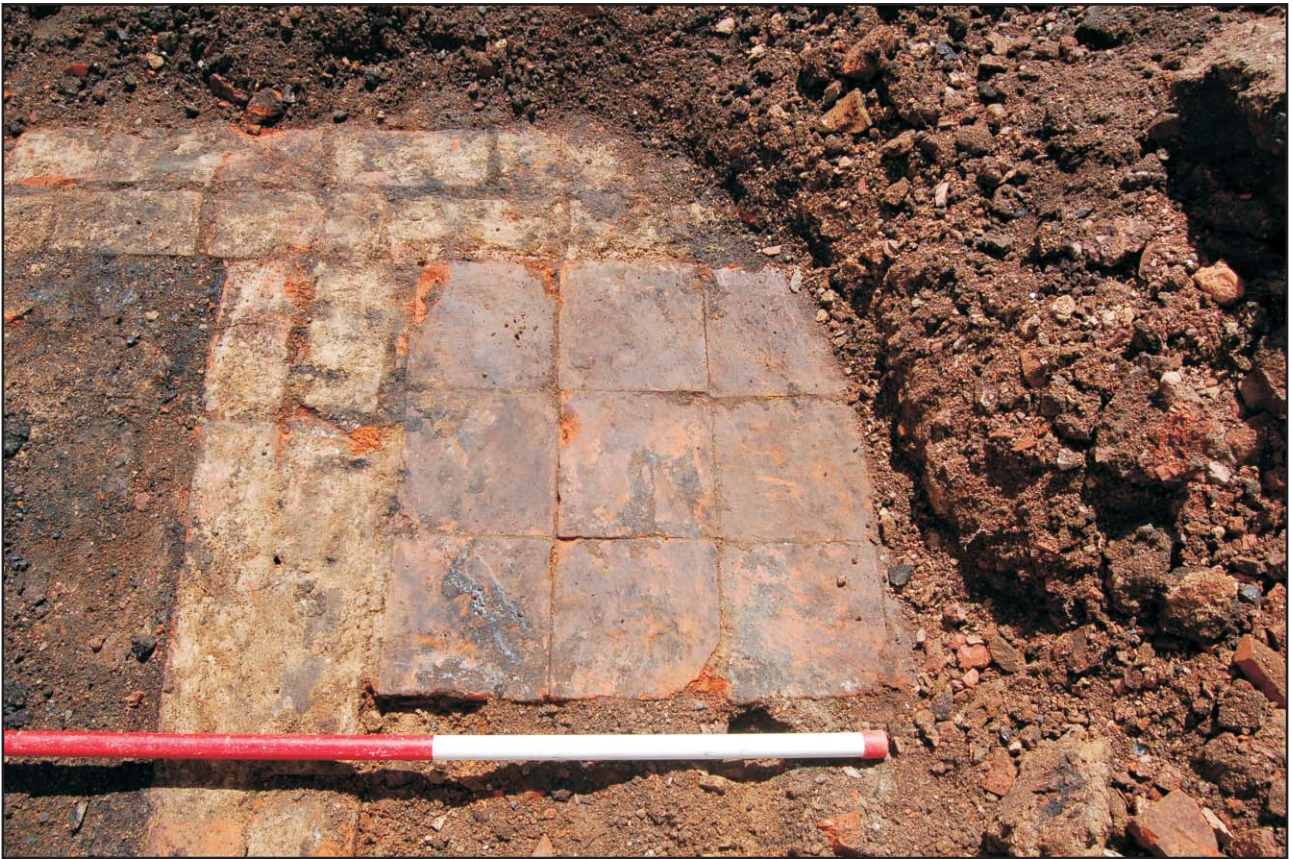
- 4.7 In only one place along the former row of houses was a fragment of flooring uncovered (Fig 22). This indicates that in this location, at least, the floor was of red ceramic un-glazed quarry tiles, 195mm square and 50mm thick (7 ¾ x 2 inches). It is assumed that this remnant indicates the original flooring, and as it was located in the back room which was most likely the scullery/kitchen it makes sense to have tiling in this location where there would likely have been a sink and perhaps copper for heating water. It is probable that the front room had a wooden floor although no evidence for this was found.

Quarry tile floor to rear kitchen/scullery, looking south Fig 22

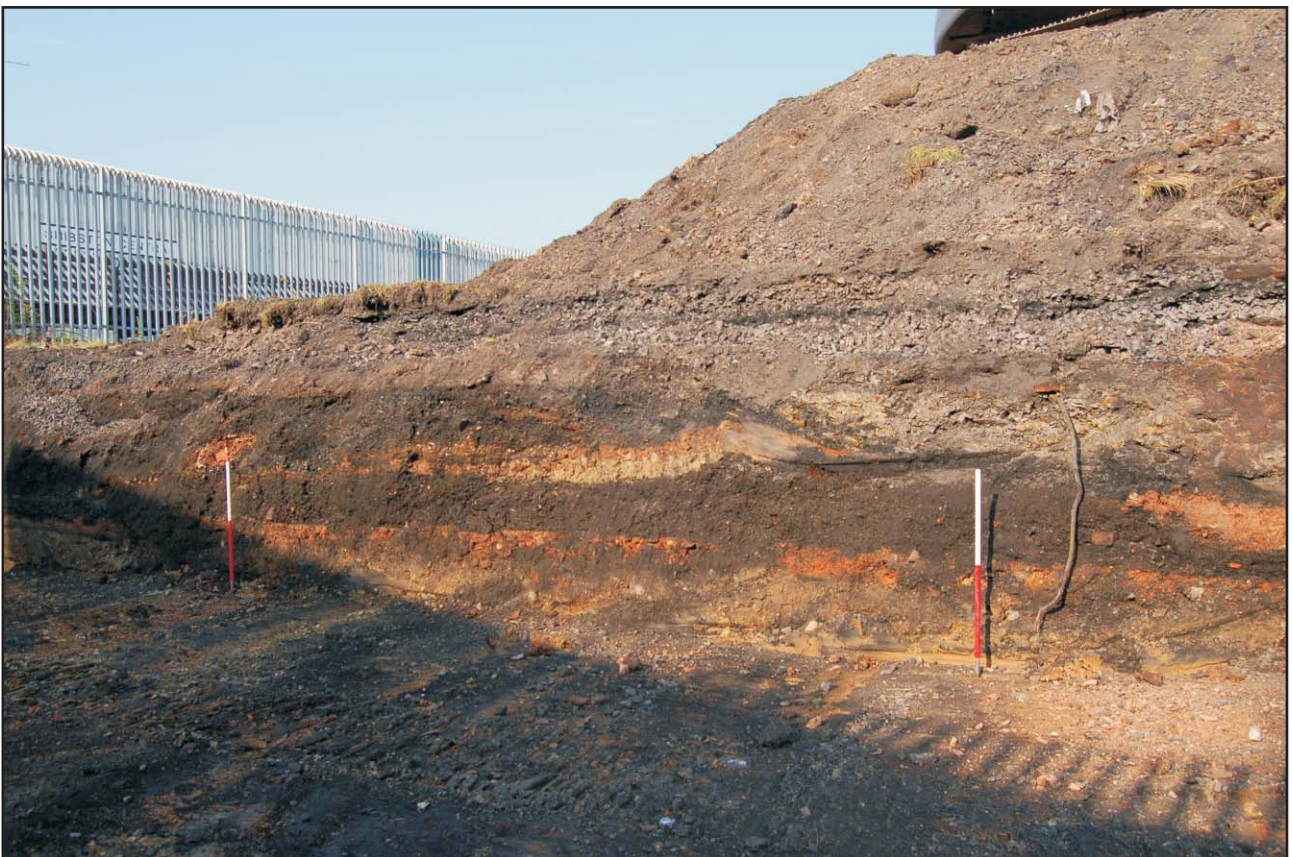
- 4.11 This great depth of ground reduction was most clearly observed at the southern edge of the site where approximately two and half metres of made-ground was removed (Fig 23). This made ground appears to be the result of both dumping of waste material and deliberate levelling for the 1970's coal preparation plant. It stretches from immediately adjacent to Ashby Road on the north side of the site, and the present southern limit of the development area. All of this made ground was removed as part of the re-development so that any pockets of un-compacted or unstable ground and remnants of foundations could be removed. The concrete was crushed and the soil was then graded and replaced before being compacted in layers to restore the former recent ground level prior to development.

Made ground at the south-east corner of the site, looking south-west Fig 23
