Archaeological building recording at former  
RAF Chelveston, Chelveston  
Northamptonshire  
October 2011

Report 11/274

*Northamptonshire Archaeology carried out a buildings recording action at the former RAF Chelveston Airfield, Chelveston, Northamptonshire to record two Nissen huts of possible WW2 construction prior to their restoration for reuse as storage.*

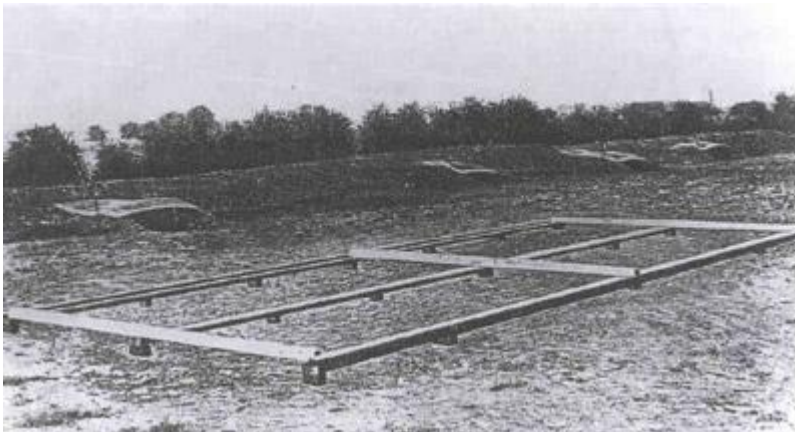
Fig 2

Wooden bearers are laid on level ground

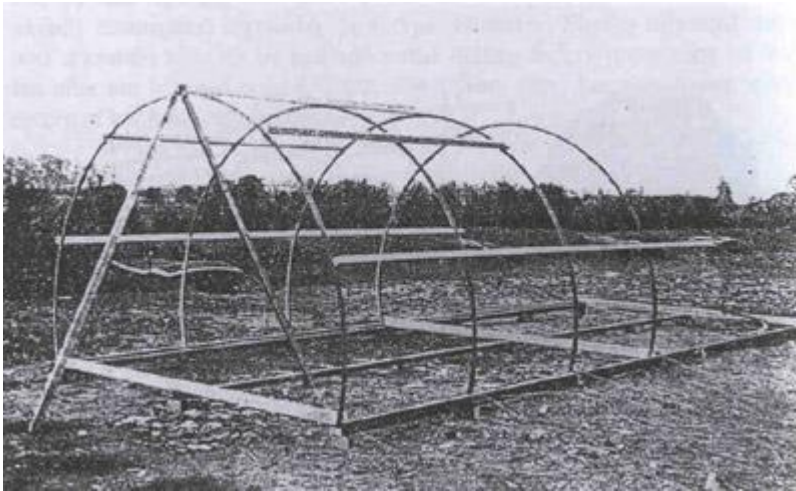
Steel ribs are bolted to the bearers and wooden purlins are fixed to the ribs with hook-bolts Fig 3

The purlins were attached to eight T-shaped ribs (1¾ × 1¾ × ⅛ inch; 45 × 45 × 5mm) set at 6 feet 0.5 inch (1.8m) centres. Each rib consisted of three sections bolted together using splice plates, and each end was bolted to the floor at the bearers. With each rib were two straining wires, one on each side and a straining ratchet (or in some cases a simple fencing wire strainer). The wires were strained during construction. The straining wires do not appear in the original Nissen patent.

The purlins were attached to the ribs using a "hook" bolt, which hooked through a pre-drilled hole in the rib and was secured into the purlin. The hook bolt was a unique feature of the Nissen design.

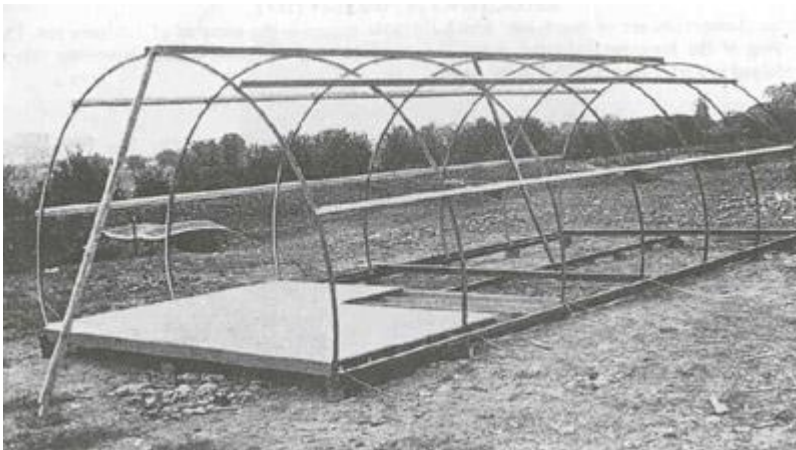
Wooden joists, to support the wooden floor panels, are screwed to the bearers Fig 4

The walls and floors rested on foundations consisting of 4 × 4inch (100 × 100mm) blocks with 15 × 9 inch (380 × 230mm) sole plates. On these were 4 × 3inch (100 × 80mm) bearers and 4 × 2 inch (100 × 50mm) joists at 2 feet 10 inch (1.0m) centres. The floor could be made from tongue and groove floorboards or concrete as at Chelveston.

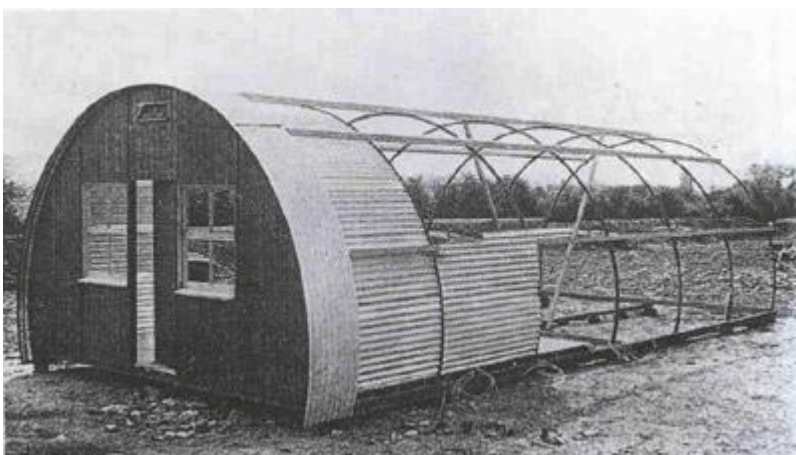
The hut is clad in corrugated iron Fig 5

The cross-section was not precisely semi-circular, as the bottom of the hut curved in slightly. The exterior was formed from curved corrugated steel sheets, 10 feet 6 inches by 2 feet 2 inches (3.2 × 0.70m), laid with a two-corrugation overlap at the side and a 6 inch (180mm) overlap at the ends. Three sheets covered the arc of the hut (about 54 sheets in all were required, for a standard 6 bay hut). These were attached to five 3 × 2 inch (75 × 50mm) wooden purlins and 3 × 2inch wooden spiking plates at the ends of the floor joists.

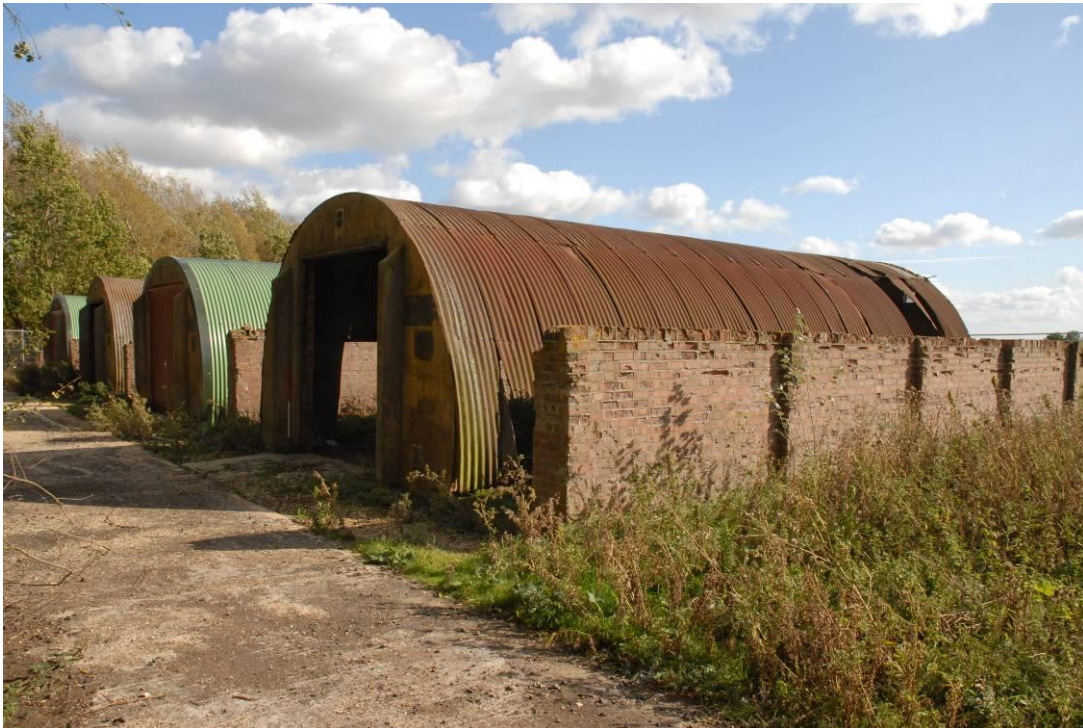
Fig 6

View looking south-east showing the group of four huts

The four Nissen Huts and dividing walls appeared to be contemporary with each other, with the huts being numbered in sequence (141-144) with the same stencilled information on each. Nissen Huts 141 and 143 were the two which were recorded.

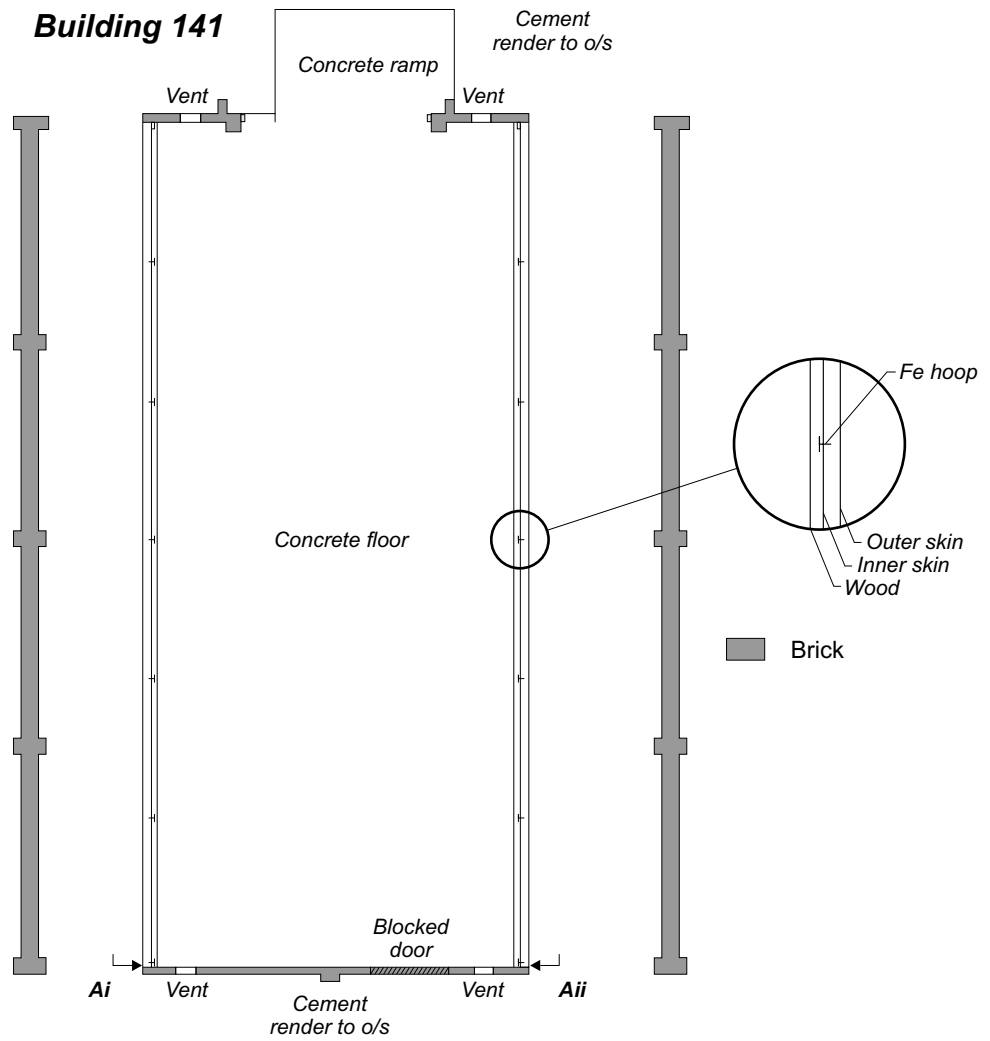
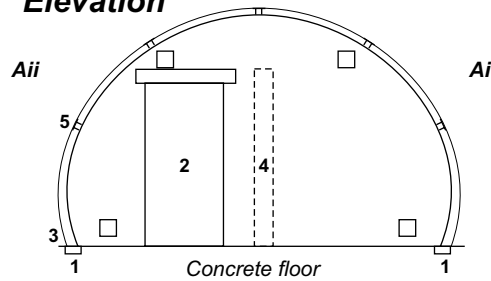
**Building 141**

- 1 Wood sole plate
- 2 Blocked door
- 3 Fe Hoop
- 4 External buttress
- 5 3" x 1½" timber purlins for outer skin

The two surveyed Nissen Huts were to all intents and purposes the same and are described together. All four of the huts in the group are six bay Nissen Huts, with brick walls blocking either end (Fig 8). No windows were present in the huts. The rear walls of the two surveyed examples had originally had a door, which had been subsequently bricked up (Figs 8, 10 and 11). The outside of the wall had been rendered in cement covering the bricked up doorway indicating that there was a change of function or need at some point in the use of the buildings. Four iron rungs were built into the back of the surveyed huts, the bottom pair were horizontal and the upper pair were placed vertically (Fig 11), the function of these was not clear.

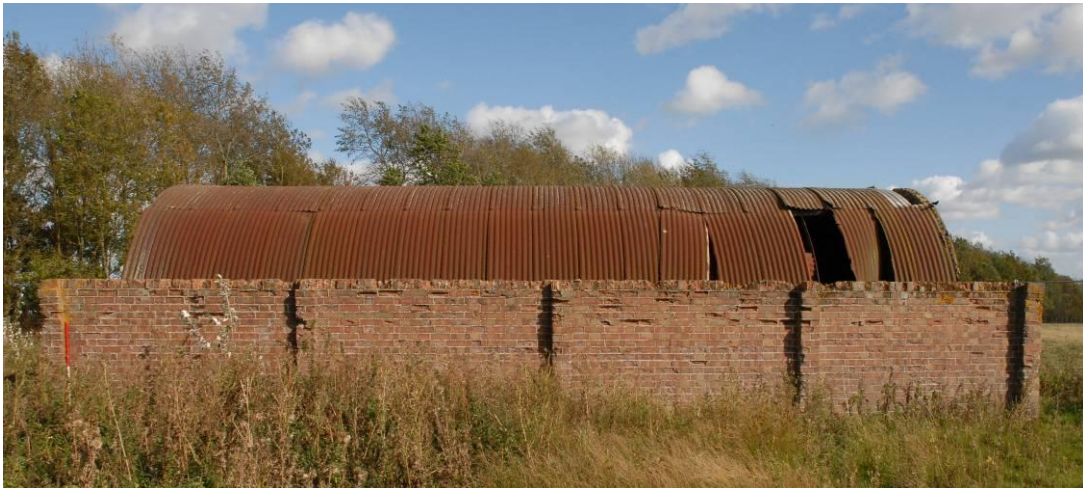
Fig 9

View looking east showing the dividing wall

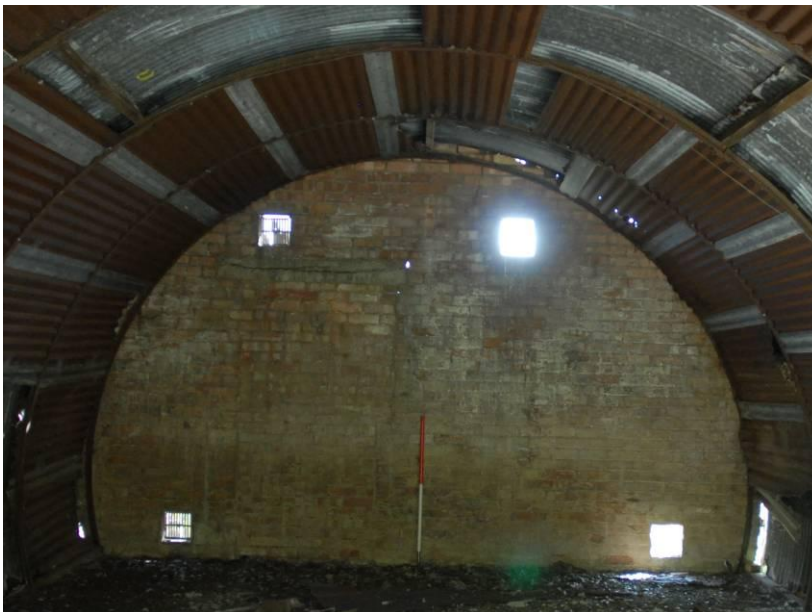
Interior of Hut 141, showing blocked door (left of the ranging pole), looking south Fig 10

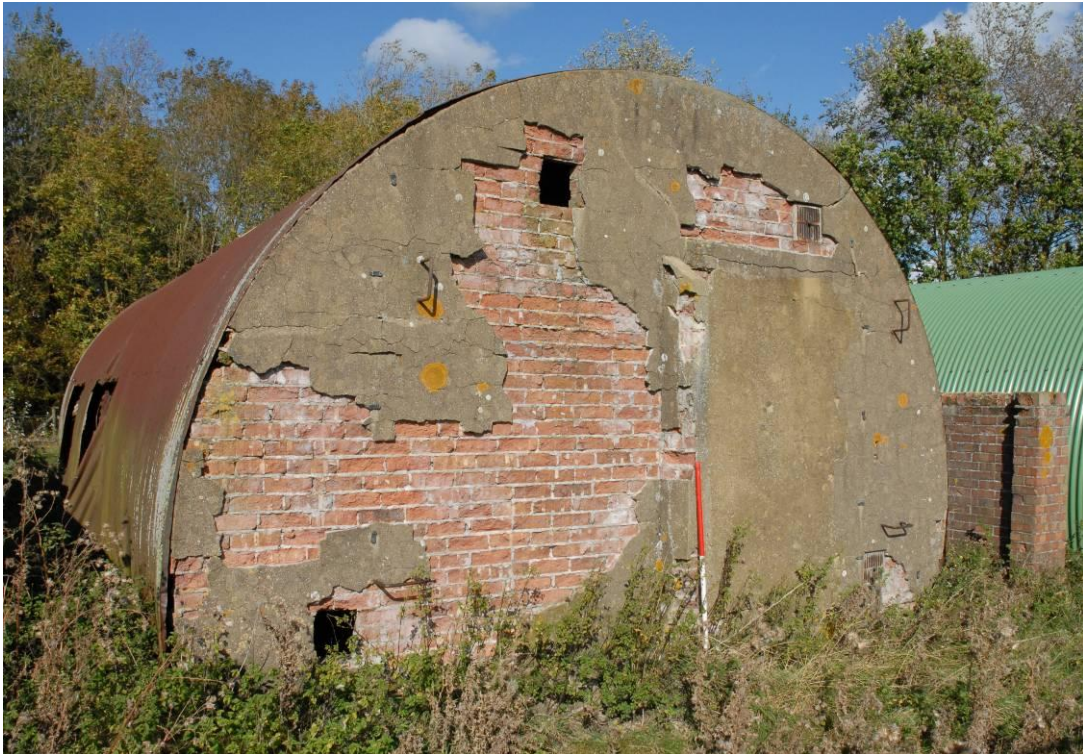
Back wall of Hut 141 showing concrete render over the blocked door, the vents and four iron rungs, looking north Fig 11

The survey recorded the two Nissen Huts in the group of four which had not been previously renovated. The survey demonstrated that the huts were of standard build, and within the variations of the basic structures that were available. The only alteration which appears to have taken place was the blocking up of the door on the back wall of the two surveyed huts. It was noted that on the two previously restored huts that the door in the back wall had been reinstated, no doubt for use as a fire exit.

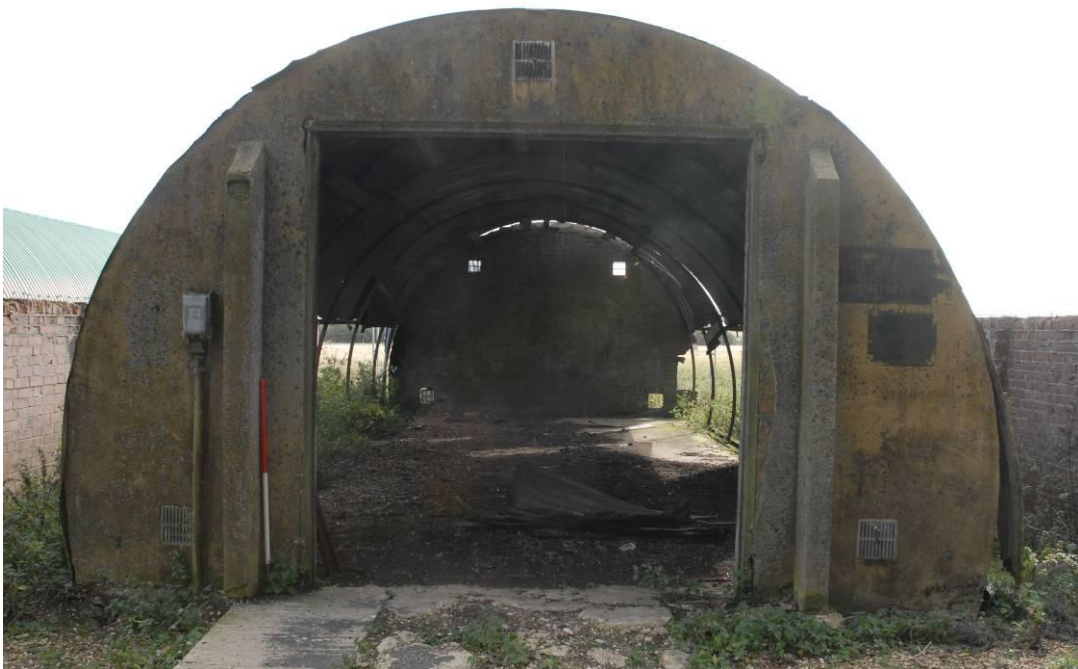
The front brick wall to each hut had a 2.4m wide opening, the doors to which had been removed (Fig 12).

Front wall of Hut 143, looking south Fig 12

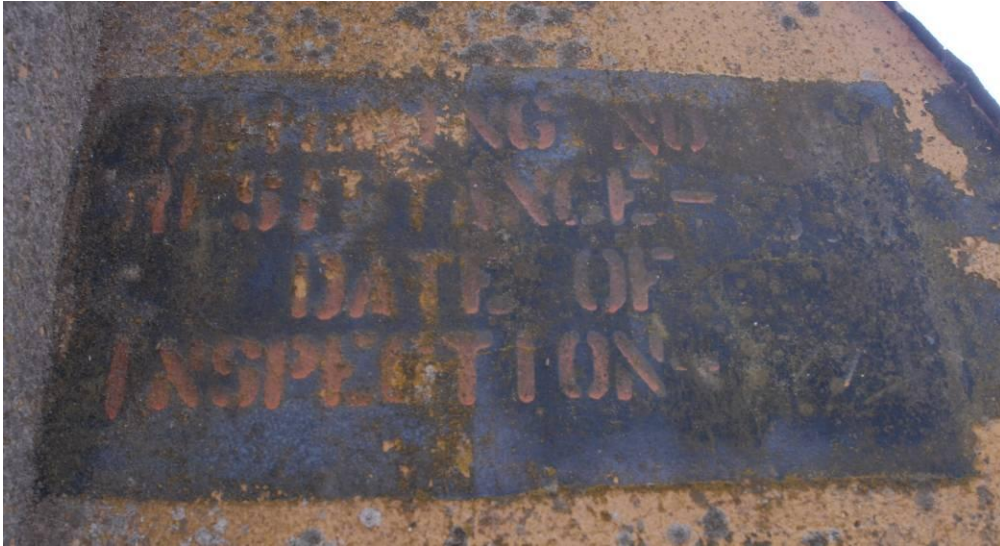
Fig 13

The front walls were also cement rendered and each building had a small stencilled panel (Fig 13) giving the;

Stencilled panel on the front wall of Hut 143

The resistance reading may relate to the building's earth as it was a metal building, which may have been used for storing munitions, where sparks would have been very undesirable.

The stencilling would suggest that the huts had been used for storage of electrical or electrically sensitive material during the second period that the airfield was under the tenure of the USAF at the time of the Cold War.

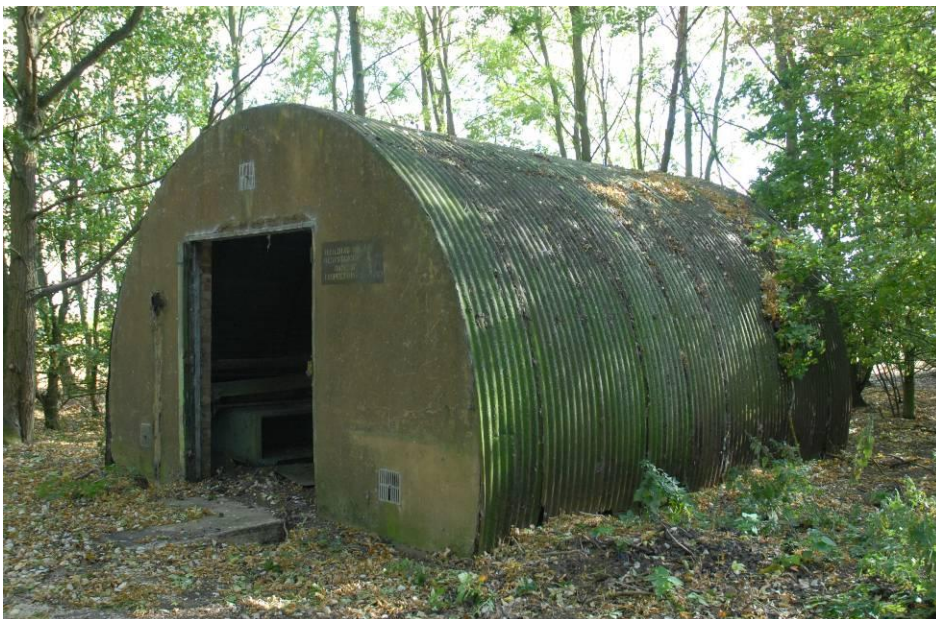
Fig 14

It was not possible to determine the date of inspection on the two huts which were surveyed, although Hut 140 which stood in the woods to the west of the surveyed examples, was inspected on 22/11/63 (Figs 7, 14 and 15). The date would indicate that the huts were rendered pre-1963.

Hut 140, looking south-east

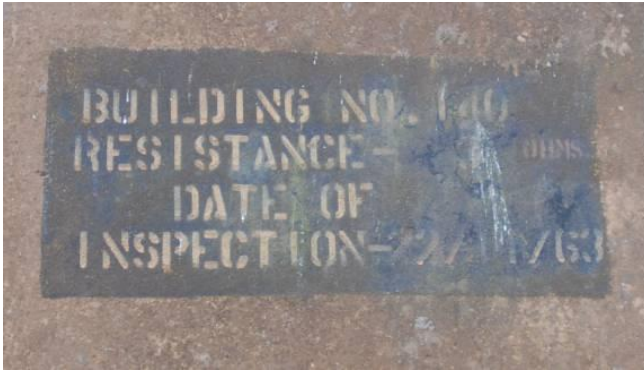
Fig 15

Stencilled panel on Hut 140

The date of the buildings inspection raises a slight issue as the USAF left Chelveston in 1962 and the readable stencil on Hut 140 gave a date of 1963, suggesting that there may have still been a USAF presence, as the site remained as a reserve airfield.

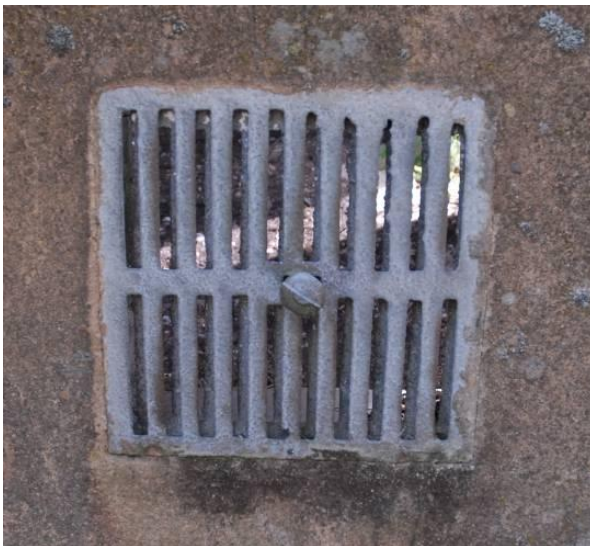
Fig 16

Simple vents were present in the brick end walls of each hut, three in the front wall and four in the back (Fig 16).

Vent detail

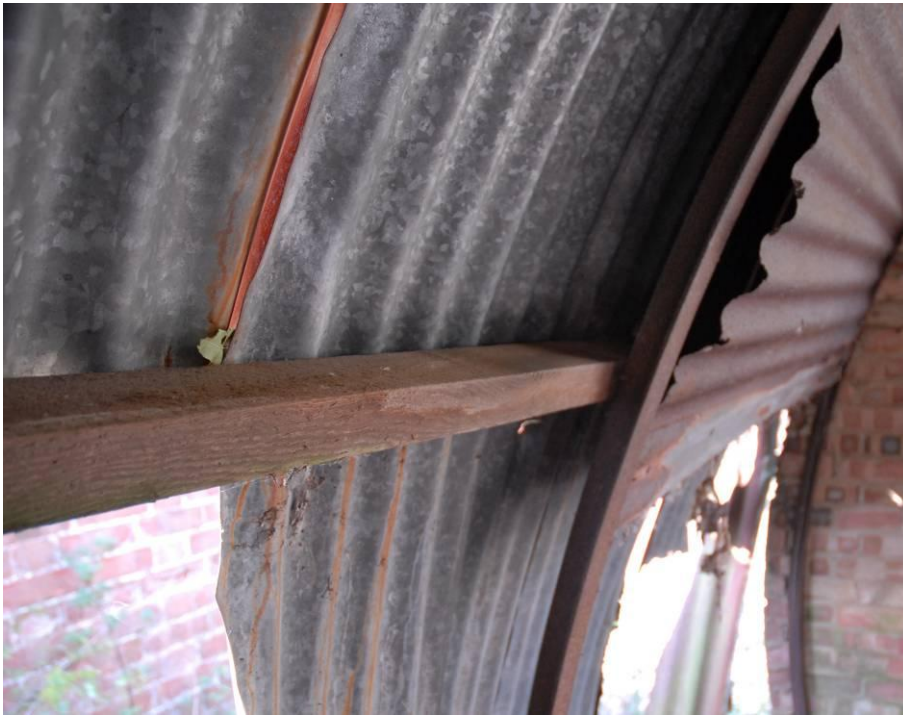
Fig 17

The huts were clad in corrugated iron sheeting in accordance with the description in Section 3.2. The covering varied in its state of completeness and condition, allowing the various details of internal construction and fittings to be viewed (Figs 17 and 18).

Purlin detail, Hut 143

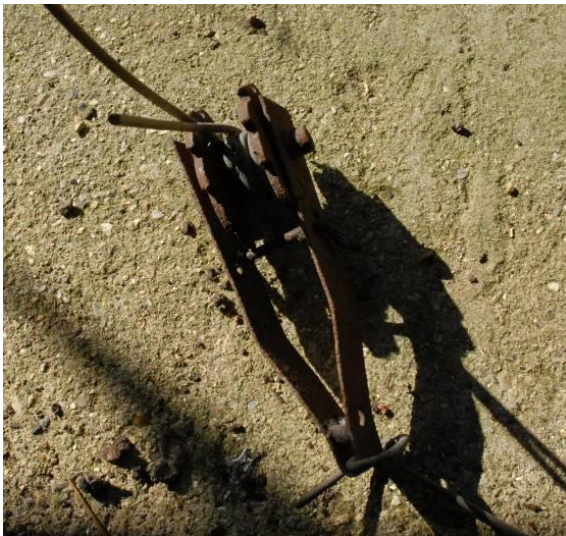
Straining ratchet detail, Hut 143      Fig 18

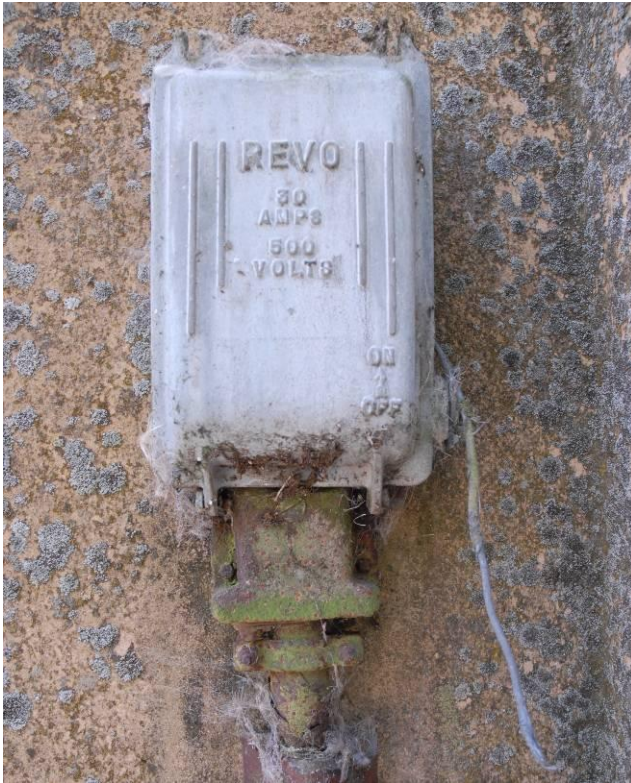
Fig 19

Each of the two surveyed huts had an electrical supply with the junction boxes surviving on the front walls to the left side of the opening (Fig 19). The associated internal wiring had been removed (Fig 20).

Electric junction box on Hut 141

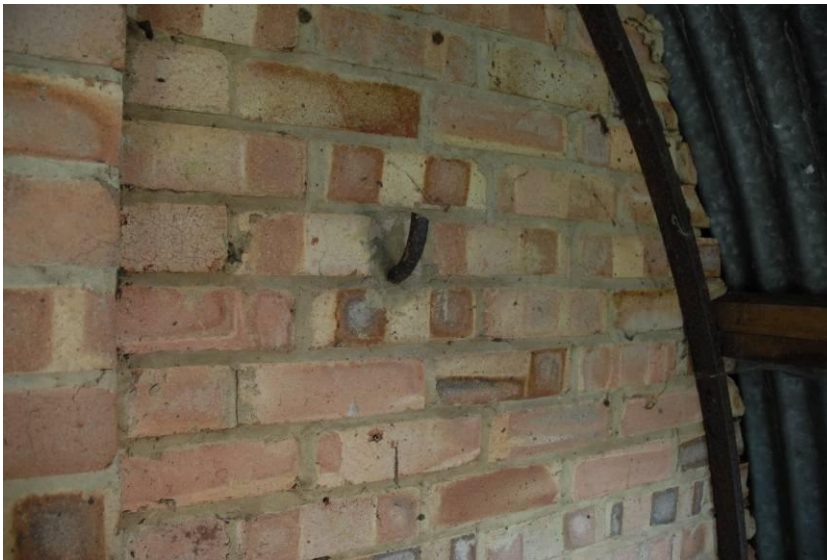
The inside of the front wall showing where the wiring came through from the junction box  
Fig 20

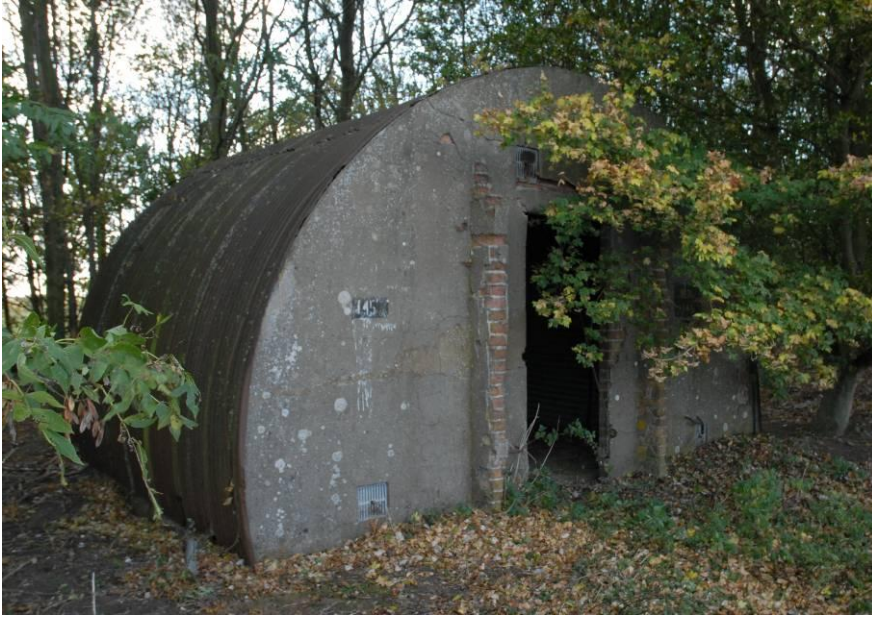
Fig 21

A further hut, 145, which was not subject to survey was observed to the east of the surveyed huts in the woods. This hut appeared to be in its Second World War condition, with no sign of the later stencilling (Fig 21). This hut had a steel framed window in its back wall (Fig 22).

Hut 145, looking north-east

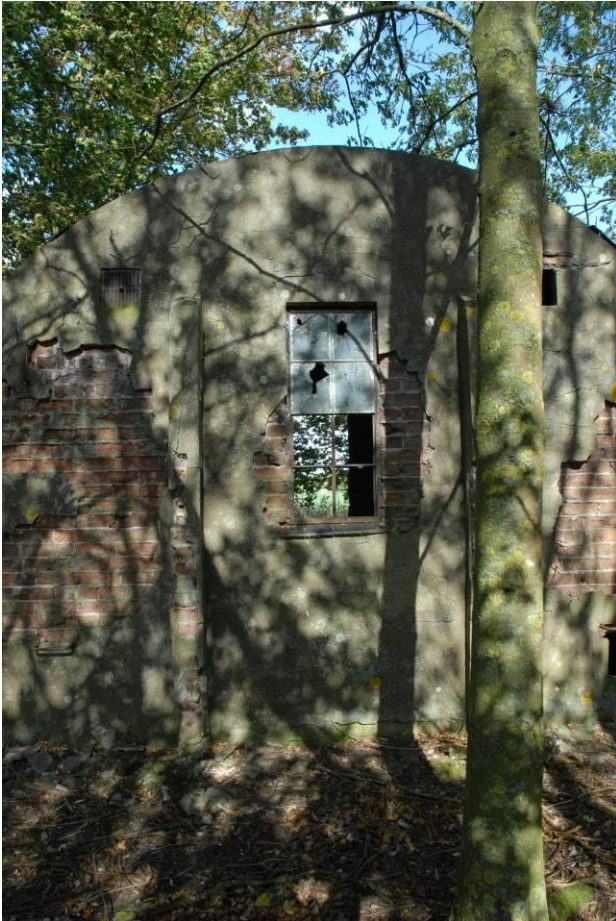
Fig 22

Hut 145, looking south-west

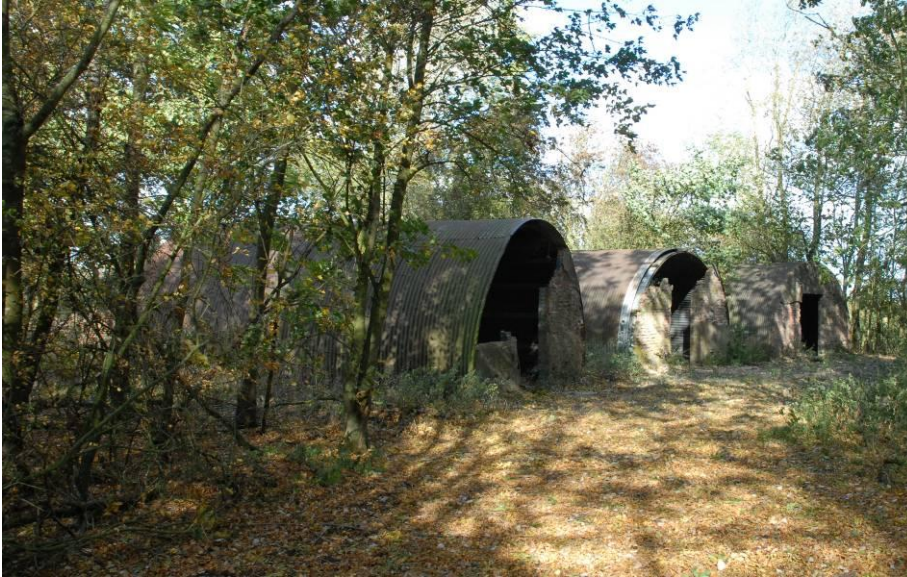
A further group of three huts was located to the north-west of the surveyed group, these huts were in a poor state of repair (Fig 23).

Group of three huts to the north-west of the surveyed group, looking north-east Fig 23
