Archaeological building recording at the Potting Sheds, Ashton Wold, Northamptonshire February 2012

Report 12/81

April 2012

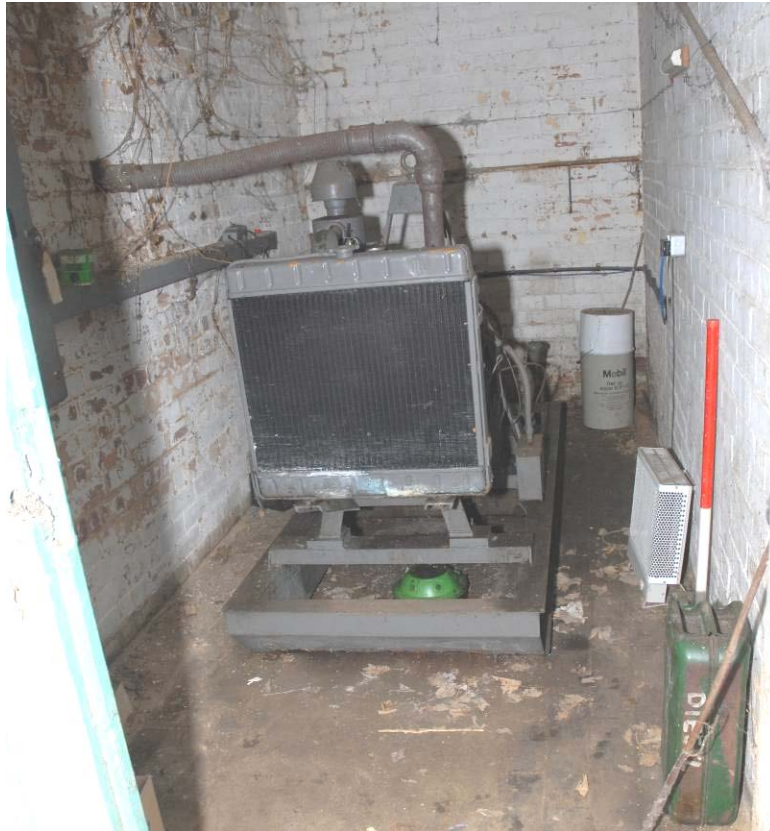
Fig 4

This room, which measures 3.83m deep by 1.84m wide, houses a 'modern' Perkins diesel generator and has the switchboard for the electrical supply for the potting shed range (Fig 4).

Generator in Room 1

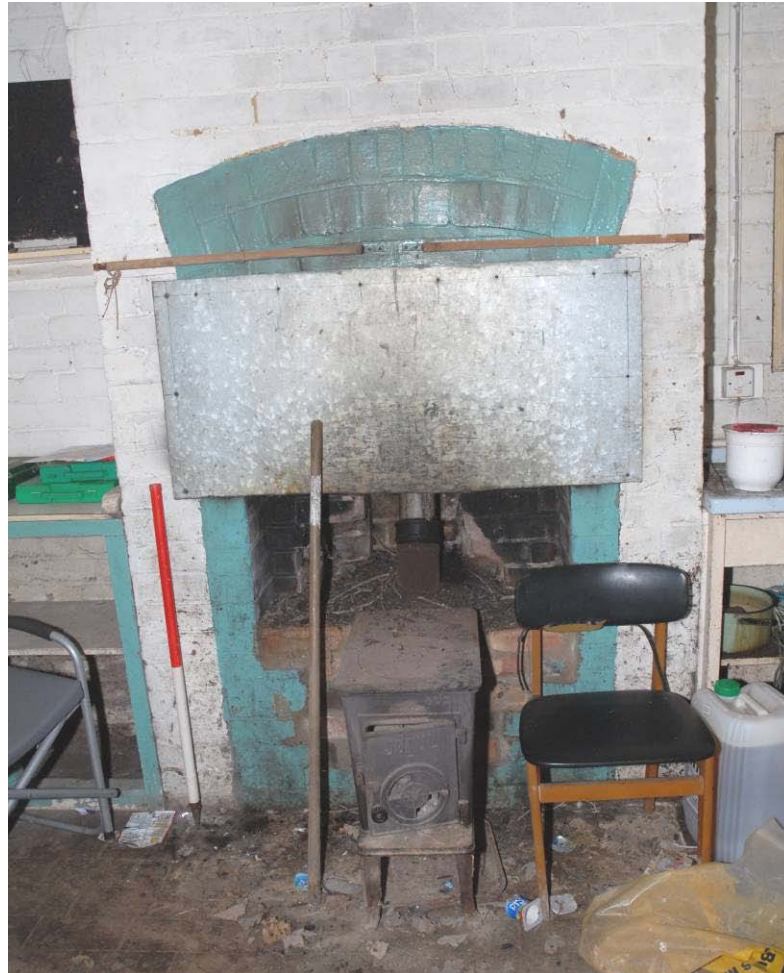
Fig 5

This room, which measures 3.83m deep by 3.21m wide, was and still serves as the mess room for the gardeners. Within the reduced fireplace opening there is a small wood burning stove (Fig 5), either side of which stand 1950s style kitchen cupboards in the alcoves. The cupboard on the right hand side has a sink top.

Room 5, mess room fireplace

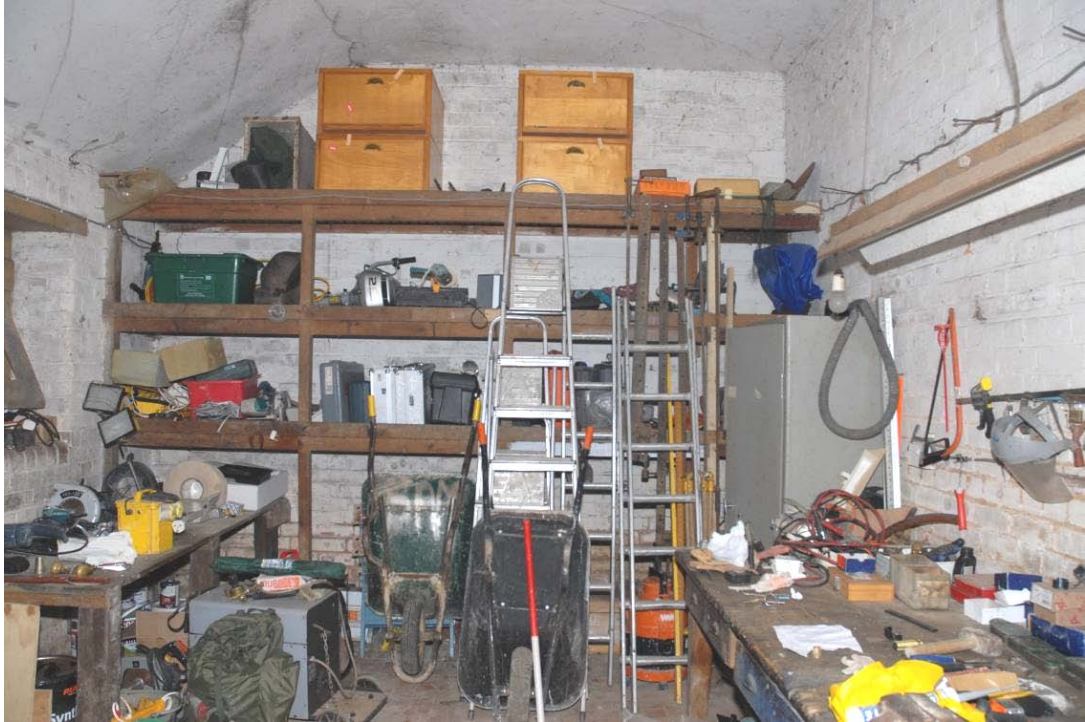
Fig 6

This room, measuring internally 3.83m deep by 6.12m wide, is in use as a workshop with benches on the north, west and south sides and shelving on the east wall. (Fig 6).

Room 5, workshop

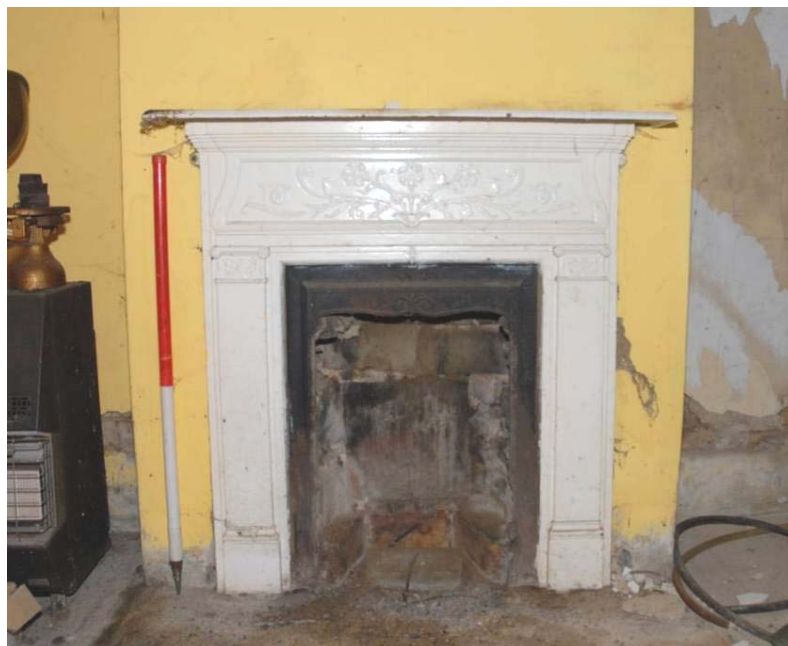
Fig 7

This was the Head Gardener's Office, measuring 3.25m deep by 3.64m wide, although it has now become a general storeroom. The floor is oak block parquet in a herringbone pattern with a doormat well in the threshold. The walls are yellow painted plaster. Together with the mess room, this is the only other room to have a fireplace, this one having a white painted cast iron surround (Fig 7).

Room 6, fireplace

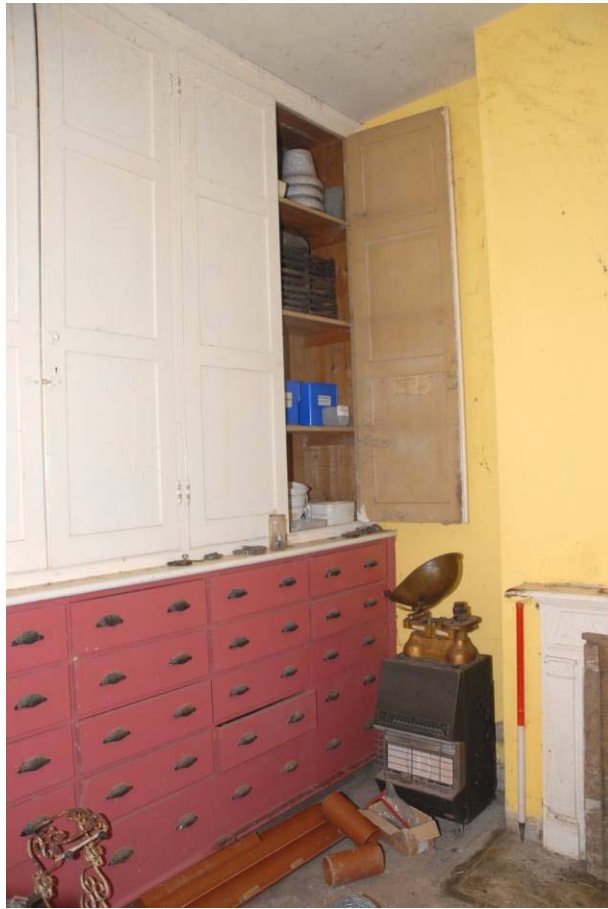
Fig 8

On the south wall of the room there is a built-in run of floor to ceiling cupboards, 0.58m deep, with drawers below, for the storage of seeds and chemicals etc, some of which date from the latter years of the garden's life in the 1980s (Fig 8).

Room 6, built-in cupboard

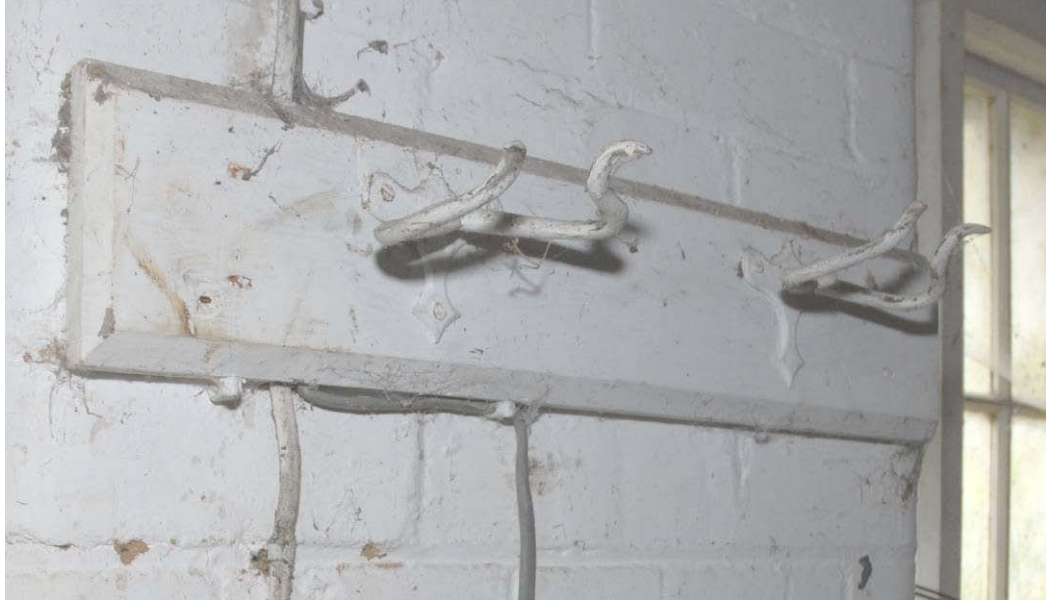
Fig 10

This was originally the tool storage room, measuring 3.83m deep by 3.66m wide. The 'cow horn' style hooks for these are still extant on the north, east and west walls (Fig 10).

Room 7, wall mounted tool hooks

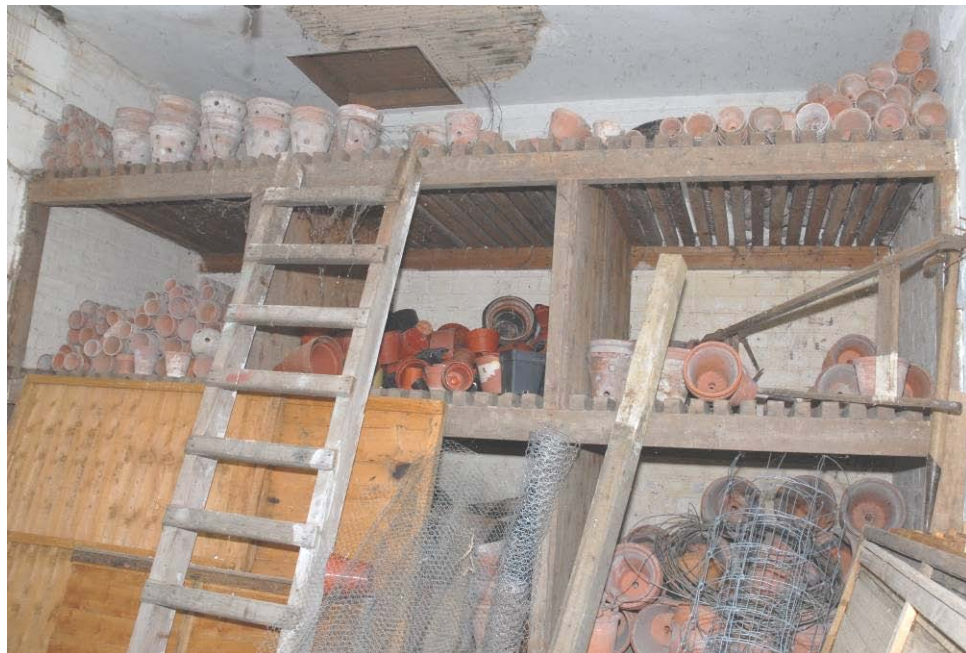
Fig 11

The back wall of the room has shelving containing terracotta plant pots of varying sizes (Fig 11). There is a small hatch in the ceiling of this room to access the loft space.

Room 7, plant pot storage shelves and ladder

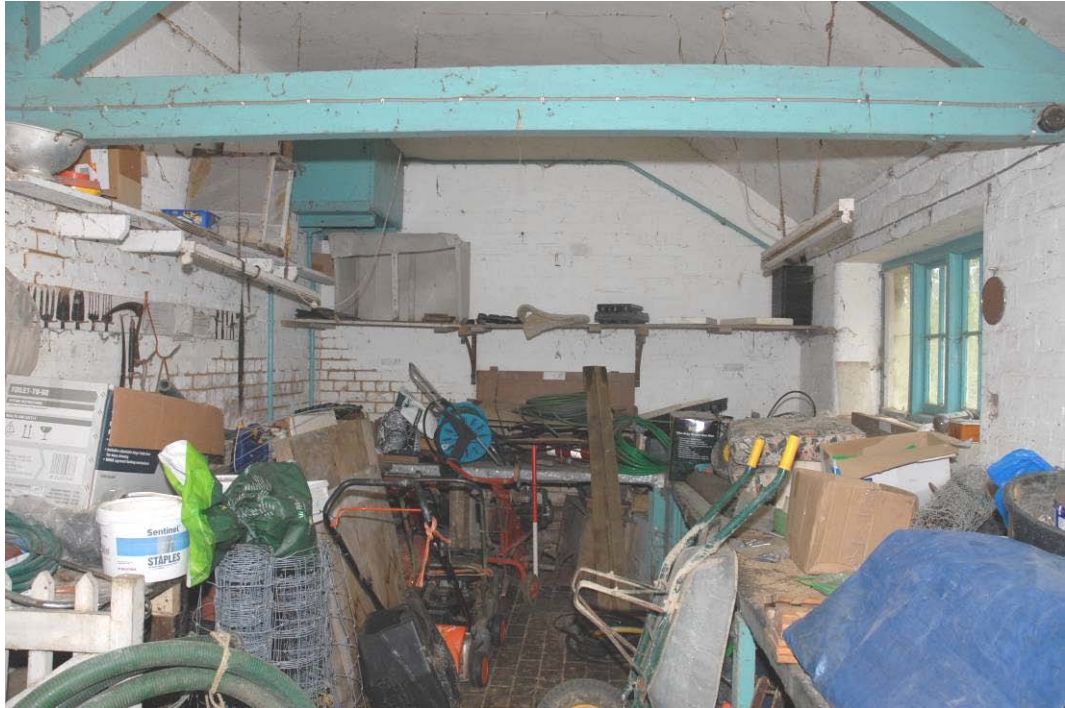
Fig 12

This is actually *the* Potting Shed, 3.83m deep by 7.41m wide, and it has a zinc-topped work bench on three sides (Fig 12).

Room 8, The Potting Shed, showing zinc-topped work bench

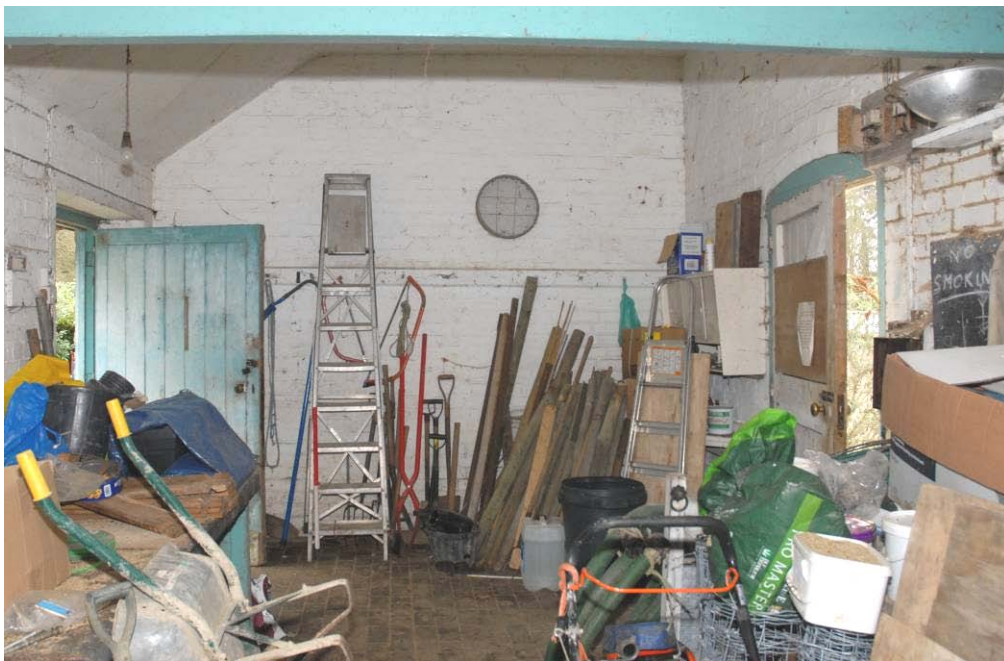
Fig 13

There are tool hooks on the east wall of the Potting Shed (Fig 13). On the south wall there is a modern shadow board for hand tools, allowing for easy identification of missing tools (Fig 12).

Room 8, The Potting Shed, showing tool hooks on the east wall

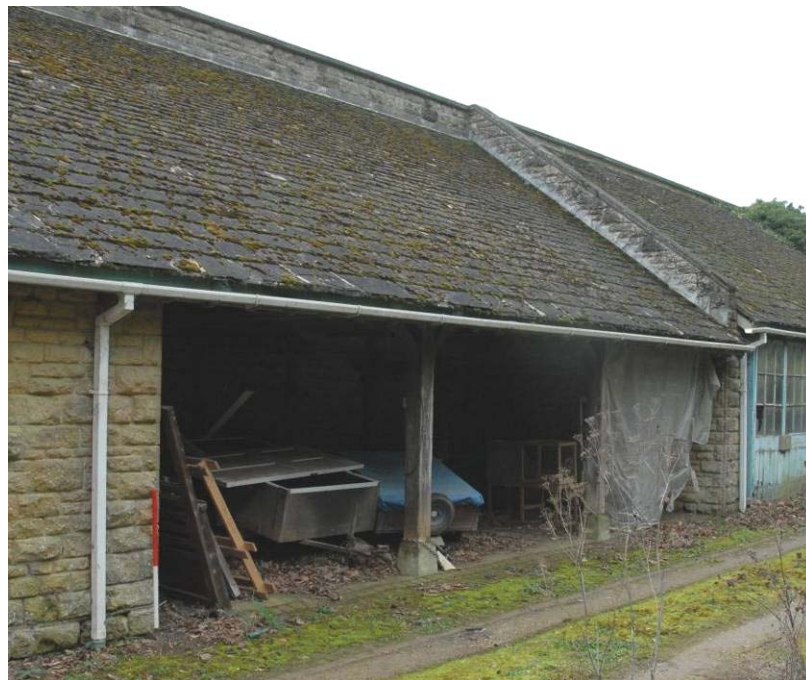
Fig 15

This is an open-fronted three-bay cart shed, measuring 3.92m deep by 9.10m wide, with an open loft space above (Fig 15). The internal walls are as the external walls, in coursed rock-faced limestone.

Room 9, the cart shed

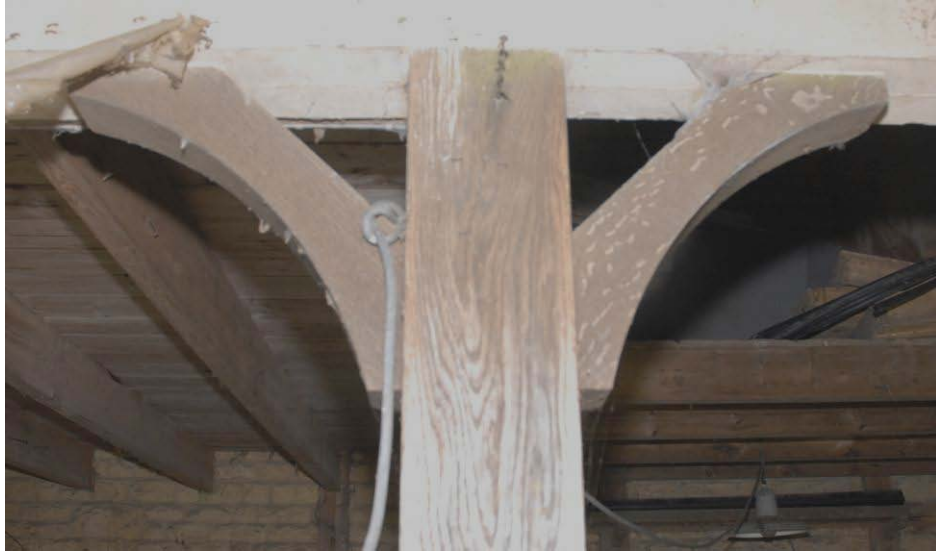
Fig 16

The three bays are separated by wooden posts, with a curved brace either side to support the wall plate (Fig 16).

Room 9, post and curved braces

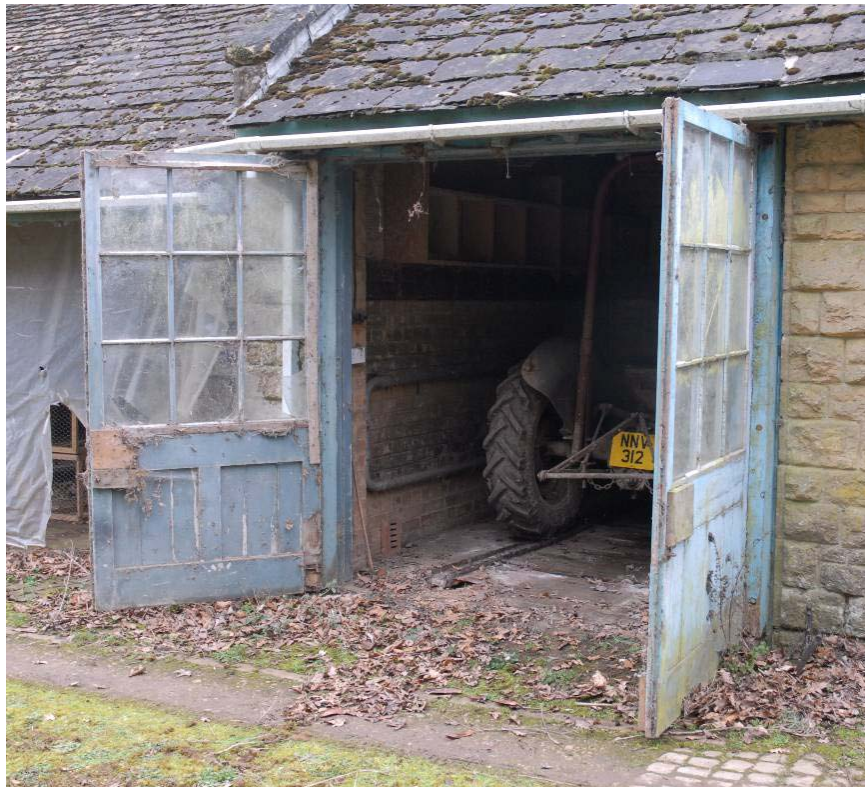
Fig 17

This room, which measures 3.83m deep by 2.68m wide, has double doors with nine glass panels in the top of each, across the width of the room (Fig 17).

Room 10, the garage doors

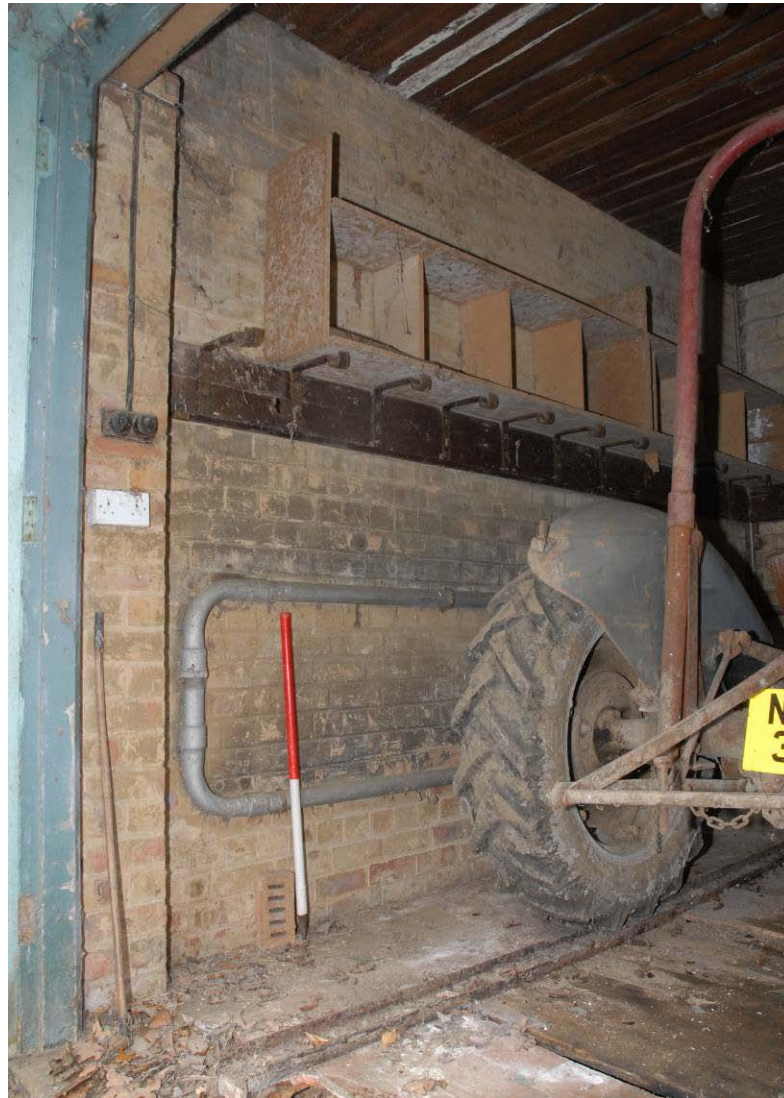
Fig 18

The floor is red quarry tiles, with an inspection pit, and the ceiling is pine tongue and groove. Around the three sides of the room there are hooks, possibly for the storage of ladders (Fig 18).

The room appears to have originally been for a motor vehicle. Although 1900 is an early date for a motor vehicle, it is not impossible. The room at the time of the survey housed a grey Massey Ferguson TE 35 of mid 1950s vintage.

Room 10, the garage room

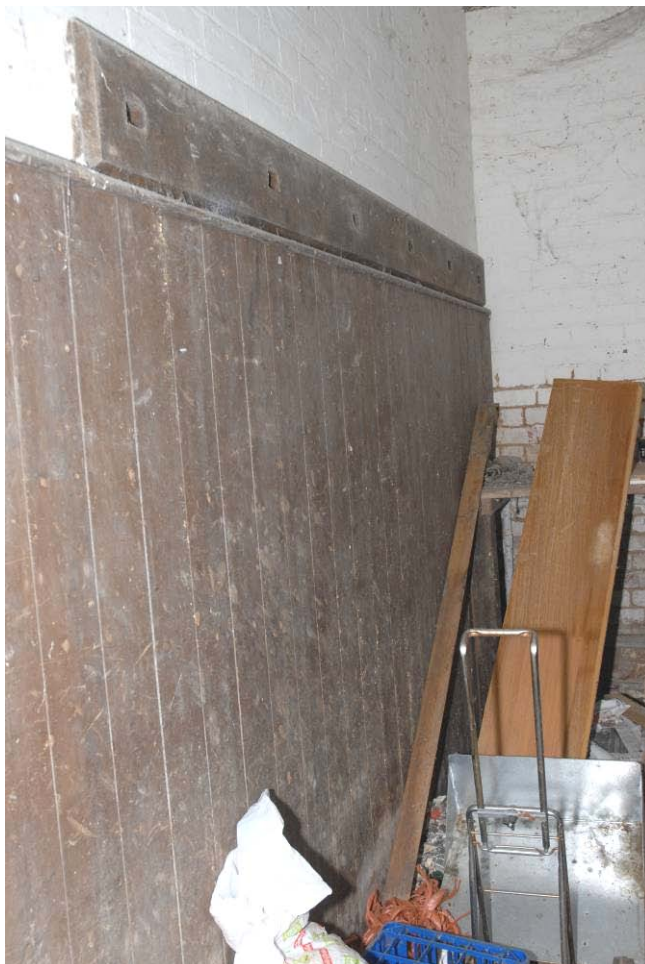
Fig 19

This room, which measures 3.83m deep by 2.30m wide, has a bench on two sides and the eastern wall has tongue and groove wooden panelling (Fig 19). There is no evidence for the original function of this room.

Panelling in Room 11

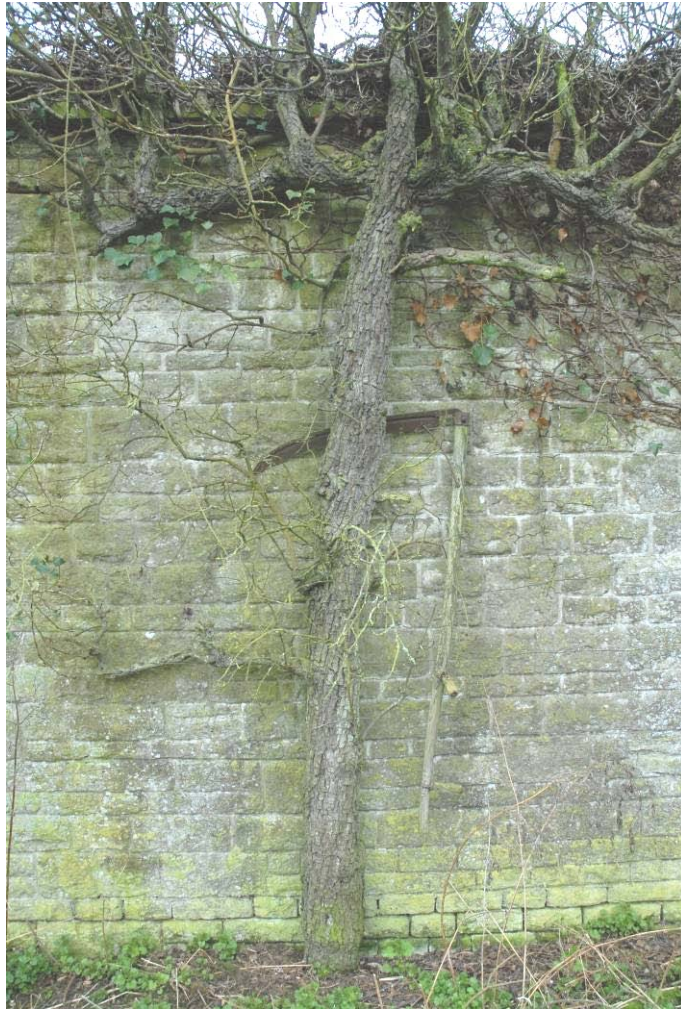
Cordoned fruit tree on south wall of the garden
(note the scythe left hanging behind it) Fig 22

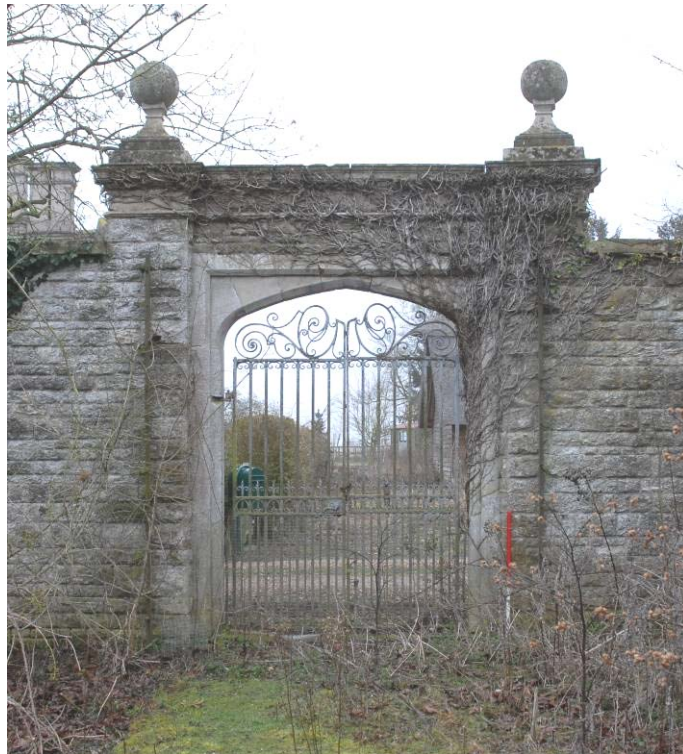
Fig 23

The walled garden itself was not the part of the original survey but a photographic record was made of the surviving structures to put the Potting Shed complex into context (Fig 2). The garden itself is split into quarters, boarded in part by cordoned fruit trees, the beds overgrown. Around the inside of the wall are tensioned wires for the training of cordoned fruit trees (Fig 22). There are three principal entrances into the walled garden for the family to use: in the middle of the east, south and west walls. These have iron gates and stone arches (Fig 23).

The entrance in the west wall

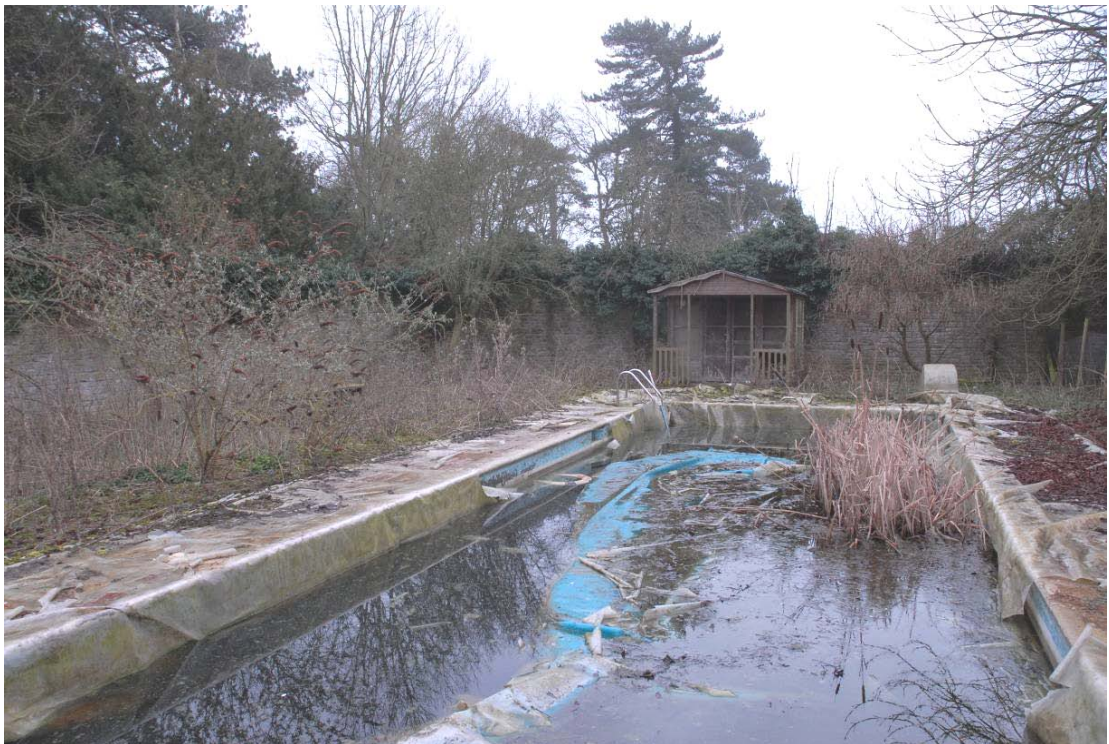
Fig 24

The south-east quadrant of the garden had a tennis court and outdoor swimming pool added, both of which were very overgrown at the time of the survey (Fig 24).

The swimming pool

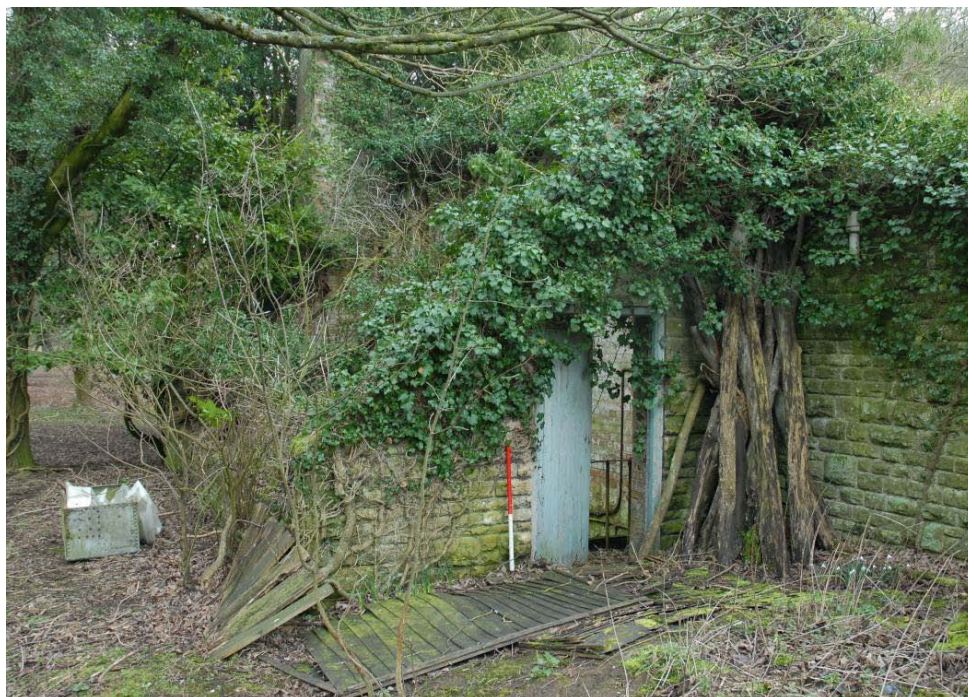
Fig 25

The former boiler house is located on the north-east corner of the walled garden and was in very poor condition, the roof having been removed or collapsed (Fig 25). The boiler, a 'Beeston Robin Hood Colonial' was at basement level and was accessed via an iron spiral stair. The boiler was installed by Foster and Pearson and examples of similar boilers can be seen in a sales catalogue of 1909 on the company's web page (<http://www.fosterandpearson.co.uk/assets/content/files/jamesonBook.pdf>).

The boiler house

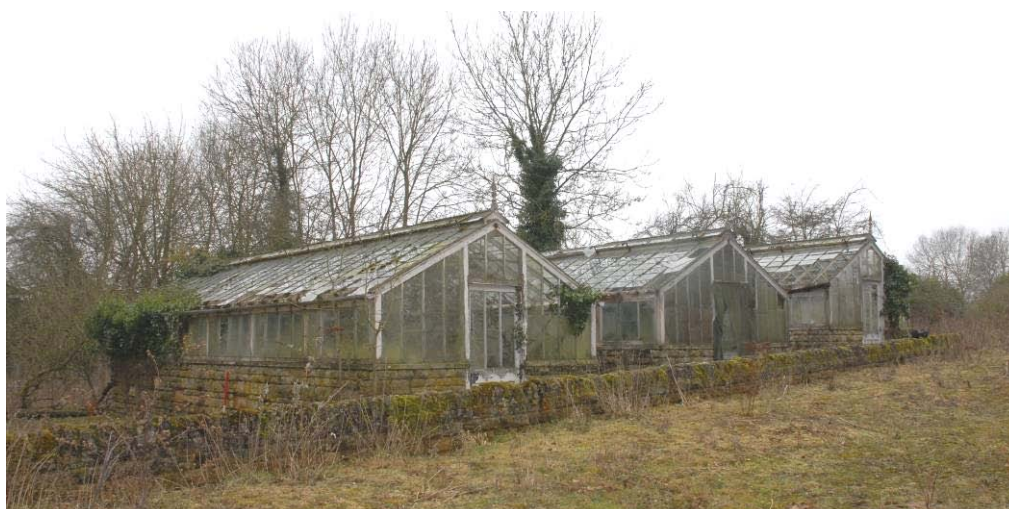
Fig 26

Three freestanding greenhouses survive within the walled garden (Figs 26, 27 and 28). They are all the same, made by Foster and Pearson, to a design which is still available. The company is no longer based in Beeston but has been revived in Sussex and still makes greenhouses to the same patterns as it did from its foundation in 1841.

The three freestanding, surviving greenhouses

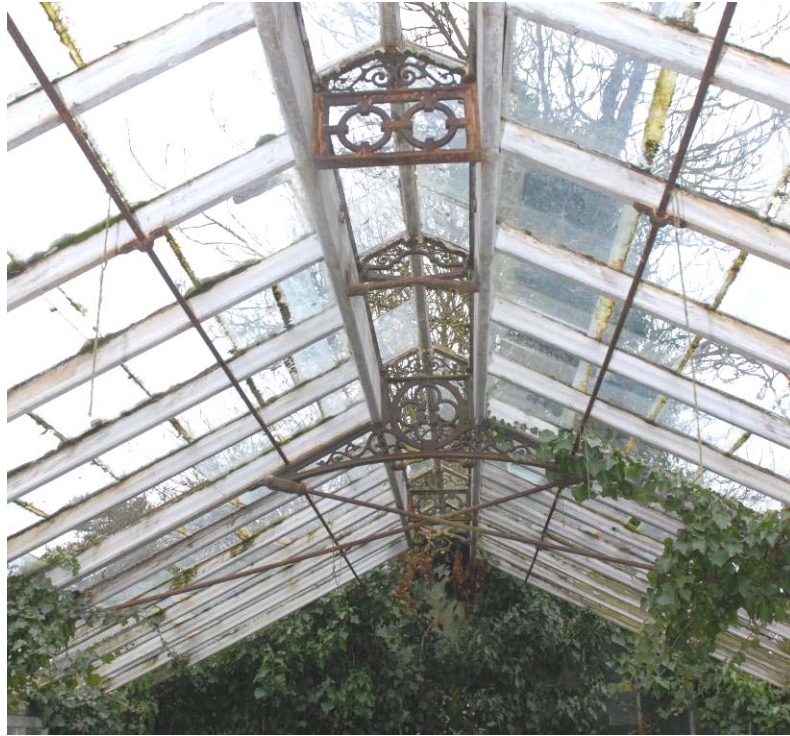
Fig 27

Detail of cast iron window opening mechanism

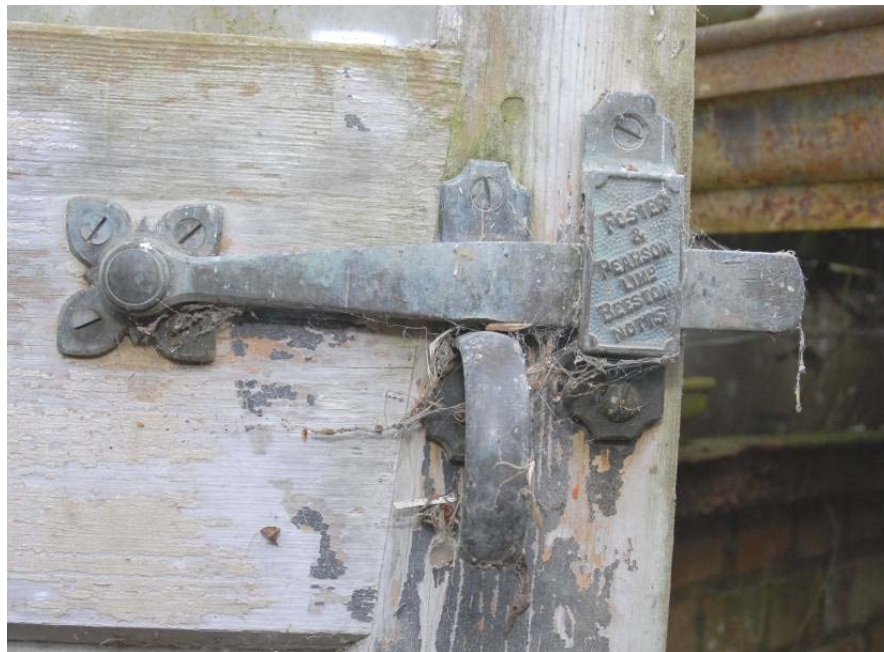
Fig 28

Door latch detail

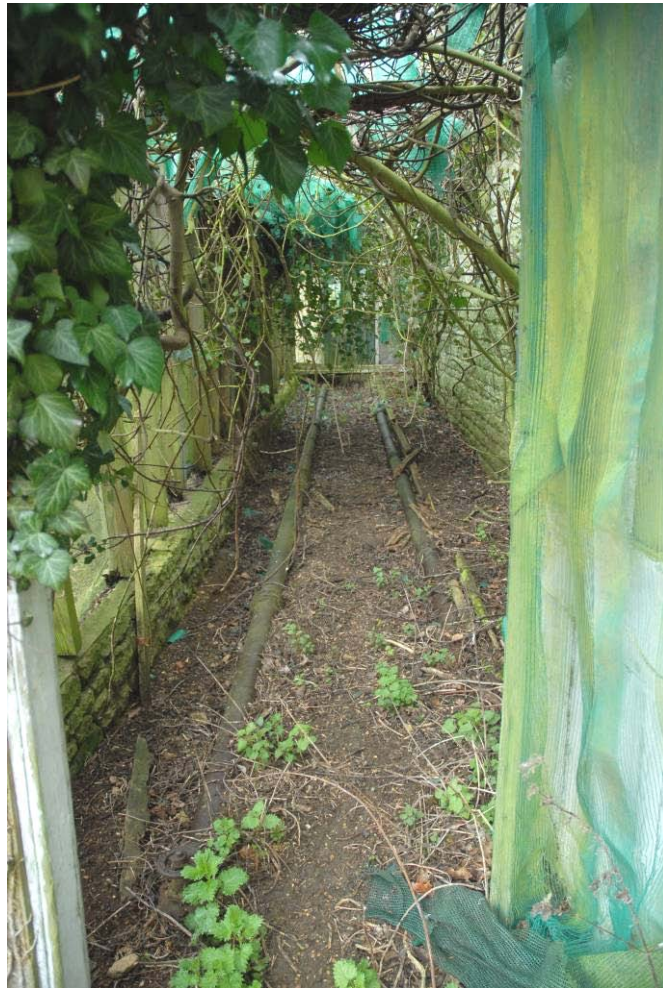
Fig 29

A small lean-to greenhouse survives on the inside of the north wall of the garden although in a very overgrown state (Figs 2, 29 and 30).

Lean-to greenhouse interior

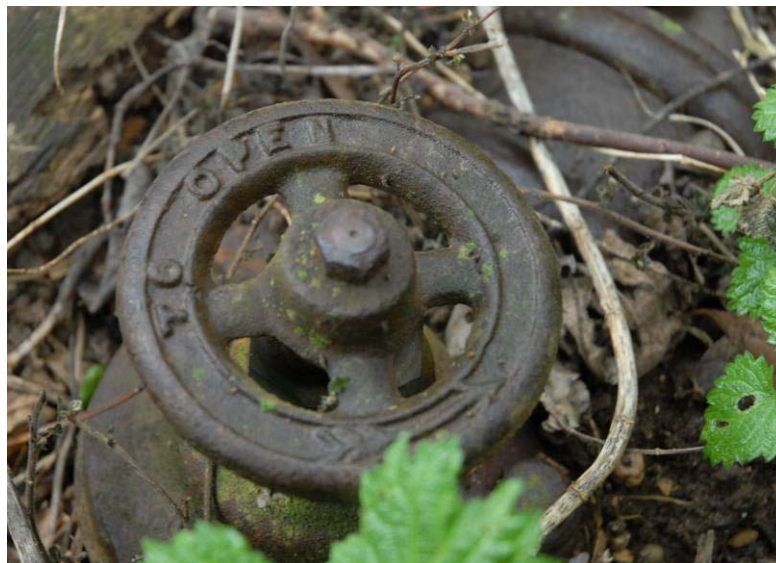
Fig 30

This greenhouse had cast iron pipes for heating at floor level, with a valve (Fig 30), to open.

Heating pipe, valve detail

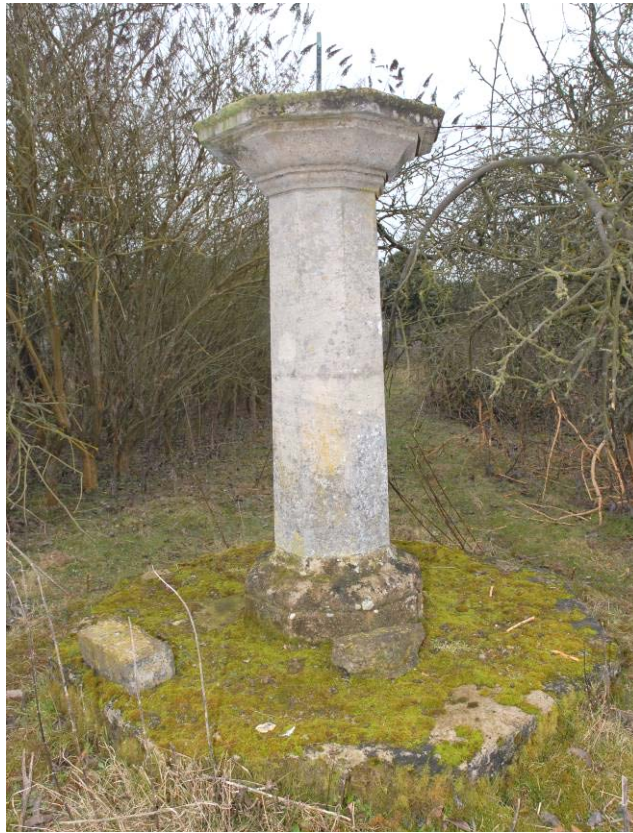
Fig 31

A sundial mounted on an octagonal stone column (Fig 31) survives in the central crossing point of the paths within the garden. The dial is bronze and retains its gnomon (Fig 32).

Sundial column

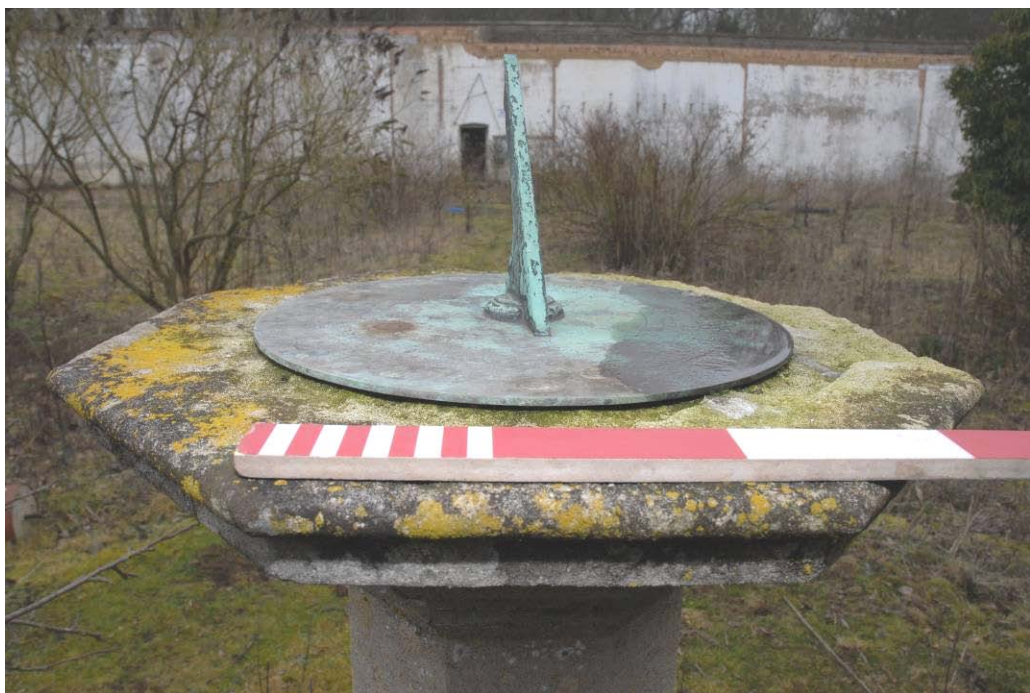
Fig 32

The dial and gnomon

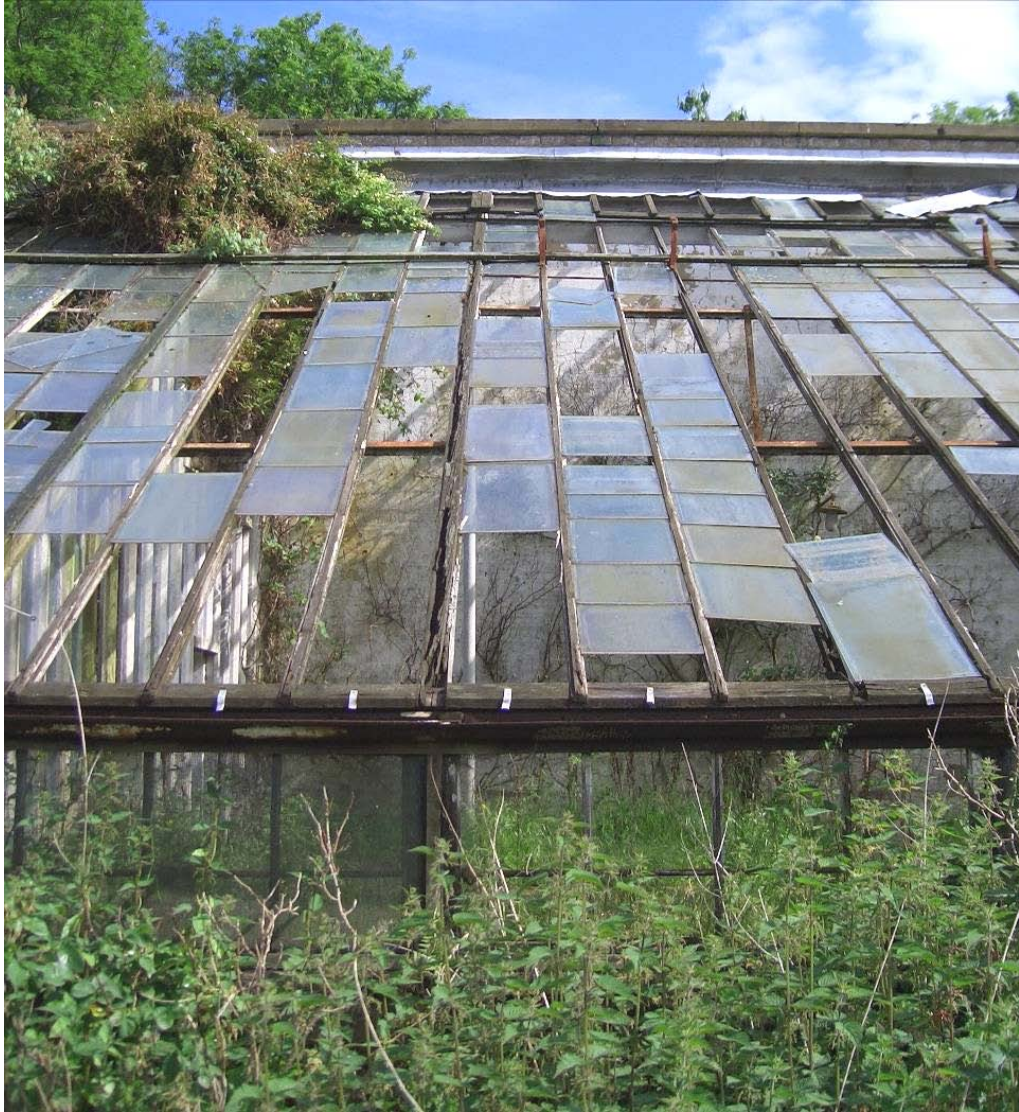
The main greenhouses (Figs 2 and 33) which backed onto the Potting Shed wall had been demolished as they were in a dangerous state.

Main greenhouse prior to demolition (image courtesy of
David Jackson Architectural Services) Fig 33

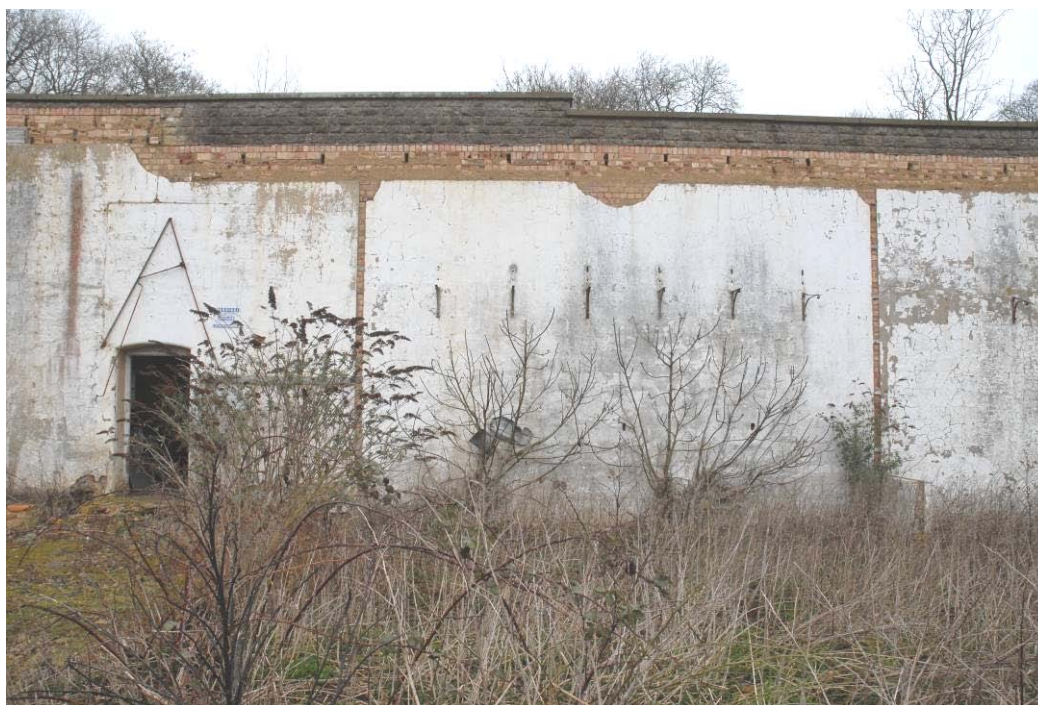
All that remains of the main greenhouses is a scar on the inside of the north wall of the garden, with its single doorway opening through into the potting shed. To the east of this door are two fig trees, survivors from a time when this part of the greenhouse was heated (Fig 34).

Area of main greenhouse with fig trees to the right, and door to Potting Shed Fig 34
