## Archaeological building assessment of The Cottage, Hellidon Grange Hellidon, Northamptonshire March-April 2012

Report 12/84

April 2012

**ARCHAEOLOGICAL BUILDING ASSESSMENT OF  
THE COTTAGE, HELLIDON GRANGE,  
HELLIDON, NORTHAMPTONSHIRE  
MARCH-APRIL 2012**

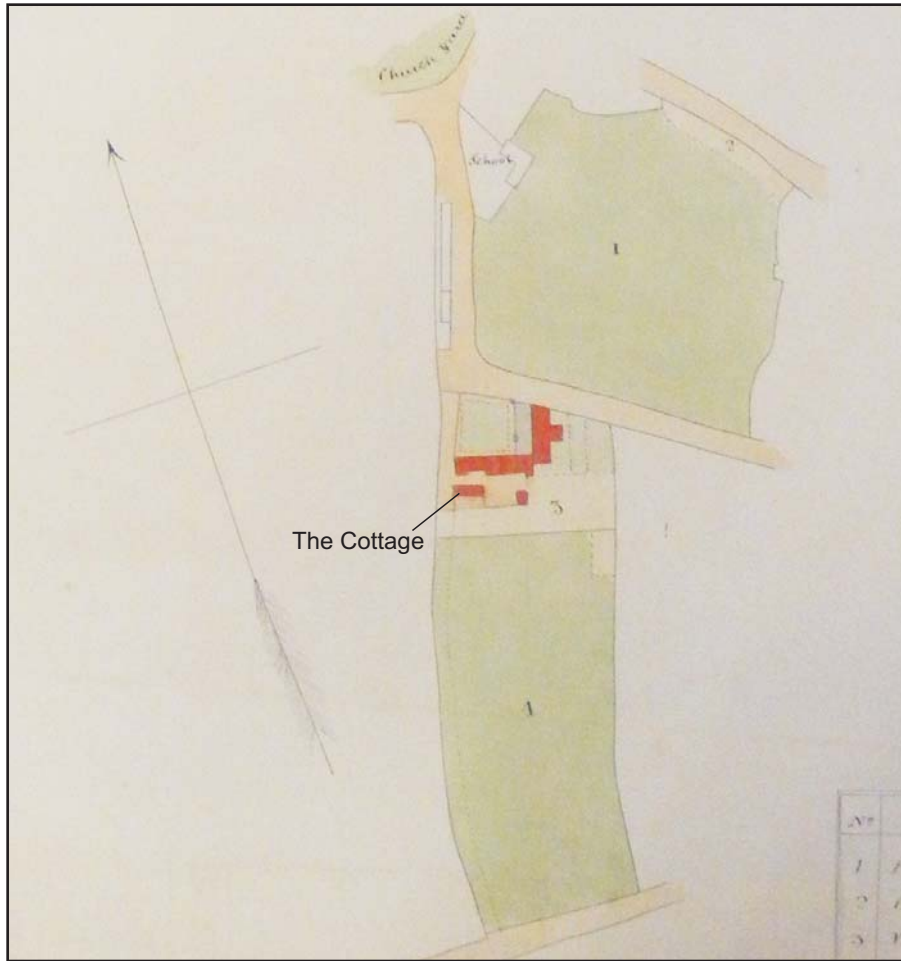
Extract from plan of Hellidon Vicarage, 1853 Fig 2

A plan of 1853 shows 'Hellidon Vicarage and Crofts'. This clearly shows the Vicarage, the School, and two detached outbuildings, one of which is in exactly the right location and alignment to be The Cottage (Fig 2).

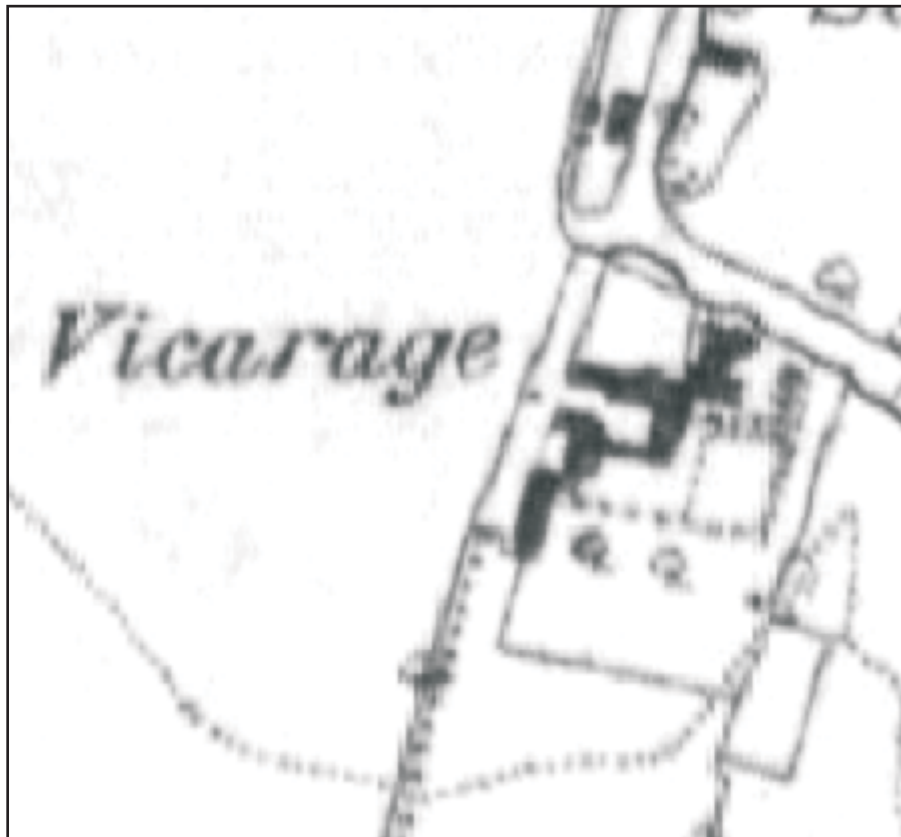
Ordnance Survey map, 1880s Fig 3

The First Edition Ordnance Survey Map of the 1880s shows that the complex to have reached almost its maximum extent. The cottage is depicted, as is the range of other ancillary buildings to the south (Fig 3).

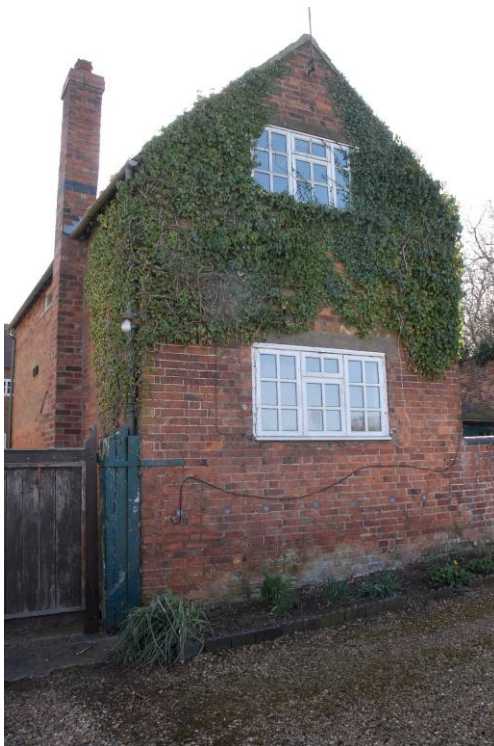
The Cottage, west gable Fig 7

The west gable of the cottage, at a slightly eccentric angle to the other walls of the building, faces the private gravelled access lane alongside Hellidon Grange (Fig 6). It presents a plain red-brick aspect with simple modern timber casement windows at ground and first floor levels beneath concrete lintels (Fig 7). Ivy obscures some of the first-floor brickwork, which is of Flemish Garden Wall Bond, also sometimes called Sussex Bond. There are closers at the corners. Clear mortar/cement changes show where the windows and their lintels have been inserted.

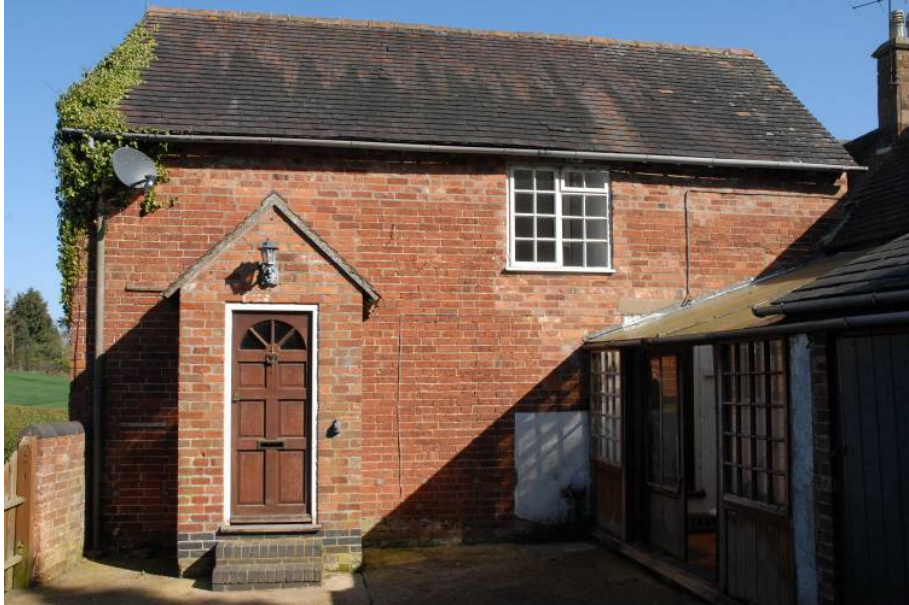
The cottage, north side      Fig 8

The north-facing long axis of the building looks into the courtyard garden, entered through a wooden gate in a brick perimeter wall with Staffordshire Blue engineering brick half-moon cappings. The brickwork of the facade is unremarkable, of Flemish Garden Wall Bond, and clearly exhibits colour and mortar changes where modern windows have been inserted, and where the eaves have been raised as part of the 1972 conversion from a stable. At ground floor level the brickwork has been rendered close to the kitchen window, which looks out into a utility room lean-to made out of the courtyard's north-east corner. The principal entrance into the Cottage is in this side, through a brick and timber porch with a pitched roof, the whole arrangement entirely of 1972 (Fig 8).

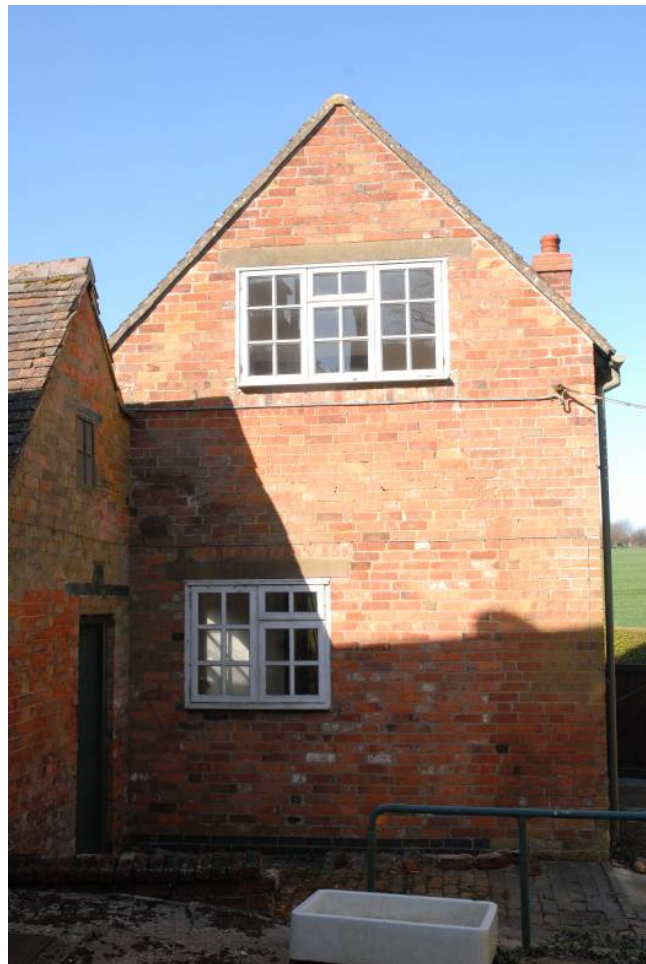
The Cottage, east gable      Fig 9

The east gable of the building is not dissimilar from the west but it does not share the same slightly eccentric layout, being fully square with the long axes of the building. The modern timber casement windows with their concrete lintels have been inserted, the first floor example requiring the dismantling of the entire gable apex to put in. A line of Staffordshire Blue engineering bricks marks the base of that lower portion of gable wall rebuilt as part of the 1972 works. There was formerly a lean-to which covered the area outside this gable end, shown on the 1925 Ordnance Survey map, the scars of its roof being visible on the adjacent (Fig 9).

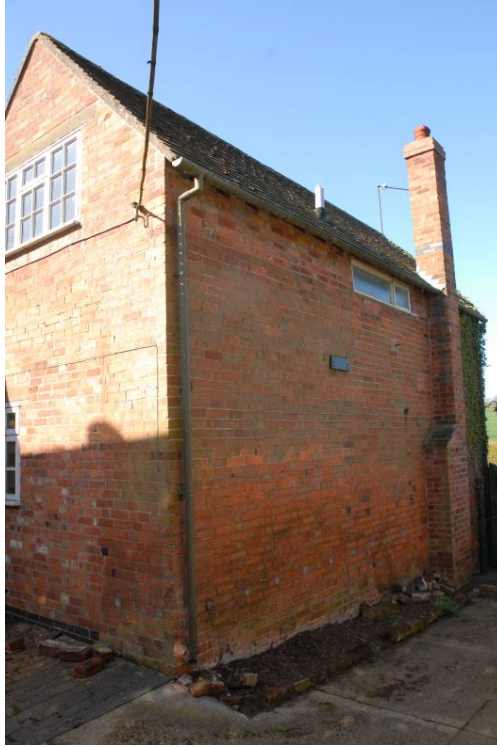
The cottage, south side Fig 10

The south-facing long axis is very plain, devoid of windows before the 1972 bathroom window was inserted within the contemporary raising of the eaves (Fig 10). A single vertical joint in the brickwork near the south-western corner marks a probable previous opening, although no such reveal is shown on the late 19th century prospectus plan. The tall chimney at about the midpoint of the wall was attached as part of the 1972 conversion, having a characteristic blue engineering brick damp proof course.

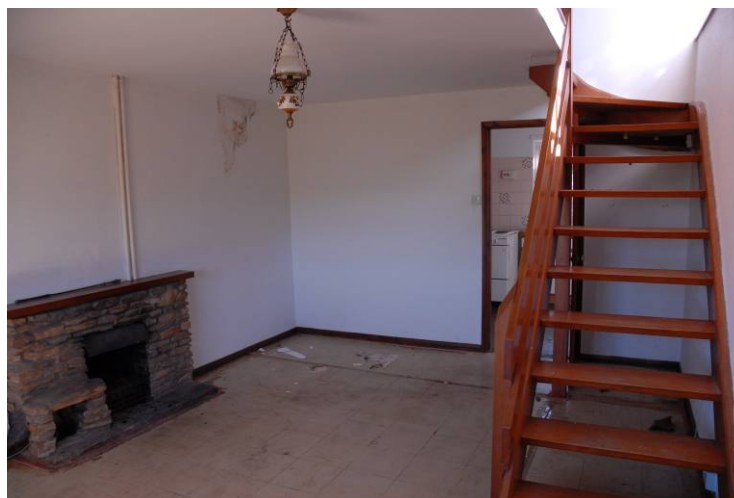
The Cottage, ground floor interior Fig 11

The downstairs is entirely of 1972. The floor is of vinyl tiles on concrete. Plasterwork is modern, with woodchip wallpaper to finish. Woodwork is stained pine, including the pre-fabricated open-tread stair. The interior doors are hollow plywood-faced and finished with contemporary modern door furniture. A local stone fireplace with stained pine mantle-shelf surrounds a gas fire venting into the chimney attached to the west wall (Fig 11).

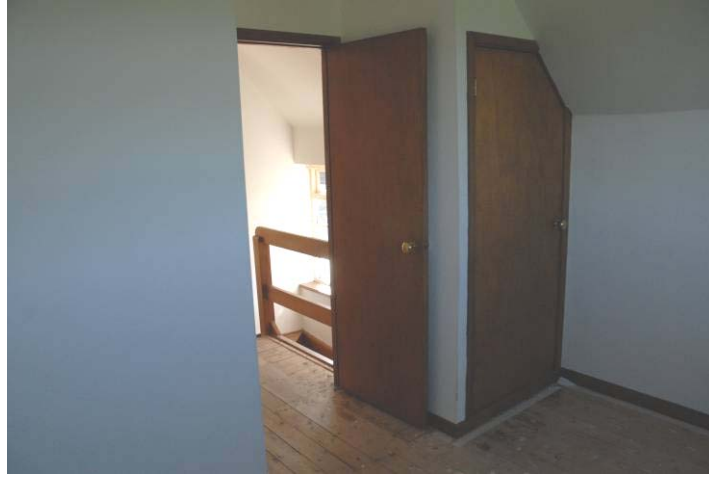
The Cottage, first floor interior Fig 12

Upstairs the interior has identical finishes to downstairs. The floor is of pine tongue and groove floorboards. The interior throughout has storage-heating radiators. There is a modern suite in the bathroom. The single-glazed windows are all accessible from the interior and all are off-the-peg builders' catalogue-derived types as specified in the 1971-2 plans (Fig 12).

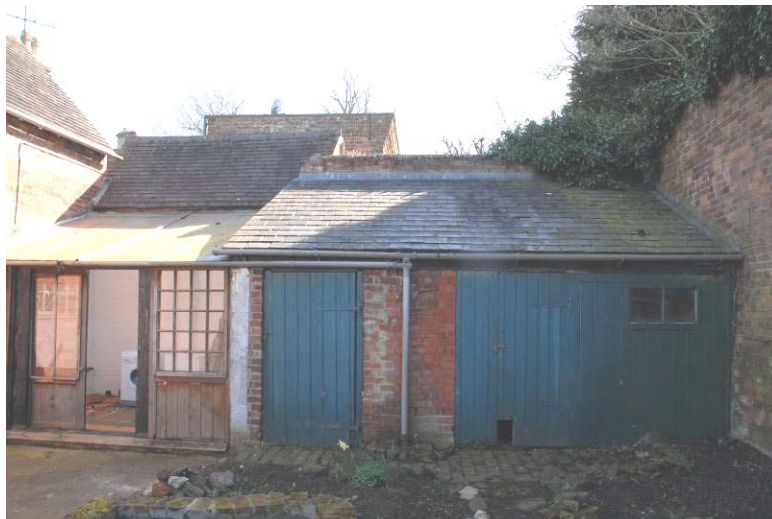
The Cottage, adjacent shed Fig 13

Adjacent to the cottage a pair of brick-built lean-to garden sheds with a Welsh slate roof began life as stables, retaining interior holes in the brickwork where a former timber manger/hay rack socketed into the walls. The building had been divided into two by a brick wall. It was otherwise devoid of detail (Fig 13). The doors and timber front had been replaced as the current ledged and braced doors are unsuitable for stable use, being far too thin and rickety, and lacking the standard two-part stable-door configuration. This outbuilding is much decayed. To both its rear (east) and its end (south) on the far side once stood two large lean-to greenhouses, as shown on the 1925 OS map, from which deep beds and cordoned fruit trees can still be seen in the gardens. The roof is Welsh slate but has been re-set on modern pine rafters.

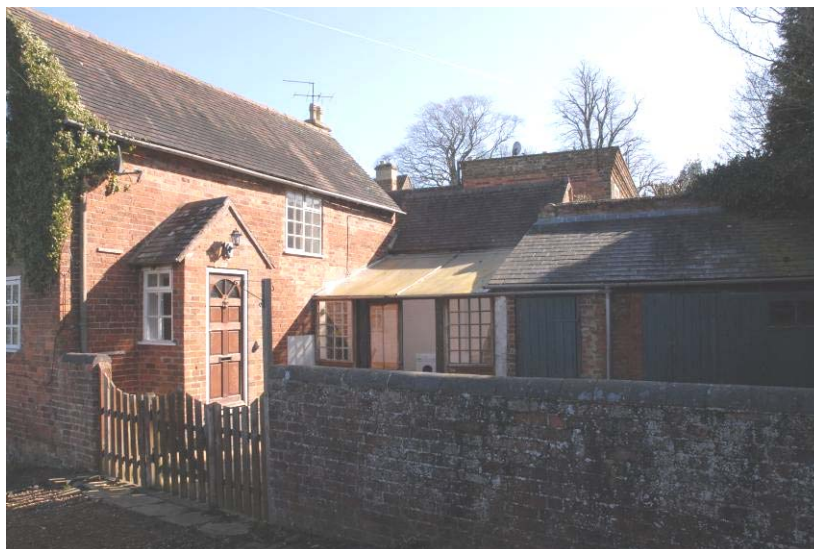
The Cottage, utility room Fig 14

Between the cottage and the former stable is a post-1972 timber, glass and perspex lean-to which has been used as a utility room and store (Fig 14). The small brick, pitch-roofed 19th-century brick store against which it is built, formerly had two windows in it but these were bricked-in no earlier than 1972 and the wall heightened to allow for the greater height of the lean-to (Fig 15). One of the lean-to's double, sliding doors has been broken off its rails. The rather flimsy construction as a whole has begun to disintegrate.

The flimsy utility room, which lies between the cottage and the sheds, is of post-1972 date is an organic accretion and has no architectural or historic merit.
