An archaeological watching brief at

Longridge, Church Walk, Harrold

Bedfordshire

Report 09/151

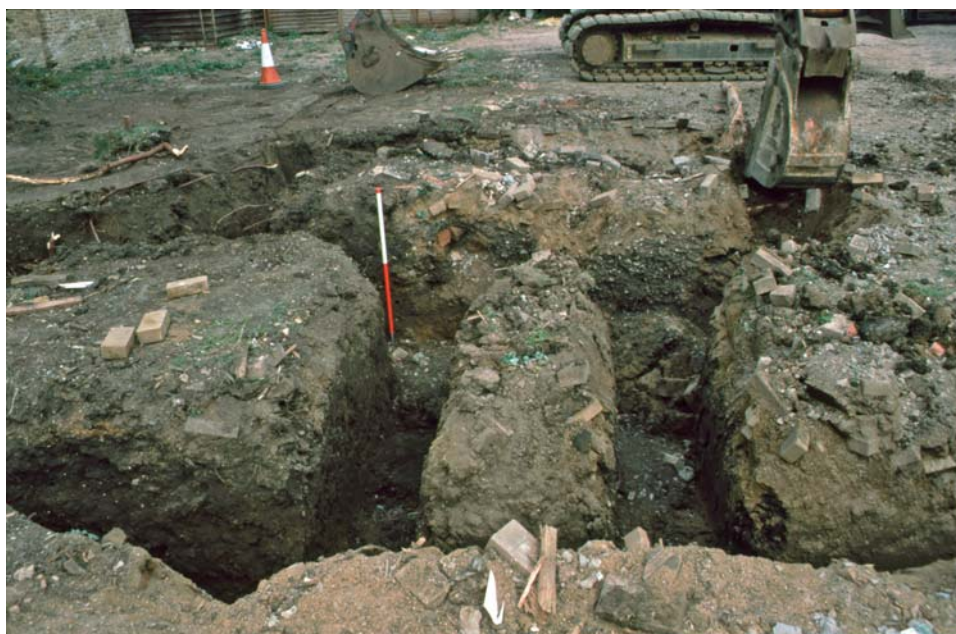
Front cover: Building 1 footings

The foundations for Building 1 and its garage were cut from the level of the modern ground surface at c43.2m above Ordnance Datum to the surface of the natural substrate at between 1.0-1.6m below (front and back cover). The process was undertaken using a mechanical excavator fitted with a 0.5m wide tooth bucket. All of the foundation trenches were observed by an attendant archaeologist who cleaned and investigated the sides of the footings, relating the extant deposits with the results of the forerunning evaluation Trench 1 (Burke and Bassir 2009).

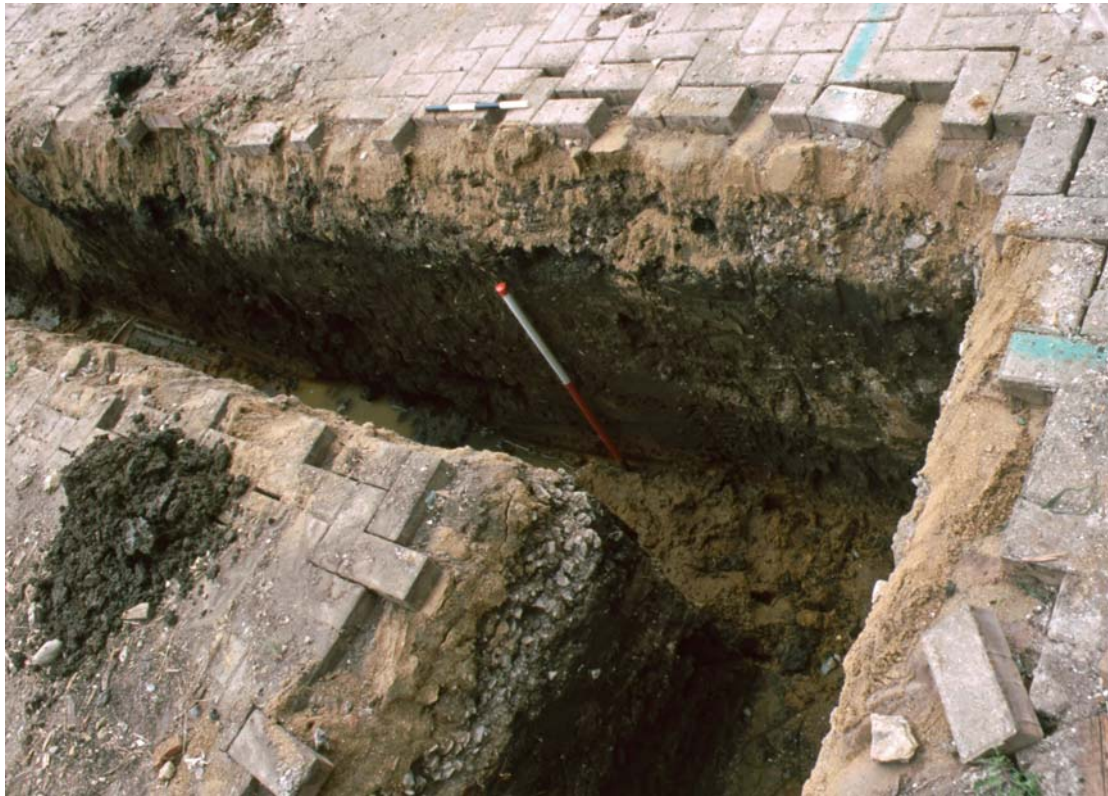
Pit [317] within the foundation of Building 1 Fig 3

Natural orange gravel was encountered at the base of the foundation trenches at between 1.0-1.6m below ground level. Cut into the gravel was pit [317], located in the north-west corner of the building footprint (Figs 2-3 and 5). The pit was 2m wide and the top of it lay 1.6m below the ground surface, it could not be safely excavated within the foundation base. The shoulder of the pit cut sharply into the gravel at a steep angle and the foundation is laid across its surface rather than cutting into it. The uppermost fill was examined and it comprised soft wet dark bluish-grey clay silt (316) with moderate charcoal flecks. The pit produced two sherds of medieval pottery.

Above the medieval layers were modern deposits. Mixed orange-brown sandy clay loam (303) with frequent fragments of sandstone and gravel were present between 0.14-0.36m thick across the foundation trenches and up to 0.5m thick beneath the former bungalow (Fig 3). This was a levelling deposit created at the time of the former bungalow and extended across the former building footprint, the parking areas and the edge of, but not the whole of, the garden areas.

In the former parking areas a bed of yellowish-orange sand (302) that was 0.15-0.18m thick overlay layer (303) and was covered at the surface by light grey bricks (315) laid in an interlocking herringbone pattern (Fig 3).

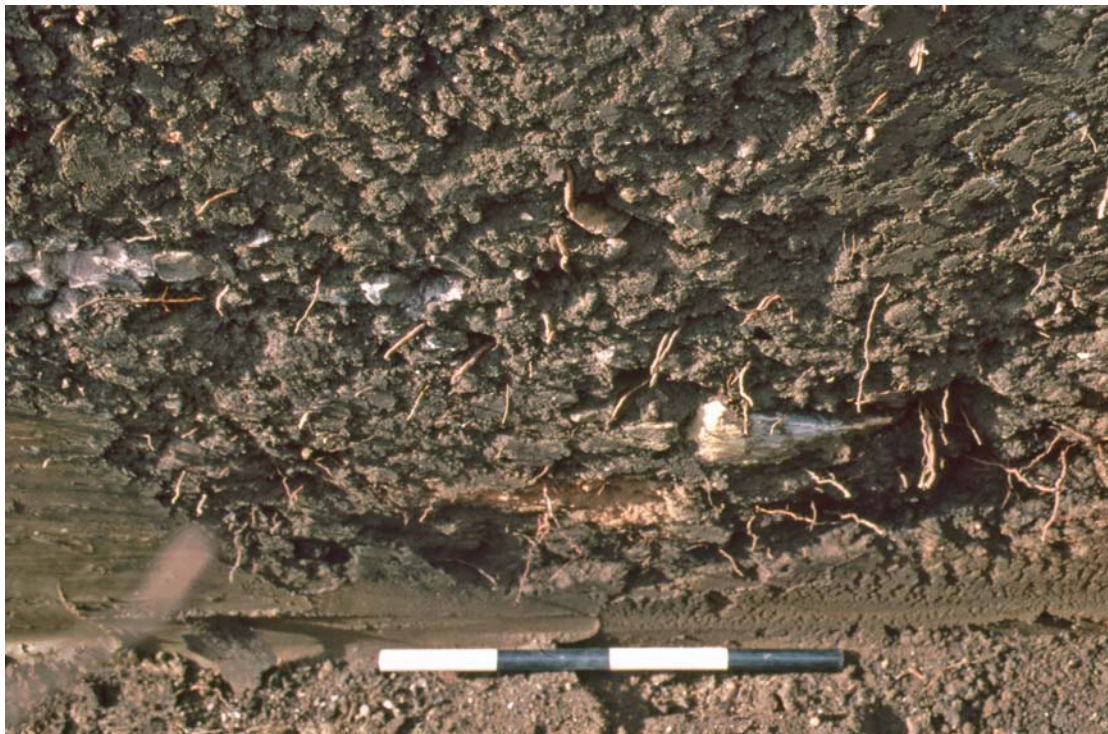
Pit [405] within the foundation of the garage Fig 4

In the north-west corner of the garage footprint the clay deposit (406) was cut by pit [405] (Figs 4-5). The pit was 0.78m wide by 0.48m deep, it had sharp steep sloping sides and a flat base, which was 0.52m wide. Its basal fill comprised black silty ash (404) containing charcoal flecks up to 0.18m thick, probably the sweeping from a small fire. It contained a single sherd of medieval pottery. On top of this was a dump of mixed dark greyish-black silty clay (403) containing moderate pebble flint and limestone fragments up to 50mm in diameter, up to 0.30m thick.

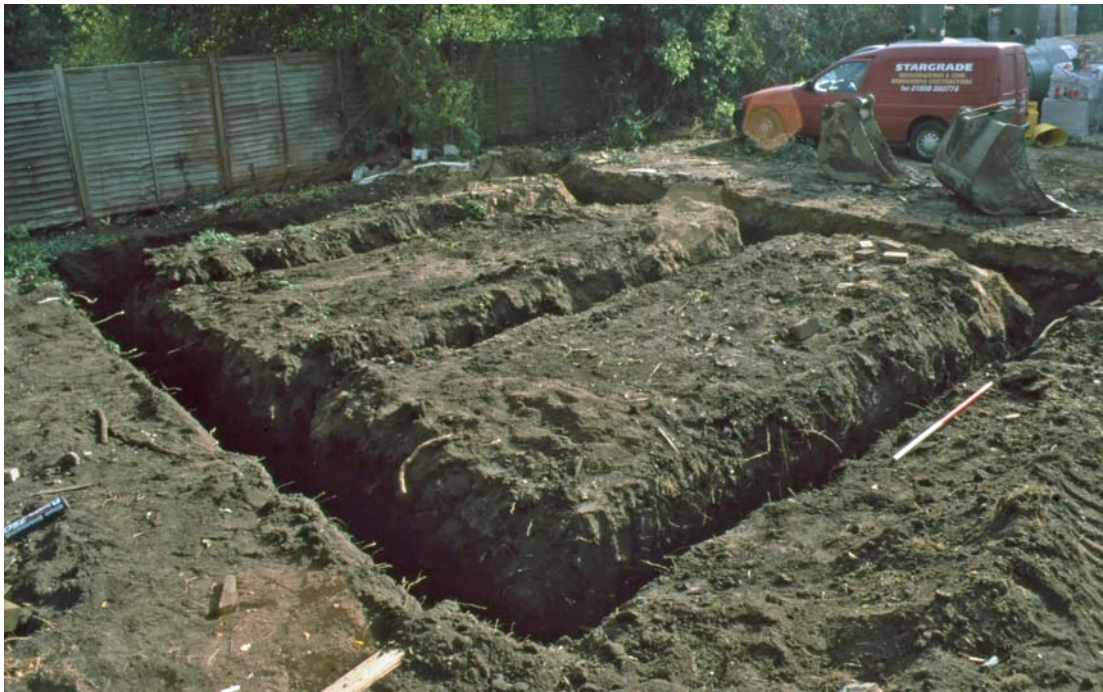
Back cover: Garage footings

Natural orange gravel was encountered at the base of the foundation trenches in the south-west of the footprint only. In the remainder of the garage footprint, overlying the gravel, hard mid-greenish-grey clay (406) with dark smears and chalky limestone flecks lay at the base of the trench. It is not certain whether this was a palaeo-alluvial deposit or the upper fill of a sediment deposit for a large feature such as a pond. The trench depth was between 0.90-1.16m, with a general slope of deposits evident towards the north-east.
