#### Archaeological watching brief at Bridle Road, Burton Latimer, Northamptonshire October 2011

Mark Holmes
Report 11/260
December 2011

# AN ARCHAEOLOGICAL WATCHING BRIEF AT BRIDLE ROAD, BURTON LATIMER NORTHAMPTONSHIRE OCTOBER 2011

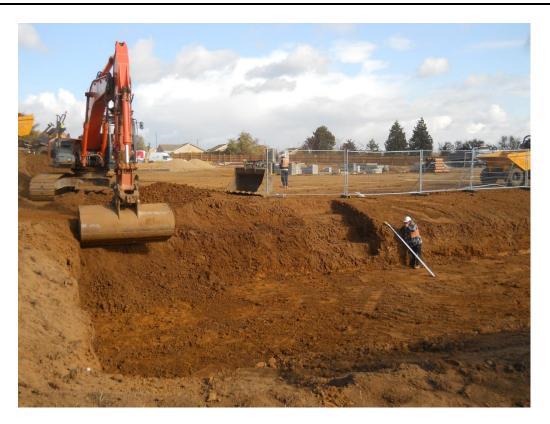
Excavation in progress, looking east Fig 2

The groundworks were undertaken using a 360° mechanical excavator fitted with a toothless bucket (Fig 2). The fieldwork comprised monitoring the excavation of the sunken area designed to hold the water tank and the overlying balancing pond. Due to the depth of excavation, the majority of the observations were carried out from the side of the trench. Spoil heaps were examined for stray finds.

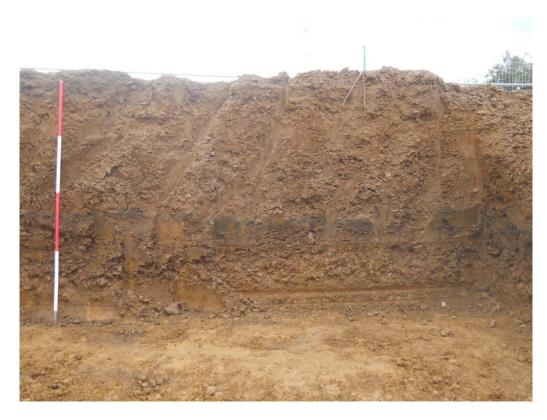
General stratigraphy Fig 3

The natural Ironstone sand geology was located approximately 1.6m below the modern ground surface (5) (Fig 3). Above this was mid brown clay sand, 300mm thick containing moderate small pieces of ironstone (4). This is interpreted as a former subsoil since it was overlain by a well sorted and predominantly stone-free grey silty clay, 100mm thick, which represents a buried topsoil (3). The topsoil had been buried beneath 900mm of made ground comprising dark brown sand clay with very frequent ironstone pieces (2). The present topsoil was a friable greyish-brown sandy clay, 300mm thick, containing frequent large angular ironstone pieces (1).

The general stratigraphy in the watching brief area confirmed the earlier geotechnical investigations, showing that approximately 1.2m of soil had been deposited upon an earlier ground surface to build up this part of the site.
