Archaeological watching brief at Castlethorpe Fish Ponds, The Chequers, Castlethorpe Buckinghamshire

Accession Number: AYBCM:2011:169

Report 11/111

June 2011

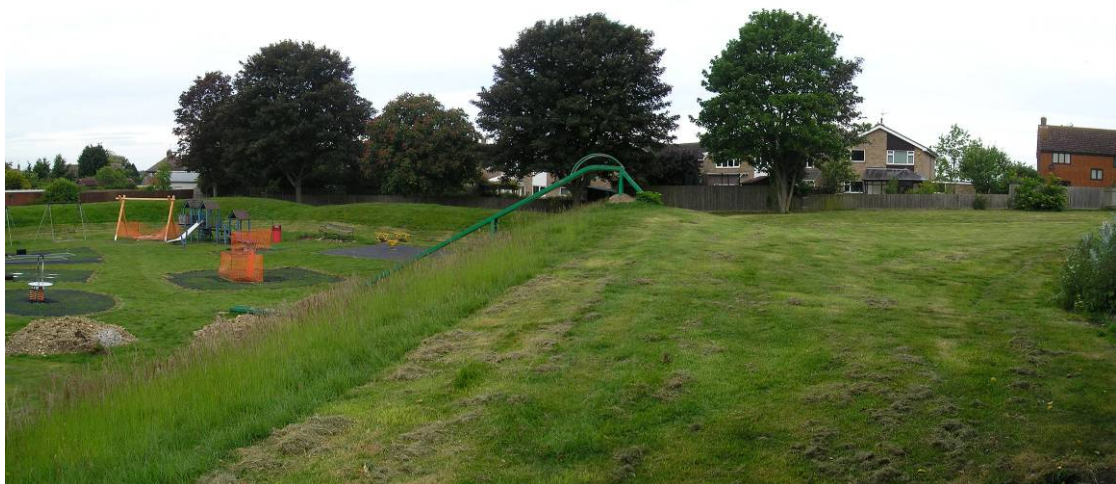
The northernmost corner of the site is divided from the area currently used for the play area by a bank aligned approximately east-west. The ground level of this northern corner is approximately two and a half metres higher than the ground level of the play area (Fig 4). From the north-west corner of the play area, the ground slopes very gently towards the south-east, the play area being seemingly level. The northernmost corner is further divided by an inverted T-shaped shallow bank approximately half a metre in height.

The change of level between the play area and the possible fish ponds Fig 4

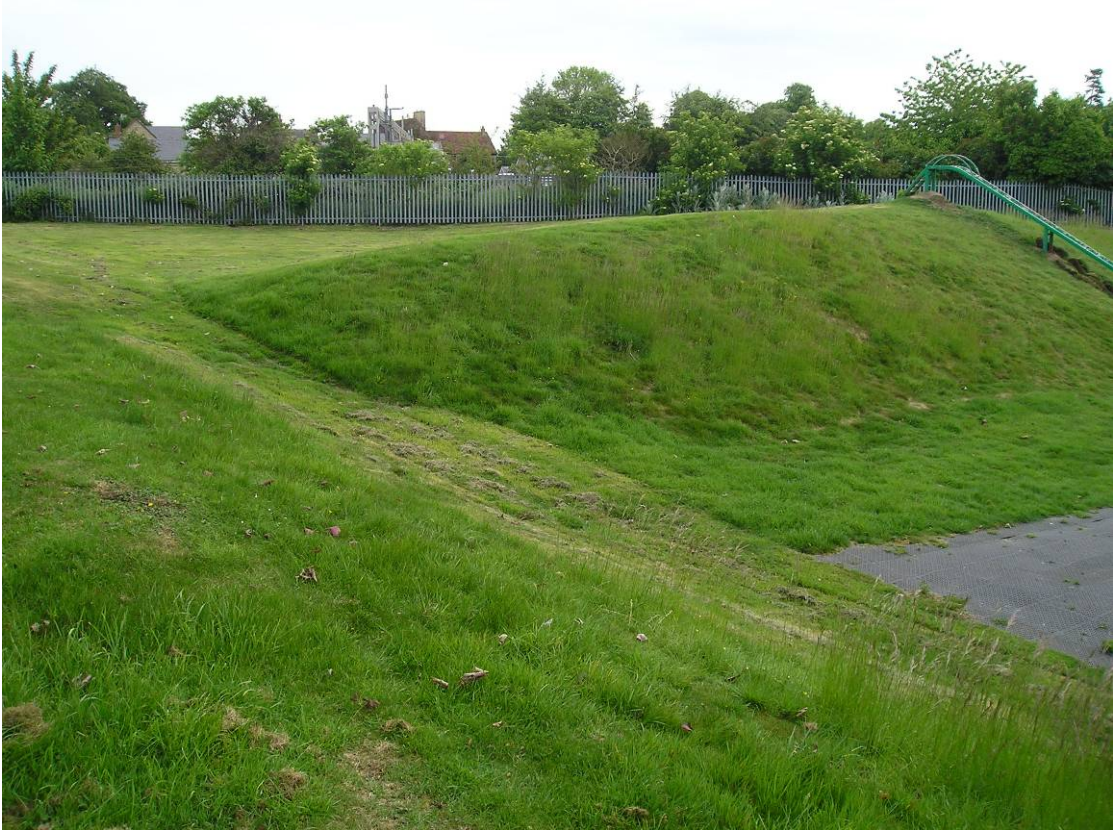
The site has been partially destroyed by the railway line, opened in 1838, which cuts through the north-east corner of the site. Figure 5 illustrates the proximity of the railway cutting (beyond the railings) to the surviving earthworks and the area now used as a play area.

The location of the railway line, beyond the railings Fig 5

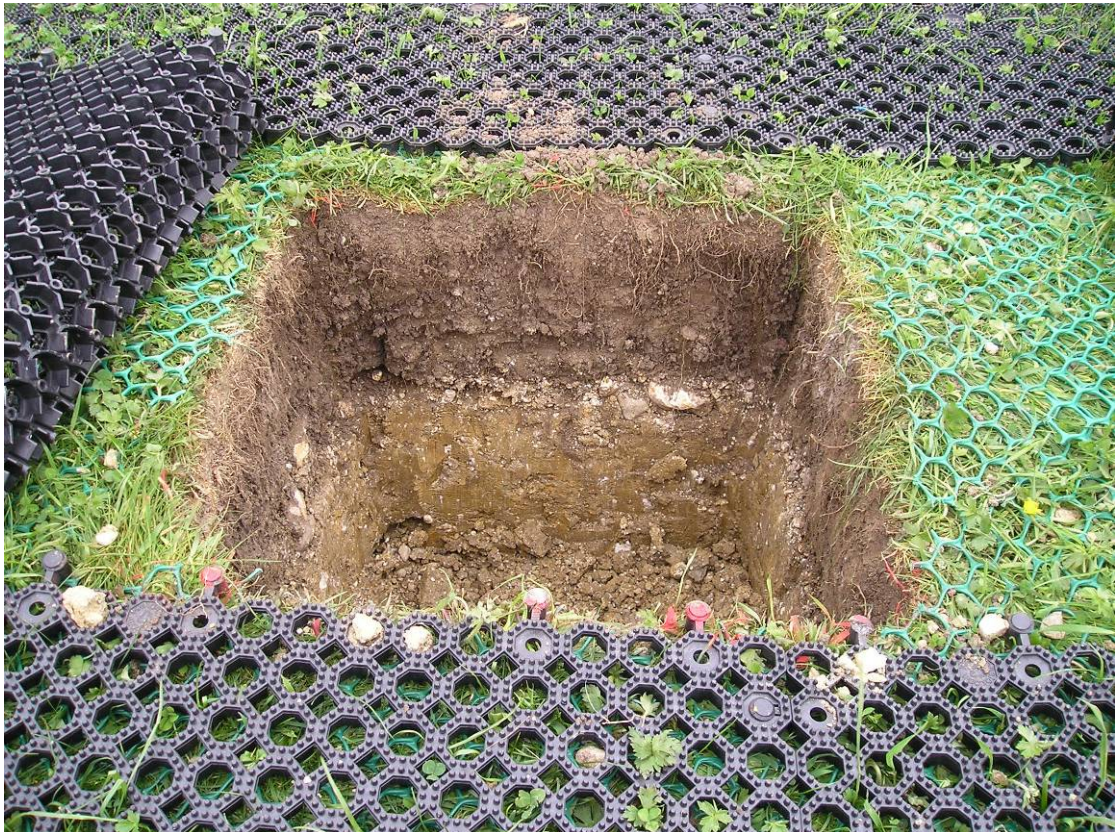
Area 1, an example of the stratification Fig 6

The underlying geology was glacial till, which was encountered between 260mm - 300mm below the modern ground surface in all excavated areas. This occurred as mid brownish-yellow clay mottled with mid blueish grey clay. Inclusions consisted of pieces of chalk up to 50mm in diameter, pieces of flint up to 150mm in diameter and very occasional small pieces of ironstone. Occasionally, a subsoil consisting of an indistinct interface, about 25mm in thickness, occurred between the topsoil and the natural geology. The topsoil was a dark yellowish-brown silty loam with very few inclusions (Fig 6).

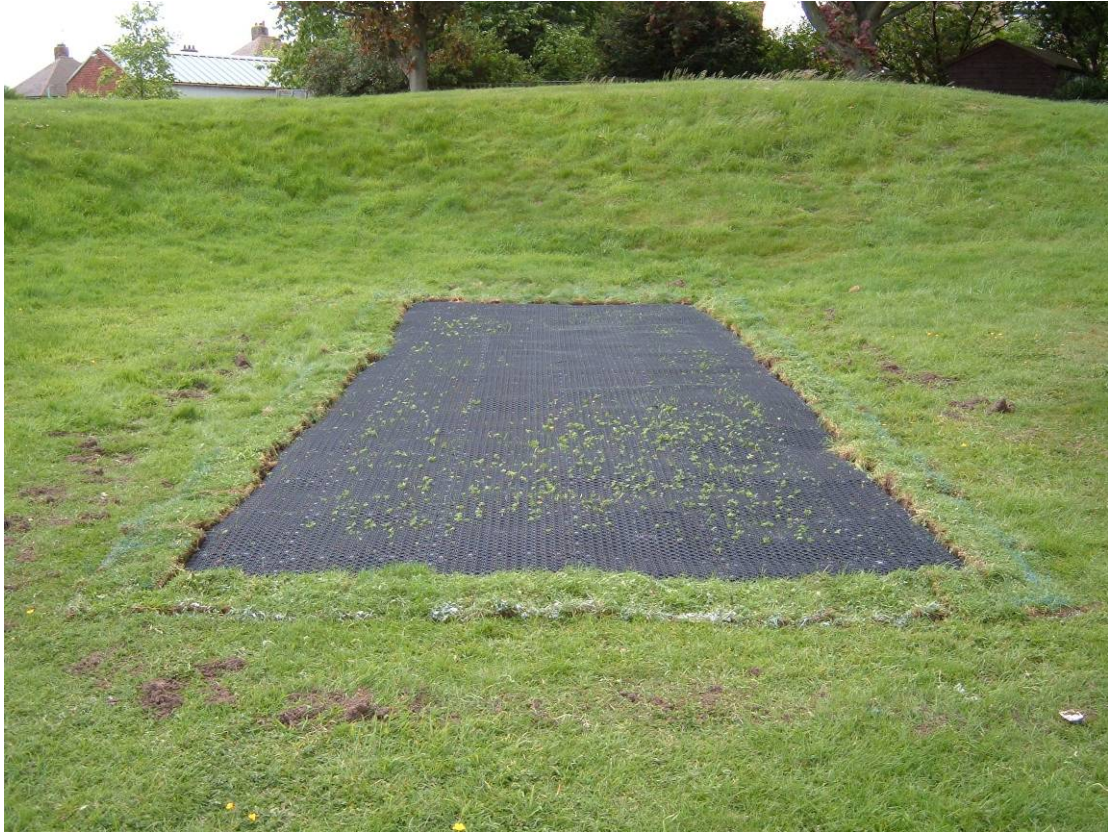
Area 2, an example of the safety matting after the edges have been buried Fig 7

Thirty-two individual foundations for the new play equipment were excavated to the individual dimensions required, in accordance with the plan approved by English Heritage (simplified in fig 2). All foundations were hand dug and the sections cleaned sufficiently to enable the identification and definition of potential archaeological features (Fig 6). The edges of the safety matting laid around each piece of equipment were buried beneath the surface to a depth of approximately 100mm, the turves being removed by hand and replaced over the matting (Fig 7).

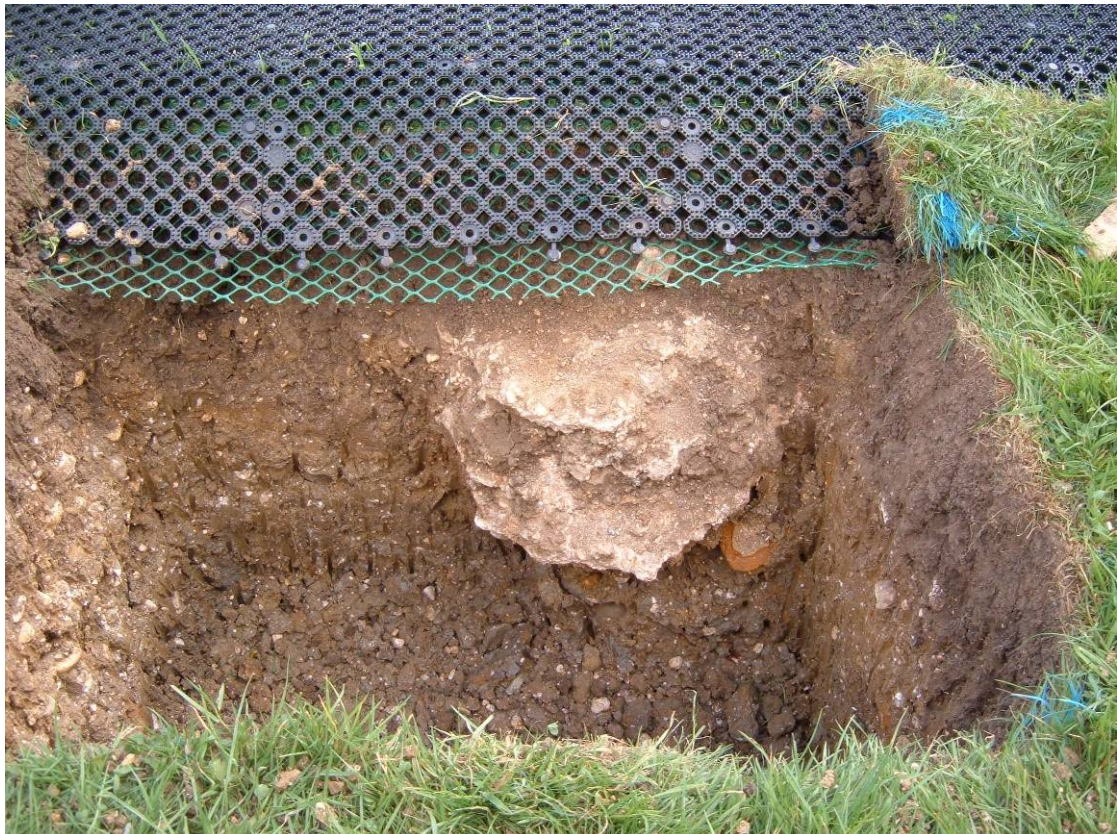
Four holes measuring 1000mm x 800mm x 800mm deep. The concrete base and remaining reinforcement for a now-removed piece of play equipment was encountered in the north-westernmost hole (Fig 8). No archaeological finds or features were encountered.

Area 2, north-westernmost foundation, including the concrete base of an earlier piece of equipment Fig 8

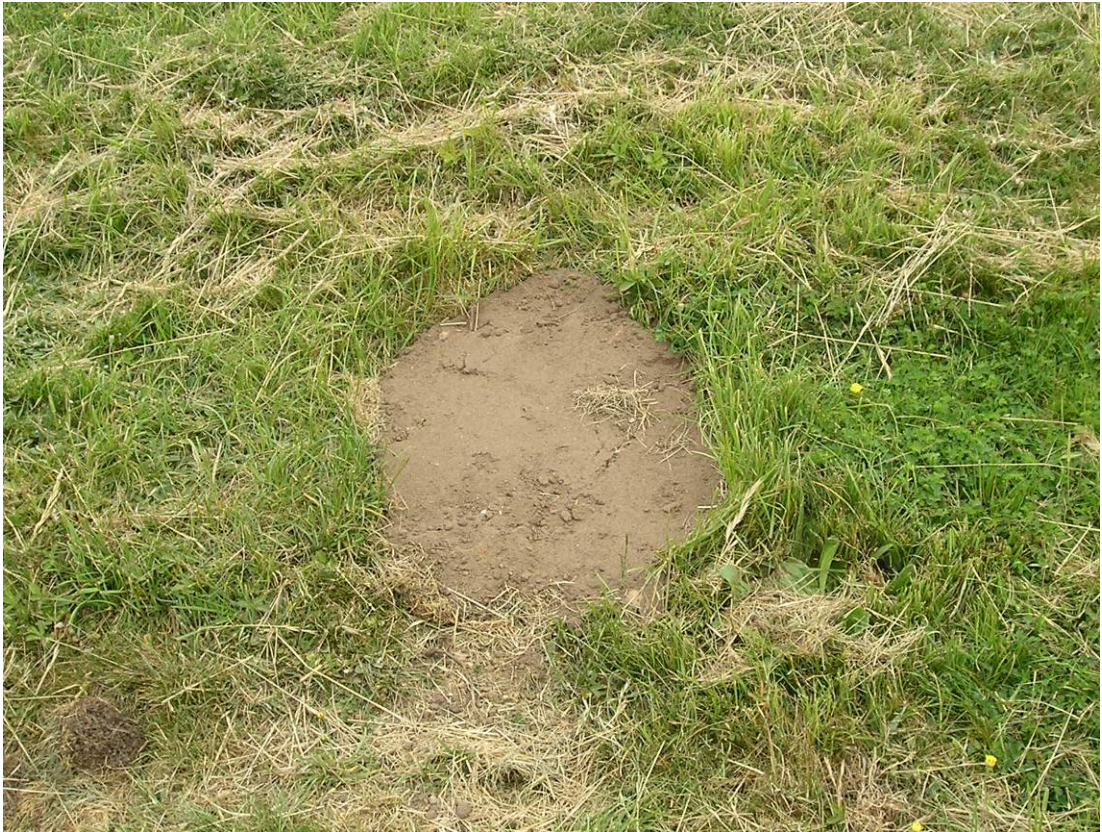
None of the rabbit holes in the embankments were observed to be deeper than approximately 130mm. The rabbit and mole holes inside the monument were shallow and therefore back-filled with the original spoil created by the animal.

Rabbit damage to the bank filled with excess natural spoil and imported topsoil Fig 9

Excess spoil from the natural geology was used to fill the deeper rabbit holes in the earthworks and covered with imported topsoil (Fig 9). The shallower holes were filled with imported topsoil or with excess turves from the burying of the edges of the grass matting.

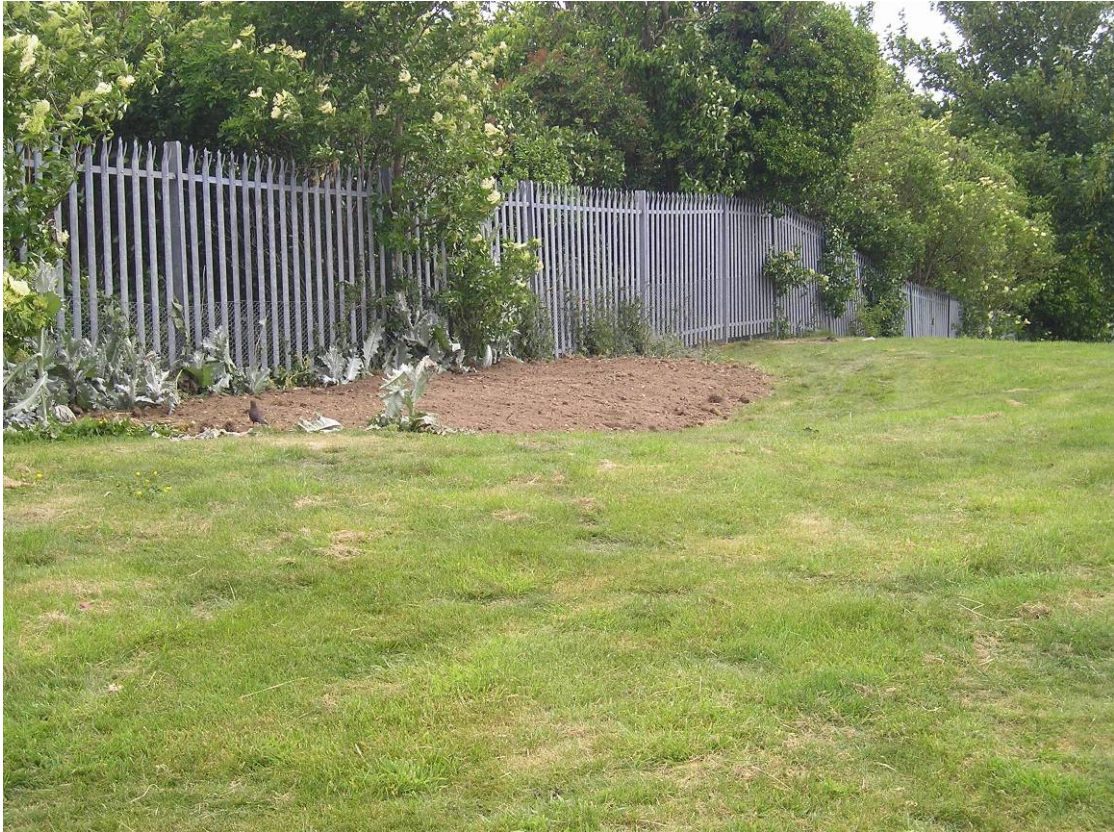
One large area of extensive rabbit damage, located within the shallow earthworks to the north-east of the site, was covered with a layer of excess natural spoil and covered with imported topsoil. Figure 10 indicates the location within the easternmost portion of the inverted T-shaped earthwork.

Large area of rabbit damage filled with excess natural spoil and imported topsoil
Fig 10

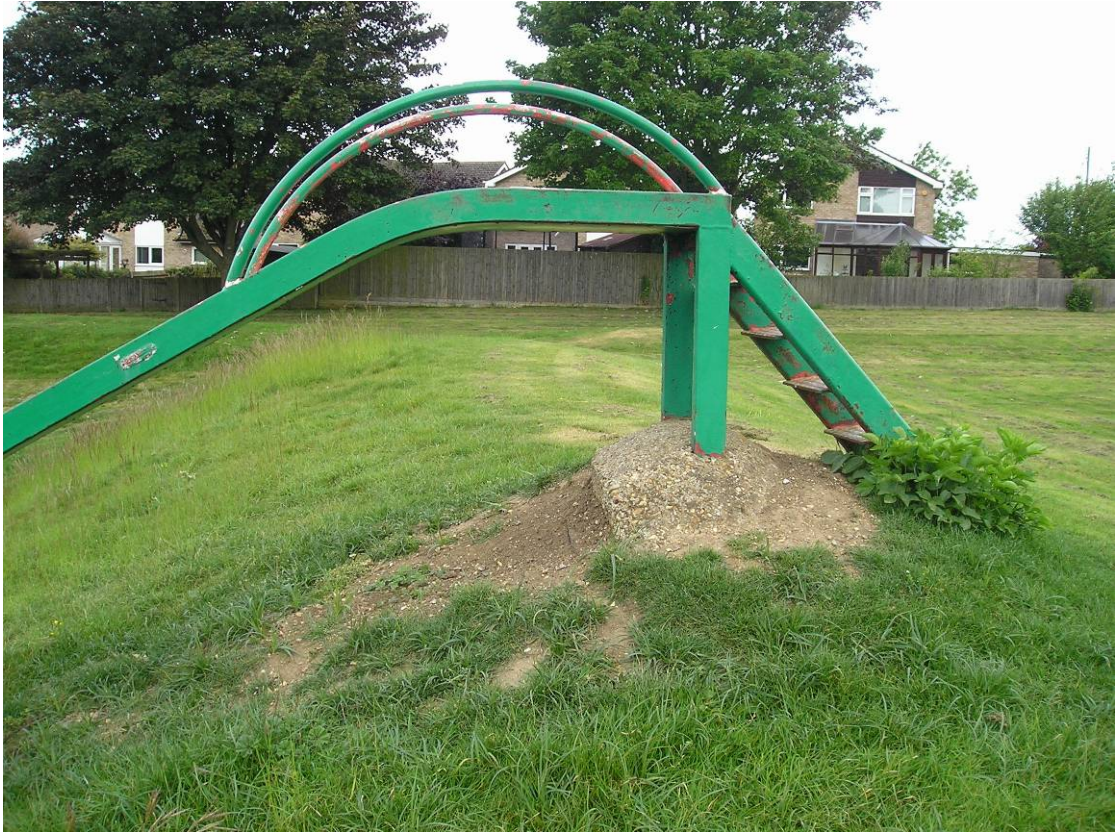
Erosion around the slide Fig 11

Excess spoil and imported topsoil was used to cover areas of erosion around the existing slide in the east-west bank (Figs 11 and 12). This was then covered with the safety matting to prevent the spoil being washed away and to prevent further erosion (Fig 13). The edges of the safety matting were buried using the same method as the rest of the site. No archaeological features were encountered: sweet wrappers and glass were present in the topsoil which were contemporary with the installation of the slide in 1977 to celebrate the Silver Jubilee of Queen Elizabeth II.

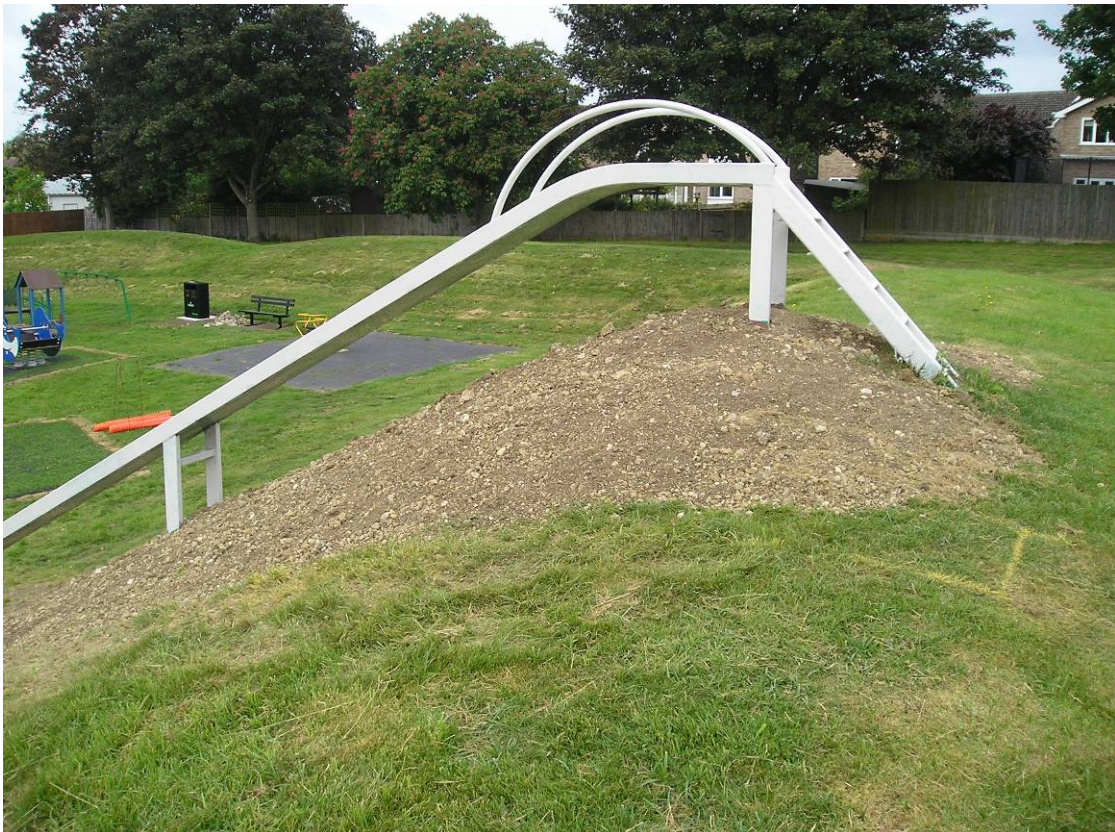
The same erosion covered with excess natural spoil and imported topsoil Fig 12

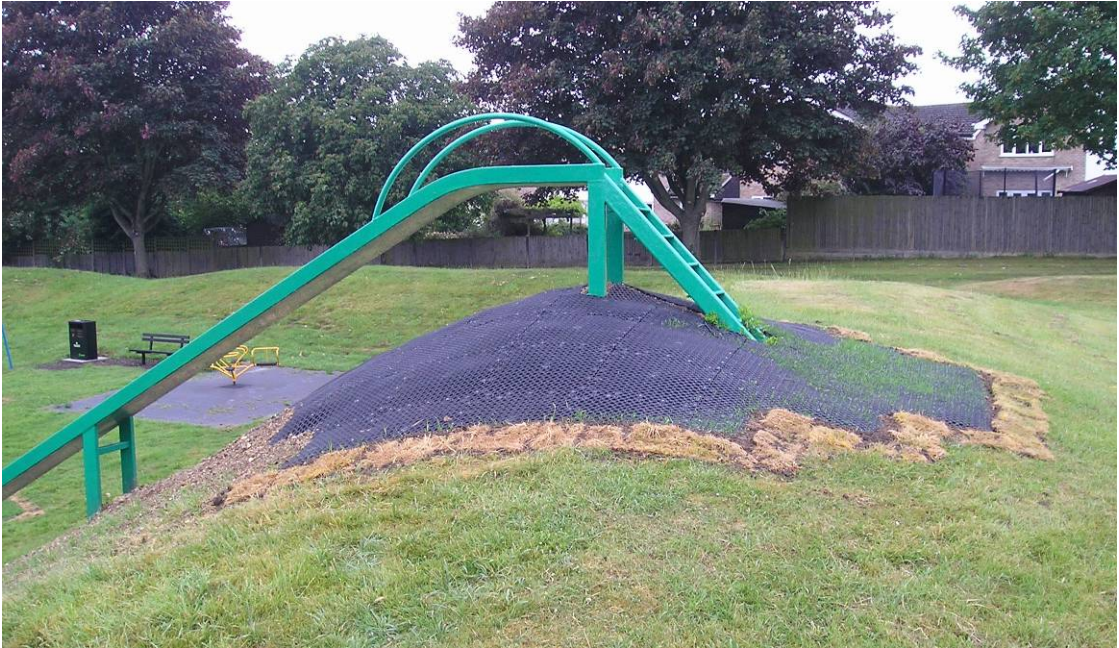
The erosion mitigation works completed by the installation of safety matting Fig 13
