Archaeological evaluation at Boughton Hall Park,
Boughton, Northamptonshire
October 2011

Report 11/216

**ARCHAEOLOGICAL EVALUATION AT
BOUGHTON HALL PARK, BOUGHTON, NORTHAMPTONSHIRE
OCTOBER 2011**

An archaeological evaluation comprising three trenches was undertaken within the grounds of Boughton Hall Park, Northampton in advance of excavation to create a new lake. The evaluation revealed the presence of an undated ironstone wall and culvert along with modern field drains.

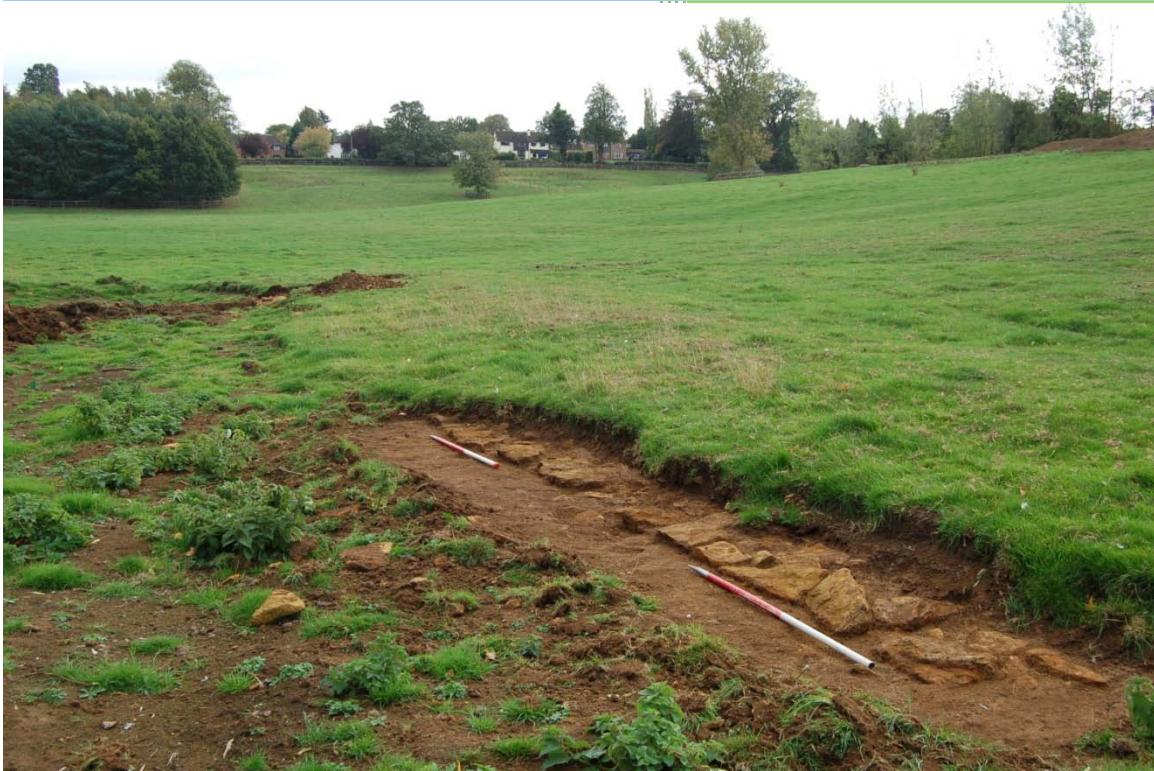
Cover photo: Remains of stone wall, looking south-east

Between trenches one and two, along the southern edge of the area previously de-turfed a line of stonework had been revealed (Fig 5). After cleaning by hand this was revealed to be a continuation of the stone wall uncovered in Trench two (Figs 5 and 11). This continuation of the wall, on a very slightly different alignment, comprised the same construction as previously noted. At the north-western end the wall either terminated, turned southwards or had been removed although it is not certain which is the case. Since Trench 1 did not reveal any indication of the wall, or evidence of scattered stonework which might have suggested that it had been partially dismantled, the latter two options seem the most likely.

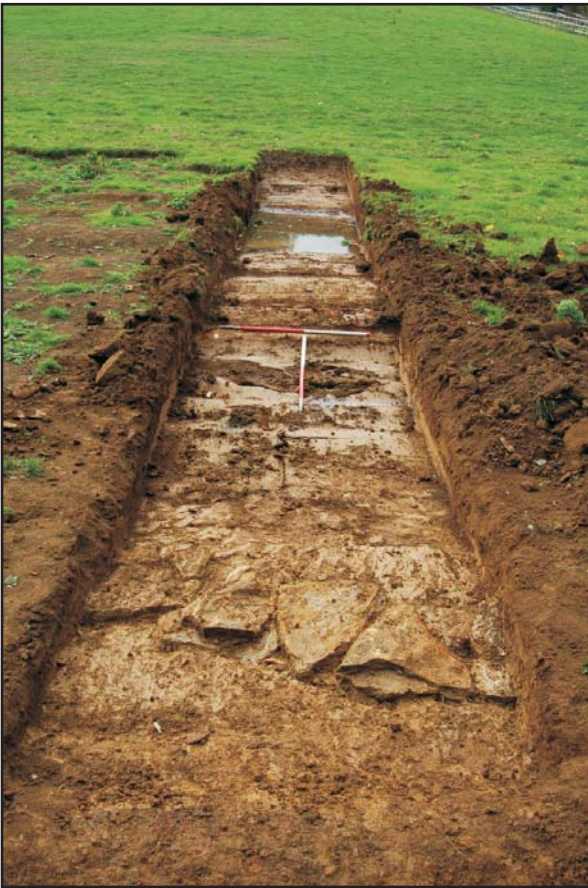
Trench one, looking south Fig 7
with culvert [103]

Located at the western end of the new lake, this trench was 13m long and aligned roughly north-south (Fig 5). The southern end was located to the south of the proposed new lake edge where the land rises slightly (Fig 7). Beneath thin topsoil [101] the natural subsoil was uncovered which comprised a pale brown clay [102]. Into this were cut four modern red ceramic land drains, all aligned roughly south-east to north-west (Fig 5). At the north end of the trench the cap stones of an ironstone culvert or field drain [103] were revealed on a similar alignment. Since the cap stones were *in situ* they were not removed, but recorded intact, since the same feature without the cap stones was uncovered in Trench 2 (see below). The stone culvert was also aligned roughly south-east to north-west which suggests it was constructed for drainage rather than conveyance of running water.

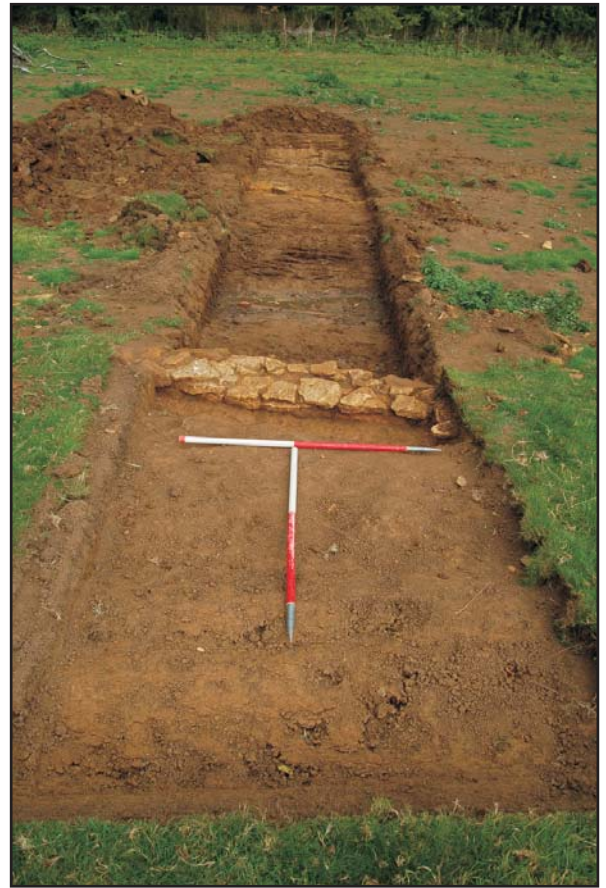
Trench two, looking north-east with Fig 8
wall [203] in the foreground

Located on the southern edge of the proposed new lake this trench, 11m long, was positioned to investigate an area of stonework partially revealed during the previous turf removal (Fig 5). The southern edge of the trench lay just up-slope of the proposed new lake edge, and the northern end extended roughly northwards from that point. The ironstone wall [203] was revealed to be aligned in a north-west to south-east alignment and comprised un-mortared stone fragments, all undressed, laid in two neat courses (Figs 6 and 8). It lay directly beneath topsoil [201]. No construction trench was visible which suggests that the wall was trench-built. Individual stones measured up to 400mm in length with larger pieces with relatively straight edges being selected for the outer edges, whilst the core of the wall was filled with smaller, more irregular, fragments. This type of construction is typical of drystone wall construction.

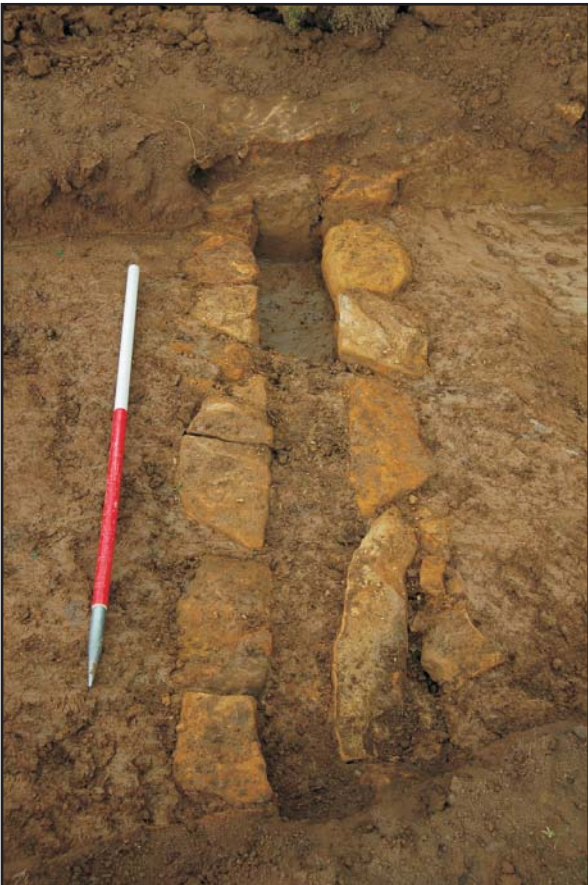
Trench two, ironstone culvert [206], Fig 9
looking north-west

North of this the ironstone culvert revealed in Trench one was uncovered, here without the capping stones apart from a single stone just outside the western edge of the trench [Figs 6 [206] and Fig 9). The culvert comprised two parallel rows of single, roughly dressed, but un-mortared ironstone pieces laid approximately 200-250mm apart. These two rows of stone formed the sides of the culvert which had been capped with larger, un-

dressed fragments of the same stone although within the trench they were missing. The culvert did not have a stone base and was entirely filled with silty clay [207] indicating that it had not functioned for a considerable length of time. The general lie of the land suggests that the water would have flowed east to west originally.

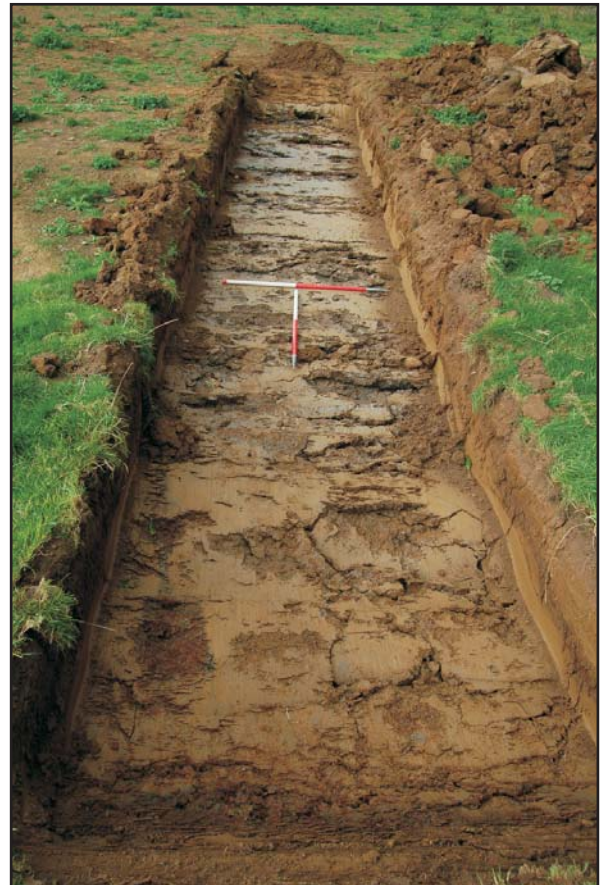
Trench three, looking west Fig 10

Located at the eastern end of the proposed new lake, this trench was aligned roughly west-east (Fig 5). Beneath the topsoil [301] and subsoil [302] the trench was excavated approximately 0.5m into the natural clay (Fig 10).

No archaeological features were identified.

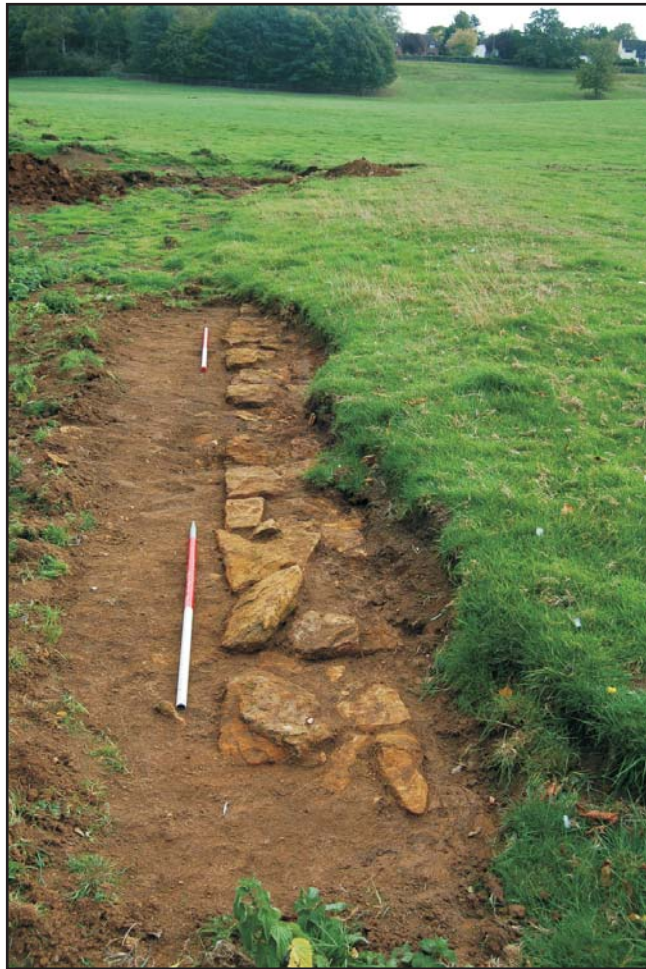
The stone wall between trenches one and two, looking south-east Fig 11

- 6.4 The stone wall located along the southern limit of the area investigated remains undated, but its shallow foundations and probable relationship to an earthwork feature suggests that it may have formed a simple drystone boundary wall, perhaps relating to an earlier lake, or division of the park. There is no evidence to suggest that it relates to human occupation on the site and the presence of a single, small fragment of late seventeenth- or early eighteenth-century pottery is most likely a casual loss or the result of a manure scatter.

- 6.5 It is understood that the client is keen to retain buried archaeological features and is agreeable to moving the footprint of the proposed new lake in order to preserve the section of wall and ironstone culvert *in situ*.
