Archaeological evaluation, Cranford Estate Wind Turbine, Northamptonshire May 2011

Anne Foard-Colby Report 11/117 May 2011

ARCHAEOLOGICAL EVALUATION CRANFORD ESTATE WIND TURBINE NORTHAMPTONSHIRE MAY 2011

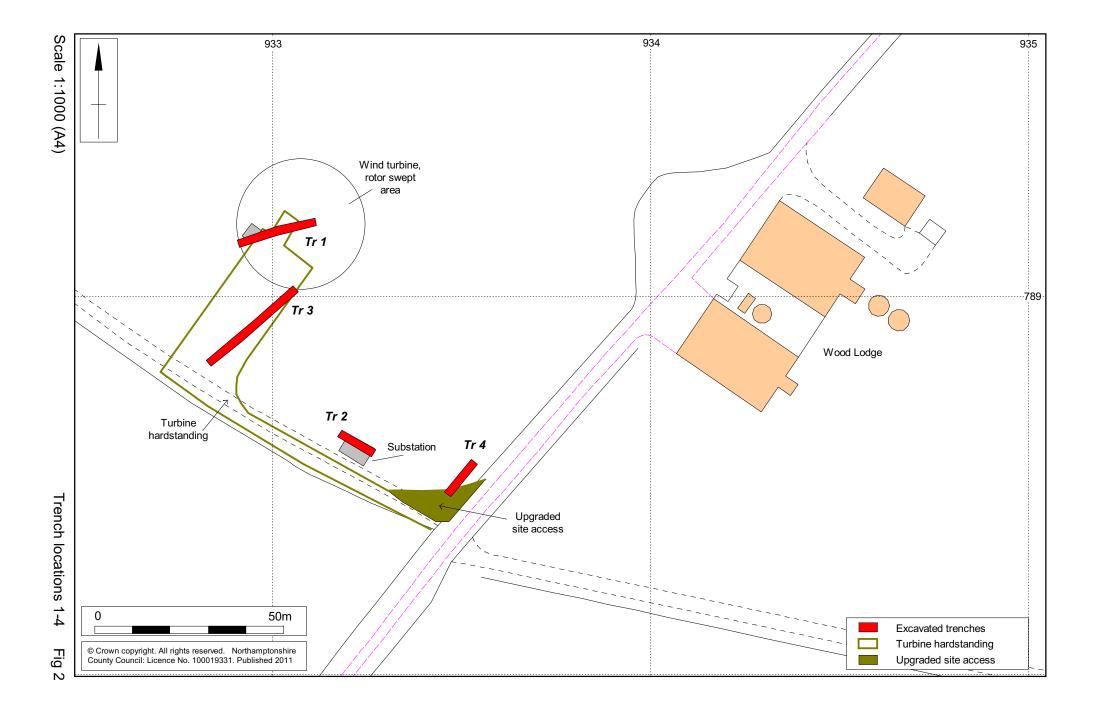
Two trial trenches, one measuring 20m long and the other 10m long by 2m wide (Trenches 1 and 2), were excavated on the turbine and substation sites in accordance with the trench plan approved by NCCAA (Fig 2). In addition, a further two trenches one measuring 30m and the other 10m (Trenches 3 and 4) were excavated to investigate the hard standing for the turbine and the upgraded site access area (Fig 2). They were positioned using a Leica 1200 GPS surveying system.

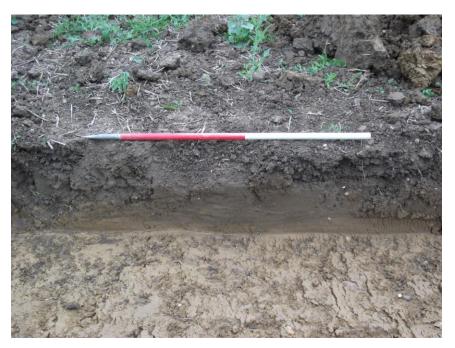
Fig 3

Trench 1 (Figs 2 and 3), was aligned north-east to south-west and was located in the north of the site over the position of the proposed turbine. Within the trench was a tree throw, an area of root disturbance and a land drain. There were no archaeological features or artefacts present.

Trench 1, section looking north-east

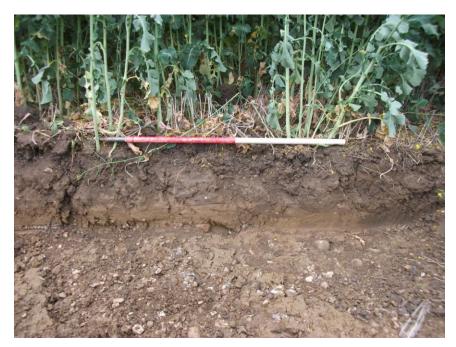
Fig 4

Trench 2 (Figs 2 and 4), was located in the south of the site and aligned north-west to south-east, to investigate the position of the proposed substation. There were no archaeological features or artefacts present.

Trench 2, section looking north-west

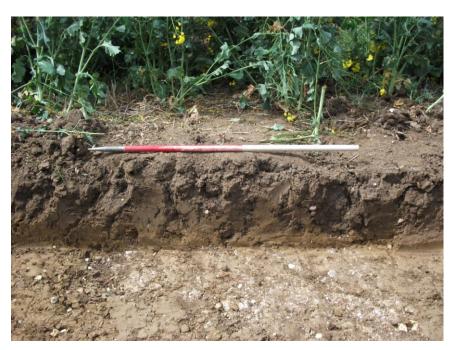
Fig 5

Trench 3 (Figs 2 and 5), was positioned across the area of proposed turbine hard standing and was aligned north-east to south-west. It contained a tree throw and areas of root disturbance. There were no archaeological features or artefacts present.

Trench 3, section looking north-west

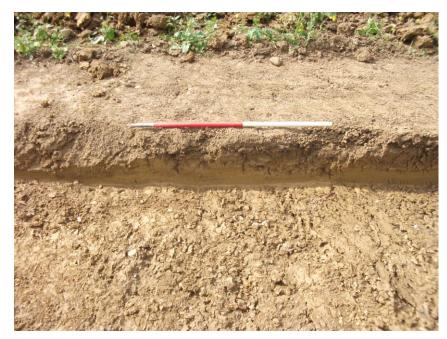
Fig 6

Trench 4 (Figs 2 and 6), was positioned across the site entrance area, which is proposed to be upgraded. It was aligned north-east to south-west. A disturbed area of rotted roots was present. There were no archaeological features or artefacts present.

Trench 4, section looking north-west
