Archaeological building assessment of Hellidon Grange, Hellidon, Northamptonshire March-April 2012

Iain Soden
and Charlotte Walker
Report 12/95
May 2012

**ARCHAEOLOGICAL BUILDING ASSESSMENT OF
HELLIDON GRANGE, HELLIDON,
NORTHAMPTONSHIRE
MARCH-APRIL 2012**

OASIS REPORT: No. 126962

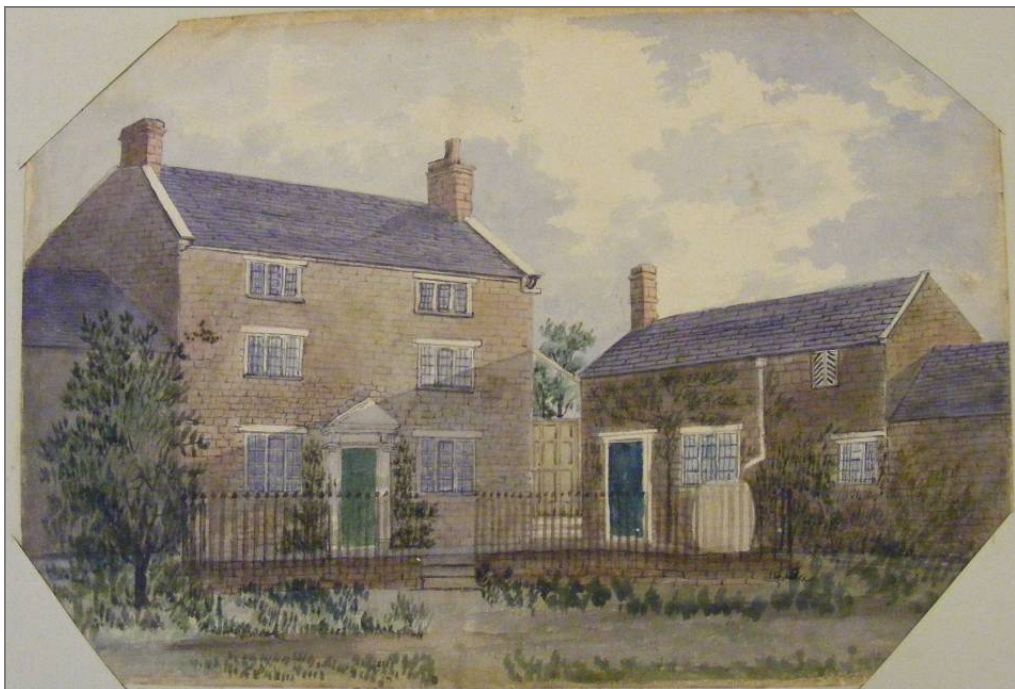
The farmhouse in 1849 (NRO: HOLT 619) Fig 2

Holthouse personally bought a plot of land adjacent, later known as Vicars' Close. He described the existing farmhouse as unsightly. It was painted by Holthouse's aunt in 1849 and shows a fairly plain three-storey stone house with a central pedimented doorway (Fig 2). Attached to the left of the main house was a further, possibly two-storey range, although little detail is shown. To the right was a detached range, the main part probably single-storey with limited upper storey. It is possible that was a bakehouse or detached kitchen (given a later description of the property by Butterfield- see below).

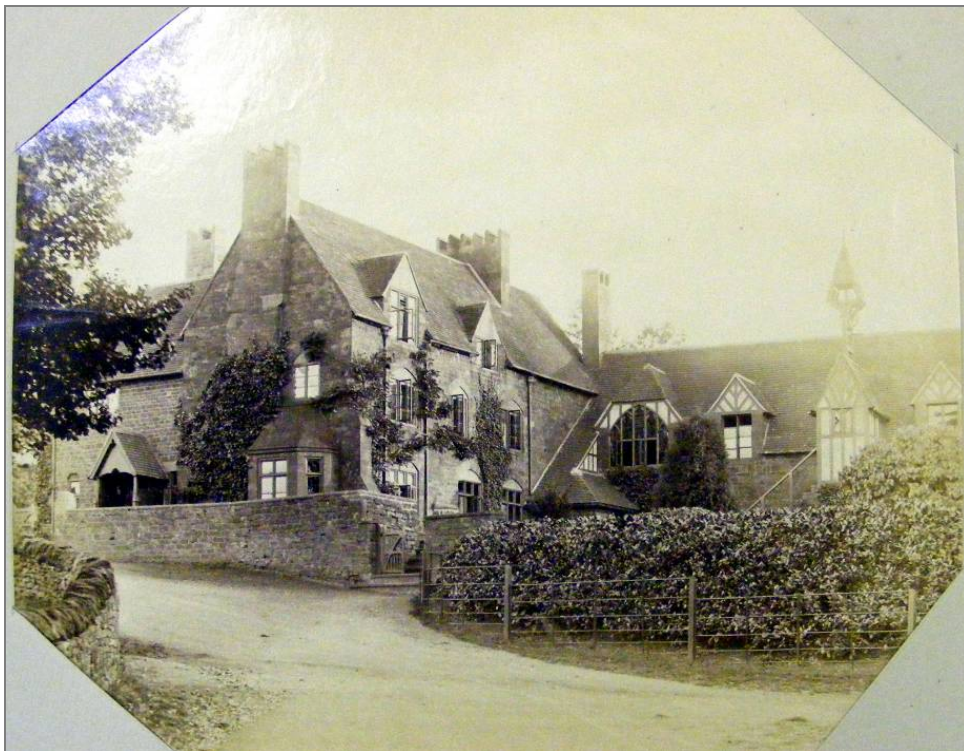
The vicarage in 1870, looking south-east Fig 15

In 1867, CSH notes that a storeroom which stood on the east side of the building (probably the one built in 1858) was pulled down and enlarged and a bedroom built over (HOLT 552). There do not seem to be any specifications or plans surviving for this piece of work, but it seems likely that he is referring to the extension of what was known as the china closet in the original building to form a larder. In 1868, a further excavation of soil was undertaken in order to let more light into the storeroom, in the process more than 400 loads of soil were removed. This phase of work was certainly completed by 1870, as shown in the photograph (Fig 16). Indeed, by 1870, much of the main range of the house looked very similar to today. One of the few obvious changes to the north and west fronts is the absence of the bell turret above the gabled doorway (Fig 15).

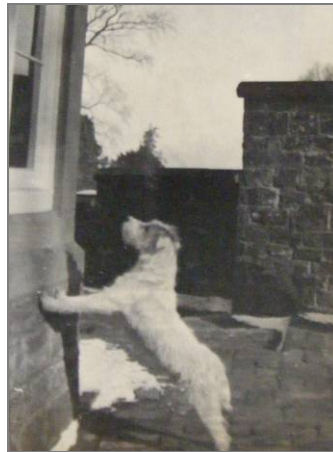
'Cubby' and bay window, dated 1928 Fig 19

The study (G1) bay window was converted into French doors at sometime after 1928 (Fig 19).

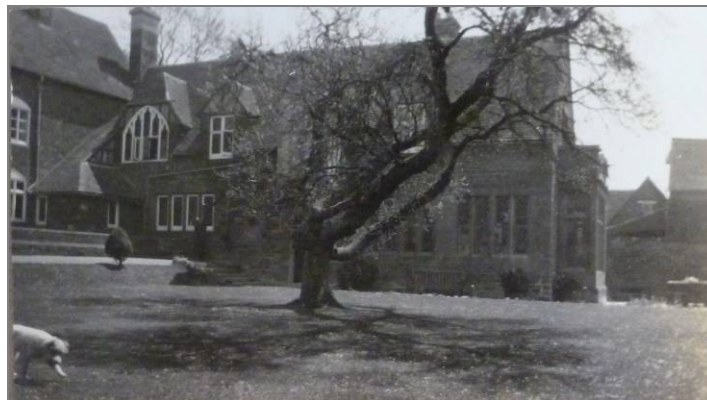
Photograph showing projecting bay window, 1929
(Note too the four-light window on the ground floor) Fig 20

The square sectioned bay window at the west end of the former dining hall (G11) is a 20th century addition, since a detached building lay immediately to the west of this range until at least 1925 (Fig 23). Photographs of 1929 show the bay window in position and it seems likely that the main dining room windows were also altered at the same time (Fig 20). The small square extension to the eastern front of the house is a further 20th-century addition not present on the 1925 Ordnance Survey map (Fig 23). Similarly, photographs dating to 1929 show this small extension.

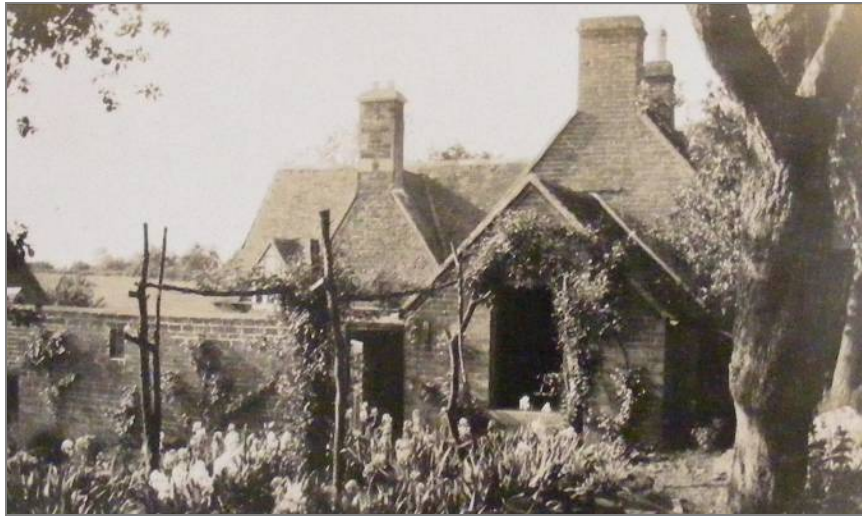
The *Garden House* in 1928 Fig 21

Photographs dating to the 1930s indicate that the present flat-roofed garden room was added in the period 1933-5, replacing a small building known as the *Garden House*, which had certainly been present since the late 19th century (Figs 21 and 22).

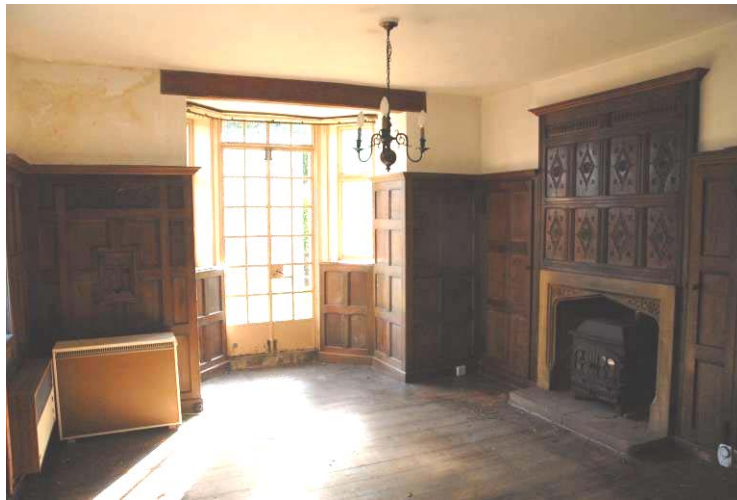
General view of Room G1 Fig 25

The house is entered through its small stone and timber porch and unprepossessing main entrance doorway in what is actually the 1860 extension, present on numerous historic photographs (see above). Documents show the porch was moved from an earlier location on the west wall. Built as a study, Room G1 is very poorly lit by two tiny wooden casement windows to the north, and a stone bay window to the east. This would have originally been an entirely private view, until the leading face of the bay was taken down to provide French doors in the late 1920s when the current sunken garden was laid out (from photographic evidence). The current doors are metal-framed replacements of the 1950s, probably because the timber ones expanded and stuck in what is a potentially damp exterior.

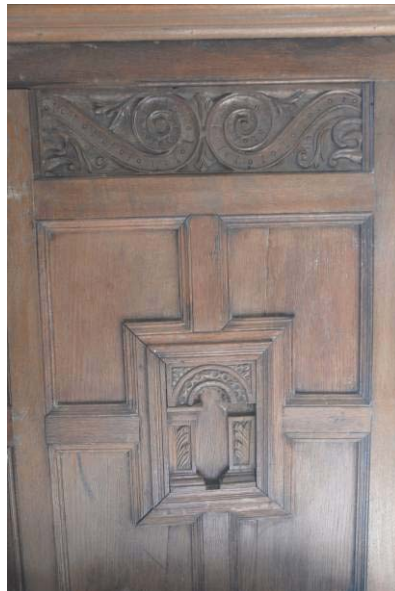
Room G1, re-used furniture panels Fig 26

The room itself is very neatly oak-panelled to three-quarters height, but this aspect is dominated by the uneasy (but entirely intended) incorporation of re-used Jacobean decorative furniture panels as features. The overmantel in the room is also of Jacobean origin, although probably was itself not originally intended as an overmantel, but just panelling. Similar re-used decorative timberwork has been used to provide a laminated

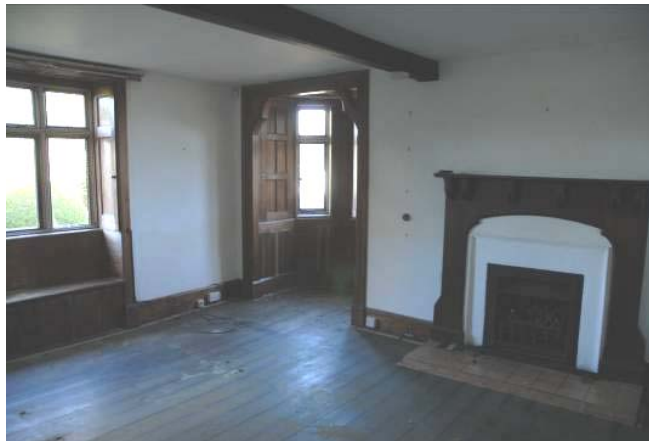
Room G2 Fig 27

This room leads off G1, the study, to the west. This was originally designed as the dining room in the 1850 Butterfield layout. A plain, massively-timbered fireplace stands in the north wall, adjacent to an equally massive but squat and asymmetric projecting bay, well panelled in firm solid pine, with ill-fitting but equally fine shutters. It looks straight out to the road but takes a squinting view off to one side and the gardens. It deliberately has no view to the east, apparent from the beginning. It is also divided from the room by a simple arch-braced timber frame, more decorative than structural. A deep skirting unites all timber elements.

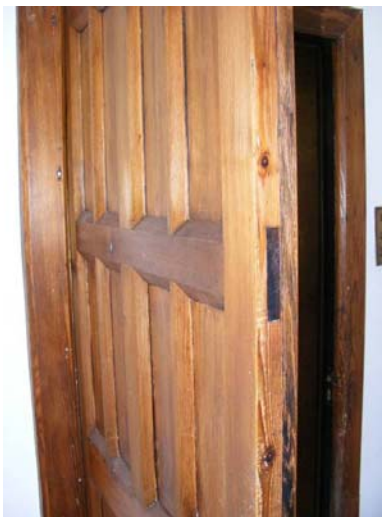
Room G2, the laminated door Fig 28

The floor is boarded out, since the room stands fully above the cellar. There is a timber casement window with shutters looking west above a timber-lined window-seat. The door face from G1 is panelled in pine, affixed as an exceptionally well carpentered laminate to the back of the Jacobean arrangement described in G1 above. This

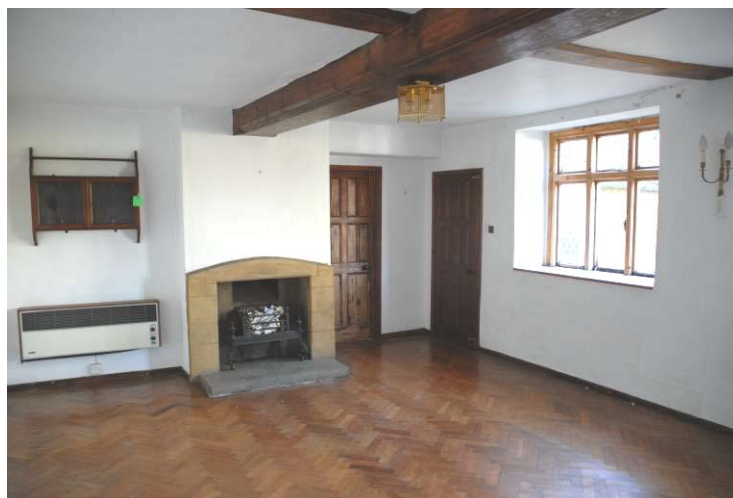
Fig 29

This room was intended as the study in the 1850 plans, and between it and G2 was intended to lie a timber-partitioned hallway leading from the former front door in the west wall, which was moved, porch and all, to its present location in 1867. No trace of the doorway or the timber partitions can now be seen. The combined space was most recently the dining room, to which the west-facing windows are eminently suited, maximising the last of the afternoon and evening light, along with the direct access from the kitchen, with which it shares almost identical parquet flooring.

Room G3, looking towards the kitchen

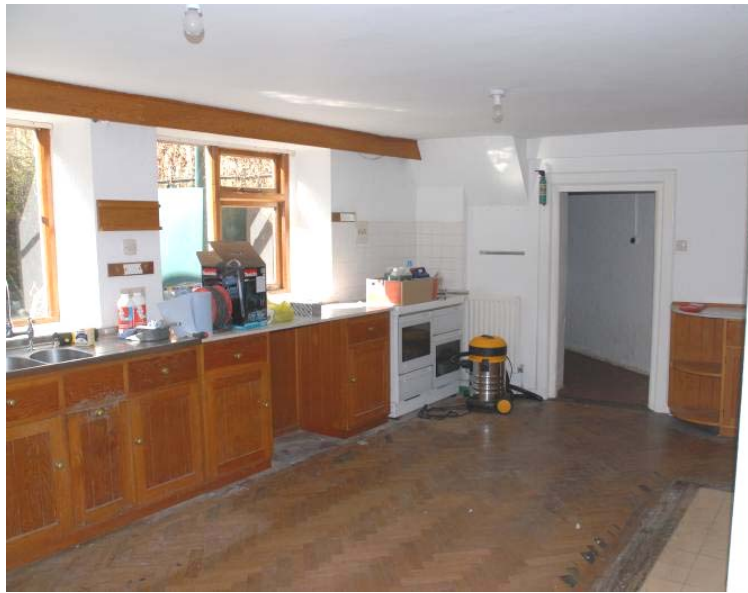
This room, latterly the kitchen, was designed as such in the 1850 Butterfield design, but with its eastern end, which was originally partitioned off as a 'china closet', now as part of the room. The location of the fireplace is original to the 1850 design but not the link to G3, which was the study. Any former cooking range has gone. Strangely, the kitchen and the dining room were at opposite ends of the house in that early layout. In the original layout a single, three-light timber casement window lay opposite the fireplace. This has been supplanted by two later openings either side of a central pier; today they contain timber casements of no earlier than 1960s vintage, very slightly different in size and awkwardly set on earlier concrete sills. These lintels in turn had been put in to reduce two earlier openings which seem to have stretched almost to the ground, possibly even doors into the yard. There is nothing left of the original design in this wall.

Room G4, looking south-west

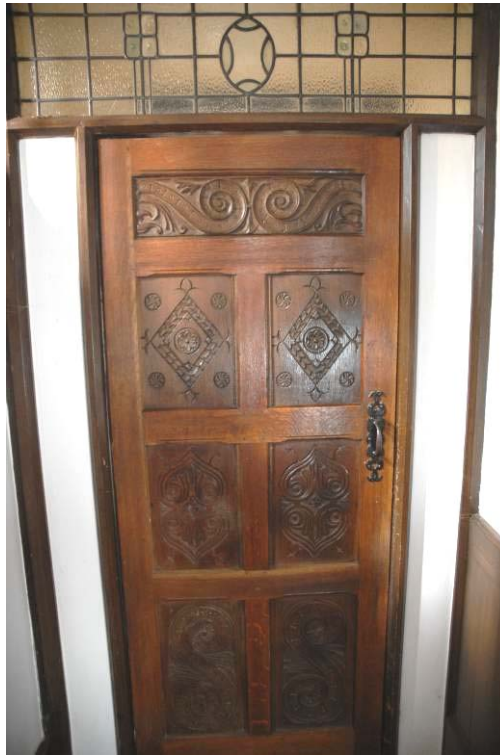
The entrance to the lobby, G5 Fig 31

Of note is the glass panel which surmounts the door from G1 to the north (Fig 31). This was simply to borrow light from the stair window for the service corridor. However, the form of the leading and selected, delicately-tinted panels are fully within the cross-over between the Arts and Crafts Movement and Art Nouveau, especially the work of Charles Rennie Mackintosh (see also below). As such it probably dates to around 1910-14, when the vicarage and school were sold and became solely a home first of all. The interdependence of this panel to the door panelling with its re-used Jacobethan feature-panels, together with related detailing, strongly suggests a contemporary date for many of the design details which today characterise the house.

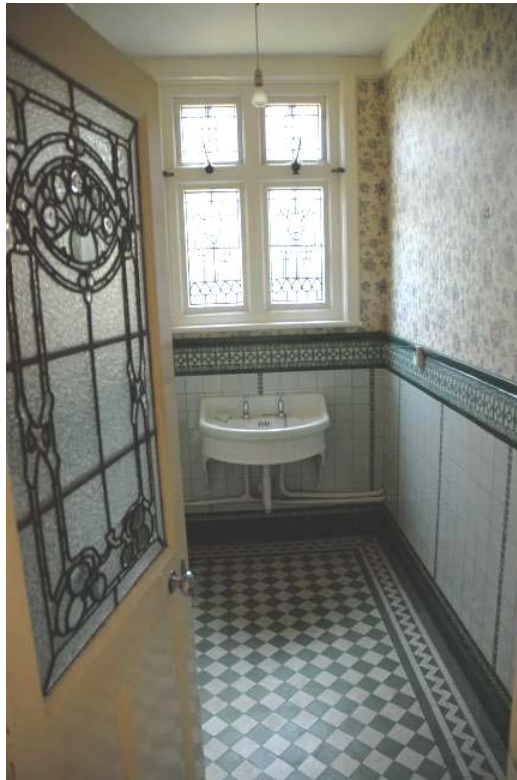
Wash-room, G6 Fig 32

Leading off from this corridor is a very gaudy and quite startling later addition. This flat, lead-roofed single storey extension contains a separate toilet and wash-room. They are both lavishly and decoratively tiled on both walls and floor with a green and white scheme. The doors and the windows throughout are entirely of Arts and Crafts/Art Nouveau styling with very distinctive leading patterns. The block dates between 1925 and 1928 on the grounds of map and photographic evidence, at the very end of the influence of the two stylistic movements. That it survives unaltered, given the likely polarised opinion on how gaudy and busy a scheme it is, remains all the more remarkable.

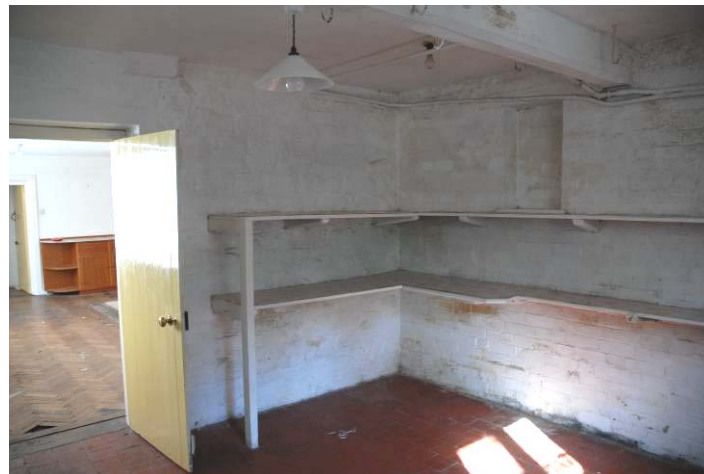
Former larder, Room G7 Fig 33

Connecting to the east side of the kitchen is the former larder, (G7). This is a plain square room of entirely functional character, for which the original bill of quantities of 1867 survives (see above). It is the only room in the house in which an absence of plaster fully elucidates the structural functionality of the Butterfield design. Thus it can be seen that although the exterior face of Butterfield's walls are of distinctive stonework, the interior face is just as likely to have been built in brick, as here. This is whitewashed for antiseptic properties as well as to maximise the light in an otherwise poorly lit room (Fig 33).

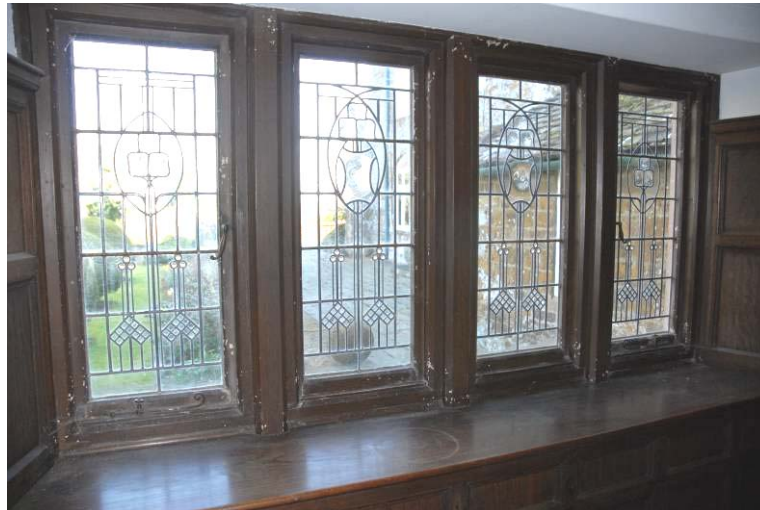
Connected to the south-west corner of the former study and dining room G3 is one half of the ground floor of the school. This effectively forms a corridor and no more, although its current arrangement is an awkward use and division of a once larger space (Fig 35). The walls are three-quarter panelled in oak, utilising a wainscot almost identical (but lacking feature panels), to that added to the 1860 study around 1910 (G1). Photographs show that this area or room was once lit by two small 1850-53 timber casement windows set beneath pointed relieving arches (see above). These were subsequently replaced by a row of four very distinctive lights in a row.

Room G8, Mackintosh-style windows

This is a classic fully-fledged Arts and Crafts window-arrangement in a row and is enhanced by the use of the finest artistic leading which is highly redolent of the designs of Charles Rennie Mackintosh and his contemporaries working in Art Nouveau (Fig 34). It contains motifs already seen in the door-head light between G5 and the service corridor. This is a feature window and admits far more light than the two previous windows would have done and represents a move to lighten the space once the corridor was in place. This probably took place c1910-14. It is tempting to push the window forward to 1916-19, when Mackintosh himself was working on Northampton properties, but there is no evidence for this. Since she was married into a firm of London Solicitors, the then owner of Hellidon, Rosa Rooke, would have been fully conversant with the latest artistic fashions, and would have needed no local flowering of Mackintosh himself to commission such high quality work in the latest styles. Strangely the opening casements are fitted with restrained brass handle-catches and lockable stays with very ordinary monkey-tail stays of that period.

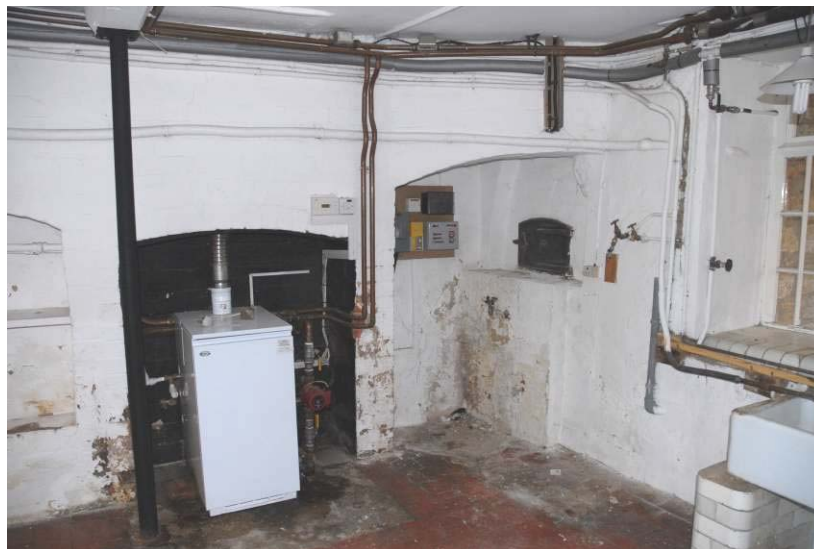
Former scullery, G9 Fig 36

This is a back-kitchen or scullery, present in some form from 1850, but was awkwardly cut off from the rest of the house by the insertion of the corridor (G8) about 1910-14 (Fig 36). The move effectively created a much reduced scullery and created the space for a butler's pantry (G10). Previously it would have been a single large space which would have prepared food for the school, which dined next door in G11. In this way its function had been fully separable from the Vicarage kitchen (G4).

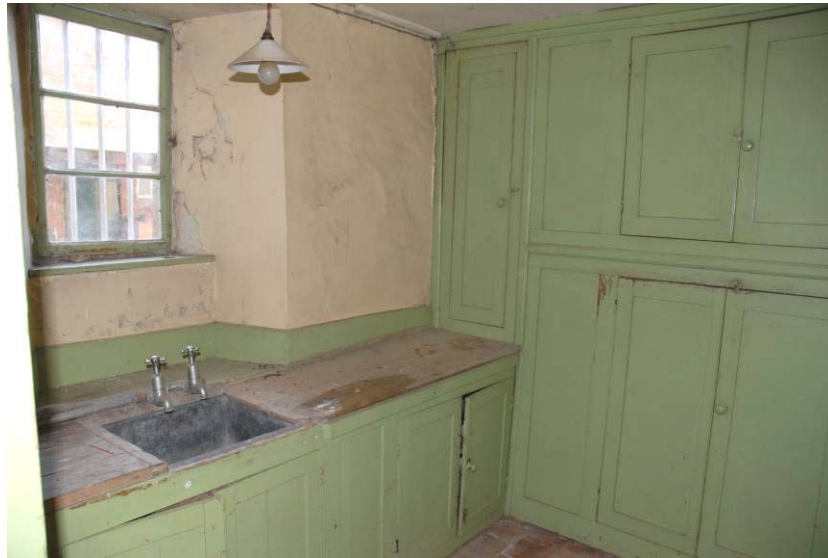
Leading off G9 is a small rectangular room with an array of built in cupboards, racks, shelves and a sink with draining board. It appears to all have been fitted out as one and as part of the division of the whole G8-9-10 juxtaposition, represents a room created c1910-14, probably for the property as a proper home for the first time. It is likely to have been the cook's pantry. The array of cupboards and shelves etc all appears to be original and are painted, possibly in their original colour (Fig 37).

Former cook's pantry

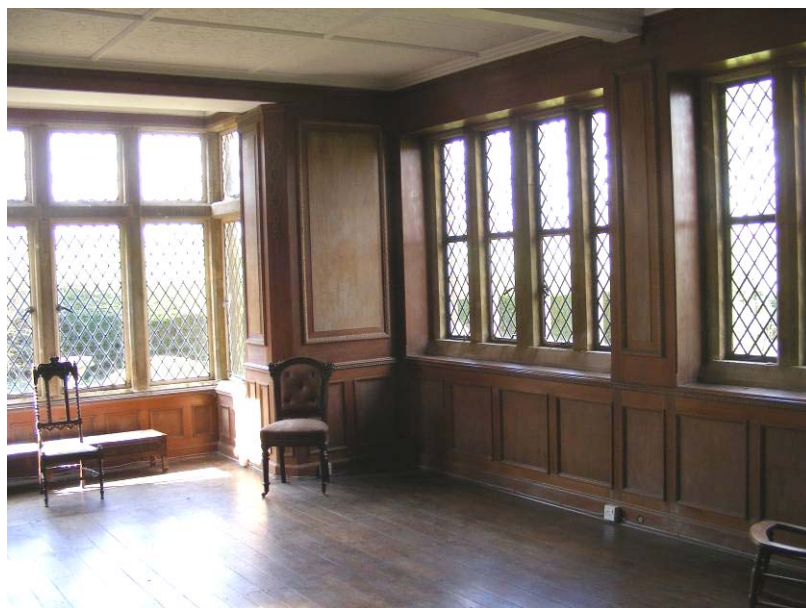
It is fitted out from floor to ceiling in panelling in a manner which is clearly designed for the room, but in a style which is reminiscent of the period c1670-1720, after which time full panelling fell rapidly from favour. It seems to be deliberately hark back to a Restoration-period decor in a room which did not exist before 1850.

Late 1920s panelled room, G11

Closer inspection shows that the panelling is made up (although well made-up) using plywood. Although this material was known from the 1850s, it found widespread favour in the 1920s and 1930s, such that *Homes and Gardens* ran a feature on its potential properties for an aspiring mass market in 1926. What makes the look even more incongruous is that it is left unpainted. Had it been original, this full-height panelling would have been fully painted in the 1670-1720 period and not left as bare or varnished wood. While bare wood is appropriate to Arts and Crafts interiors, they would have aped medieval and vernacular styles and forms, while the Restoration/Queen Anne period would have been marked by copious light-coloured paintwork throughout and would never have attracted Arts and Crafts attention had it existed at the time. They would also not have used plywood as it was not what practitioners called an 'honest' material.

The whole is an attempt at what is loosely called Queen-Anne-revival and fits well into the period of the 1920s at the height of plywood's dubious popularity. Comparison of maps shows that the massive projecting stone bay window on the west end of the room was erected in the period 1925-8 (see 'lost buildings', below). With matching new windows to the north (from photos) and a probable blocked matching large window to the south, now discernible only as a stone blocking, the room may originally have been set up as a medieval hall for school dining, with a well-lit medieval-style dais for the masters to eat at the east end (the staff would have to process through the ranks of boys to their seats). A new emphasis on the east face in 1925-8, and the blocking of whatever faced north at the east end, may suggest that its function was changed to a morning room under its private owners.

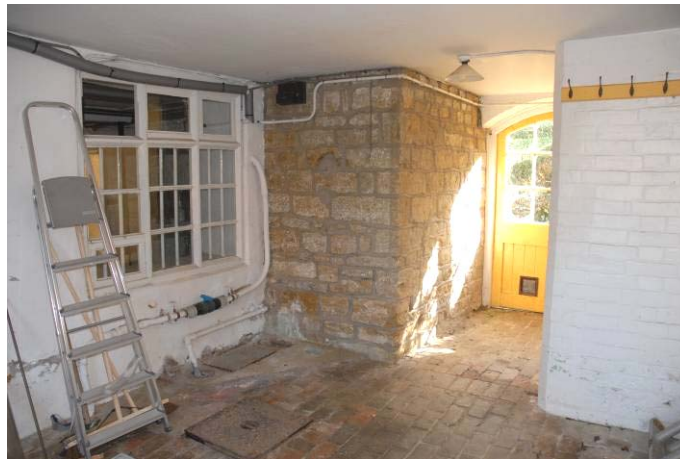
The covered-in courtyard of 1871, G12 Fig 40

These rooms entirely constitute an extension or at least major alteration of 1871 (Figs 40 and 41). Downstairs they were probably designed to serve both the Vicarage and estate on the one hand, and the school on the other. They are of stone and brick, the latter being reserved around the house for less-important facades. They have no notable interior fittings, but for a small (not original) art Nouveau-style cast-iron fireplace in G14. Either side of this are the marks on the walls where the brewing coppers stood (Fig 41). This juxtaposition suggests the coppers were removed when the present fireplace was put in, perhaps around 1910.

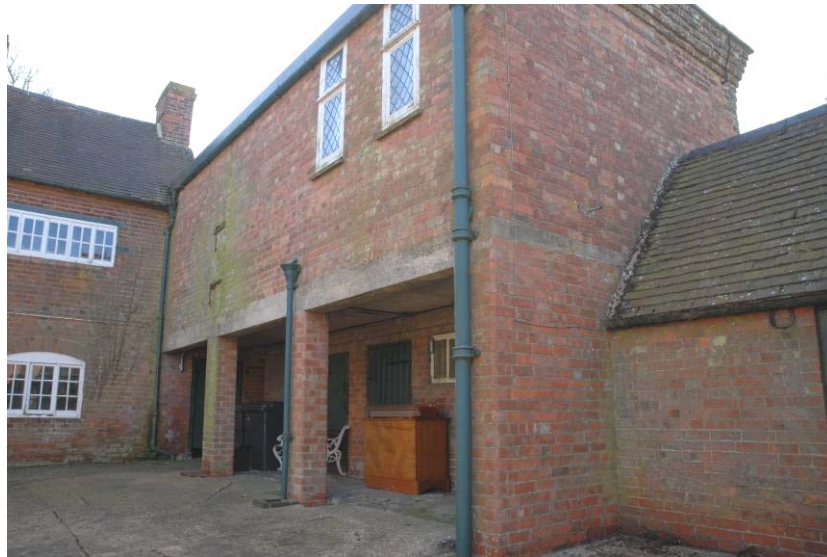
These rooms, or more particularly, sheds, only exist by virtue of alterations made in the period 1933-6. They comprise entirely the result of that area being in two different levels. Until 1933, photographs show that a tall garden retaining wall and a gabled brick shed stood here on the end of the 1871 range. In that year the terrace was pushed back and the gardens re-laid, with the insertion of a raised garden room above. The semi-basemented space in the terrace below was filled with brick sheds for all sorts of storage and ancillary purposes, coal, wood, boilers etc. A crawl-space at the back may have allowed for the insertion of underfloor heating, although it is not clear if this was ever used. All is built in brick with copious use of shuttered concrete and concrete lintels in very utilitarian inter-war style (Fig 42). The ground floor is plain, functional and largely now unused, since such things as boilers are so much smaller, heating is cleaner and does not require huge quantities of different kinds of fuel to be stored.

The 1930s store-rooms under the garden room, G15

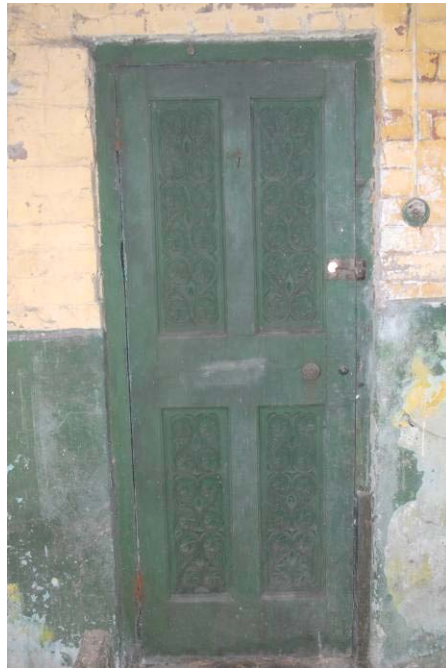
The re-used door, G17 Fig 43

At their west end the stores were built onto the ranges of out-buildings which included 'The cottage', a 1972 conversion of a former stable. The two small sheds among these which adjoin the cottage are unremarkable but for a reused Arts and Crafts door, which lies at the entrance to G17. Painted green, the door is highly decorated, as is the door-knob, and has probably been re-used here, having been taken out of the main house at some point (Fig 43). It is unique in the complex.

- Preserve and restore, where necessary, the exterior form: simple, long sweeping roof-lines broken by cross-gables and dormers; tall chimneys; complicated ashlar masonry coursing.
- Very notable is the bewildering capacity for re-use of interior fittings and panelling, already demonstrated in the numerous extensions and alterations to the house and school. A reused door in G17 is the most startling example noted

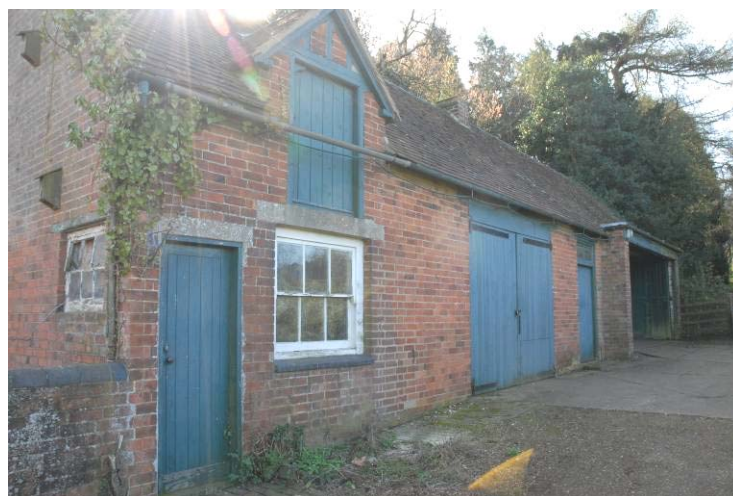
The ancillary range: stables and garage Fig 44

To the south of the cottage lies a range of brick buildings put up probably in the 1860s or 1870s. They existed by the time of the 1st Edition Ordnance Survey in the 1880s. They were not fully accessed for the purposes of this report, although their exterior has been photographed for this survey. They are not under consideration for any alteration at the present time.

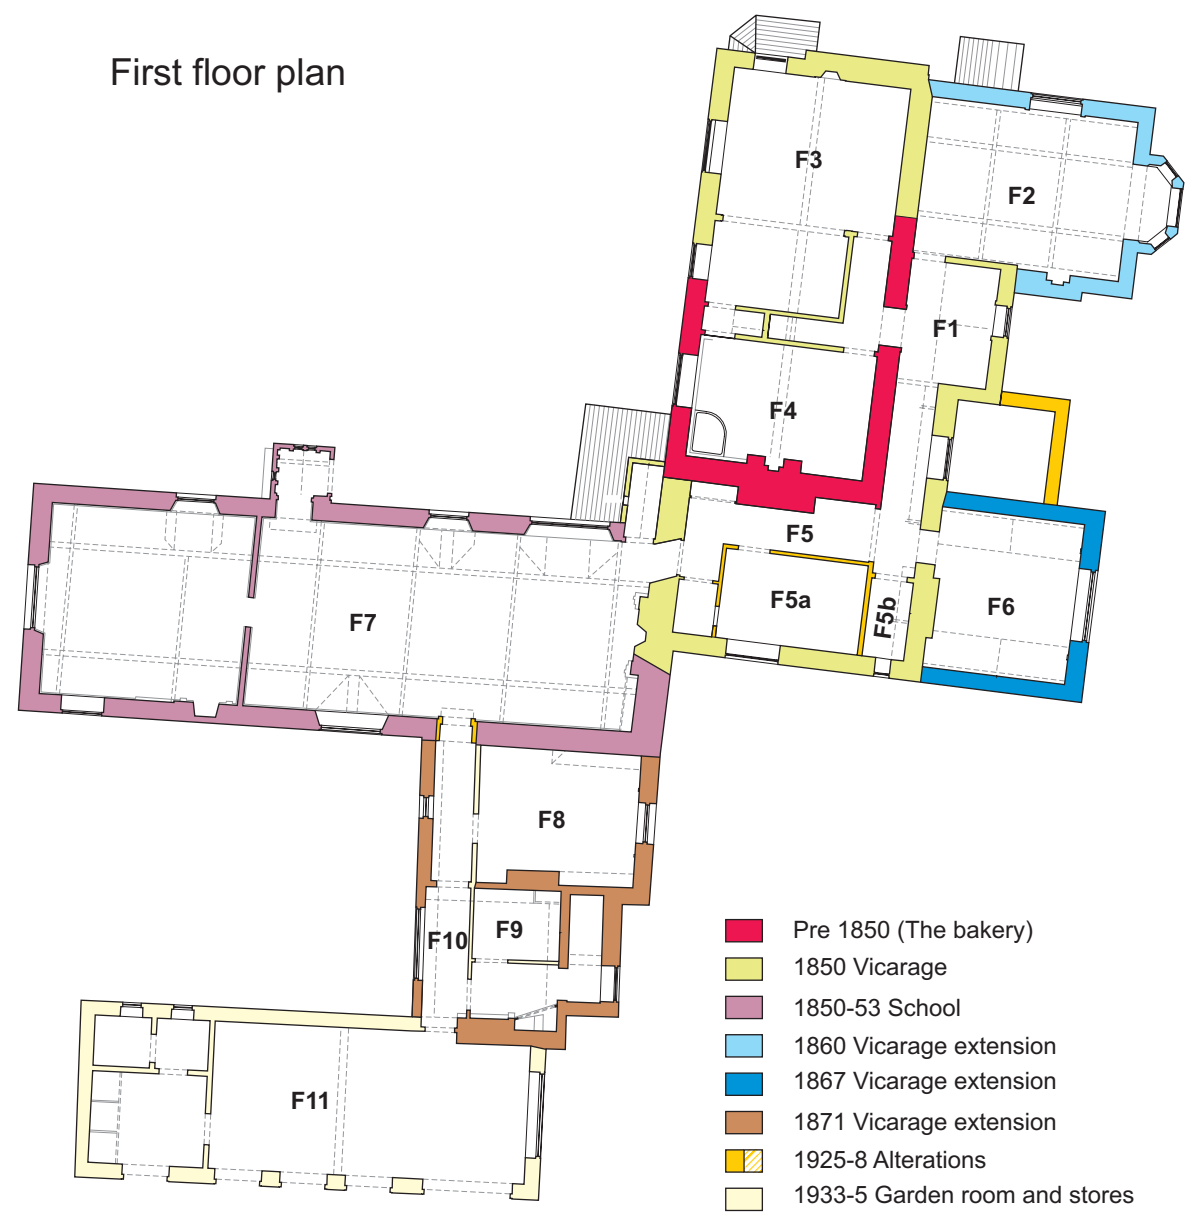
First floor plan

- Pre 1850 (The bakery)
- 1850 Vicarage
- 1850-53 School
- 1860 Vicarage extension
- 1867 Vicarage extension
- 1871 Vicarage extension
- 1925-8 Alterations
- 1933-5 Garden room and stores

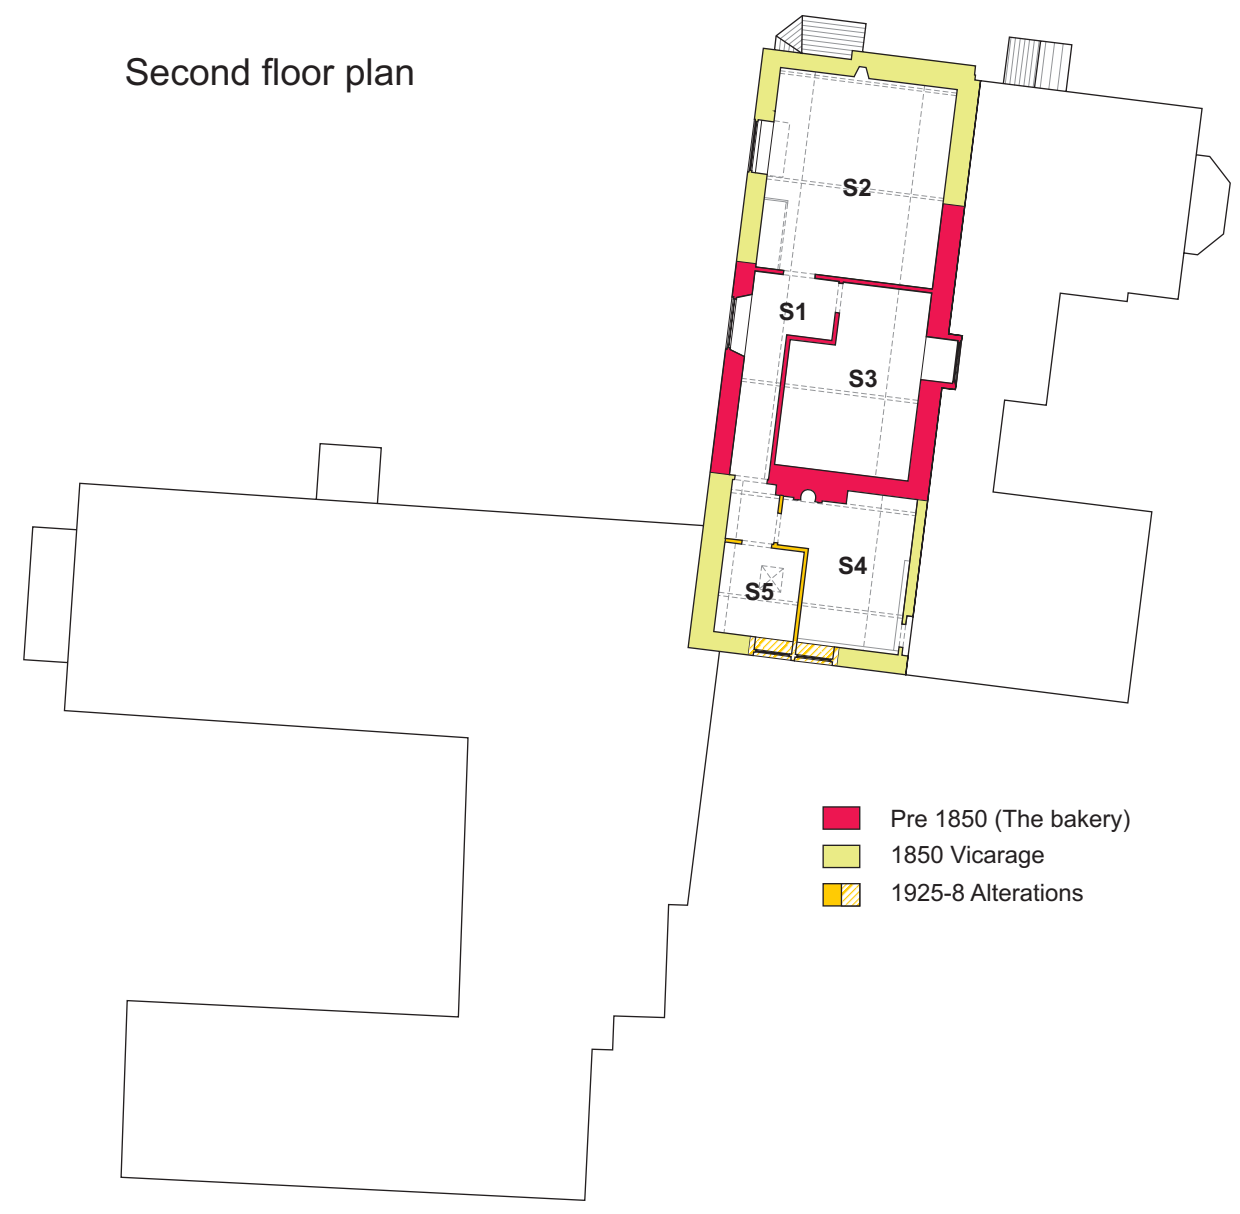
Second floor plan

- Pre 1850 (The bakery)
- 1850 Vicarage
- 1925-8 Alterations

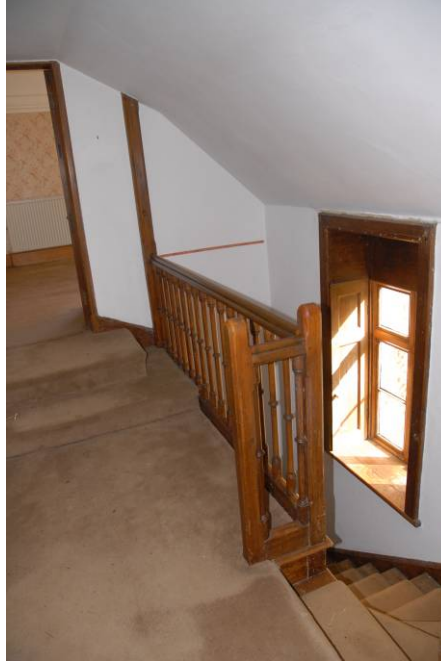
Landing, F1, and the stairs Fig 46

The timber stairs up from the ground floor have already been described above. A landing (F1) provides access along a corridor to all parts of the first floor (Fig 46). The stairs are lit by a large timber casement window which documents show was moved from the north wall at the foot of the stairs when study was built in 1860.

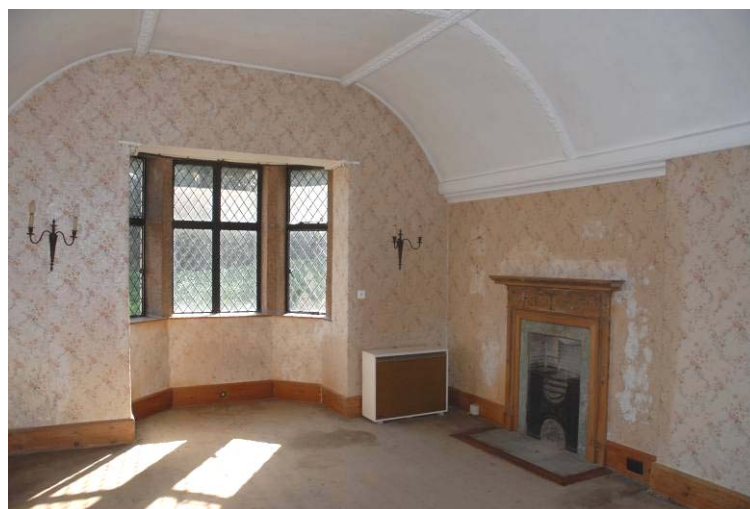
The upper floor of the 1867 Vicarage extension is the principal bedroom. It is lit from the north by a timber casement window and from the east by the upper portion of the same bay of the study below (Fig 47). This incorporates massive stone mullions and has a rustic, unfinished look which is its most striking feature, very much at odds with the fussy decoration of the rest of the room.

Principal bedroom, F2, of 1867

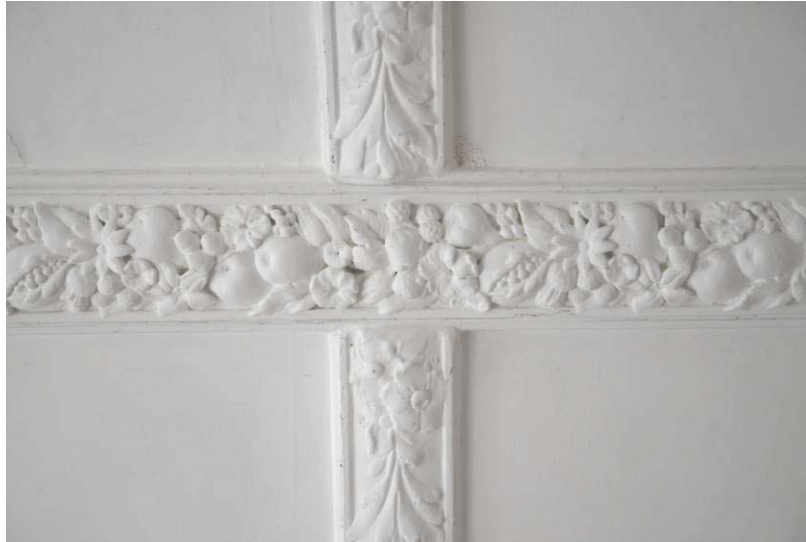
bear foliage, nuts fruits and seeds in a feast of nature's bounty, as if perhaps, representing the produce of a semi-tropical Garden of Eden (figs and pomegranates are discernible), suitable fare for a vicarage (Fig 48). The Adam-style fireplace surround, however, is out of place and is probably a later replacement for something more simple and vernacular. The simple pine skirting board seen here is carried throughout most of the first floor rooms.

Plaster decoration in F2, 'nature's bounty'

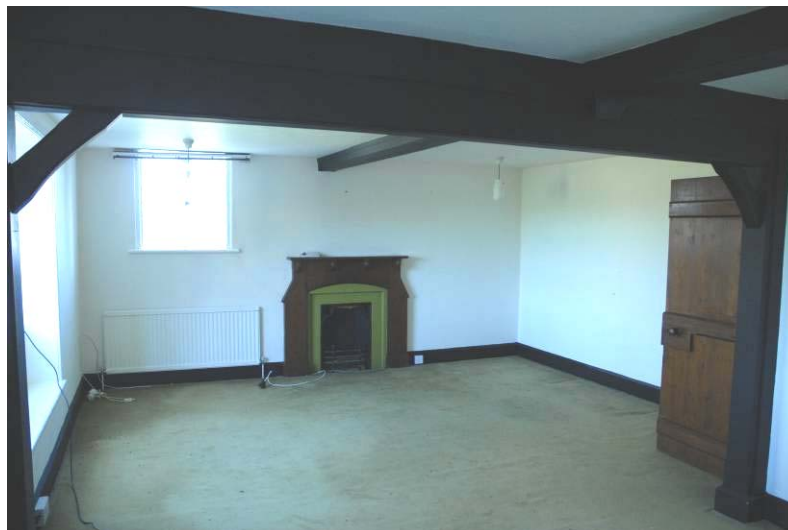
This room is one of the former school dormitories, simply a bedroom in the early vicarage. The L-shape to the room is a later creation as there was originally a timber partition beneath the east-west aligned axial beam, which cordoned off a dressing room. Today it is framed and appropriately braced in Arts and Crafts style. The closet space which actually lies beneath the stair to the second floor is part of the 1850 plan (Fig 49). There is an original fireplace surround in dark-stained wood and windows to the north (small-and therefore minimising heat-loss, high and private) and the west (larger, with seat for view).

Room F3

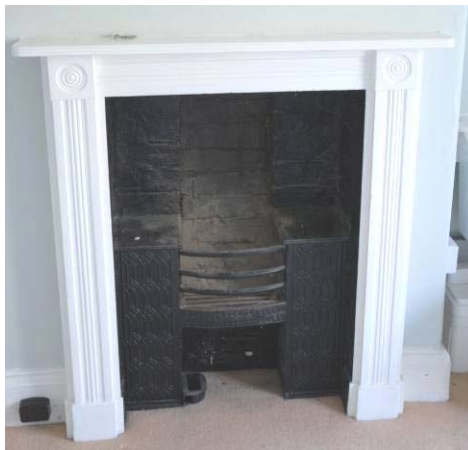
Room F4, fireplace Fig 50

The former bedroom F4 has been converted into a large WC and shower-room, although there is plenty of space for this to have been a bathroom too. However, the only notable feature in the room is a probable original (c1850) fireplace in the south wall (Fig 50). F4 is the only pre-1850 space to survive on the first floor, although this can only be inferred from the contemporary plans by Butterfield.

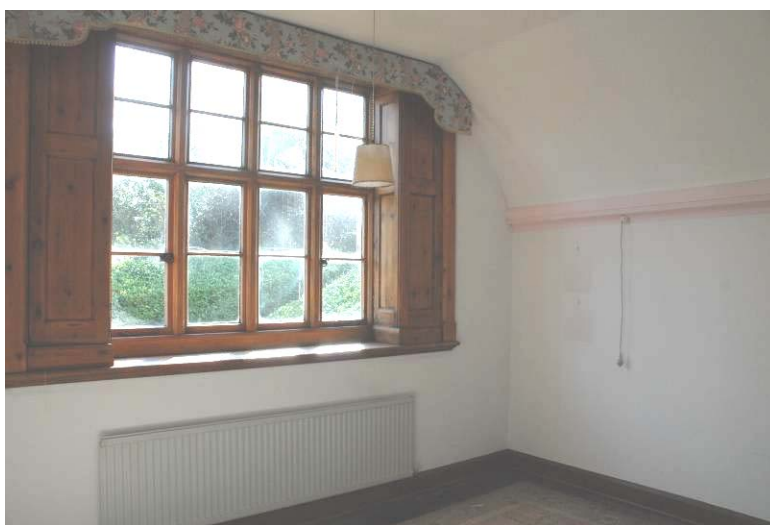
Bedroom F6 Fig 51

Also a main bedroom, this room is distinguished by its plain curved ceiling and a set of large east-facing windows with full-length shutters. East is not usually chosen for bedrooms, unless for servants' quarters, as the morning sun is either deferred (by the master) or employed for early waking (by the servant). However, the extension of 1867 was deliberately in an easterly direction and the gable demanded an east-facing window. The shutters and window furniture, doors and door furniture are original 1867. The chimney which stands above F6 is the only one which retains its original chunky stone capping as designed by Butterfield.

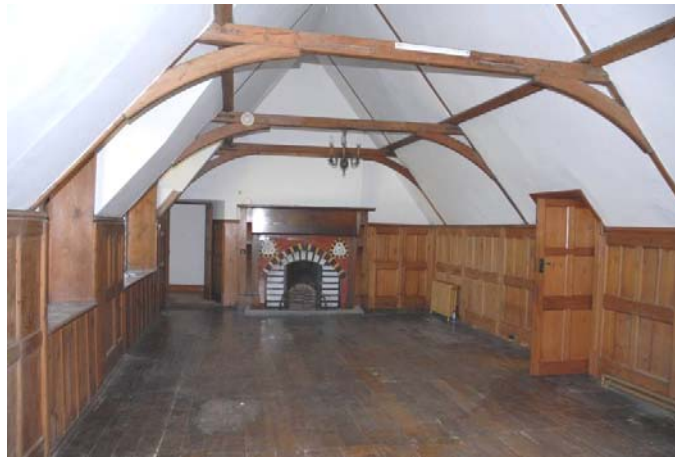
The schoolroom is the largest room in the complex and was the place of instruction for the entire school from 1851-c1900. It is notable for its softwood panelling to protect the walls from the boys and exposed high trusses and relatively flimsy-looking principal rafters. Its two gothic windows, one on each side at each end, is indicative of the teaching methods. The east end, with its massive, Holthouse-monogrammed and Minton-tiled fireplace for warmth, looked out on the world and its distractions – and the church – for the Vicar/headmaster and his staff to teach from (Fig 52). The west end looked out on the service-yard and was inward-looking, for the boys. At the end of a session of classes the boys would exit via the northern flight of external stone stairs, set in its own timber porch which was originally surmounted by an almost steeple-like bell-cote which was taken down sometime before the 1920s. This room was used for village functions well into the 20th century.

The former schoolroom, F7

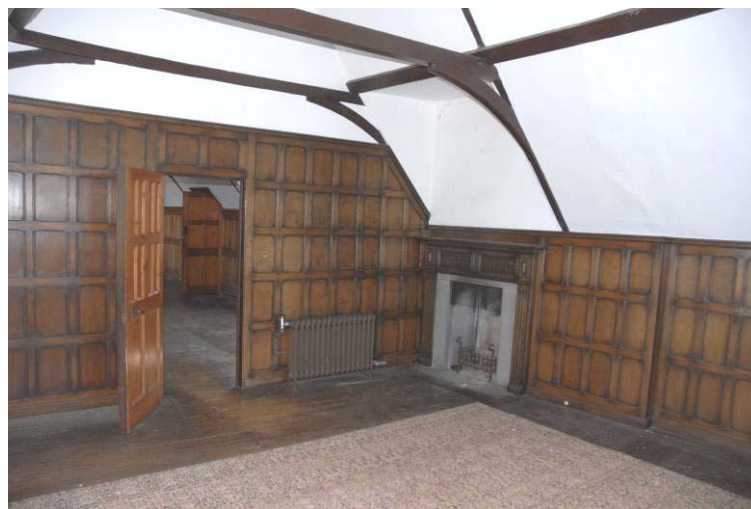
A panelled partition at the west end screened off a panelled room which may have been used for teaching or was for staff only (Fig 53). There is a suggestion from a thumb-nail sketch in the 1891 prospectus that the room may once have contained wash-basins (attested in a builders' specification) but this is not confirmed by the clarity of the location mentioned. If so the panelling is surely not original to this location. It is notable that when originally built there was panelling in room G3, when it was hall and study combined. When the room G3 was created in 1867, the panelling there was moved elsewhere although no indication of its destination. The room sizes of G3 with the former hallway, and the western element of F7, are very similar.

Partitioned end of Room F7

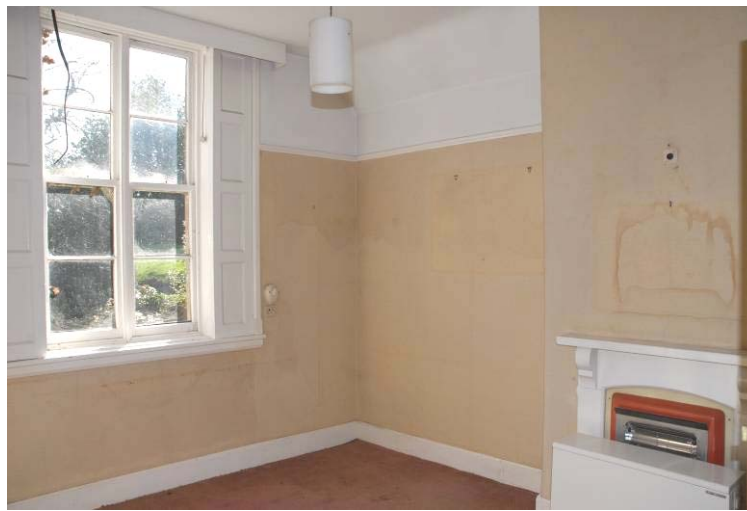
In 1871 an extension was added to the south, which included a brewhouse and covered court on the ground floor, while at first-floor level were three gables, which contained (north-to-south) the school infirmary, the matron's room and the garden house. The last of these was demolished in 1933 for the present garden room. The infirmary (F8) included a hand-operated dumb waiter down to the covered court, which meant fresh water and food could be sent up without affecting the running of the rest of the school. A high window on the west prevented boys in class viewing the sick and vice versa. The adjacent bedroom was probably that of the school matron, the longest-serving being buried in the nearby Parish Church. This smaller bedroom is today divided up, with a small, windowless kitchen at its core. The former fireplace in the south wall is blocked up and a built in cupboard infills around the chimney breast (Fig 54). It links directly to the covered courtyard G12, via stairs to the east.

Former infirmary F8

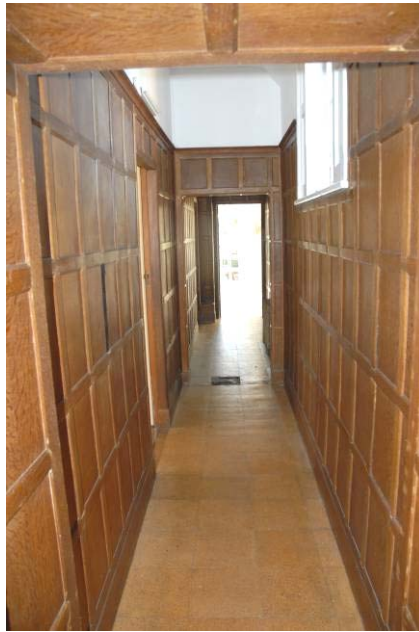
With the demise of the school by 1910, the infirmary and adjacent room lost their intended function although they may still have been used as bedrooms. The separate access from the covered courtyard meant that they could function independently of the rest of the house so were ideal either for guests or for serving staff. In 1933 a long narrow corridor (F10) was cut through both rooms from north to south to serve a newly built garden room (F11). This took out the lift/dumb waiter which formerly stood in F8, although it probably utilised existing doorways from F7 and between F8 and F9. A new doorway was almost certainly needed in the south gable of F9 since there had previously been a gabled brick garden store (known as the garden-house) which stood here, and is shown on numerous 1920s photographs. The corridor was finished off with a 'lining' of appliqué panelling formed of machine-cut beading for the rails and muntins and plywood sheets for the panels (Fig 55). The floor was made of light brown cork tiles, very popular in the 1920s and 30s.

Corridor F10

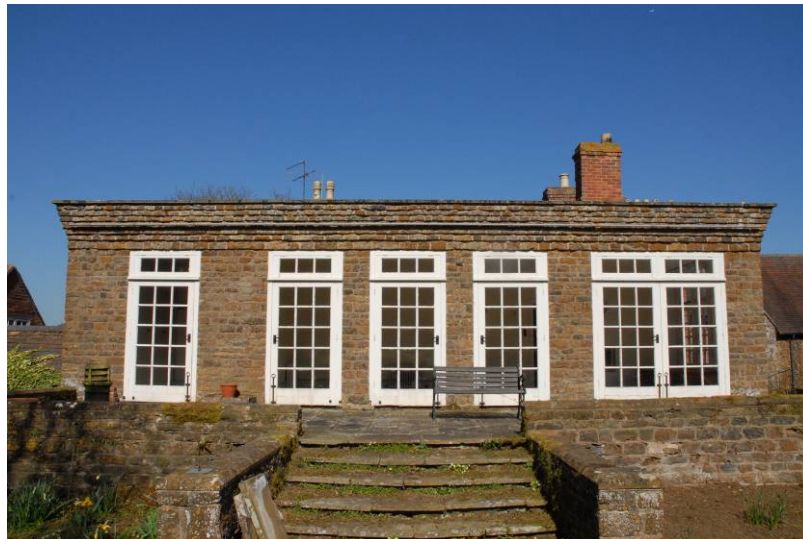
The 1933-5 garden room, F11

Like the ground floor stores over which it stands, the garden room is of brick to the rear, braced with concrete. It is founded on a concrete floor, but its forward-facing and side walls are of ironstone with a projecting entablature, but incongruously without the
