Archaeological building assessment of Hellidon Grange, Hellidon, Northamptonshire March-April 2012

Iain Soden
and Charlotte Walker
Report 12/95
May 2012

**ARCHAEOLOGICAL BUILDING ASSESSMENT OF
HELLIDON GRANGE, HELLIDON,
NORTHAMPTONSHIRE
MARCH-APRIL 2012**

OASIS REPORT: No. 126962

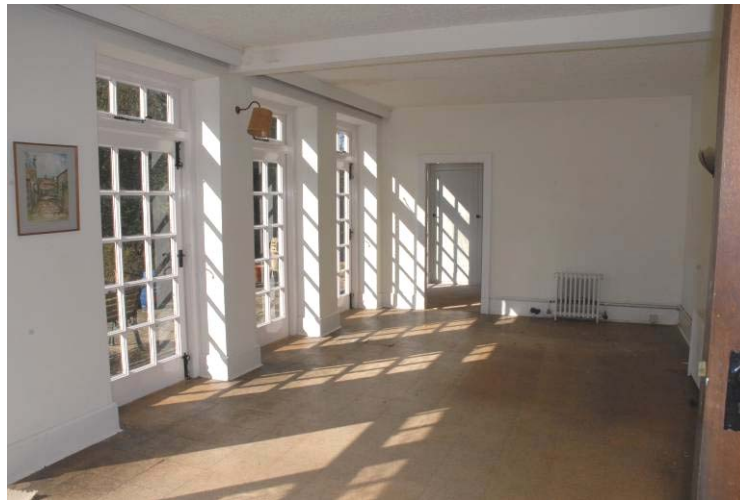
Fig 57

The garden room is of stone, with a row of French doors along the south front onto the garden, which give it superb natural lighting on the interior (Fig 57). A dressing room at the west end, with a WC and washroom, show that it could function independent of the house, but for food preparation, and it is likely that it served as a pavilion for the regular grass-court tennis which characterised the use of the gardens in the 1930s.

Like the ground floor stores over which it stands, the garden room is of brick to the rear, braced with concrete. It is founded on a concrete floor, but its forward-facing and side walls are of ironstone with a projecting entablature, but incongruously without the

distinctive Ecclesiological mixed coursing which characterises the main house. The detailing, although restrained and plain, has slight Art Deco undertones, not least in the wall-light and other electrical fittings. Door furniture is very typical 'reproduction' ironwork of the inter-war period and even has identical counterparts at the local village pub, The Red Lion. The room has a floor of brown cork tiles, in common with the access corridor, and contains contemporary central heating radiators, showing that it was designed to be used throughout the year, not just as a summer-house or fair-weather garden-room.

Garden room, F11, interior

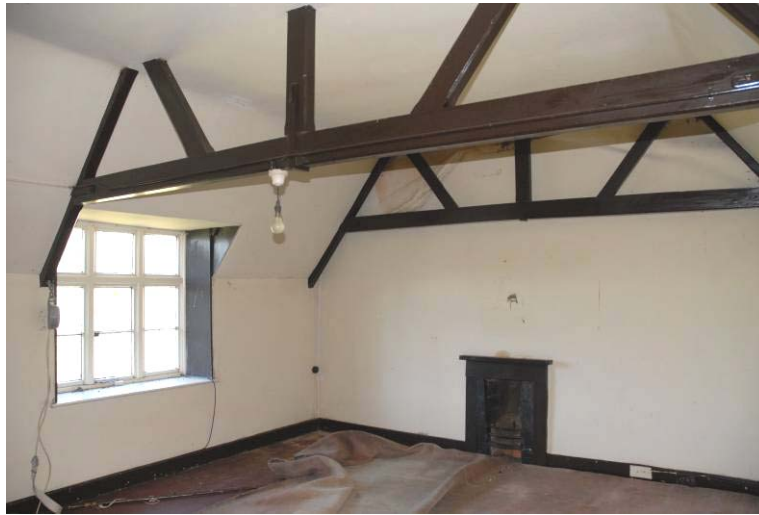
Room S2 Fig 58

The second floor of the main house is basically a subdivided attic space, although very large and cavernous as a result of the steep, sweeping slopes of the Butterfield rooflines. The attic is, however, restricted to the main block of 1850 and a comparison of the modern layout with Butterfield's original specification drawings shows that little has changed since the bakery was extended in that year. The basic division into a row of three bedrooms (S2, S3 and S4) accessed via a landing and corridor (S1) is as was intended in 1850 (Fig 58). The timber of the trusses has probably always been exposed.
