Archaeological Building Recording at The Cricketers' Arms, Hervey Street, Northampton

Report 12/97

May 2012

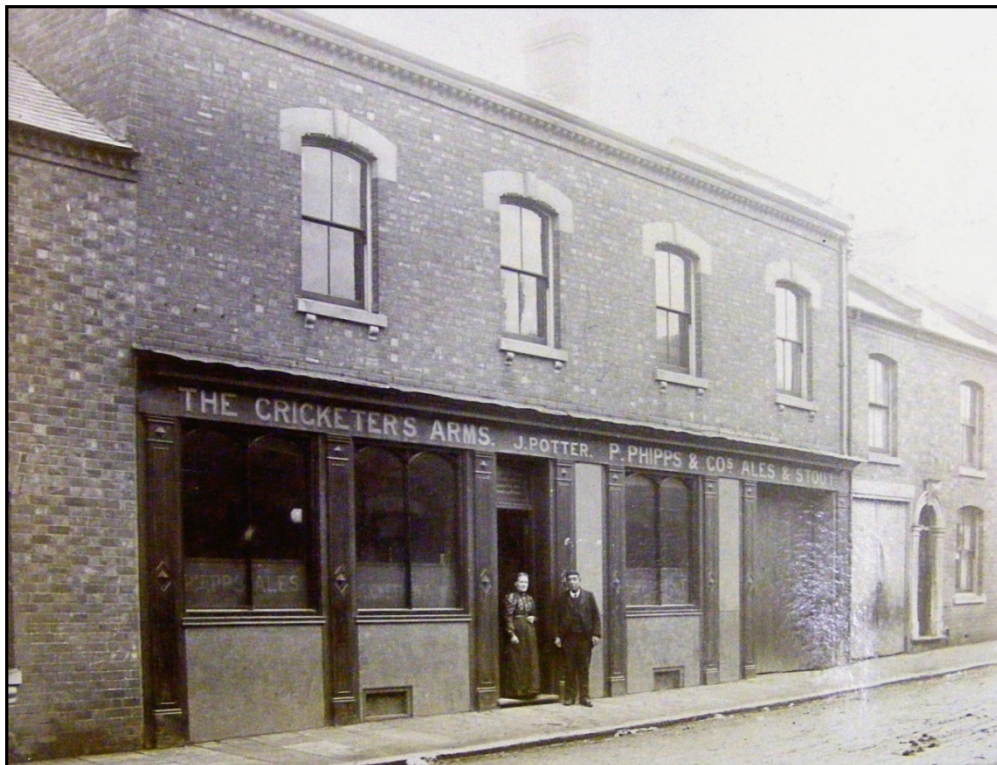
Undated photograph of The Cricketers' Arms Fig 2

A search of the NRO revealed the purchase of a plot of land on Hervey Street by Pickering Phipps in 1878 (ZB 108). The document does not specify the exact plot of land on the road but it is probable that the purchase is the site of The Cricketers' Arms (a Phipps Brewery pub). The census of 1881 lists a William Cordley, Licensed Victualler at The Cricketers' Arms. Wrights Northampton Directory of 1884, lists a W.M.C. Gubbins at The Cricketers' Arms. The building is visible on the first edition Ordnance Survey map of 1884, though it isn't annotated as a public house. The Kelly 1894 trade directory lists a Joseph Potter as "Beer retailer" at plots 43 and 45 of Hervey Street. The name J.Potter can be seen on a historic photograph of the building's frontage (PBP 189, Fig 2).

The survey has shown that The Cricketers' Arms was conceived of and built as a Public House in the late 19th century to serve the flourishing boot and shoe industry of the area. The building retains some of the original street facade as shown on a historic photograph (Fig 2). Evidence for some internal alterations such as the removal of a ground floor wall and fireplace can be seen. Very few original features survive in the building due to cosmetic alterations and upgrading of the property.

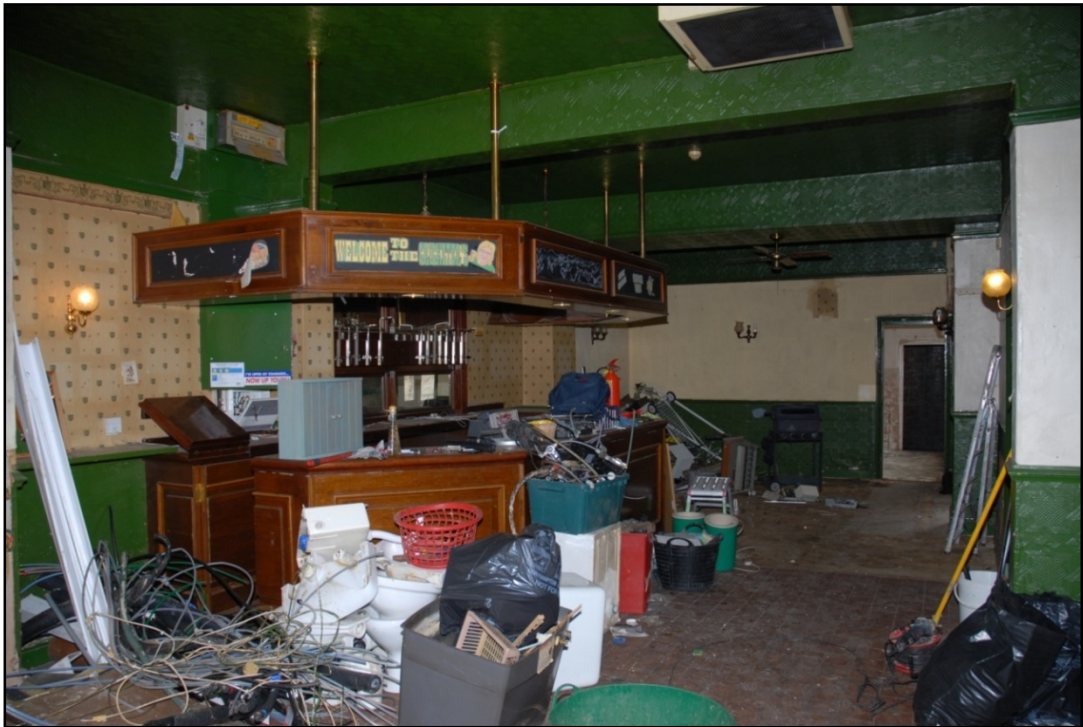
The pub and bar, looking south-east Fig 5

The main entrance opens into a large bar area which is on an L shaped layout (Fig 3). The room has a white colour scheme with dark green patterned panel borders and ceiling and a dark brown-red, square tiled floor (Figs 5 & 6). The eastern wall of the room has yellow wallpaper between the green panel borders. The room retains the pub light fixtures with brass fittings. An original cast iron fireplace with tile surround is present on the eastern wall of the room (Fig 7). A red stained timber bar with a mirrored back and brass fittings is built against the eastern wall of the room. A pair of wooden ceiling fans with brass fittings are also visible in this room (Fig 5). A collection of pub games such as a Northamptonshire skittles table, pool table and a piano were also present (Fig 6).

Evidence for 20th-century structural alterations can be seen in a pair of boxed-in girders in the ceiling of the bar (Fig 5). One supports the blocked fireplaces in the first floor bedrooms and the other represents a removed wall.

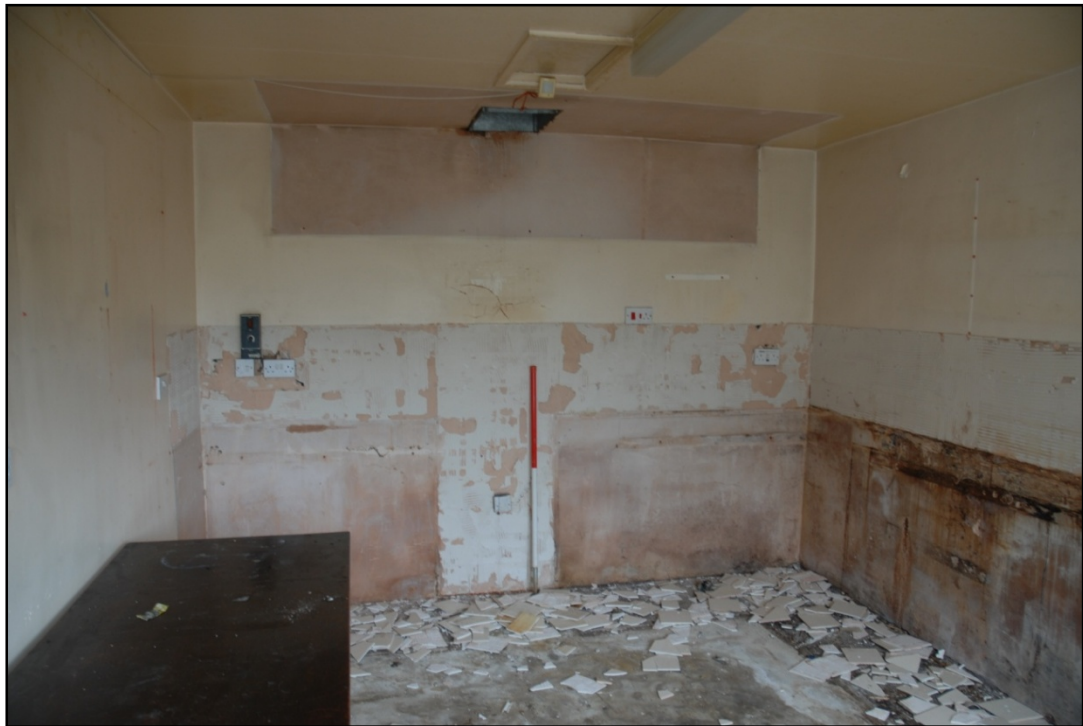
The ground floor kitchen, looking east Fig 8

A doorway in the southern wall leads into the kitchen. No fixtures or fittings remained in this room at the time of the survey. The south and eastern walls have white tiles and the room is painted plain white (Fig 8). Two square vents are built into the ceiling above where the cooking equipment would have been. The floor was plain concrete. A door and large window are built into the western wall opening onto the beer garden (Fig 9). It was unclear whether this room was a later addition between the house and stable.

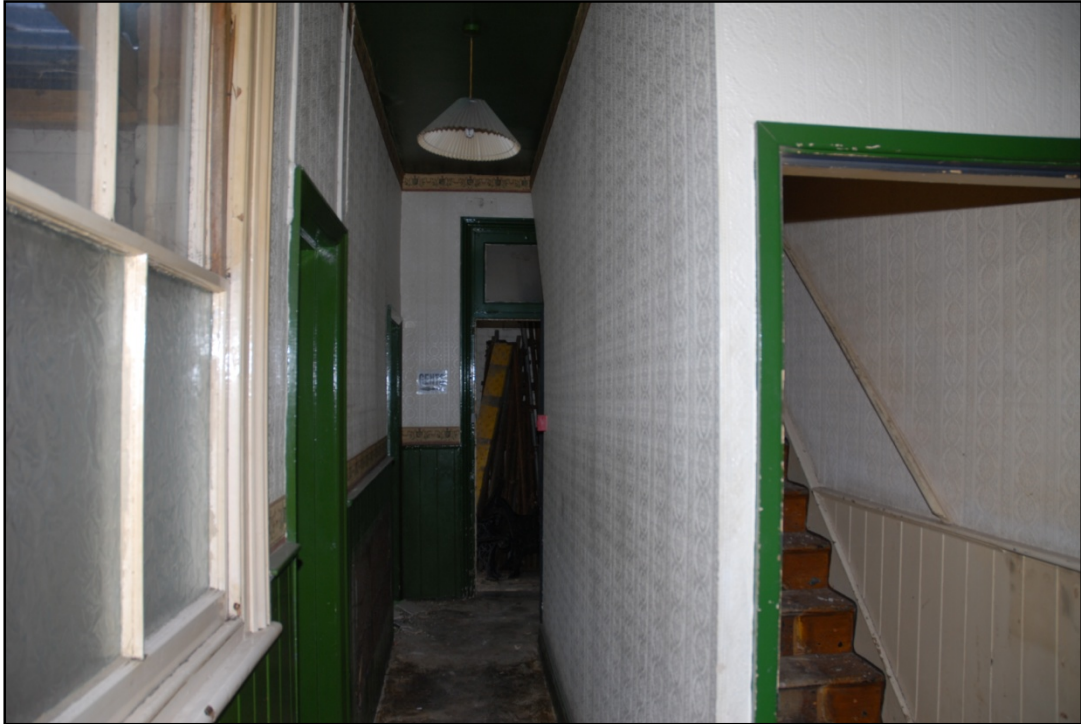
The ground floor corridor with access to the first floor, toilets and passageway Fig 9

A corridor leads from the main pub area to the passageway, with access to the toilet block and stairs leading to the cellar and the first floor (Fig 9). The corridor continues the dark green paint scheme of the pub and has white patterned wallpaper. Two doors provide access to the male and female halves of the toilet block. The toilet block is brick built with white and pink tiles (Fig 10). The structure is a later extension to the main building.

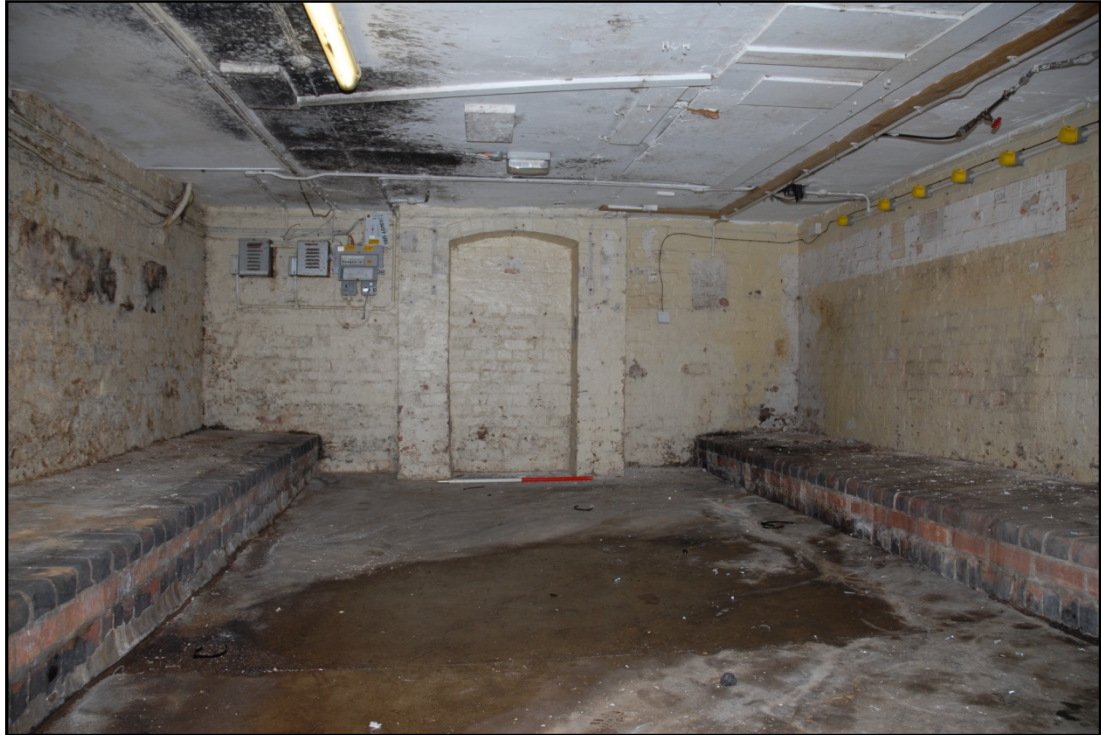
The cellar showing arched recess on the rear wall, supporting chimney Fig 11

The cellars appear to be purpose-built for use as pub cellars with raised, brick walkways for storing beer kegs. A chute at the bottom of the stairs end rises to a trapdoor in the garden from which kegs could be rolled down wooden runners to the cellar (Fig 12). The cellar is divided into two rooms with an arched recess in each room, on the west and east walls respectively (Fig 11).

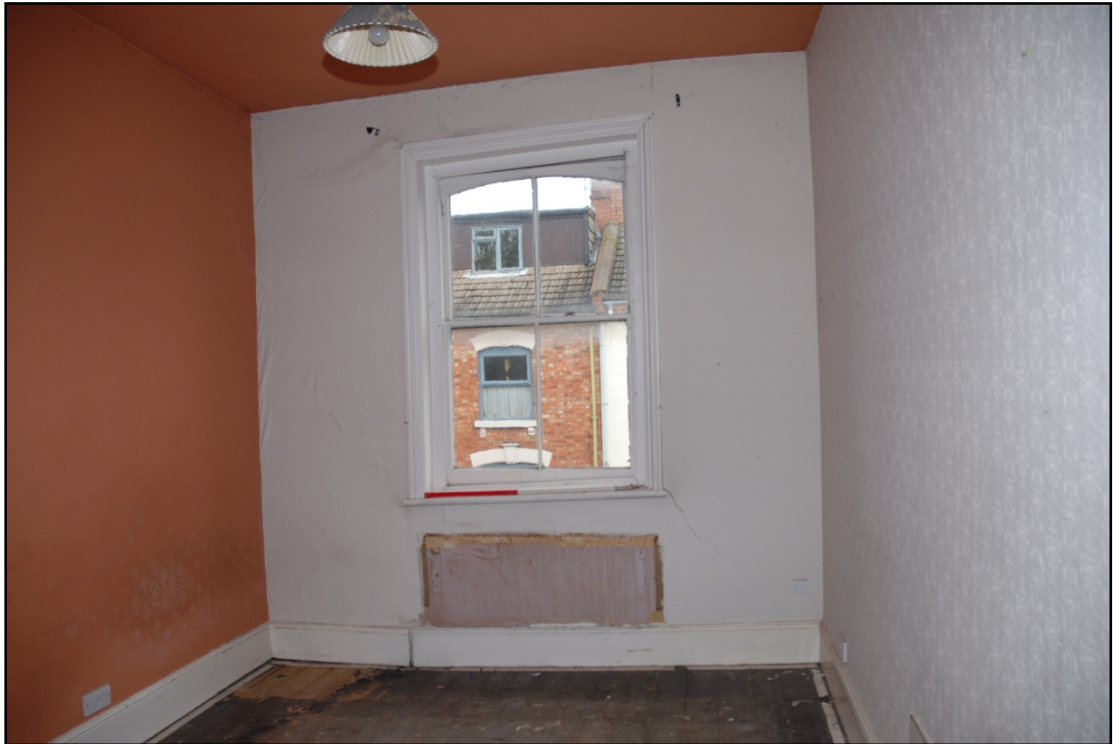
The landing bedroom Fig 13

The first floor bathroom and landing bedroom overlie the passageway. The bathroom was wallpapered and tiled and a sash window was built into the south wall. The bathroom juts into the space of the landing bedroom. The room has pink and white wallpaper and no furniture or fittings remained. The floor of the room is noticeably sagging beneath the sash window on the north wall. The window frame is also at a distinct angle to the window (Fig 13).

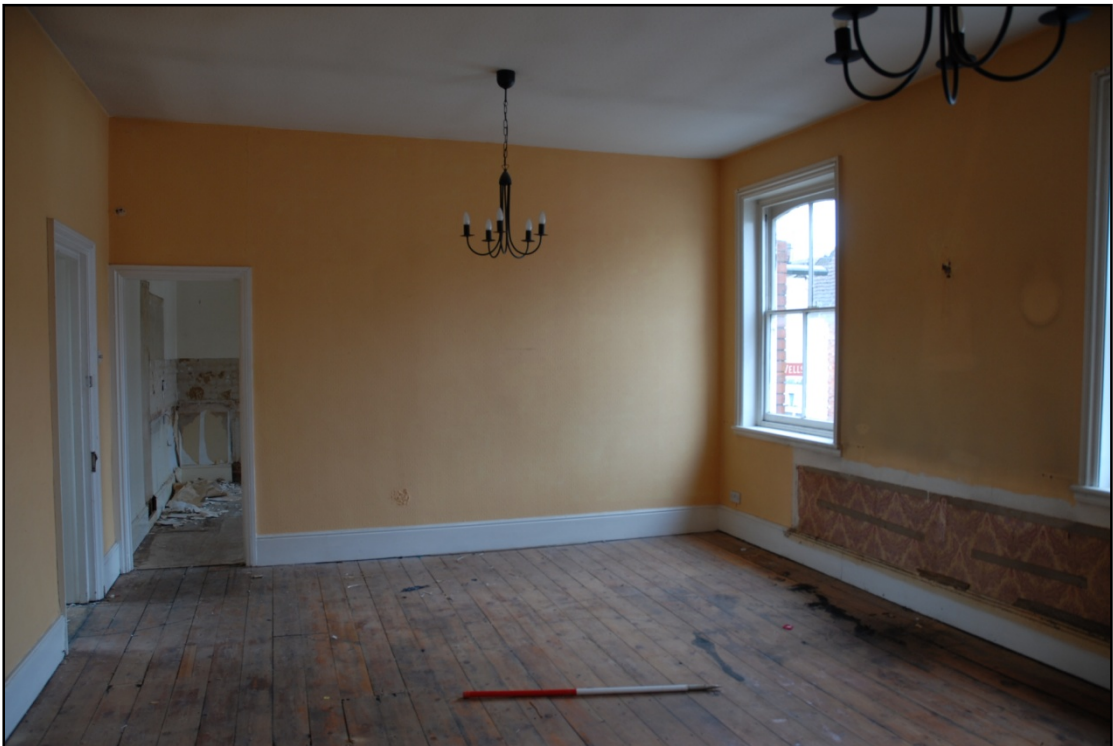
The first floor living room Fig 14

The corridor from the stairs leads to a set of doorways opening on the bedrooms and the living room. The living room is very spacious with a pair of sash windows overlooking the street (Fig 14). A fireplace opening and flue are present on the eastern wall of the room. No furniture or fittings remained in the room except a pair of modern light hangings.

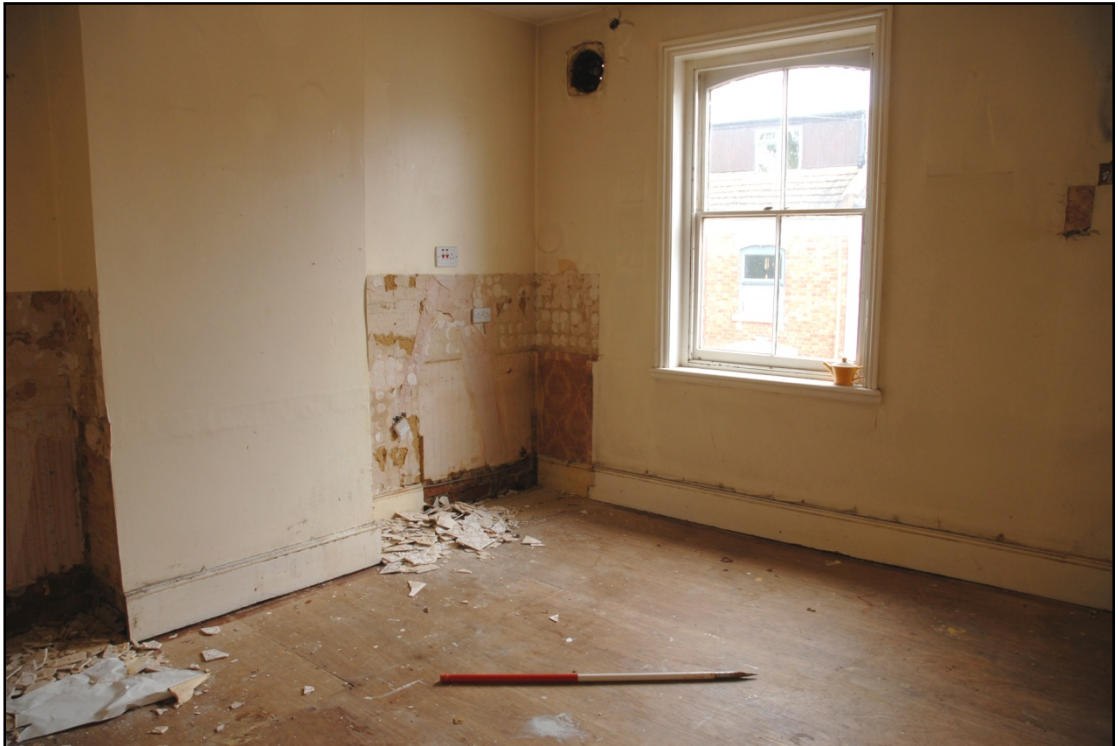
The first floor kitchen Fig 15

The kitchen is accessed via a doorway in the western wall of the living room (Fig 12). No fixtures or fittings remain. A single sash window in the north wall overlooks the street. A pair of circular vents flank the window (Fig 15).

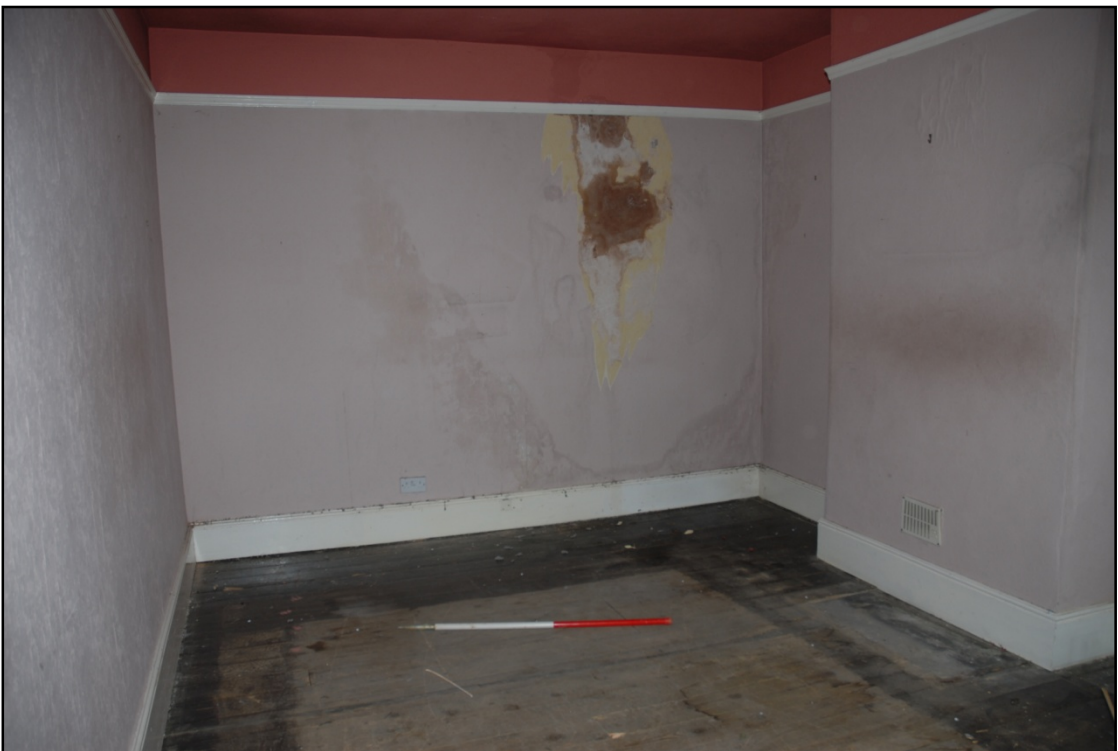
Bedroom 2, showing the blocked fireplace Fig 16

The back bedrooms contain a similar suite of skirting and sash windows and wardrobes flanking a blocked fireplace (Fig 16). No furniture or fittings were present during the survey.

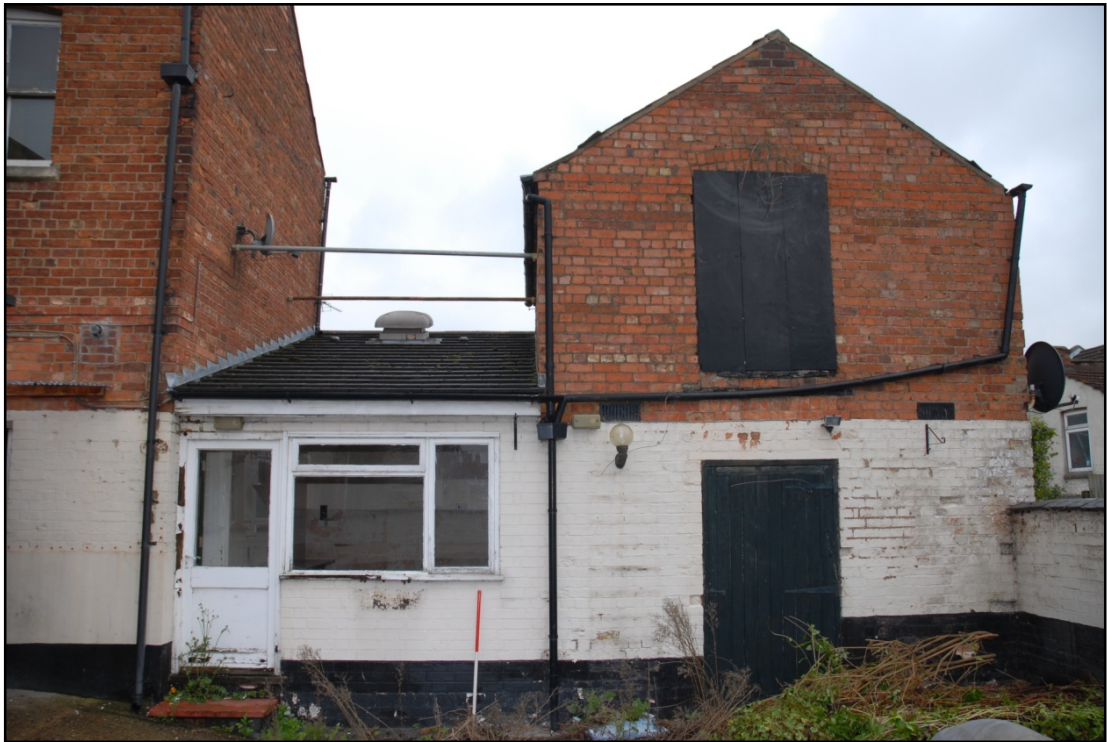
The kitchen and stable, looking east Fig 17

The ground floor outbuilding is accessed via a doorway in the south wall of the kitchen. This was probably a stable and a wooden feeding trough against the eastern wall with iron rings supports this (Fig 18). Patches of white wash and black paint remain on the walls. In the angle of the north-east corner of the room there is a scar on the wall from the removal of a corner manger (Fig 18, left). The brick floor is lower than other ground floor rooms in the building and two brick steps with concrete treads lead down from the doorway. A stable door with iron hinges is built into the western wall opening onto the beer garden (Fig 17 & Fig 20). A square opening in the ceiling provides access to the first floor hay loft. Several iron fittings hang down from the joists. A pair of rectangular vents flank the doorway at ceiling level. A boarded up opening with an arched top, of equal size to the stable door is present at first floor level (Fig 17 & Fig 20).

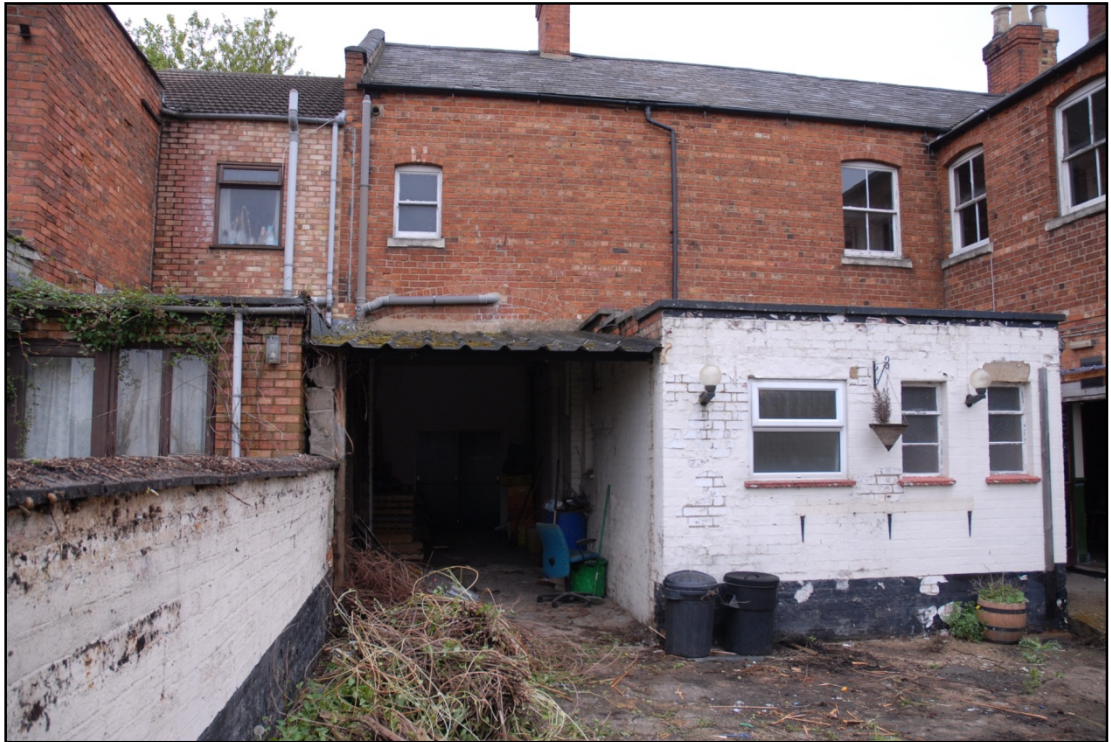
The south elevation showing the toilet block and passageway Fig 19

The passageway from the street to the garden is fronted by two pairs of blue painted double doors. The inner doors are modern fire doors. The construction of the toilet outbuilding extended the passageway and an asbestos roof was built over the extension (Fig 19). The original extent of the passage can be seen by the presence of bull nose bricks in the wall.
