Building recording at Manor Farm Barns
Stainton, South Yorkshire
April 2012

Report 12/103

May 2012

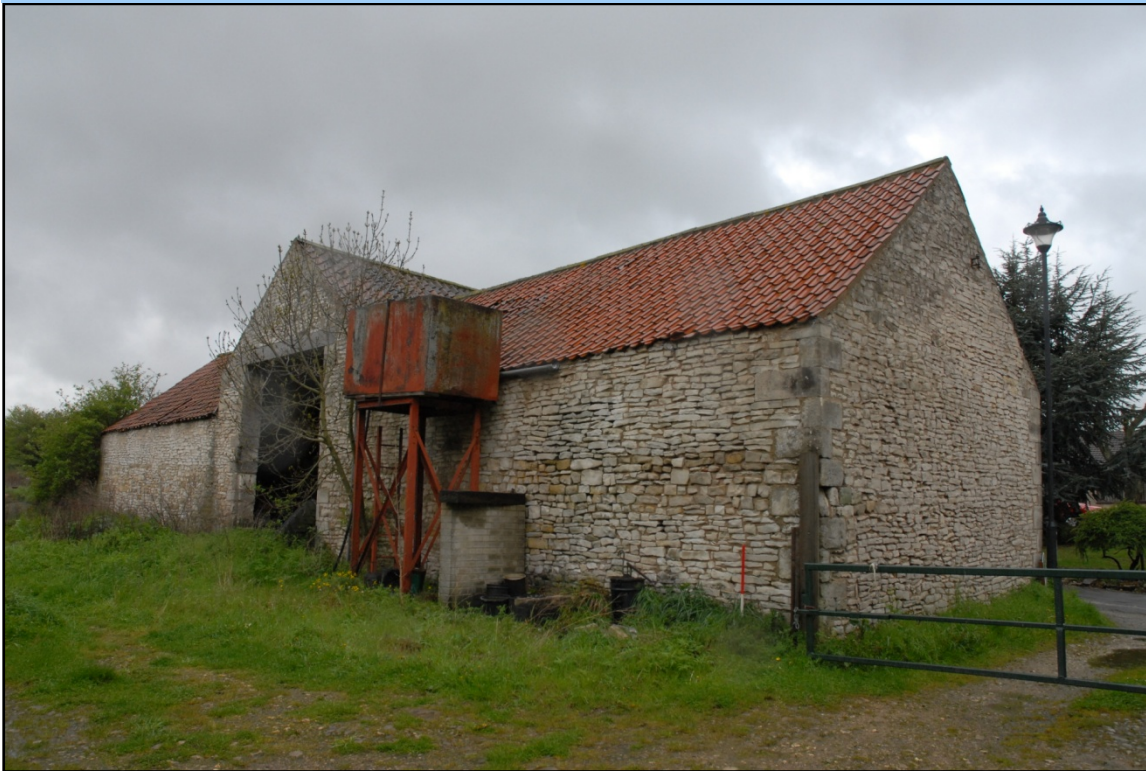
Front cover: Unit 1 rear elevation

Unit 1 is a cart shed on the north-western side of the farm complex which is open to School Lane (Fig 2), the remaining elevations are constructed in coursed limestone rubble, with faced limestone quoins. The building consists of five bays, four of which have open fronts, the fifth (north-eastern bay), has been boxed in with plank doors fitted onto the School Lane frontage (Fig 6). Apart from the north-eastern bay there are no internal divisions within the building. On the School Lane side of the building the roof is supported by square wooden posts. Only the central bay opens to the farmyard on the south-eastern side of the building (Front cover).

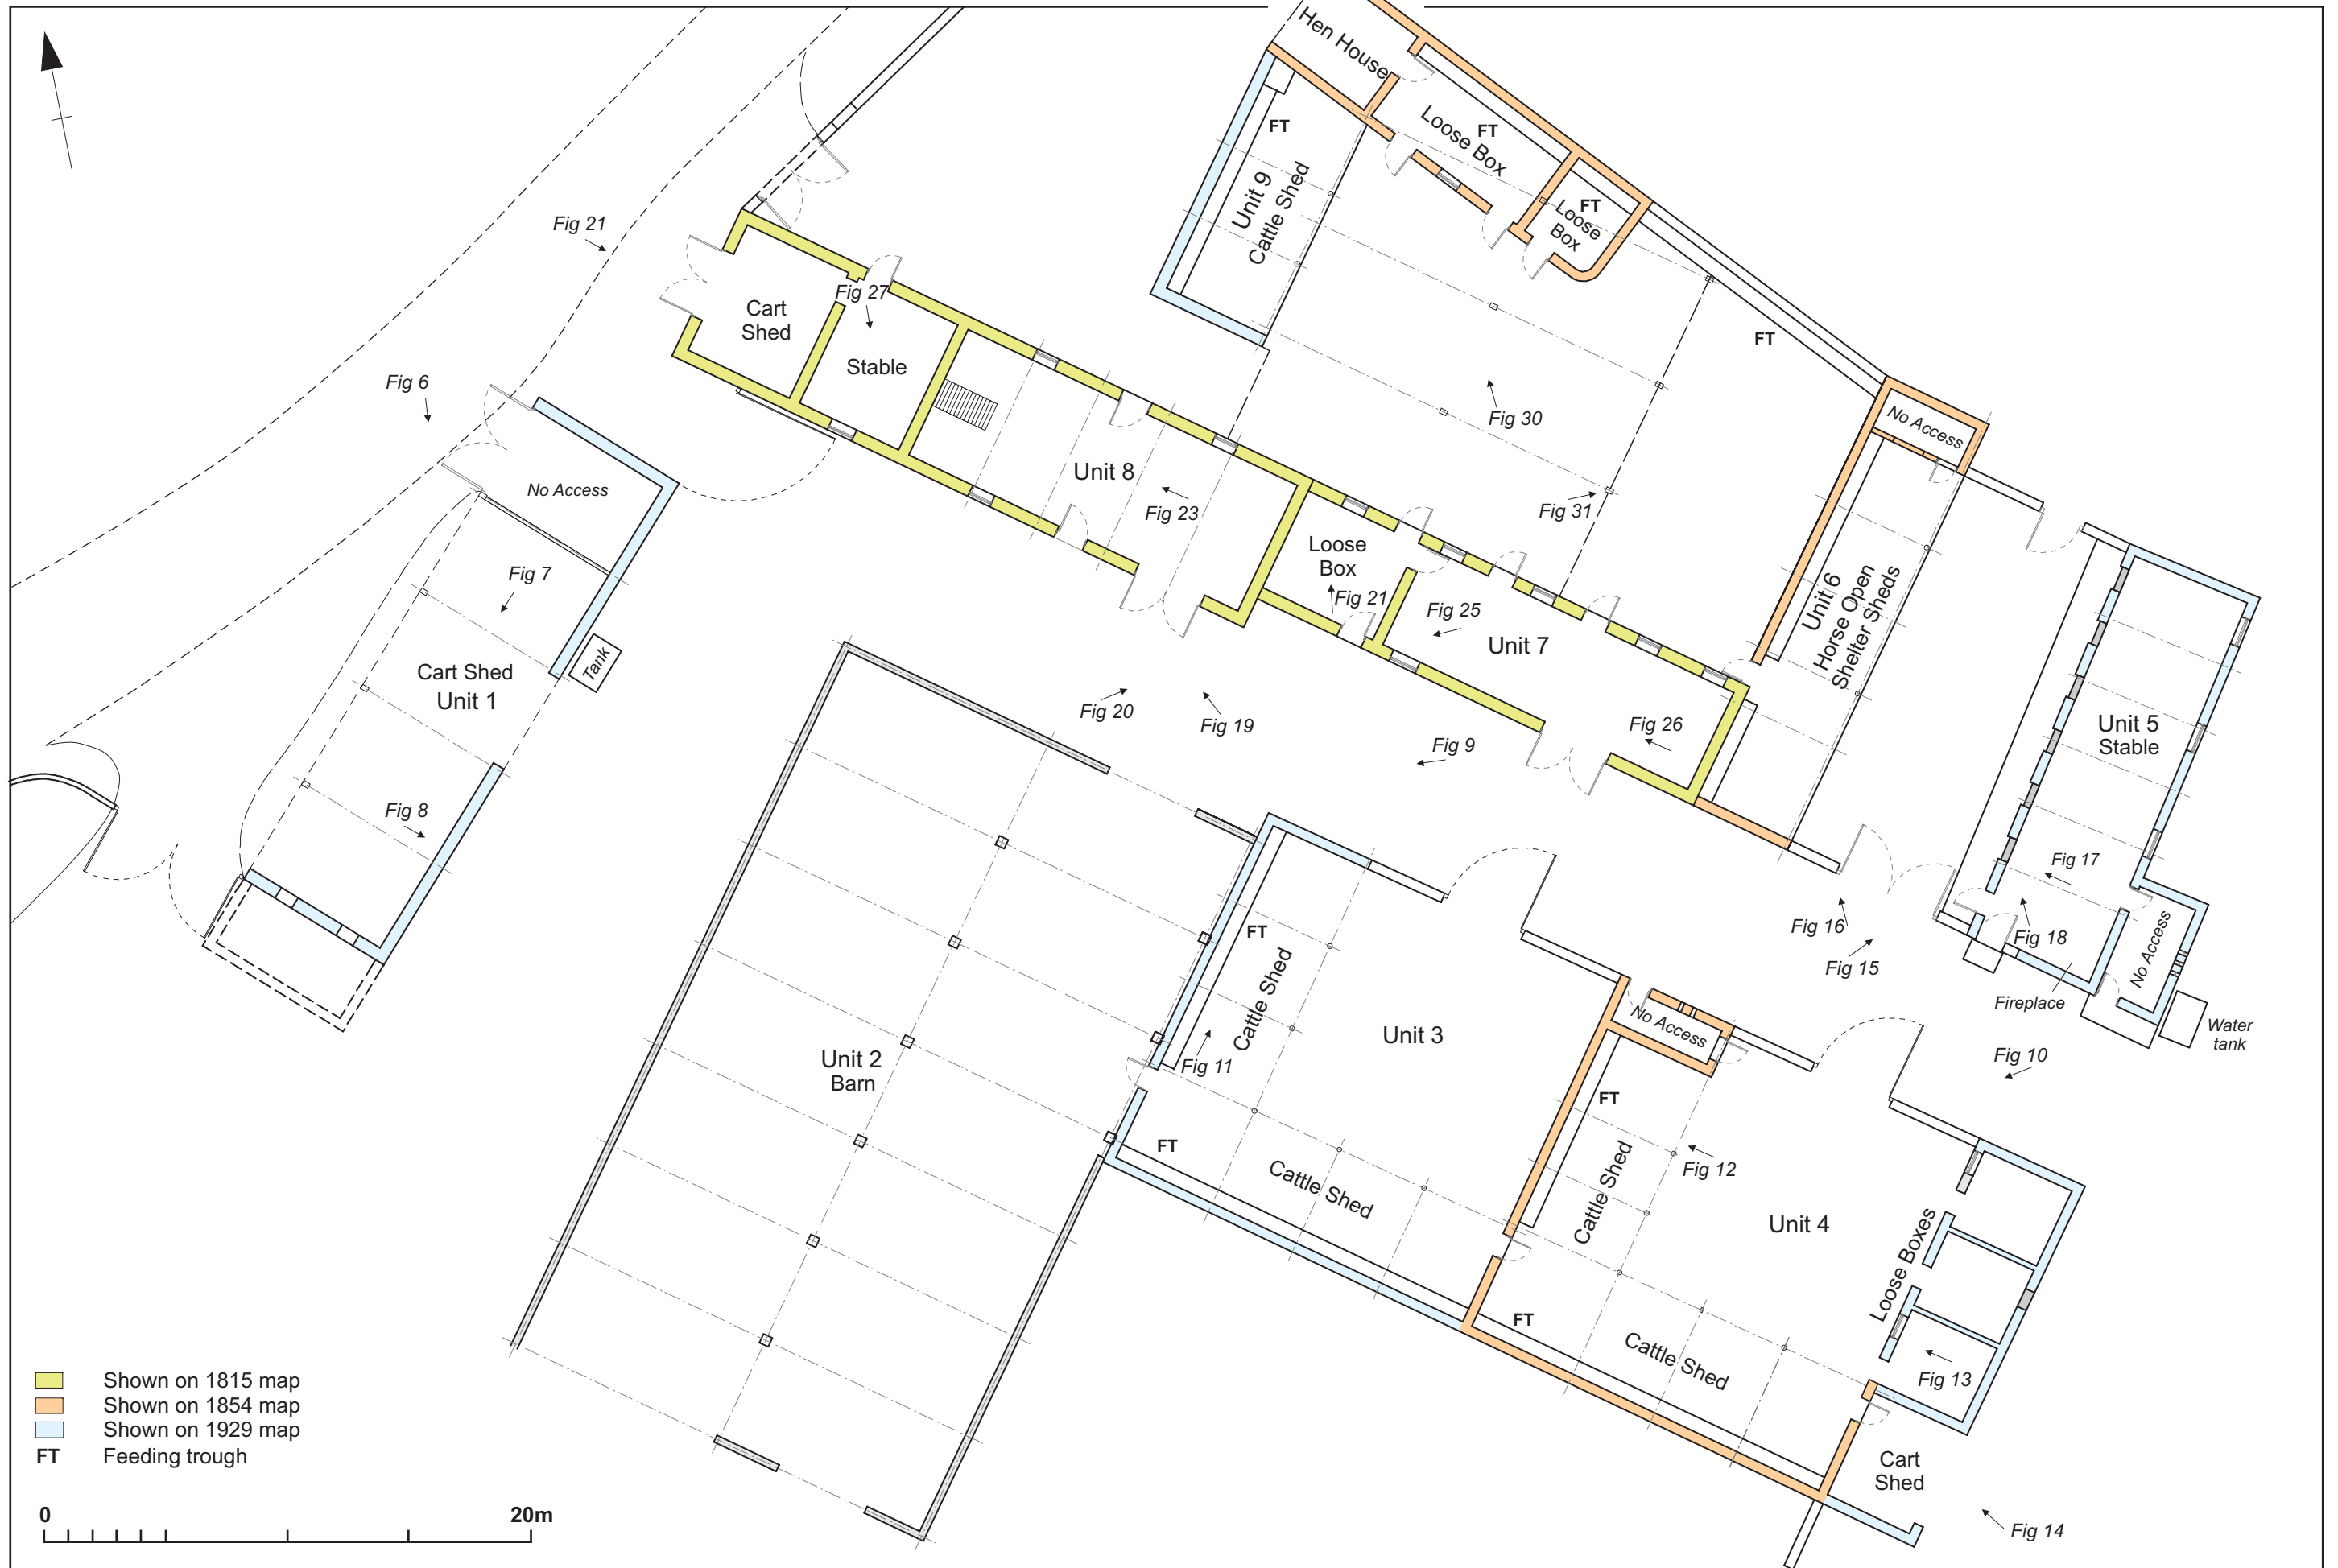
Ground floor plan of the barns, showing photographic locations and phasing Fig 2

The buildings which fall within the scope of the survey consist of 19th-century and later farmyard complex (Figs 2 and 3). The yard is split into discreet elements, with two enclosed yards for cattle, one for horses, and a further one which may have been originally for cattle, but which latterly (since the 1920s, see Fig 4) has had a roof inserted over the yard. In addition there is a cart shed fronting onto school lane and a long barn which had a cart shed stable loose box and crop processing areas.

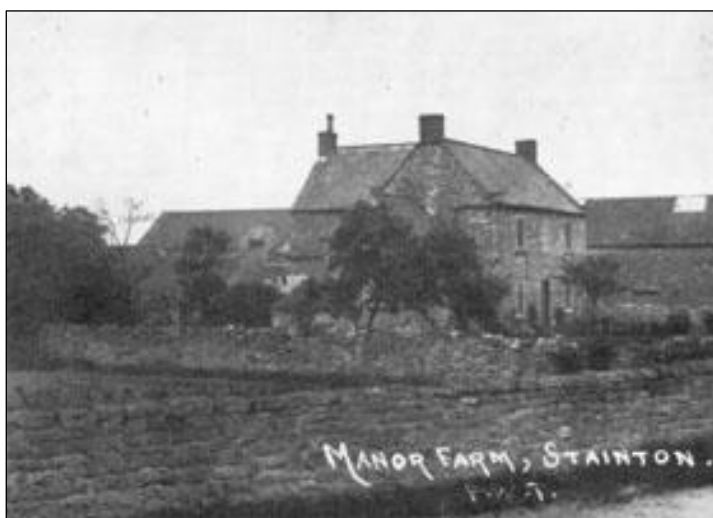
(<http://www.staintonvillage.net/thehistoryofstainton.htm>) Fig 4

Manor Farm, farm house 1907

The farmhouse (Fig 4) which fronted School Lane was demolished and replaced with a new house in the 1970s.

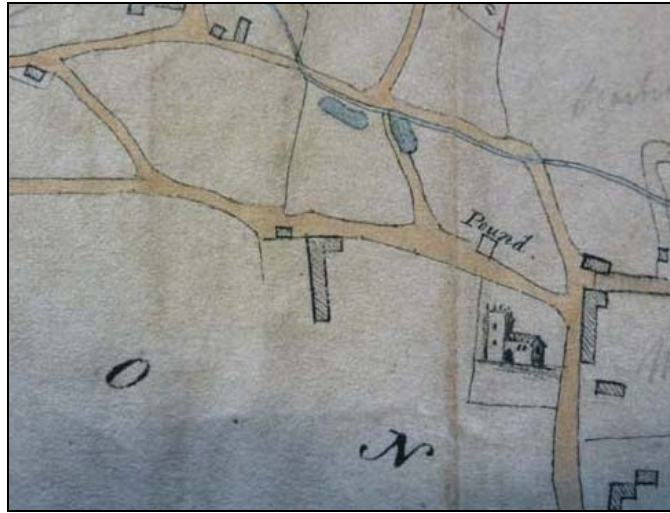
1815 Stainton & Edlington Inclosure Award map Fig 5a

The farm is first shown on the 1815 Stainton and Edlington Inclosure Award Map (Fig 5). The map shows a long narrow building which broadly corresponds to the existing Units 7 and 8 (Fig 2); it does, however, show a return fronting onto School Lane, which is no longer extant. A small rectangular building is also shown fronting onto School Lane in the position of Unit 1, but it is not the same building and may have been replaced by Unit 1.

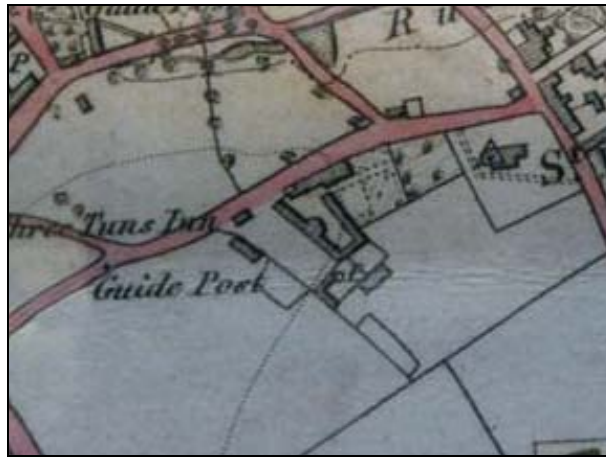
1854 1st Edition 6" Ordnance Survey map Fig 5b

The next available map is the 1854 1st edition 6" Ordnance Survey (Fig 5). This map shows the same long building (Units 7 and 8). By this period though there has been some expansion to the farm, with the addition of Unit 4, although the loose boxes on its south-eastern side have yet to be added. The plan also shows Unit 6, but not the corresponding stable block of Unit 5. The north-eastern side of Unit 9 is also shown but not the north-western side. There is a curious semi-circular extension shown on the north-eastern side of Unit 7, for which there appeared to be no surviving evidence within the fabric of the existing building.

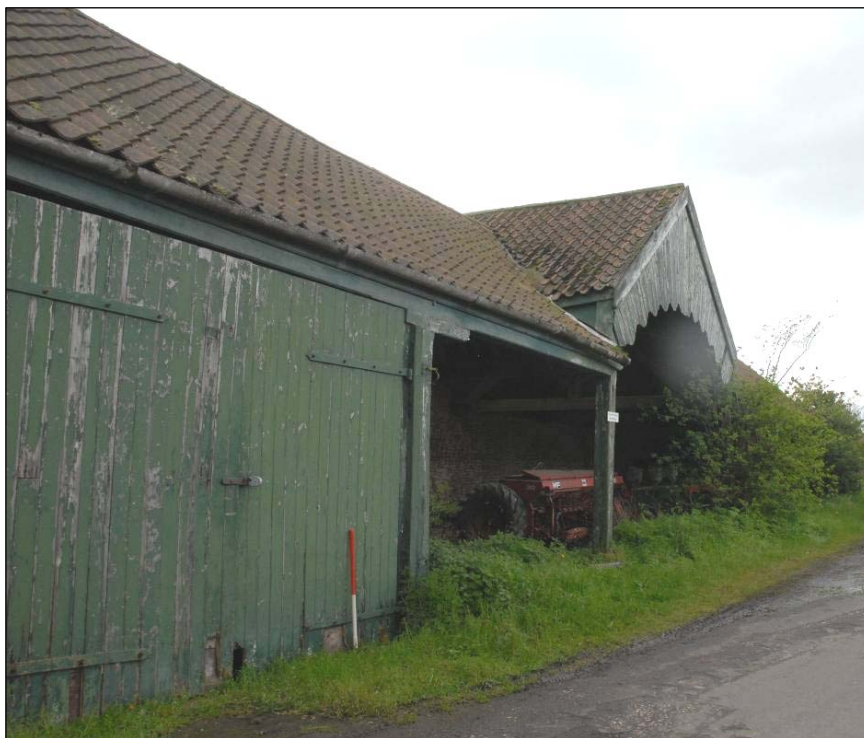
Fig 6

Unit 1, north-western elevation, looking south

The cross roof is supported on a kingpost truss and is covered with terracotta pan-tiles. The gable of the cross roof over the central opening on the School Lane frontage has decorative barge boards cut in a style reminiscent of Victorian railway platform architecture (Fig 6).

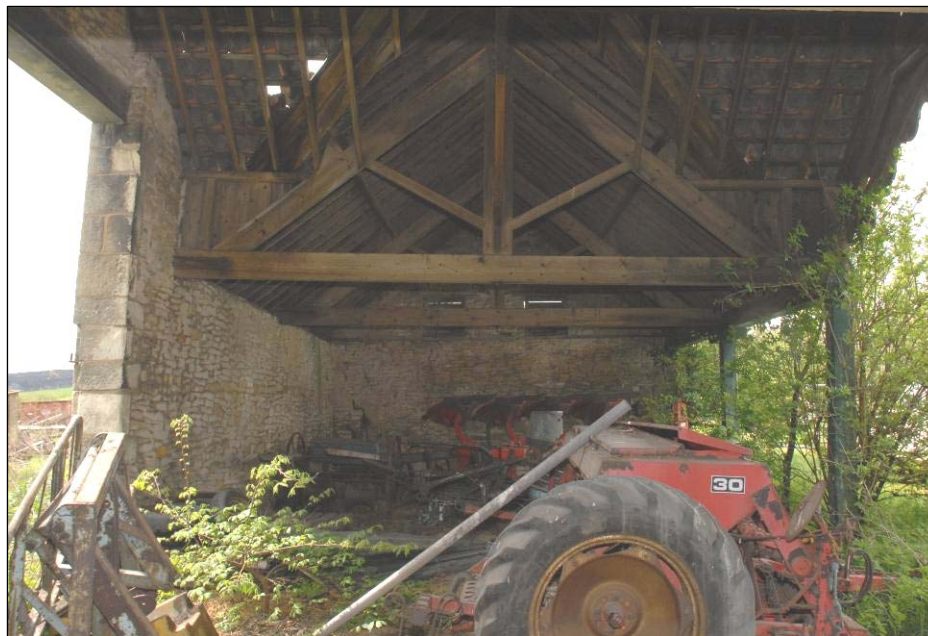
Fig 7

Interior of Unit 1 showing the kingpost truss

The timber work of the kingpost truss is machine-sawn pine with iron straps joining the truss to the tie beam, there is also an iron bolt joining the kingpost to the tie beam (Fig 7). There are two small square openings high in the south-western gable wall. The floor, where visible, is laid with red brick and stone flags.

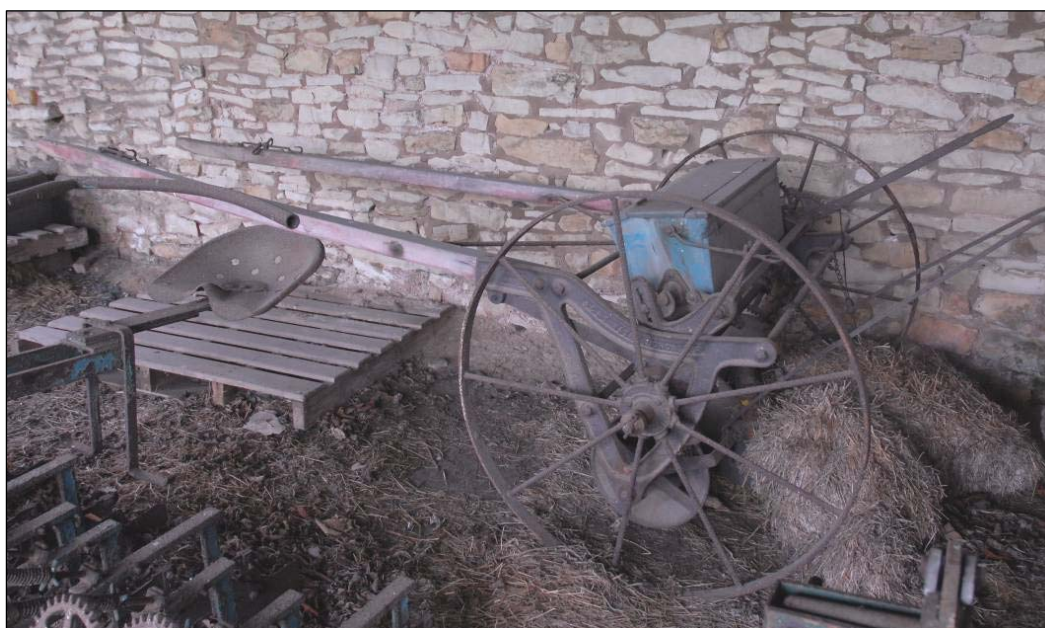
Fig 8

This building was originally built as a cart shed; at the time of the survey the building contained old farm machinery of varying dates, including an early 20th century horse drawn implement made by J C & T Yates of Doncaster (possibly a turnip cultivator?) (Fig 8).

Possible turnip cultivator, in Unit 1

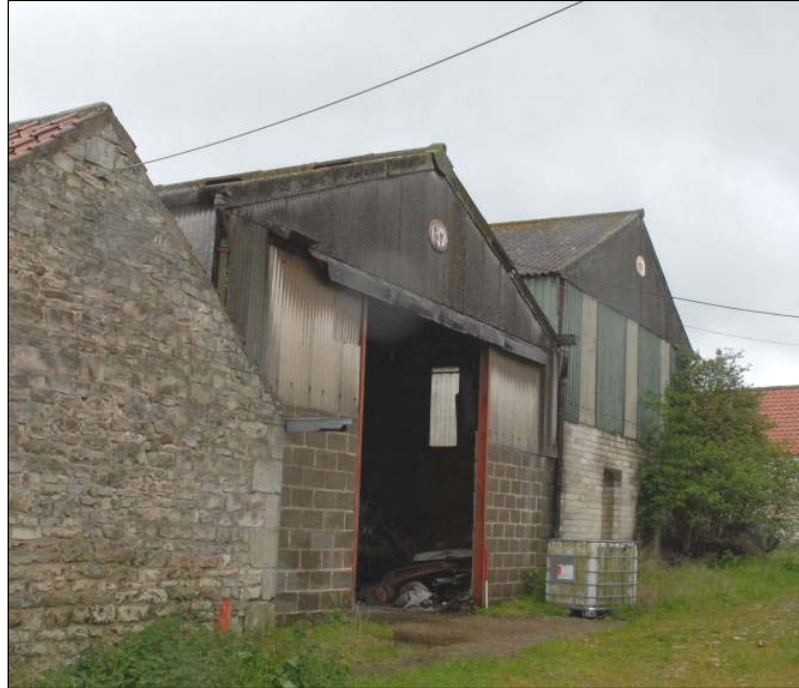
Fig 9

Unit 2 is a modern steel frame and breeze block barn, built in two phases, which is to be demolished as part of the proposed works and as such does not inform the early development of the farm (Figs 2 and 9).

Unit 2, modern barn

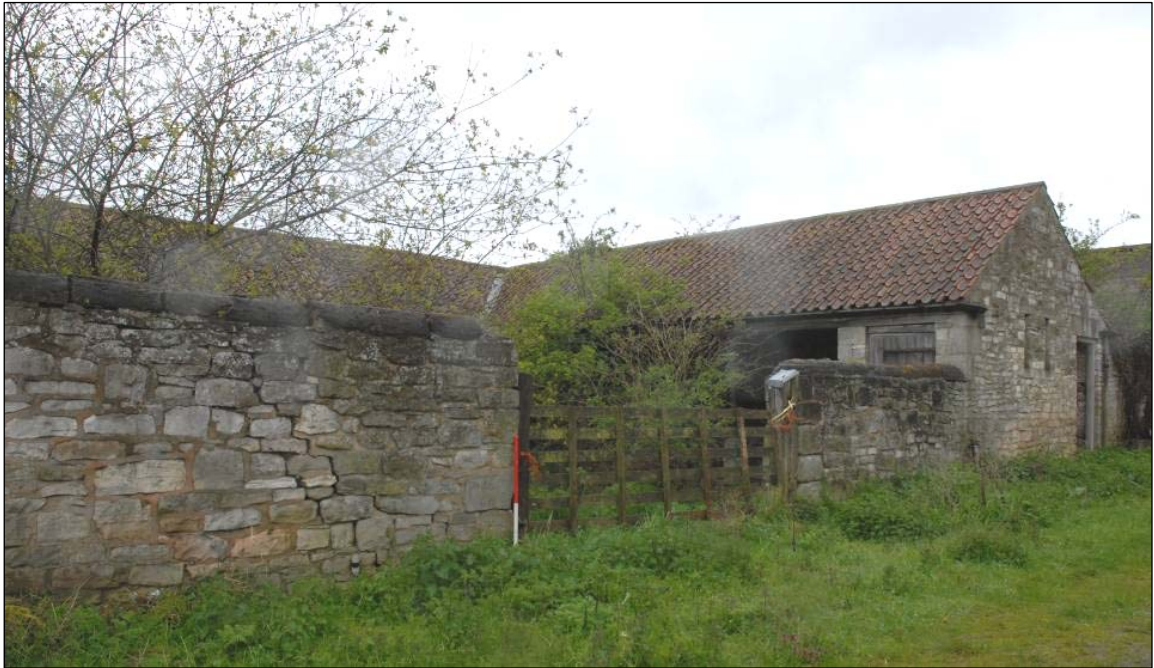
Fig 10

These two ranges consist of adjoining L-shaped open-fronted cattle shelter sheds, opening onto enclosed yard areas (Figs 2 and 10). Unit 4 has three loose boxes opening on to its north-western side and a cart shed opening to the south-east (Fig 2).

Unit 4 showing enclosed yard

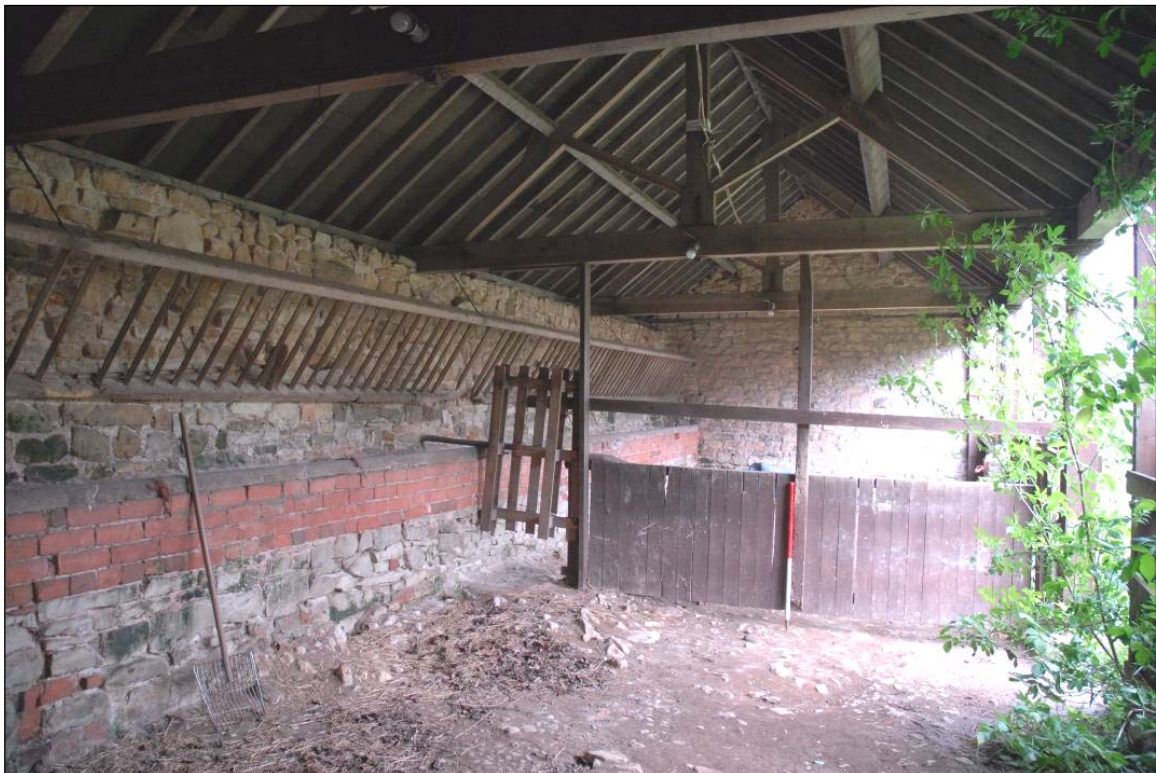
Fig 11

The open cattle sheds have built-in stone and brick feeding troughs with a timber edge and wooden feeding racks over for hay or straw, the racks are normally provided prior to 1840 but after this they are generally omitted (Peters 1991, 66) (Fig 11). The floors of the open sheds and the yard surface had been grubbed up, but appeared to have been a mix of stone and laid brick. The kingpost trusses of the roof are supported on cast iron posts with a moulded capital (Fig 12). This style of post is also used on the horse open shelter shed, Unit 6.

Interior of Unit 3

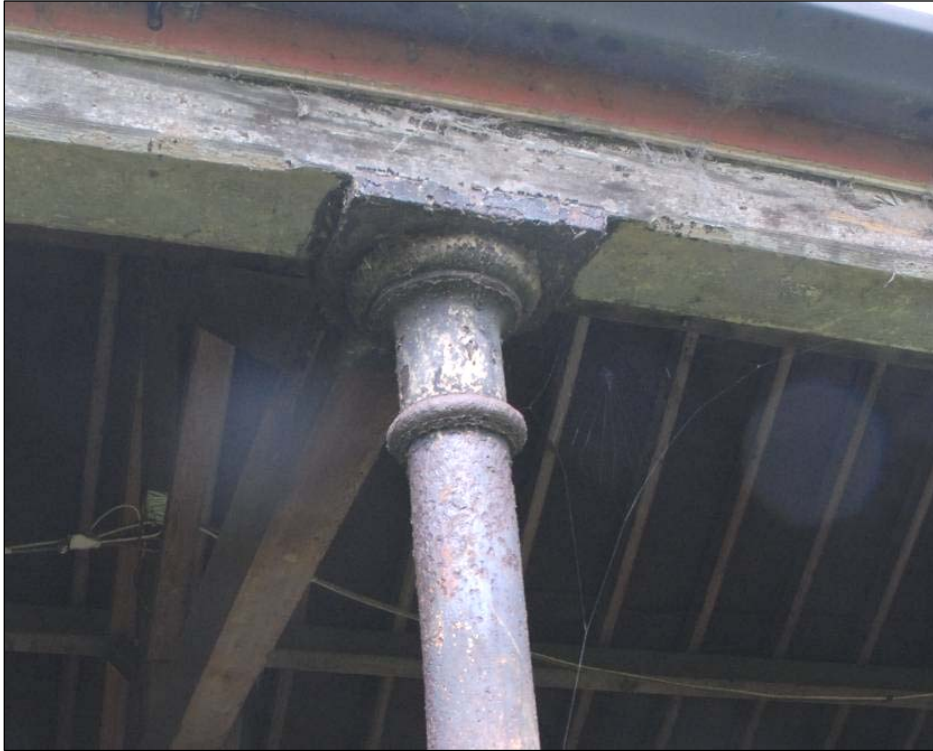
Fig 12

Cast iron capital, Units 3, 4 and 6

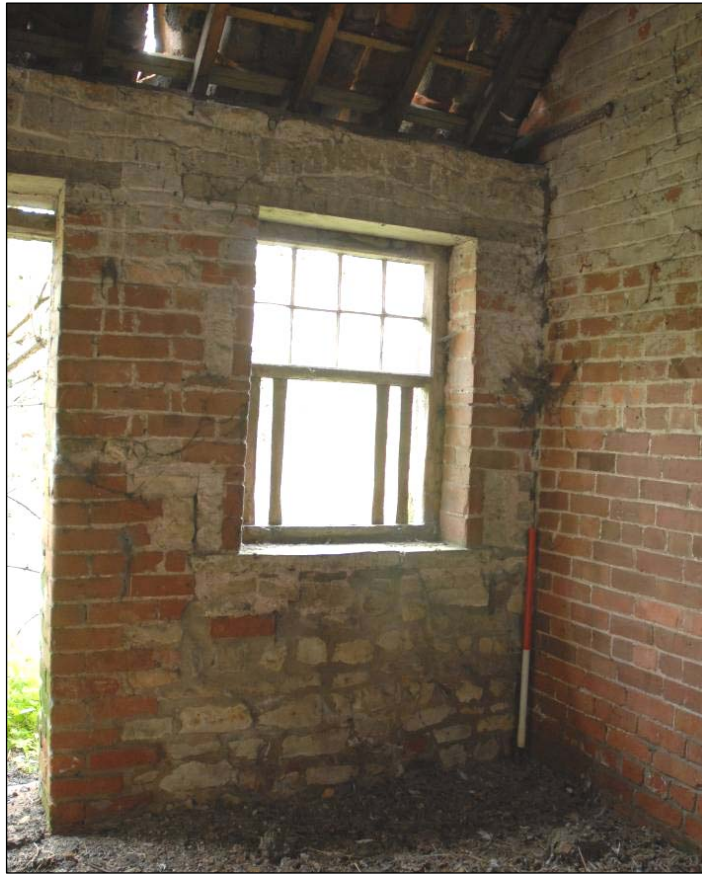
Fig 13

The loose boxes on the south-eastern side of Unit 4 would have been used to separate cattle for calving or to isolate sick animals from the rest of the herd. There are no feeding troughs in the loose boxes although one retains a wall-mounted iron corner manger. The two end loose boxes have windows opening onto the yard, these consist eight light top halves with sliding vertical slat shutters below (Fig 13). The central loose box had a window facing the south-east, which is now blocked (Fig 14). The doors to the loose boxes have been removed. There is a small room in the north-west corner of Unit 4 to which access could not be gained.

Loose box window, Unit 4

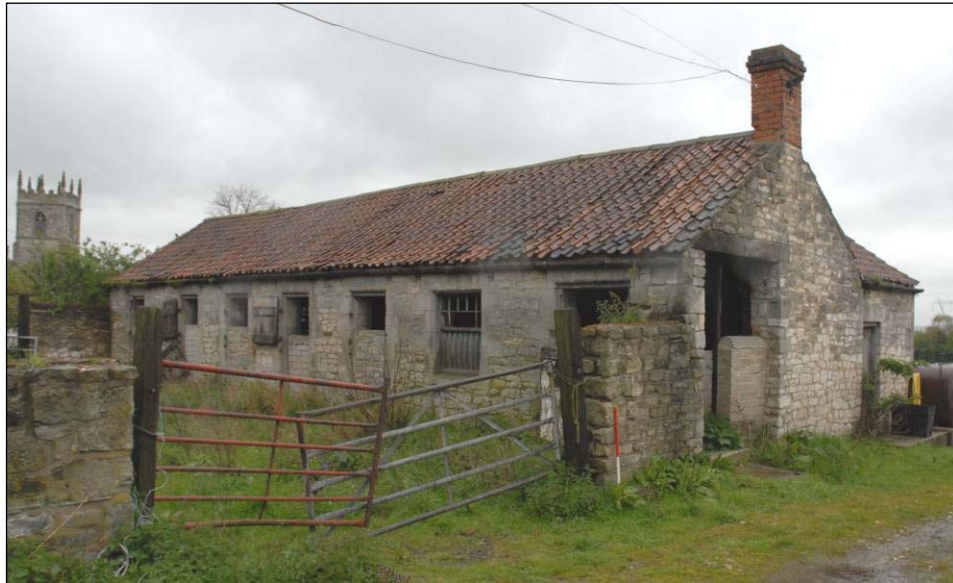
Fig 15

These two units, although separate buildings, form two sides of an enclosed yard area for horses, with Unit 5 to the south-east being the stables (Figs 2 and 15) and on the opposite side of the yard Unit 6 being the open shelter shed for the horses (Fig 16). Open shelter sheds for horses are more commonly found in Suffolk and parts of the Midlands and date generally to the mid 19th century (Peters 1991, 61). In this case Unit 6 is shown on the 1854 1st Edition Ordnance Survey map, but Unit 5 is first shown on the 1929 map, which would indicate that the farm was built up in a piecemeal fashion, perhaps as and when resources allowed. The overall farm as it appears today would, however, indicate that its layout was planned but just not completed in one phase of building.

Unit 5, stables

The original internal fittings of the stable have been removed and the divisions between the stalls replaced with breeze block walls. The roof, as elsewhere, was a kingpost truss with terracotta tiles. There was a fireplace in the south-east corner of the stable block (now removed) suggesting that this may have been a separate room perhaps for the groom. Access was not gained to the room on the south-eastern side of the stables.

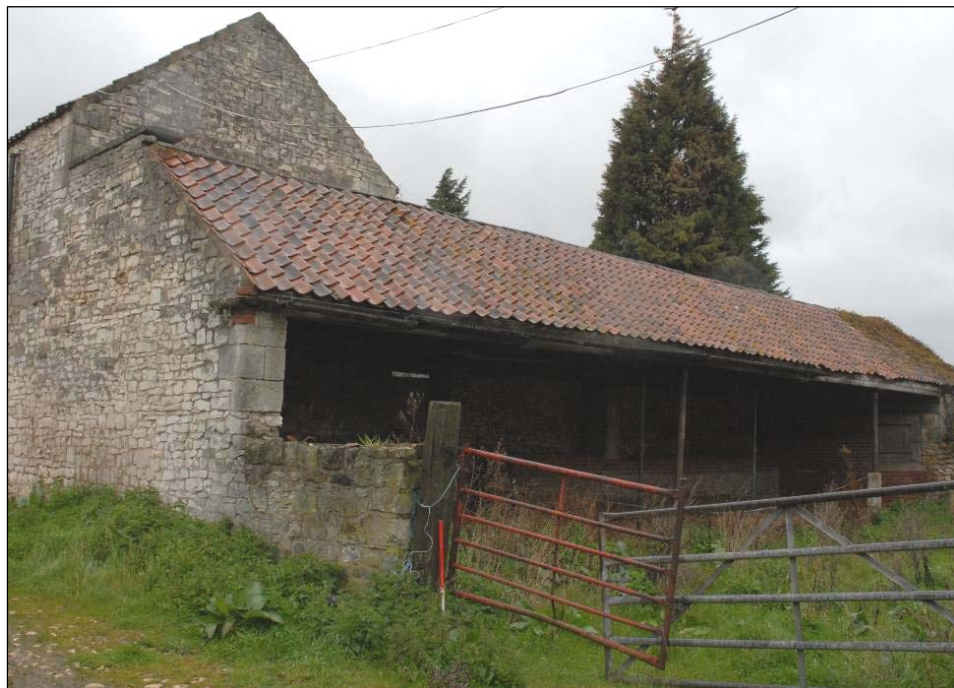
Fig 16

Unit 6, horse open shelter sheds

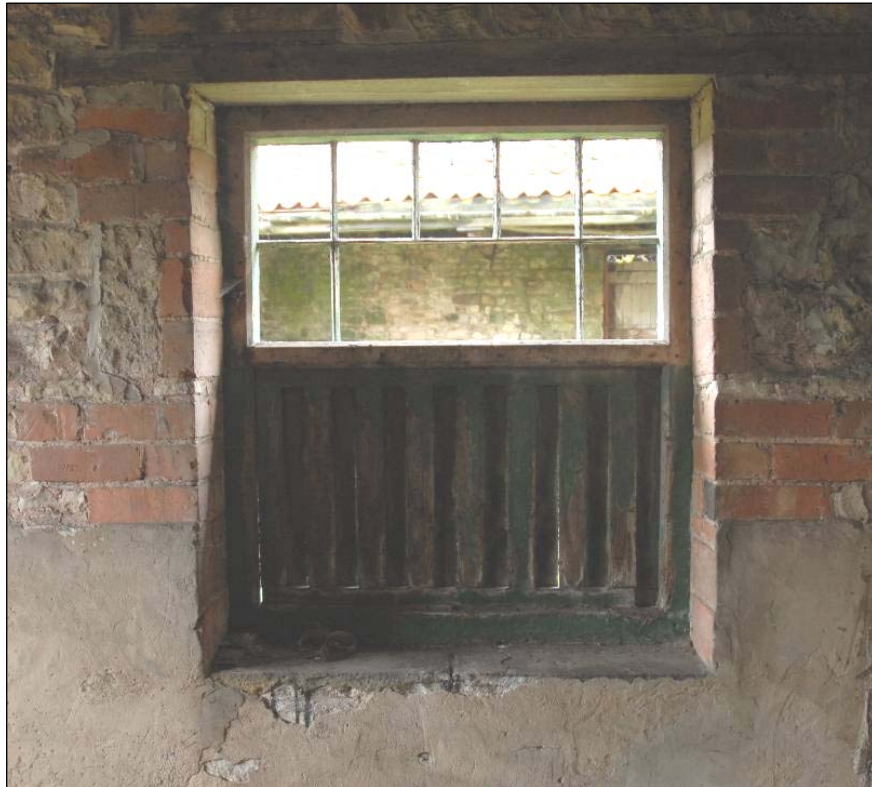
Fig 17

The windows, as elsewhere, had ten top lights with vertical sliding wooden ventilation slats below (Fig 17). The door openings to the stalls had chamfered stone openings to reduce the chance of injury to the horses (Fig 18). The doors, where they survived, were split ledged and braced stable doors. The floor was laid red brick with a later concrete surface in parts.

Stable window

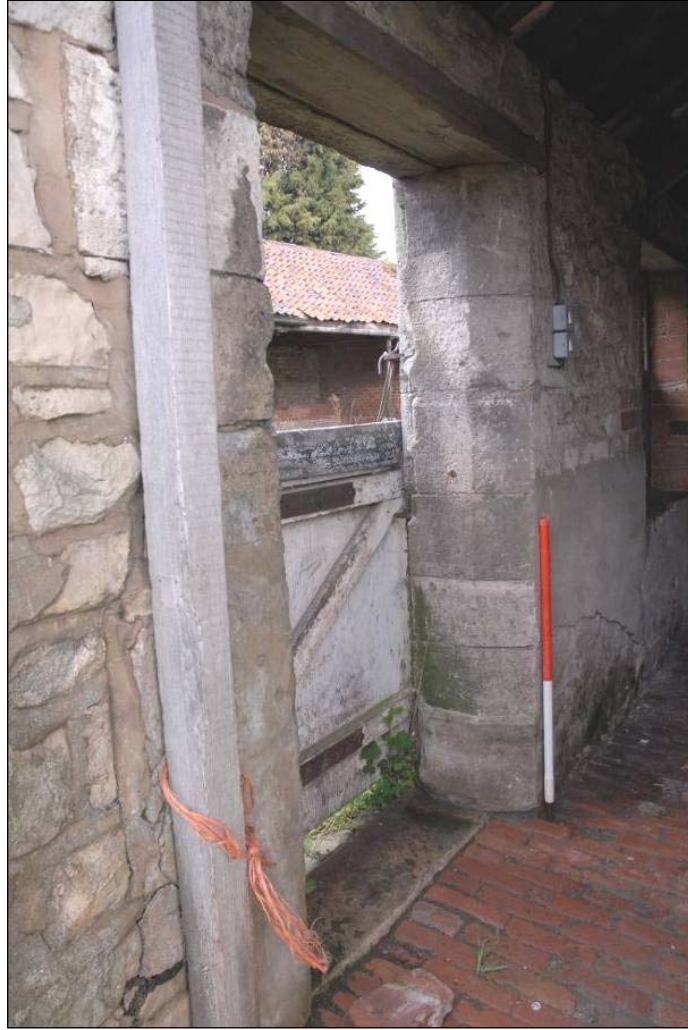
Fig 18

Stable door opening showing chamfered edge

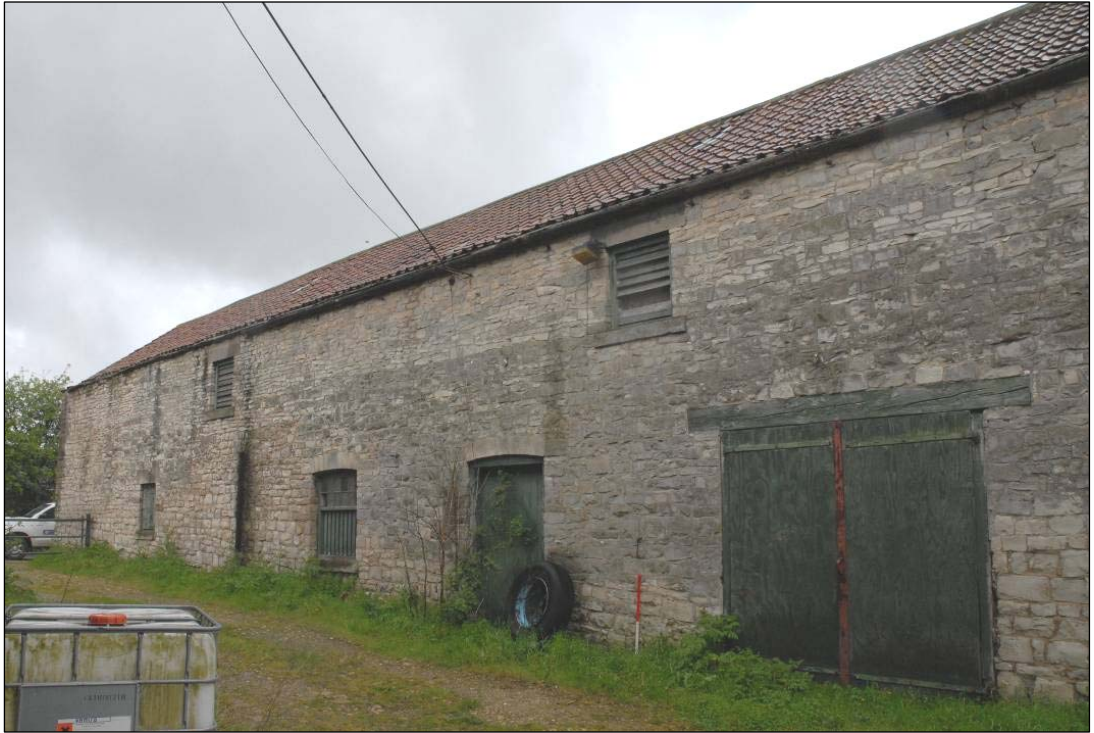
Fig 19

These units are the earliest buildings of the complex and form a long narrow two storey barn (Figs 2, 3, 19 and 20), which maybe that shown on the 1815 Inclosure Award Map (Fig 4). At its north-western end is a cart shed opening onto School Lane (Fig 21), behind which is a stable with wall-mounted mangers for three horses, no internal divisions have survived in this room (Fig 22). However, in the corner of the room there is a boxed in area, possibly a grain bin as there is a later pipe feeding into it and in Units 7 and 8 there are several pieces of machinery associated with grinding grain.

Unit 8, barn and stable

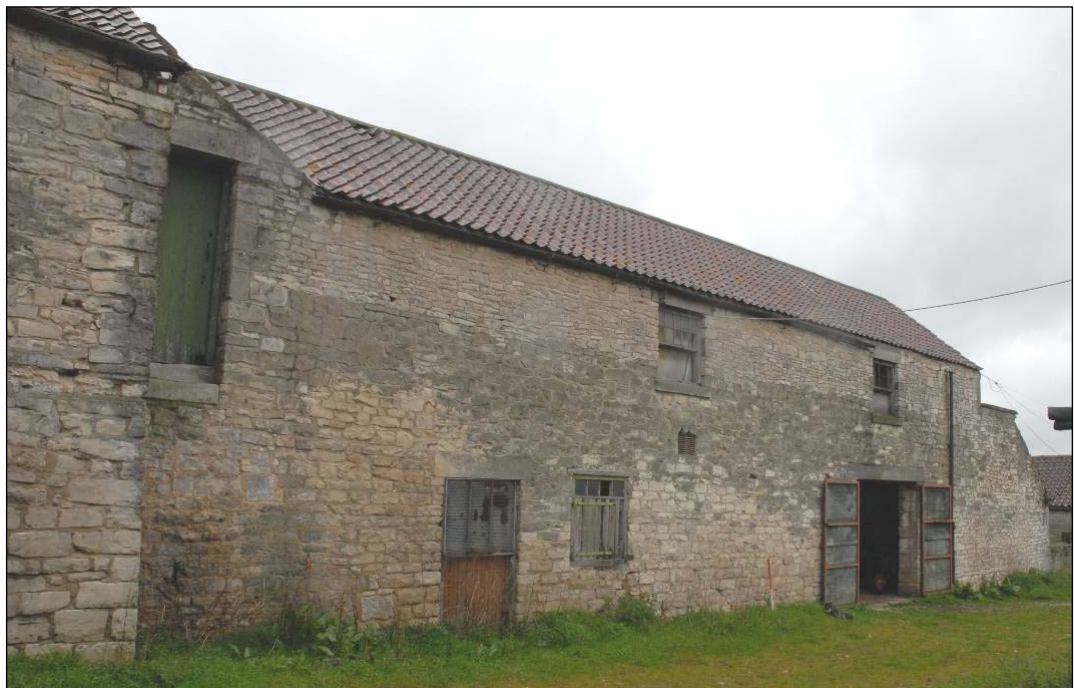
Fig 20

Unit 7, barn and loose box

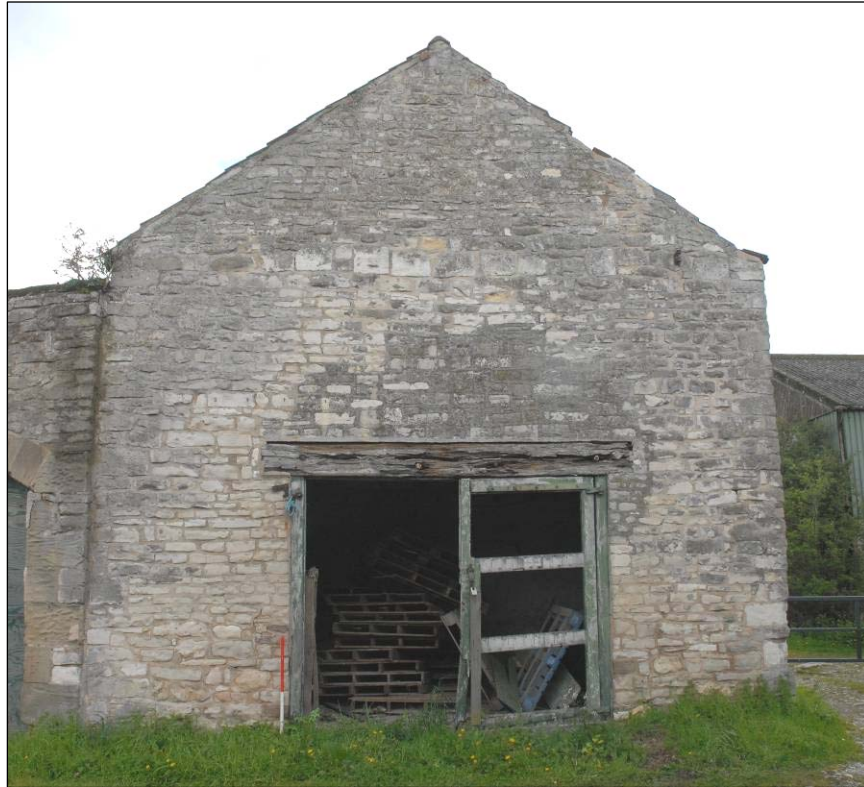
Fig 21

Unit 8, cart shed

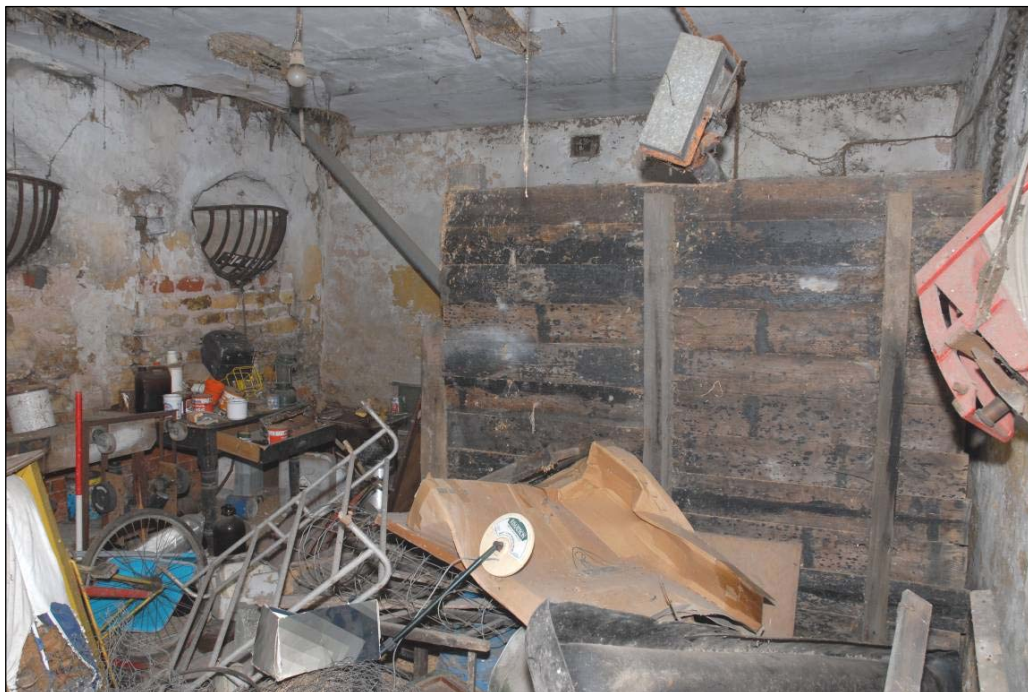
Fig 22

Unit 8, stable

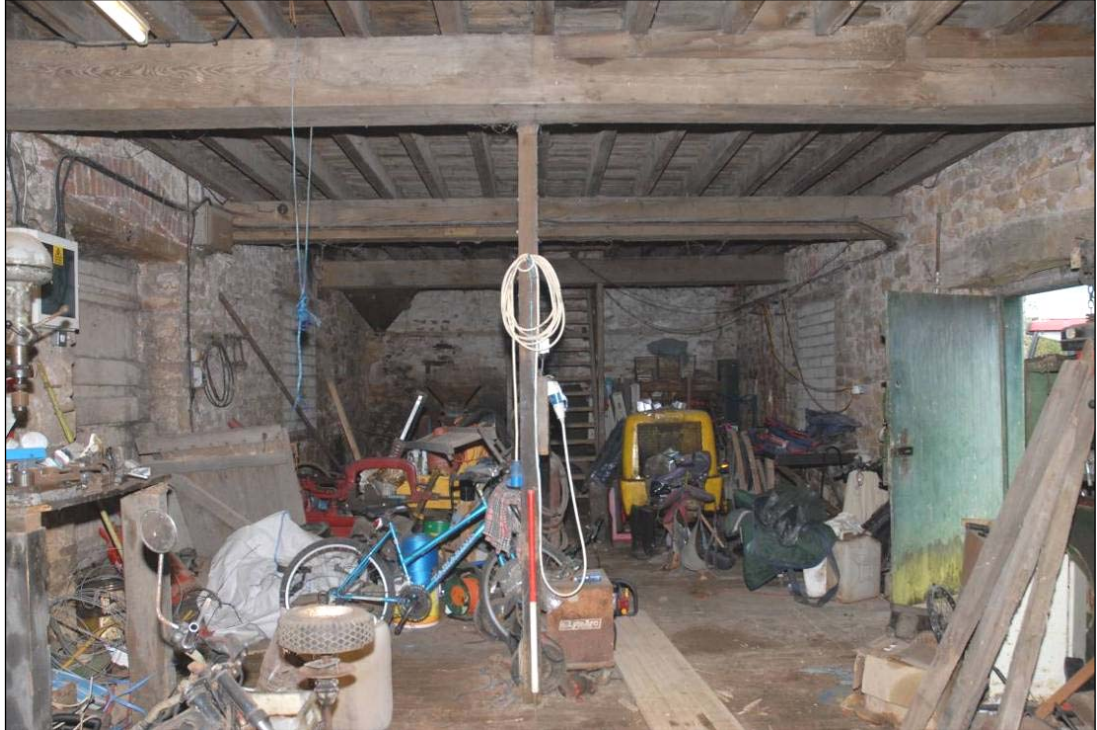
Fig 23

Although both units have a double door entrance on the south-western sides there is no evidence of openings on the other side to suggest that they were threshing barns. The double doors in Unit 8 open into a room which is currently being used as workshop and has the stairs up to the first floor (Fig 23).

Unit 8, ground floor

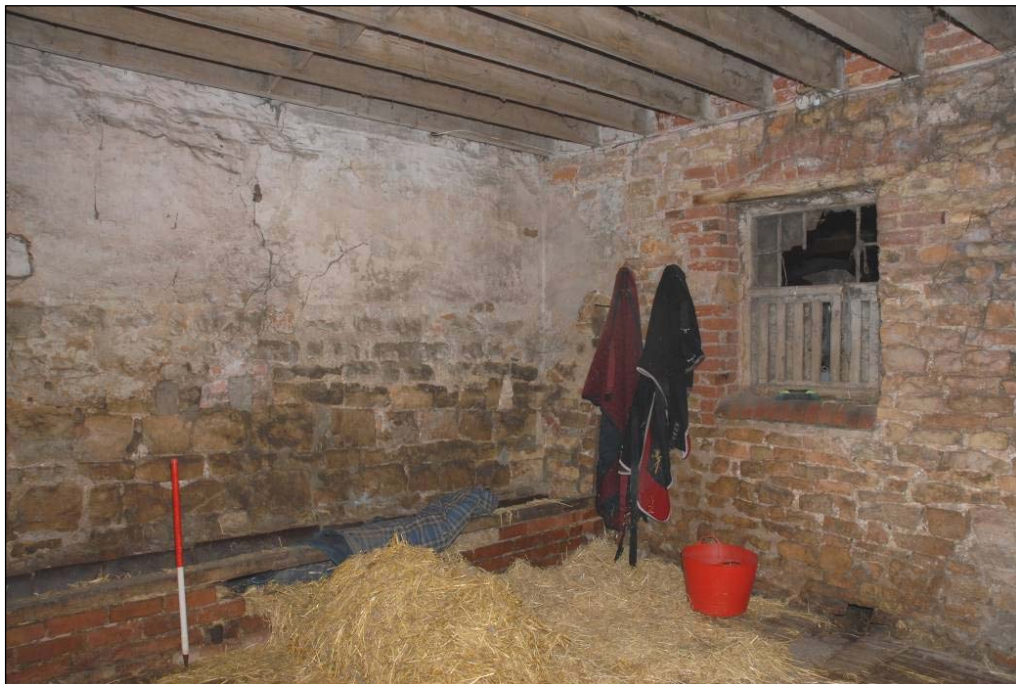
Fig 24

The ground floor of Unit 7 comprises two rooms, the smaller possibly serving as a horse loose box (Fig 24). The larger of the two rooms has a double door entrance on its south-western side. The windows as elsewhere have sliding vertical wooden ventilation slats in the lower half.

Unit 7, probable loose box

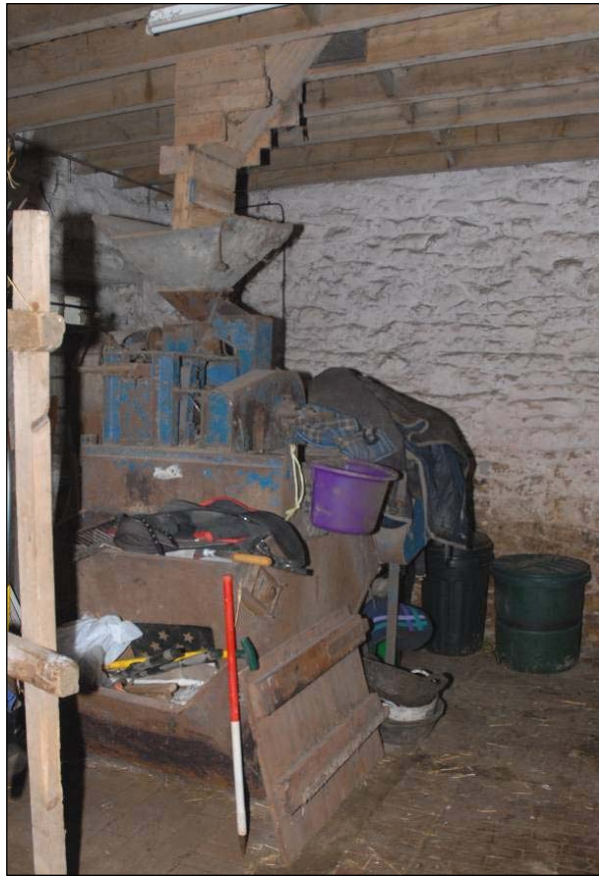
The larger of the two Unit 7 rooms may have also latterly been used for crop processing as there was a hopper from the first floor into a grain grinding machine in this room (Figs 25 and 26).

Unit 7, grain grinder with hopper from floor above, Fig 25

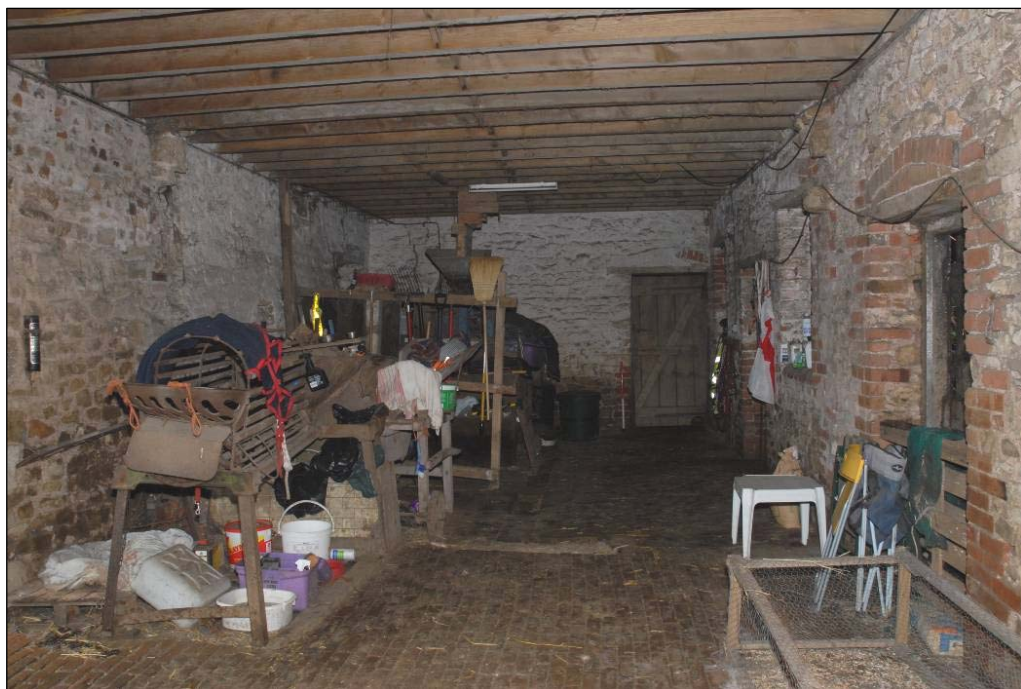
Fig 26

Unit 7, ground floor looking north-west

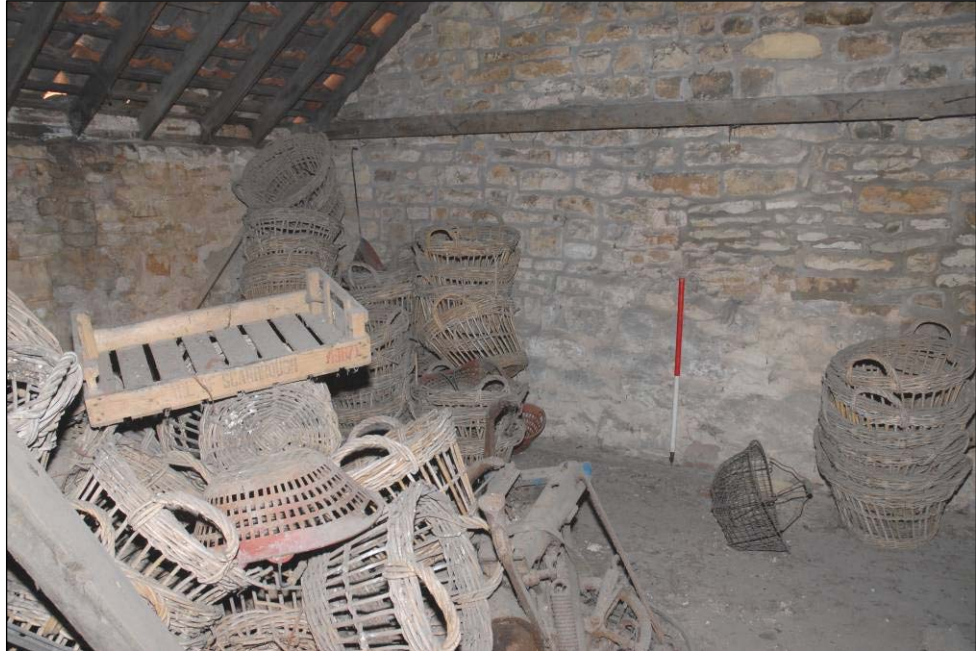
Fig 27

Units 7 and 8 are the only two buildings which have a first floor (Fig 3). There is no direct access between the two at ground floor level, however, there is a doorway between at first floor level, with a ramp down into Unit 7 from 8. The north-western bay of Unit 8 had been partitioned off from the rest of the loft space and is being used for the storage of baskets (Fig 27). These baskets were used for collection of the potato crop, as the farm, when it was active practised a mixed economy.

Potato baskets, Unit 8, first floor
