Building recording at Manor Farm Barns
Stainton, South Yorkshire
April 2012

Report 12/103

May 2012

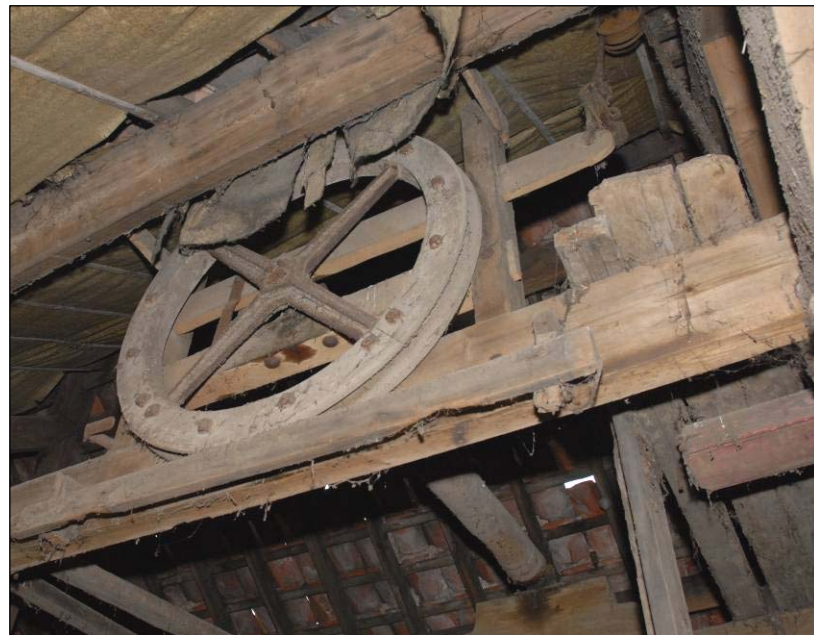
Fig 28

Also present are a butter churn and a knife grinding wheel. There is also a hoist pulley wheel in the roof for hoisting loads up from the ground floor (Fig 28).

Pulley wheel hoist

The shaft connected to the pulley wheel is reminiscent of a drive shaft which may have been connected to a portable engine, as there was no evidence of a fixed engine in the building.

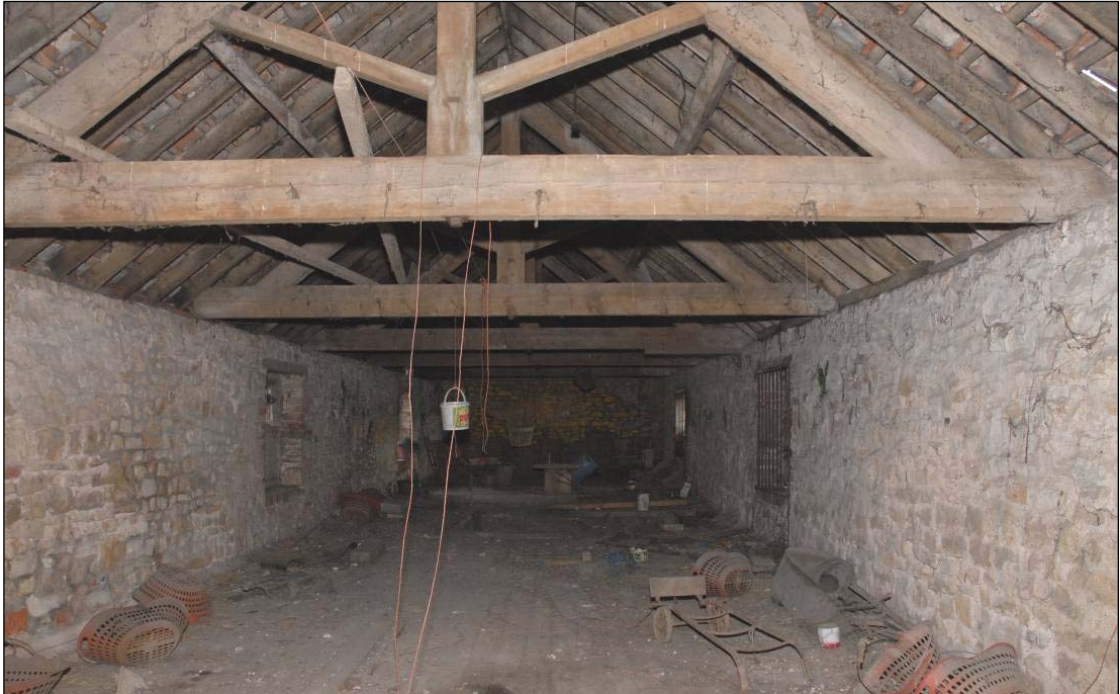
Fig 29

The loft space of Unit 7 was a single open room which has latterly been used for storage of odds and ends (Fig 29).

Unit 7, loft space

The roof structure, as elsewhere in the farm buildings is a kingpost truss, with terracotta tiles over.

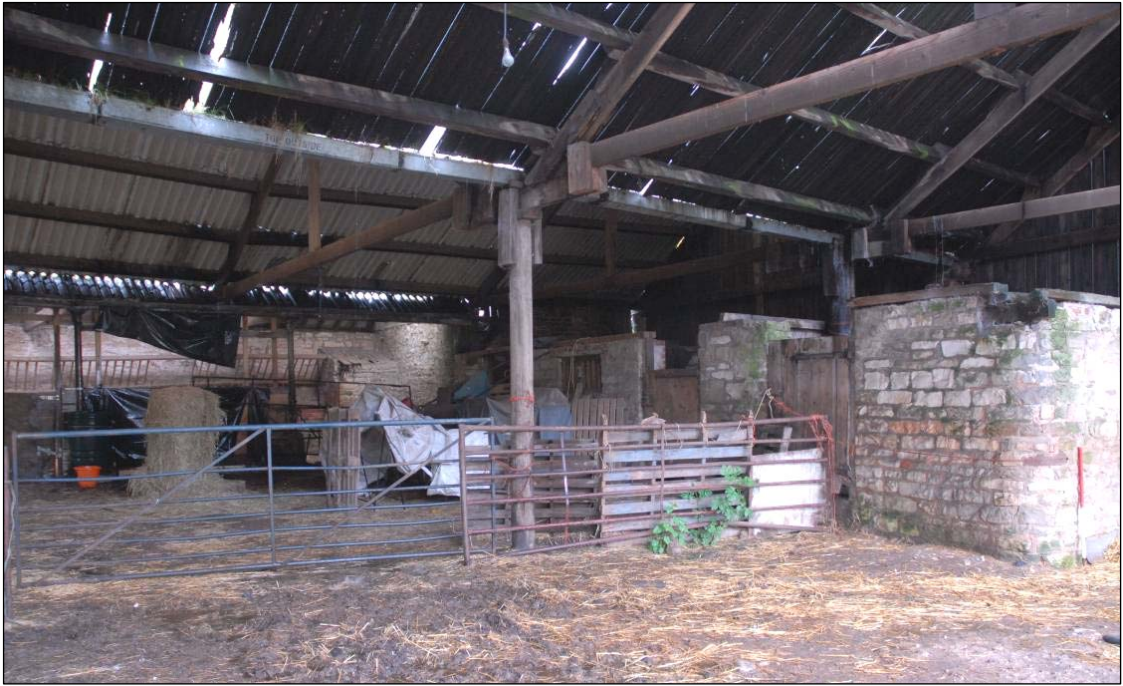
Fig 30

This was the most altered part of the farm yard complex (Figs 2 and 30). It originally comprised an L-shaped range with, on the western side, an open cattle shed and on the north side two probable loose boxes, the feeding trough along the north wall, to the east of the loose boxes, indicates that there was an open shelter shed here also, although this has now been demolished (Fig 31). In the north-east corner of Unit 9 is a room which opens to the north-east, which is currently used as a hen house (Fig 2).

The original roofs had been removed from these buildings and a new roof inserted which covers most of the yard area as well as the buildings (Fig 30). The 1929 map evidence and a surviving scar on Unit 7 suggests that the entire yard was roofed over at this time, and that one bay has latterly been removed.

Unit 9, Showing covered yard

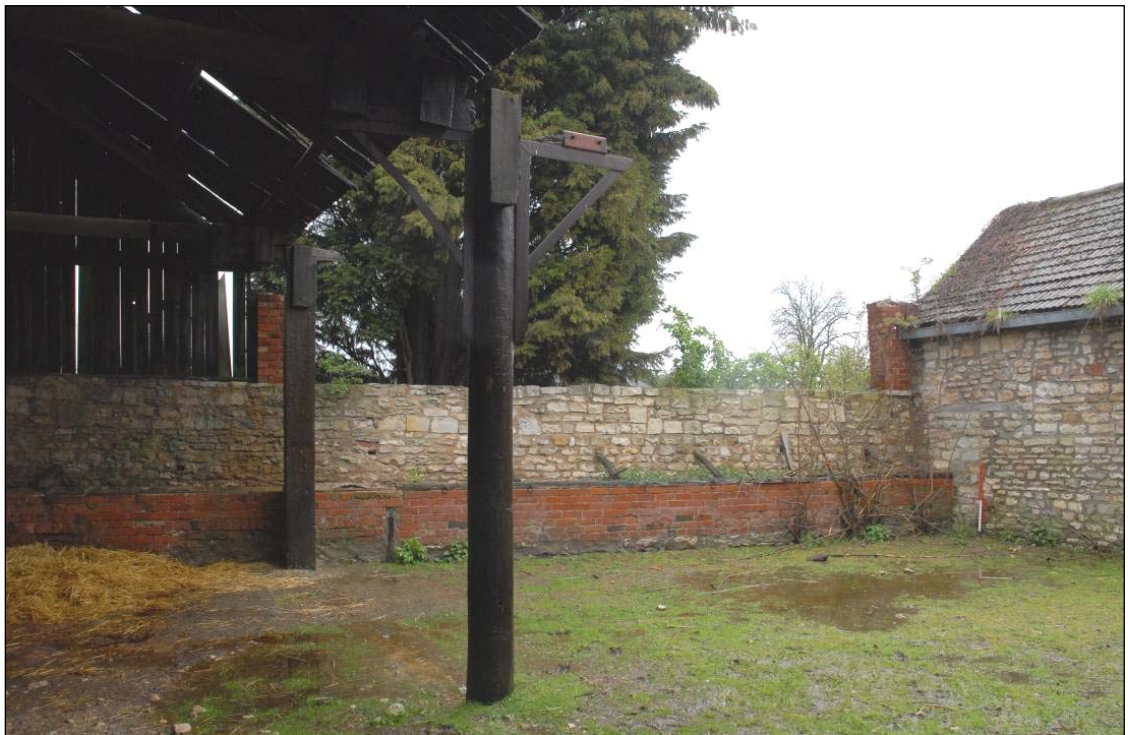
Unit 9, showing the brick feeding trough in the now demolished open shelter shed Fig 31
