Building recording and an archaeological
watching brief at Vine House
42-42a High Street East, Uppingham, Rutland

Report 12/104

June 2012

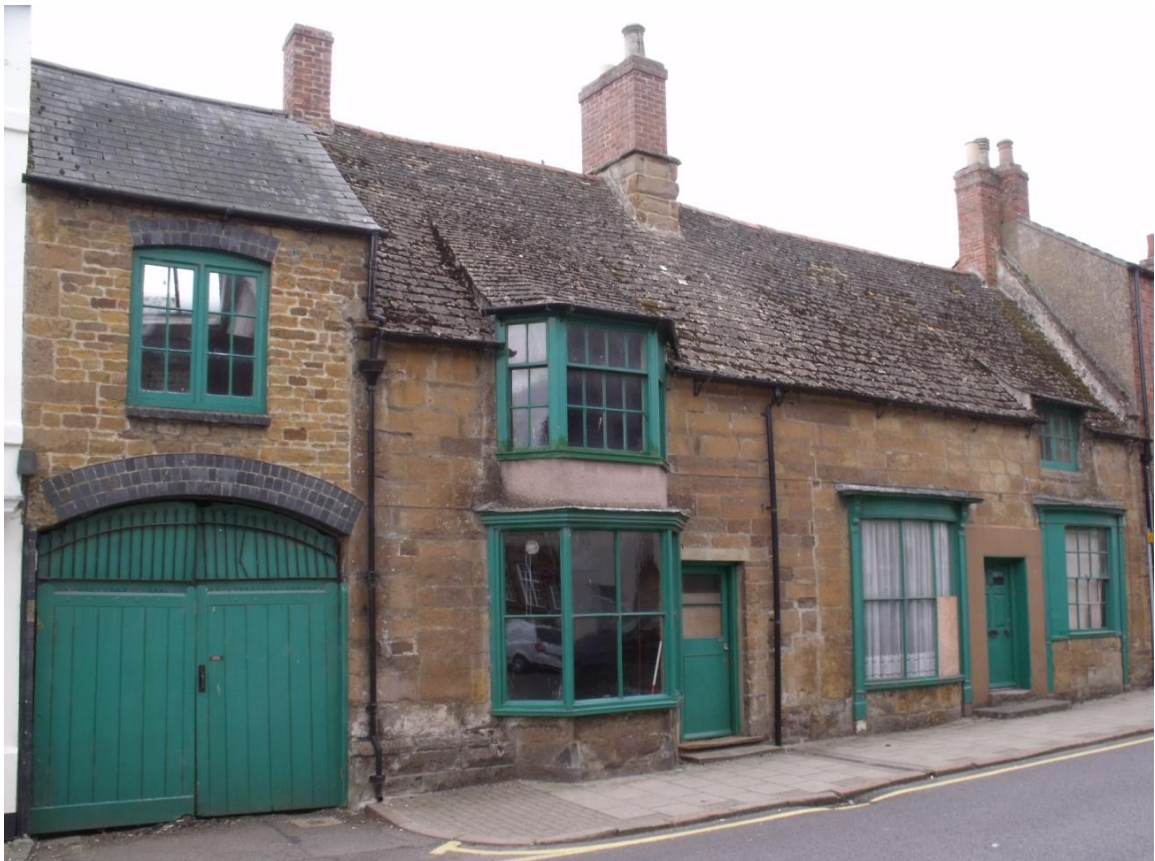
Frontage of Vine House, looking south-west Fig 6

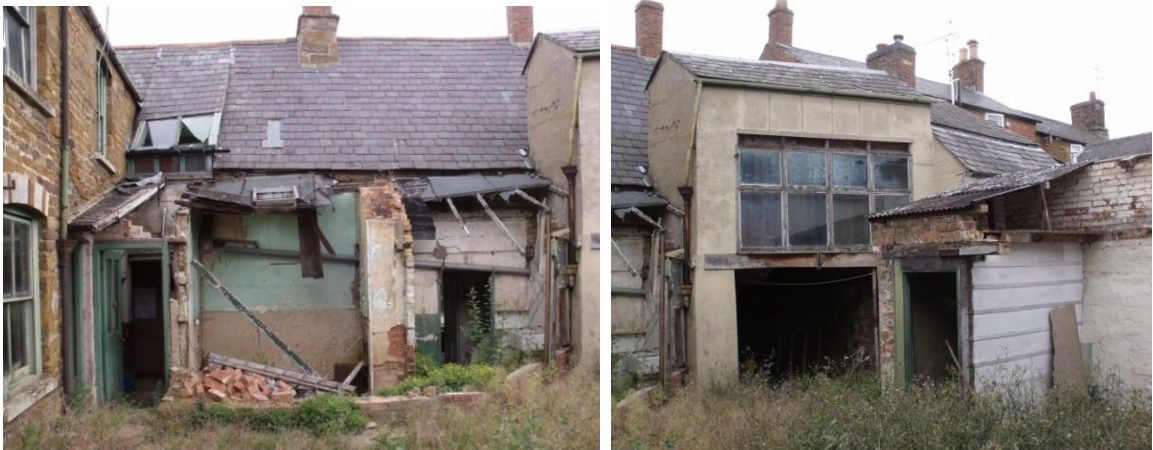
The rear elevation of the street frontage was heavily obscured by the derelict remains of modern building extensions (Figs 7-10). The outer wall and roof of one of the extensions had collapsed. The principal walls were built with a mixture of different types of brick and it would seem that it had been intended as a conservatory style extension, the roof glass later being covered by roofing felt. There is a doorway from the east (conservatory) side of the extension into the yard and a doorway from the west (kitchen) end of the extension, via two steps up, into the yard, both with splayed reveals. The latter contains a panelled door with two smaller lower panels and two long vertical frosted glass panels above with a lion decorated door knocker set upon the centre section between the two (Fig 11), a brass doorknob and box lock.

Rear of the Vine House frontage building, looking north Figs 7-8

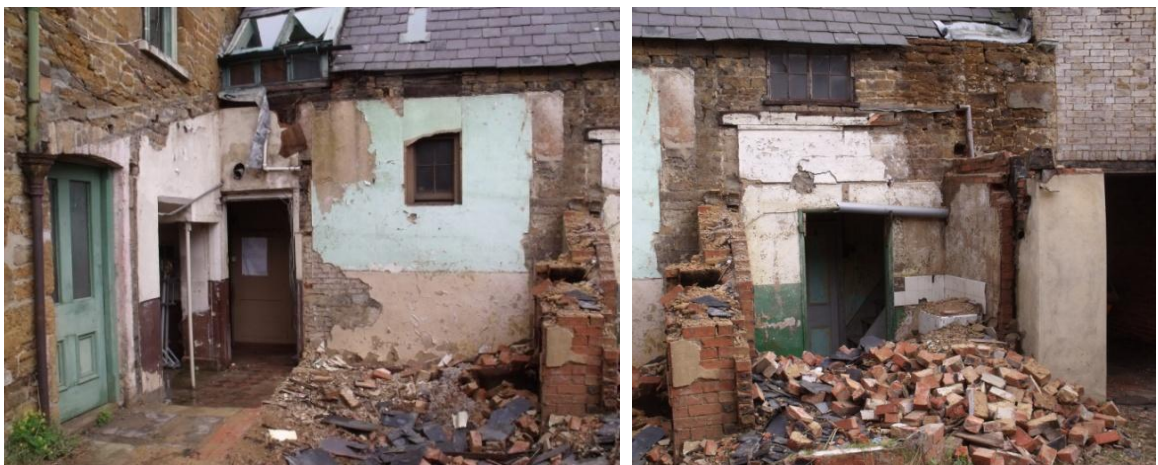
Rear of frontage after demolition of modern extensions Figs 9-10

After the modern extensions were stripped away it was possible to see more of the rear of the original frontage building, although still largely obscured by wall plaster. There are two bays covered by the extensions. One to the east lies above an open doorway and contains a casement window with eight panes, the top of which is flush with the eaves. The west bay contains an eight pane sash window, four above and four below, which was subsequently walled up. The slate roof of the main building had been modified to insert a partial-skylight

window for a modern bathroom and a single glass pane skylight above the stairwell. The bathroom window is similar to a dormer at the west end, protruding above the roof line. The window comprises five fixed panes, two large panes on the roof and three smaller panes in the wall. At the east end of the wall, where the join to the brick rear carriageway extension wall was clear, a stone kneeler was visible protruding from the original gable end (Fig 12). The kneelers and the top of the rear windows flush with the roof line suggest the present roof has been lowered.

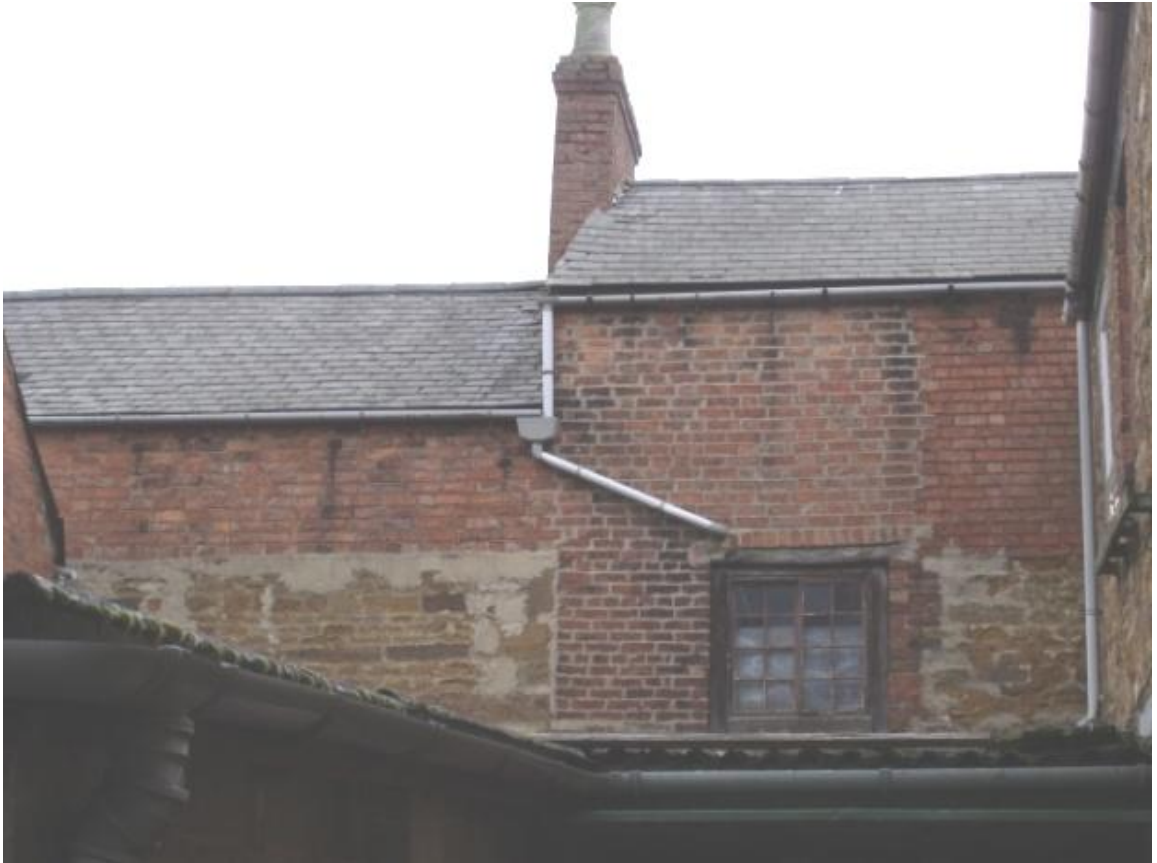
In addition the south gable contains evidence of a blocked top storey window, in the brickwork just to the left of the apex of the former stone gable (Fig 15). This is better seen from the inside. A second storey casement window overlooking the neighbouring property to the west is four panes by four. The roof is slate with plastic guttering and downpipes. A chimney stack is rebuilt in brick when the additional floors were added, and has one pot remaining (Fig 14).

Rear extension of Vine House from the west side Fig 14

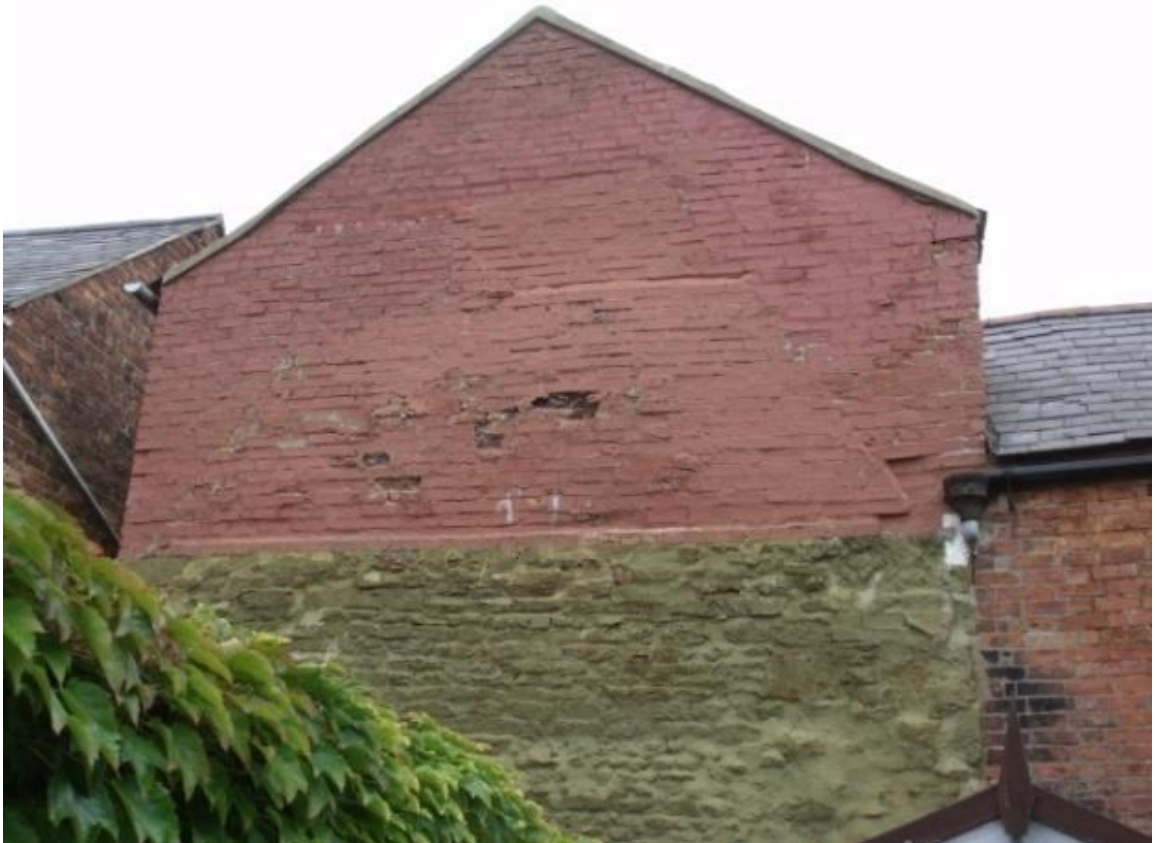
Rear extension of Vine House, south gable Fig 15

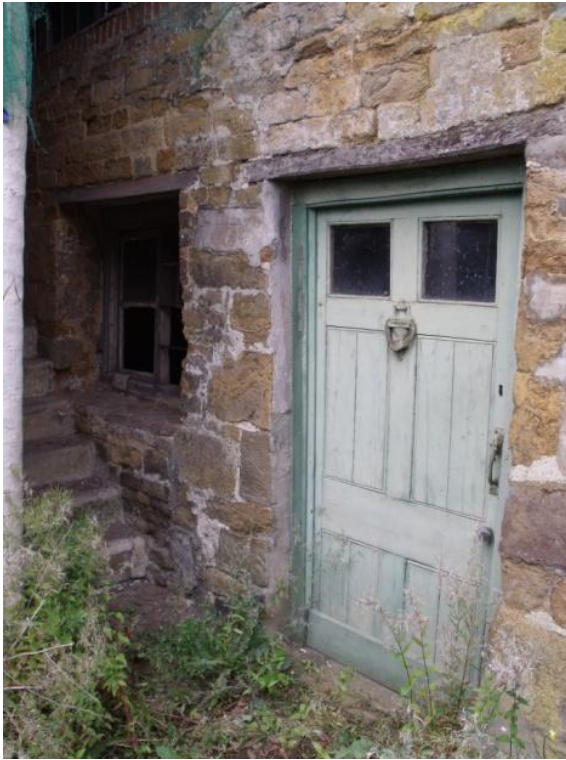
The final addition to this extension probably involved heavy remodelling of the southernmost part of the building, thought to have been school rooms, changed into storage for the general dealer. In this development the roof was completely removed and two storeys added in red brick (Fig 13). The chimney of the initial extension was rebuilt and its west wall partially rebuilt in brick (Fig 14). One of the windows on the ground floor was modified, following the contemporary addition of a neighbouring workshop and the stair blocked the light from the east (Fig 16).

Second extension door Fig 16

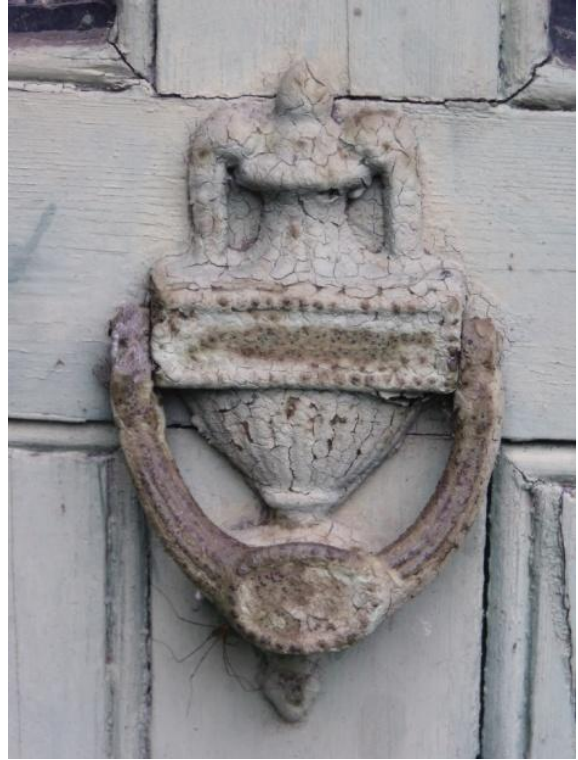
glass panes in the upper two panels, an urn decorated door knocker on the central section, a drop latch, brass door knob, keyhole and wooden lintel above (Figs 16-17). At the south gable end the original stone of the gable is visible, with a later brick skin covering it where the upper storeys have been added (Fig 15).

Urn decorated door knocker Fig 17

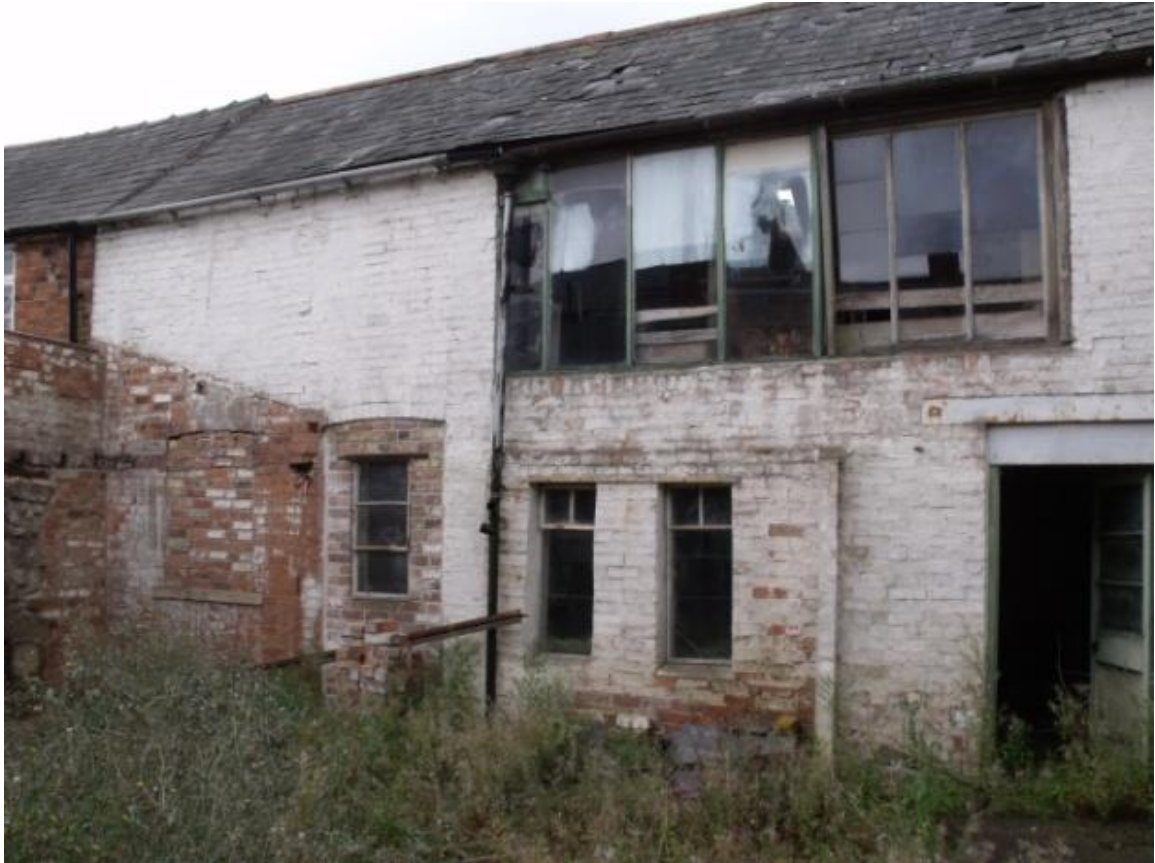
The upper storey has one single large fixed window that comprises seven vertical panes, the top of which reach to the eaves. Below the east end of the window is a row of brick headers suggesting that this window is an enlargement of an earlier one. In the furthest eastern bay there are two windows blocked up with brick, which have been white-washed over. The roof is slate with plastic guttering and downpipes.

The east end of the building elevation retains a distinct break in the white-wash that marks the roof line of a former adjoining building, a lean-to built against the east courtyard wall.

Carpentry workshop, looking south Fig 18

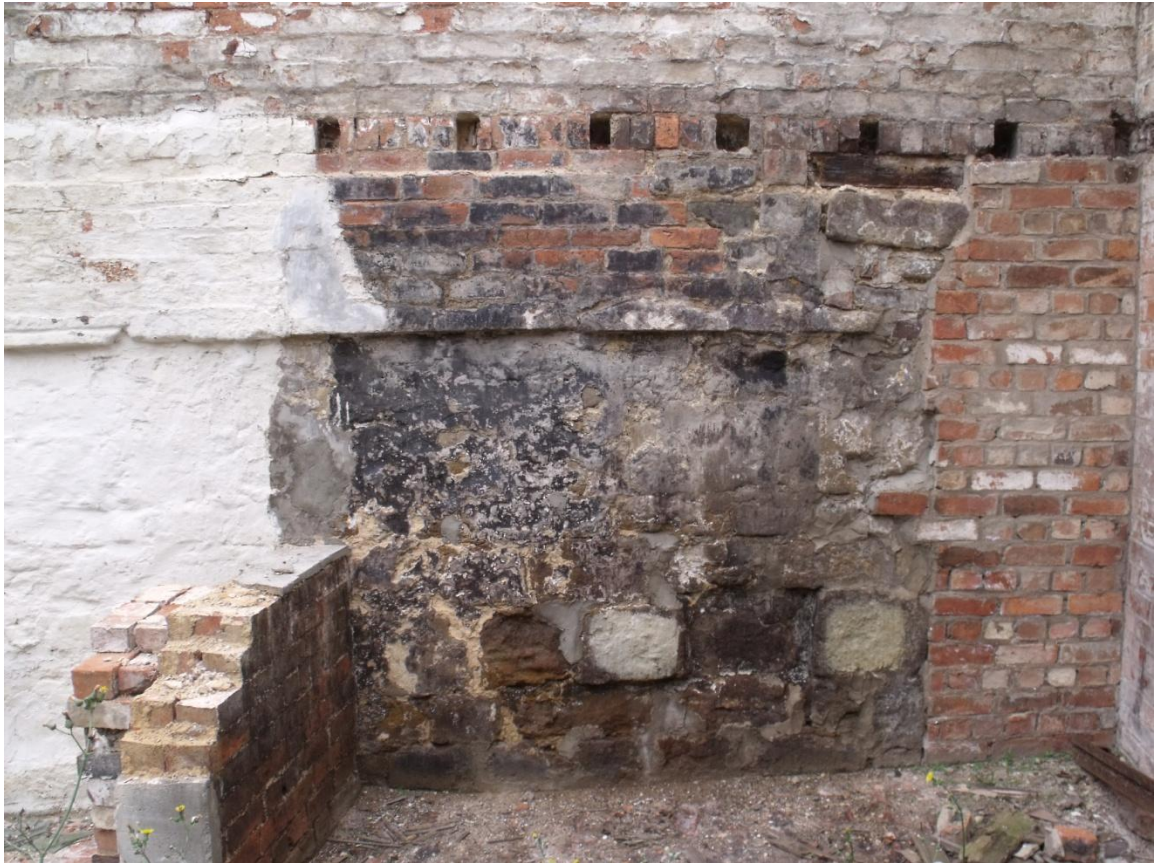
The rear wall of demolished ancillary buildings, looking east Fig 19

The east courtyard wall has at least two phases; a lower rough hewn ironstone wall has been plastered, white-washed and partially rebuilt in brick, raising its overall height. Little remains of the ancillary buildings that were built up against it. The wall is scorched at the southern end (Fig 19). A lack of jambs for a fireplace or a flue for a chimney suggests that this was simply scorching from a bonfire. Above this, set into the wall, are holes for joists, whilst the slope of the roof is visible on the north elevation of the workshop above the line of the perkins (Fig 18). A low stack of brick is all that remains of a dividing wall.

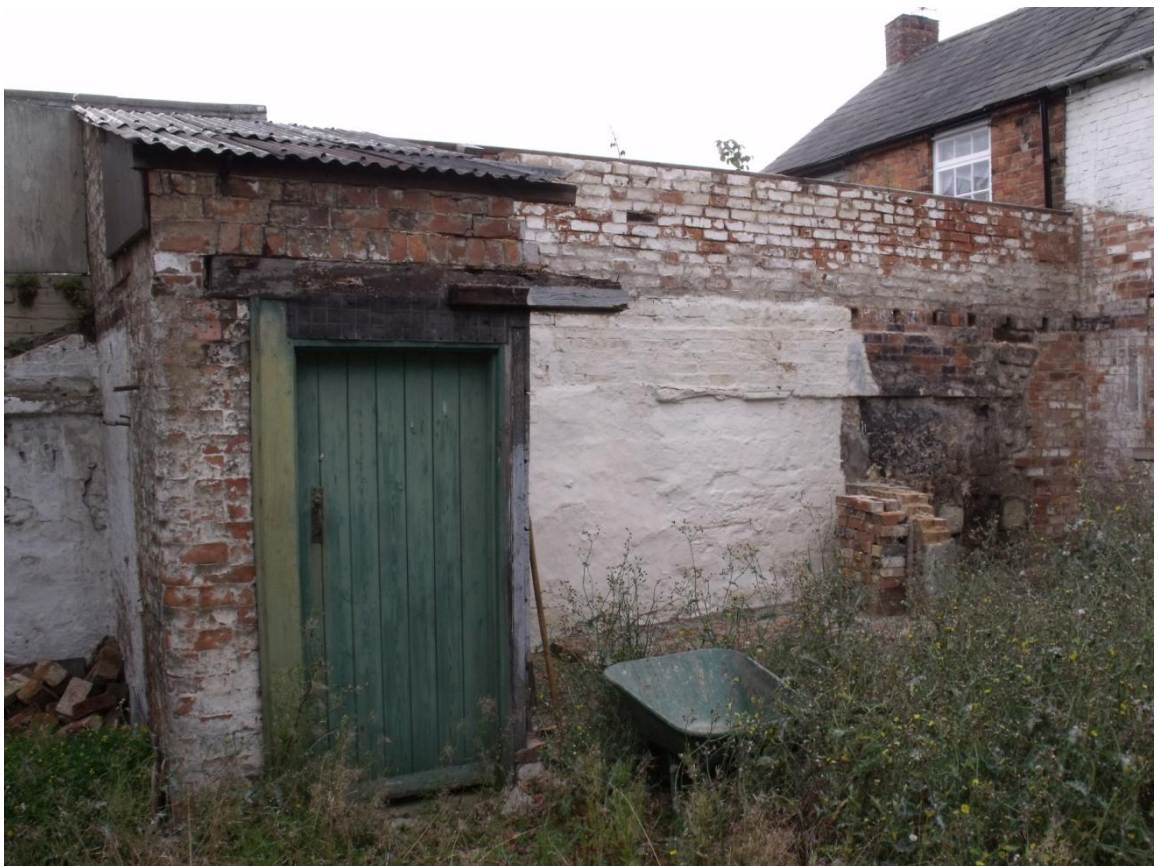
A lavatory still stands at the northern end of the ancillary building range (Fig 20). It is a single storey lean-to style structure built in red brick. It has a vertically planked and ledged door with an iron handle and drop latch. Above the door is a timber lintel that formerly extended across the front of the ancillary building range, but has been broken off during demolition. The roof is sloped up to the top of the courtyard wall and is of corrugated iron.

Lavatory building, looking east Fig 20

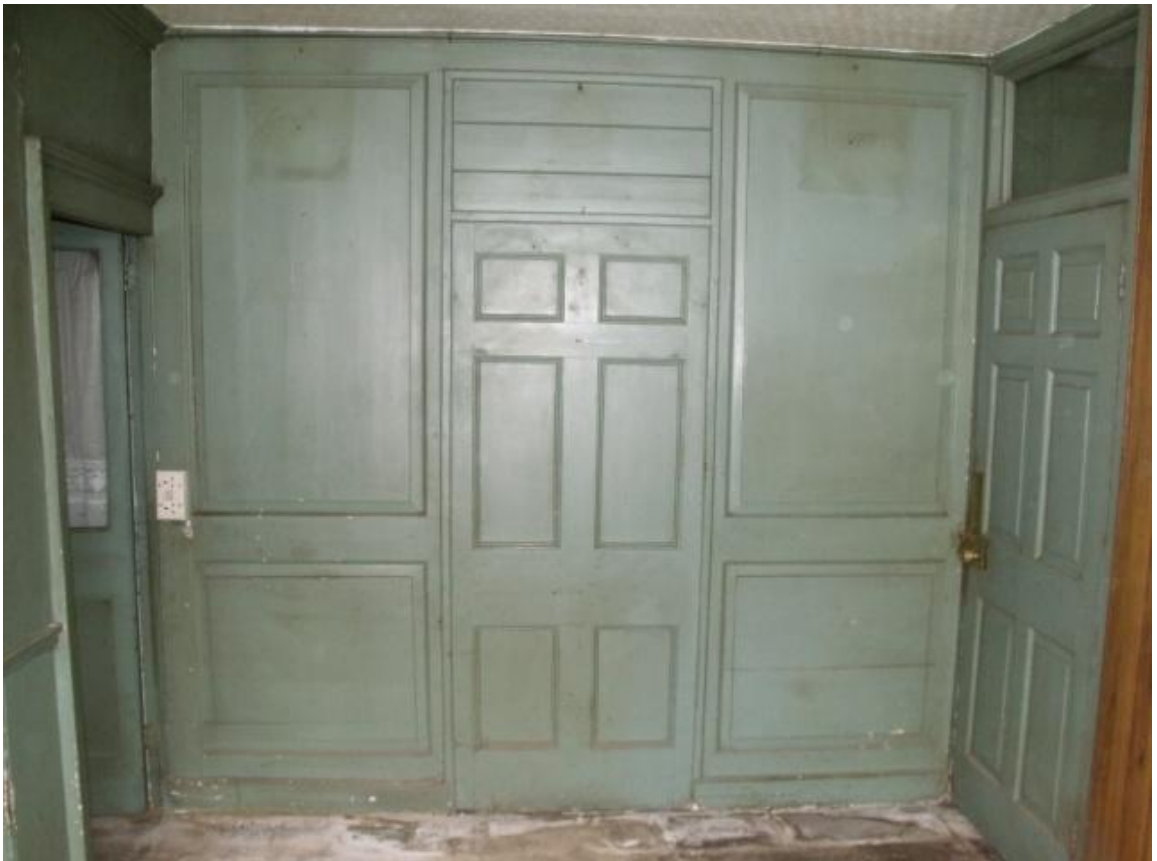
Room G7, looking south Fig 21

The room is rectangular, 3.82m by 3.03m, with a ceiling 2.35m high. The floor is covered by rectangular stone slabs of differing sizes and there is a wooden skirting board. The entrance is in the south end of the west wall from corridor G6 and has a door with six panels, a brass knob and box lock, with a glass pane window above. The rest of the west wall comprises oak veneer (not illus). The window onto the street is large, c2.0m by 1.95m, and is a shallow fixed canted bay, filling most of the north wall. It has a 0.3m wide sill. The east wall is occupied by a grand fireplace with a mirror above it and four deep cupboards to either side (Fig 22). The fireplace is probably late Georgian, 1.13m wide by 1.05m high, it has a stained black oak surround decorated simply with a floral motif and contains a register grate from the Regency period that conceals an inglenook fireplace. The mantelpiece is stained oak, with the same floral decoration along its edges and the frame of the mirror is also late Georgian combining elements of decorative ribbing with a gold and black leaf design above flanking pilasters. To either side, the cupboards each contain single or double shelves, the doors match the 18th-century panelling, which is painted turquoise green throughout, and they have small brass catches. On its south side is a short corridor which formerly connected to room G1, but which has now been blocked off and turned into storage. The door to this has vertical panels, the upper two of which are glass, it has a brass knob and box lock. In the south wall of this corridor, under stairwell G6, is a small cupboard. The south wall of room G7 is an 18th-century wooden panel partition divided into four parts with a door at its centre and horizontal planks blocking the window above (Fig 21). The door is divided into six panels but has been sealed and no longer has a handle. The ceiling is white painted floral paper over plaster with a central light fitting.

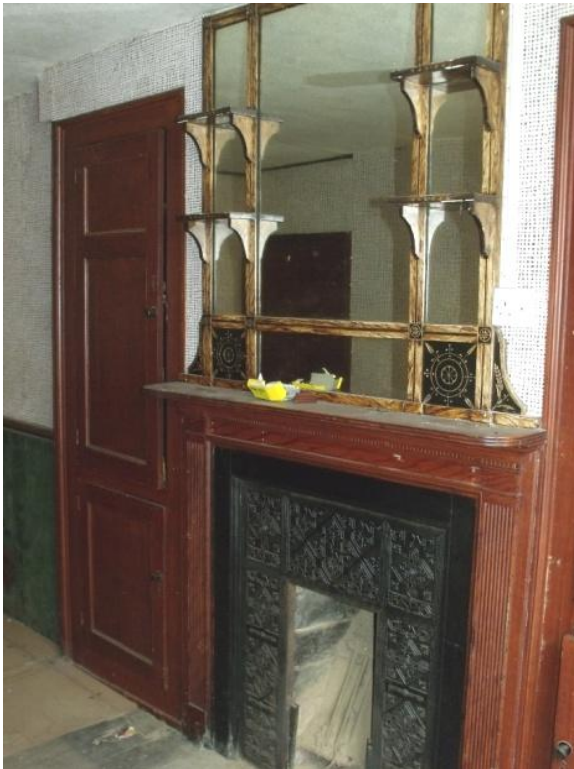
Room G8, looking south-west Fig 23

The north wall contains a large eight pane sash window with splayed reveals facing onto the street. The west wall has an iron fireplace with a mirror above and is flanked by deep cupboards (Fig 23). The fireplace has a narrow grate decorated with surrounding geometric design which is probably Victorian. The mantelpiece and surround carries simplistic ribbed decoration, suggesting that the grate replaced a Georgian fireplace. The mirror frame incorporates eight separate panes, with small shelves for ornaments, and two circular decorative motifs.

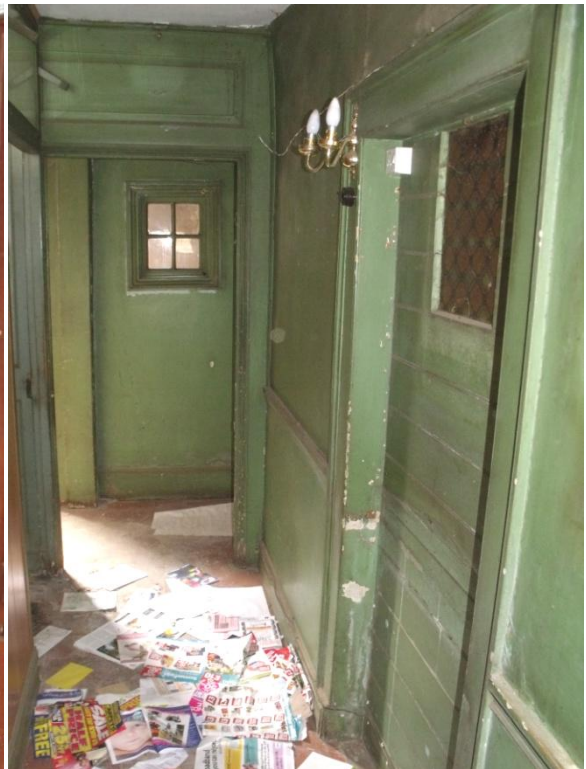
Corridor G6, looking south Fig 24

The hall is 4.67m long by 0.96m wide, with a ceiling 2.37m high. The floor is laid in a standard square pattern with 6" by 6" red tiles but no skirting board. The corridor runs north-south from the front door and turns east to the stairway at the southern end. The front door has six panels with the uppermost two containing glass panes. There is a brass

doorknob, a yale lock, two box locks, a letterbox and two bolts. One side of the hall and stairway is panelled, the east wall of the hall corridor is in beech veneer, and the west wall is a green painted partition with a dado. The stairway has 18th-century panelling, painted brown. In the west wall of the hall corridor is a blocked up doorway into room G8, which contains a single pane window with straight jambs (Fig 24). The present door is at the south end of the corridor in the west wall. The door into room G7 is in the east wall. At the south end of the corridor is a fixed window with four panes and straight jambs. The east-west corridor at the base of the stairway is open on the south side into the kitchen, G5. The stair is a fourteen step winder that splits into two directions at a small landing where there is a banister (Fig 25). An eight pane sash window with spayed reveals had been walled up in the south wall and replaced by a glass pane skylight above (Fig 26). The lower part of the wall has beech veneer panels the height of the wooden hand rail, above this is brown and white wallpaper. The ceiling is plain white-wash plaster. There is a late 18th-century neo-classical brass wall sconce in the main hall (Fig 24), a coat rack at the base of the stair with four pegs and an electronic doorbell. There is a small wall shelf at the base of the stair where the south wall of the hall corridor opens in to the kitchen, G5.

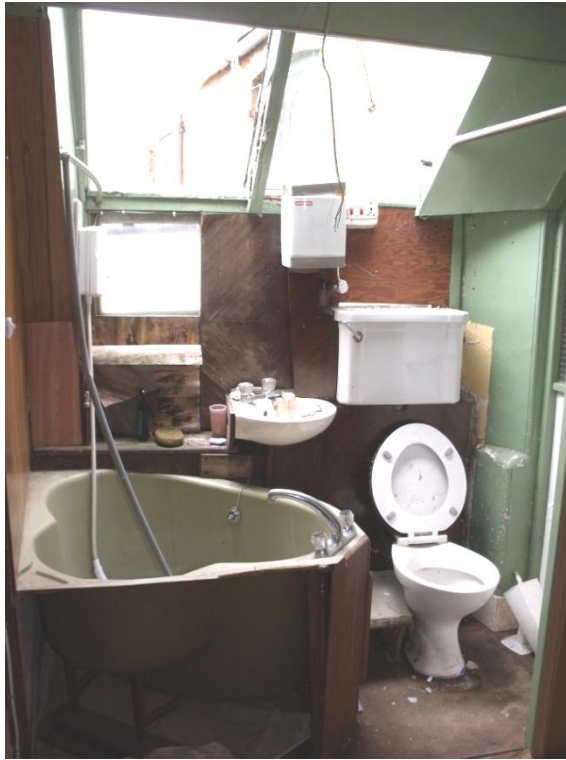
The bathroom window is partially boarded up, although the part which is skylight remains uncovered (Fig 27). There is a shadow on the north wall of the corridor which marks the position of a former shelf, cupboard or overmantel mirror (Fig 28). The doors from the corridor are all panel doors with six divisions, except the smaller door that has been knocked through into F8 which has two panels above and below. The door into room F7 has a specially made lower bracket to accommodate the crooked angle of the frame. The bathroom contains a white porcelain cistern and toilet, green fibreglass corner bath tub, cream wash basin, water heater and shower unit.

Room F5, looking south Fig 27

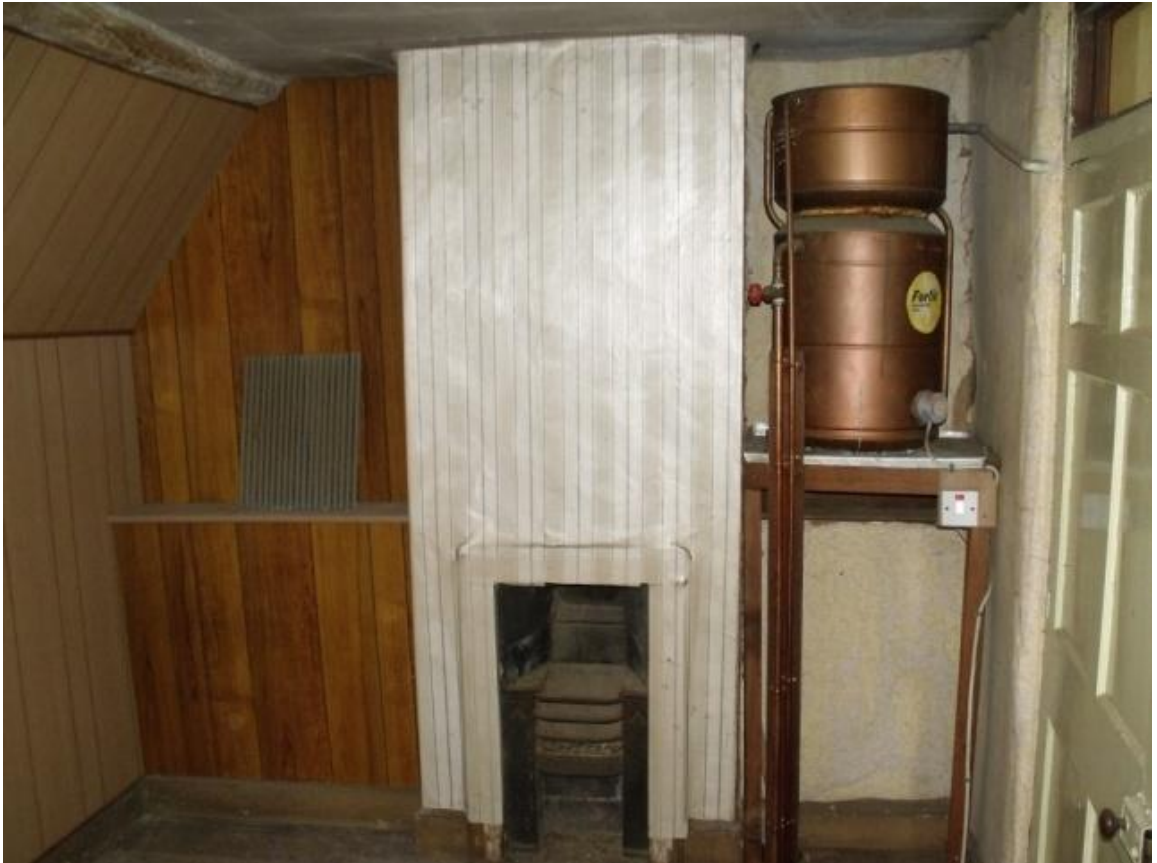
Room F6, looking east Fig 29

The room is rectangular, 3.75m by 2.57m, with a ceiling 2.20m high. The room has pine floor boards and skirting boards. There is an entrance from the south. The door is panelled into six parts, it has a brass door knob and box lock. The north wall is covered full length by birch veneer panelling and has an exposed wooden beam at the join of the eaves (Fig 29). The east wall contains a narrow Victorian iron box grate that bears a simple diamond pattern, the surround and chimney breast is wallpapered over, the recess to one side is panelled with oak veneer and the other contains the boiler. The west wall has striped wallpaper and the entire south wall partition is of pine boards with a row of glass windows along the top. There are no external windows, light is borrowed from the corridor. The ceiling is plain white plaster.

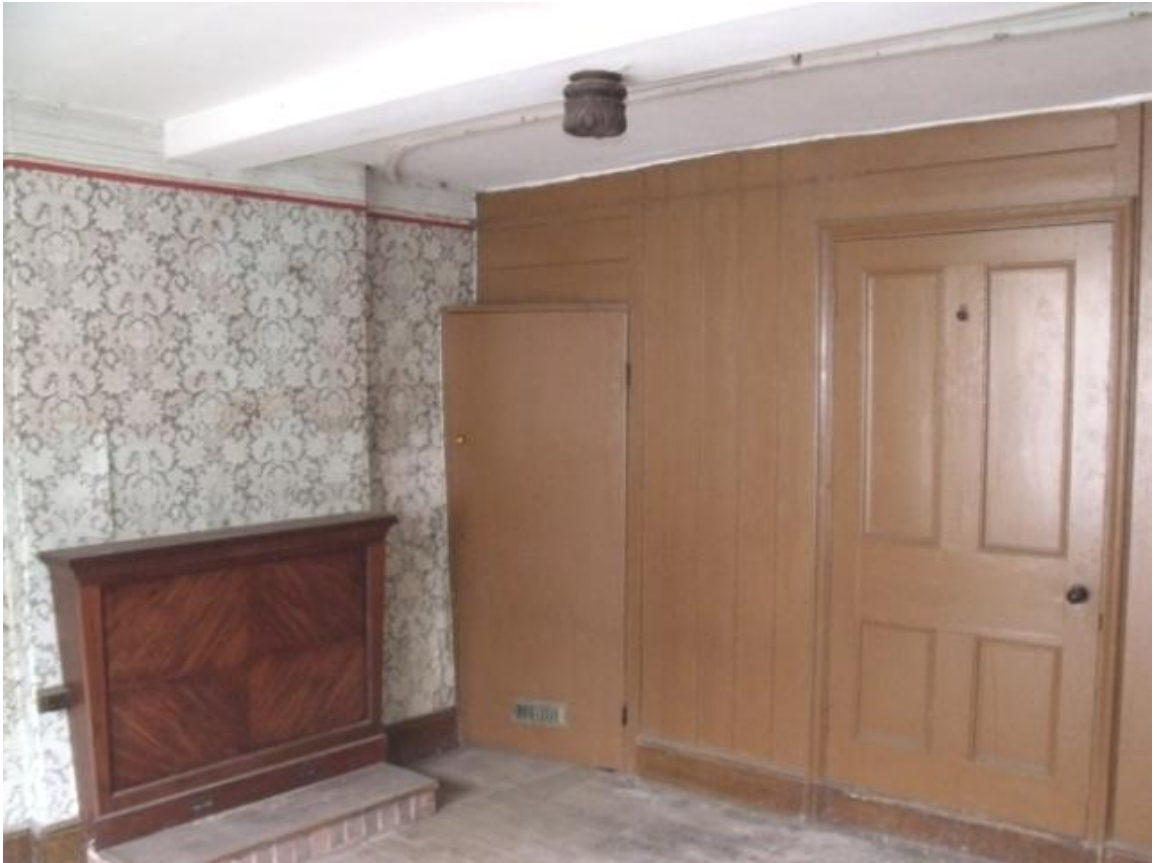
Room G1, looking south-east Fig 31

The original room is rectangular, 3.98m by 4.97m, with a ceiling 2.47m high. The room has pine floor boards and skirting boards. There is an entrance from the street in the north-west corner that is an addition and a doorway to the south. The door from the street is panelled into two parts, top and bottom, with the upper part divided into two frosted window panes. The original doorway to the south is open. The north wall contains a large canted bay window, with eight fixed window panes, which is also an addition (Rogers 2003, 16). It has room to accommodate a window seat. The west wall is in full birch veneer panelling, resembling planks, covering a former doorway in the south-west corner, to room G7. The east wall has black and white floral wallpaper with red trim around the top and decorates a chimney breast for a hearth, which has been blocked off with a mahogany box cover (Fig 31).

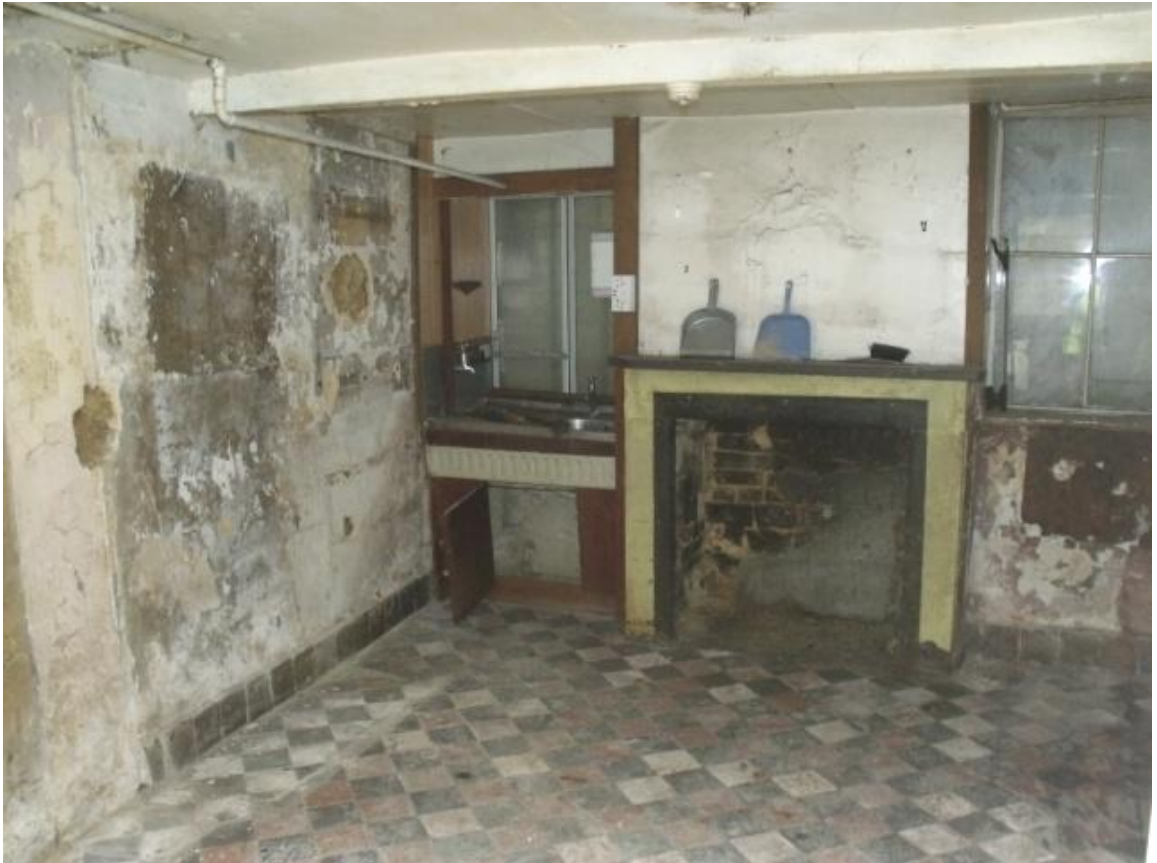
The walls and ceiling are brown and cream painted plaster. The ceiling has a central north-south steel supporting cross beam (Fig 35). There are two windows in the north wall looking into the hall, G6, and office, G8, which have four and six panes respectively and straight jambs. The latter is a sash window. There is an open hearth at the west end of the room that is plain and unadorned, 0.97m high by 0.95m wide and 0.53m deep. To either side are windows; the window to the right is fixed with four panes, the window to the left is above a stainless steel kitchen sink and is split into two frosted panes with a window vent. Both windows have straight jambs. Below the steel sink is a cream china sink with ribbed decoration along the side and a diamond in the middle.

Room G5, looking south-west Fig 35

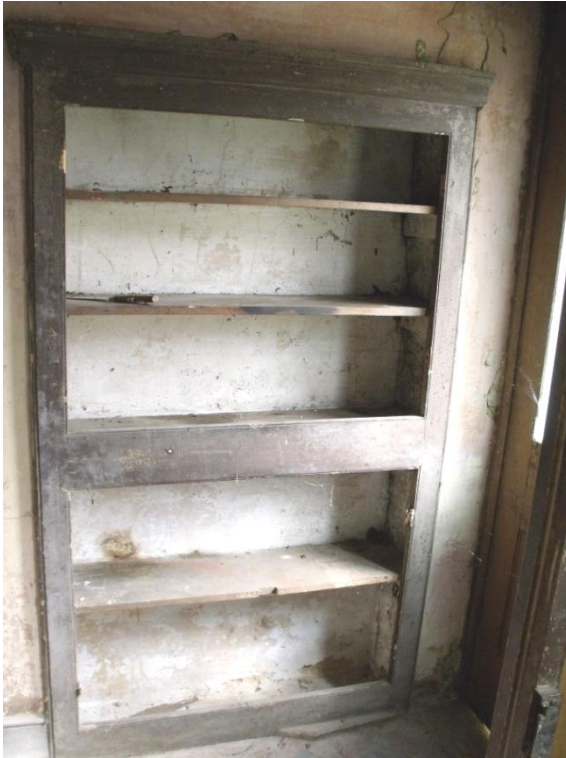
Stair F9, north cupboard Fig 37

The stairway is 2.96m long by 0.81m wide, with a ceiling 4.35 high, and thirteen wooden steps between the base and the entrance to room F10. There is a small hall at the base of the stair with a door into room G9 on the south side, a door into the back yard on its east side and a fitted cupboard filling a recess on the north side. There are four shelves within the remains of a fitted cabinet, the doors of which have been removed (Fig 37). The door to room G9 is described above. The door to the yard has two small lower wooden panels and two long vertical frosted glass upper panes, a brass door knob and box lock. The walls are painted plaster over stone and ceiling is painted plaster over wooden reeds. There is a small plain glass, single pane, window above the stair in the east wall from room F10 with straight jambs.

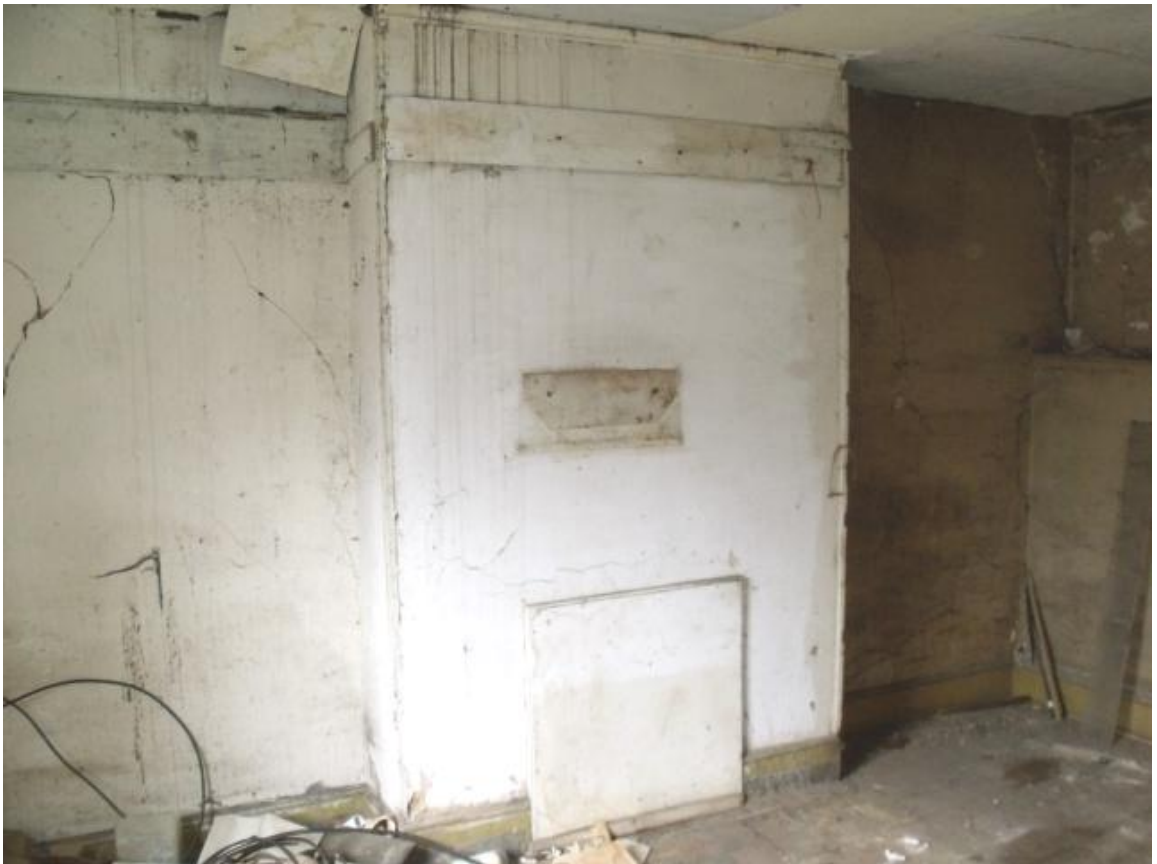
Room F10, looking south-west Fig 39

This room contains a large quantity of scattered sheet music; hence it is referred to as the 'music room'. The room is rectangular, 4.36m by 3.08m, with a ceiling 2.41m high. The floor has pine boards and skirting boards. The door to the north-west, along the north wall, leads from the top of the stair, F9. There is a four panel door with a brass knob and two hooks on the back of the door. The walls are painted plaster. The ceiling is painted plaster over wooden laths. There is a sash window in the east wall with four panes and splayed reveals, and a chimney breast on the south wall. The hearth has been blocked up and there are wooden boards around the upper part of the south wall and chimney breast (Fig 39). A small single pane window lies on the west wall of a recess in the north-east corner of the room, providing light to the stairwell. There is a deep shelf at head height within the recess.

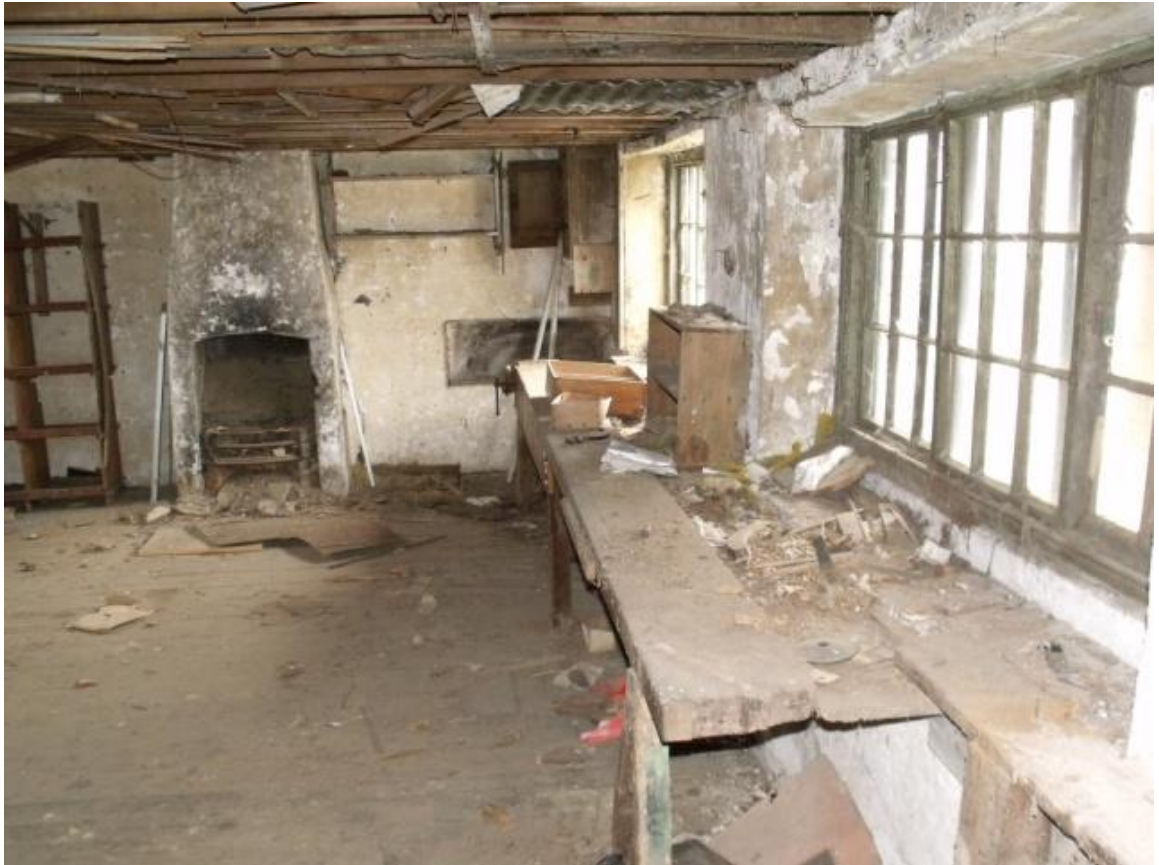
Room F11, looking north Fig 42

The room is rectangular, 7.48m long by 4.24m wide, with a ceiling 1.98m high. The floor has pine boards. The doorway is from the south-east and is at the south end of the wall. There is a wooden stairway with eleven slats opposite the door, to the next floor. The walls are white wash over stone. The ceiling has no main beam and the floor joists of the room above are exposed, east to west. There are two large open casement windows in the east wall with splayed reveals, each divided into three parts with nine panes in each (Fig 42). In front of these is a long work bench. There is a smaller casement window in the west wall at its north end which is in two parts with six panes in each and splayed reveals. An open hearth and chimney breast lies against the north wall, which is unadorned and contains a portable iron grate.

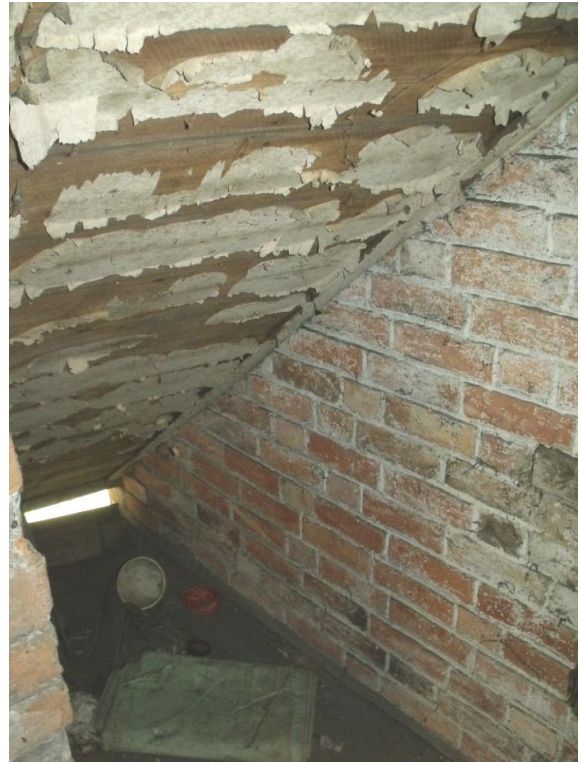
The room forms a small attic space between two buildings and is rectangular, 4.13m long by 0.83m wide, with a ceiling 1.84m high, sloping down to the eaves (Fig 45). There is a door frame, but no door. The floor has pine boards. The walls are plain brick but retain traces of lime wash. The underside of the slate roof forms the ceiling and is covered by pine boards. There is a small casement window with straight jambs on the east side looking into room F12 which has three panes and is hinged at the top to open vertically.

Room S3, looking north-east Fig 45

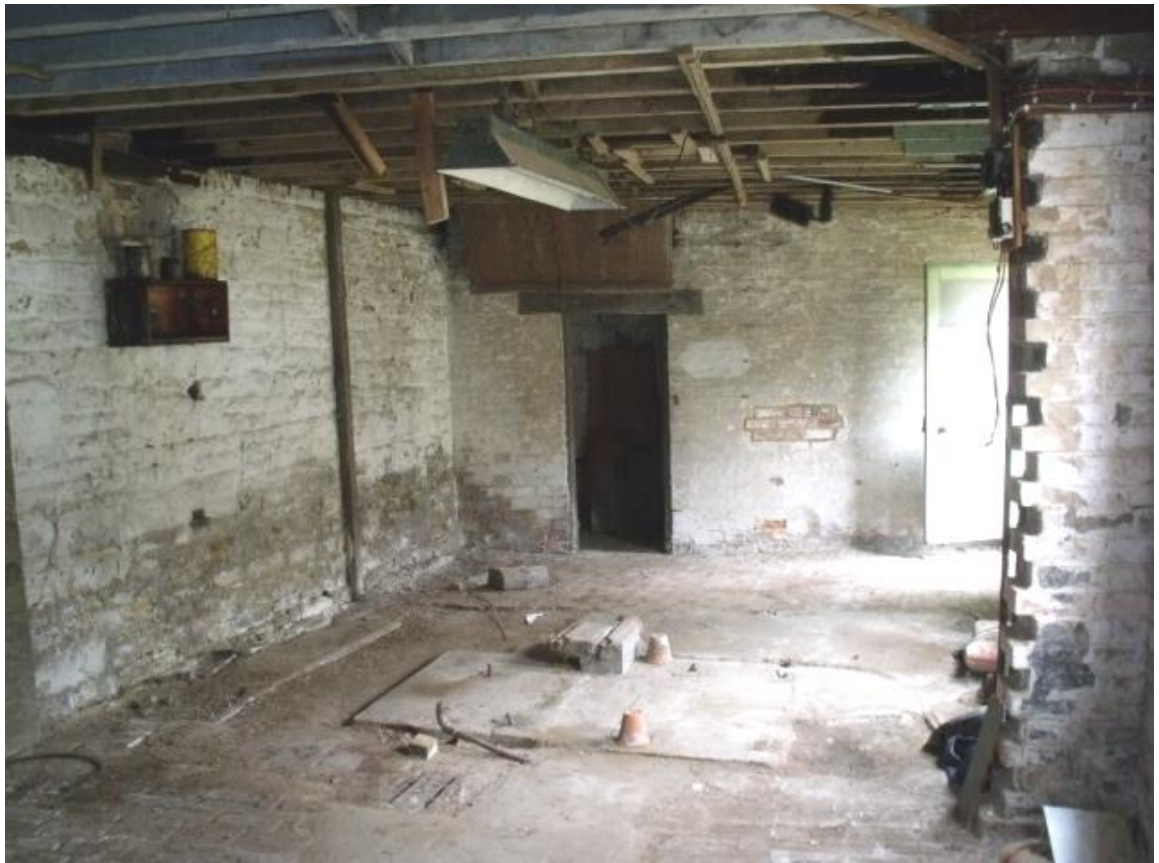
Room G13, looking west Fig 46

The room is trapezoidal, 8.55m long by 4.05m wide, with a ceiling 2.46m high. The floor was originally brick bats and had a brick drain, but the central section has been ripped up to install a concrete machine base powered by electric and with piped water coolant, probably a cutting tool used by Toon & Son (Fig 46). There are the remains of a north-south partition wall, which has been knocked through, protruding from the north and south walls. The entrance is at the west end of the north wall. The door is horizontal panelled and split into four sections; the top three sections are glass, it has a bakelite
