Building recording and an archaeological
watching brief at Vine House
42-42a High Street East, Uppingham, Rutland

Report 12/104

June 2012

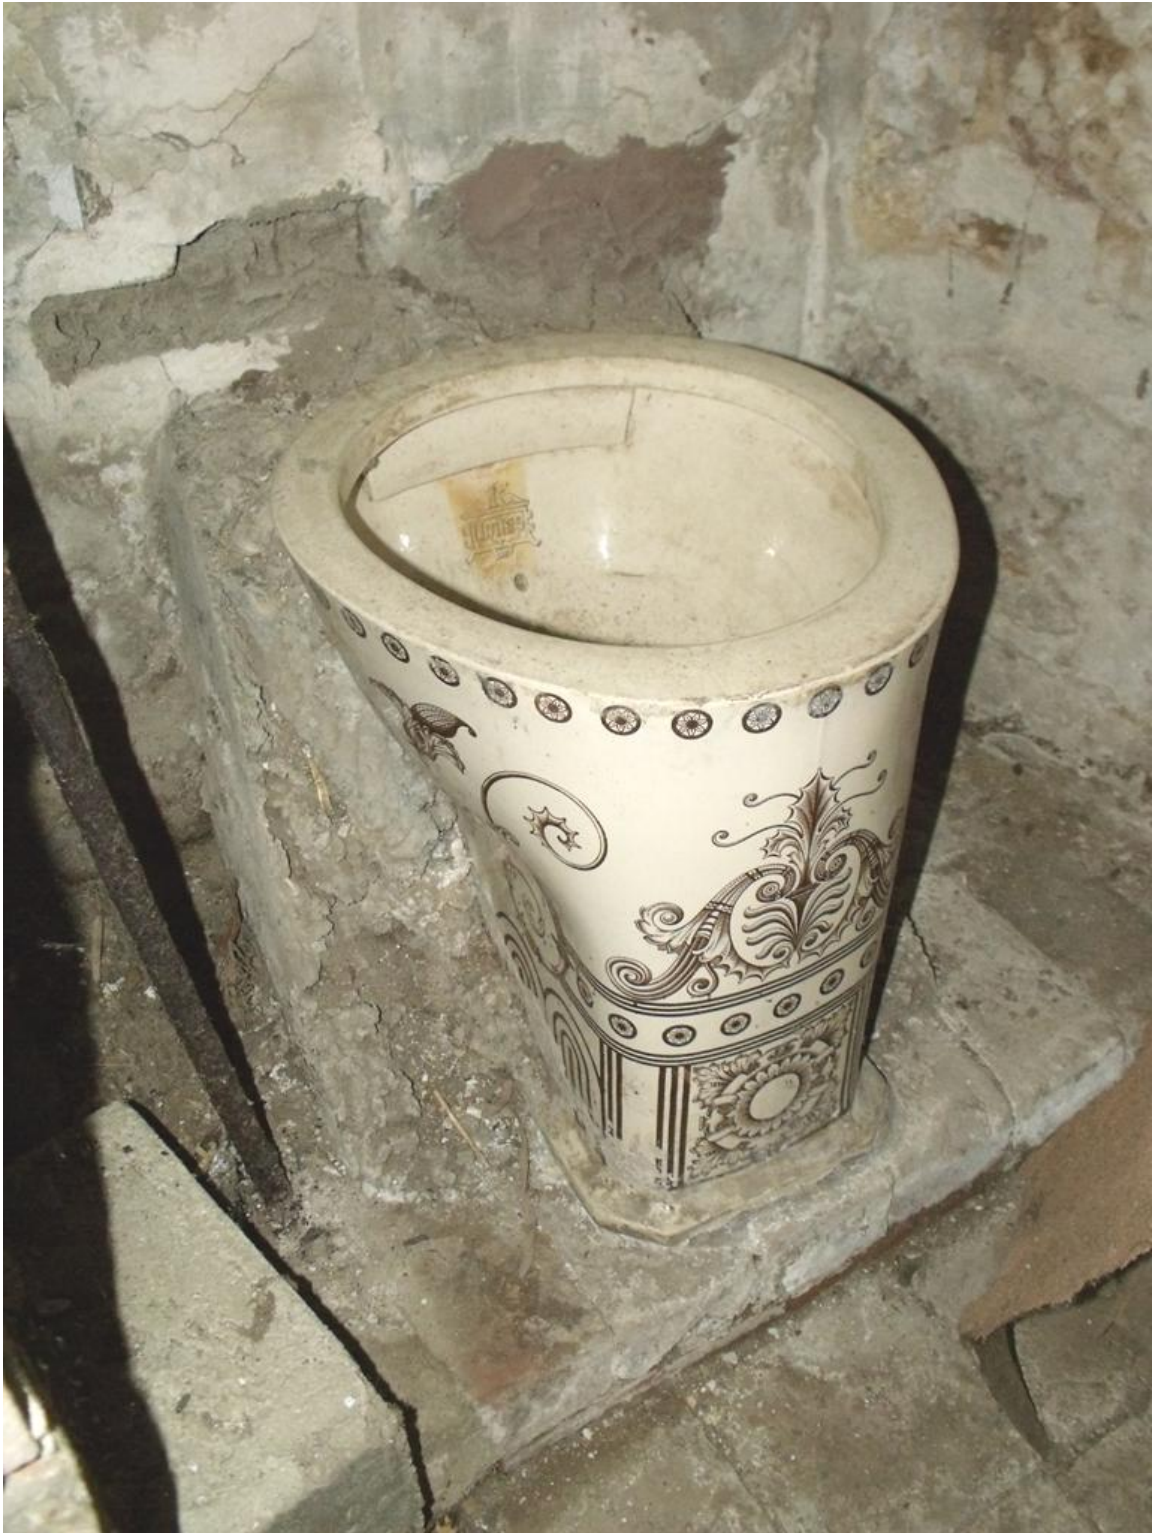
Room G13, toilet Fig 47

door knob and brass box lock. There is an opening in the west wall beneath the exterior stairway which houses a 19th-century toilet bowl, but there is no door or window inside (Fig 47). The toilet is branded 'UNITAS', which was the first one piece ceramic pedestal closet, launched in 1883 and designed by Thomas William Twyford. The toilet also featured a remarkable wooden seat which was hinged so that it could be raised to allow the use of the toilet by gentlemen as a urinal. This example has cream and brown floral decoration. An iron cistern is on the wall above it, but the lack of connecting pipes suggests it is no longer functional. The south wall of the main room is white wash plaster over stone, the rear wall of the plot, whilst the rest is in stretcher bond brick. The ceiling has no main beam and the floor joists of the room above are exposed, north to south. The north wall contains two identical narrow casement windows; each has a single pane with two smaller panes above and straight jambs. On the east side of the demolished brick partition is another fixed window with three horizontal panes set within a blocked up doorway. There is a blocked up window adjacent to it and signs of a blocked up vent or other aperture, which cannot easily be seen from the exterior.

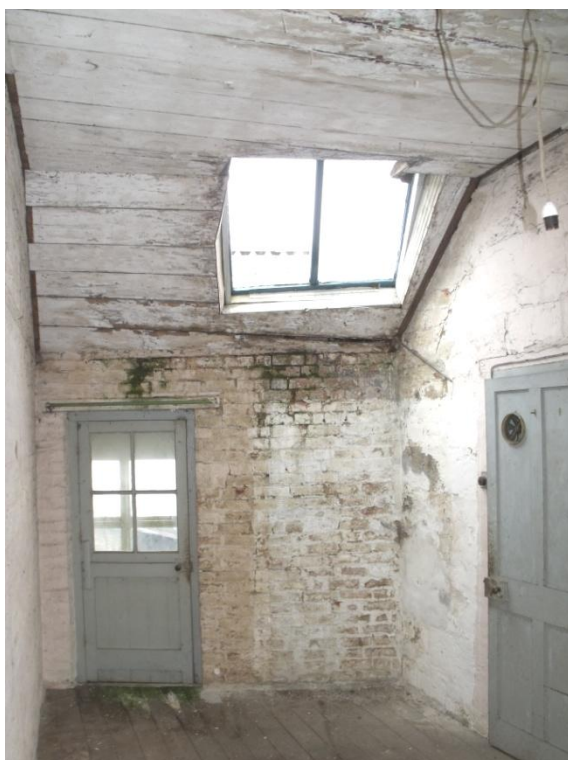
Room F2, looking south Fig 49

This single rectangular room is directly above the carriage arch and is 5.14m long by 2.62m wide, with a ceiling that is 3.12m high. The floor has pine boards. The entrance is in the west wall and the door is divided into four panels with a vent inserted in the top left panel (Fig 49). There is a door in the south wall into room F2, which is a later addition. A skylight above the south wall is split down the middle with two panes and is not set square to the ceiling, but follows the eaves. A casement window with splayed reveals is set in the north wall looking onto the street. The walls are painted white over brick surfaces. The ceiling extends the angle and shape of the eaves from the adjoining frontage building, which is boarded with wooden planks.

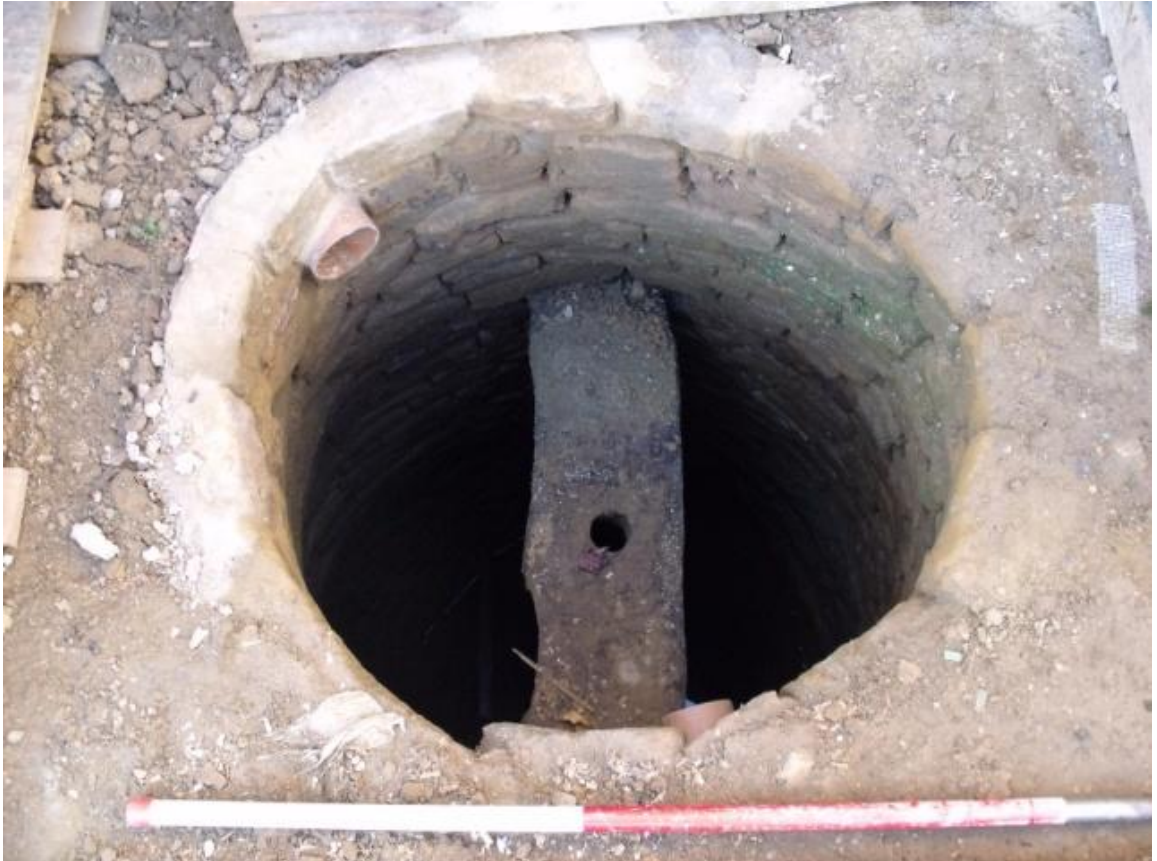
19th-century well shaft Fig 54

The well was circular (Fig 54), lined with cut and shaped ironstone blocks of similar sizes (250mm by 120mm by 100mm), and had a wooden cross beam with a hold in it below the lip. The shaft was vertical, with no cistern chamber below and still retained water at over 3.8m depth.

A 19th-century well was found within the yard, which will either be capped or retained as a period feature. The wall footings for the new build were the subject of an archaeological watching brief which found no evidence for further archaeological deposits below the brick yard surface. An replacement extension will be added above and to the rear of the carriageway and the brick yard surface will be resurfaced at its current level. Further archaeological work is not anticipated.
