Building recording at the former Tudor Gate Hotel,
29-35 High Street, Finedon, Northamptonshire
May 2012

Report 12/108

ARCHAEOLOGICAL BUILDING RECORDING
AT THE FORMER TUDOR GATE HOTEL, 29-35 HIGH STREET, FINEDON,
NORTHAMPTONSHIRE

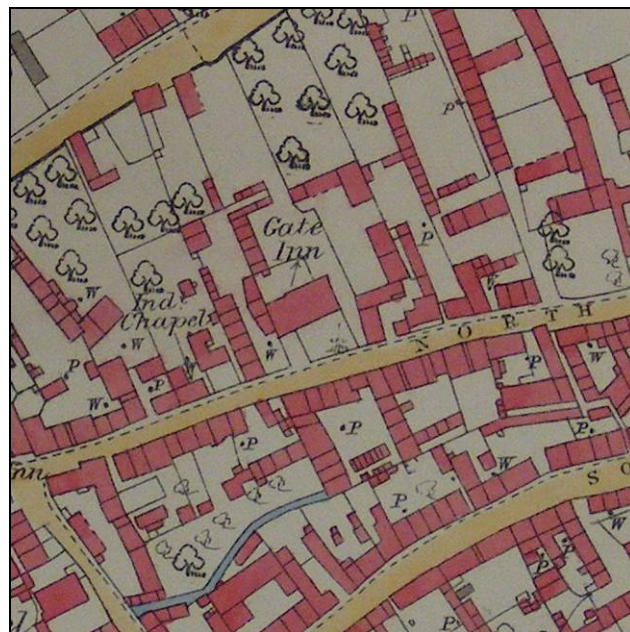
First Edition Ordnance Survey map, 1884 Fig 4

In about 1841, the inn was bought by Mr Mackworth-Dolben and Edward Everett became the farming tenant landlord in about 1859. He was the landlord until at least 1879, when he is listed in Whellan's Directory. The Gate Inn is depicted for the first time in 1884 (Fig 4). The barns to the east have been modified and extended and there are further ranges of outbuildings to the north and north-east of the inn. North of the outbuildings, the orchard still survives. The tenements to the west of the inn are also depicted and a well (W) is also marked.

To the rear there is a, two-storey flat-roofed extension constructed from limestone with ironstone quoins (Fig 14), which appears on the 1884 Ordnance Survey map (Fig 4). The roof line of which has been altered in more recent times as testified by the brick parapet.

These buildings were built after 1884, but before 1900, as they do not appear on the 1st edition Ordnance Survey map (Fig 4), but they are there on the 2nd edition (Fig 5). Elements of the rear of the range may date back to the late 18th century or early 19th century as these are first shown on the Finedon Inclosure map of 1806 (Fig 3).

The interior of this part of the complex has been much altered during the hotel period of the building's life, no original fixtures or fittings survived and the rooms were uniform in nature (Fig 24), with the modern partitions for the en-suite bathrooms surviving (Figs 9-11). Elements of the ground floor, Rooms G12-14 may be pre 1884 in date incorporating elements of the block shown on the 1st edition Ordnance Survey map (Figs 4 and 9).

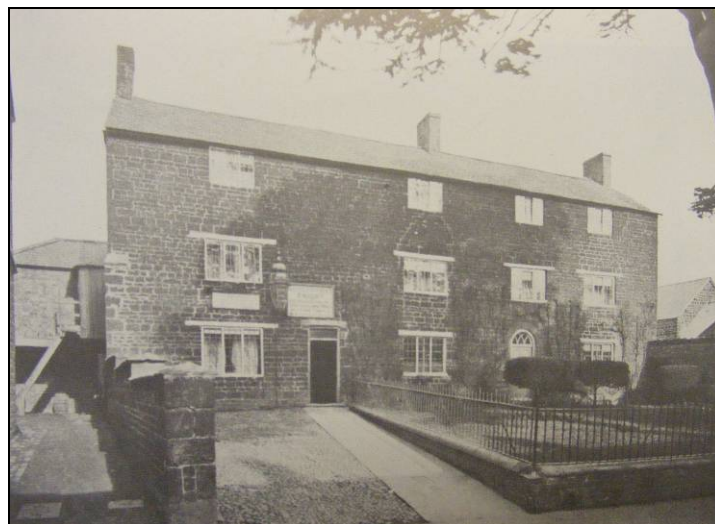
Between 1884 and 1900 the tenements to the west of the inn are modified with the addition of the present building on the frontage of the High Street, although the tenements still survive to the rear (Figs 5 and 7). The inn is depicted on a photograph of 1912 when Alfred Herbert Knight was the landlord (Fig 6). The fenced garden area at the eastern end appears to demarcate the domestic side of the building, while the inn is located at the western end. Above the western ground floor window was a sign with the rhyme:

The Gate Inn, 1912 Fig 6

The windows in this room both have splayed reveals, the eastern window is a three light casement with leaded lights, the shutters for this window have been removed and the window seat boxed in to create a window sill. The other window in this room is the horizontal 'Yorkshire' sash, which from the historical research post-dates 1912 (Fig 6) and therefore is not an original feature to the building.

Evidence for the former Gate Inn was likewise limited, the horizontal sliding sash window in Room G3 may relate to this part of the life of the building and is likely to have been used as a serving window to the front garden area. However photographic evidence shows that this feature post dates 1912.

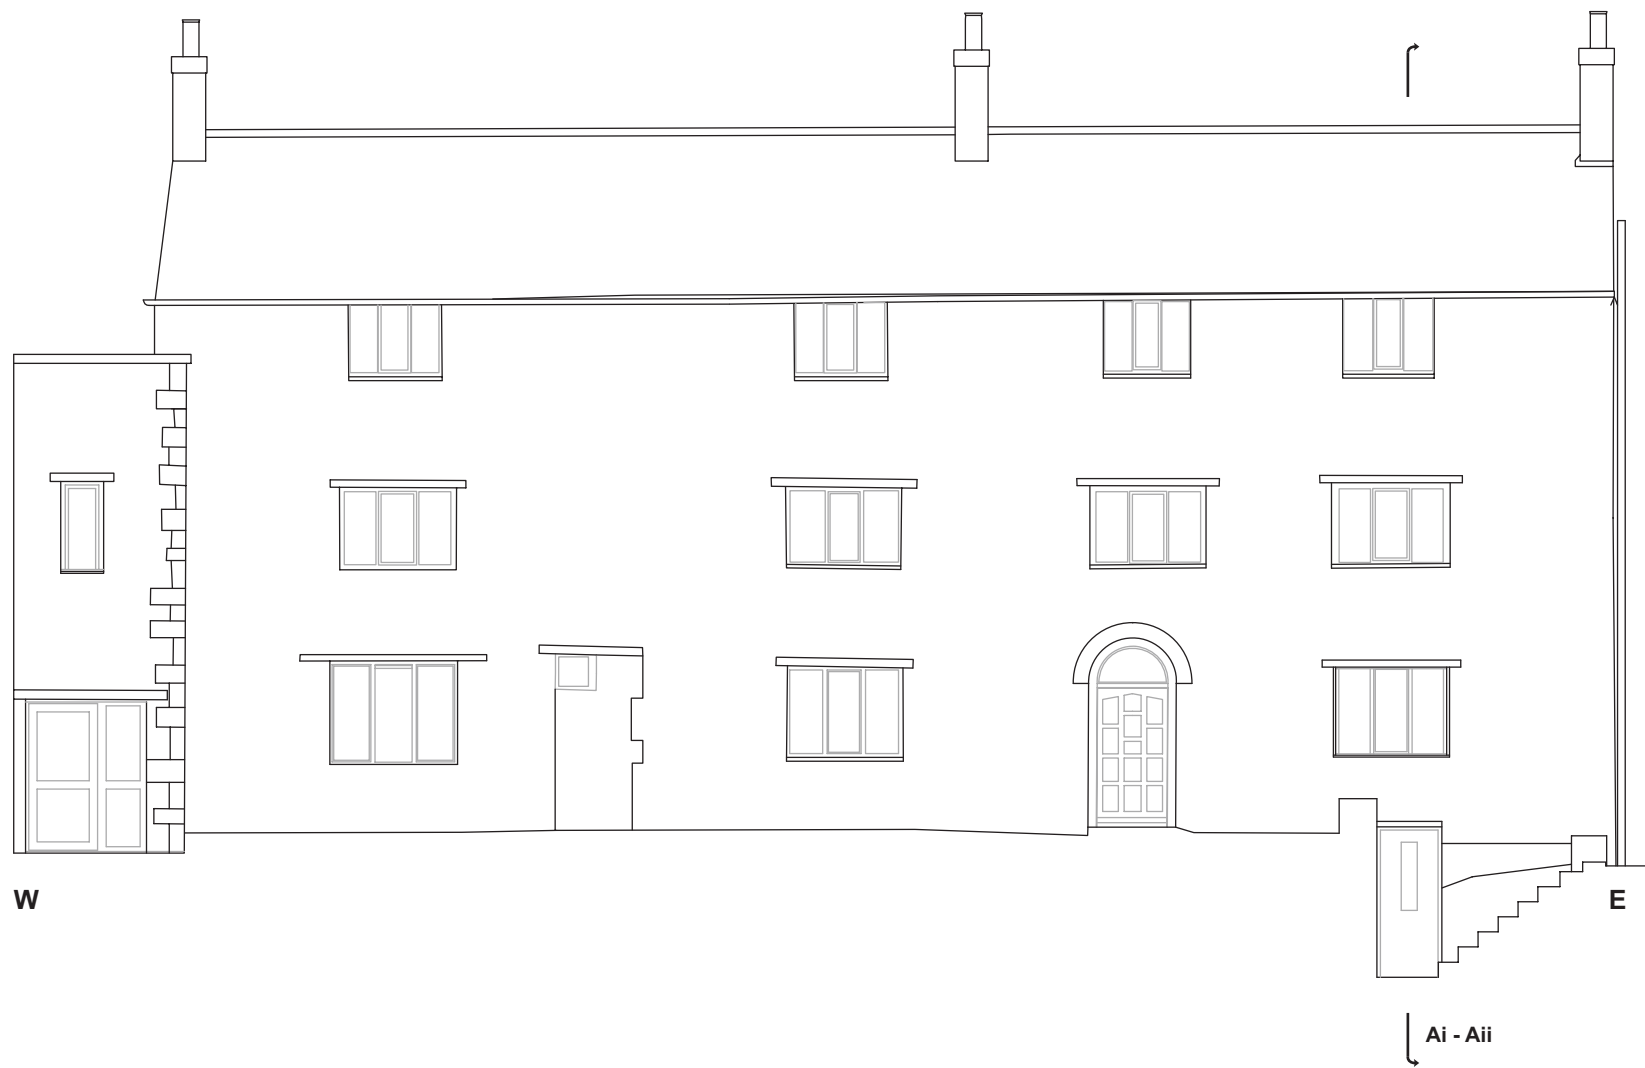
Fig 8: Elevation and section

The former Gate Inn has a squared coursed ironstone facade and limestone rear with a slate roof, with brick stacks at ridge and either end (Figs 8 and 12). The building is of three storeys, with a four window range of three light casements with leaded lights, the majority of the windows on the facade are modern replacements with soft wood frames and the leaded lights are stick on fake lead strip, all of the windows are under wood lintels. The exception is on the west side on the ground floor there is a horizontal sliding 'Yorkshire' sash. Although this window is mentioned in the listing description it post dates 1912 when the window is shown as a three light leaded casement (Fig 6). This would indicate that the window may have had more to do with the functional life of the building as a pub and may have been a serving hatch. To the right of centre there is a modern door, in an original opening, with an arch head with an early 19th-century fanlight with intersecting glazing bars (Fig 13). The blocked door to right of centre, was the entrance into the pub part of the building and is likely to have been blocked when the building was converted to an hotel and the room behind became the dining area.

The room was likely originally to have been two rooms with the partition along the line of the boxed-in RSJ (visible at the top of Fig 17). If the inglenook fireplace is original then it would suggest that the eastern room was originally a principal receiving room. During the building's life as the Gate Inn, this half of the room would have been in the private part of the house. The western room accessed from the now blocked door (Figs 8 and 12) would have been the bar area of the Gate Inn.

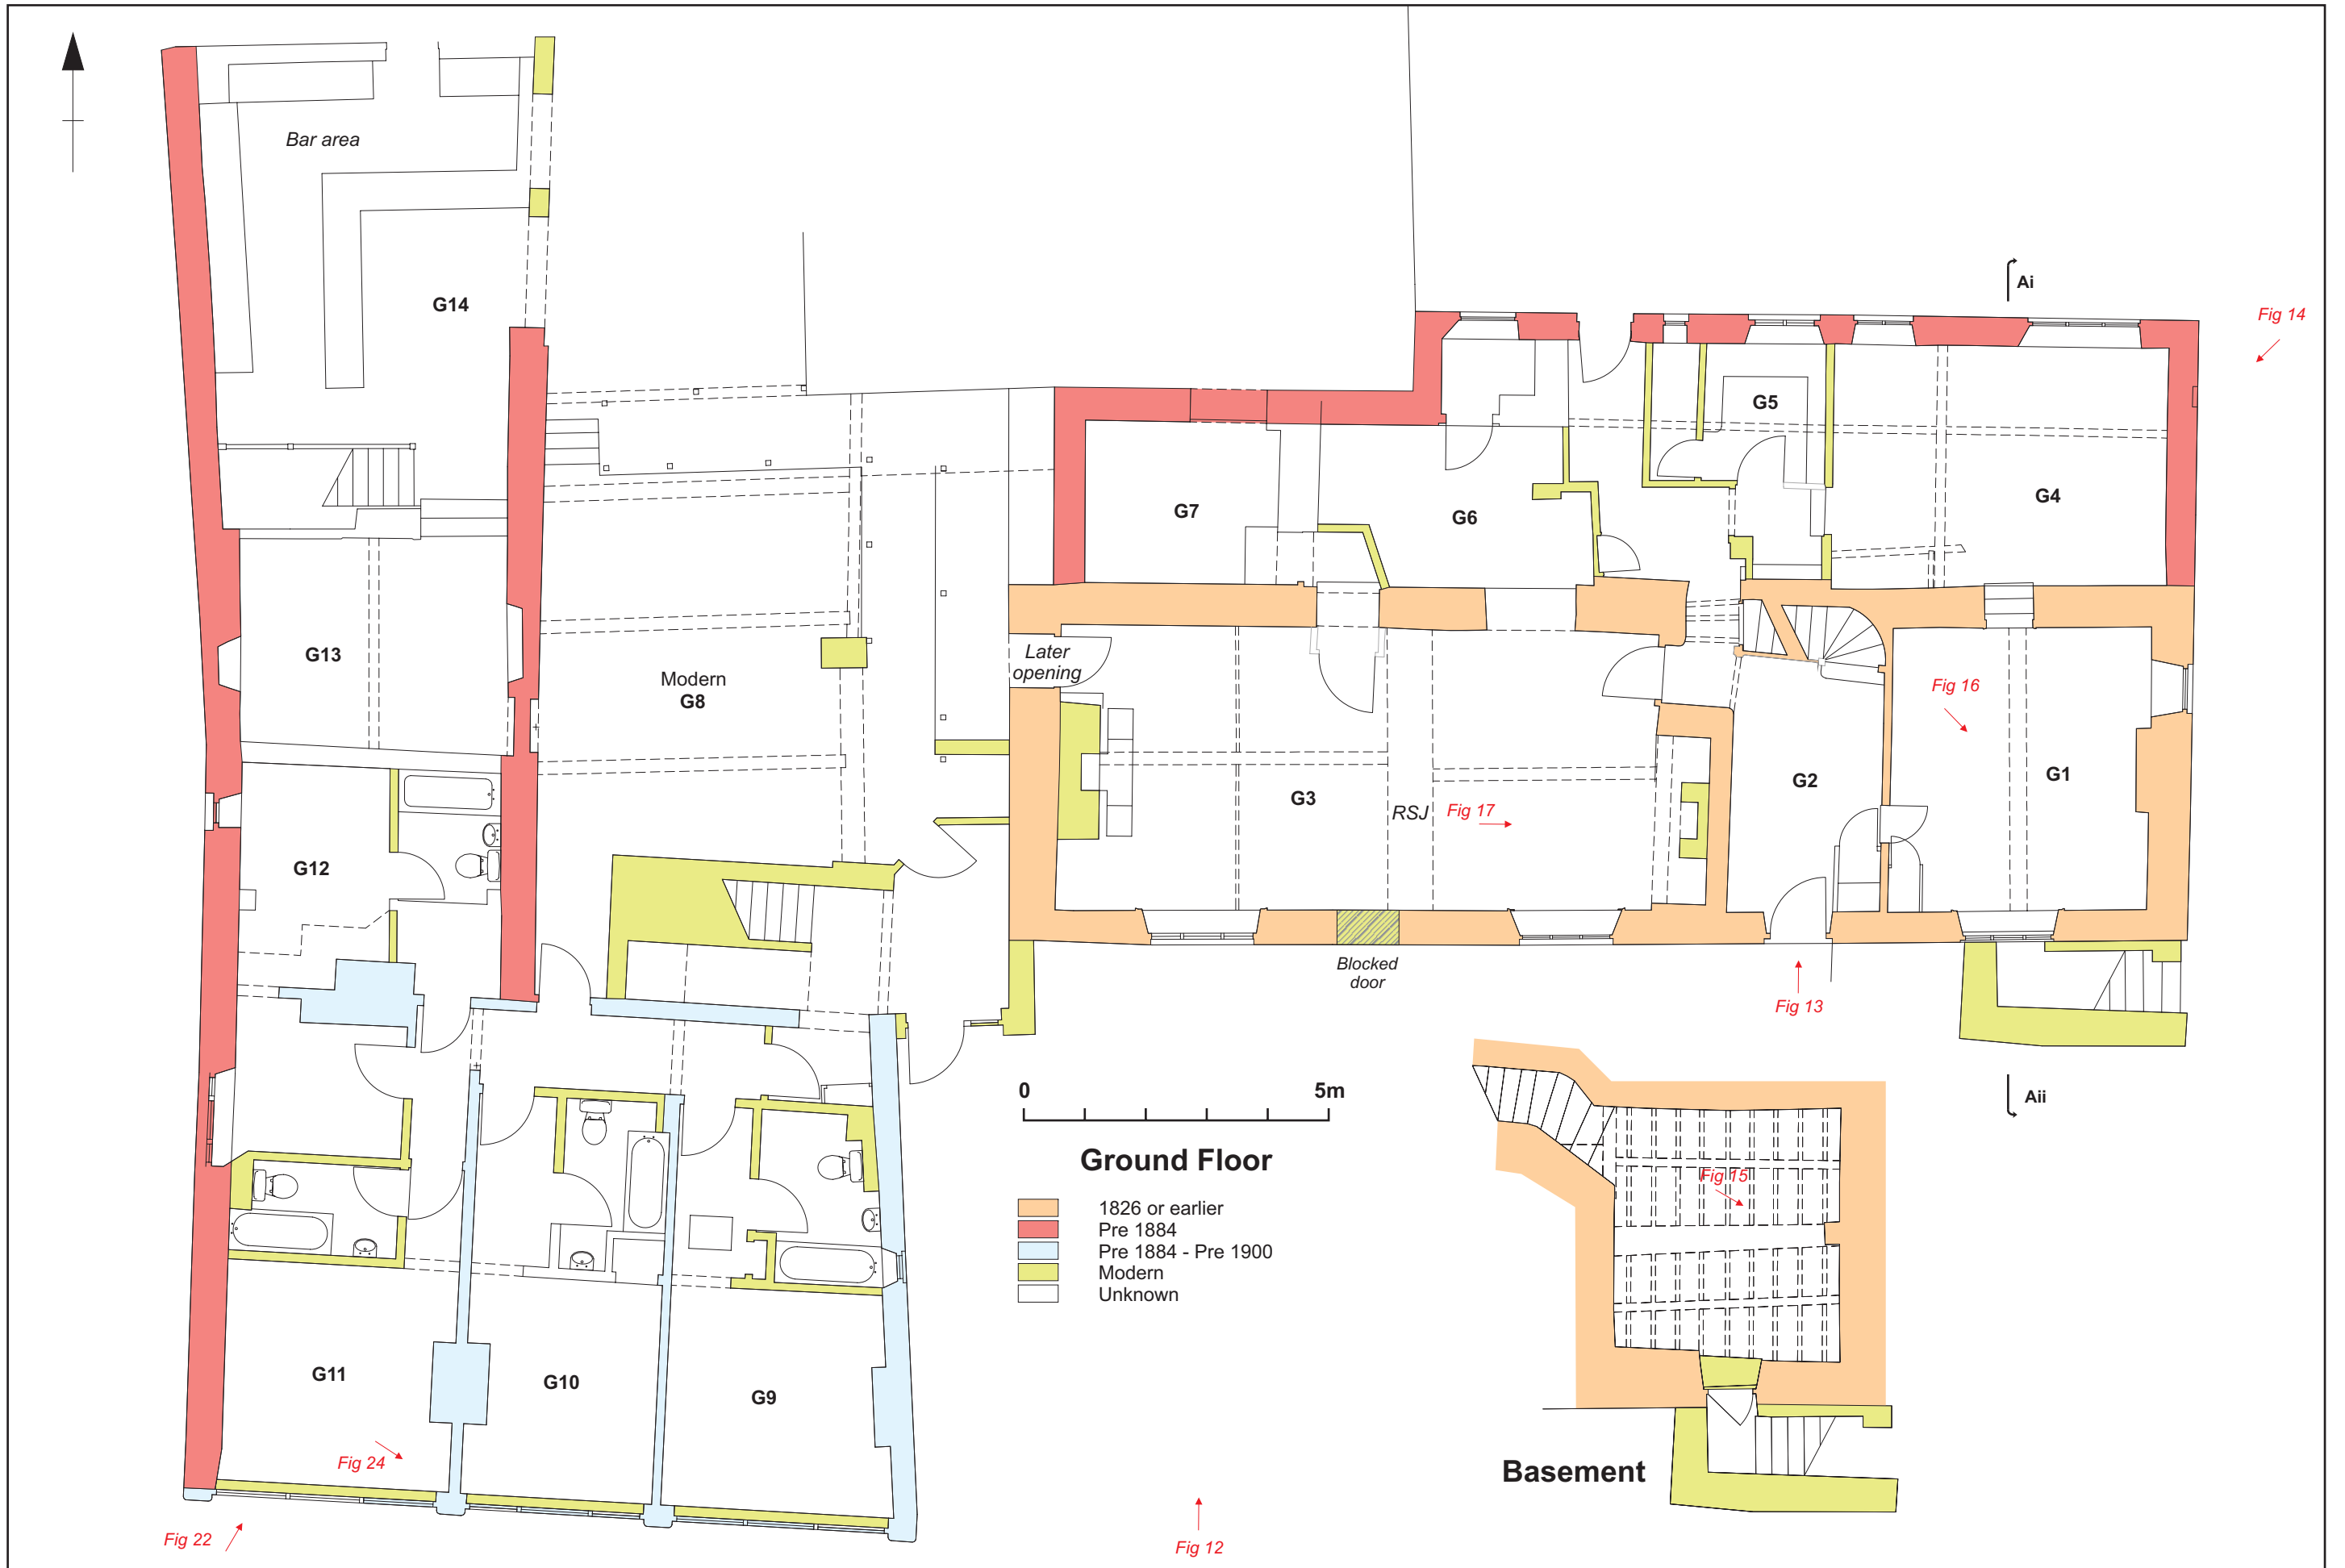
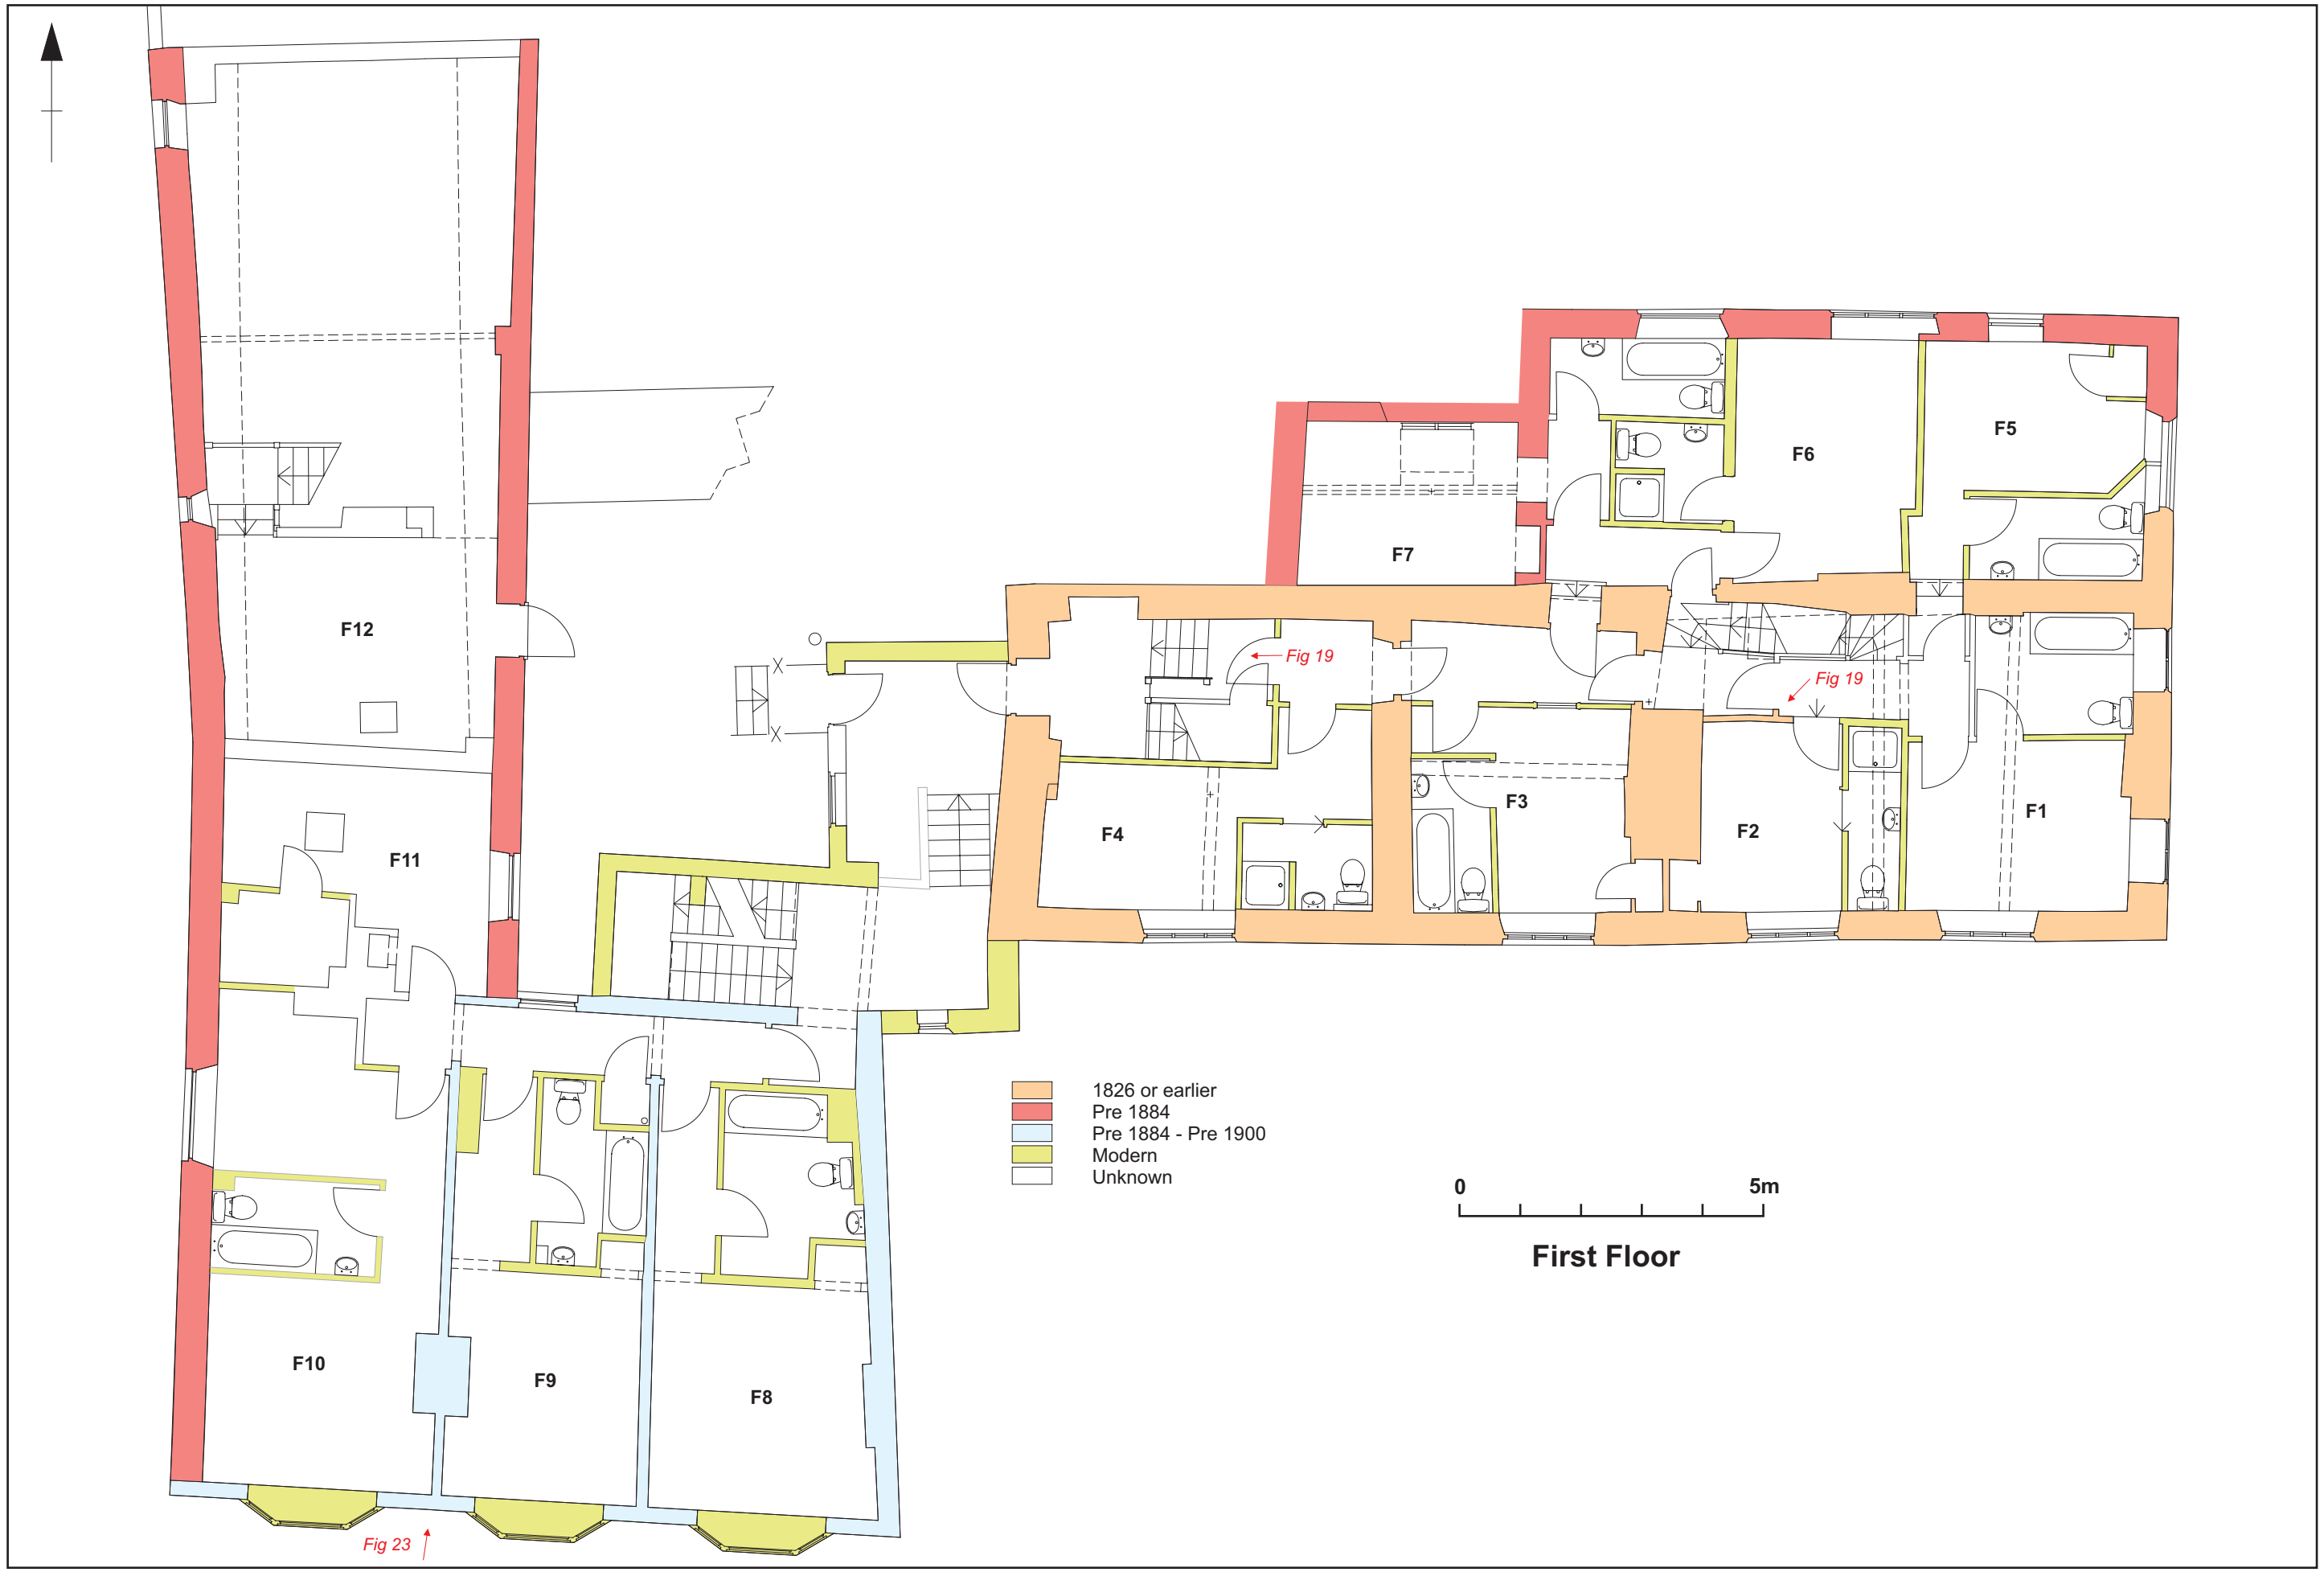
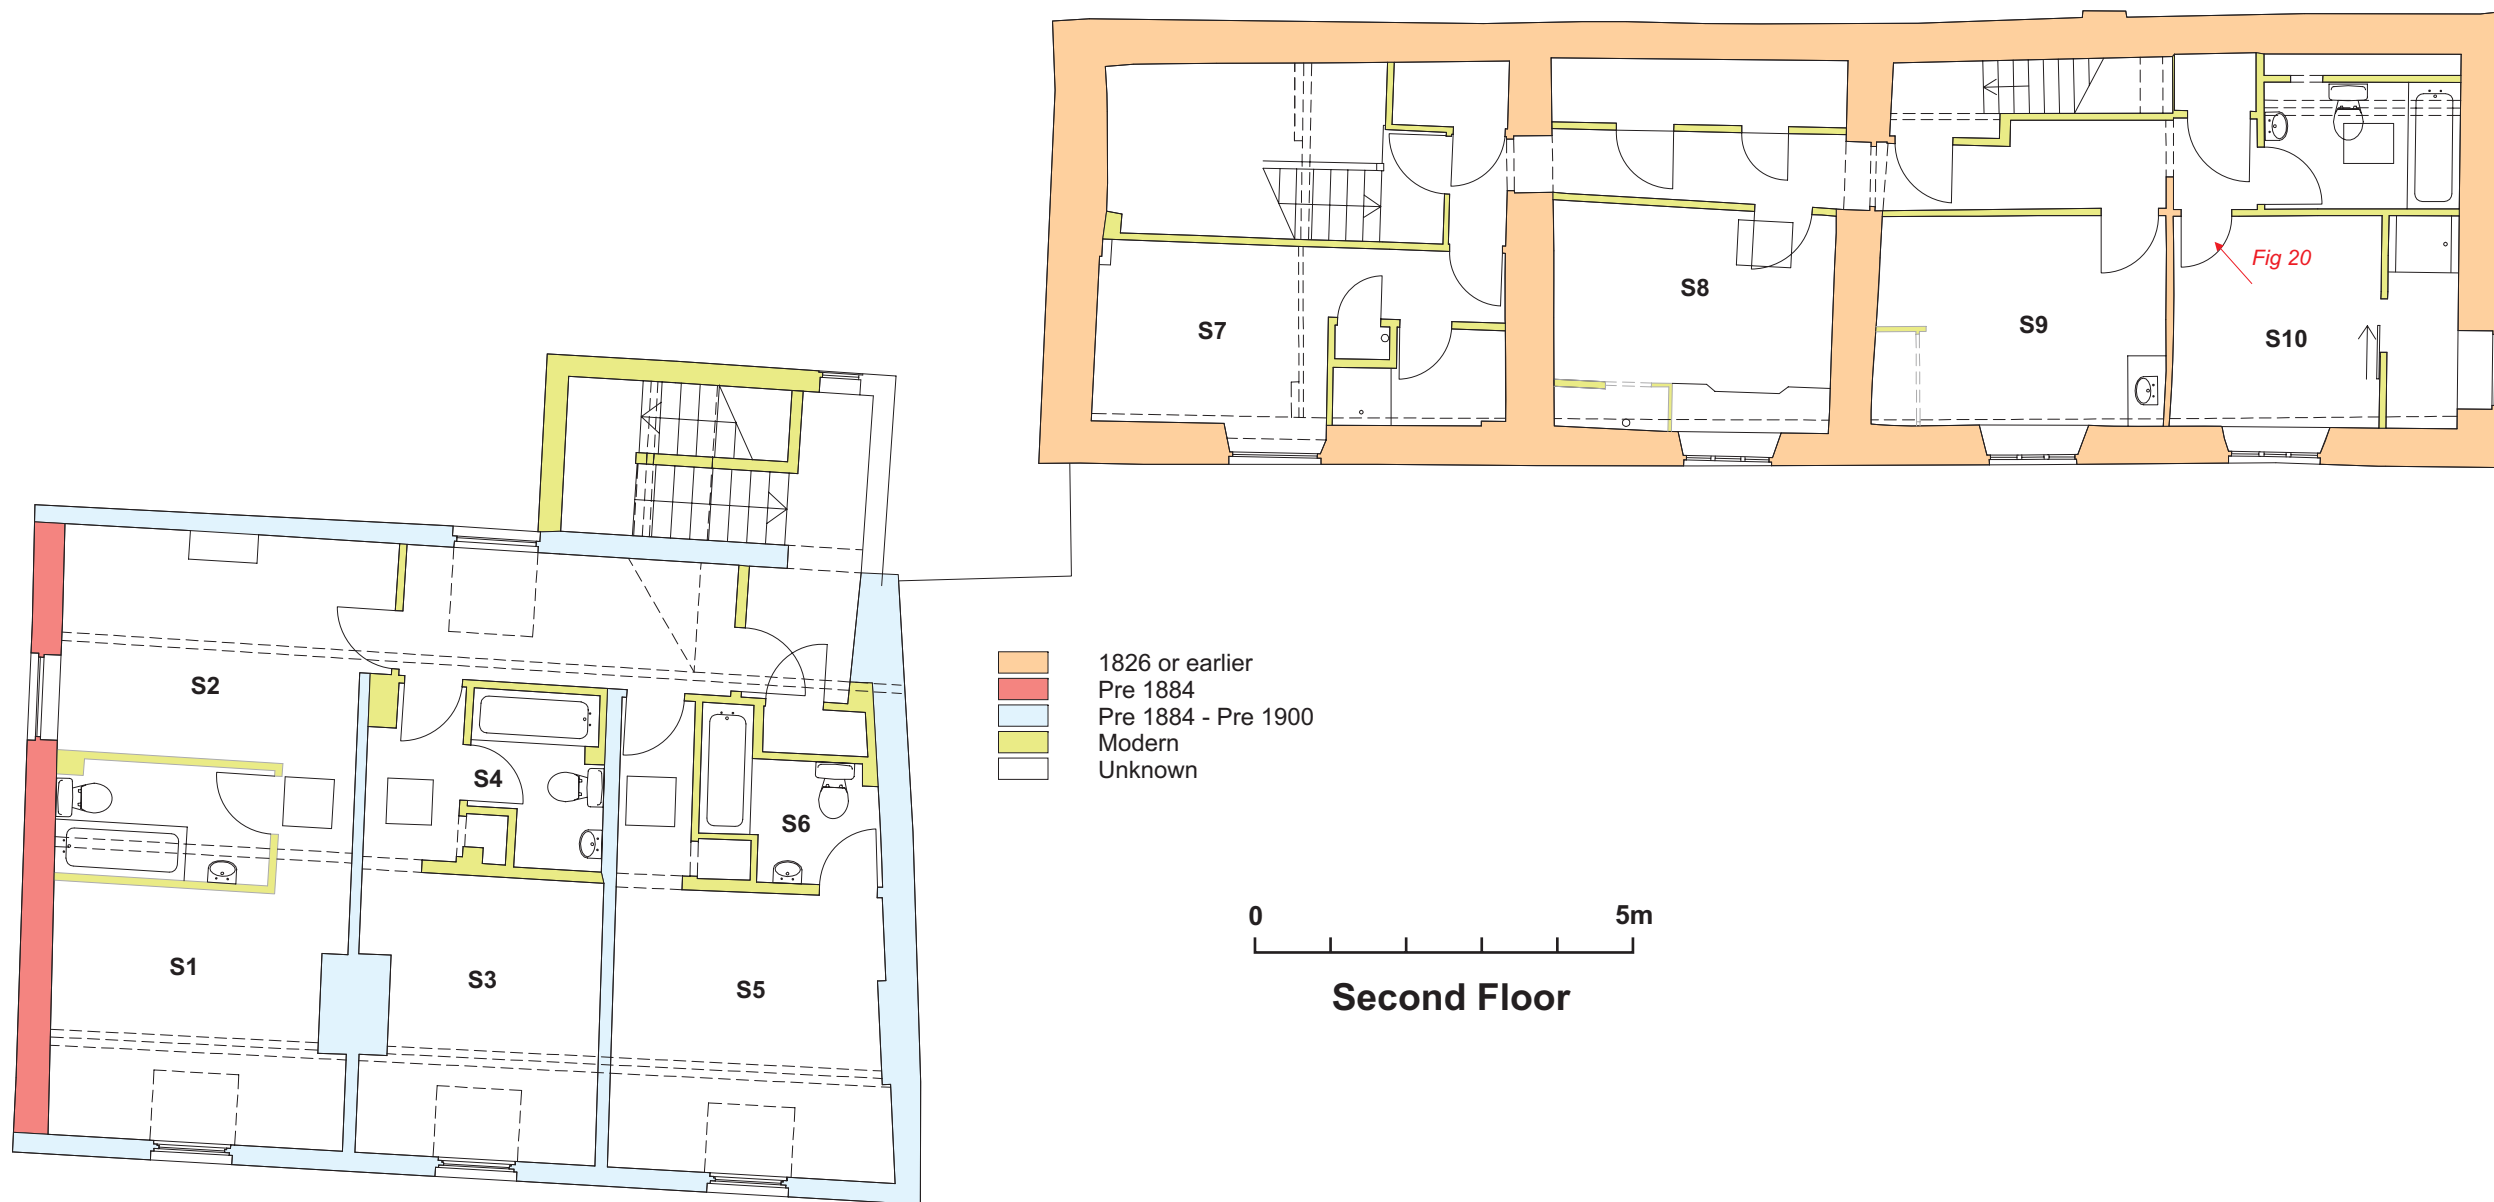
The buildings were visited between 9 and 10 May 2012 to carry out a photographic and drawn survey of the buildings to be affected by the proposed works (Figs 8-11).

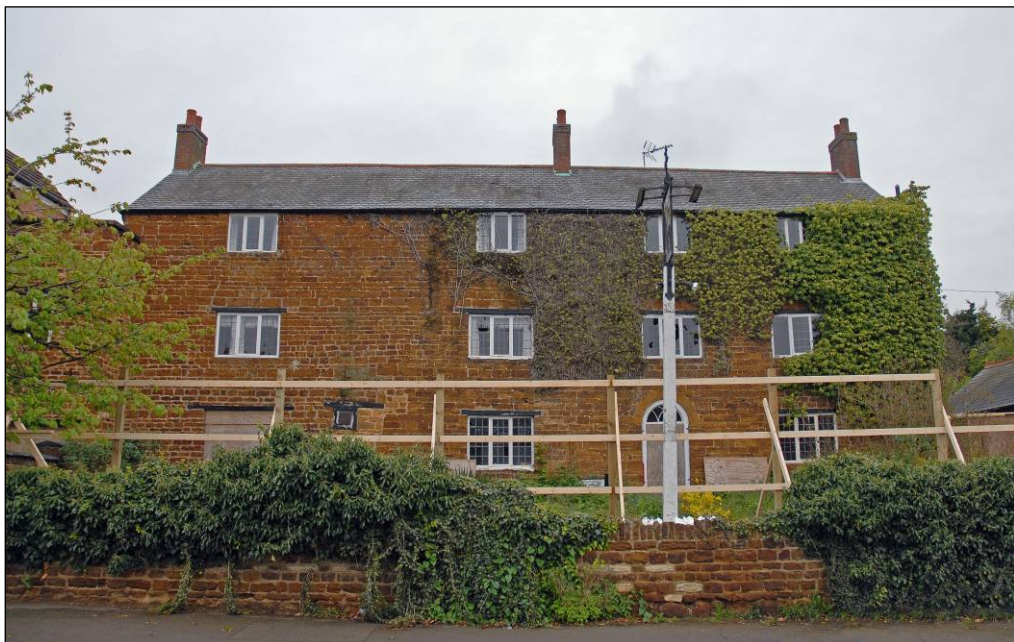
Fig 12

Former Gate Inn, facade

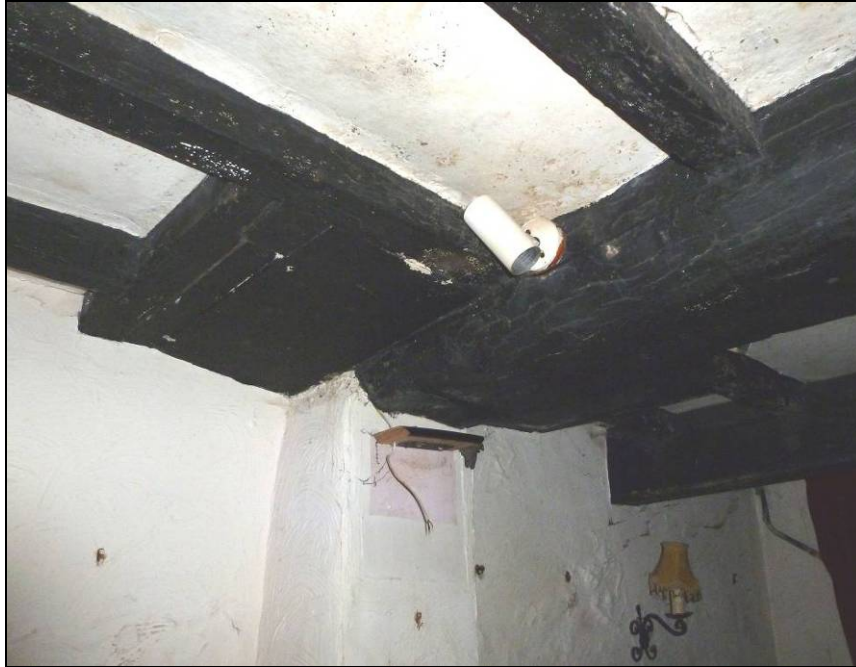
The single room basement was reached by a stone stair. The walls were painted with white 'artex' over stone, the lower half was covered with modern wood panelling. The ceiling has an exposed black painted principal beam and joists, there are further two fake beams to add 'olde worlde' charm to the room (Figs 9 and 15).

Basement showing exposed beam and joists, with fake beam to the right of the principal beam Fig 15

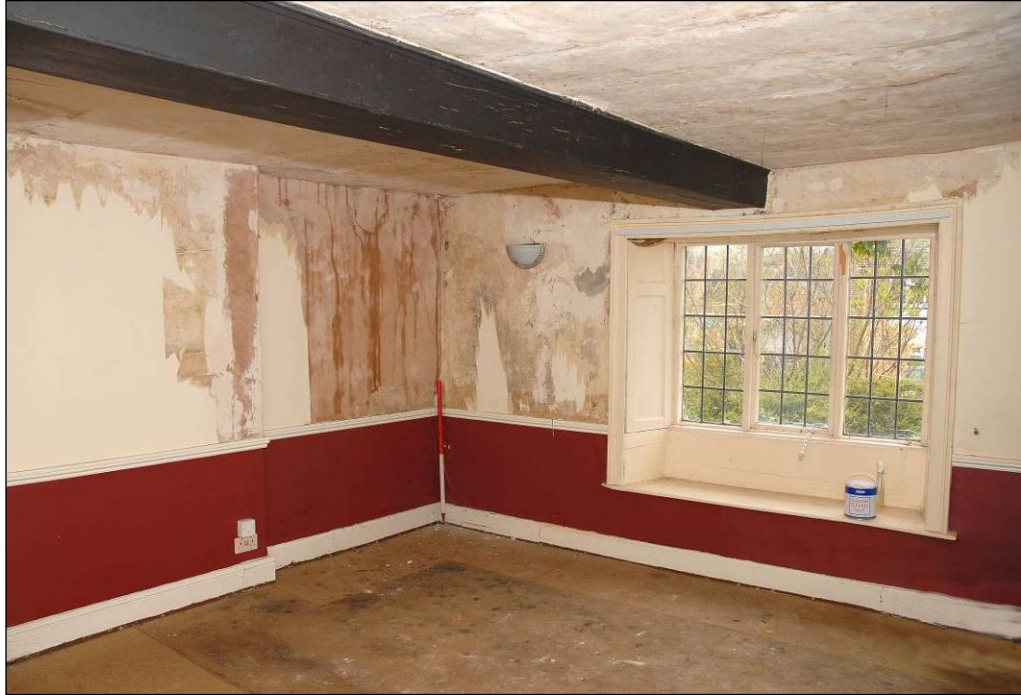
Fig 16

The only surviving 'early' feature in this room is the window, which is a three light leaded casement, in a splayed reveal, which retains its shutters and window seat. However, the shutters have been painted shut (Fig 16).

Room G1, showing 'early' window

The survey recorded the buildings as they stood in early May 2012. The survey has demonstrated that the buildings underwent a lot of change in recent years with the conversion of the property into a hotel. Original/early architectural features were limited in their survival; with the window in G1 being an exception but even in this case the shutters had been painted closed.

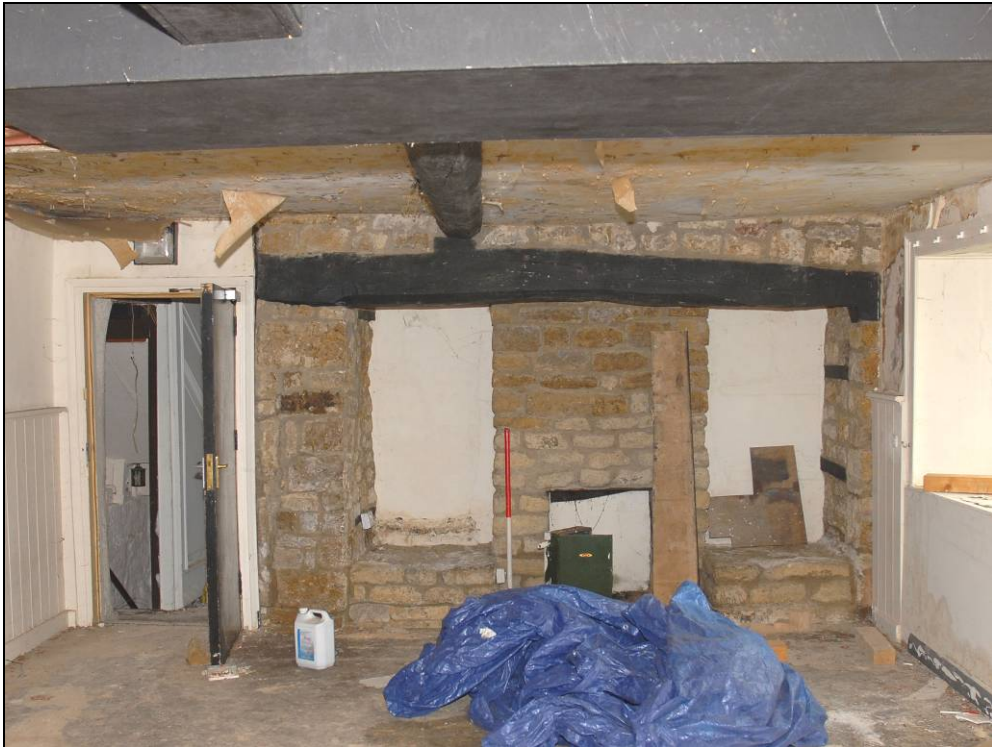
Fig 17

Latterly this large room served as the restaurant for the hotel. There are fireplaces at either end of the room that at the eastern end is an inglenook style with an exposed lintel and stonework; it has a smaller more recent stone fireplace inserted within it (Fig 17). That at the western end was modern with an exposed rough stone surround. The inglenook did not seem, to this recorder, to be quite 'right' and does not sit well in the room.

Room G3, the inglenook fireplace

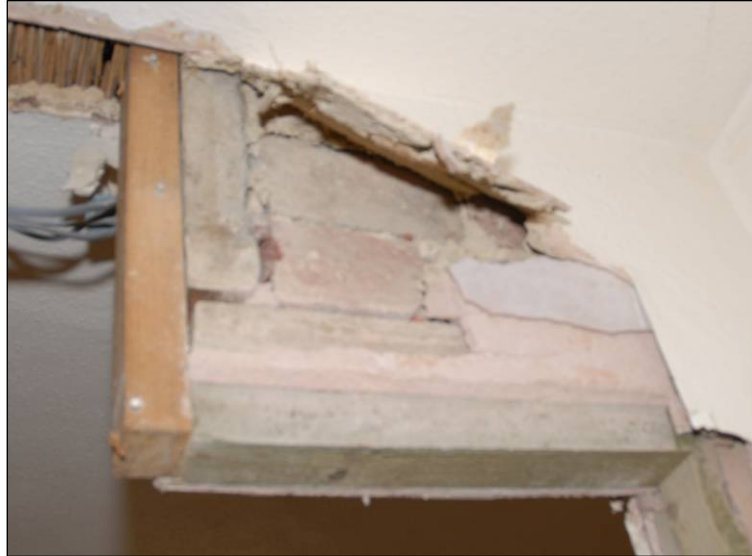
These rooms retained their principal original layout and evidence survived in Room F2 of the original corridor which would have lead from the stairs to access the four rooms. The wall between F2 and the corridor still partially survived and was constructed from brick on edge, between studs (Fig 18).

Room F2, Detail of surviving brick on edge construction Fig 18

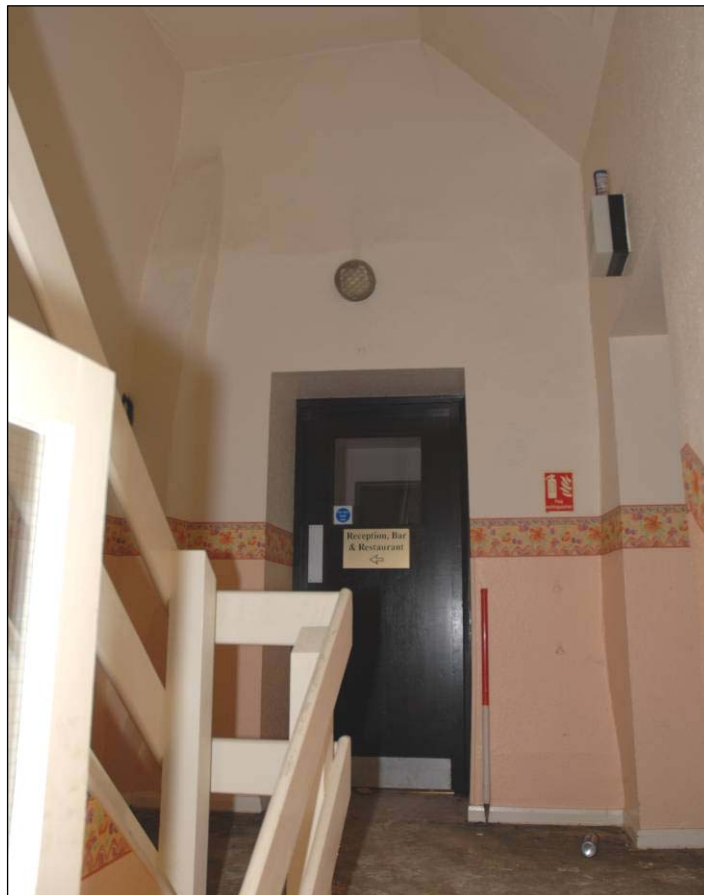
Fig 19

A modern stair and half landing had been inserted into Room F4 to access the modern extension which joined the late 19th-century building to the former Gate Inn.

Modern stair inserted into Room F4

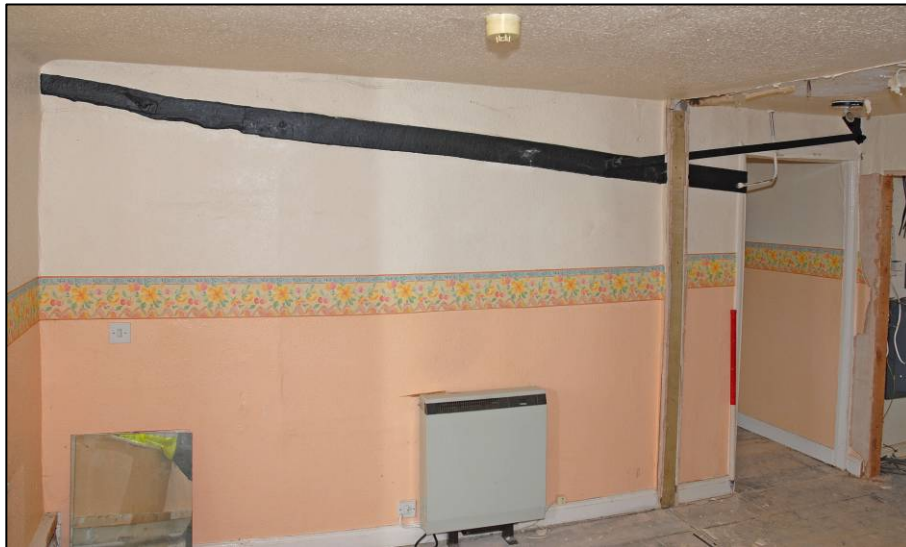
Fig 20

These four rooms, like those on the first floor, retained their basic original layout. The dividing wall between S9 and S10 was a stud wall with brick on edge infill. Exposed in this wall was a repaired tie beam, the broken end of which appeared to have been cut to facilitate entry into Room S10 (Fig 20).

Room S10, repaired tie beam

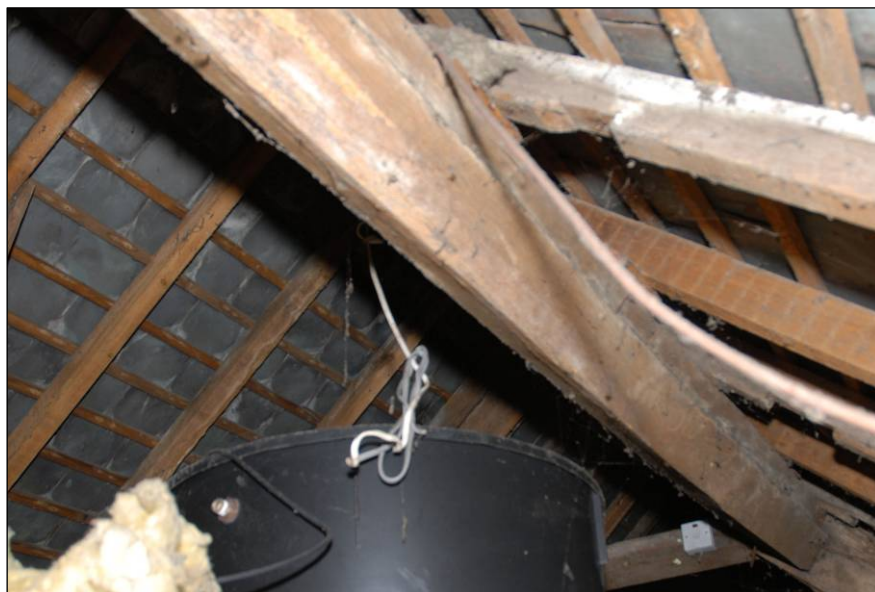
Fig 21

It was not possible to gain full access to the loft space, however, the visible elements of the roof structure were modern sawn pine (Fig 21).

Roof structure above Room S10

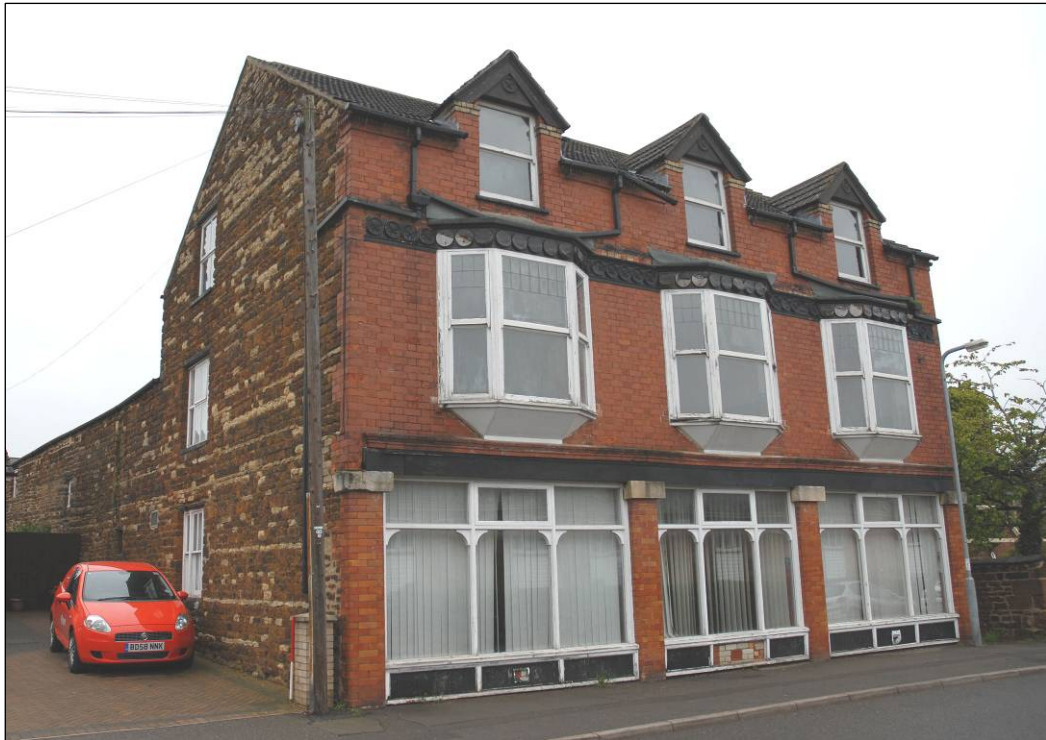
Fig 22

The three bay facade is in red brick, with modern glazed infill to the ground floor (Fig 22). At first floor level there are three inserted oriel windows, with modern hinged casements made to look like sash windows (as are all of the windows in this building). Between the first and second floors there is a decorative band of, now black painted, terracotta floral roundels. These have been rather inexpertly carried round the inserted oriel windows using circles of painted plywood (Fig 23). There are three dormer windows on the second floor, again with modern hinged casements made to look like sash windows (Fig 22).

The gable ends of this building are ironstone with some limestone banding (Fig 22).

Late 19th-century shop building facade

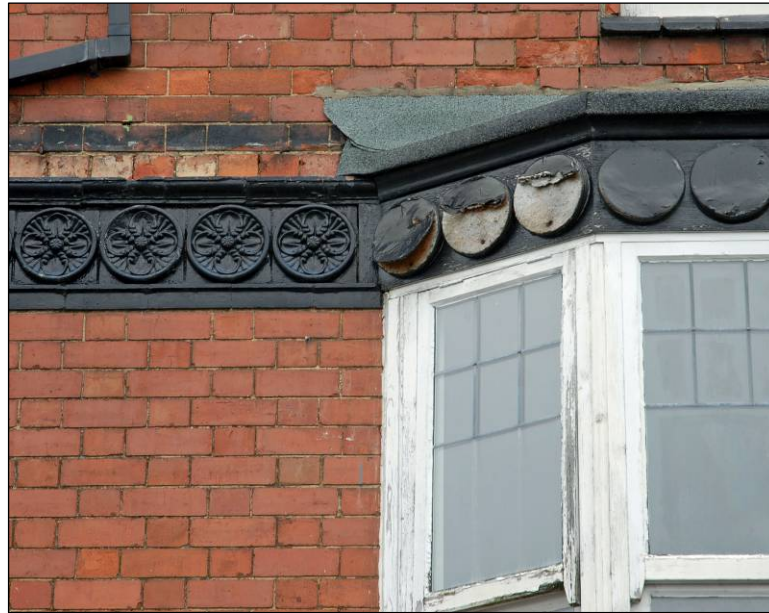
Fig 23

Facade detail

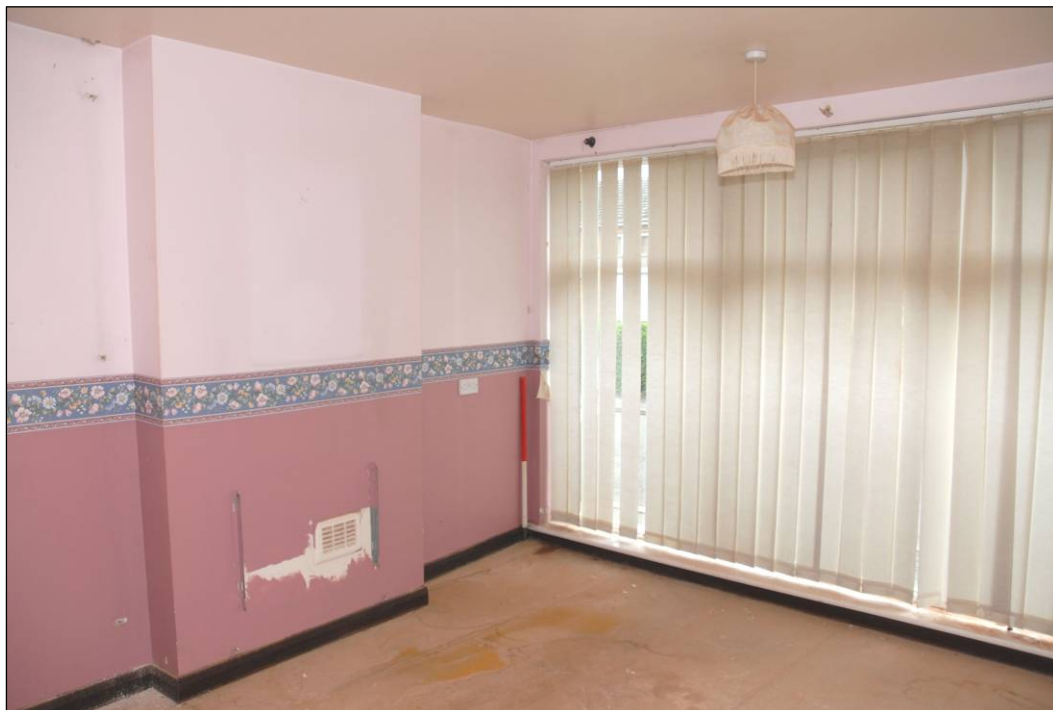
Fig 24

Room G11
