Assessment of Sunny Hill Farmhouse, Old End Padbury, Buckinghamshire June 2012

ASSESSMENT OF SUNNY HILL FARMHOUSE

OLD END, PADBURY, BUCKINGHAMSHIRE

Northamptonshire Archaeology carried out an assessment of elements of the 16th/17th-century Sunny Hill Farmhouse, Old End, Padbury, Buckinghamshire. The assessment demonstrated that the partition and chimney are likely to date to 1842 when the facade of the building was rebuilt in brick.

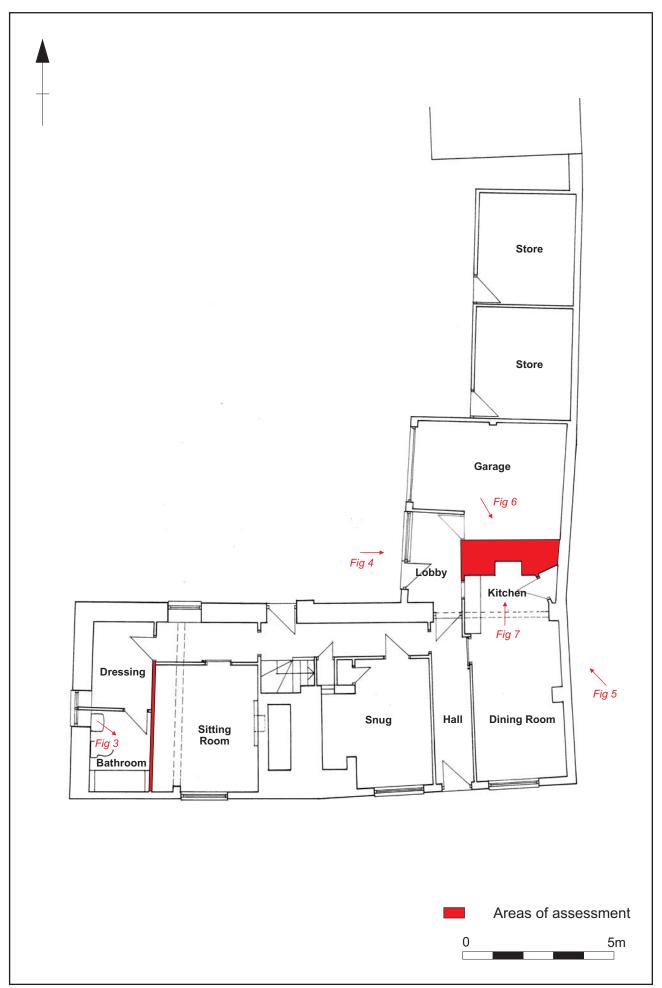
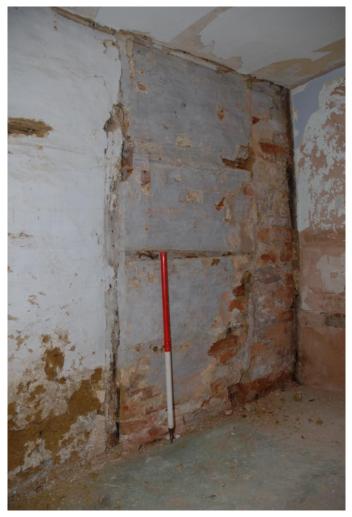
Fig 3

Where the plaster has been removed from the partition wall it was possible to see that it incorporated several different types of building material. The southern end of the wall has some brickwork in it which appears to be contemporary with the re-fronting of the house in 1842. There are also elements of timber work in the wall in the form of uprights with lath and plaster infill, also there is an area of lath and cob surviving within the wall (Fig 3).

The presence of the brickwork in the wall and the fact it appears to be tied into the brickwork of the 1842 facade would suggest that the wall is broadly contemporary with this work, with later patching of the plasterwork as this has been needed. The sitting room side of the wall has been faced with modern breeze block, the reasoning for this is not immediately clear although it may have been done to provide a flat surface for ease of decorating.

The internal partition wall

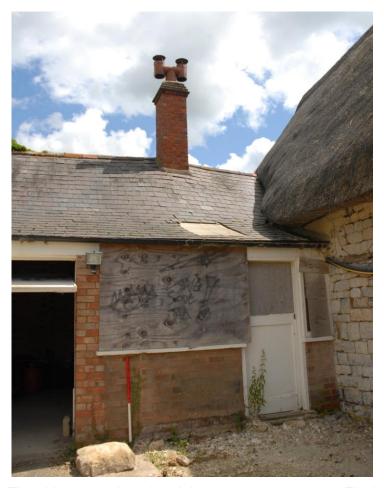
Fig 4

The structure of the chimney is enclosed by a modern lobby area and a garage (Fig 4). Also, the eastern gable of the building has been rebuilt in modern brick which has removed any traces of joins in building work on this gable (Fig 5).

The chimney and modern lobby area

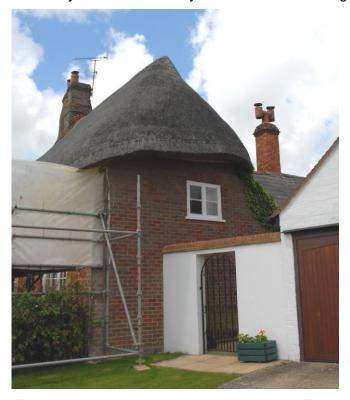
Fig 5

Due to the rebuilding of the eastern gable end it is not possible to ascertain the date of the stone wall into which the chimney is set.

The eastern gable end

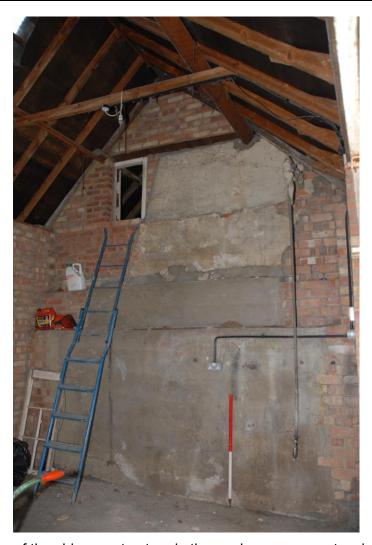
The chimney itself is built in red brick; internally within the garage the back of the chimney structure has been rendered (Fig 6). Within the kitchen area of the house it is clear that the wall into which the fireplace for the chimney has been inserted is stone and that the fireplace has either been inserted or altered to its current form (Fig 7).

The rear of the chimney structure in the modern garage extension Fig 6

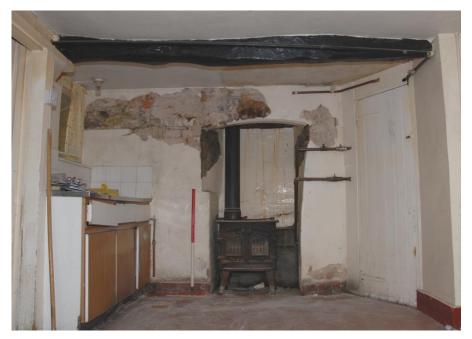
Fig 7

The use of brickwork would again indicate a 19th century date for the work and it is reasonable to infer that this work may also have taken place in 1842 when clearly the house underwent an extensive renovation/rebuild.

The fireplace opening for the chimney in the kitchen
