## Archaeological Building Recording at The Elms Yardley Gobion, Northamptonshire

Report 12/126

July 2012

*Northamptonshire Archaeology carried out buildings recording on outbuildings at The Elms, Yardley Gobion, Northamptonshire. The stone and brick-built, single-storey outbuildings, dated to the 19th century, were found to be unused, in a state of disrepair and partially demolished. The fabric of the buildings showed evidence of alterations such as blocked doorways and inserted and removed partitions.*

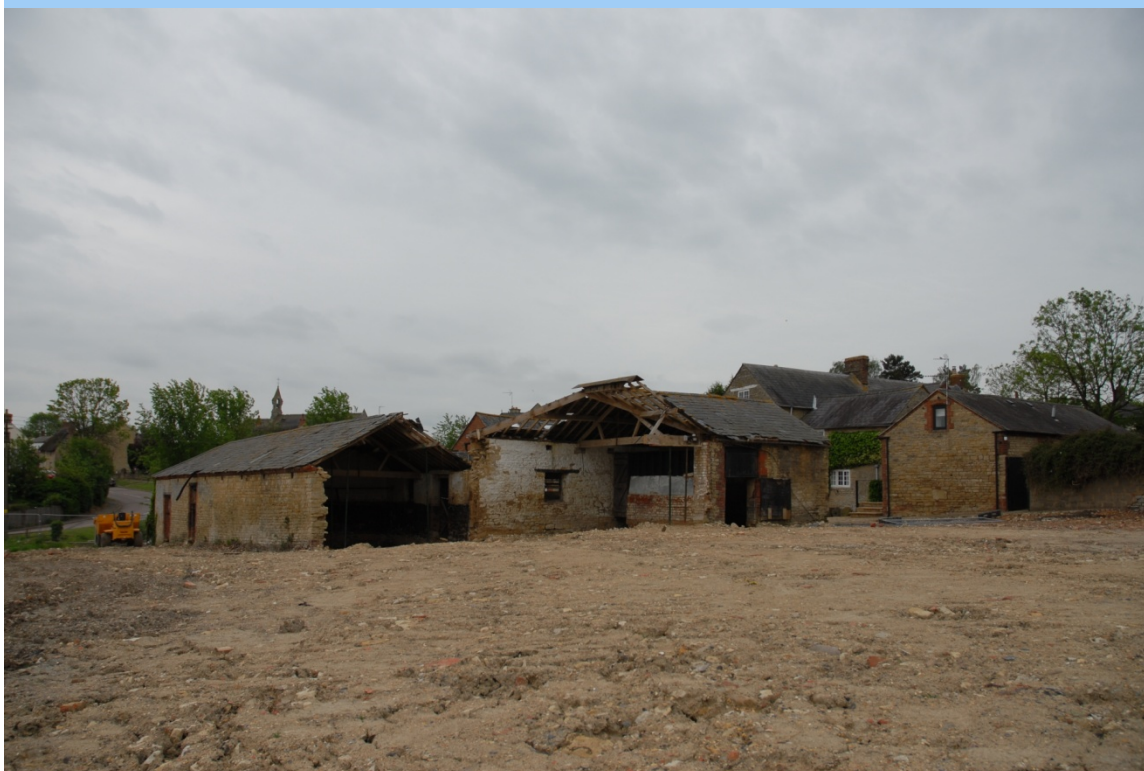
Cover: View of the outbuildings, looking south-west

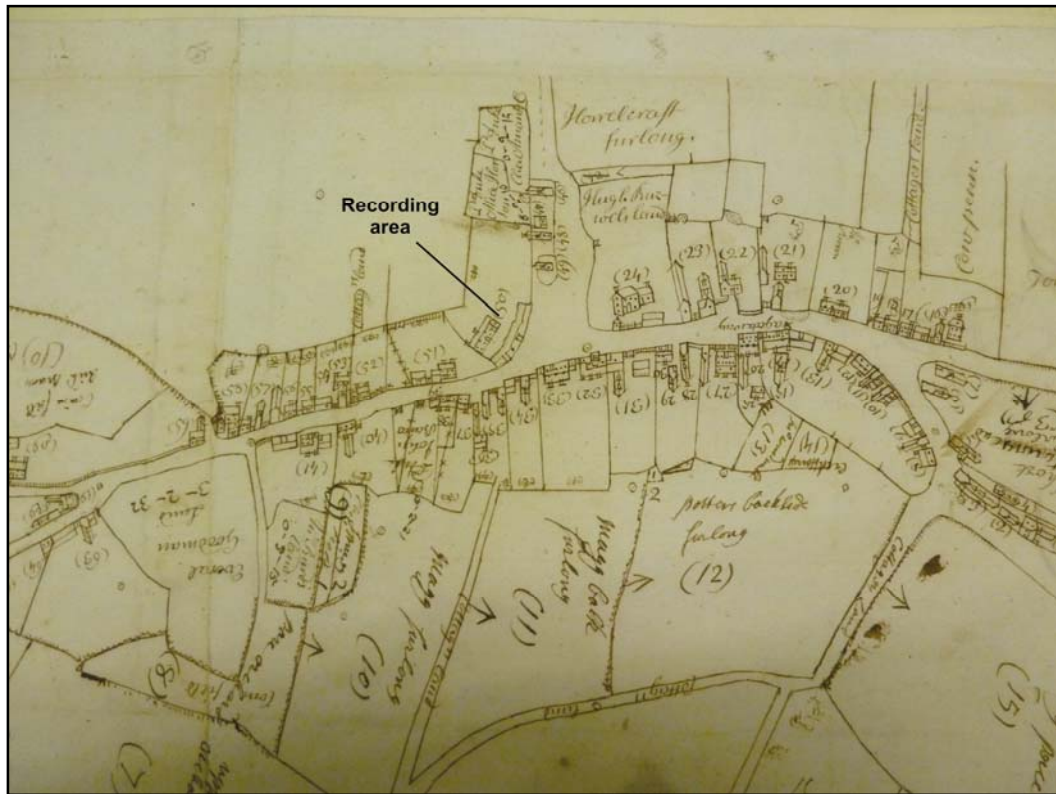
Collier and Baker's map of Yardley Gobion c1725 Fig 2

This map shows two parallel buildings on the site of The Elms. It is difficult to say with certainty how these relate to the buildings currently on the site but it is possible that these are earlier buildings which were demolished before the construction of the current structures.

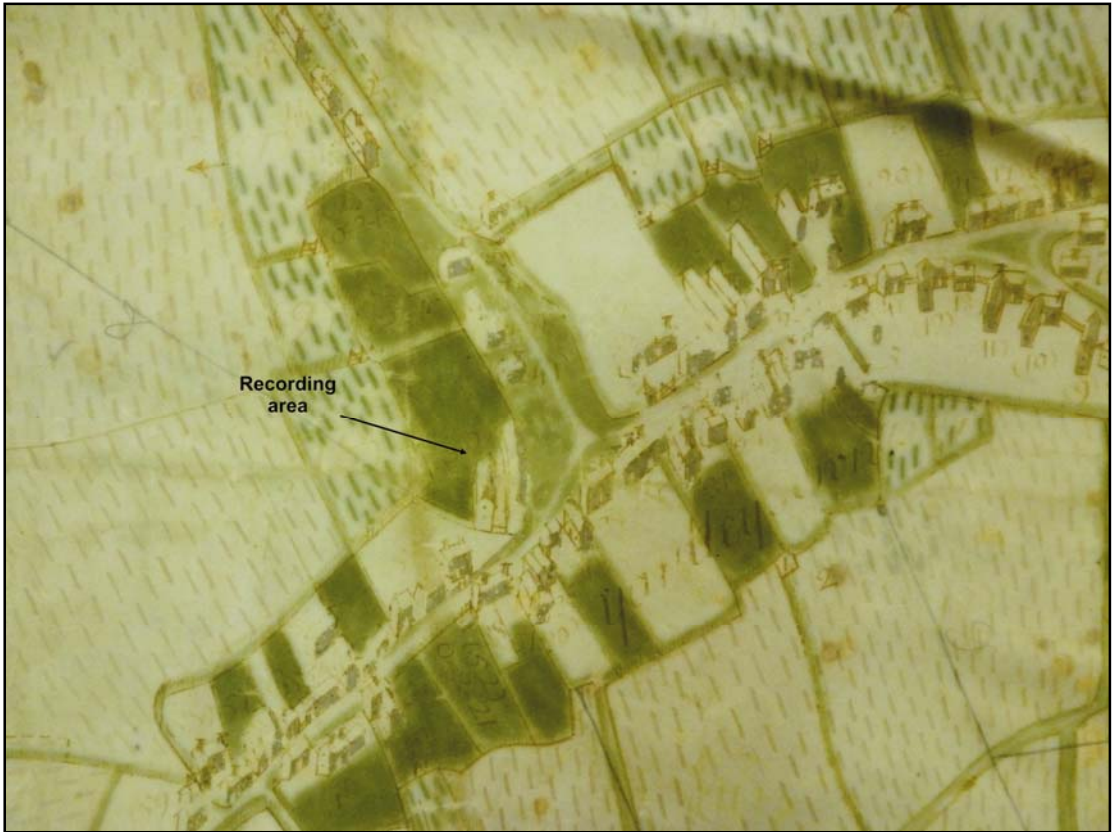
Historic map of 1728, showing the recording area Fig 3

There is little change from the earlier map. The two parallel ranges of buildings are still present with no new structures depicted.

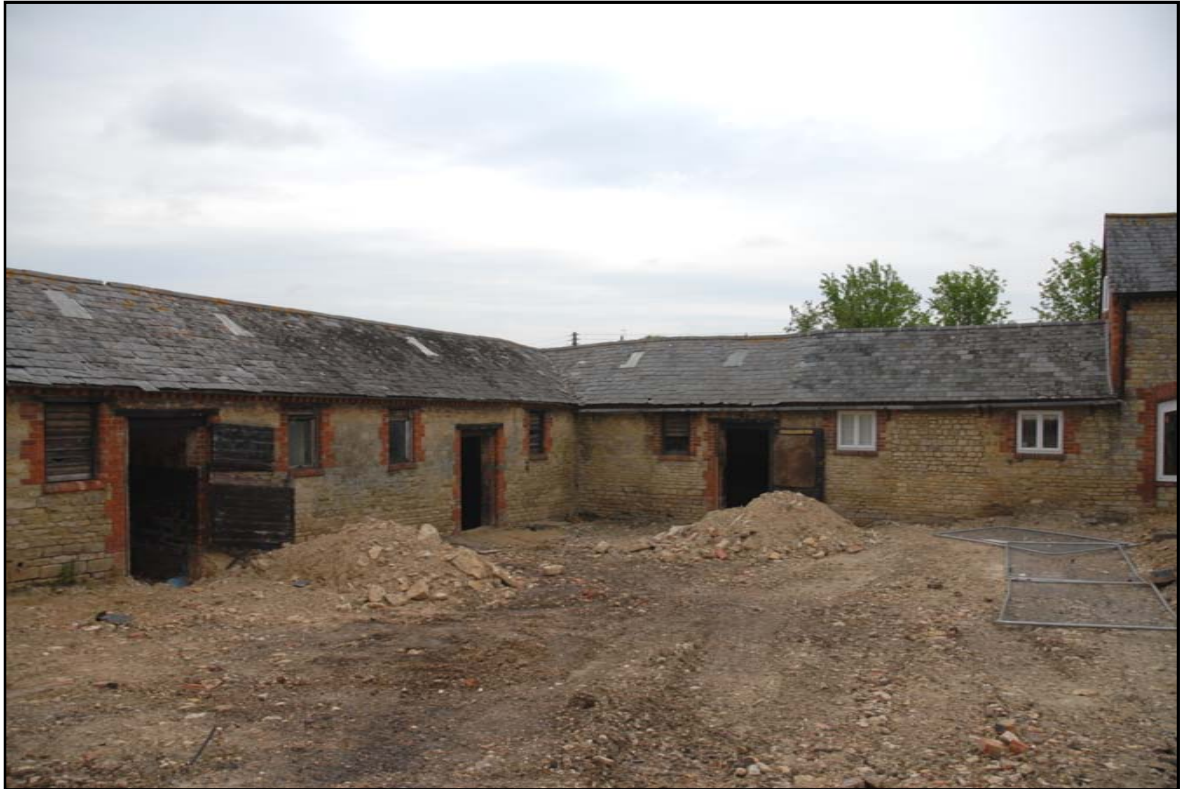
The southern range of the recording area, this building adjoins a two storey house to the west (Fig 8). Half of the range has been incorporated into the house and was not part of the surveyed area. A blocked doorway can be seen on this area, probably dating to the conversion of the structure to a residential function (Figs 6&7). Building 1 is divided into two rooms, G1 and G2. Room G1 is accessed via a doorway on the northern elevation, facing into the central courtyard (Fig 8). An iron hayrack remained against the southern wall of the room (Fig 14). A louvered window is built into the northern wall of the room. The upper wall of room G1 is whitewashed and the lower extent of the wall is painted black.

Room G4, the smallest room of Building 2, is accessed via the central courtyard (Figs 8 & 9). A hay rack was present on the eastern wall of the room (Fig 18). A louvered window in the western wall provides light and ventilation into the room.

Buildings B1 and B2, looking south-east Fig 8

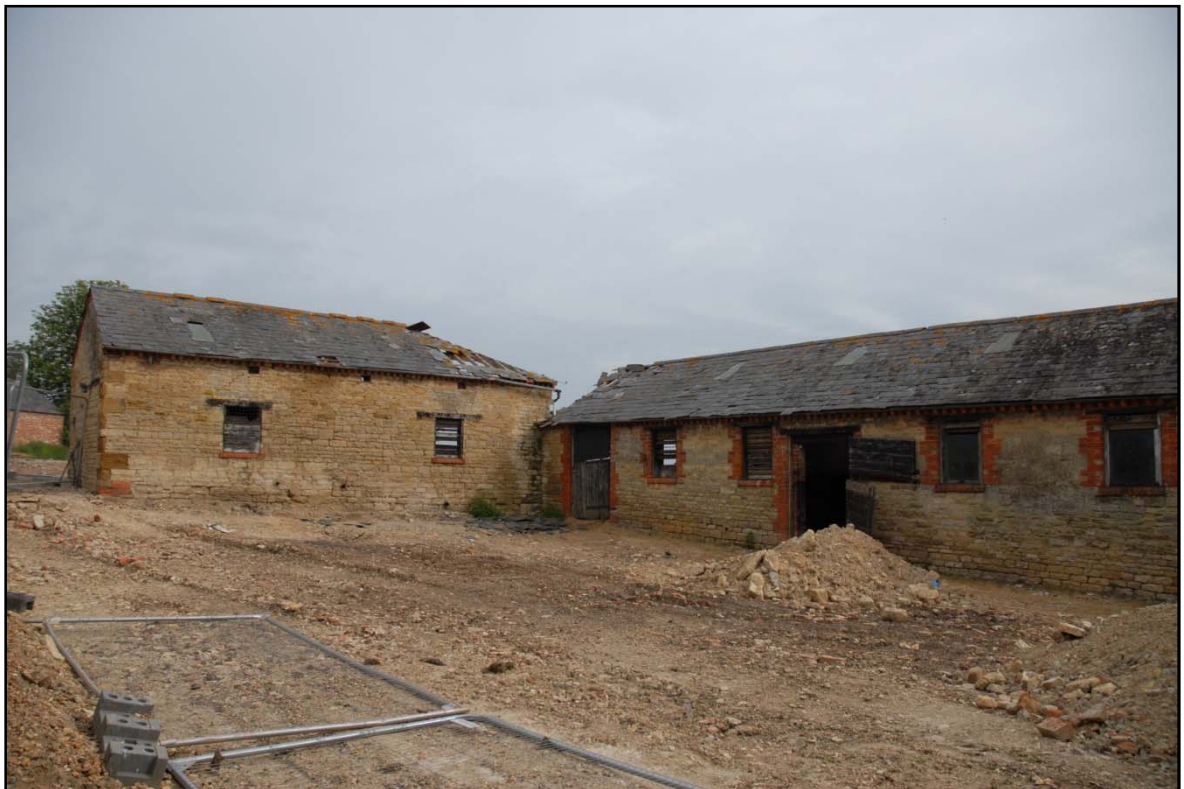
Buildings B2 and B3, looking north Fig 9

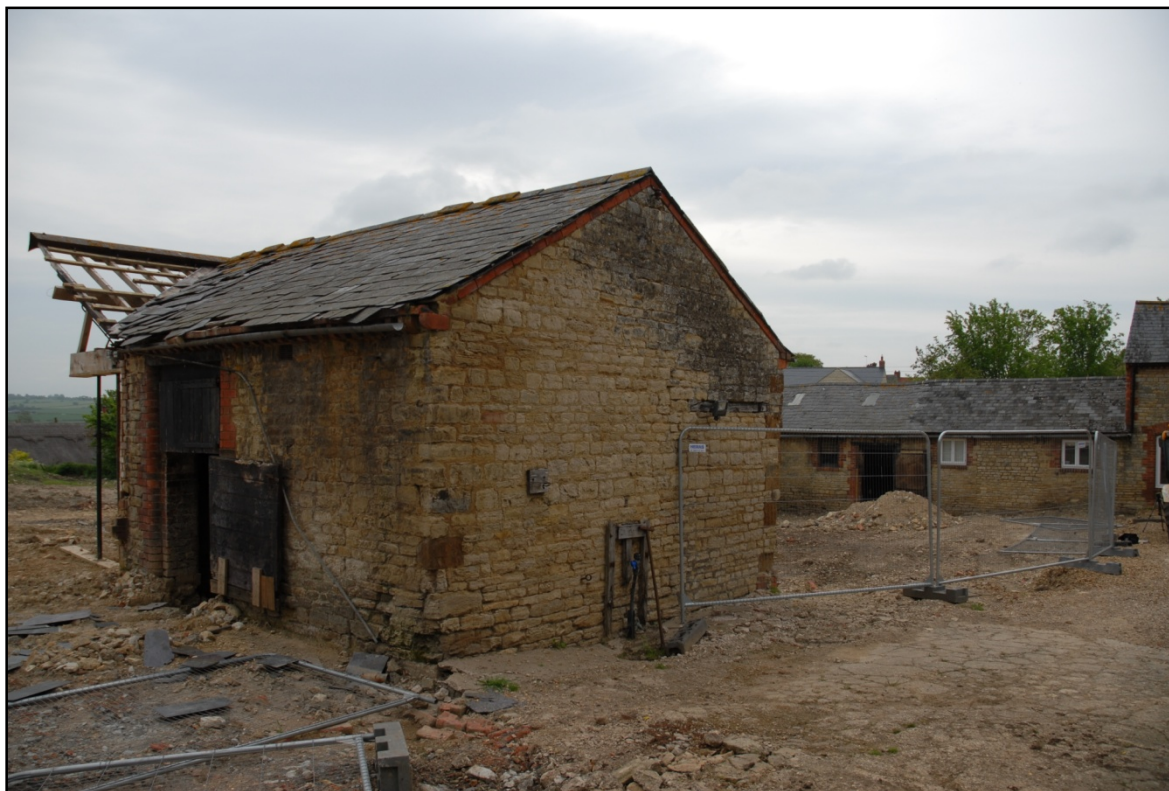
The buildings are primarily constructed from pale yellow sandy limestone set in a coarse, gravelly, yellow-brown mortar. Quoins of ferruginous sandstone are present on the corner of Building 3 (Fig 10). The jambs and reveals are stressed with quoins of contrasting squared and bullnose brickwork, laid to courses with the walling stone (Fig 22). The hinges of the doors are embedded either in timbers inserted into the brickwork or larger blocks of a medium – fine grained, grey sandstone. Inverted bullnose dentils run the full length of the buildings, below the eaves (Fig 22). Square vents are present at regular intervals below the eaves, with external metal meshes. Occasional timber beams are present, both internally and externally, to allow equipment and lighting to be hung from screws and nails.

The western elevation of building B3 with sandstone quoins visible to the right, looking east Fig 10

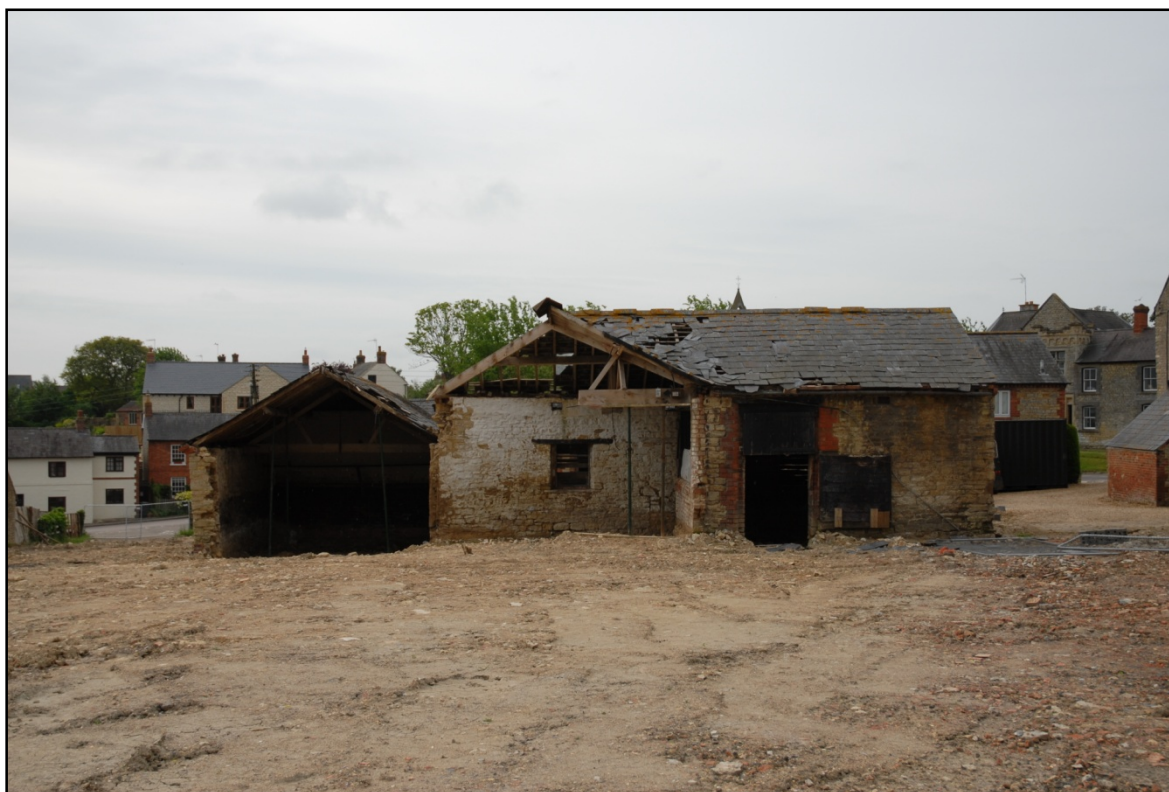
The northern elevations of buildings B3 and B2, looking south-east Fig 11

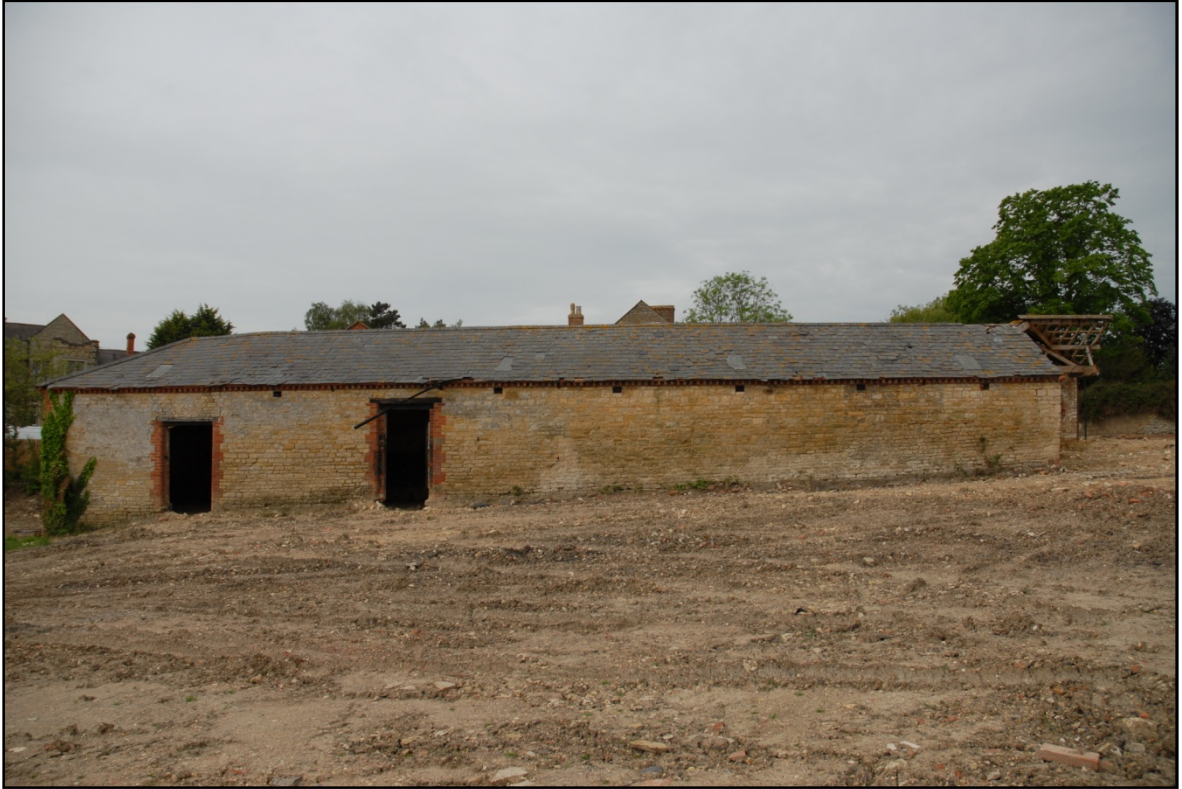
Room G2 is accessed via an external doorway on the eastern elevation and an internal doorway which provides access to room G3 of Building 2 (Figs 12, 13, 15 & 17). Evidence for a removed partition could be seen on the south-western wall of Room G2. *In-situ* wooden supports on this wall indicate that a small hay loft was present here (Figs 15 & 17). This partition can be seen on the 2010 architect survey plan. The walls of room G2 are whitewashed to the extent of the eaves/gable.

The eastern elevation of buildings B2 and B1, looking south-west Fig 12

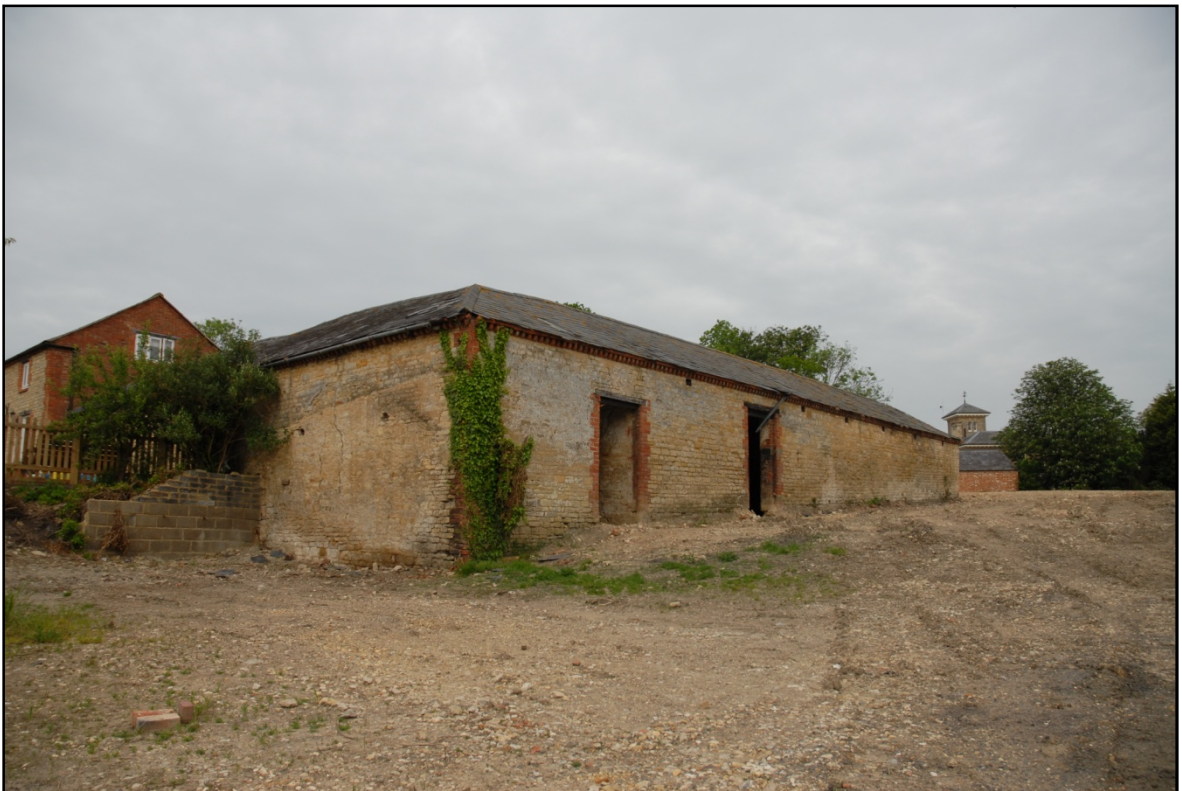
The southern elevation of building B1, with the scar of a former building visible to the left, looking north-west Fig 13

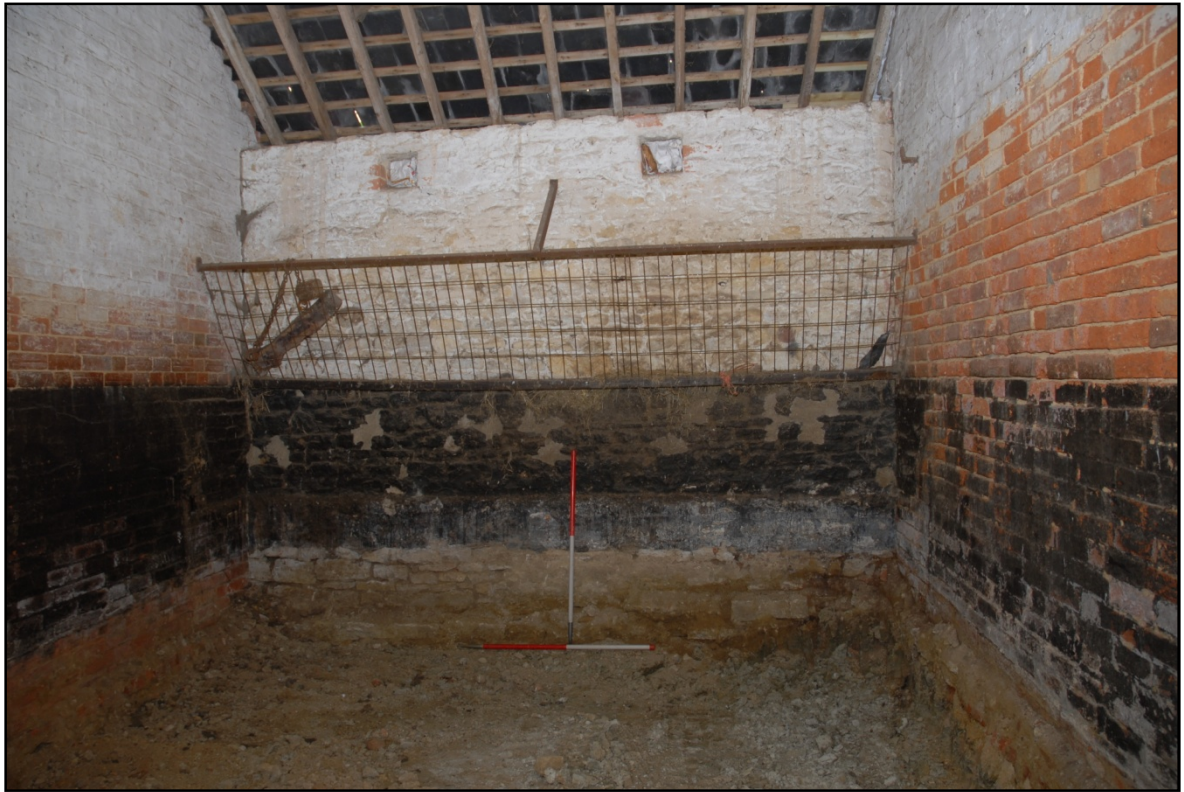
Room G1 with hay rack on the rear wall, looking south-east Fig 14

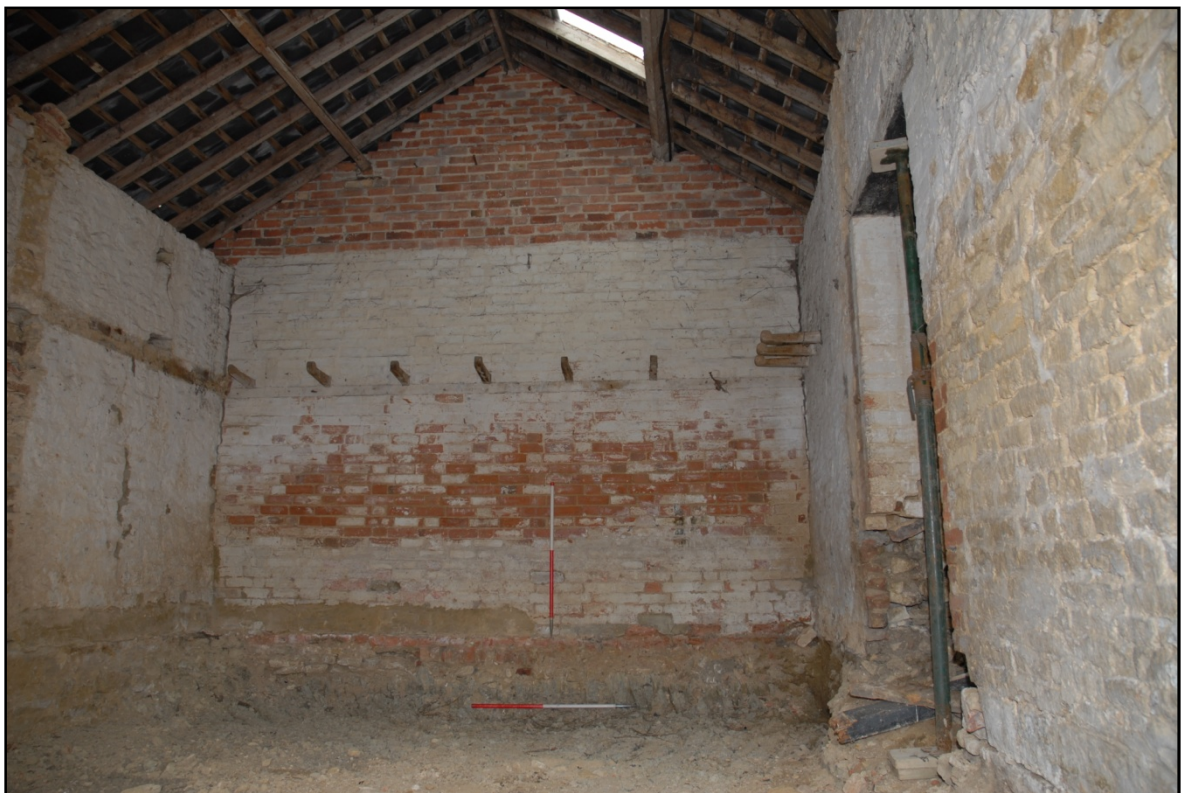
Room G2 showing the scars from a removed partition and former hay loft, looking south-west Fig 15

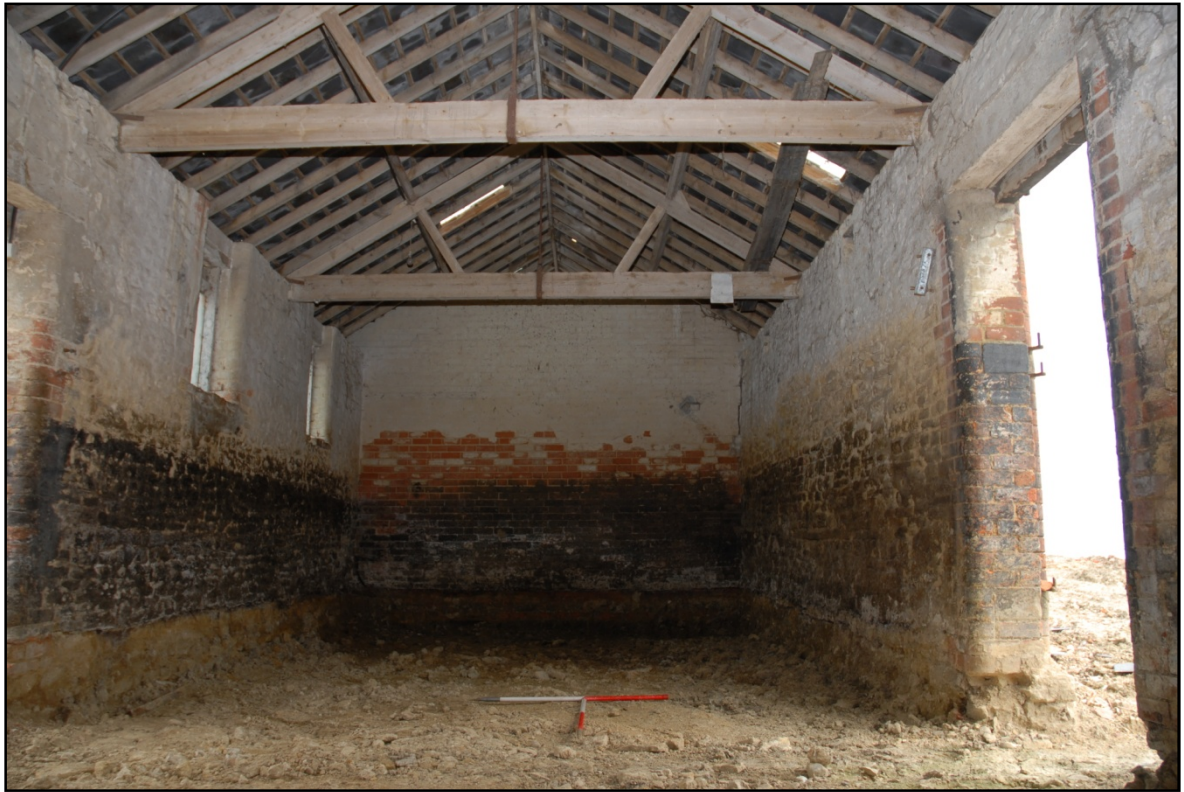
The roof is Welsh slate nailed to a machine sawn timber frame of battens, rafters and purlins supported by a simple king post truss with an iron supporting rod instead of a central post (Figs 16, 17, 20 & 23). Rectangular roof lights are present at regular intervals throughout the structures. It was unclear if these were original to the structure or were later additions.

Building 2 forms the eastern range of the recording area and is divided into three rooms, G3, G4 and G5 (Figs 6&7). Room G3 is accessed via doorways on the east and western walls (Figs 16 & 17). Two louvered windows are built into the western wall. A doorway in the southern wall of the room provides access to room G2 of Building 1. No fixtures or fittings remained in the room during the survey. The room has a combination of whitewash and black painted walls (Figs 16&17).

The interior of room G3, looking north-west Fig 16

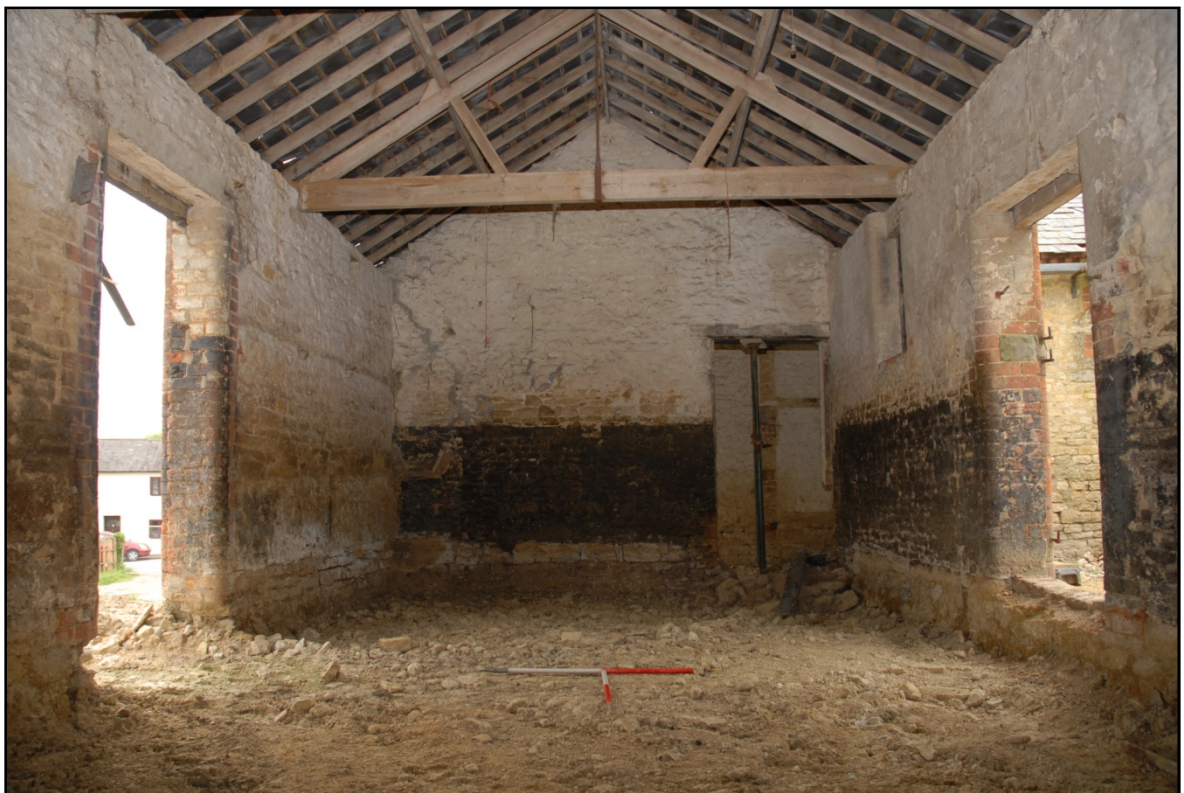
The interior of room G3 with room G2 beyond, looking south-east Fig 17

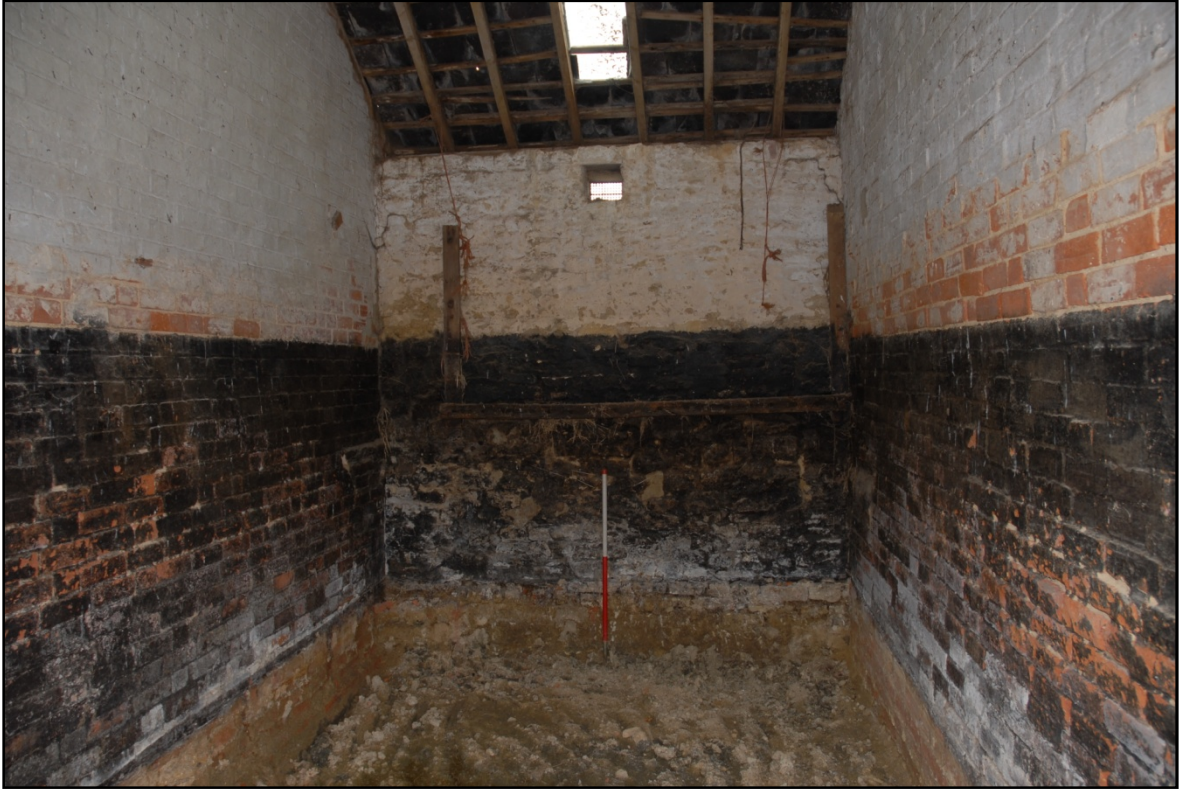
Room G4 with hay rack on the rear wall, looking north-east Fig 18

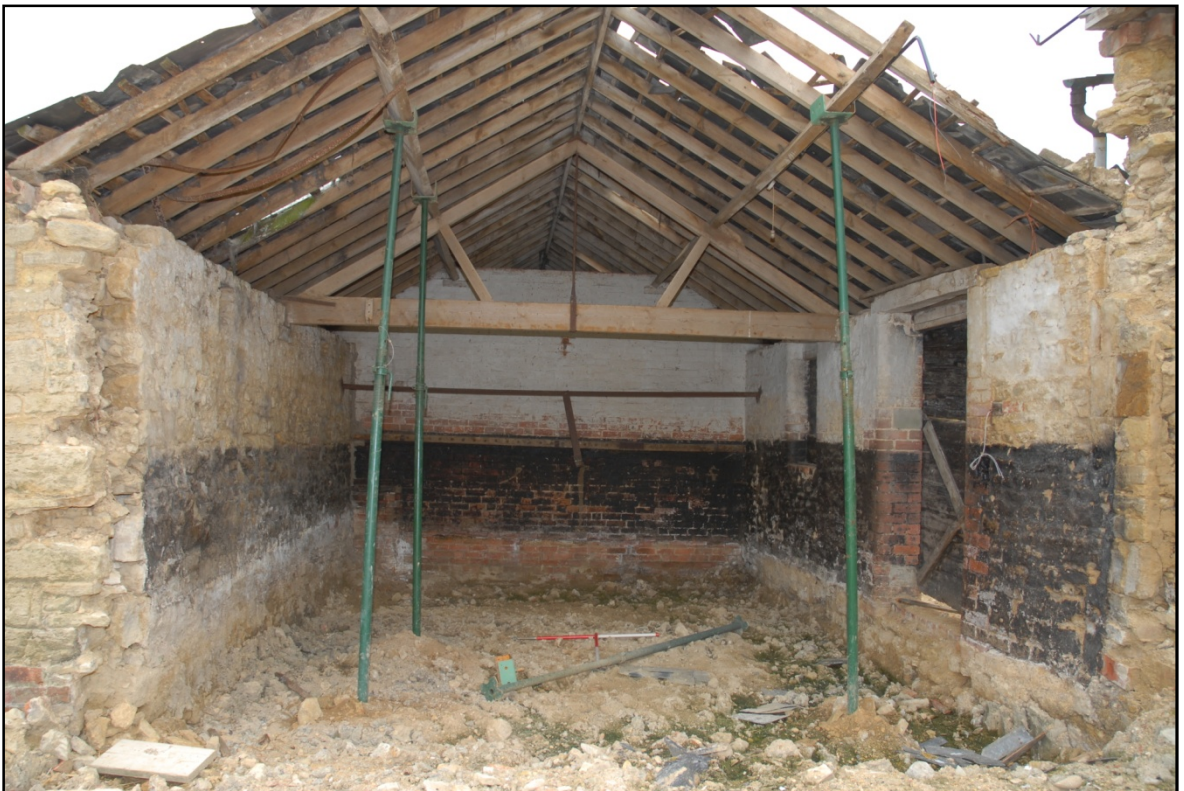
Room G5 forms the northerly room of the range. It was partially demolished and unroofed at the time of the survey. The northern wall of the room, visible on the 2010 plan had been removed by the time of recording. The room is accessed via a door in the western wall, facing the courtyard. A second doorway in the north wall is shown on the 2010 plan. A hayrack remained on the southern wall (Fig 19).

Room G5 with hay rack on the rear wall, looking south-east Fig 19

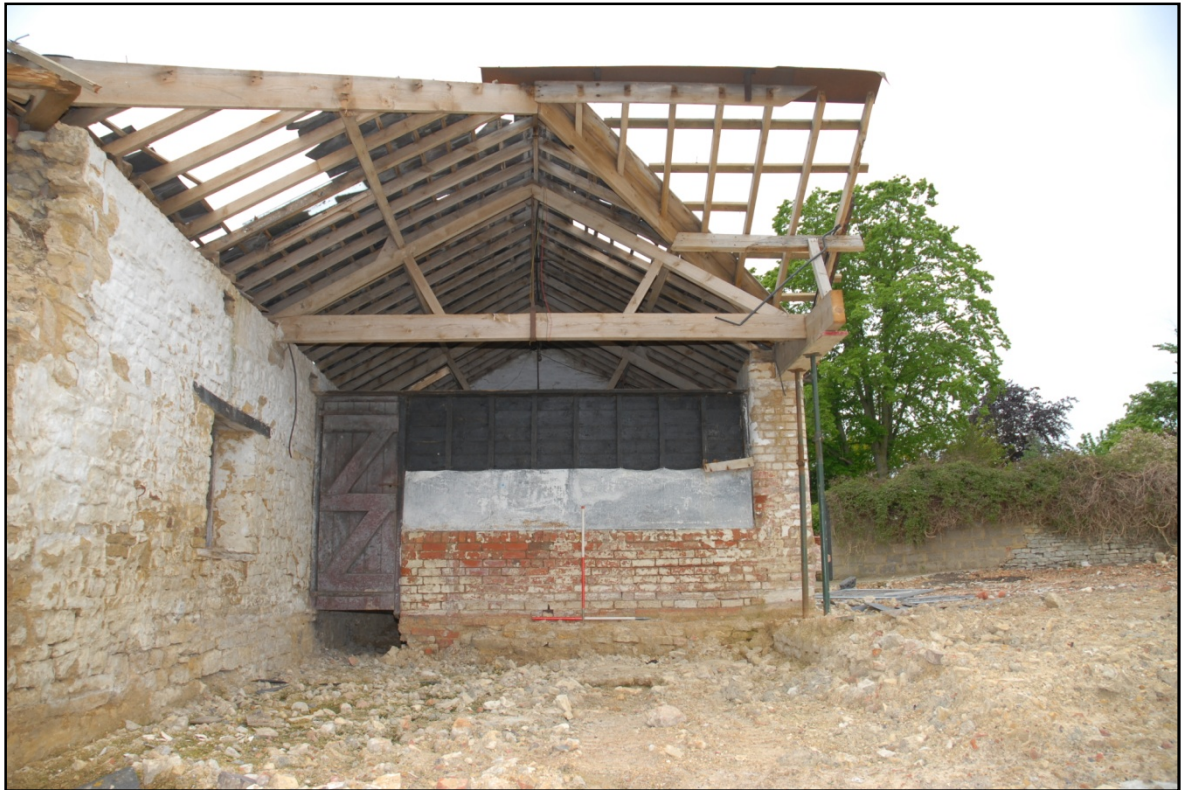
Room G6 showing the inserted half wall and timber partition, looking south-west Fig 20

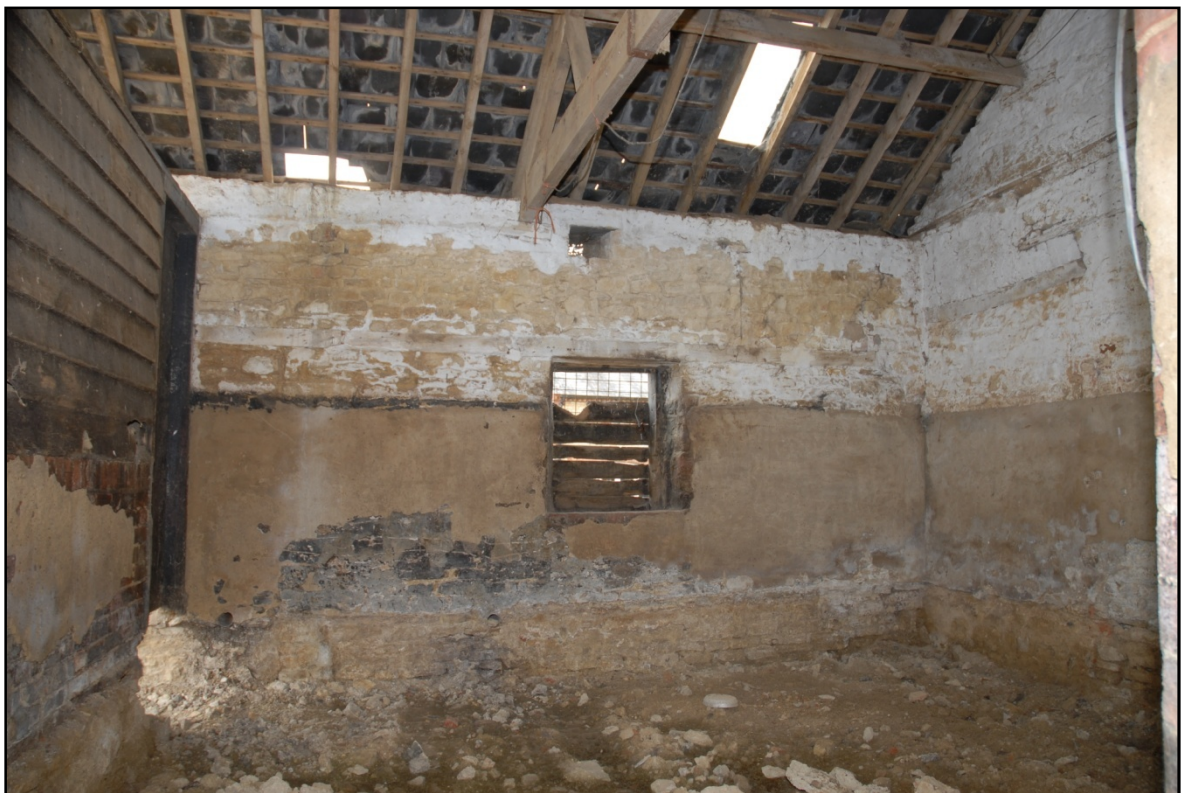
Room G7 with the inserted partition to the left, looking south-east Fig 21

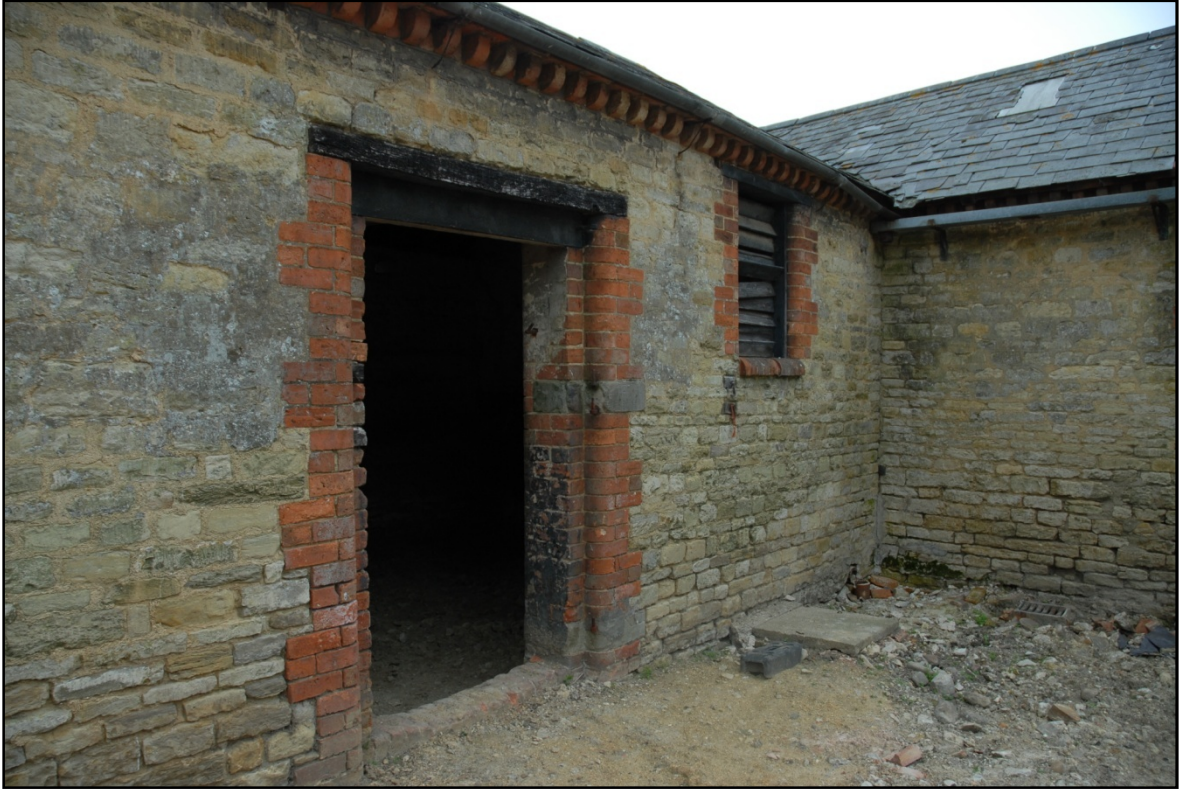
Louvres with black painted wooden slats are set within reveals of bullnose bricks and framed with timber lintels and internal timber sill plates (Figs 22 & 24). Externally, there are bullnose brick window sills. Several of the timbers in the buildings show signs of re-use.

Detail showing the construction of the doors and windows, also showing the inverted bullnose dentils Fig 22

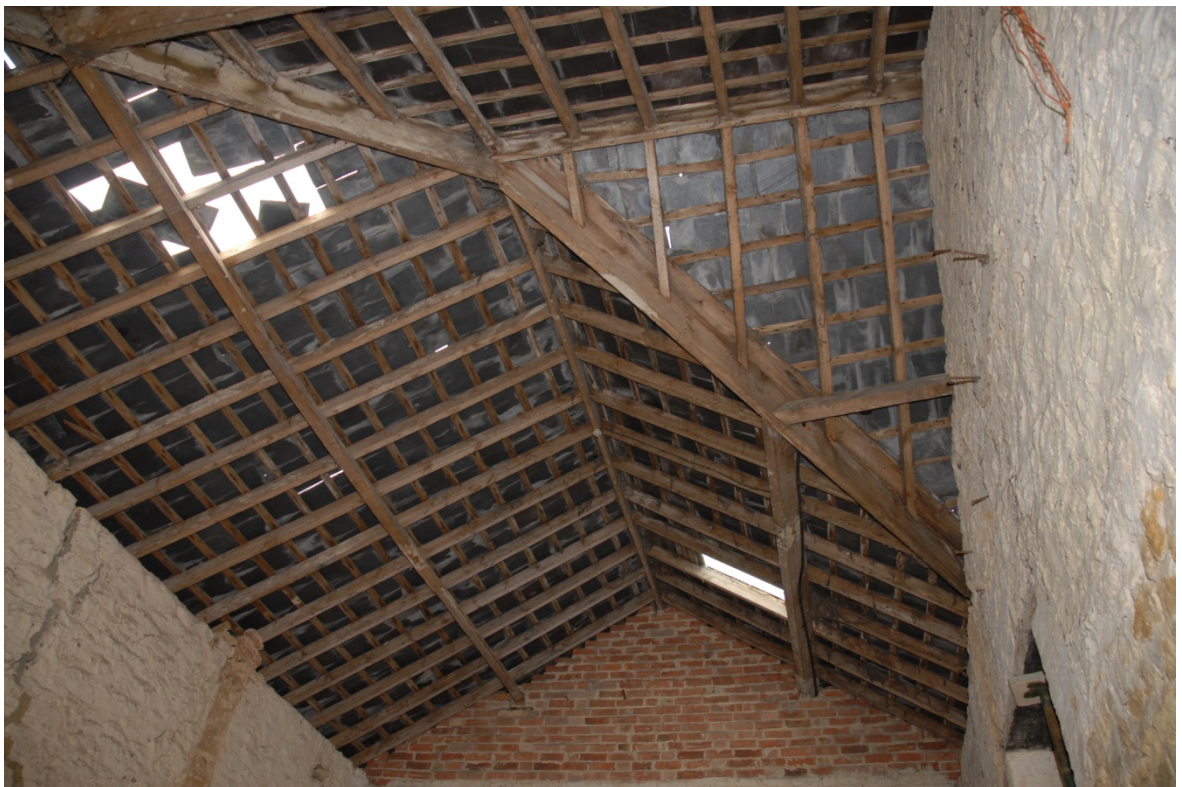
The roof structure above room G2 Fig 23

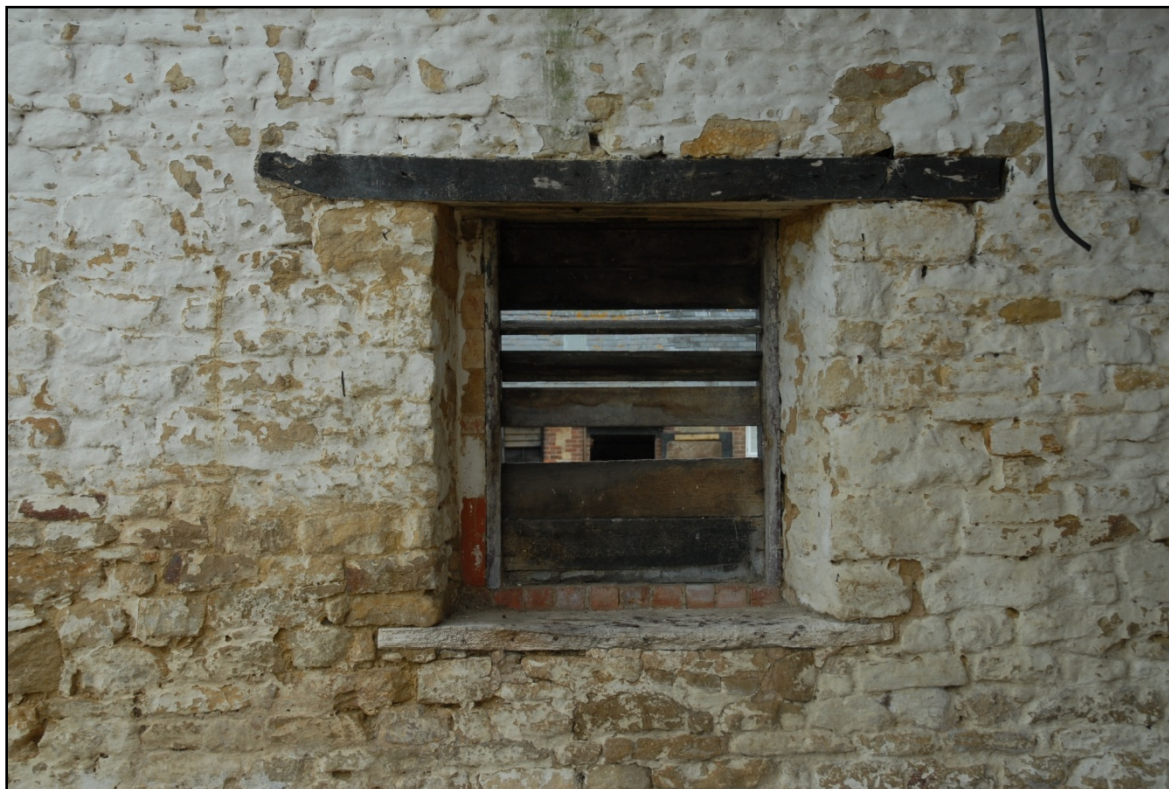
Detail of the interior of the window in room G6 Fig 24

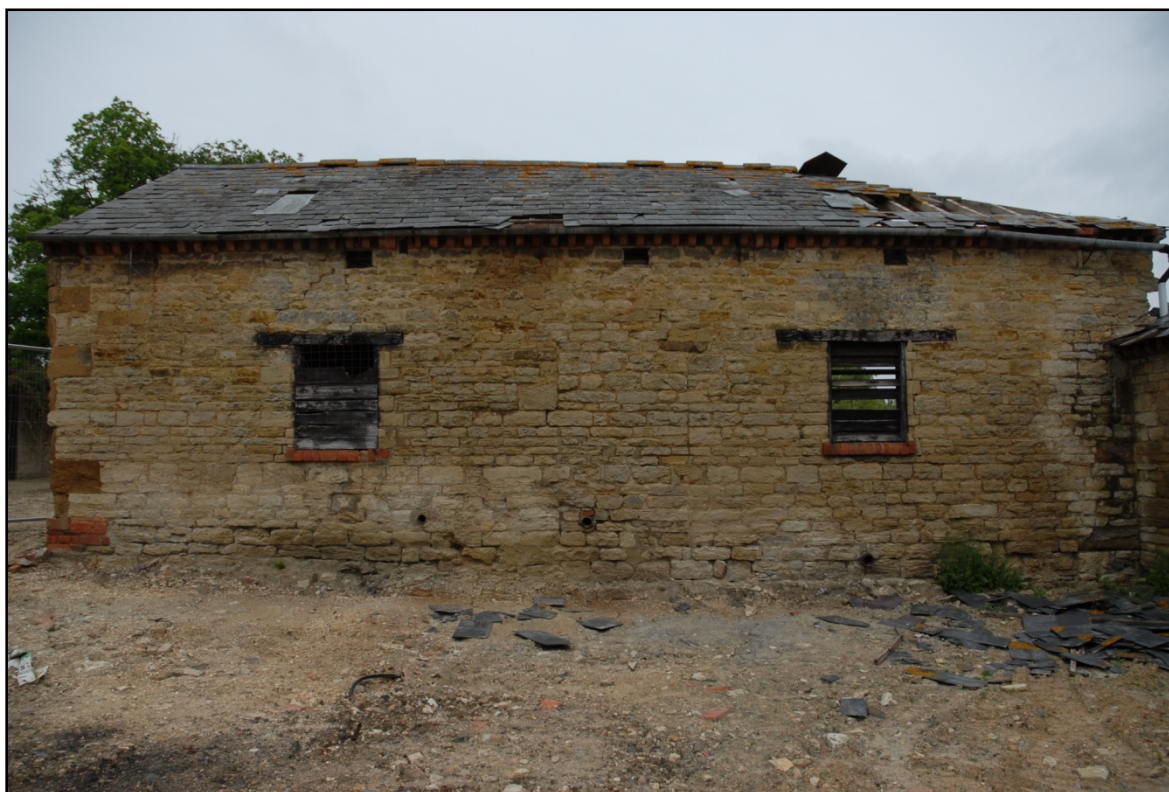
The blocked door on the southern elevation of building B3, looking north-west Fig 25
